An Historic Building Survey (Level 2) at
The Empire Hotel, 217-219 Fosse Road
North, Leicester.

ULAS Report No. 2014-231
©2014

For: Lidl

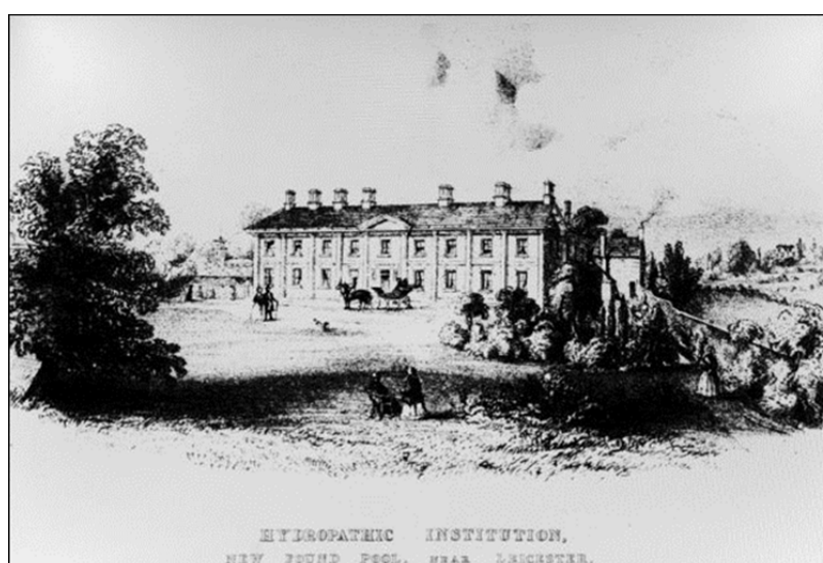
Figure 3. An engraving of the 'Hydropathic Institution' or Newfoundpool House, showing the east elevation (J.D Bennett 1993)

In 1830 the area of Newfoundpool was owned by Isaac Harrison, one of a number of local market gardeners who owned pockets of land on the outskirts of the city. Harrison also attempted to exploit a natural spring on the site, which was said to have medicinal properties and this is presumably how the name originated. He built a large house, known as Newfoundpool House, to create a 'hydropathic institution' or a small health spa establishment (Fig 3).

The grounds to the west of the house had a number of smaller houses for the resident doctor and his attendants. The engraving shows additional buildings to the north. These may relate to the bath houses or simply have had a domestic function. This enterprise obviously had limited success as by 1835 Harrison was searching for coal deposits and had converted the house to a private residence, although according to advertisements the baths did remain open in to the 1850's. The building remained within the family until a descendant of Isaac, Beatrice, sold the house and land to a local builder and property developer Orson Wright, in 1885.

There are some modifications which break the original symmetry of the building as depicted in the engraving shown in Figure 3. Two ground floor windows have been modified into bay windows and are clearly later additions as the southern bay is showing signs of settlement and the lintels have been foreshortened to abut the pilasters. The southernmost ground floor window has been obscured by the later extension which joins the stable block to the main building. At the northern end a stepped access has been created to an inserted door. At first floor level, the third bay from the north end has a double width window which was in place by 1955. The first floor windows are now all double glazed modern uPVC sash style replacements, presumably attempting to match the windows they replaced. Red brick chimney stacks are set along the ridgeline and number the same as seen in the engraving, although the northernmost double stack has been partially lost.

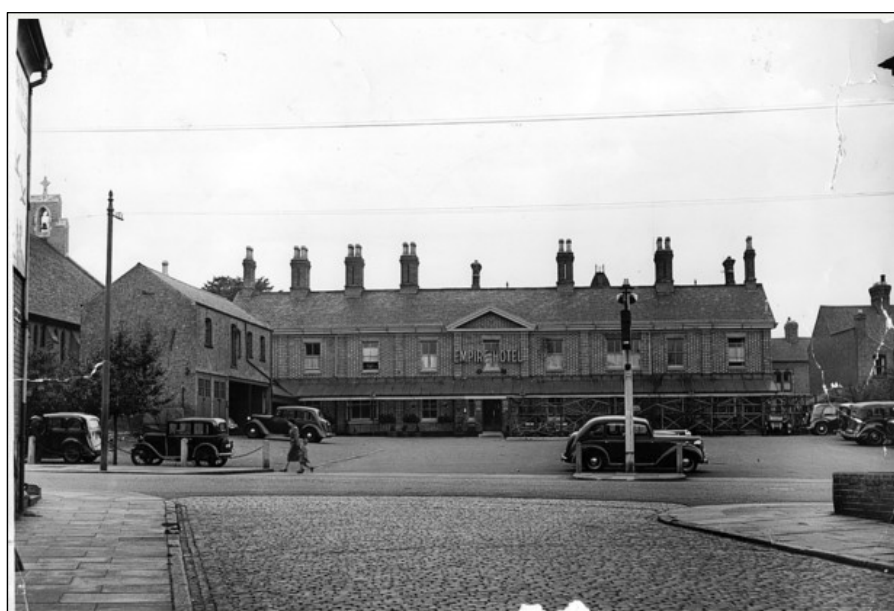
**Figure 4. The Empire hotel from Fosse Road North, looking west, in 1955
(Leicester Mercury 1995)**

Figure 4 shows the Empire as it existed in 1955. This photograph shows the eastern elevation and adjacent stable block to the south, here being used as a garage.

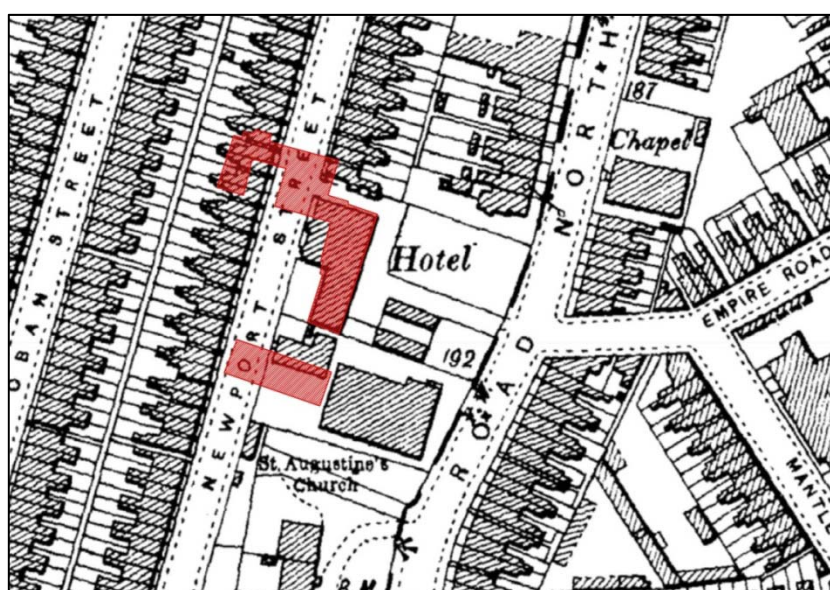
Figure 8. Newfoundpool House buildings superimposed on 1904 OS map

Subsequent editions of the OS maps are unchanged up to the 1955 edition when one of the stable buildings to the south-east of the hotel has been removed and the one closest to the site boundary has been extended to join the hotel. A single outbuilding has also been built in the south-west corner between the two parts of the Empire. Since the 1955 edition more small service blocks and outbuildings have been clustered into this corner.

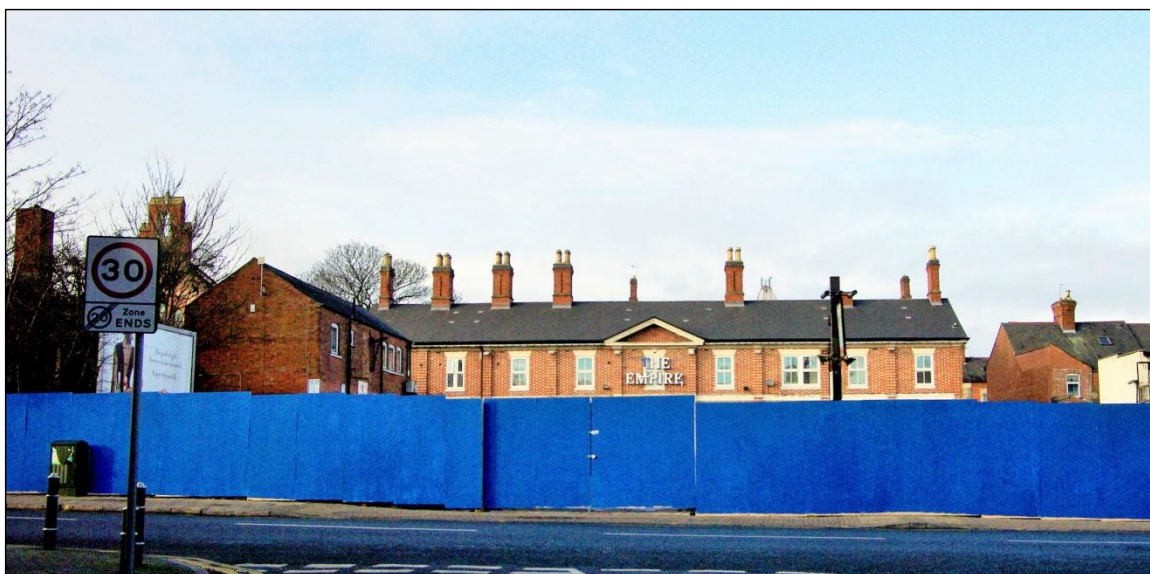
Figure 9. The site of the Empire, from Fosse Road North, looking west.

The site is currently unoccupied and has not been in use as a public house for approximately six years. The building was partially redeveloped, but work was halted and the ground floor is now boarded and secured. A perimeter hoarding has also been erected to secure the site (Fig. 9).

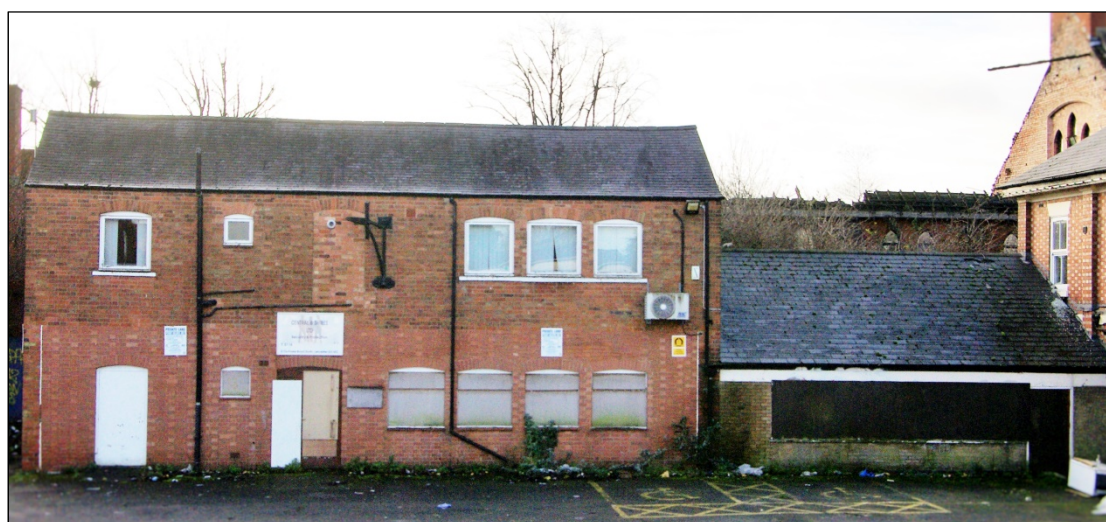
Figure 10. The buildings to the south, adjoining the east range. Looking south.

The main building consists of two distinct ranges, one east facing and one west facing and these reflect the history and development of the building. The eastern range, the surviving wing of the original 1830's Newfoundpool House, now faces on to a large car parking area accessed from Fosse Road North (Fig. 9). To the south of the car park, a two storey stable block is joined to the eastern range by a single storey extension (Fig. 10). The west facing range, built in 1888, is aligned with Newport Street and an ornate tower and portico overlooks the contemporary housing of the Orson Wright development (Fig.11).

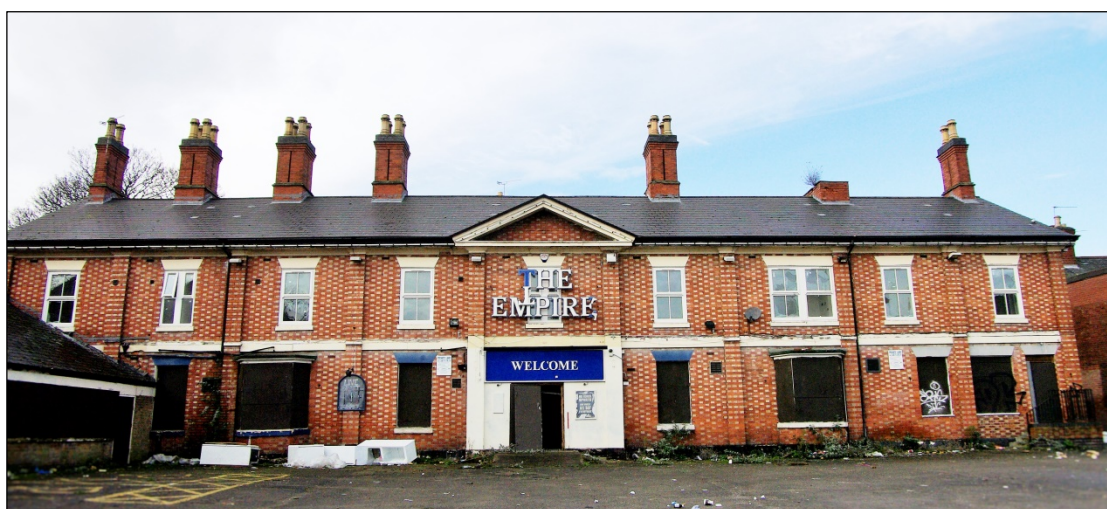
Figure 14. East facing elevation, looking west, with 1m scale

The east range is a two storey brick-built structure with a slate roof. The walls are constructed using a Flemish bond of alternating buff coloured headers and red stretchers, creating an elongated chequerboard pattern (Fig. 14). There are four bays either side of a large central pediment. The pediment extends above the eaves over the main entrance doorway and now displays a modern name sign. Each bay is separated by brick pilasters with a rat trap chequerboard pattern of brickwork. A projecting painted stone band divides the ground floor from the first floor and runs across the top of the stone lintel of each ground floor window. Above this is a wooden rail which may have supported the canopy seen in the photograph of 1955 (Fig. 4). A painted stone plinth supports the brickwork at ground level.

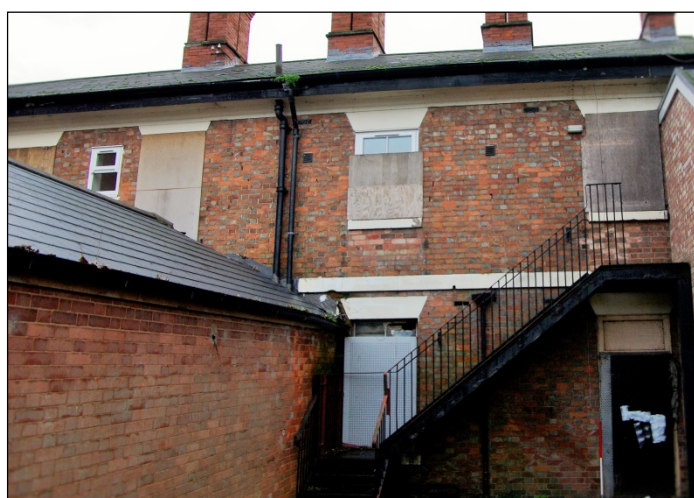
Figure 15. The eastern range seen from Newport Street, looking east, 1m scale.

This east facing elevation was clearly intended as the principal elevation and this becomes more evident when comparing the east and west elevations. Although most is obscured by later outbuildings, a small portion of the west facing elevation of the can be seen from Newport Street. Whilst some attempt has been made to produce the chequerboard pattern, the pale headers are less pronounced and the overall effect is less imposing.

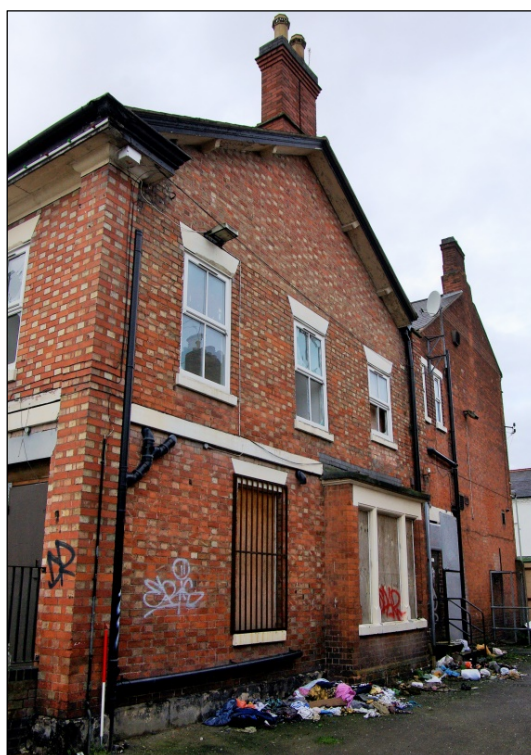
Figure 16. North facing elevation of east range, looking south west, with 1m scale

The north facing gable of the east range, matches the main east facing elevation in terms of style, although again there have been modifications. The ground floor window to the west has been enlarged and made into a rectangular bay (Fig. 16). As a consequence some of the stone banding has been lost and the first floor window sill has been raised. This is, however, the area in which the engraving shows additional buildings and these alterations may be masking earlier building lines. The north facing gable also displays the point at which east and west ranges are joined, notably by a raised brick pilaster. The acute angle at which the two ranges have been joined is unusual and the buildings do not sit comfortably together. It appears that the west range was re-aligned to fit with the new street plan. This odd juxtaposition is more apparent inside the building. The south gable of the east range is almost totally obscured, but it can be assumed that the ground floor window no longer exists, as this is not visible internally.

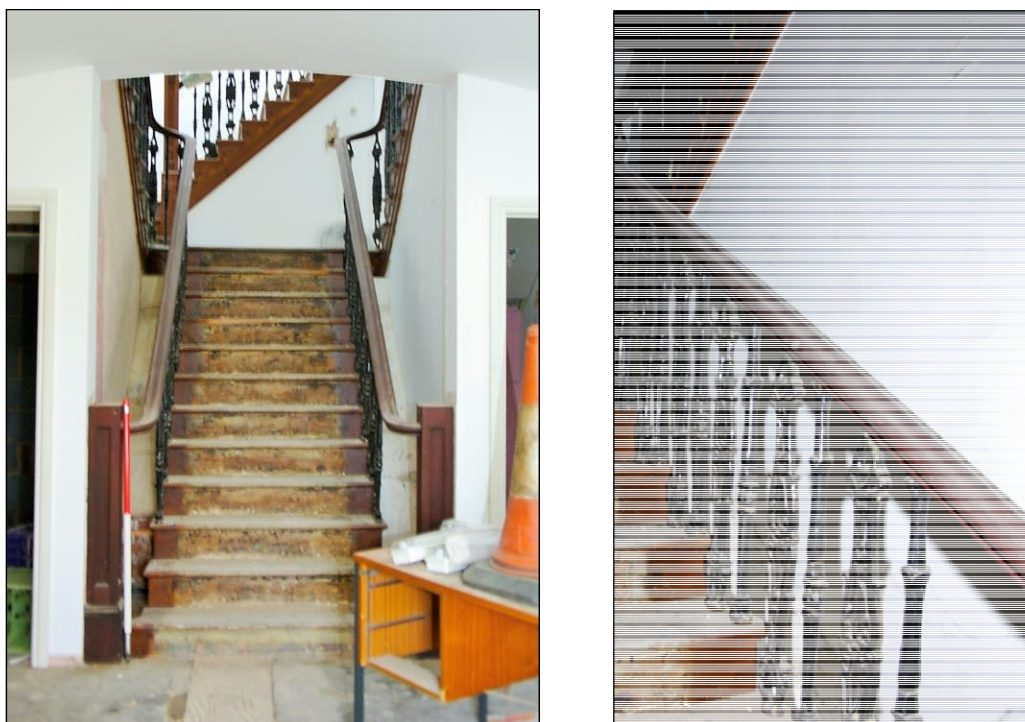
Figure 17. The hallway as seen from the east range main door looking west (left) and the balusters looking north-west (right)

The ground floor of the east range forms three large bar and social areas accessed by a central foyer or hallway. From this hallway the main stairs lead to the first floor. The stairs lead into both the eastern and western ranges and as a result are probably from the late 19th century when the house was partially demolished and converted into a hotel. The stairs have decorative iron balusters typical of this time (Fig. 17).

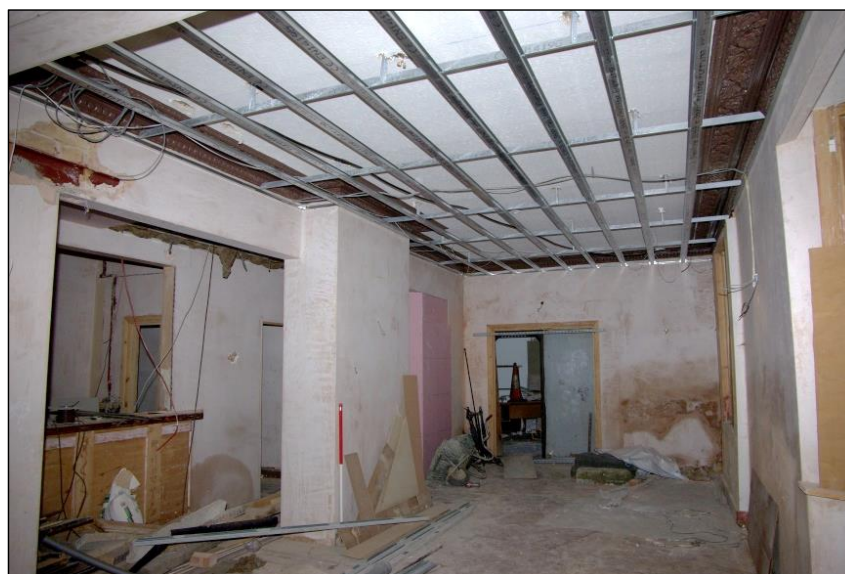
Figure 18. The southern lounge looking north with 1m scale

Most of the ground floor rooms have been quite heavily modernised. The southern room is now an open plan bar area with evidence of one blocked chimney breast (Fig. 18). There are no longer windows in the southern end and a fire exit door has been inserted (Fig. 19). The line of the cornicing suggests these were at one time separate rooms, possibly with a west corridor.

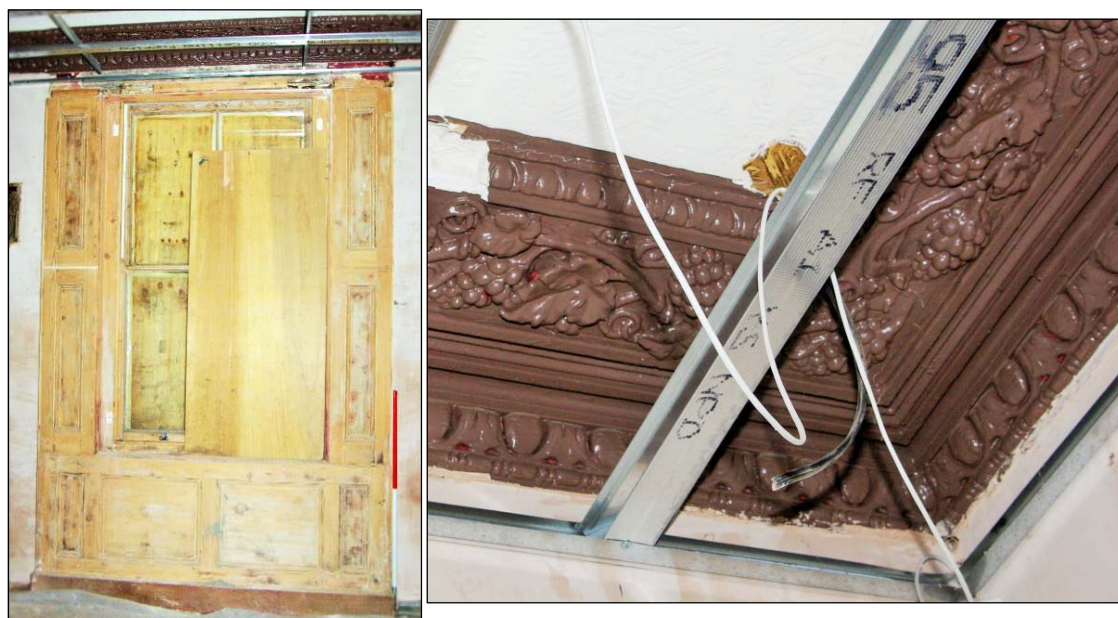
Figure 20. Surviving early details in the southern lounge, the panelling, looking east, with 1m scale (left) and cornicing (right)

There are some earlier fixtures and fittings surviving including wooden panelling to the sash windows and cornicing decorated with a grapevine design (Fig. 20).

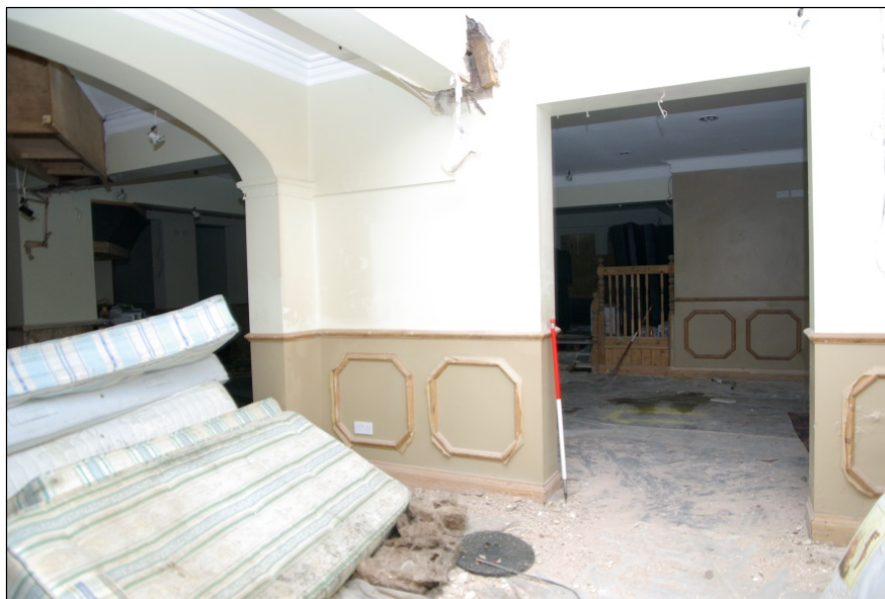
Figure 21. Reception room and open corridor now leading to northern lounge – looking north with 1m scale.

The rooms to the north of the foyer have also been heavily modernised and again create an open plan bar area. A small area, possibly originally a reception room, divides the hallway from the lounge. This now opens into the two main east range rooms. (Fig. 21) The dividing wall between these two main rooms has been removed

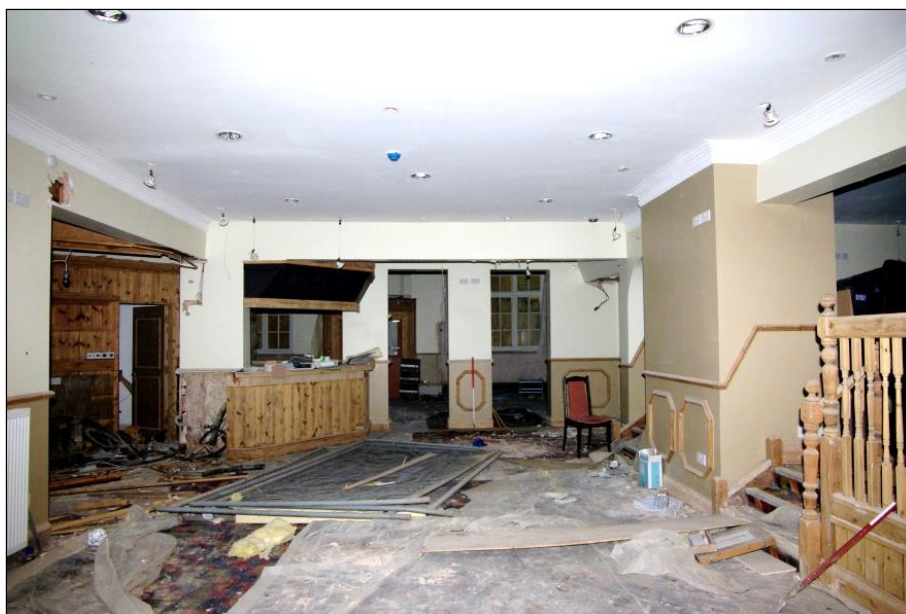
Figure 22. Northern lounge looking west towards west range with 1m scale

leaving only the blocked up chimney breast in position (Fig. 22). Open doorways on the west wall of this room lead westwards into the west range.

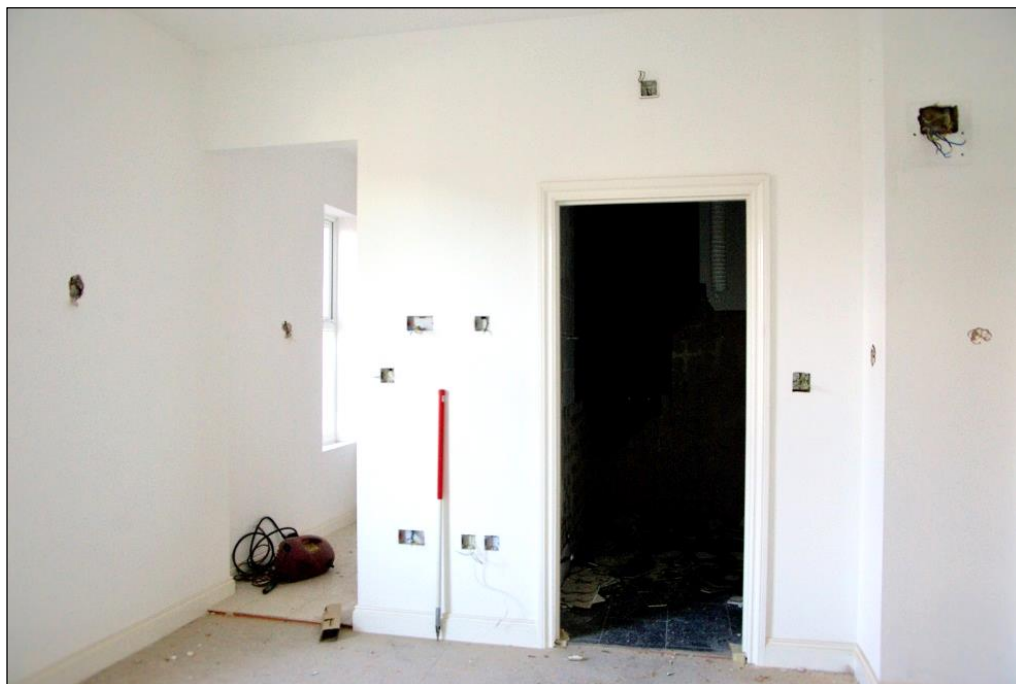
Figure 23. A modernised first floor bedroom with ensuite, looking southeast with 1m scale

On the first floor, access to all of the rooms is from a central corridor running the length of the building. The corridor and rooms have all been extensively modernised in accordance with the earlier development proposals which were halted midway through the work. Most of the walls and ceilings have been covered with modern plasterboard leaving few earlier features visible. The rooms are now all similar in appearance and layout, with individual ensuite bathrooms created using inserted stud walling (Fig. 23). All windows are replacement uPVC. One small window has been inserted on the west side.

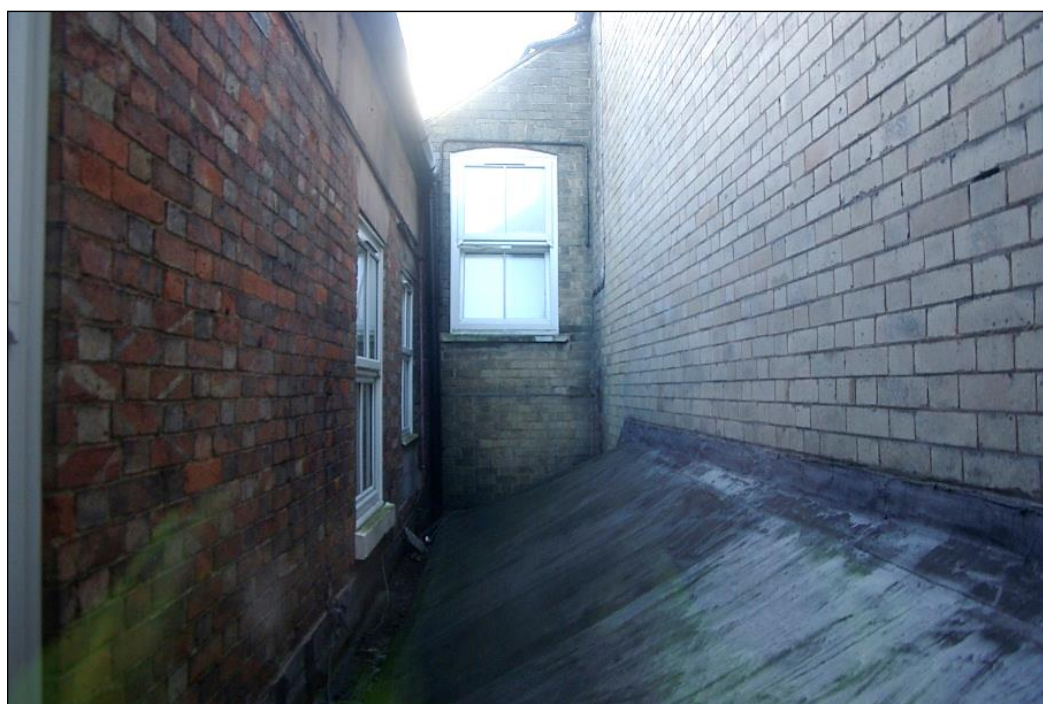
Figure 24. The point at which the two buildings are joined, looking south.

The space between the east and west ranges and the manner in which they have been joined can be viewed at first floor height (Fig. 24). This gap is not visible on the north gable as the west range has been structured to compensate. There is also a difference in floor height between the two ranges and stairs have been inserted in two places to accommodate this.

The way in which the two buildings were joined was unusual. Possibly, some residual feature of the old Newfoundpool House, a corridor for example, may have been utilised. The 1888 map shows a staggered wall line on the west side. Recent work internally has revealed this point where the two wings join (Fig. 35). There are two possible interpretations, firstly that there was a deliberate attempt to re-align the west frontage, or secondly, that there was a desire to incorporate some of the rear

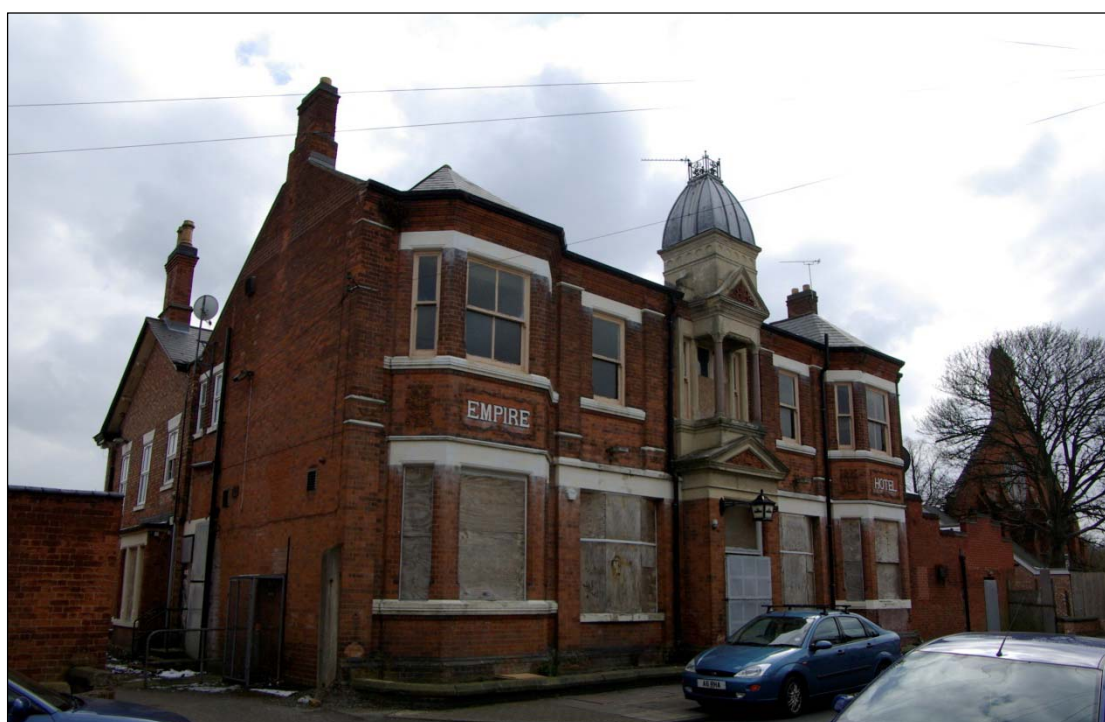
Figure 25. West facing elevation, photograph taken before erection of hoarding, looking southeast (ULAS report no. 2013-054)

The west range is attached to the north-western half of the east range. As previously mentioned the west range is not quite parallel to the east range and appears slightly narrower towards the southern end. It is very different in architectural style from the east range and the main west facing elevation has many of the late 19th century decorative embellishments seen on public buildings of this time.

On the west facing elevation there are two large projecting bays at each end. Between the ground and first floor windows on each bay are panels with the words EMPIRE and HOTEL displayed in raised brickwork (Fig. 25). The wooden sash windows have stone sills and lintels. Above the lintels, on raised pilasters, are a series of repeated motifs in terracotta relief. Two flat bays sit either side of a projecting porch. The porch has a pediment at ground floor level over which is an open balcony with polished marble pillars; this balcony supports a smaller pediment. The ground floor pediment contains a terracotta relief design of a crown, whilst the first floor pediment has an intertwining 1888 motif. Above both is a small stone tower with a four sided leaded dome. Moulded stone detailing on the tower mirrors the cup and dart mouldings seen in the brickwork on the rest of this elevation (Fig. 26). The roof is slate and there are two gable end chimneys.

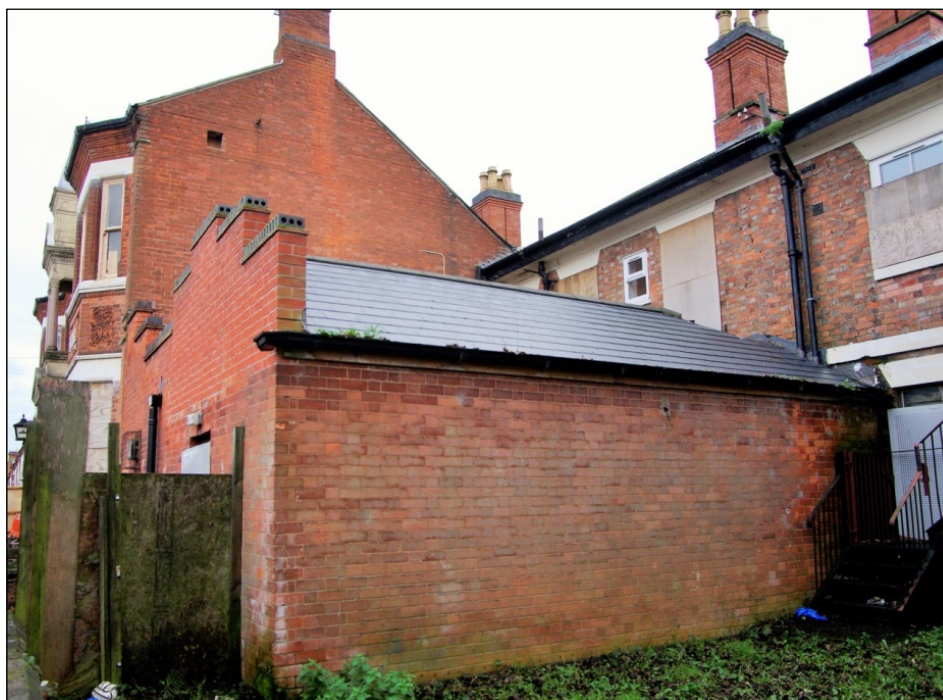
Figure 27. South facing elevation of the west range, looking north east

The remainder of the west elevation is a series of boundary walls and outbuildings. A wall has been added to join the end of the west range to an outbuilding and create a roofed courtyard (Fig. 27). The kitchen window which at one time marked the southern end of the west range is, thus, now enclosed. A modern fire exit corridor has also been added on this western side.

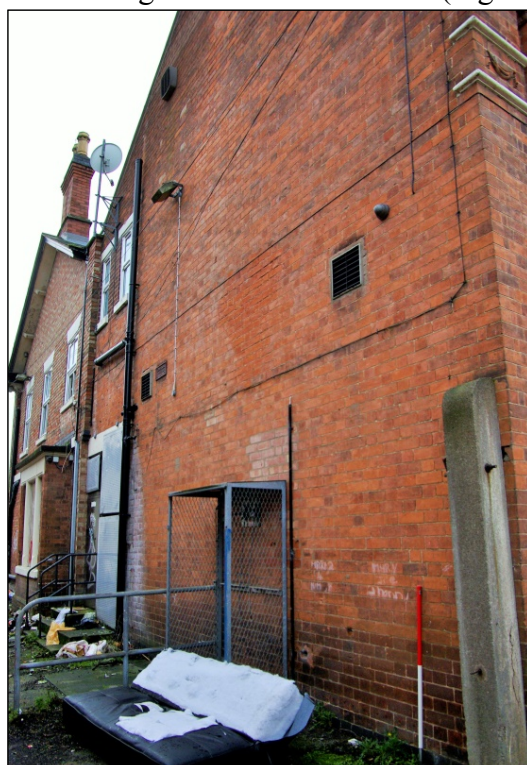
Figure 28. North facing elevation of west range looking south east with 1m scale.

The west range gable end is built of plain red brick. The north gable has two entrances; to the left, a back stairs leading to the first floor and to the right, a fire-exit from the ground floor. Two small windows have been inserted above the doors at first floor level. There appear to have been alterations to the brickwork at ground level which may relate to changes in basement access (Fig. 28).

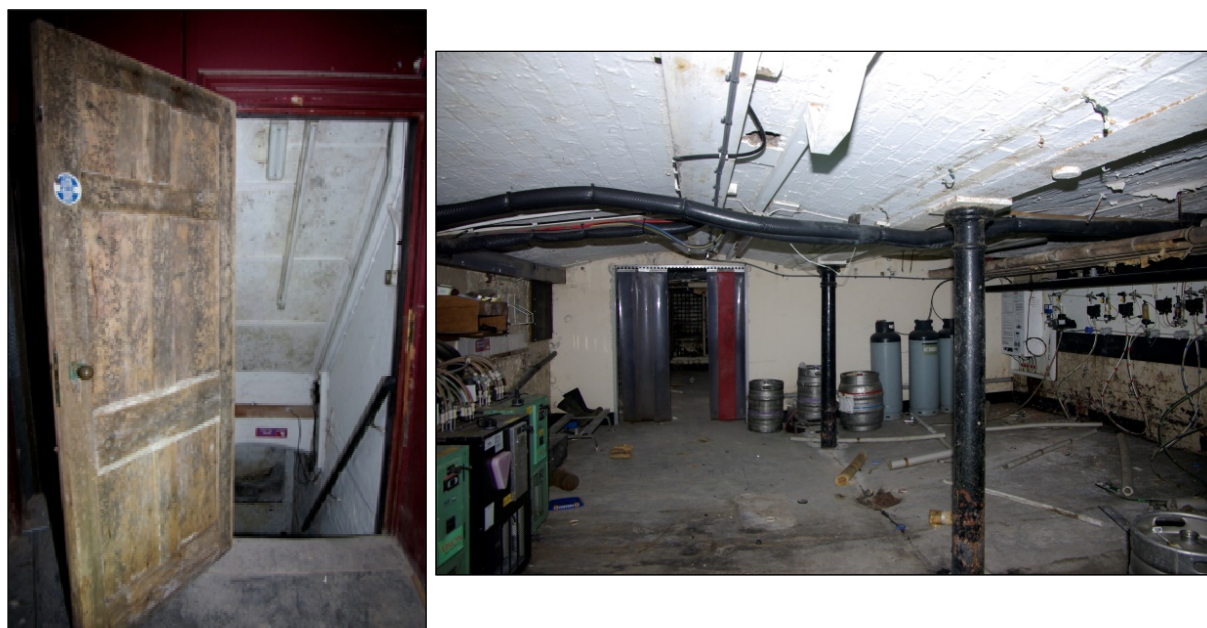
Figure 29. The basement stairs, looking north and the vaulted cellar, looking south

The west range has a basement, not visible from ground level, which runs the length of the whole range. A window on the north gable wall has been blocked as have access points on the north and west walls. Presently, the only access is from a steep staircase descending from a narrow passageway which exits in the north gable. The basement itself contains a lift, a boiler room and two vaulted storage rooms, supported by iron columns (Fig. 29).

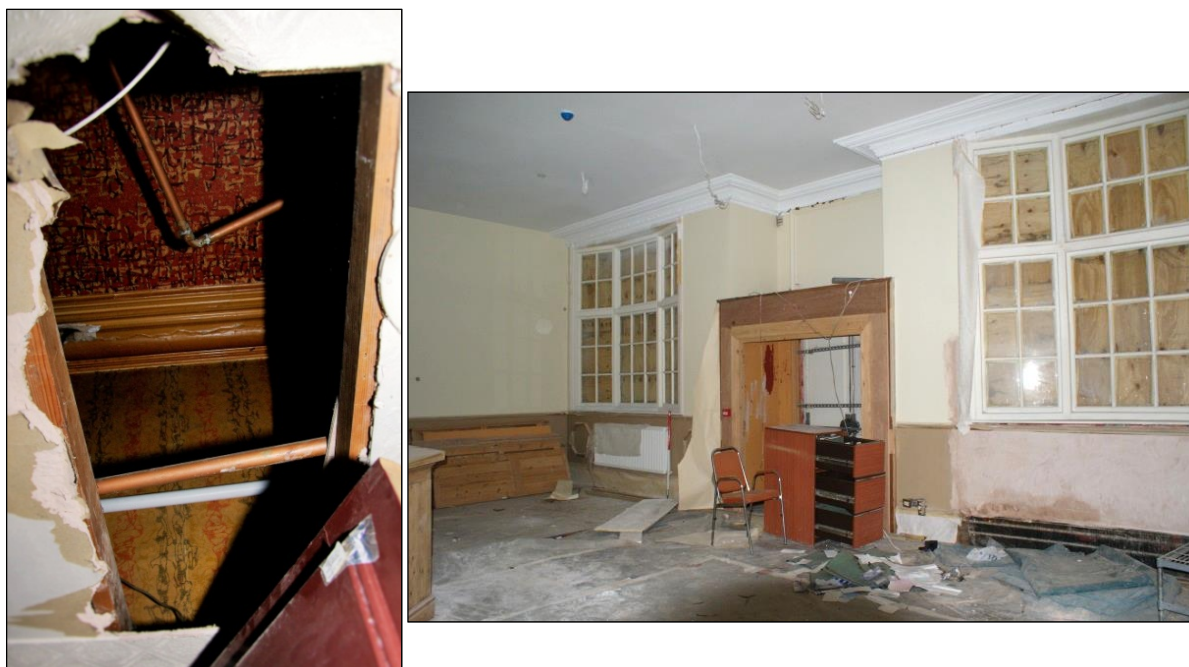
Figure 30 . Ceiling detail in small north room, looking east (left) and central ground floor room of west range, looking southwest (right)

At ground floor level the west range forms three small bay fronted rooms. The northernmost room is accessed from the narrow passageway and has been used as a storage room. The bay has been purposely blocked and the ceiling height lowered. Preserved behind this ceiling is some early 20th century décor and cornicing (Fig. 30). The central ground floor room, which has probably always been a bar area, has access on to Newport Street. This main door is flanked by two shallow bays. The room also retains moulded cornice details on three sides, but not to the south where a wall has been inserted to create a third small room (Fig. 30).

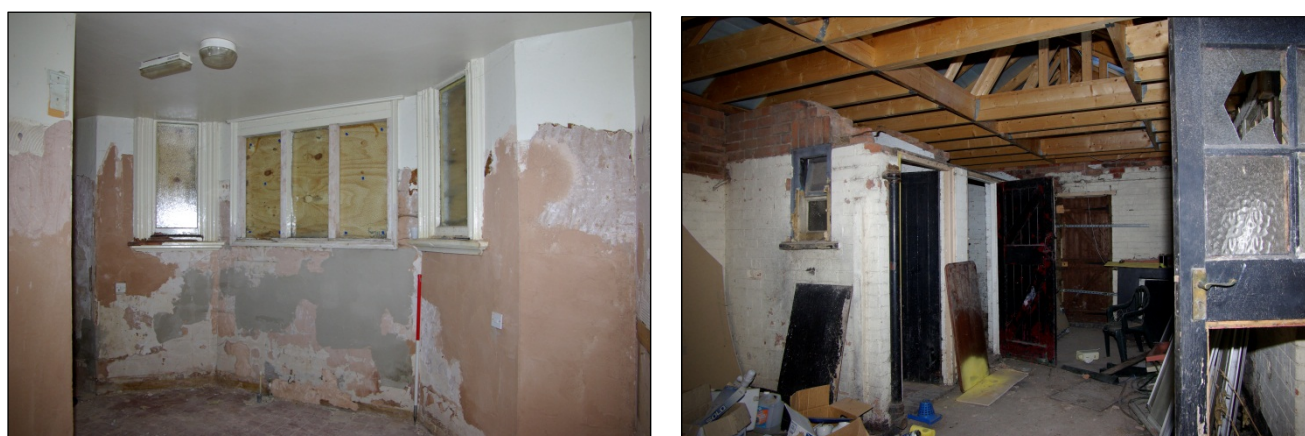
Figure 31. Small southern room of west range, looking southwest (left) and enclosed courtyard looking west (right)

The small southern room contains one of the deeper bay windows. The ceiling has been lowered to conceal the top of the bay and the south wall contains a small blocked fireplace; the floor is quarry tiled (Fig. 31). Modernisation of this room has begun and stud walls erected to create a corridor leading to a small kitchen alongside an enclosed courtyard with outbuildings. The kitchen was a single storey addition to the original west range. There are three large windows on the southern end of the kitchen which suggest that it originally overlooked the courtyard. At a later date, an additional space was created by joining the kitchen and outbuildings (toilet and outhouse) to the east range (Fig. 31).

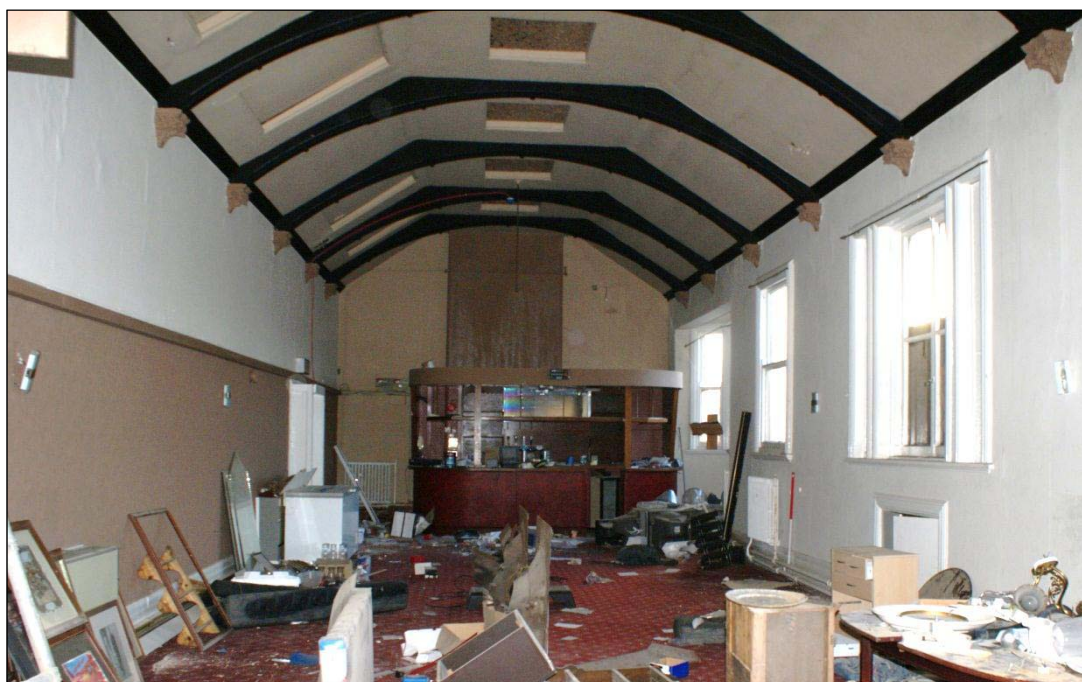
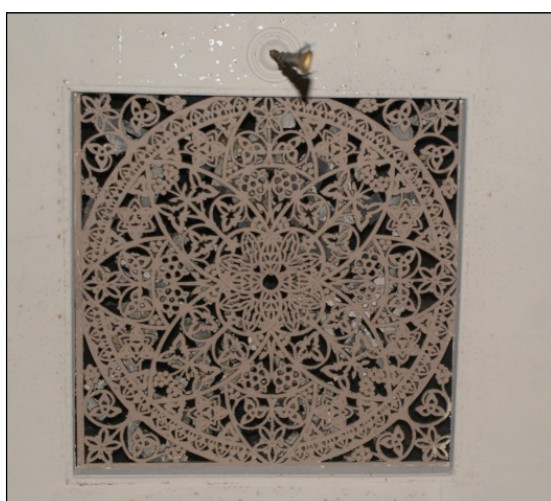
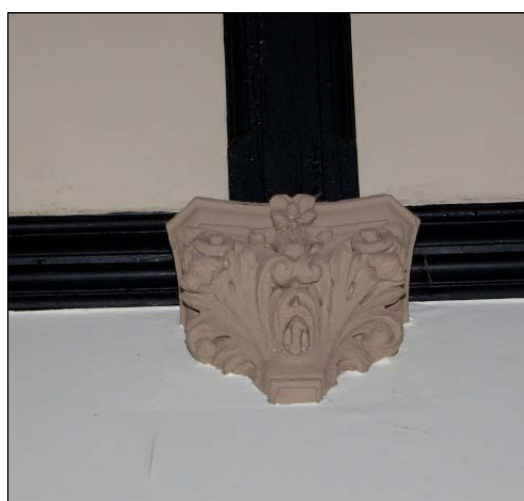
Figure 32. The first floor function room of the west range, looking south (top); the decorative grilles (left) and stone corbels (right)

The first floor can be reached via the ornate central staircase or from a much plainer set of stairs in the north-west corner of the building also with access from the north gable. This floor consists of a single large function room with a high ceiling (Fig. 32). Beams are exposed as a feature and rest on carved stone floral corbels at eaves height. Decorative iron grilles are set into the ceiling to aid ventilation of this large function room (Fig. 32). There are wooden sliding sash windows on the west side, including an unusual arrangement overlooking the portico. A lift by Evans Lifts of Leicester has been inserted into the south-west corner of the room and extends from this floor down to the basement.

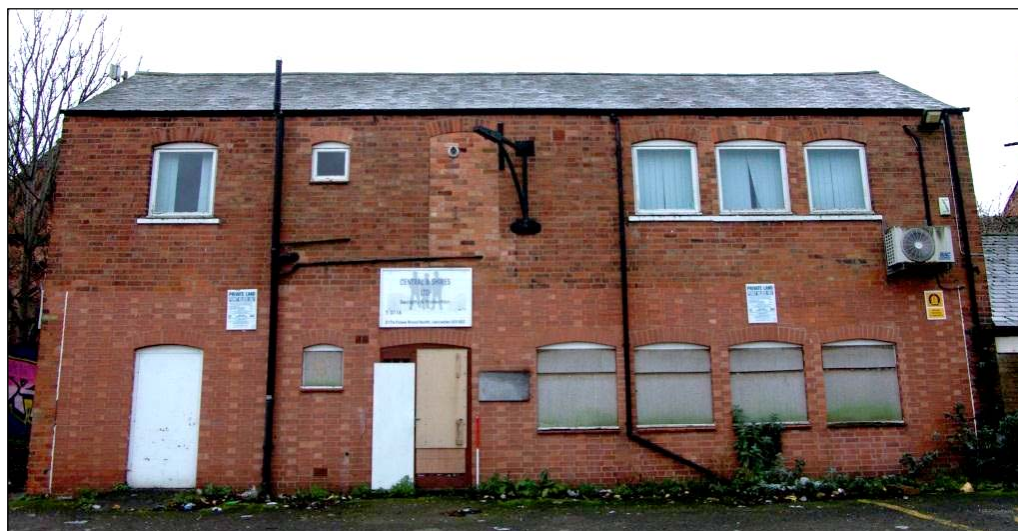
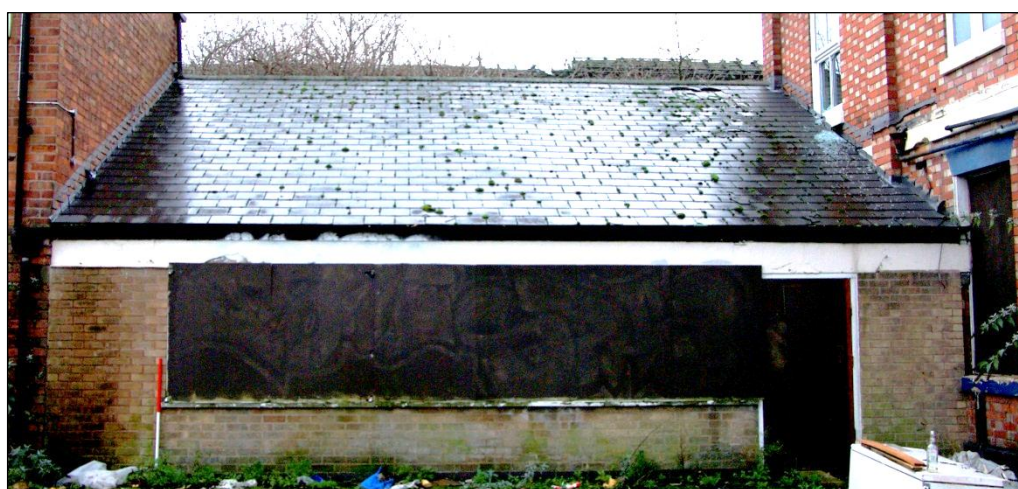
Figure 33. The stables and low extension, looking south with 1m scale

The stables, to the south-east of the east range, according to map and photographic evidence, have been modified several times during their lifetime. The brickwork is similar to that used on the west range which supports the map evidence that they were constructed at the same time. As further proof, they do not appear on the 1888 OS map either. The 1904 map also suggests there was a second block mirroring this one to the north and identifies the footprint of an outbuilding where the low extension sits today. A blocked first floor doorway with a metal hoist is further evidence that the two storey building was once a stable or carriage block. By 1955, according to photographic evidence, the second block had been removed and garages inserted at ground floor level. More recently this garage space has been infilled with brick and the two buildings together converted to two office spaces with separate access (Fig. 33). The low extension does appear on the 1955 Ordnance Survey map, but the brickwork appears more recent. The building is not tied-in to those either side.

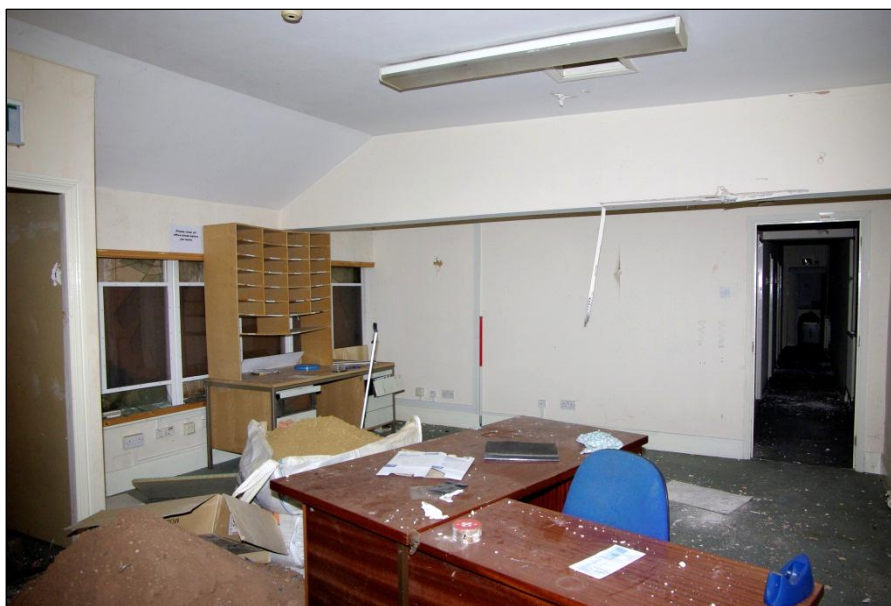
Figure 34. Office space in the low extension, looking north east, with 1m scale

The stable and low extension cannot be accessed from the main east range. The space is has been modified to create two separate modern offices accessed from the northern frontage. The first office occupies the ground floor with access through the door of the single storey building. A corridor leads from the main room to a series of individual offices (Fig. 34). The second office has an entrance at the eastern end and utilises the eastern ground floor room as well as the second floor. The small ground floor room has an internal window and the appearance of an earlier tack room. There are no other early features visible and all roof beams are enclosed.

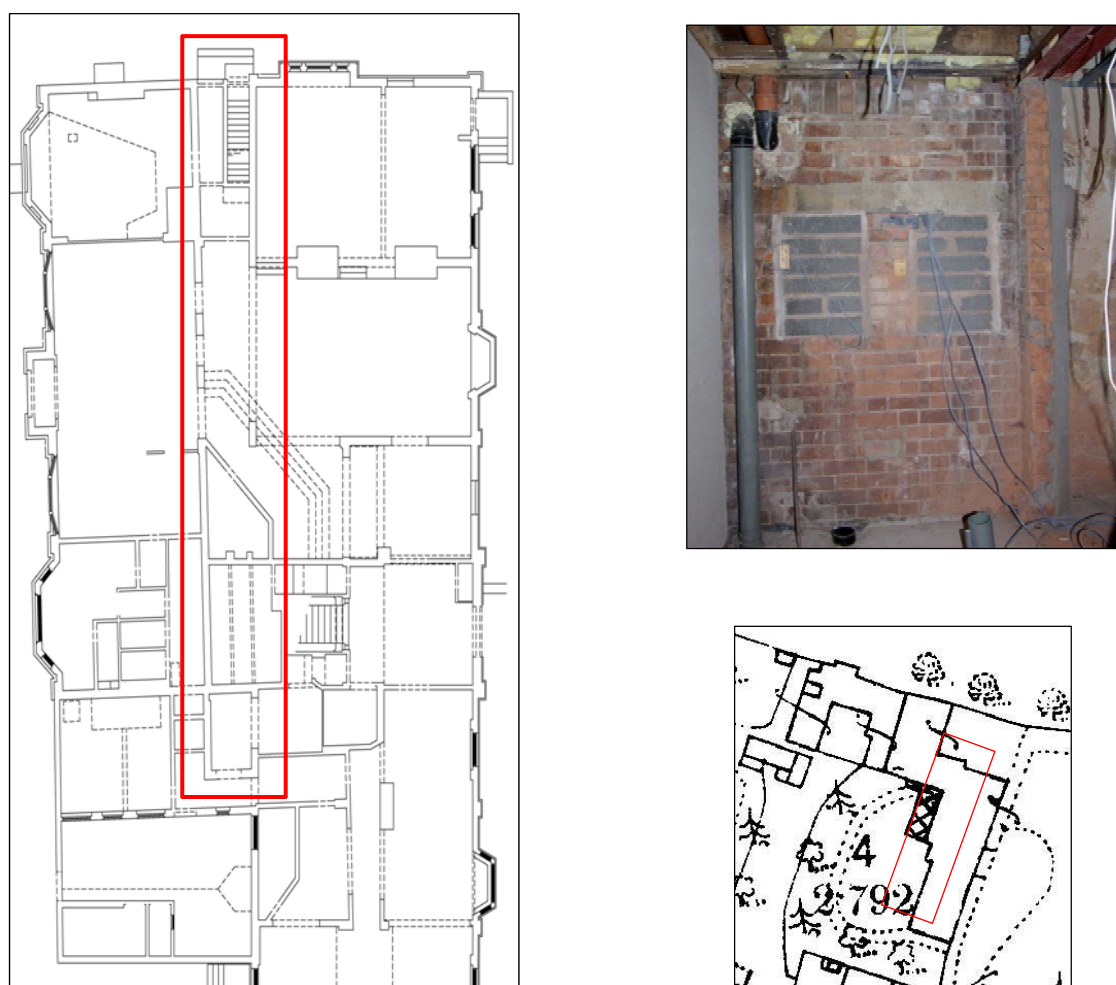
Figure 35. The area of the original Newfoundpool House utilised in the addition of the west range.

elements of Newfoundpool House. This central core of the house has certainly seen many changes in access and flow.
