**An Archaeological Field Evaluation on
land adjacent to Skew Bridge Ski Slope,
Northampton Road,
Rushden,
Northamptonshire.**

ULAS Report No. 2014-179
©2014

For: LXB RP (Rushden) Ltd and Campbell Reith Hill LLP

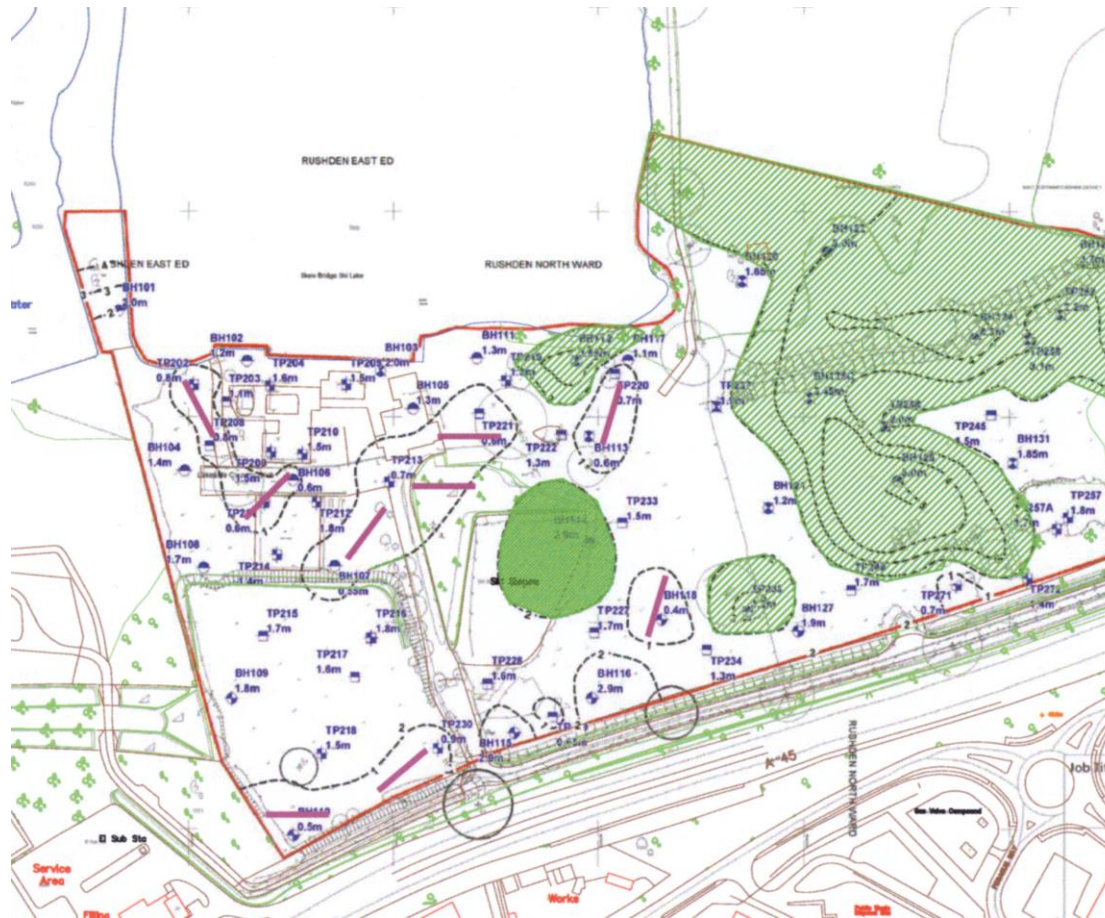
Figure 3 Development area with suggested trench locations

A c. 3% sample by trial trenching of the areas of less disturbance was proposed with an area of c. 486 sq. metres, the equivalent of nine 30m by 1.8m trenches. The provisional trench plan in Figure 3 shows the proposed location of the trenches although the size and position of the trenches indicated on the plan had to be adjusted due to the presence of existing spoil heaps and service pipes (Fig. 6).

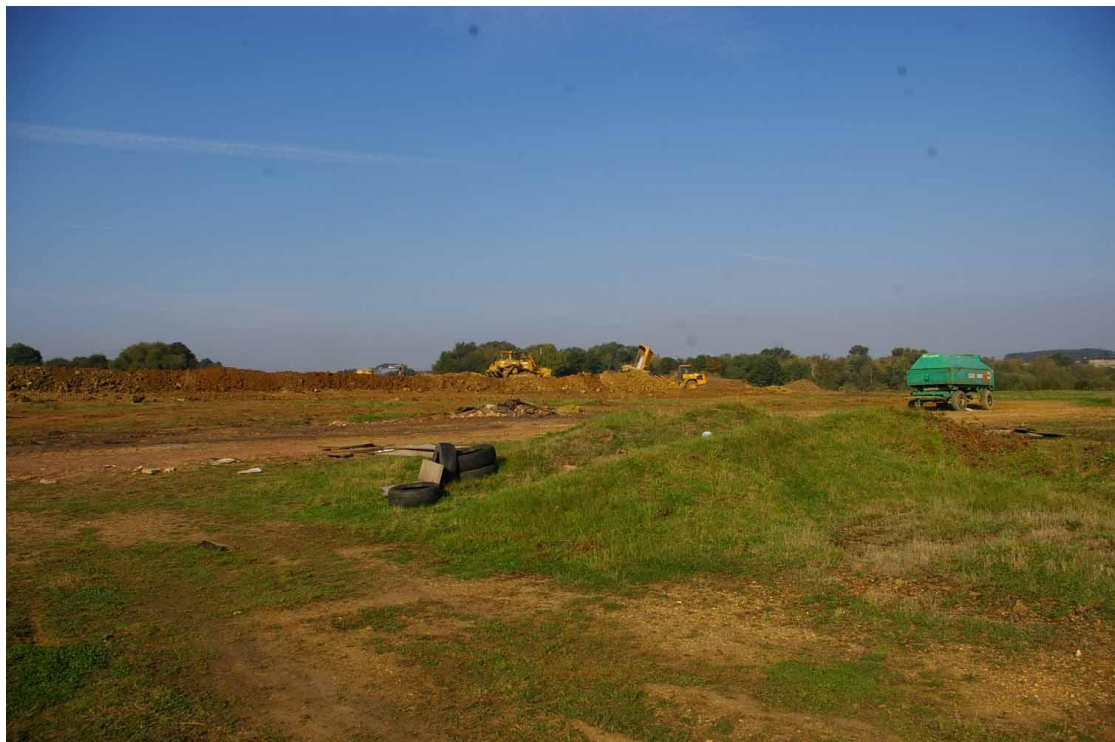
Figure 4 General view of the development area
Looking north-west

At the time of the evaluation most of the ski slope had been taken down and the spoil spread in long heaps across the western part of the development area in preparation for soil contamination testing (Figs. 4 and 5). Live services were also found to be present across parts of the development area.

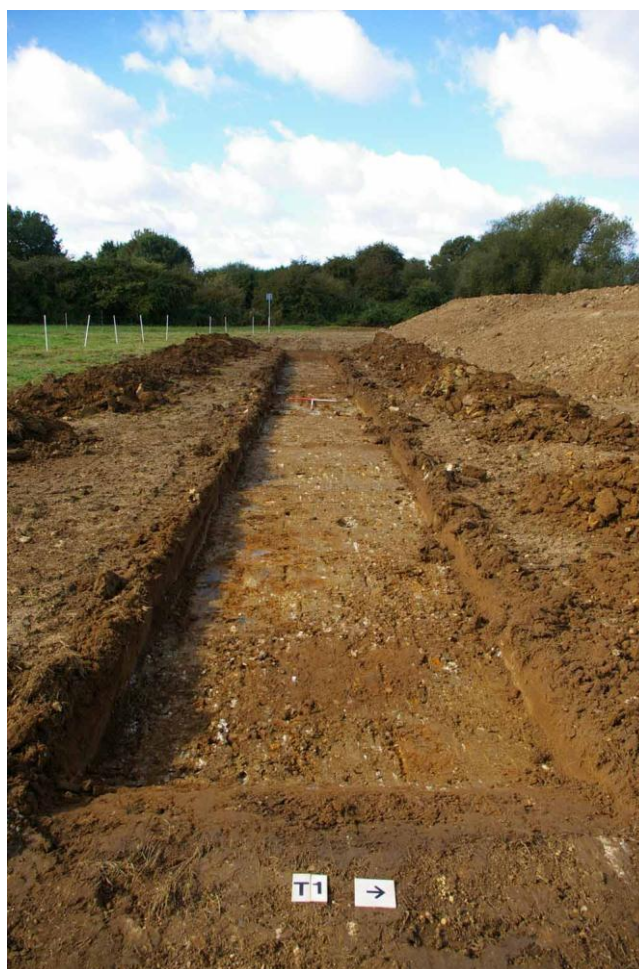
Figure 7 Trench 1
1m scales

Trench 1 was intended to be placed in the south-western corner of the development area but the presence of a gas pipe meant that it had to be relocated slightly further to the north and east. Between 0.10 and 0.15m of a mid grey-brown clayey sandy-silt topsoil was removed to reveal a mid orange brown sandy silty-clay subsoil with a depth varying between 0.05 and 0.16m. The shallow nature of the topsoil and subsoil suggested that the ground may have been truncated, possibly due to a now removed railway track which once ran across the development area at this point. Removal of the subsoil exposed the natural substratum consisting of a greyish brown sandy-clay with pockets and bands of orange brown sandy-clay (Fig. 7).

No archaeological features or deposits were observed within this trench.

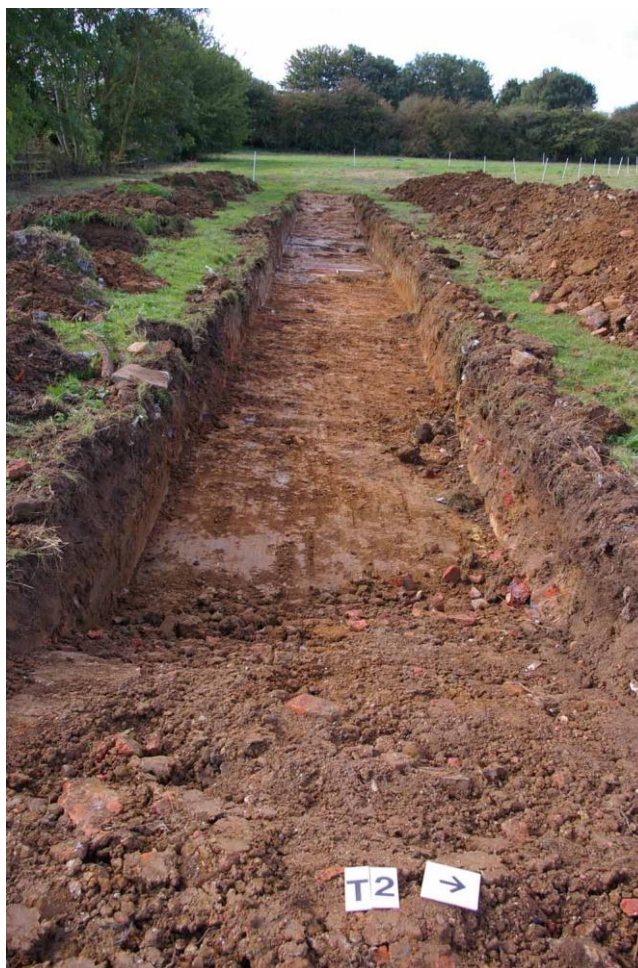
Figure 8 Trench 2
1m scales

Trench 2 was originally supposed to be near to Trench 1 in the south of the development area but again the presence of the gas pipe meant that it had to be moved slightly the north and east. Topsoil of the same consistency as in Trench 1 and with a depth between 0.10 and 0.30m was removed to reveal a disturbed subsoil consisting of a mid orange brown sandy silty-clay with a large number of bricks dispersed throughout. The subsoil had a depth varying between 0.20 and 0.50m. Removal of the subsoil exposed the natural substratum consisting of a light grey brown sandy-clay

with patches of orange brown sandy gravel and lumps of ironstone (Fig. 8). Occasional bricks had been pressed into the surface of the natural substratum suggesting that the subsoil had indeed been quite badly disturbed. A band of modern disturbance with plastic debris within the fill could be seen running across the centre of the trench. Because of the modern nature of the fill this feature was not excavated.

No archaeological features or deposits were observed within this trench.

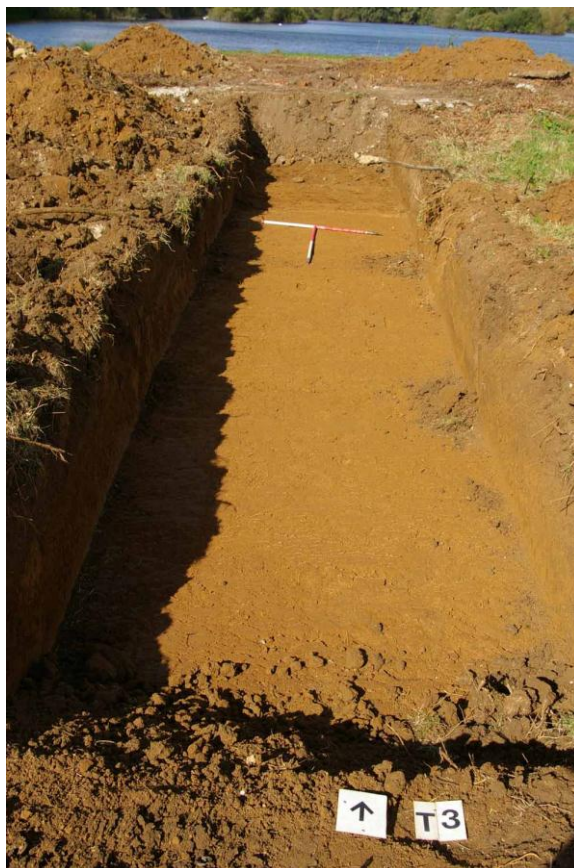
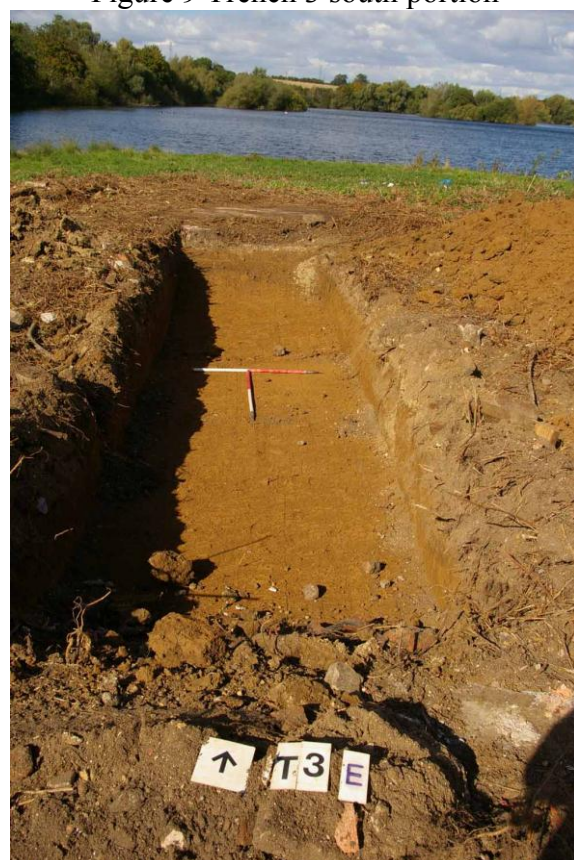
Figure 9 Trench 3 south portion

Trench 3 was located in the north-western corner of the development area. The spoil heap prevented the trench being placed in the specified position so it was relocated slightly to the east where it had to be fitted around a number of concrete bases and roadways. This necessitated a trench being excavated in two parts with a large concrete block in the middle. Between 0.20 and 0.30m of topsoil and demolition material was removed to reveal 0.30 to 0.40m of undisturbed subsoil. Below the subsoil was a clean orange brown silty-sand natural substratum (Figs. 9 and 10).

No archaeological features or deposits were observed within this trench.

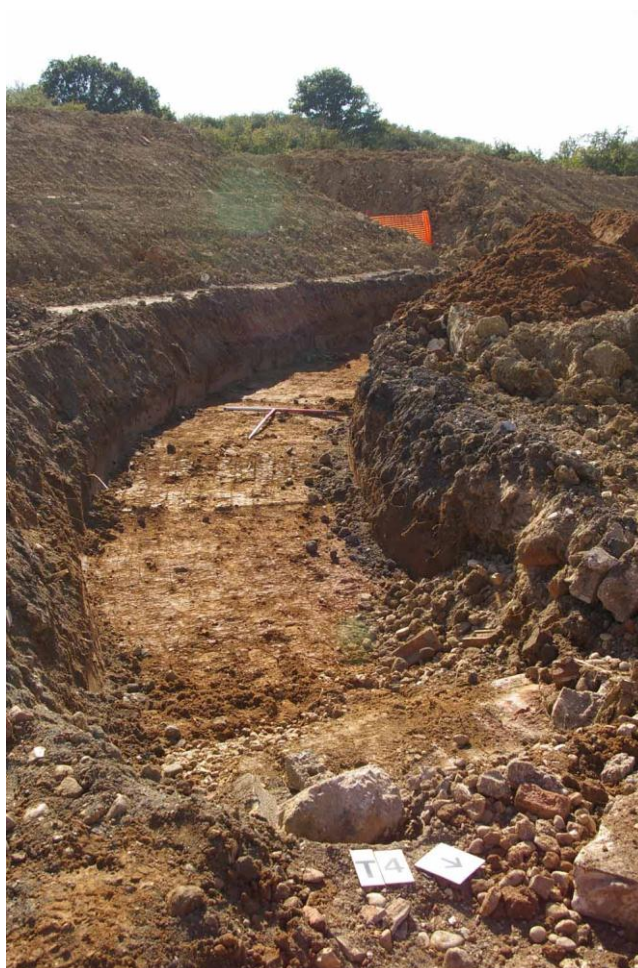
Figure 11 Trench 4
1m scales

Trench 4 was located to the south-east of Trench 3 and had to be fitted around the existing spoil heaps that had been created by the spoil from the levelled ski slope. This resulted in a rather S-shaped trench following a south-west to north-east alignment. The topsoil at this point was quite disturbed with areas of sand and gravel, made ground with lumps of concrete demolition material in evidence. Running along part of the eastern edge of the trench was a thin band of tarmac from a small trackway. The subsoil was also relatively disturbed due to the tarmac and other demolition debris. Removal of the subsoil exposed an undisturbed orange brown silty-sand substratum which had been cut through in two places by gravel-filled land drains (Fig. 11). The disturbed nature of the subsoil may indicate that the upper layers of the natural substratum may have been slightly truncated.

No archaeological features or deposits were observed within this trench.

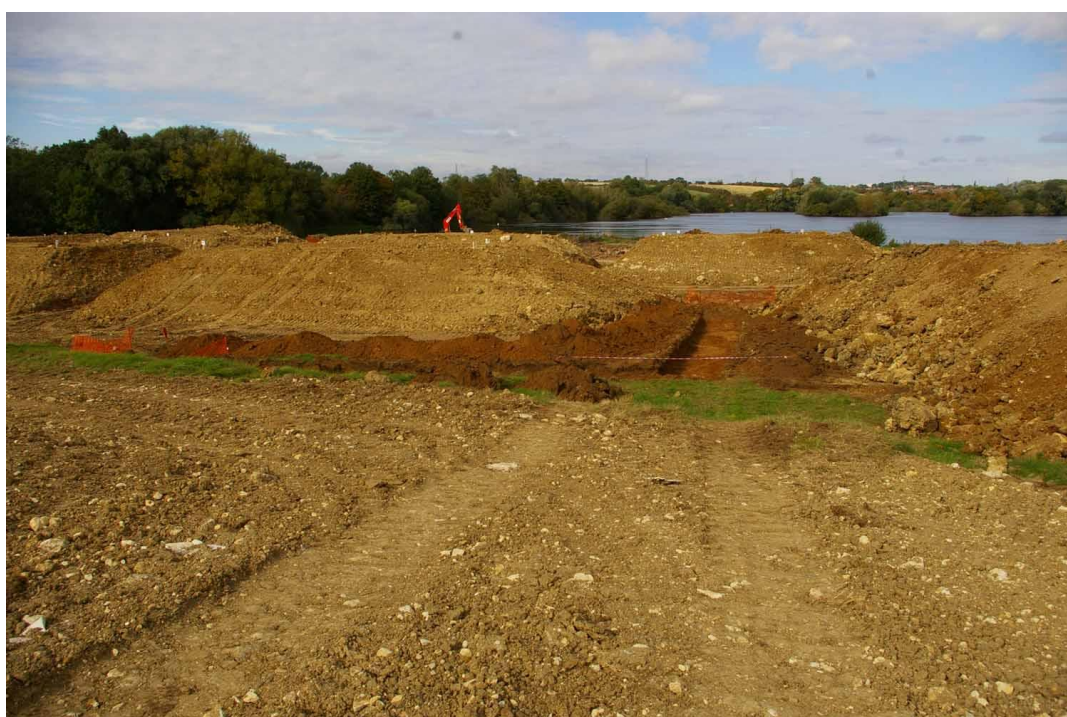
Figure 12 Trench 5

In the same way as Trench 4 Trench 5, which was slightly further south-east, had to be fitted around the ski slope spoil heaps resulting in an L-shaped trench. Prior to excavation the area around most of Trench 5 was covered in grass. To the south of Trench 5 was a long earth bank forming the northern boundary of a large flat terrace. Excavation removed between 0.15 and 0.30m of clean topsoil above the same mid orange brown sandy silty clay subsoil seen elsewhere on the development area. The subsoil, with a depth between 0.18 and 0.30m, was similarly undisturbed and lay above an orange brown silty-sand natural substratum (Fig. 12). No features were present although at the interface of subsoil and natural were a number of isolated small fragments of ironstone.

No archaeological features or deposits were observed within this trench.

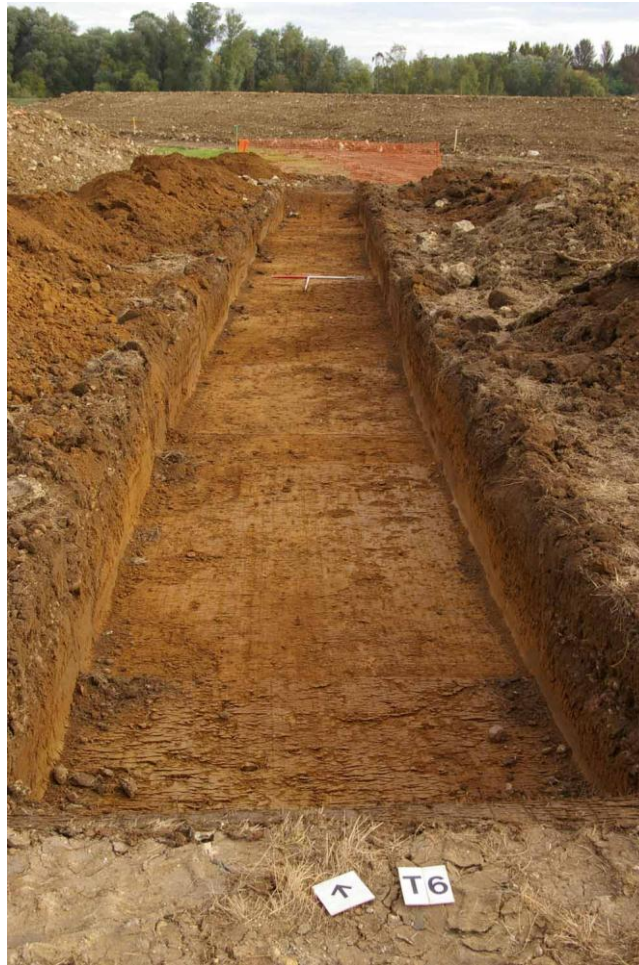
Figure 13 Trench 6

Trench 6 was located towards the south of the development area. The presence of a nearby north to south sewer pipe meant that, for safety reasons, this trench was reduced to 24m in length rather than 30m. Between 0.20 and 0.4m of topsoil was removed across the trench. At the south-western end of the trench was a 0.20m thick band of pebbles with a thin skim of tarmac just below turf level which appeared to be the remains of a footpath or narrow track. The subsoil was relatively undisturbed and had a depth varying between 0.20 and 0.30m. The natural substratum consisted of the same orange brown silty sand but with irregular bands of slightly darker material with some gravel within it (Fig. 13).

No archaeological features or deposits were observed within this trench.

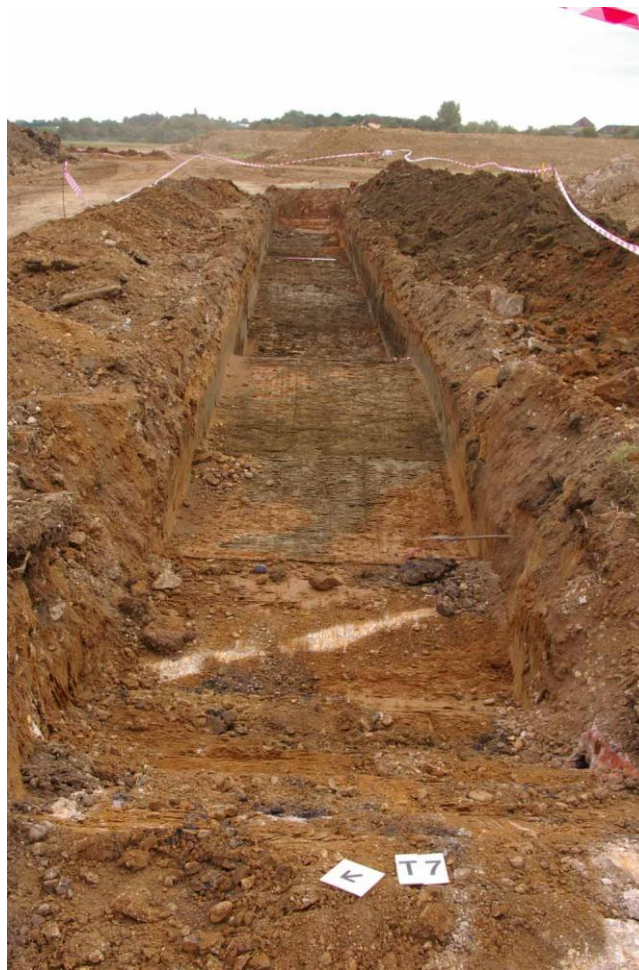
Figure 14 Trench 7
1m scales

Trench 7 was placed between a number of concrete roadways in the central northern area of the development area. In view of the proximity of the surrounding demolished buildings and roads no topsoil was present in this trench. A small area of subsoil survived at the eastern end of the trench but none was present elsewhere. The fill which was removed consisted of a dark grey sandy material full of building debris and which smelt strongly of hydrocarbons. The natural substratum consisted of mid orange brown silty-sand with large areas of stained and contaminated dark grey silty sand (Fig. 14). The level of the undisturbed natural substratum varied considerably which suggests that the upper levels may have been truncated. A concrete-covered service pipe was seen at the west end of the trench which was left intact.

No archaeological features or deposits were observed within this trench.

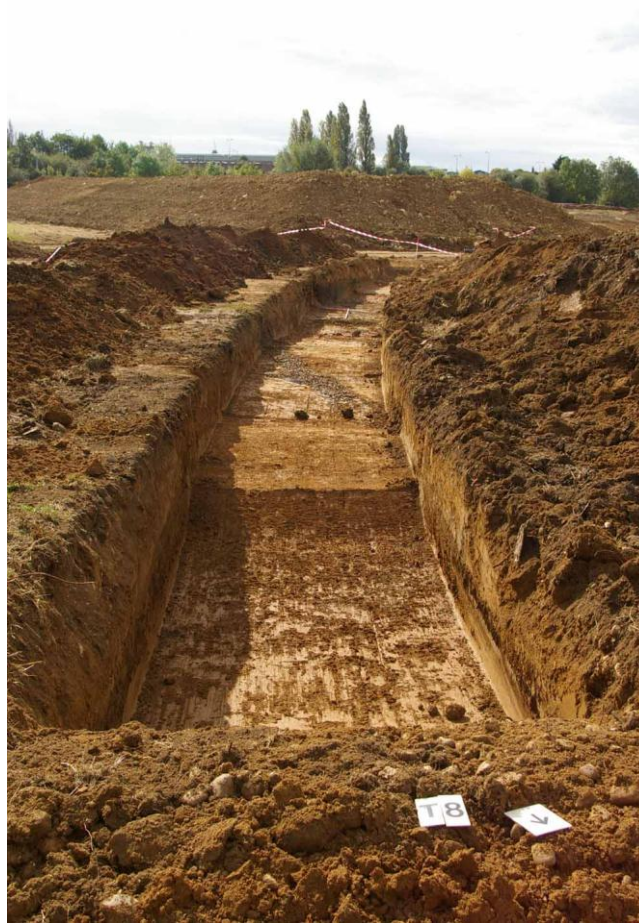
Figure 15 Trench 8

Trench 8 was located in the north of the development area. In order to avoid excavating near to the sewer pipe the trench had a slight turn to go around a large spoil heap. The topsoil or overburden in this part of the development area consisted of a light yellowish brown sandy gravel with fragments of concrete and limestone throughout. This material had a depth varying between 0.30 and 0.50m and was removed to reveal a slightly disturbed subsoil of mid orange brown silty-sand and gravel. Cutting through the subsoil at various points were three gravel filled drains which continued down into the natural substratum (Fig. 15). Around one of the drains was an area of contamination which had stained the natural substratum to a dark grey brown colour and smelt of hydrocarbons. Elsewhere the natural orange brown silty-sand substratum was relatively clean and undisturbed.

No archaeological features or deposits were observed within this trench.

Note north to south gravel-filled drain in centre of trench. 1m scales

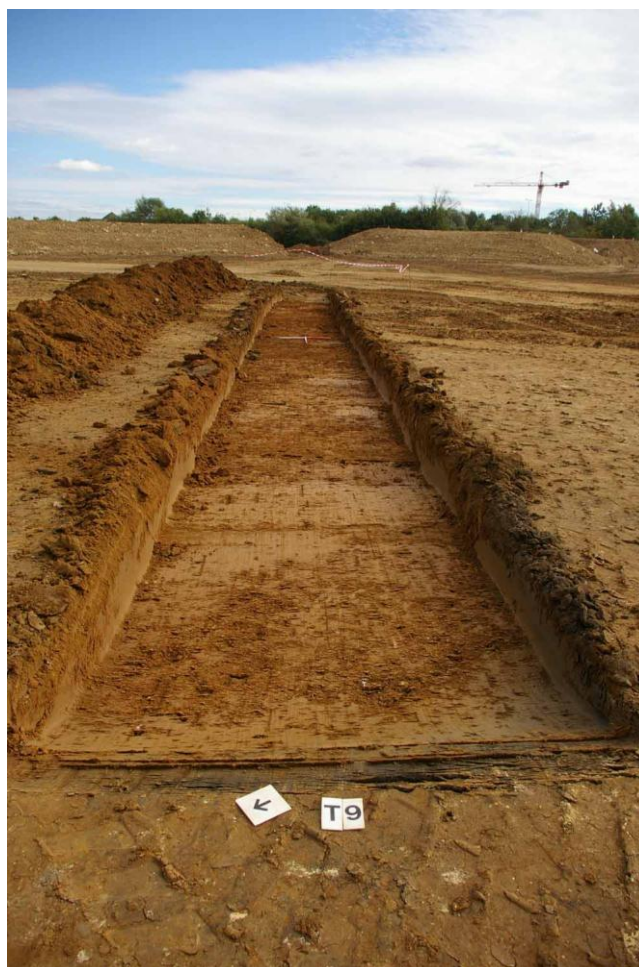
Figure 16 Trench 9
1m scales

Trench 9 was located below what was the dry ski slope in the centre of the development area. By the time that this trench was excavated the whole earth-built ski slope had been removed leaving a flat stripped area which appeared to have been levelled before the slope was constructed. A compact layer of sandy-silt which was possibly the equivalent of subsoil with a depth of between 0.20 and 0.30m was removed to reveal a mid orange brown subsoil layer of only 0.05 to 0.11m in depth. The shallow nature of the subsoil tends to confirm the suggestion that some landscaping and truncation did indeed take place before the ski slope was built. Most of the undisturbed natural substratum within the trench consisted of orange brown silty sand although the north-western end showed some evidence of a small amount of clay (Fig. 16).

No archaeological features or deposits were observed within this trench.
