An Archaeological field evaluation at Hill Farm, Packington, Leicestershire (SK 3731 1445)

ULAS Report No 2015-172 ©2015

for AECOM Ltd.

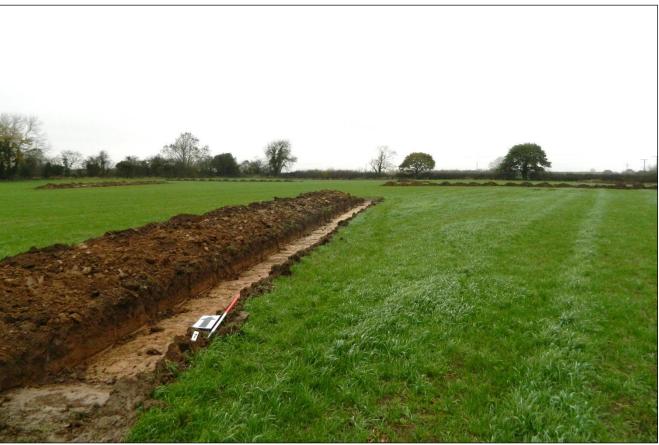
Figure 3: General view of evaluated site from Trench 7.

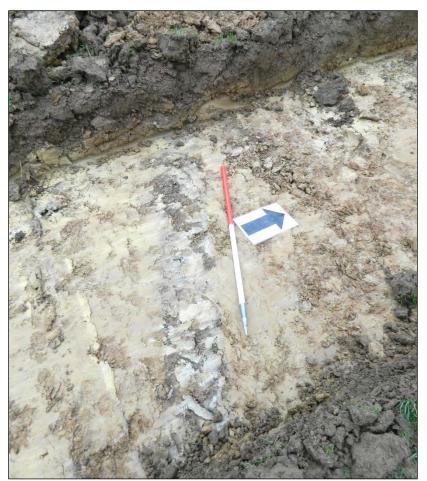
Trenches 1 and 2 exposed an east-west length of modern land drain, backfilled with a mix of topsoil and subsoil. It was this feature that was indicated on the geophysical survey crossing the north end of the proposed site (Figure 4). These and the other trenches also exposed further land drains running north-south. These were regularly spaced and tended to be within and parallel to infilled plough furrows. The plough furrows could potentially be from medieval ridge and furrow. The other anomalies identified in the geophysical survey proved to be of natural origin, with the variation in natural across the site probably explaining the anomalies in the south area of the trial trenching scheme. The south area of the proposed site outside the trial trenching regime has reportedly been mined for coal; however no evidence for mining activity was identified in the north half of site.

Figure 4: Trench 2. Modern drain (geophysical anomaly).

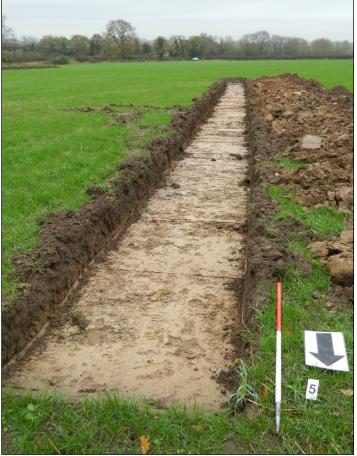
Natural in Trenches 1 to 5 was a reddish-orange clay, with occasional blue and yellowish-orange clay bands (Figure 5). Trench 6 exposed a natural outcrop of ironstone (Figure 6). Trench 7 exposed a natural consisting of manganese-rich gravel with ironstone and rounded pebbles.

Figure 5: Trench 5. Clay natural exposed.

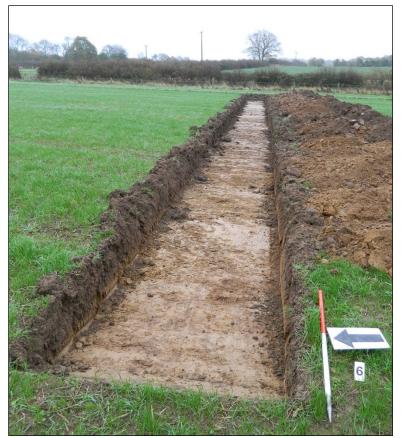
Figure 6: Trench 6. Clayey ironstone natural exposed.
