**An Archaeological field evaluation at  
Riverside Farm, Sysonby, Melton  
Mowbray, Leics.**

ULAS Report No 2014-126  
©2014

**An Archaeological field evaluation at  
Riverside Farm, Sysonby, Melton Mowbray, Leicestershire  
(SK 738 189)**

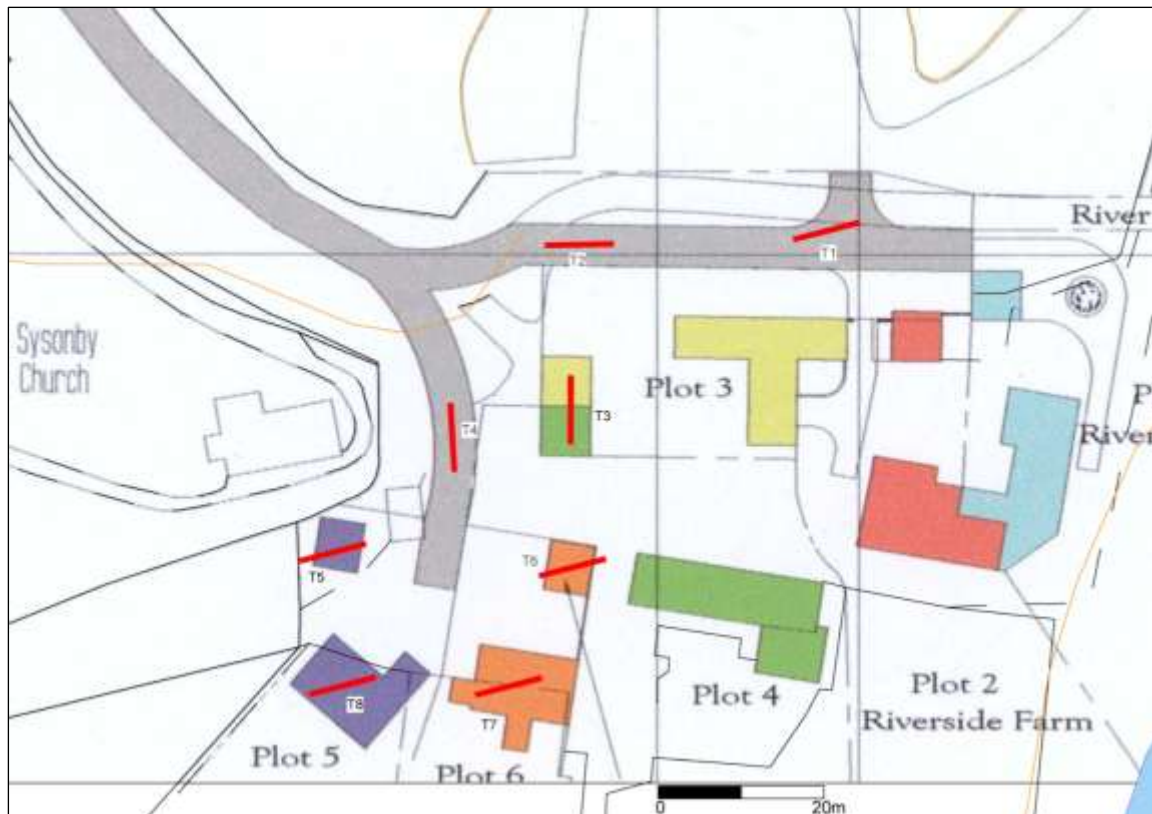
Figure 2: Client plan showing site location, proposed development and WSI trench layout.

The WSI asked for a c. 5% sample of the c. 0.5ha. area necessitating the equivalent of six 20m by 1.8m trenches (c. 300 sq. m.). The provisional trench plan attached (Fig. 2) shows the proposed WSI location of the trenches targeting the proposed house footprints, and the proposed new road line. Due to constraints observed on a site visit on 09/06/2014 (S. Clarke pers. comm.) the trenches had to be shortened significantly so two further trenches were to be added on the access road (Fig. 2, Trenches 2 and 4).

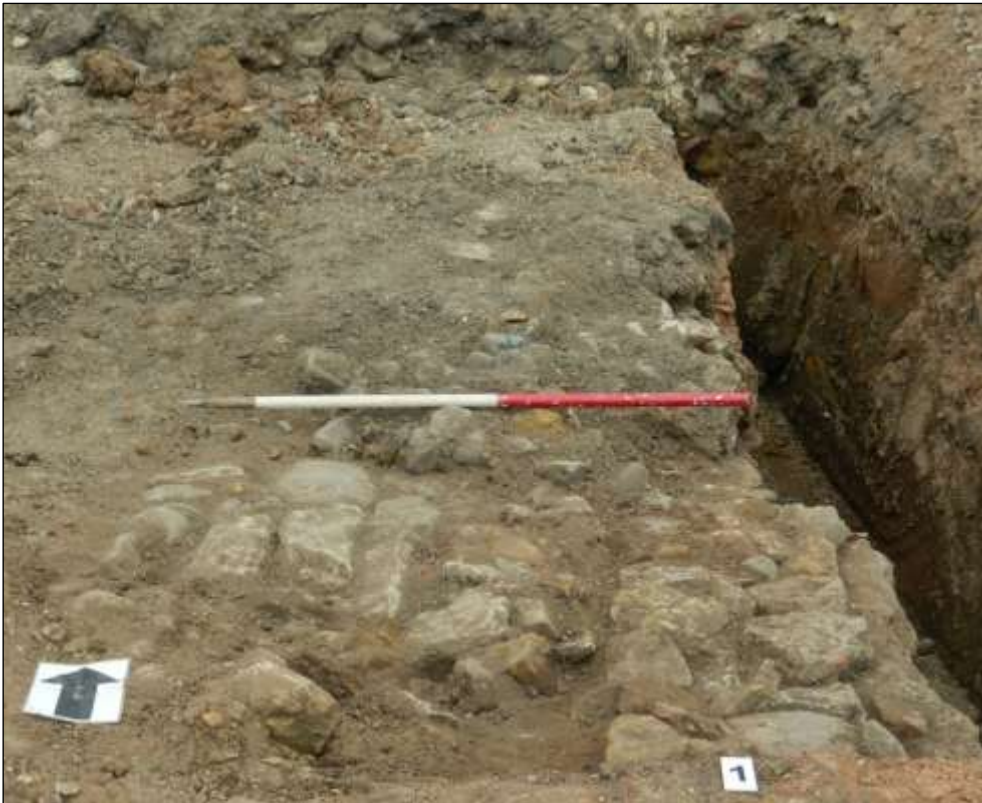
This area was for a garage (for Plot 3). The original plan had been altered from a double garage with a long axis north-south, to two separate single garages, one of which had already been constructed to the north. The south garage had a longer axis running east-west and measuring 10m east-west by 7.5m north-south. The area had been stripped of overburden, and the foundation trenches had been excavated to a depth of c.0.8m and with a width of 0.6m. Cleaning and examination of these areas identified a yard surface associated with a stone wall to the east. The stone wall context (1) ran north-south, and

the wall-line was exposed for 2.48m, Plates 2-4. Beyond this the wall was cut by the footings and service trenches, but stones in the south foundation trench on the same line probably indicate it continued southwards further. The wall was 0.44m wide and 0.47m deep. The build was of unmortared rough sandstone blocks, with a rubble core. Occasional fragments of brick were identified within the build of the wall and the yard surface to the west, with the latter also producing window glass. The alignment of the wall matches that of the earlier buildings to the east, being of a late 18th early 19th century date (Clarke 2014), and the stonework is presumably the foundation for a demolished further building. No further features were present within the area of the garage.

Plate 2: Wall line (1) and yard surface to west, in east of garage Plot/Trench 3

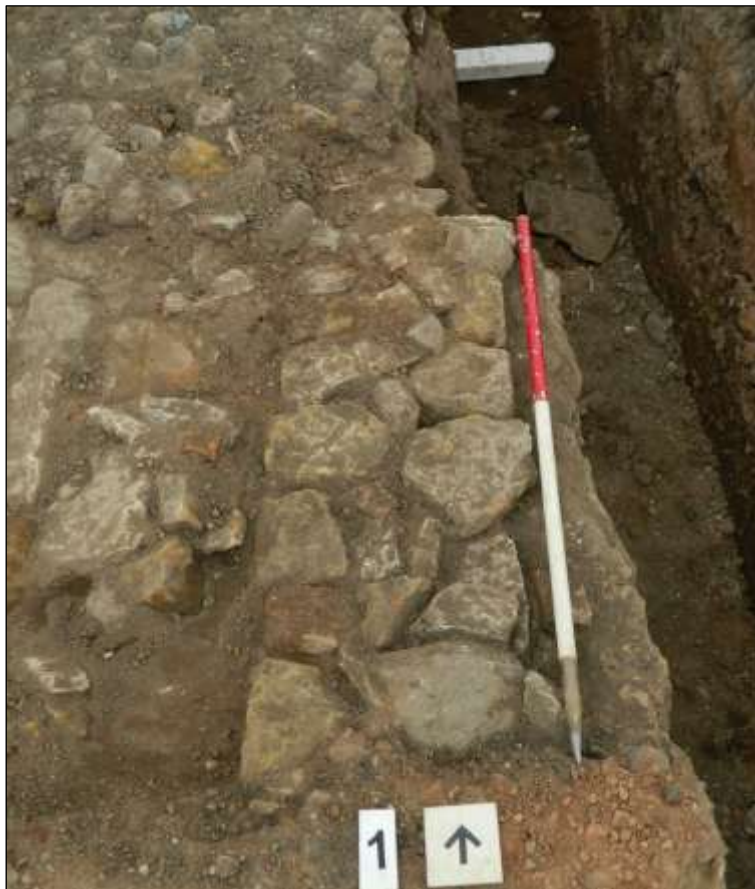
Plate 3: Wall line (1) and yard surface, in east of garage Plot/Trench 3

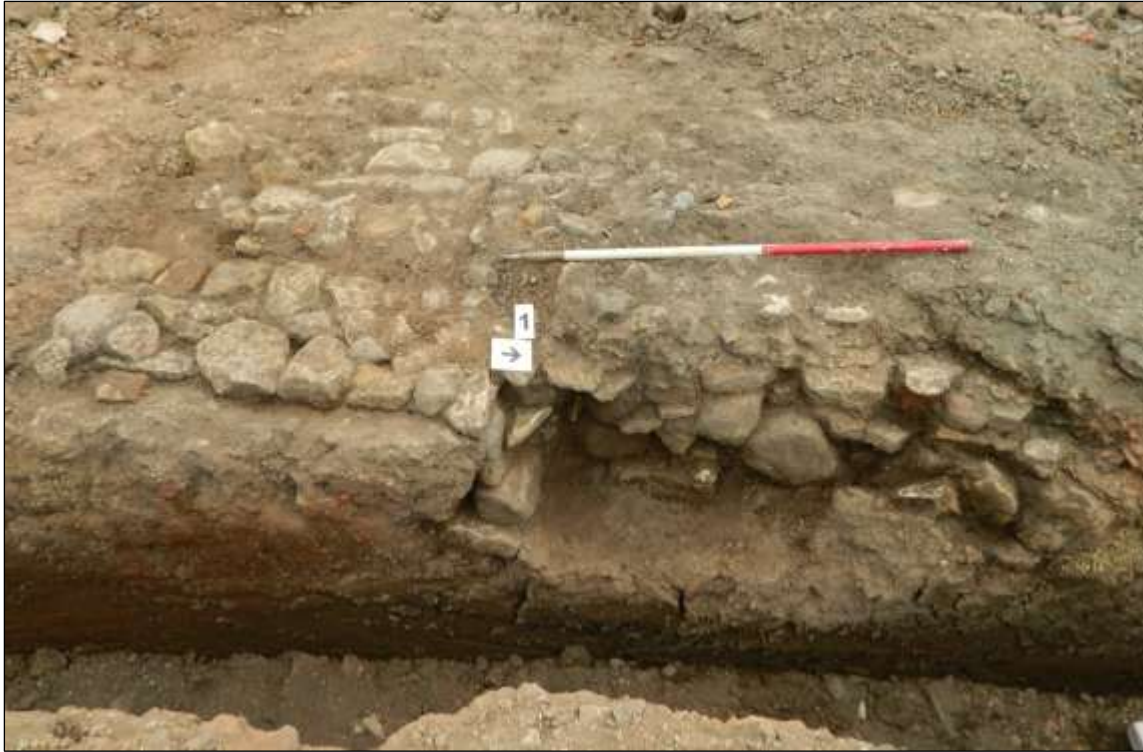
Plate 4: Wall line (1) and yard surface beyond, in east of garage Plot/Trench 3

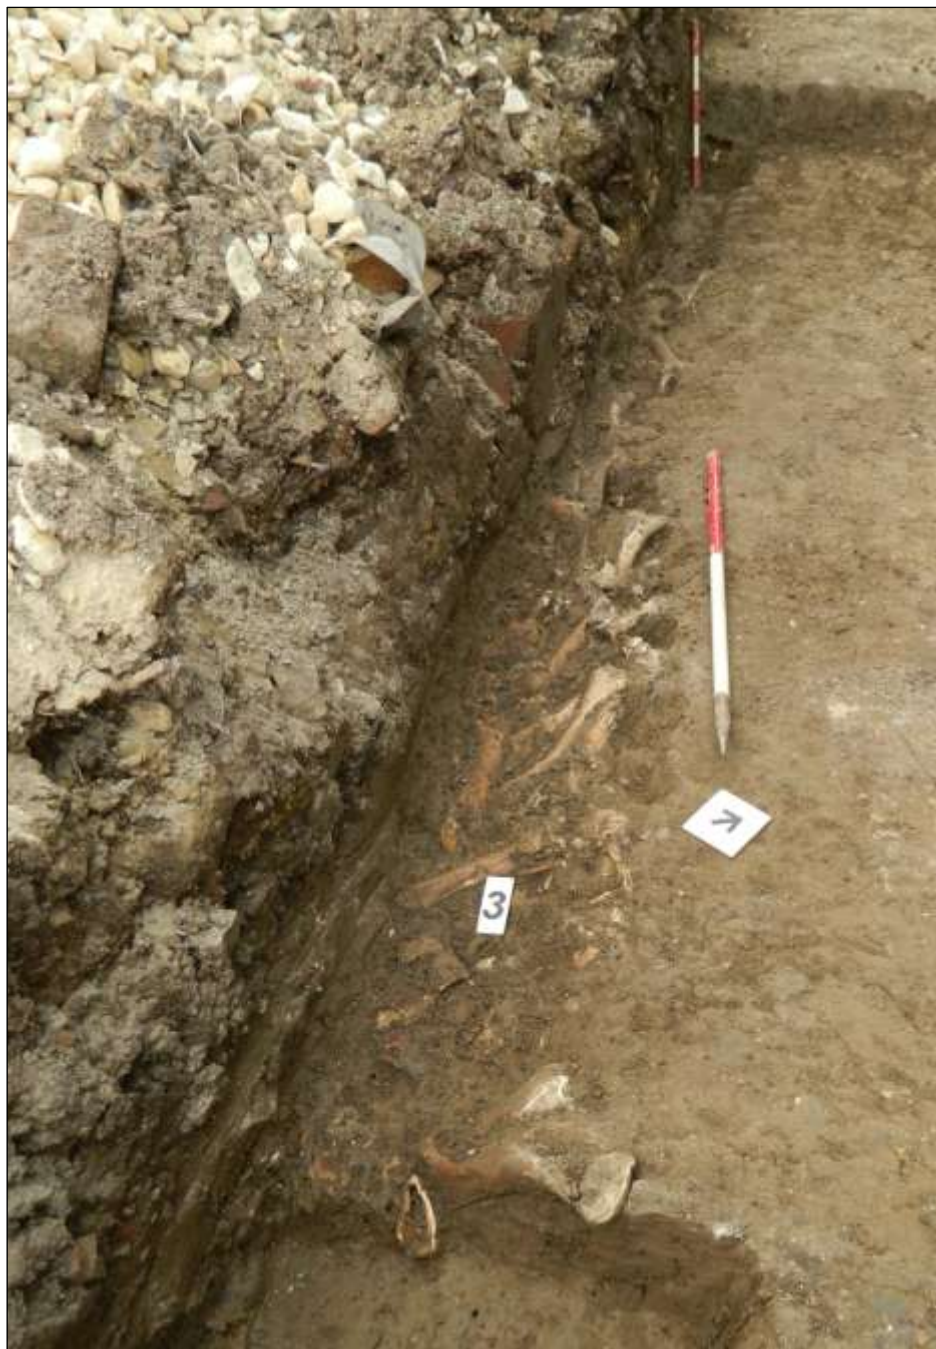
This trench was sited within the footprint of the proposed garage block for Plot 5, in the south-west of the site area. The area was quite disturbed with a large modern pit cutting in the middle area, and the overburden incorporating a large amount of modern demolition material. Below overburden levels (0.40-0.45m depth) a 5m long east-west drain was recorded [4]. This was over 0.4m wide (south edge not seen) and 0.2m deep. The drain was lined with large animal bones, occasional stone and other building materials (3). A fragment of brick was recovered from this, providing a *terminus post quem* (TPQ) of a late 18th century or later date. No other features were exposed in Trench 5.

Plate 5: Bone lined drain (3) [4] in garage Plot/Trench 5

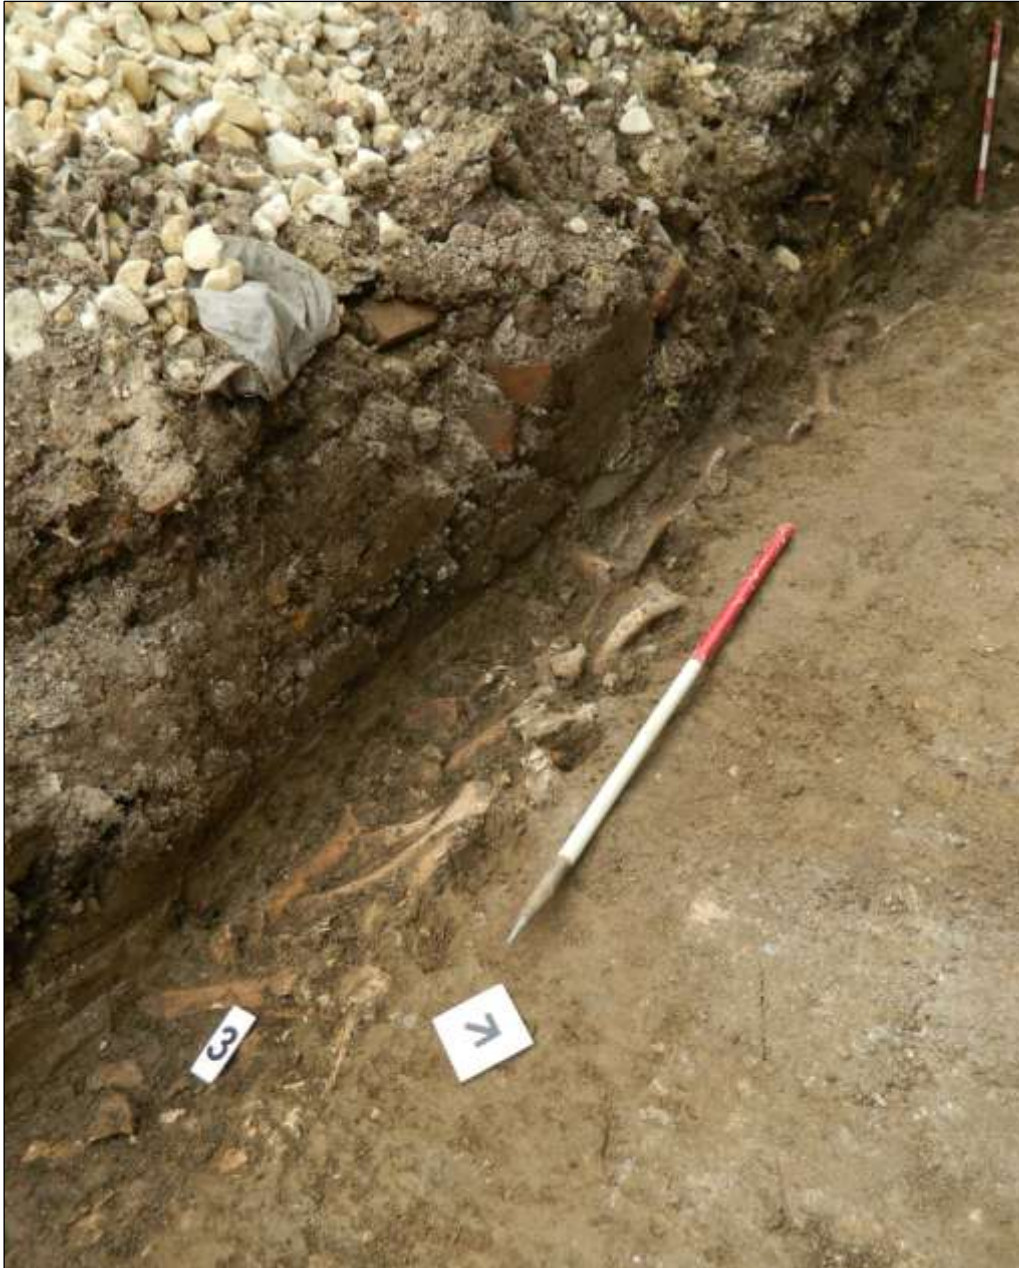
Plate 6: Bone lined drain (3) [4] in garage Plot/Trench 5

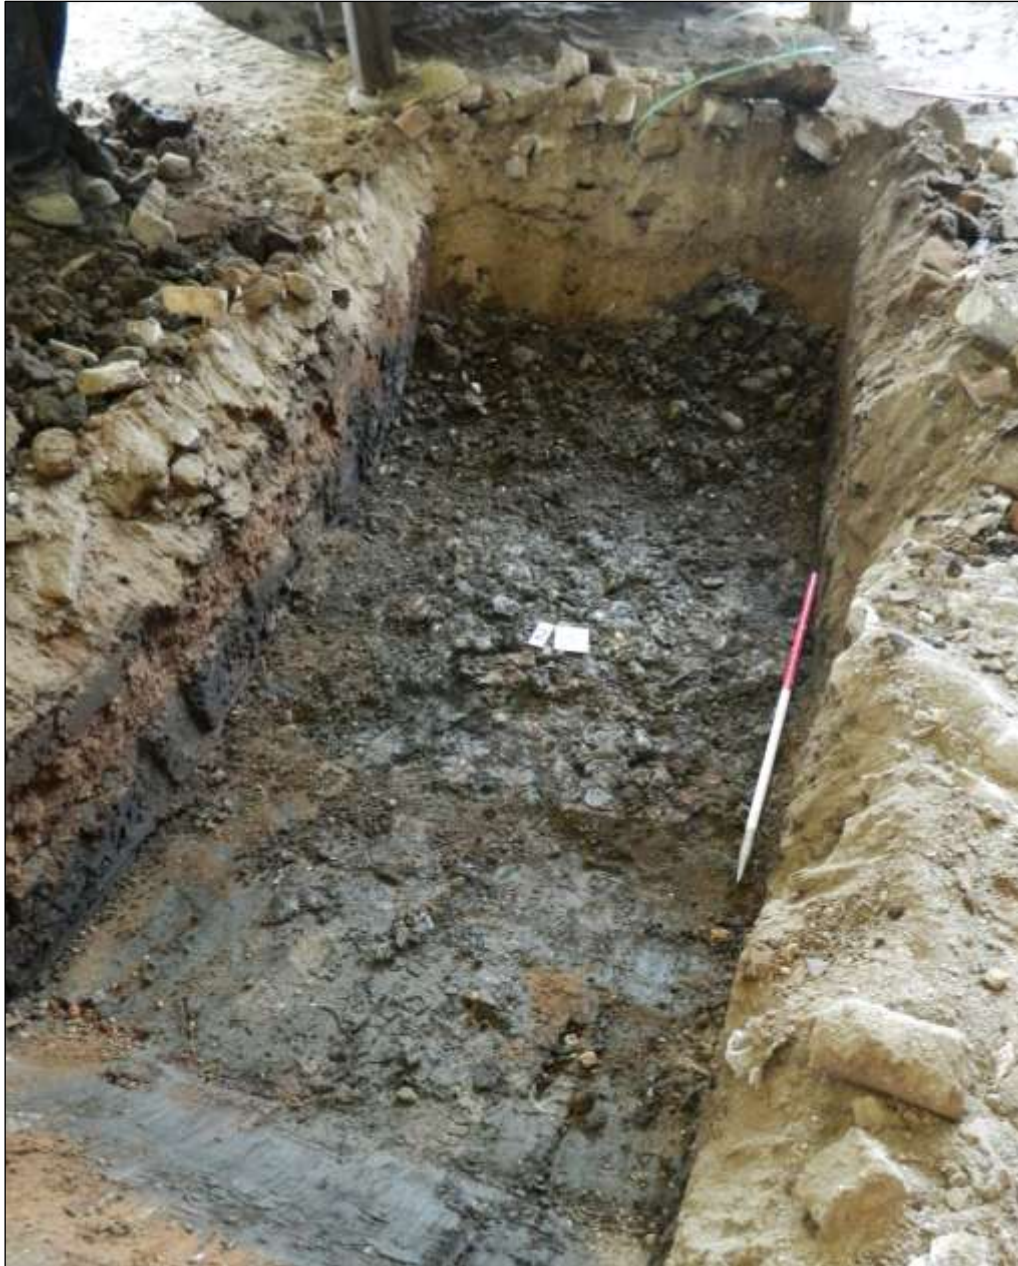
Trench 7 was sited within the footprint of house Plot 6, inside a standing modern barn hence the trench had to be dog-legged for machine access. Up to 0.6m of overburden (floor make ups) was removed to expose topsoil below. The topsoil was 0.25m deep and straight on to natural alluvial deposits over most of the trench area. From 2.5m to 3.5m north of the trench south end was a pocket of metallised surfacing below the topsoil, measuring 1.6m across and with a depth of .08m. Within the rounded cobbles were occasional fragments of limestone and a fragment of brick indicating an 18th-19th century date. After recording the surface was removed exposing only sterile grey clay.

Plate 7: Yard surface (2) Plot 6 footprint, Trench 7

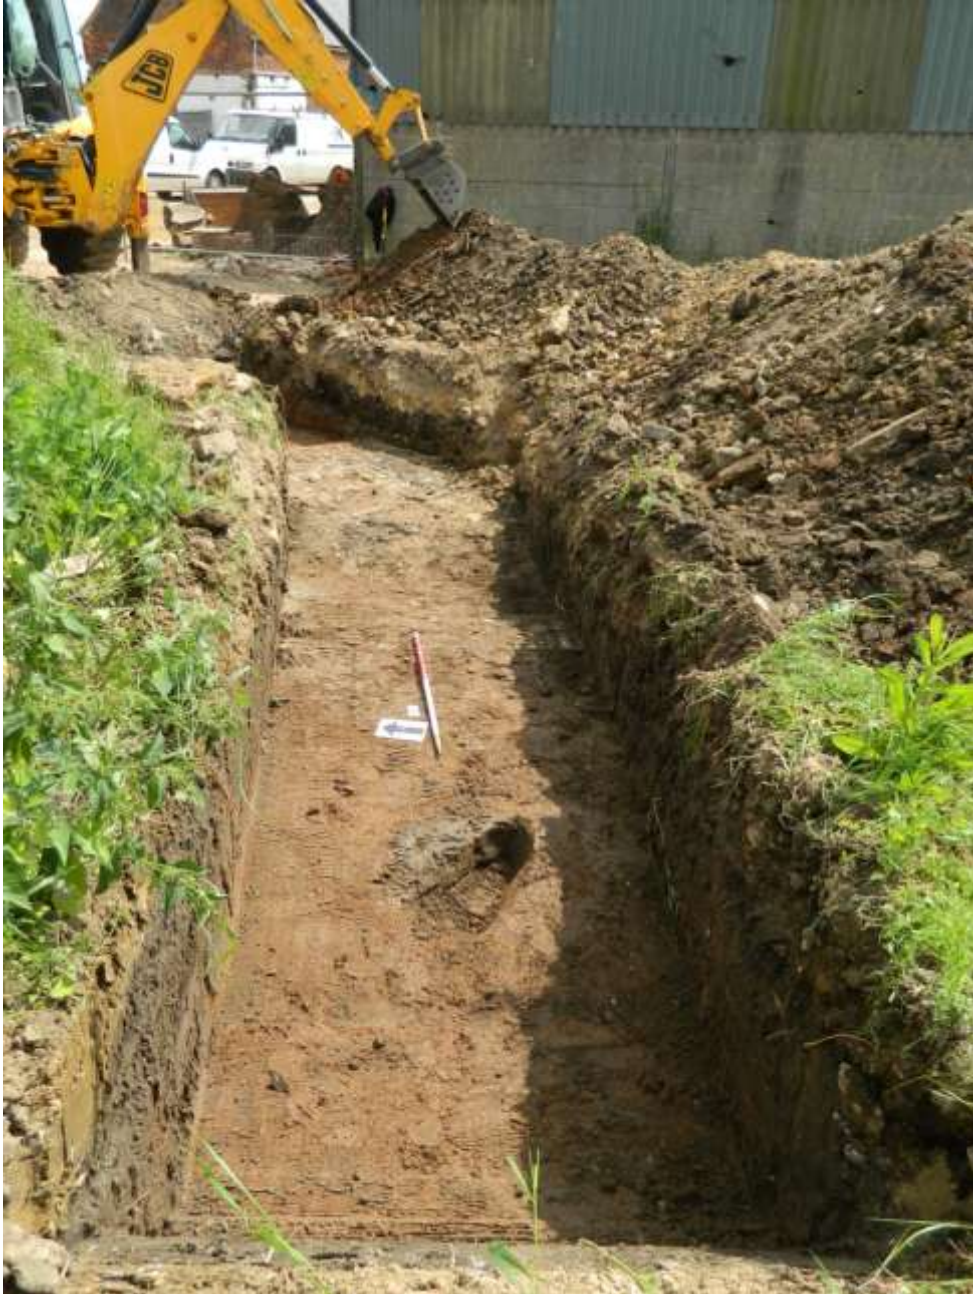
This was sited within the footprint of the Plot 5 house. This also had to be dog-legged for access purposes. Overburden consisting of modern levels and topsoil was removed to a depth of 0.6-0.65m. Below this a subsoil between 0.1-0.35m was observed. This was disturbed and produced occasional modern material. Below this, the natural substratum was a reddy brown sandy clay, which had several areas of disturbance all of which produced modern material. No further features were observed and no finds were recovered.

Plate 8: Trench 8, house Plot 5
