**A Level 2 Historic Building Recording
on land off Upperton Road, Leicester**

NGR: SK 57927 03415

**ULAS Report No.2014-146
©2014**

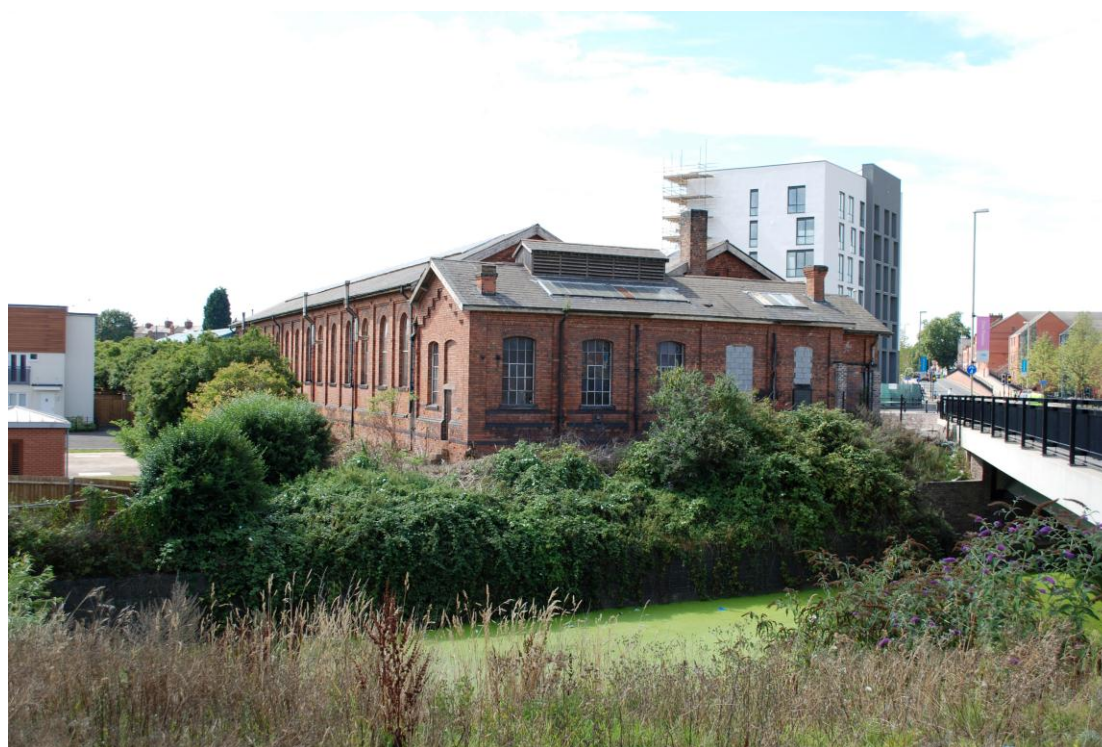
Figure 6 Relationship of building and surrounding developments
Looking south west. Photograph taken by client prior to redevelopment in August 2011

As already noted the building now stands in isolation with no clear evidence that it once formed part of a large railway goods yard. The old Upperton Road bridge has been removed and the road rebuilt at ground level making the building clearly visible from the road (Fig. 6). To the west and south west is a newly constructed block of apartments. To the south is a small housing development. No other railway buildings survive nearby.

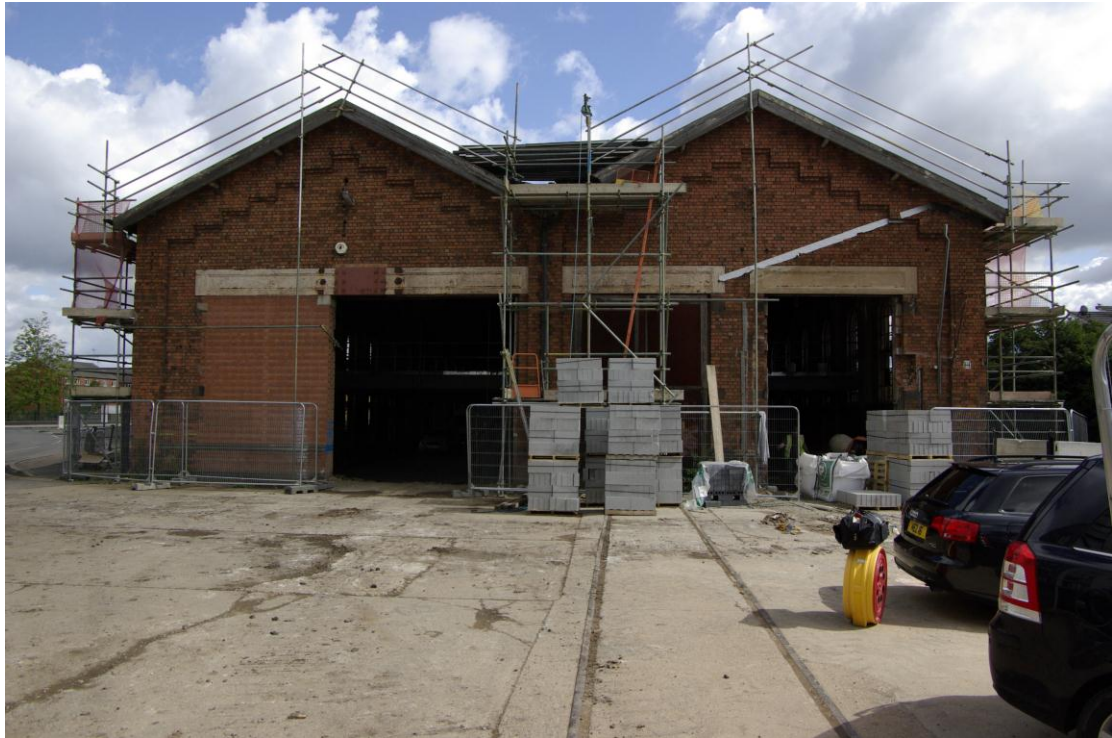
Figure 7 South-west facing elevation
Looking north east

As part of the redevelopment scheme this double gable-ended elevation will be completely demolished and shortened by approximately 7 metres. The elevation is built from red bricks laid in an English bond with chamfered blue bricks forming a low plinth that extends around the entire building (Fig. 7). At present there are three entrances reaching up to eaves height. The entrances have steel joist lintels which have been painted to create a slightly more decorative finish which appears to be original. The western entrance is of double width but, when first built, was a pair of single width doors as seen on the eastern side. Half of this has now been bricked up but care has been taken to match the bond and the chamfered blue brick detail. The two steel lintels above this have been bolted together and the original supporting pillar removed. The other two entrances are of single width with railway lines running into the central entrance. The central entrance has what appear to be the original doors which have been partially clad in steel sheet. The eastern doorway recently led into a breeze-block built shed which has now been removed. No doors survive but the door pintles remain in place (Fig. 8).

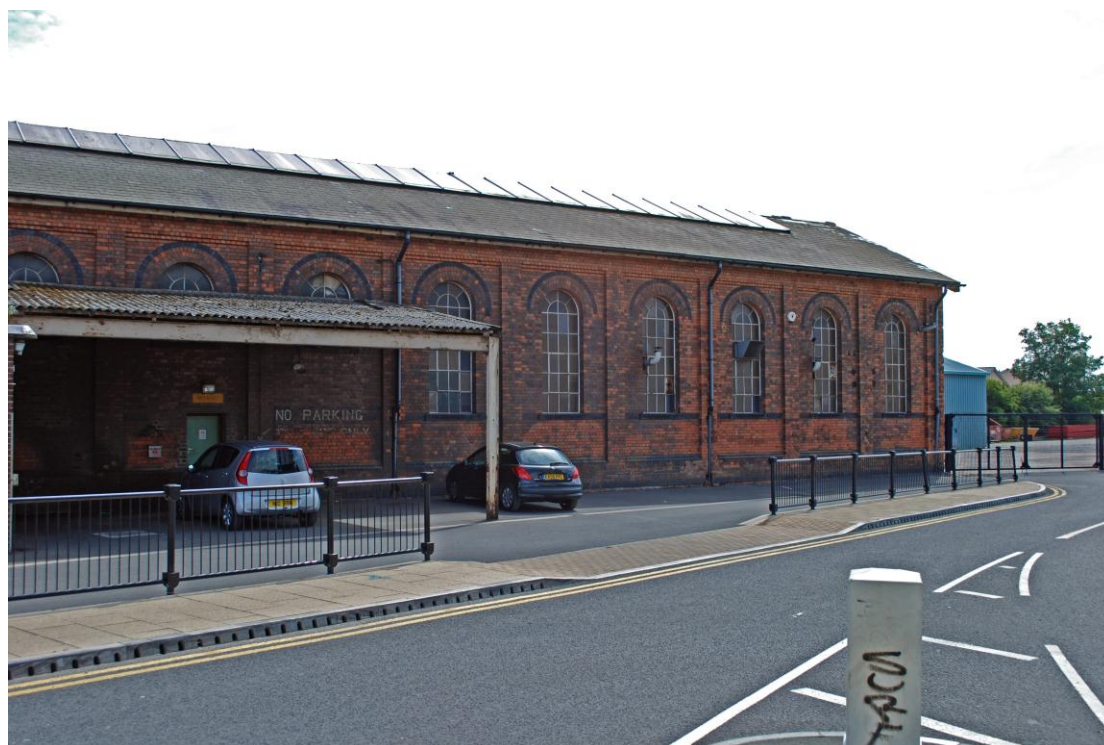
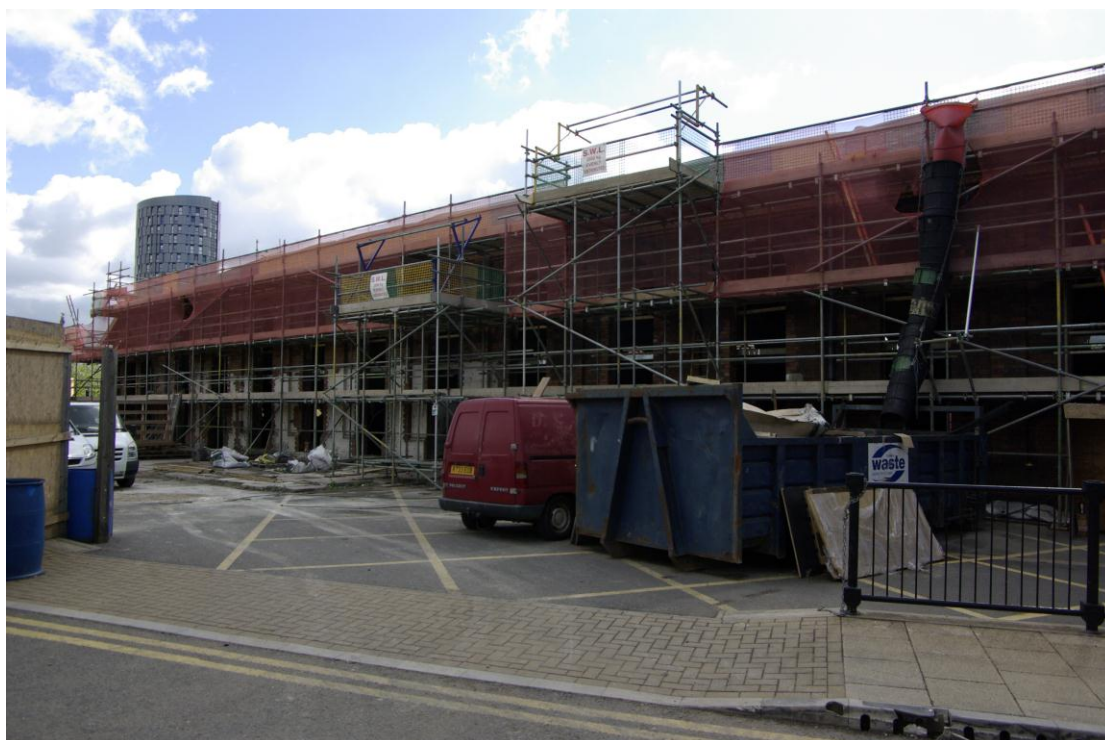
The north-west elevation is formed of 15 repeated brick-built bays which create the main shed and two smaller gable ended structures attached to the north-east end (Figs. 9 and 10). The head of each window is built from four courses of brick headers with the top course being made of blue bricks (Fig. 11). The windows were originally metal framed but at the time of the survey only the end two bays which are to be demolished still retained their frames, which are hidden behind a temporary screen of breeze blocks. The remaining windows have been extended down almost to ground level to create larger window openings. Each window had a sandstone sill, most of which have now been removed. Blue brick detail continues round from the south-west facing elevation and at original sill height. Prior to redevelopment part of the northern end of this elevation was obscured by a small lean-to and a brick-built flat roofed structure. These were later additions to the building and had resulted in the partial blocking of nine windows at the northern end. A wide doorway had also been inserted at the northern end.

Figure 9 Southern end of north-west facing elevation
Looking south. Photo taken by client prior in August 2011 to redevelopment

Figure 10 Northern end of north-west facing elevation
Looking east. Note extended length of new window openings

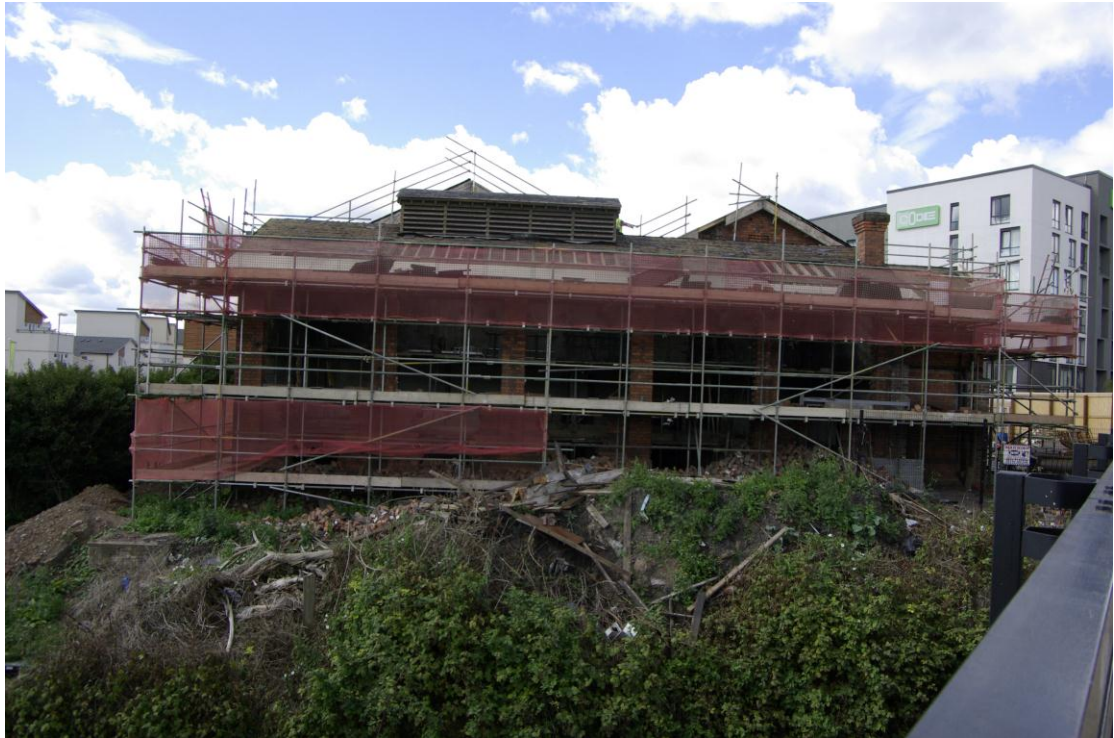
Figure 13 North-east facing elevation
Looking south-west

At the time of the survey most windows had been removed and the openings widened (Fig. 13). Prior to redevelopment the windows had arched heads which, although in the style of the main shed, were of a flatter design (see Fig. 6). The roof is covered in Welsh slate with a raised wooden louvred ventilator running along its length (Fig. 14).

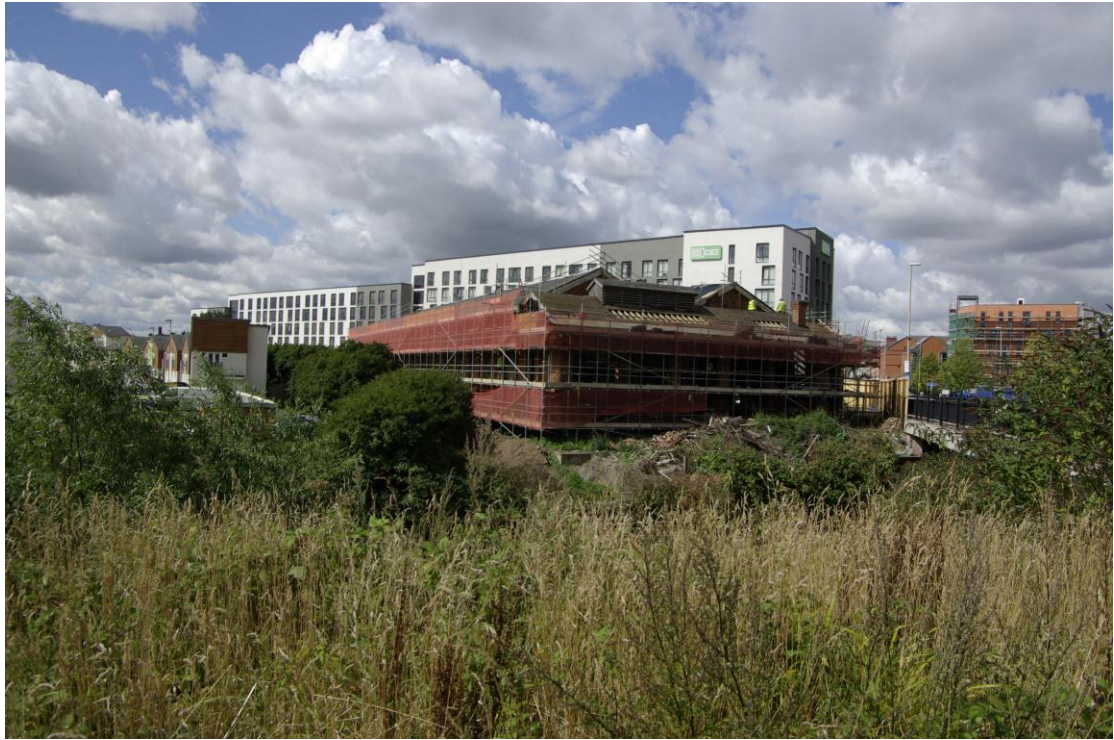
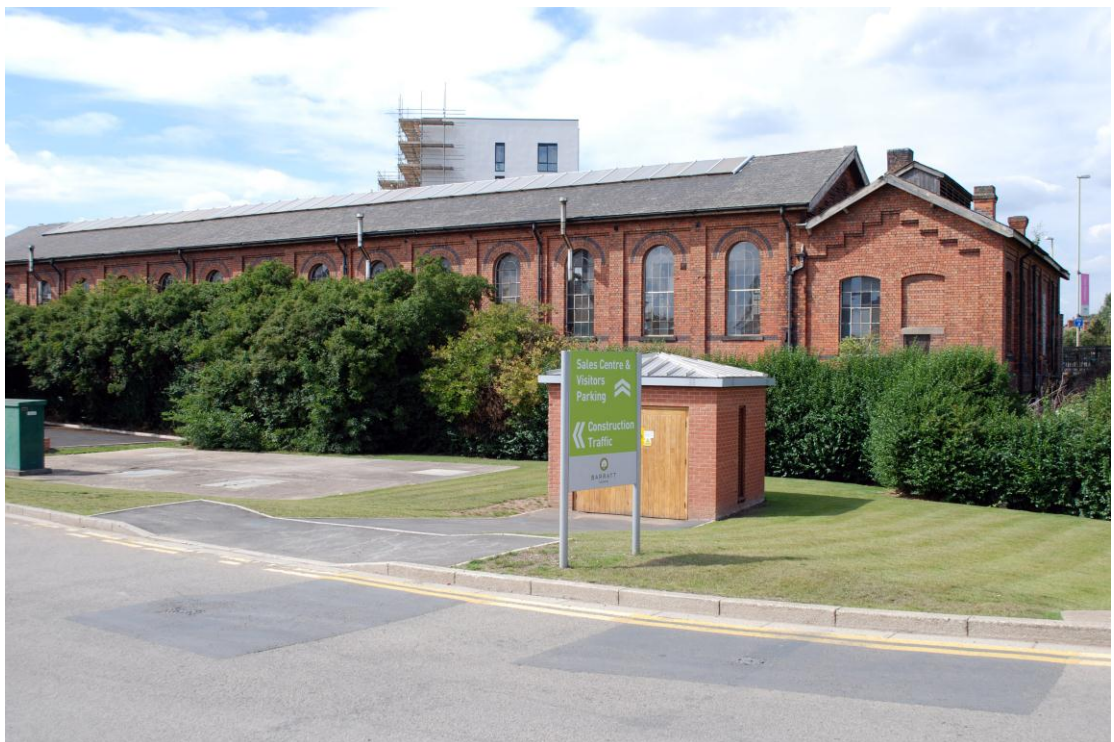
The main shed elevation was built to the same design as the north-west facing elevation but on this side none of the windows had been blocked by later buildings (Figs 15 and 16).

Figure 15 North-east and south-east facing elevations
Looking west

Figure 16 South-east facing elevation
Looking west. Photo taken by client in August 2011 prior to redevelopment

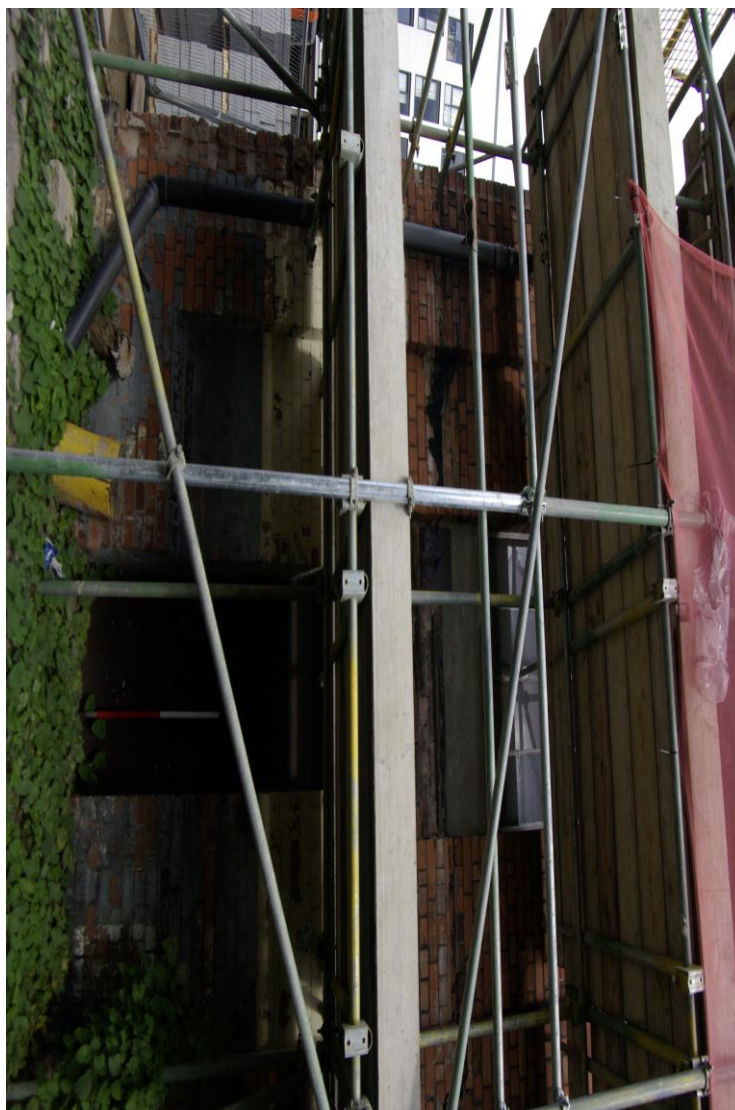
Figure 17 South-east facing elevation, south end doorway
Looking north-west. 1m scale

At the far southern end of the main shed the end window is shorter than the rest to allow for a single doorway into the building. This appears to be part of the original construction as no evidence could be seen for any blocking below the window (Fig. 17). The two bays scheduled for demolition are the only two with their original metal frames in. At ground level a series of brick relieving arches can be seen below the windows as the ground dropped away to the north. The style of the arches mirrored those at the top of each window with the exception of the blue brick upper course.

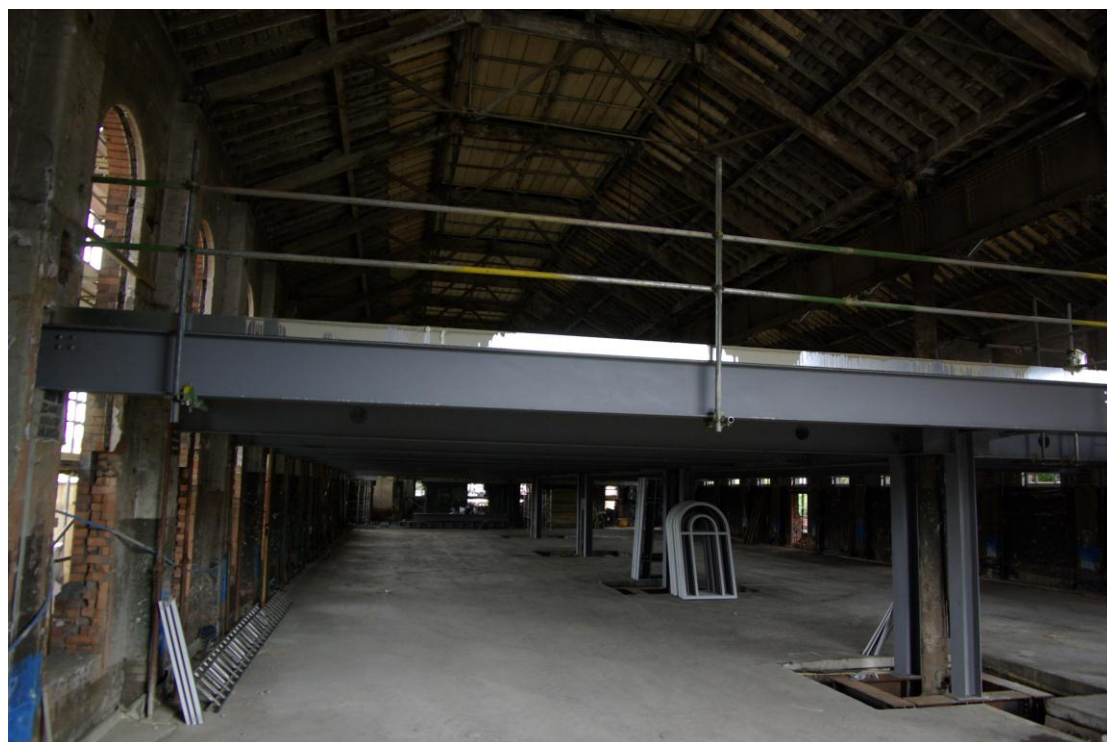
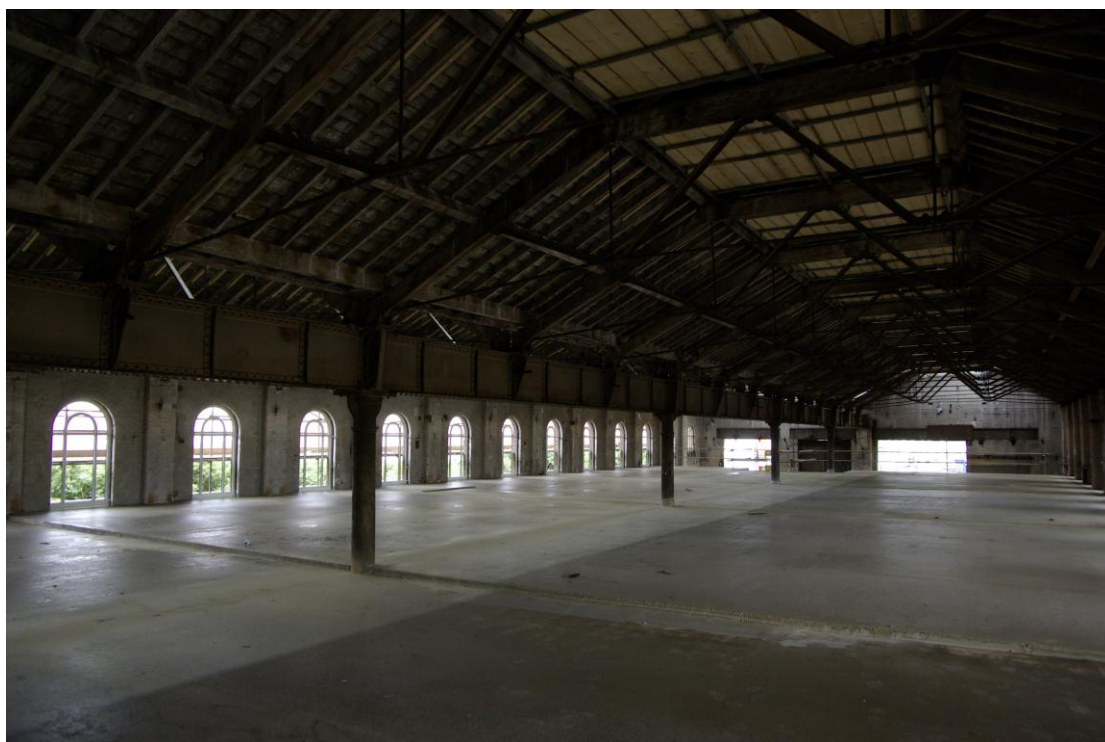
When first built the main engine shed was a single open space divided down the middle by four cast iron pillars supporting a longitudinal riveted steel girder. The redevelopment has inserted a mezzanine floor to make use of the available height (Figs. 18 and 19). The mezzanine stops short at the intended end point of the refurbished building leaving the two end bays in almost original condition. A new

Figure 18 Internal view of main shed
Looking north-east

Figure 19 Internal view of main shed from mezzanine
Looking south-west

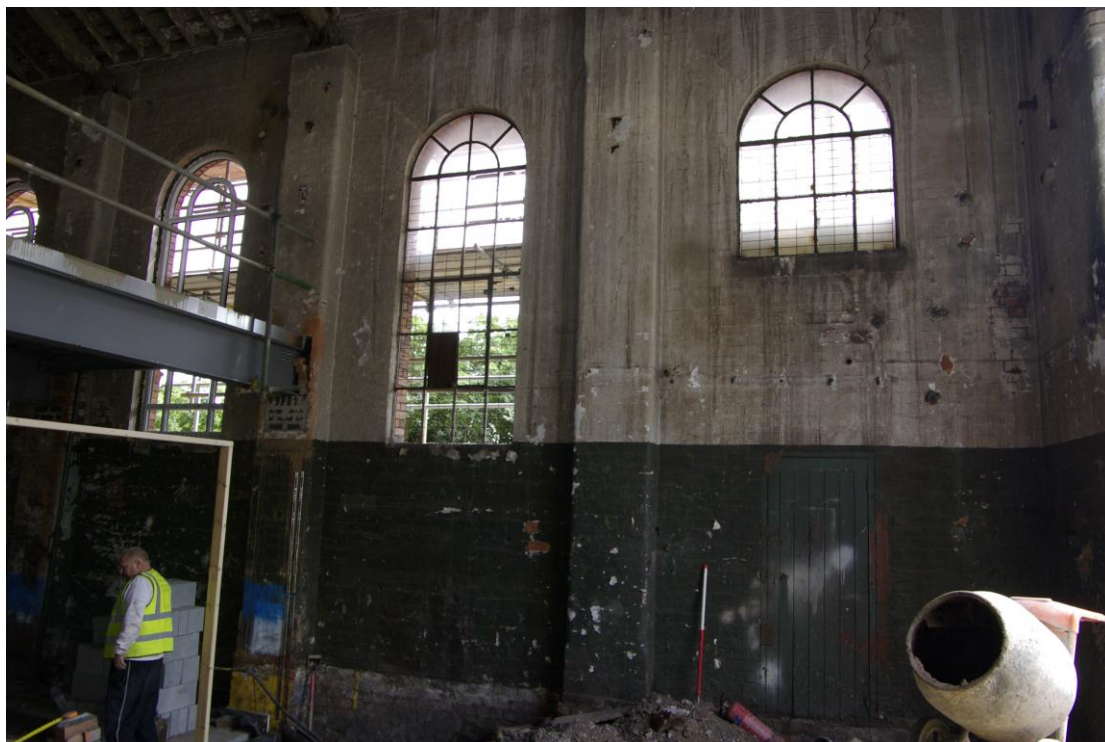
concrete floor has been laid so there is no evidence of any inspection pits which may have existed between the tracks. The window frames on both sides at the south end are still intact (Figs. 20 and 21). Parts of the door opening mechanism remain above the south end doorways as does the ground level latch mechanism on the central doorway (Figs. 22 and 23). A short length of rail extends into the shed with a sole remaining chair supporting one rail (Fig. 24).

Figure 20 Southern end of main shed
Looking west, 1m scale

Figure 21 Southern end of main shed
Looking south-east. 1m scale

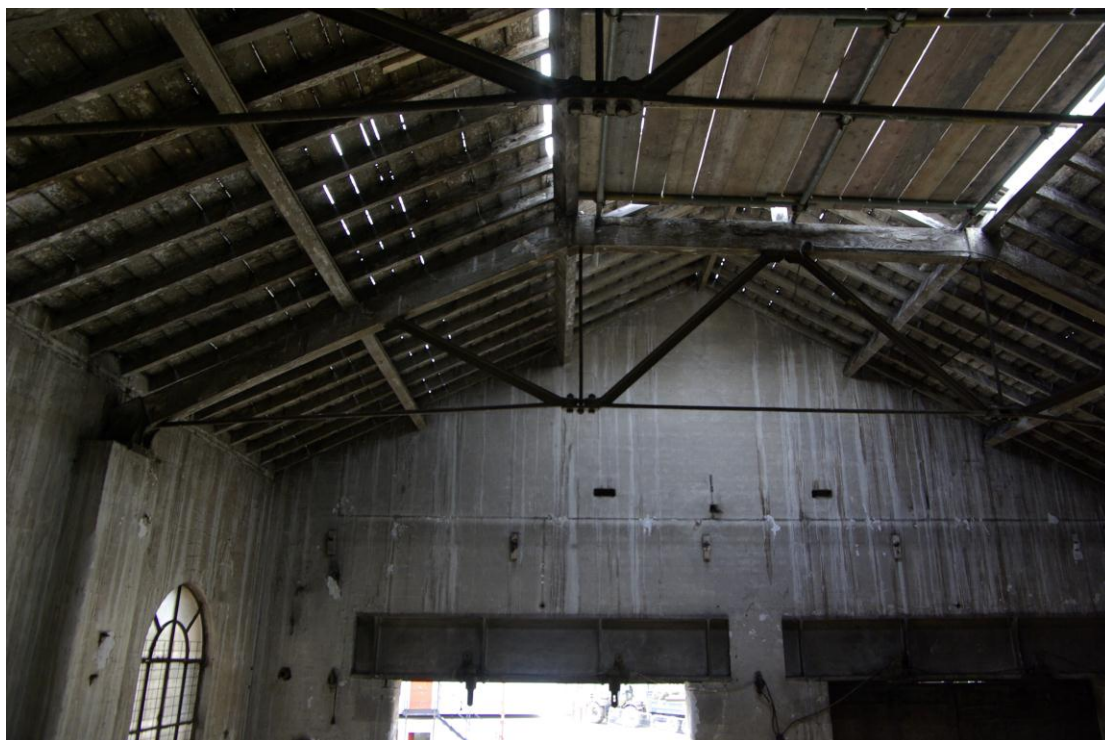
Figure 25 Roof structural detail
Looking south-west

The roof is made of relatively lightweight timber principal rafters and collar supported with iron shoes at each joint (Fig. 25). Lightweight steel T-section bars and steel rods stiffen the structure which rests on brick pilasters at each wall and in the longitudinal steel beam down the centre. Cleated purlins sit on the backs of the principals.

The construction date of the building is clearly documented, as are many of its different stages in its life. The use of metal-socketed components in the roof structure matches similar industrial roofs being constructed elsewhere in late 19th century England. This reflects some of the differences between the relatively new Great Central Railway and other earlier more established railways of the period which often used more traditional construction methods.

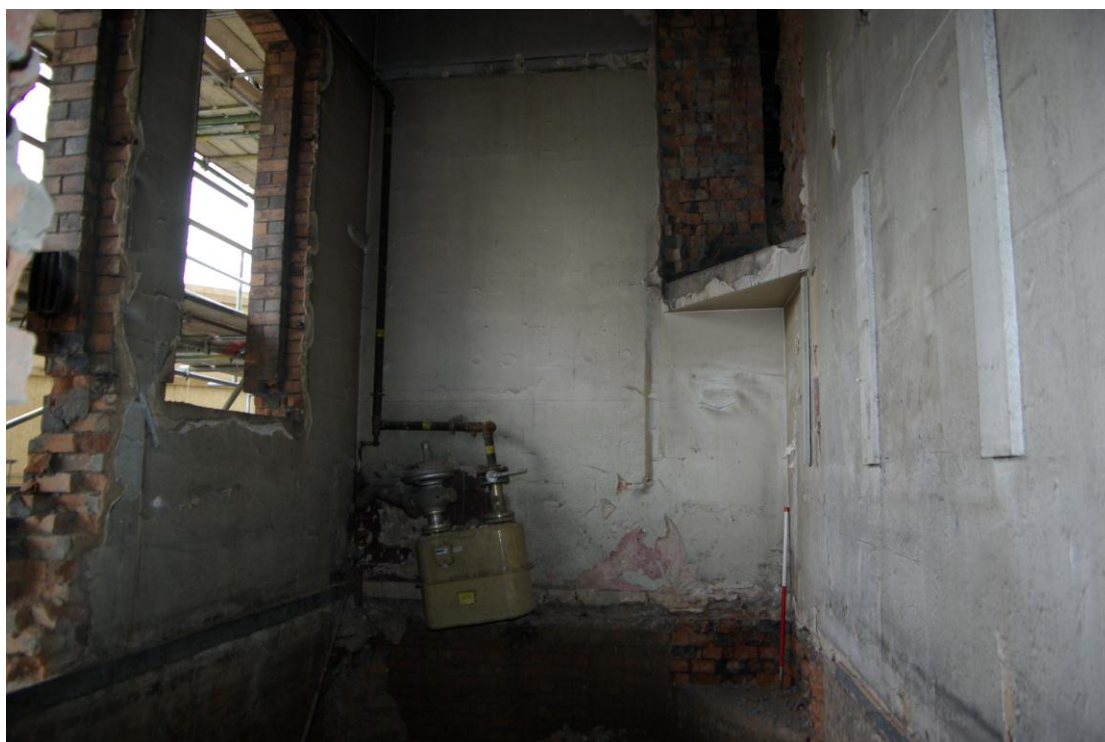
Figure 26 Northern corner building room
Looking north-east. 1m scale

The northern end rooms were in a state of demolition and were not safe to carry out a detailed inspection. The southern corner room has a small triangular block of masonry in the eastern corner which may have been for a hearth suggesting that it was built as an office (Fig. 26). The larger block on the north end is divided into two by a low wall (Fig. 27).
