**An Historical Building Assessment at
Shacklewell Lodge Farm,
Empingham,
Rutland.**

NGR: SK 96490 07778

ULAS Report No. 2014-196
©2014

For: Marrons Planning

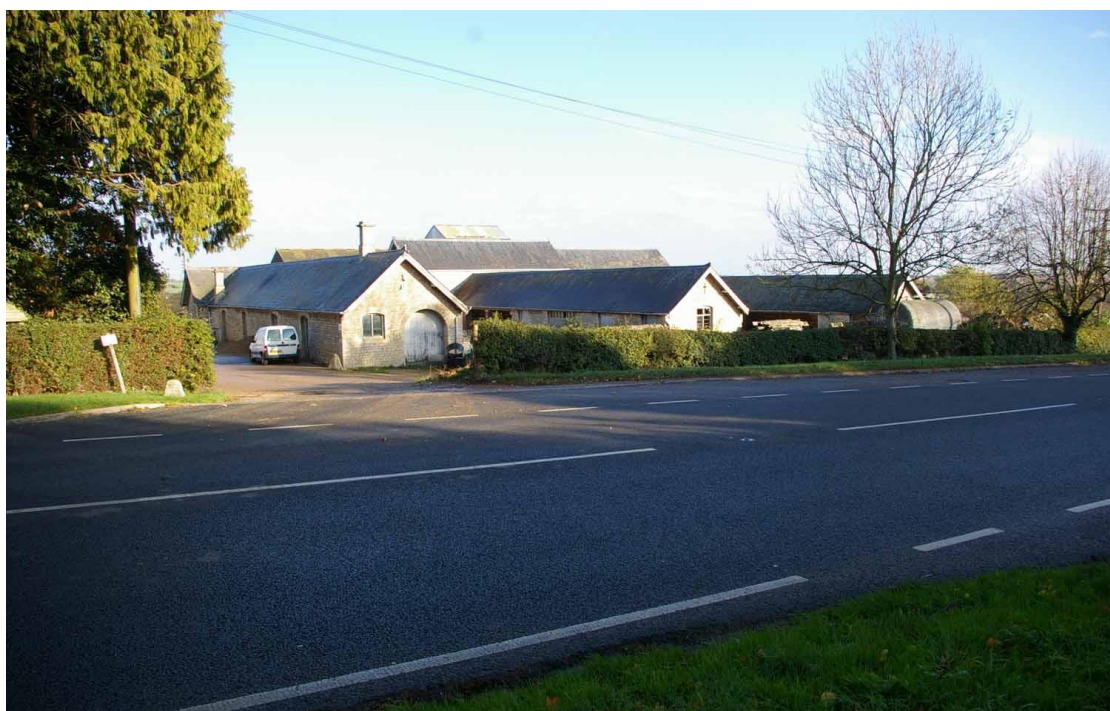
Figure 8 General view of farm buildings from A606
Looking north east

The whole farm complex forms a relatively compact rectangle following the slope of the hill down towards the north east (see Fig. 2). Because of the slope in the site most of the farm buildings are partially hidden by the boundary hedge running along the side of the road (Figs. 8 and 9). The original buildings erected by the Normanton Estate are closest to the road with the farmhouse on the western side with the old cart shed next to it on the east. A concreted track runs down the side of the cart shed and has the E-shaped farm buildings on the eastern side. Attached to the rear, northern side, of the E-shaped buildings are two modern agricultural buildings and, further north, are several more modern open-sided barns made from a range of modern materials (Fig. 10). At the time of the survey the later modern buildings were being used for storage purposes and house a number of agricultural machines.

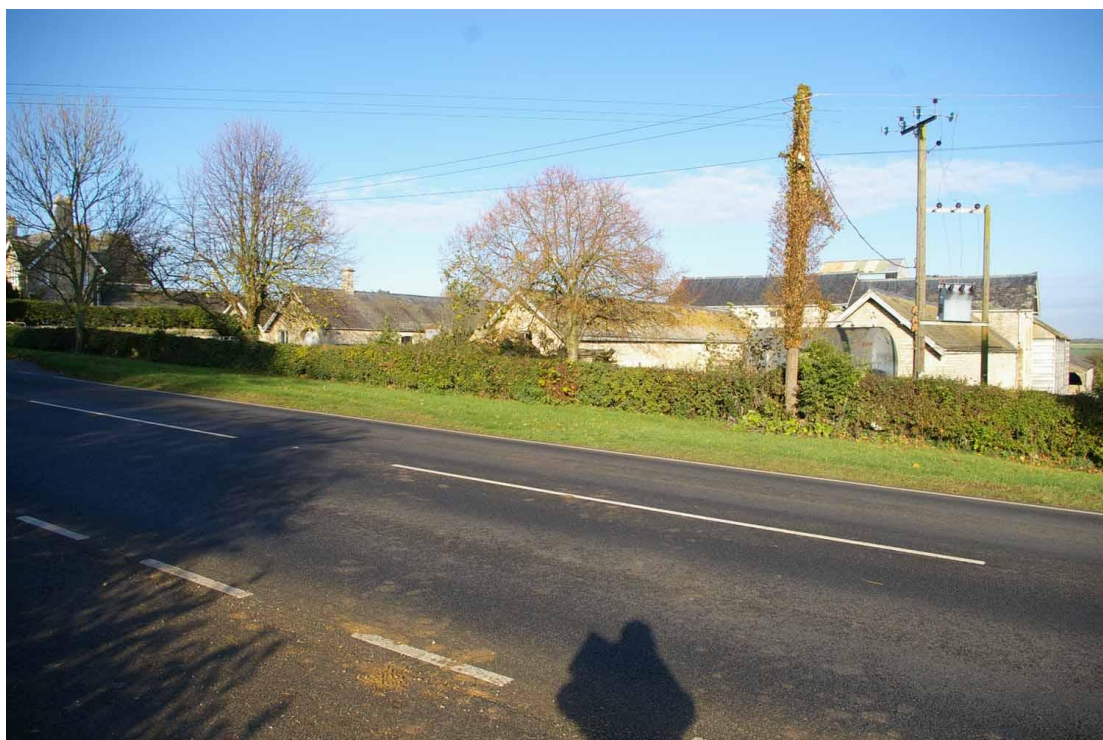
Figure 9 Farm buildings from A606
Looking north-west. Note farmhouse on far left

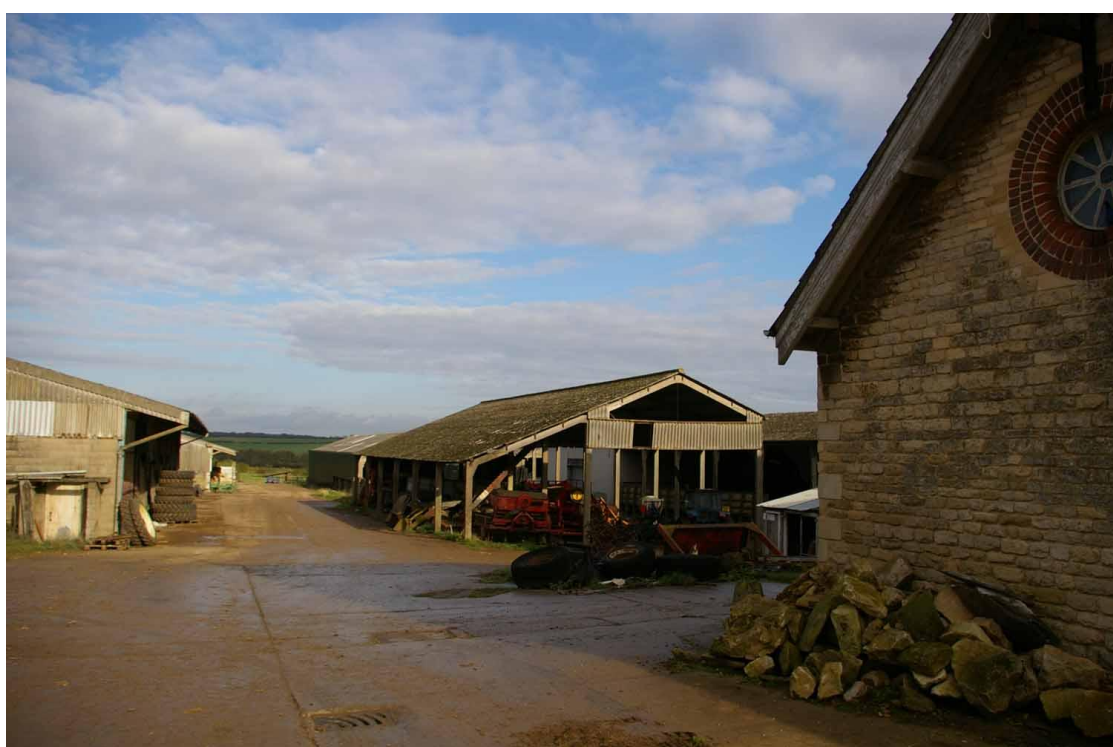
Figure 10 Modern farm buildings to north of original buildings
Looking north

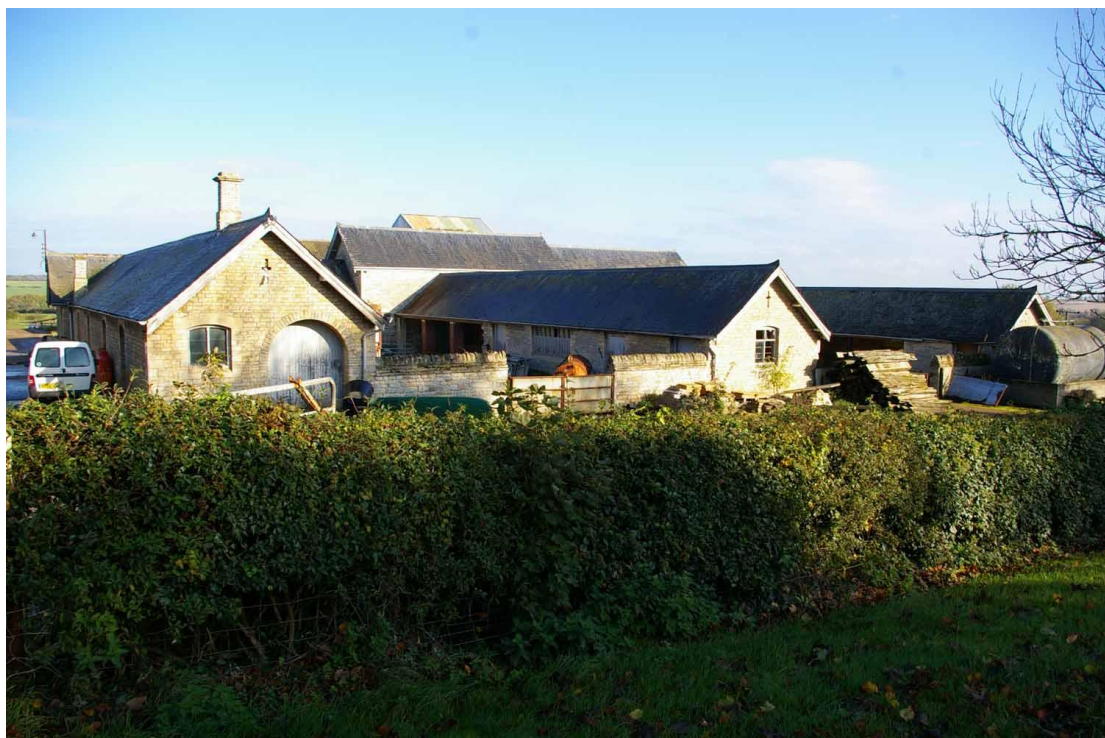
The south elevation is the principal elevation facing the A606 road and has three gable ends of three wings which create two rectangular courtyards, or foldyards as described in the 1924 sale document (Fig. 11). The western gable end has a wide double door with a curved segmental stone lintel, whilst the remaining doors and windows elsewhere are made from smooth carved limestone. Cruciform air vents are set high up in the gable ends. The southern side of each courtyard is created by a stone wall which is bonded with the main building walls. Modern metal gates have replaced the original gates and part of the western courtyard wall has been replaced with modern breezeblock. The rear range of buildings which form the northern end of the courtyards have three separate roof heights (Figs. 12 and 13). The rear range is of single storey height on the west before stepping up to two storeys to accommodate the granary. Because the land slopes down to the south east the two-storey portion also steps down hence the drop in roof height on the eastern side.

Figure 11 South facing elevation
Looking north-east

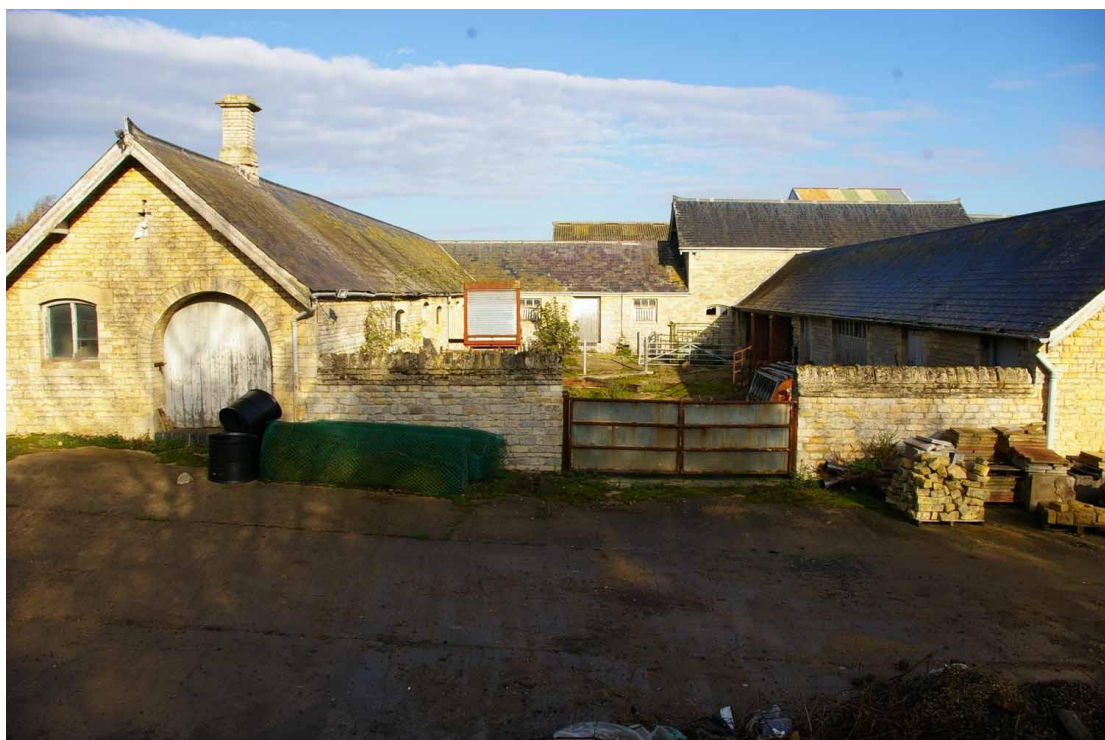
The western courtyard has a modern concrete surface with varying heights and slopes across it. The two wings open out onto it with an open brick-pillared cattle three-bay cattle shed on the east. The enclosed buildings have most recently been used for storage and stabling. The concrete floor of the courtyard extends into the cattle shed. The eastern courtyard is similar but has no openings on the western wall. The brick pillars of the two three-bayed cattle sheds have had their brick supporting pillars removed and replaced by modern lengths of railway flat-bottomed rail. Access can be gained into the north range from two separate doors. The roof structure of each wing consists of a king post with a decoratively shaped pendant design at the base. The trusses are made from two thin lengths of wood bolted either side of the king post and principal rafters with metal stirrups and rods adding to the strength of the structure. Clapsed and cleated purlins sit on the backs of the principal rafters and sarking boards are attached to the backs of the main rafters (Fig. 14). This pattern of roof structure is followed throughout the building with the exception of the south end of the west wing where stone dividing walls provide much of the roof support and king posts are omitted.

Figure 12 Western courtyard, south facing elevation
Looking north. Note decorative ridge details at gable ends

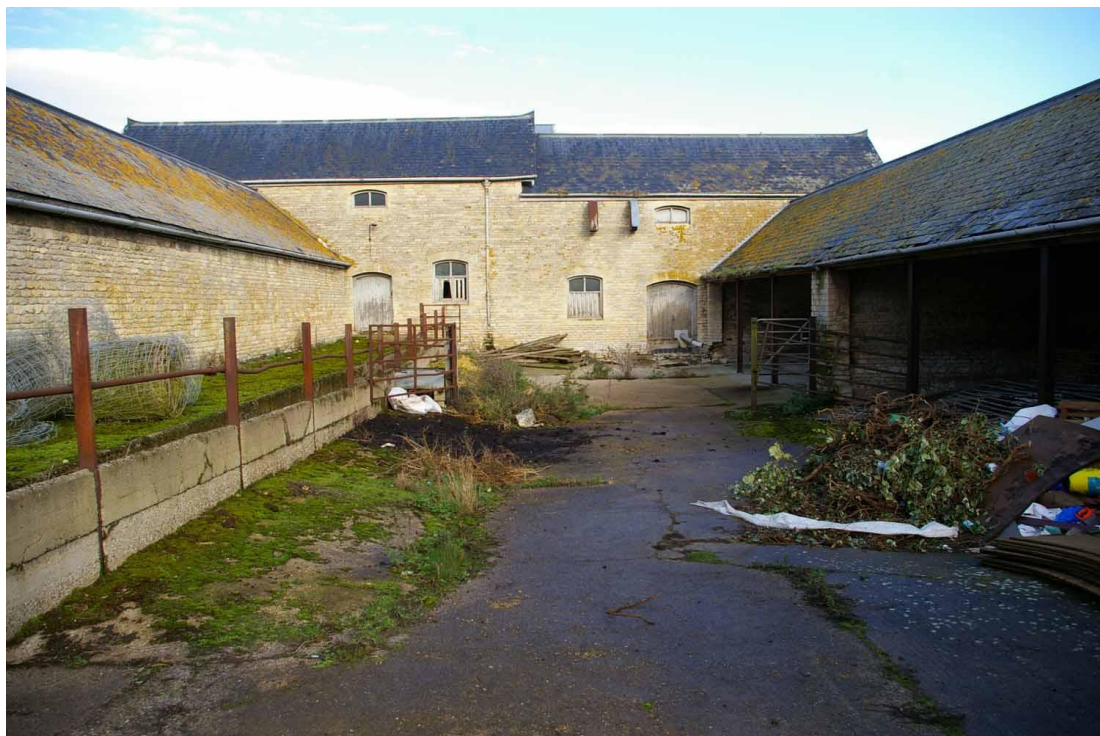
Figure 13 Eastern courtyard, south facing elevation
Looking north

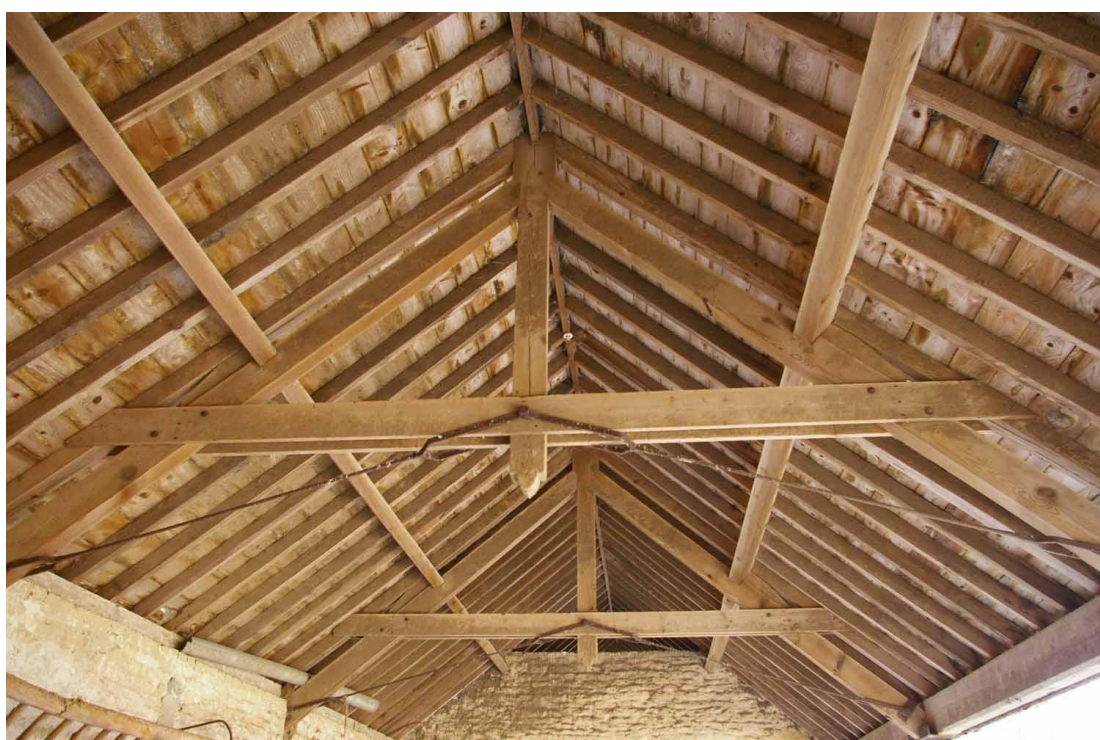
Figure 14 Roof structure detail
Eastern cattle shed. Looking south

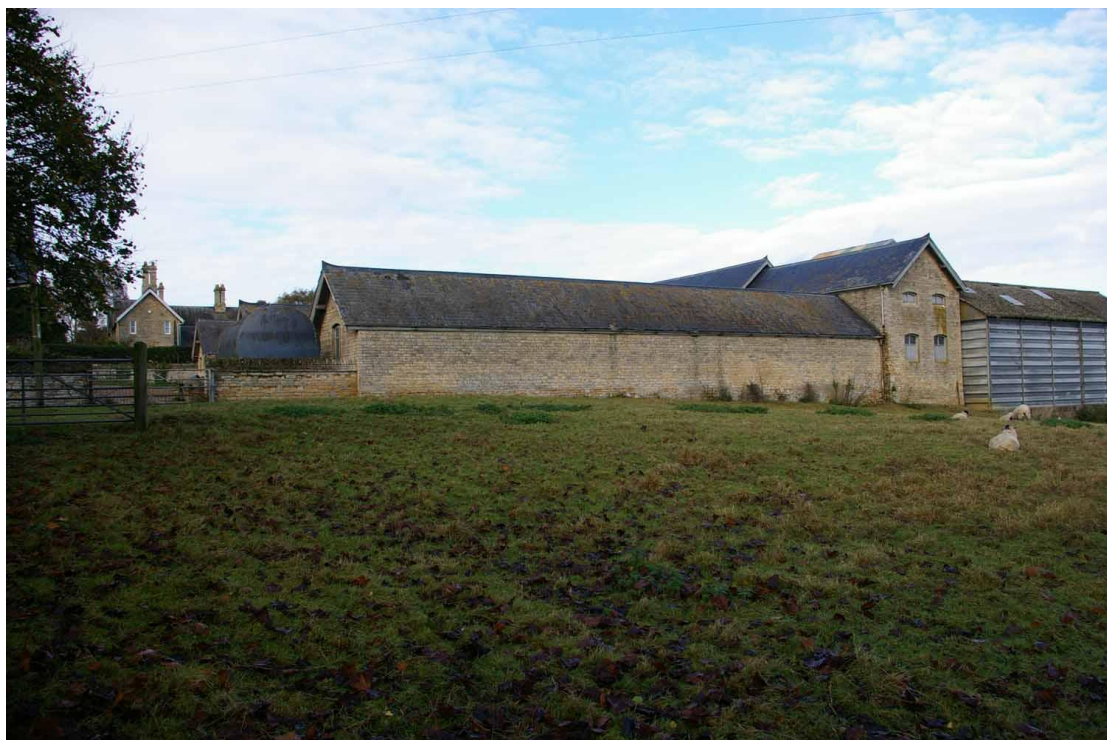
The east facing elevation of the east wing forms a boundary between the rectangular farm area and a large paddock currently used for sheep grazing (Fig. 15). As with the west wing there are no openings on the east side of the east wing but two windows on each floor can be seen on the gable end of the northern range. The first floor windows are only small windows but all of them still have the carved stone lintels.

Figure 15 East facing elevation
Looking west north-west

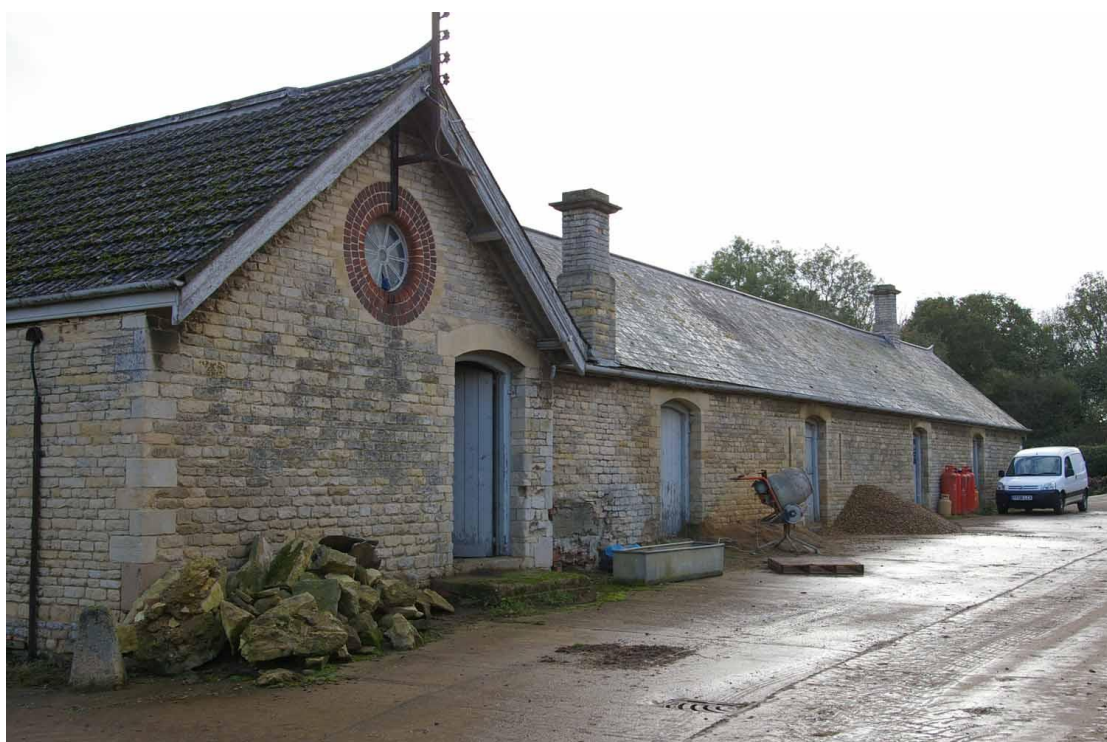
The west facing elevation of the west wing has a number of doors leading into a small office, store and stables some of which would originally have been built as pig sties (Fig. 16). Either side of the centre door are two slit vents which might indicate this was where the pigs were kept. A circular metal-framed window with a brick surround is set into the gable end of the northern range. The bricks, although slightly incongruous with the rest of the building style of decoration, do seem to match those on the brick pillars of the cattle sheds and hence are likely to be part of the original design.

Figure 16 West facing elevation
Looking south east

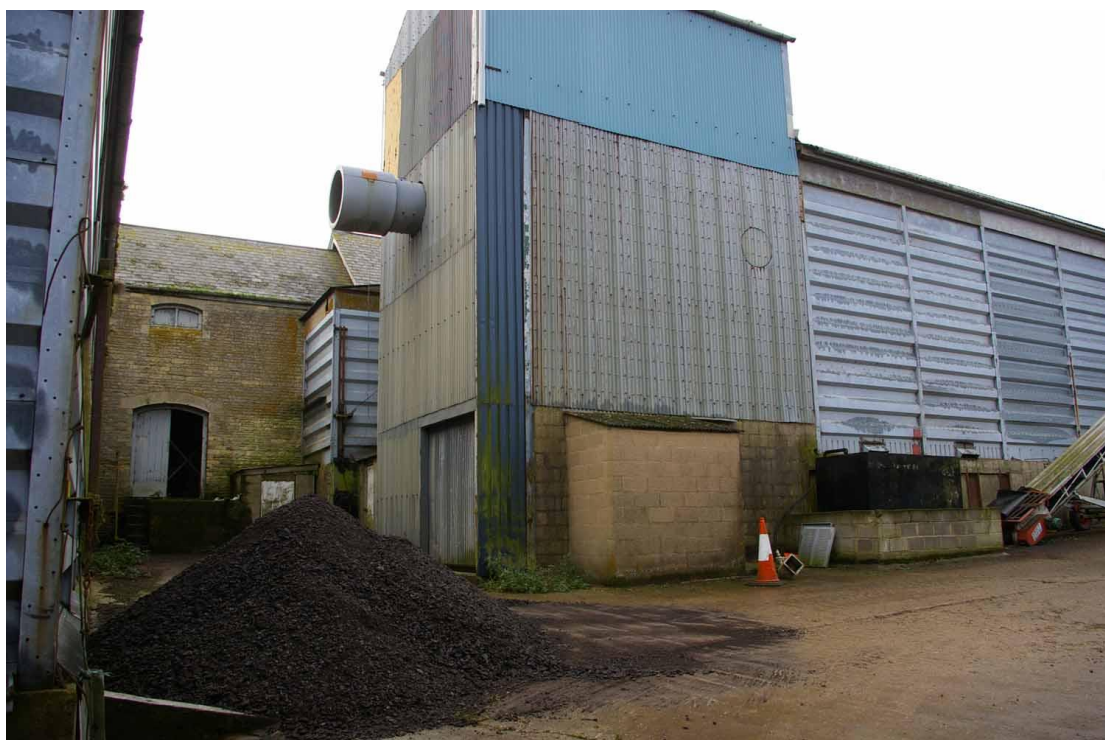
The north facing elevation is partially obscured by a later metal-clad building (Figs. 17 and 18). Despite this the differences in roof height can still be seen quite clearly. Double doors at first floor height lead into a hayloft or feed store.

Figure 17 East side of north facing elevation
Looking south. Note step in first floor roof height

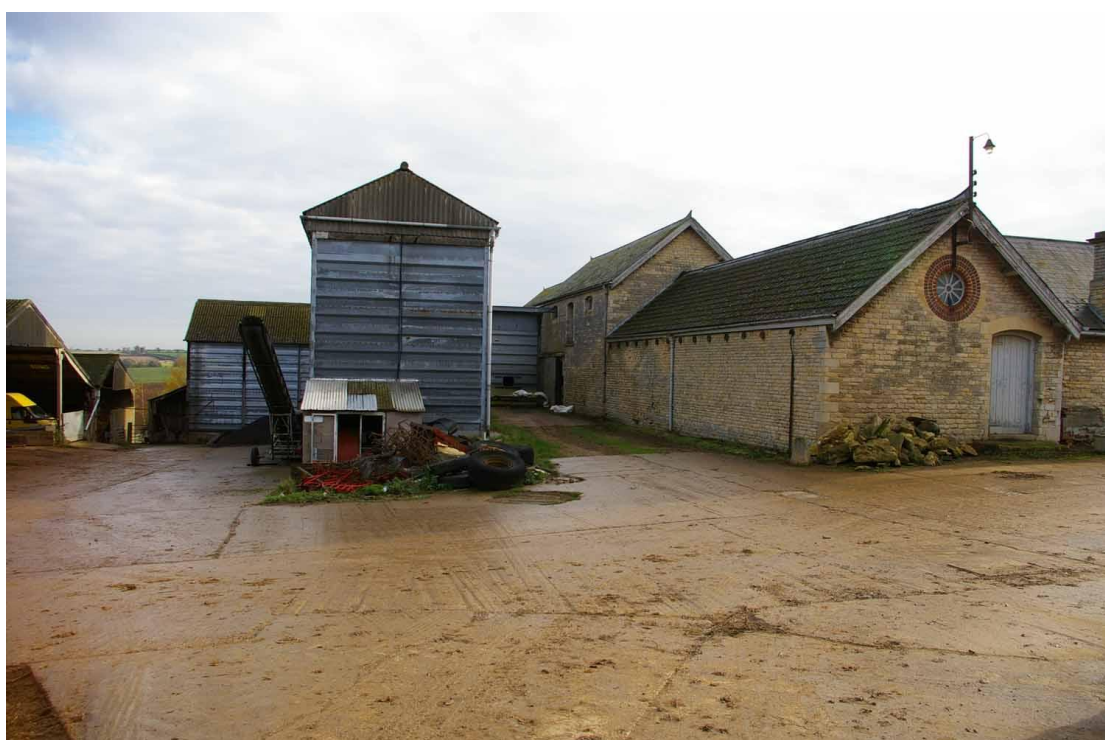
Figure 18 West side of north facing elevation
Looking south-east

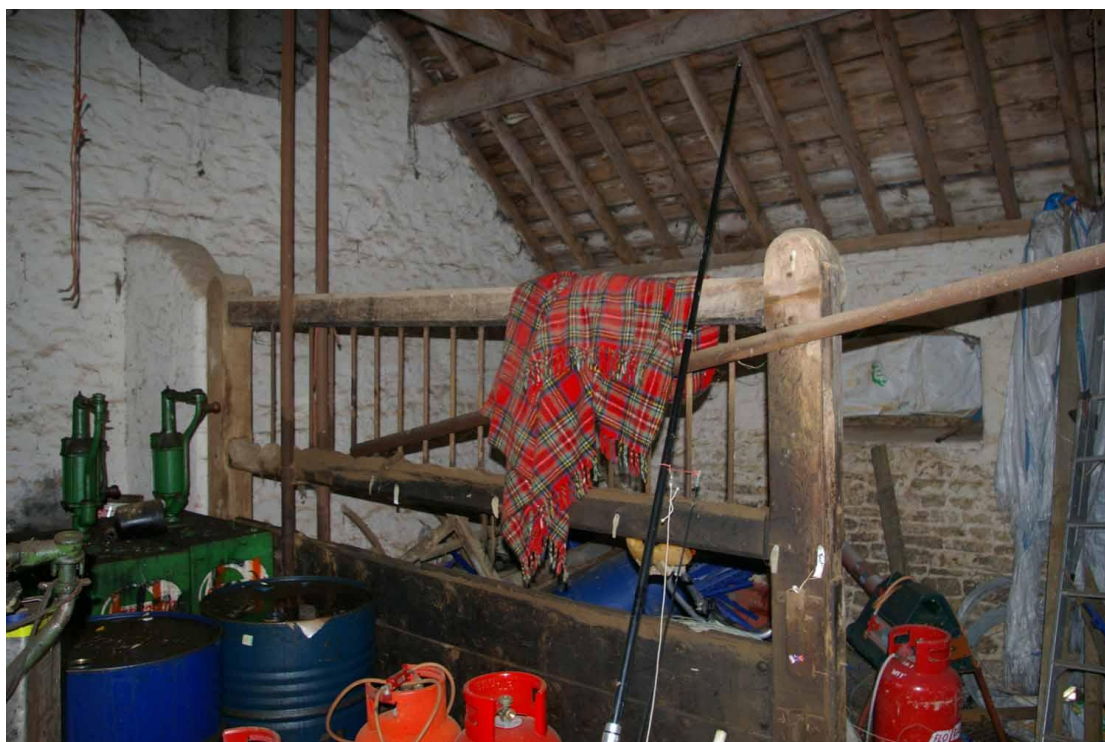
In order to strengthen the doors and windows the internal faces and surrounds have been built of brick and can be seen throughout the building. A small office and store is located at the southern end hence the arched doorway in the gable end. North of this is an individual loose box which retains its wooden partition wall (Fig. 19). A further three similarly sized rooms with brick floors complete this wing. The northernmost room has a small blocked fireplace with a chimney on the roof which is similar in style to those on the farmhouse.

Figure 19 West wing, loose box
Looking north east

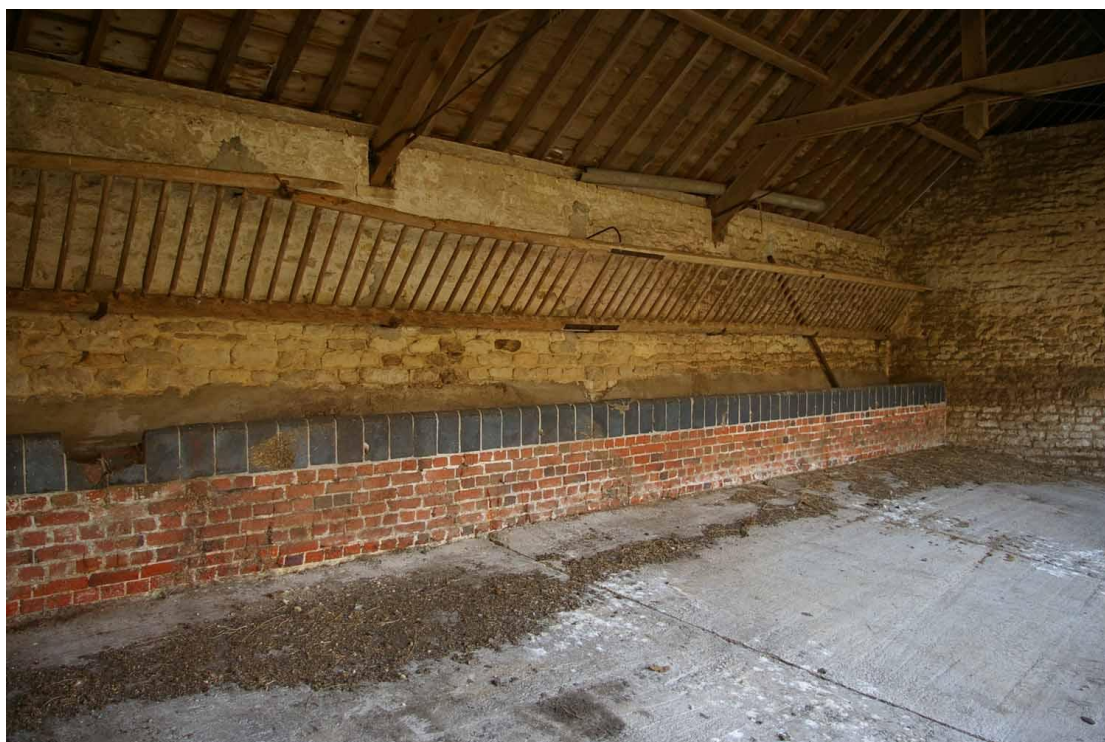
As already discussed this wing houses a three-bay cattle shed. This contains a brick built trough running the length of the shed with a wooden feed rack above (Fig. 20). A brick-floored stable with a similar brick-built trough and a wide rectangular window lies to the south of the cattle shed (Fig. 21). The remains of a stone rubble-built trough can be seen below the wide window in the courtyard. A small brick-floored store forms the south end of this wing.

Figure 20 Cattle shed trough
Looking south-east

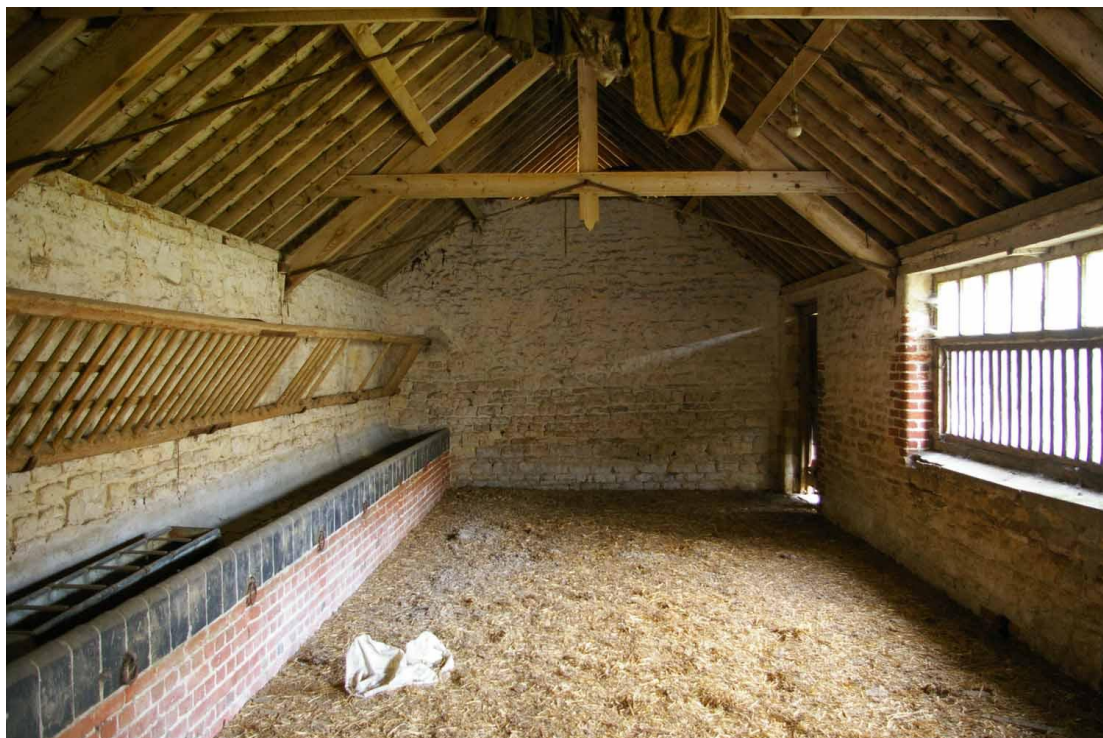
Figure 21 Centre wing stable
Looking south

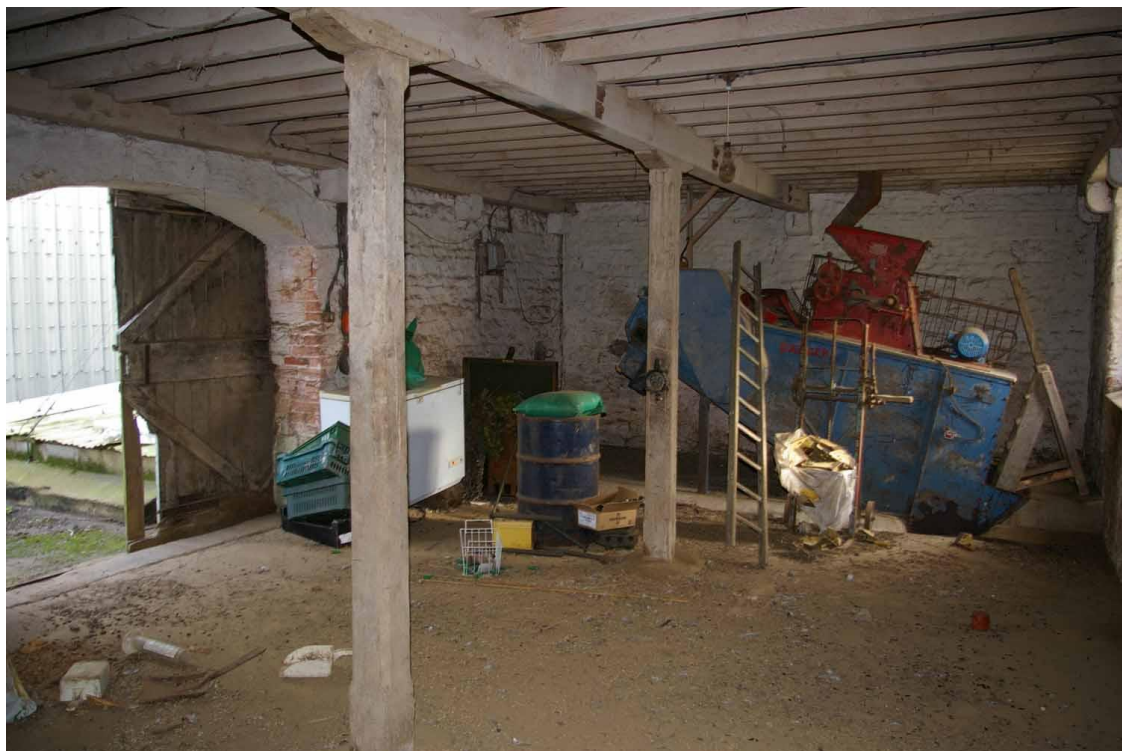
The northern range of buildings runs across the north ends of both courtyards. The single storey west end of the range houses a long single room with a modern concrete floor. A trough with a wooden feed rack and remnants of partition walls runs along the north wall (Fig. 22). A door at the eastern end leads into the middle room of the range which has a slightly lower floor level. The middle room has a concrete floor with central wooden chamfered post supporting the wooden floor above (Fig. 23). The first floor joists rest on stone corbels projecting from the side walls. The room houses some relatively modern machinery. There is no connection between the central and the eastern room which can only be reached from the courtyard or from the north up a short flight of concrete steps. The eastern room has similar chamfered posts and a concrete floor with wooden steps up to the first floor.

Figure 23 North range, centre room, ground floor
Looking north-east

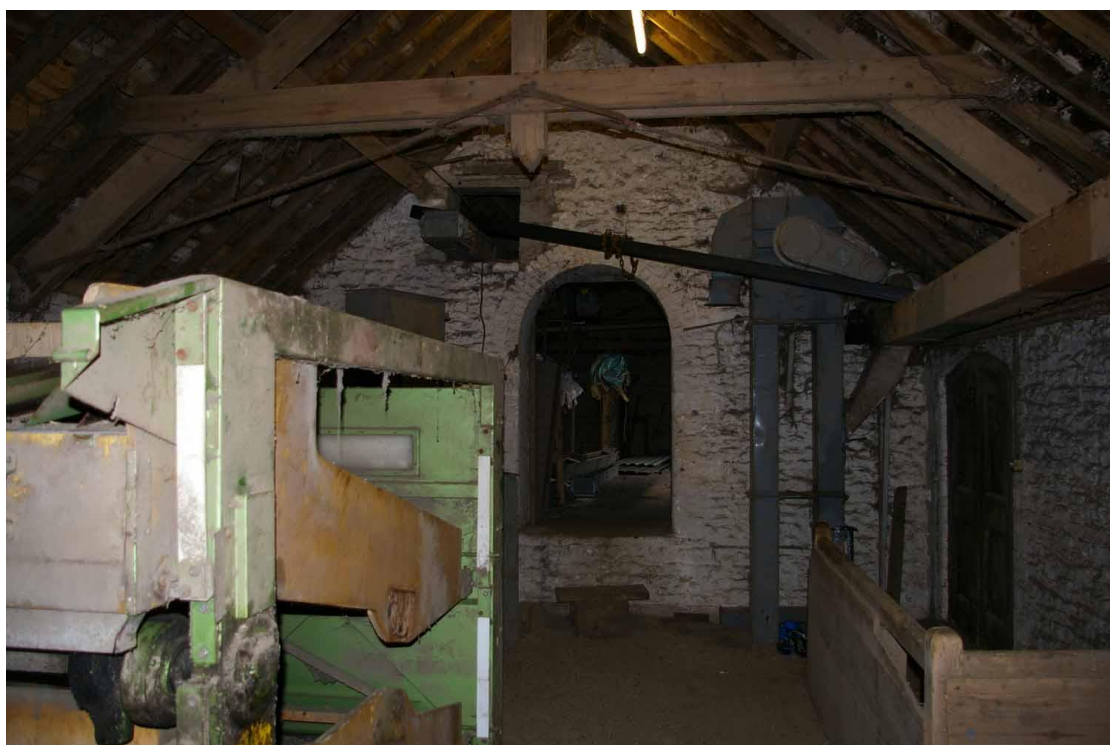
The wooden floored first floor is set at different levels due to the slope in the landscape so that the western half has to be reached by using steps through an arched doorway (Fig. 24). Some modern grain processing machinery is in place in both rooms and some holes have been cut through the floor to accommodate pipework. Parts of the flooring are beginning to rot in places but the first floor is generally sound.

Figure 24 North range, first floor
Looking west from easternmost room

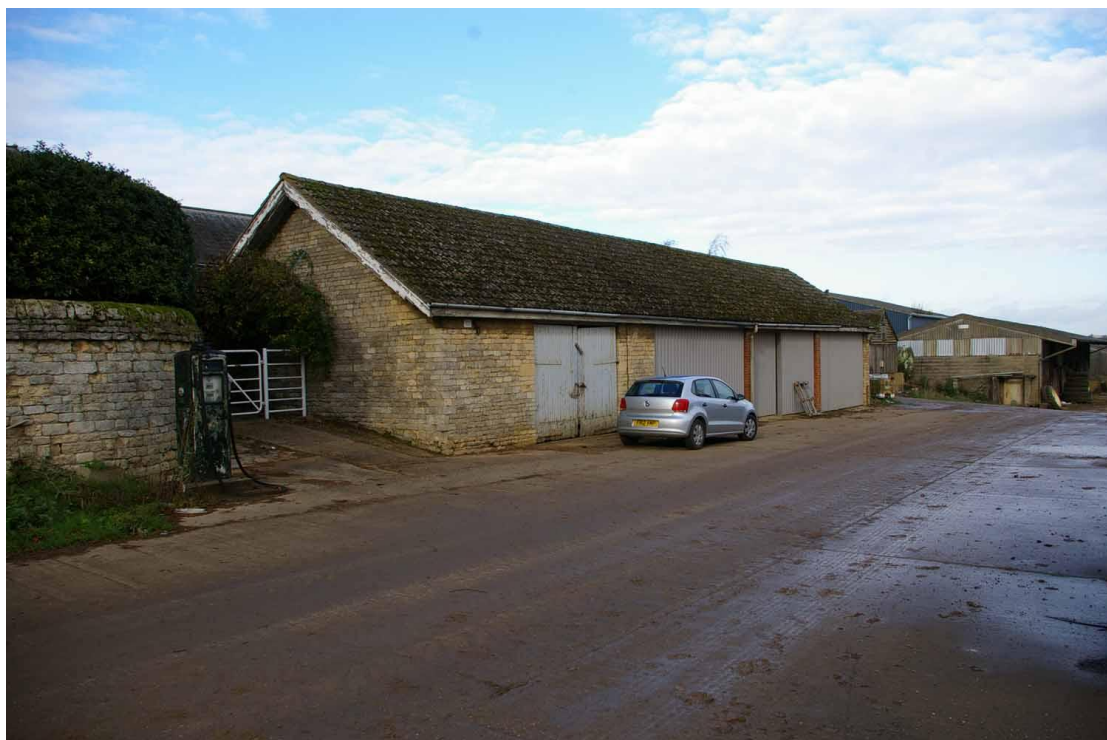
The cart shed backs onto the farmhouse back yard and faces east towards the E-shaped buildings. As with the other buildings this is built from coursed rubble limestone but has a mid to late 20th century ceramic tiled roof covering (Fig. 25). Wooden double doors lead into what is now used as a garage but was presumably originally used for harnesses and other equipment. Modern corrugated metal doors enclose the three bays of the cart shed which were built as open structures with brick supporting pillars at the front.

Figure 25 Cart shed
Looking north-west
