Archaeological Inspection and Recording at the Church of St Mary the Virgin, Ayston, Rutland

ULAS Report No. 2015-106 © ULAS 2015

Archaeological inspection and recording at the Church of St Mary the Virgin, Ayston, Rutland (SK 86032 00983)

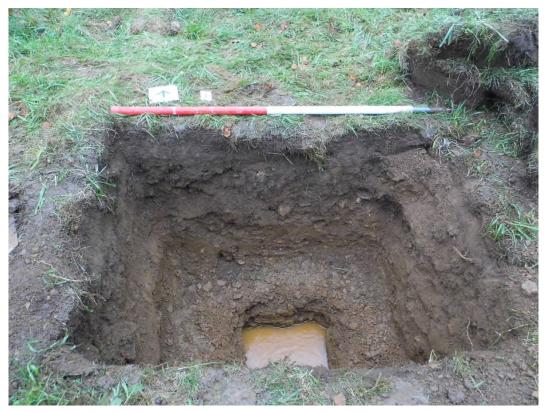
Figure 4: Test pit 1 looking north

The test-pits revealed three distinct layers of soil making up the graveyard levels with a depth of approximately 1m. The topsoil comprised a dark brown clay loam, 0.2-0.3m thick. Beneath this was an orange-brown silty-clay subsoil with ironstone inclusions approximately 0.4m thick. The natural substrata comprised orange-brown clay ironstone approximately 0.36m deep (Fig. 4).

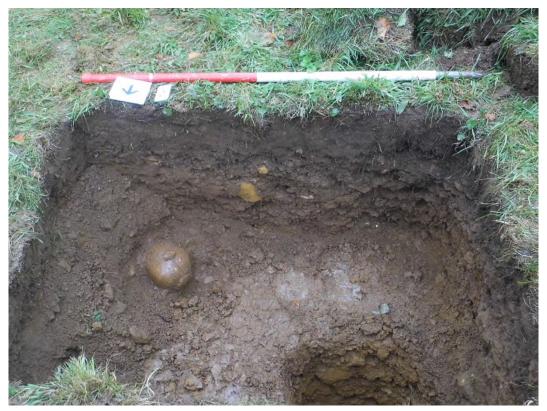
Figure 5: Test pit 2 looking south

Various disarticulated fragments of human bone were uncovered from the lower fills. The edge of a skull was identified in corner of Test Pit 2, which did not have a corresponding gravestone, and was left in situ (Fig. 5).

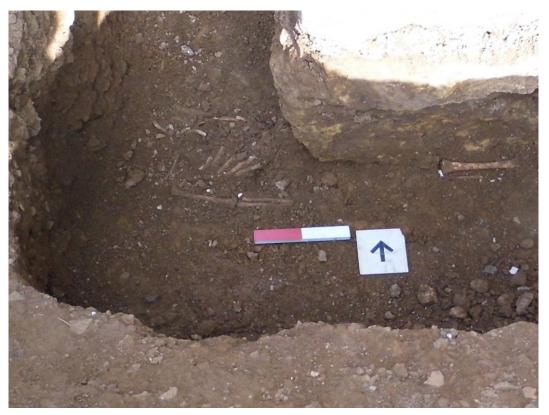
Skeletons 1-3 lay on the west side of the church tower (Fig. 3) and all lay at a similar depth of approximately 1.35m below ground level. Two (Skeletons 1-2) appeared to be juvenile whilst Skeleton 3 was neonatal. All three skeletons were truncated by the tower foundations suggesting that this part of the cemetery pre-dates the building of the tower (Figs 6-8). An articulated pair of feet (Skeleton 6) was removed from the east-facing section.

Figure 6: Skeleton 1, truncated by the tower foundations, looking north

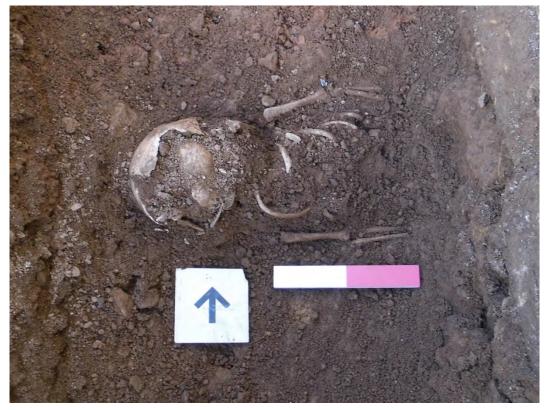
Figure 7: Skeleton 2 truncated by the tower foundations, looking north.

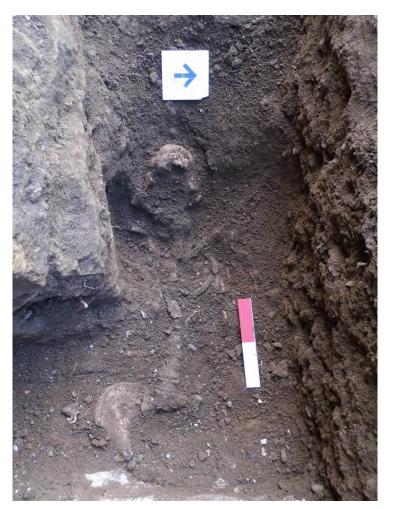
Skeletons 4 and 5 were on the north side of the corner of the tower. Both appeared to be adult burials. Skeleton 4 (Fig. 9) was truncated just below the pelvis by the modern brick wall for the boiler house and seemed to be overlying (but not truncating) Skeleton 5 making the burial later in date. Following the removal of Skeleton 4, the remains of Skeleton 5 were recorded underneath. This skeleton also pre-dated the tower at a similar depth to Skeletons 1-3. The lower legs and feet of a further inhumation (Skeleton 7) were also encountered next to the west end of the north aisle.

Figure 9: Skeleton 4 partially under tower, looking west

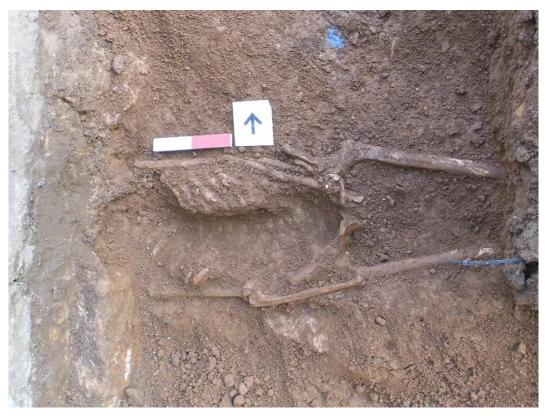
Skeleton 8 had the foundations of the 13th century north aisle built on top of the skull (Figs 10 - 11). Skeleton 10 truncated the lowers legs of Skeleton 8 and the left side of the Skeleton 9 (Figs 12-13), which only had part of the right arm and upper right leg remaining with some of the removed bones placed back with it. Only the skull and part of the right leg of Skeleton 10 were exposed and it was not excavated. These inhumations were shallow, on average 0.35m below ground level.

Figure 10: Skeleton 8, truncated by the tower foundations, looking north

Figure 11: Detail of the skull of Skeleton 8 beneath the north aisle looking west.

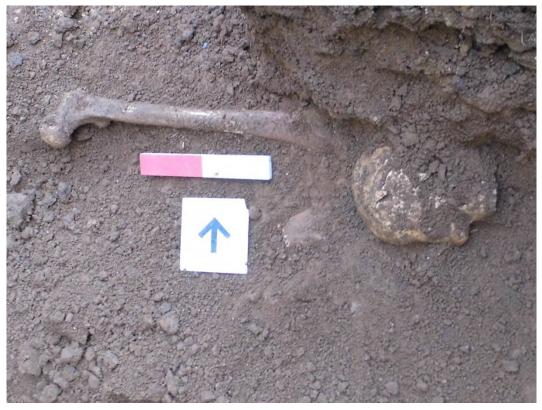
Figure 12: Skeleton10 looking north

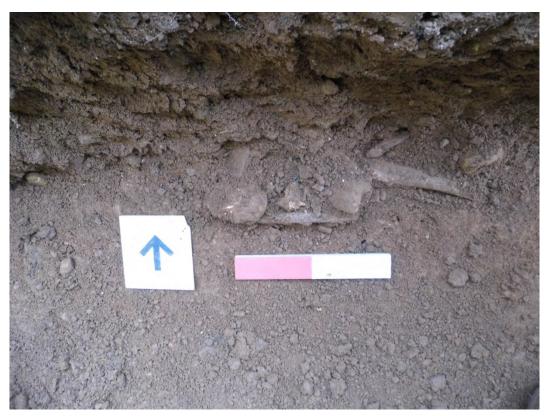
Figure 13: Skeleton 9 looking north

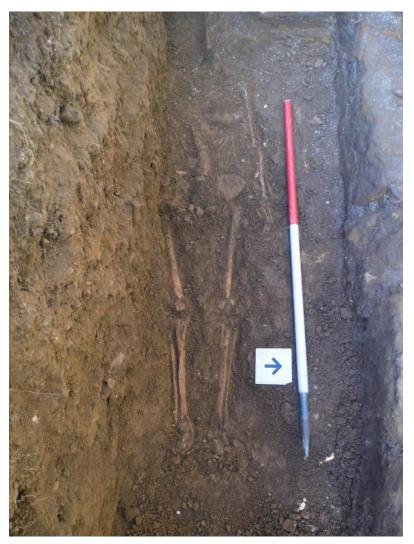
Burials continued to be uncovered from the south side of the chancel. At the east end Skeleton 17 was uncovered at a depth of 0.84m. It was aligned east-west, supine and mostly complete, but seemed to be partially truncated by the southern foundations of the 15th century chancel, (Fig. 14). The remains were juvenile as the proximal ends of long bones were not fused. Skeleton 19 lay directly underneath Skeleton 17 at a depth of 0.9m, and appeared to be truncated by it with only the left arm visible (Fig. 15).

Figure 14: Skeleton 17 looking west

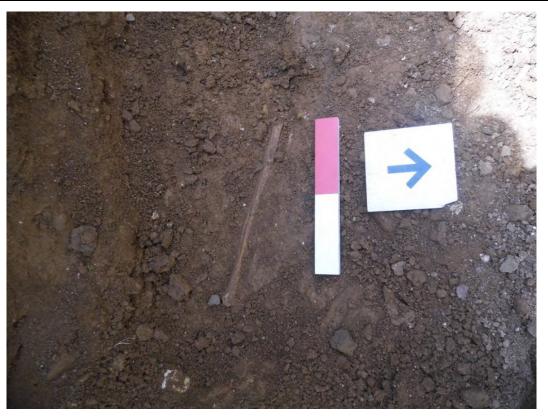
Figure 15: Skeleton 19 looking west

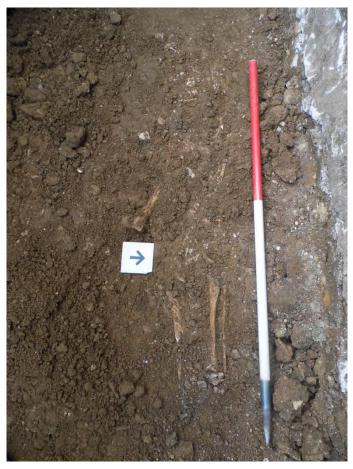
Further west, Skeleton 20 lay at a depth of 1.09m. The bone was in very poor condition as the backfilled soil had a high clay component and seemed to have been compacted (Fig. 16).

Figure 16: Skeleton 20 looking west.

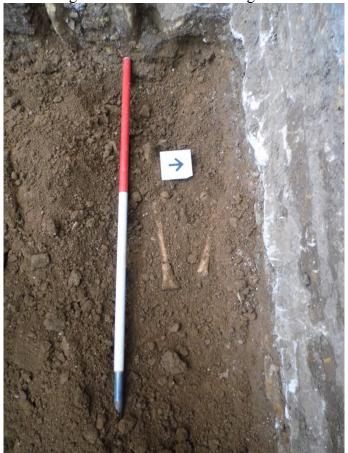
Skeleton 21 was uncovered in the corner of the chancel and south aisle at a depth of c. 1m (Fig. 17). This was a juvenile and possibly truncated by the south aisle although the excavations made it hard to determine precise the amount of truncation. A medieval buckle was recovered from the grave fill (see below and Fig. 26).

Figure 17: Skeleton 21 looking west

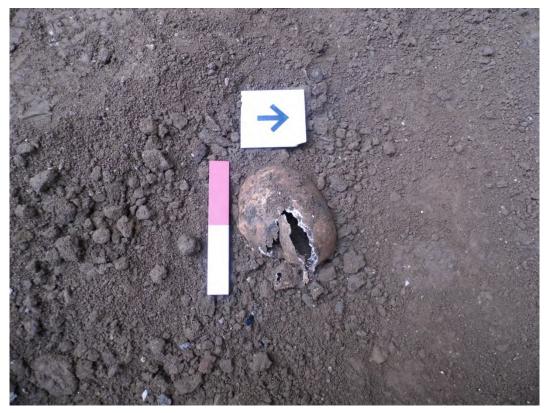
Immediately west of Skeleton 21 lay Skeleton 22 at a similar depth (Fig 18). The skull was removed but the rest of the remains were left *in situ* as they lay below the maximum depth of the drainage channel.

Figure 18: Skeleton 22 looking west.

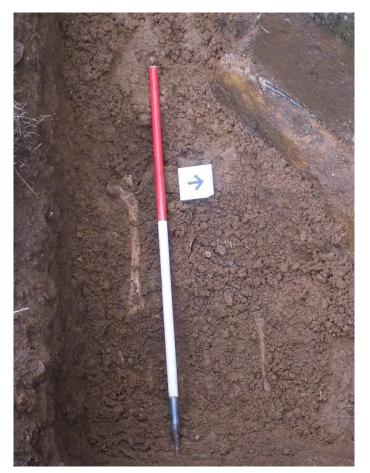
At the south-east corner of the south aisle Skeleton 23 was uncovered at a depth of 0.75m (Fig 19). This skeleton was mostly complete with the legs lying beneath the baulk and what appeared to be a disarticulated leg bone lying next the skull. No evidence for a further skeleton was noted so this appears to have been disturbed. Skeleton 24 lay directly west of Skeleton 23, at a depth of 0.9m (Fig. 20). This was in a poor condition and appeared to only consist of the skull and long bones as there was no trace of the vertebrae, ribs, scapula or pelvis.

Figure 19: Skeleton 23 looking west

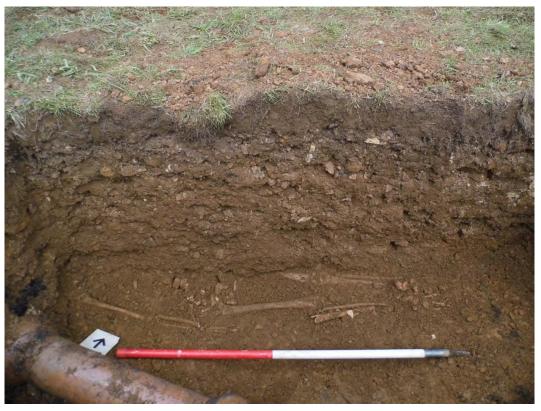
The deposition layers in the silt trap were similar to that of the test pits with approximately 0.1m of topsoil, 0.3m of subsoil with the natural ironstone geology lying at a depth of approximately 0.7m deep. Articulated remains were recorded in both areas. Skeleton 11 lay at a depth of 0.63m deep (Fig 21). Although it seemed to be fully articulated, the skull, left arm and part of the left leg remained in the section and this skeleton was unusually aligned north-east to south-west. The remains seemed to be adolescent in age as some of the proximal ends of long bones were not fused.

Figure 21: Skeleton 11 in the silt trap looking north-west

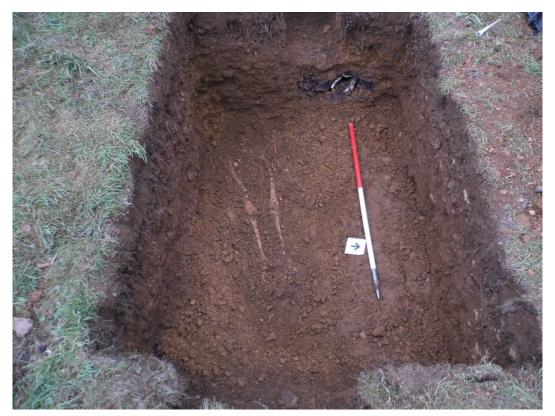
After removal of the Victorian drain pipe, a further two inhumations were uncovered at a depth of between 0.75m - 0.85m (Fig 22). Skeleton 12 was also aligned north-east to southwest parallel with Skeleton 11. The remains of Skeleton 12 truncated most of Skeleton 13; the only remains surviving were skull fragments close to the left knee which appeared to be that of a juvenile. Remnants of the grave cut were also visible and appeared to be aligned east-west.

Figure 22: Skeletons 12 and 13 in the silt trap looking south-west.

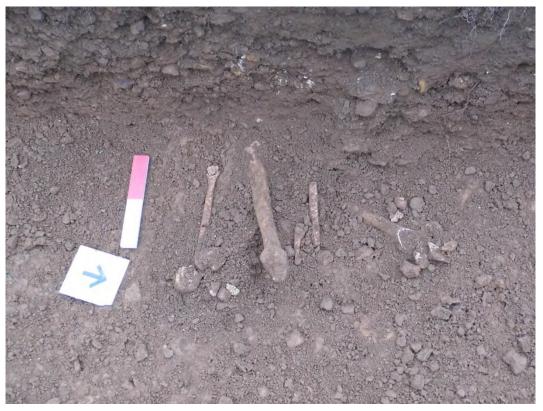
Excavation of the soakaway revealed a further three inhumations. Skeleton 14 lay at a depth of 0.6m (Fig. 23). Only the lower legs and feet were excavated, the rest remaining in the section, however the angle appeard to indicate that the burial was also aligned north-east to south-west. Skeletons 15 and 16 (Figs 23-24) were complete burials parallel with each other. Both had visible grave cuts, aligned east-west at similar depths of between 0.75m - 0.85m. The skull of Skeleton 15 lay partially in the section, but as it would have been disturbed, it was also excavated.

Figure 23: Skeleton 14 in the soakaway looking south-west.

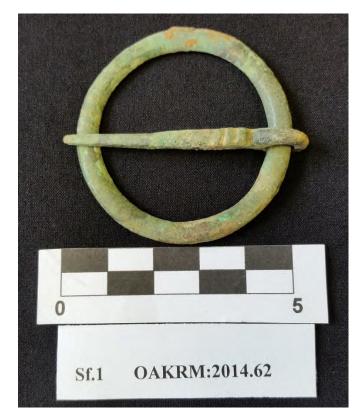
Figure 26: Buckle

Sf.1, burial soil Sk21. Complete cast copper alloy buckle of a plain circular frame d.47mm (internal 37mm). The frame is regular in thickness and ovoid in section. The pin is tapered and has a ridged grip. There is no constriction thus allowing free movement of the pin loop around the frame and thus identifying it as a belt buckle rather than an annular brooch. Examples of similar plain buckles and an identical separate pin, from London, range in date from c.1270-1400 (ceramic phases 9-11) (Egan and Pritchard 1991, 58, fig.36.36 and 38, and 115, fig. 75.541).

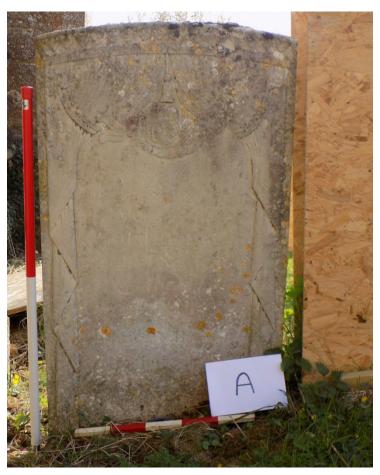
Figure 28: Headstone A

White limestone – quite eroded. Draped curtain effect and scrolled fabric down sides. Cherub in centre. 1.13m high, 0.67m wide.

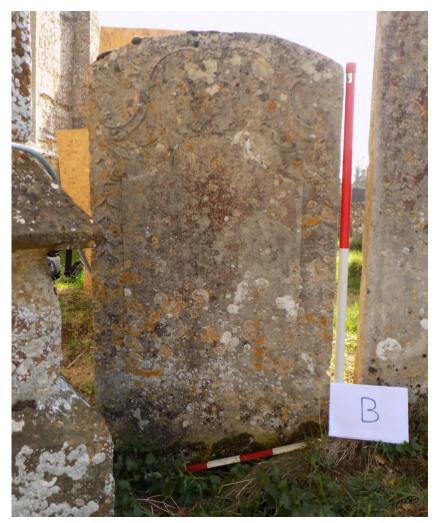
Figure 29: Headstone B

Limestone. Heavily eroded. Centre shield and floral patterns around edge. Text is unreadable. 1.3m high. 0.72m wide.

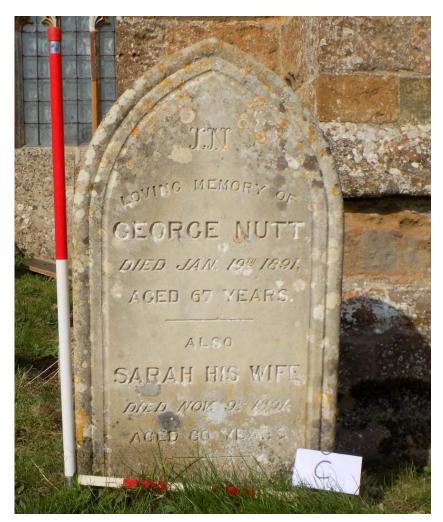
Figure 30: Headstone C

Limestone. Well-preserved. No decoration.

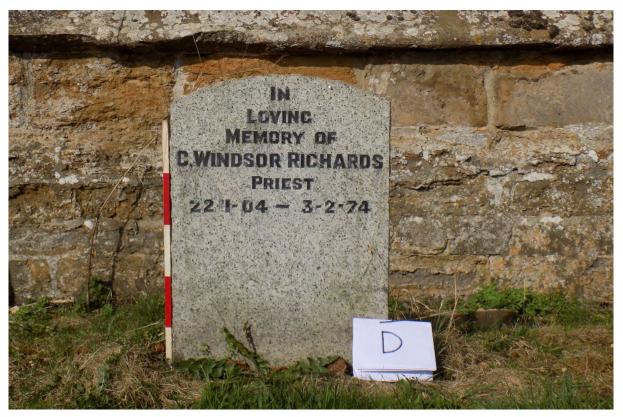
Figure 31: Headstone D

Marble (rough) with inset metal letters. Crisp and well-preserved. 0.53m high by 0.41m wide.

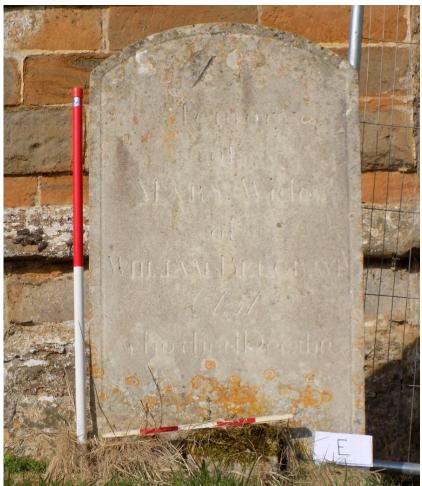
Figure 32: Headstone E

Limestone. A plain line runs around the edge as a border. Some erosion.

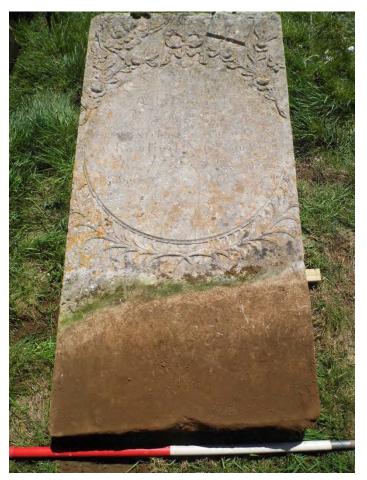
Figure 33: Headstone F

Limestone. Circular disc with roses around the top, leaves at the bottom. Top left cherub head and wings. Top right, open book. 1.56m high by 0.79m wide. Heavily eroded.

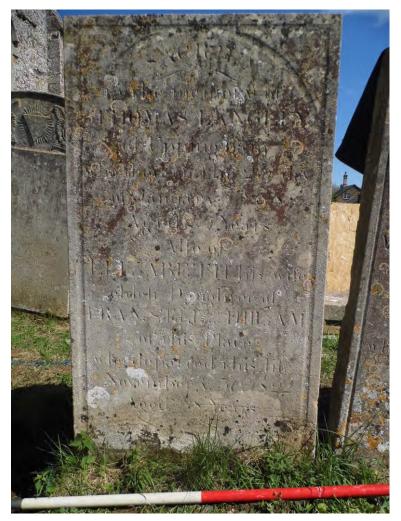
Figure 34: Headstone G

Limestone. A plain line runs around the edge as a border also with two more forming a point at the top. 1.68m high by 0.7m wide.

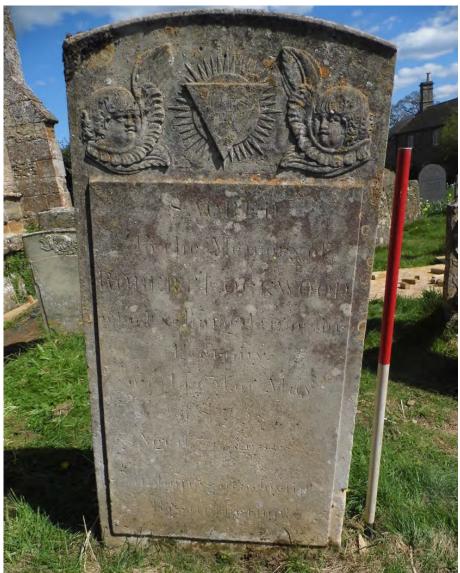
Figure 35: Headstone H

Limestone. Inverted triangle with sun behind it at centre top, cherub heads either side looking toward each other. 1.84m high by 0.67m wide.
