**An Archaeological Strip Map & Sample
on land at Leicester College, Painter
Street, Belgrave Gate, Leicester**

NGR: SK 5909 0556

ULAS Report No. 2014-210

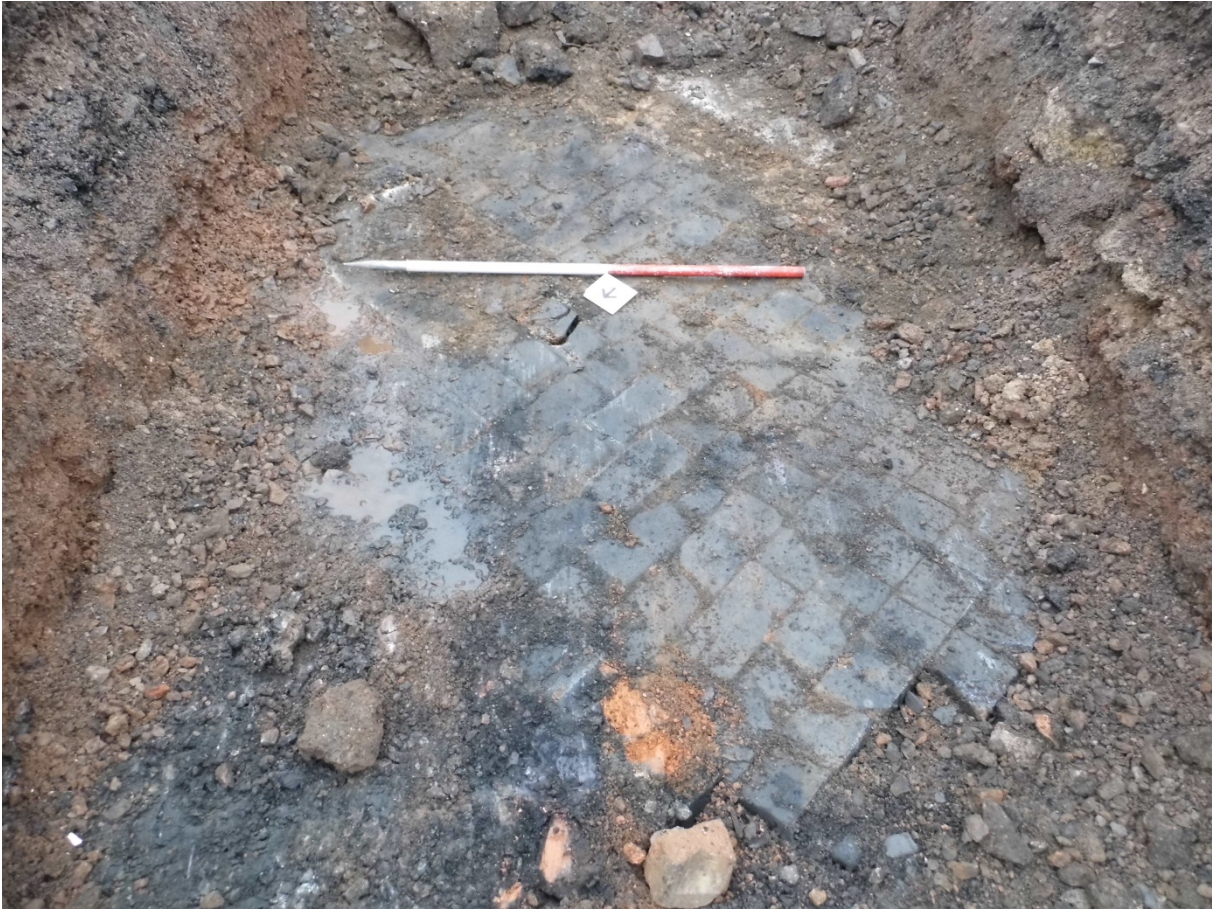
Figure 4: Brick surface looking north-east

An initial trench was excavated to assess whether there were deposits present that would warrant further machine stripping. The trench was excavated to a depth of 1.4m down to a layer of dark-grey organic clay at the north-west end of the trench. At 26m to the south-east, this layer narrowed to reveal a deposit of mixed orange-brown mottled silty-clay at the same depth. This was truncated by a series of post-medieval drains and pipes, the deposit they were dug into changing to grey-brown sandy clay. A single brick foundation wall aligned north-south was encountered at a depth of 0.9m, 0.2m wide, single skinned. A truncated square brick manhole access structure was uncovered at the same depth further to the south-east. A surface made from blue engineering brick was noted above this, 0.8m below ground level while machining.

These post-medieval (most likely Victorian) brick structures were overlain by grey-brown sandy clay with many brick and charcoal inclusions, 0.23m thick. This was overlain by a modern pink stony hard-core layer that seems to change where the north-south brick wall lies in the trench.

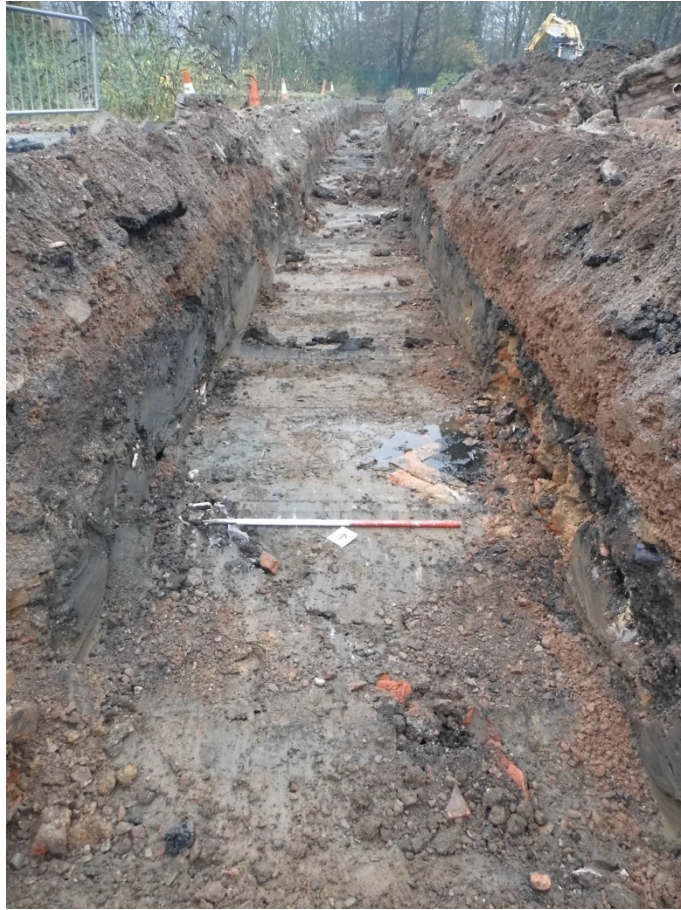
Figure 5: Trench looking north-west

In the north-western part of the trench, the organic layer was overlain by brown-orange sandy-clay with orange stone inclusions, 0.2m thick. This was overlain by red-brown clay sand 0.2m thick. These two layers narrow out towards the south-east to be overlain by a layer of thick pink clay. This was overlain by mixed dark grey clay 0.2m thick, in turn overlain by mixed grey-pink sandy-clay filled with demolition material and coal fragments, 0.26m thick. The three layers overlying this made up modern hardcore (0.4m thick) for the tarmac layer on top of it, 0.1m thick.
