An archaeological watching brief at land adjacent to Mill View, 17, Forge Lane, Stretton, Burton-on-Trent, Staffordshire (NGR SK 26066 27148)

ULAS Report No 2016-048 ©2016

Mr A Hassall Planning Application Ref: P/2014/01072

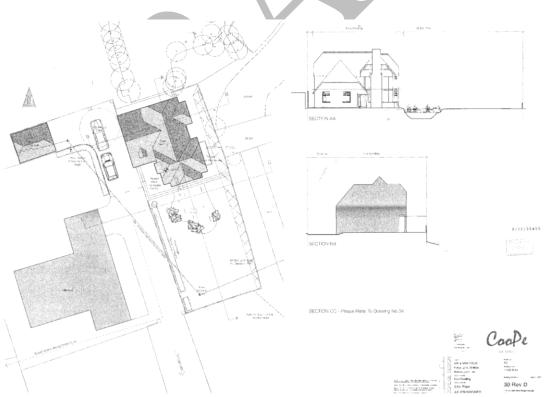
Figure 5: Plan of proposed building (taken from plan supplied by client; not to scale).

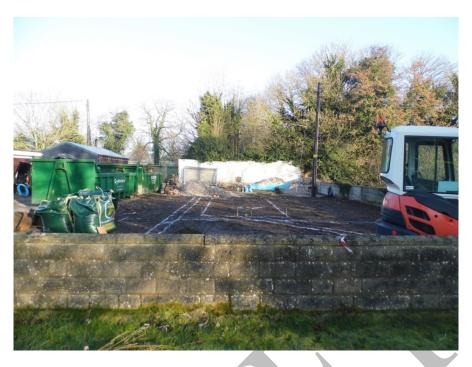
Figure 6: View of site prior to excavations. Former swimming pool in background. Looking north- west

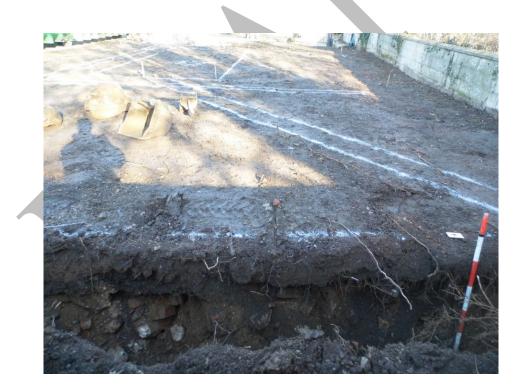
The ground-works were monitored on the 25th of February 2016 by James Patrick of ULAS. An initial photographic survey was conducted of the area prior to the excavation for service trenches. The marked out site was not for the construction of the dwelling which was to be undertaken later. However the detached dwelling was to be constructed at the far north end of the site on the site of a former swimming pool by way of piling. It was deemed that any archaeological remains present would have been destroyed by the pools construction. Excavations for an east to west service pipe began at the far south end of the site running parallel to the present wall. Brick and concrete rubble was removed to the required depth of 0.80m and was observed to continue. Observation of the pipe trench section indicated that modern disturbance comprising bricks and concrete rubble to extended across the whole width east to west and continued north towards the old swimming pool (see Figure 6). The watching brief was continued during the excavation of a water tank approximately eight metres to the north. This measured seven by three metres and 1.20 metre deep. The tank footings observed indicated that the modern disturbance continued. The brick rubble and concrete was observed at the north end of the tank excavation 15 metres east of the pipe trench. Observation of all four sides indicated the whole area to be made up with brick rubble and concrete. This was observed to a depth of 1.20 meters and appeared to continue. No archaeological remains were encountered or any artefactual evidence recovered. In view of the clear evidence of modern disturbance throughout no further excavations were observed.

Figure 7: Excavation of pipe trench showing brick and concrete rubble. Looking North.

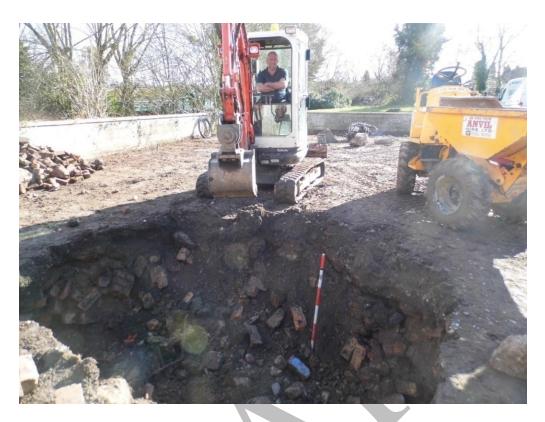
Figure 8: Excavation of water tank showing brick and concrete rubble. 1.10m scale. Looking south.

It does appear likely that the W.Podmore and Sons factory which was the last building on the site dated from 1928. Observation of the bricks showed the brick maker to be a Edwin Glossop of Ambergate. Edwin Glossop's Ambergate brickworks was in production from 1925 until its takeover by the Butterley brick company in 1947. This evidence correlates with dates of construction for Podmore's works of circa 1928 with
