An Historic Building Recording
(photographic survey) at
53 Oxford Street,
Leicester

NGR: SK 5856 0393

ULAS Report No. 2015-088
©2015

For: Evans Heritage Developments

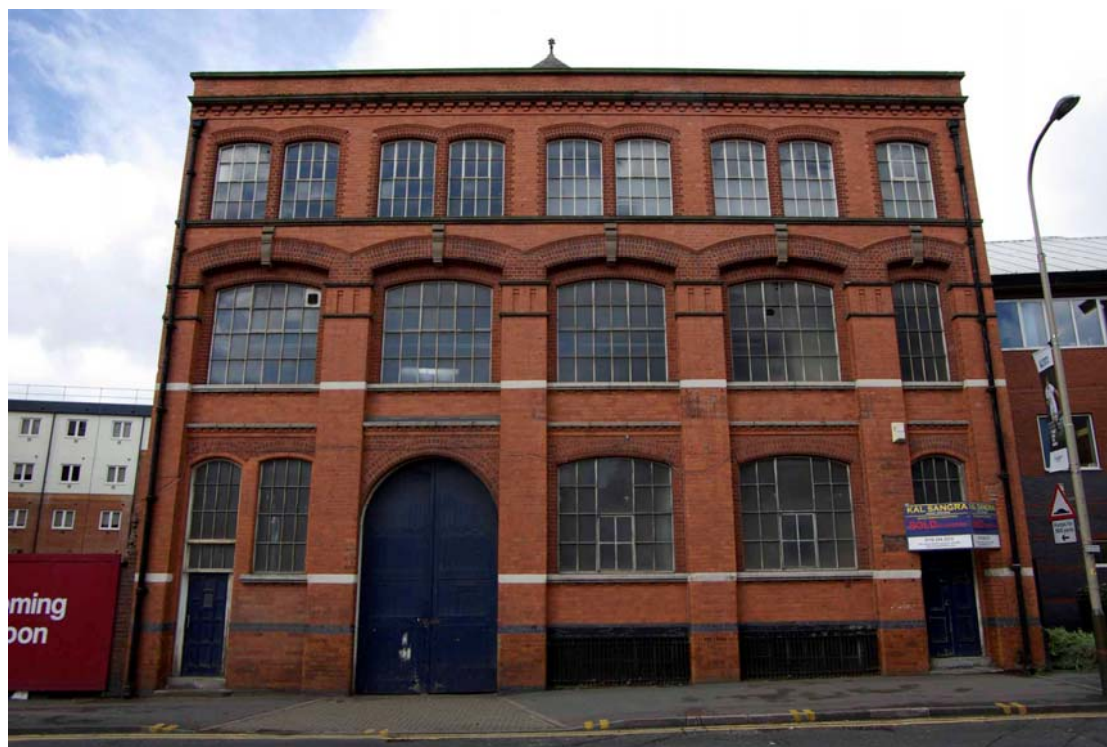
The north-east facing elevation fronts onto Oxford Street and has four main bays with a fifth narrow bay at its eastern end (Figs. 3, 4 and 5). A raised parapet hides the roof and eaves to create a much larger and imposing frontage. A large set of double gates leads into the enclosed courtyard mentioned above. To the east of the gates is a small doorway leading into a single room office which was not accessible for photography during the survey (Fig. 6). Inspection through the window showed this to be an empty room. The narrow bay on the western end has a set of narrow double doors leading into the entrance hall and main staircase (Fig. 7). Large iron-framed windows let in the maximum amount of light on all floors (Fig. 8). The basement windows are protected by low cast-iron railings and have cast-iron lintels (Fig. 9).

Figure 3 North-east facing elevation onto Oxford Street
Looking south-west

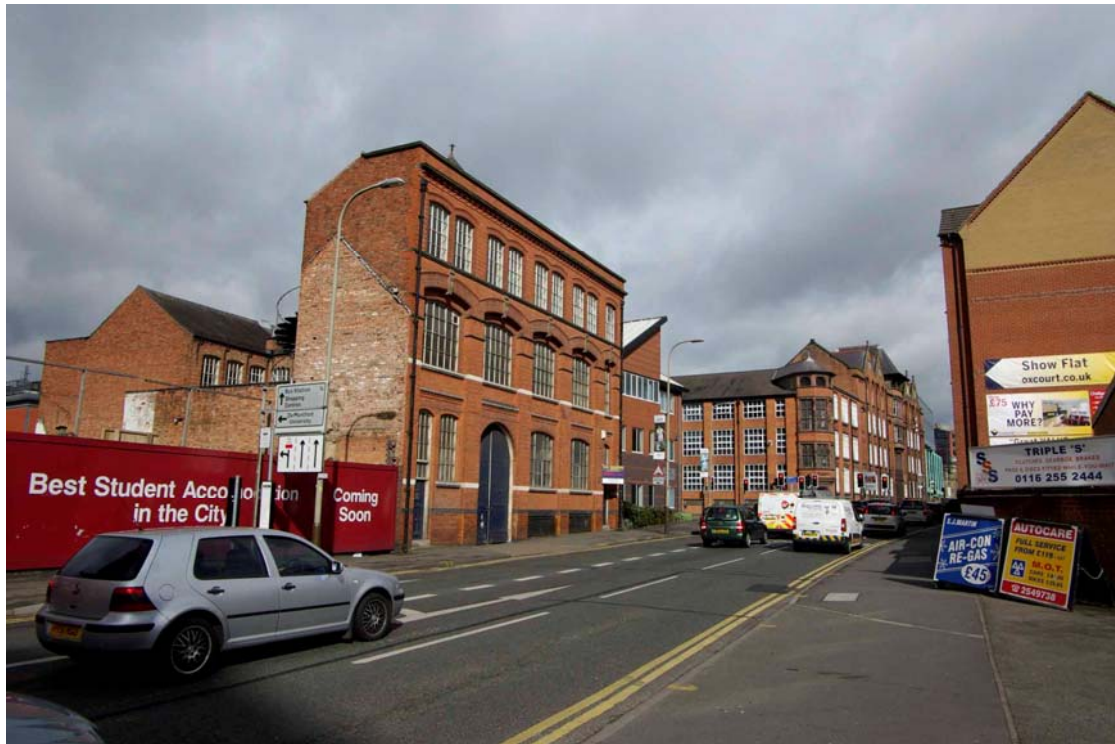
Figure 4 North east and south east facing elevations
Looking west towards junction with Bonners Lane. Note building scars and rear range

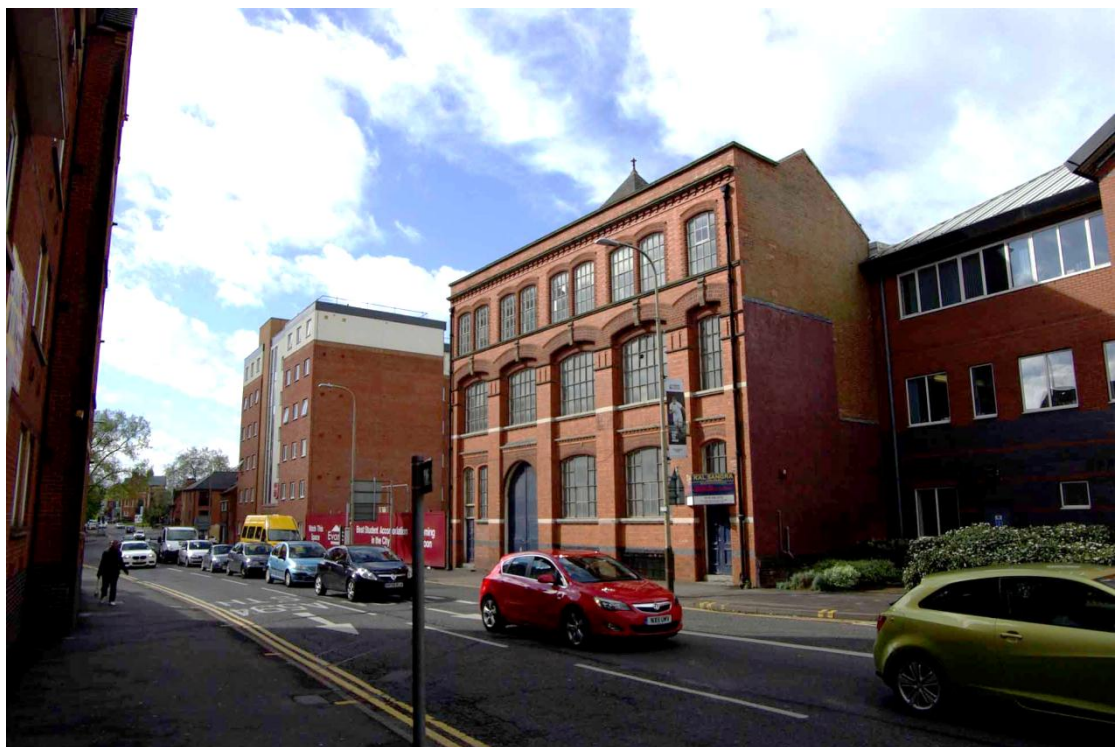
Figure 5 North east and north-west facing elevations
Looking south east

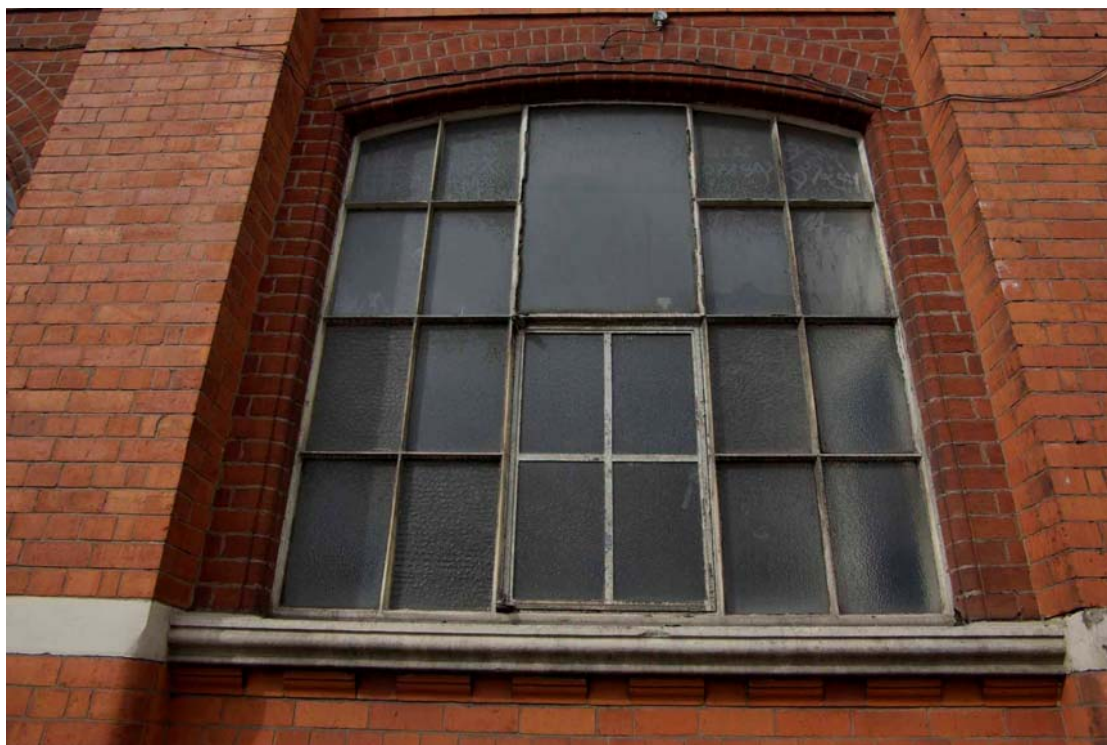
The elevation has a number of decorative touches including decorative limestone string courses, limestone keystones above the first floor windows which also have decorative brick arches, dentil work below the parapet and glazed brown bricks from street level up to the top of the semi-basement windows.

Figure 8 North east facing elevation window detail
Note decorative brickwork below stone sill

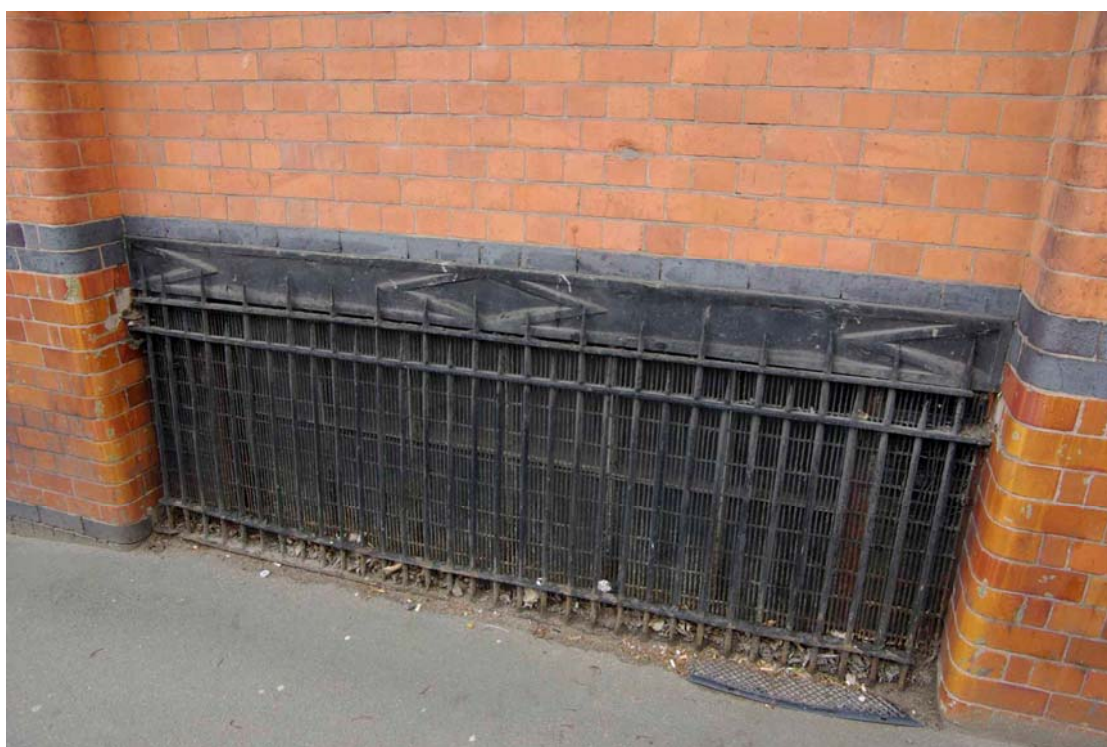
Figure 9 North-east facing elevation basement window detail
Note glazed bricks either side of window

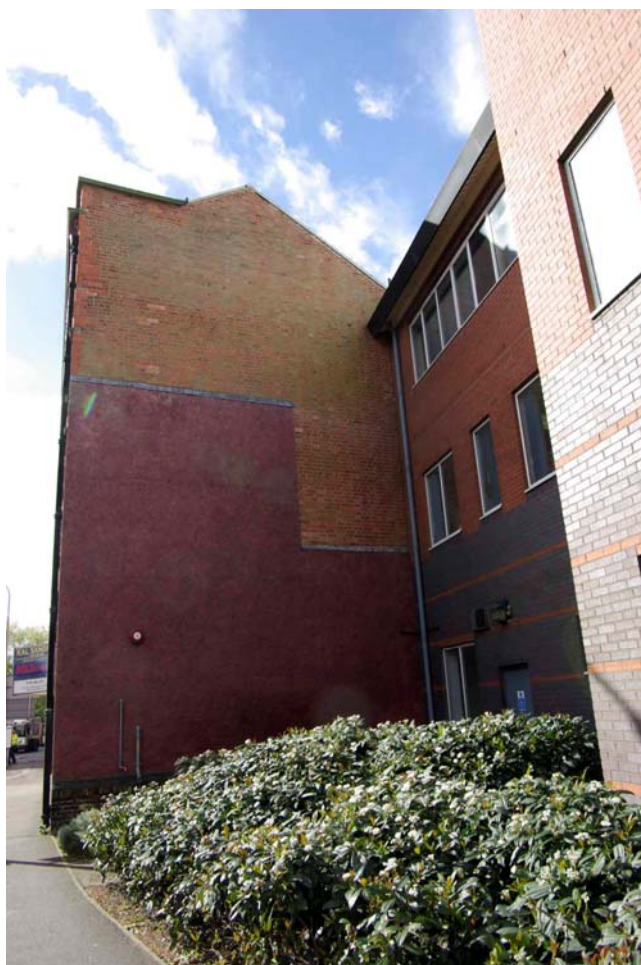
A modern building obscures the rear portion of the north-west facing elevation, however the front range shows that the flat gable end has been partially rendered to cover over earlier building scars (Fig. 10). There is no evidence of any blocked windows where the wall has not been rendered.

Figure 10 North west facing elevation
Looking south east. Note parapet facing onto Oxford Street

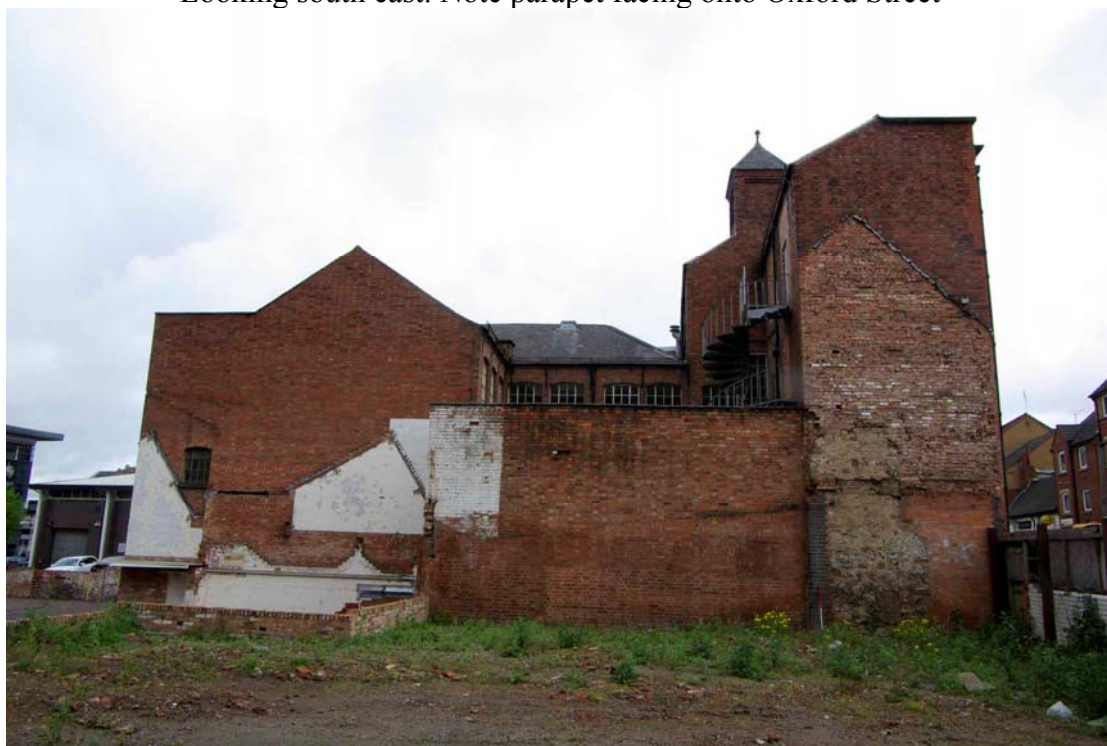
The south-east facing elevation of the front range shows the scar of a two, possibly three, storey building which has now been demolished (Fig. 11). The building appears to have been built against Number 53. At ground floor level the demolished building appears to have incorporated the gable end of a Dane Hills sandstone built single-

Figure 11 South-western facing elevation
Looking north-east. Oxford Street on right of photograph

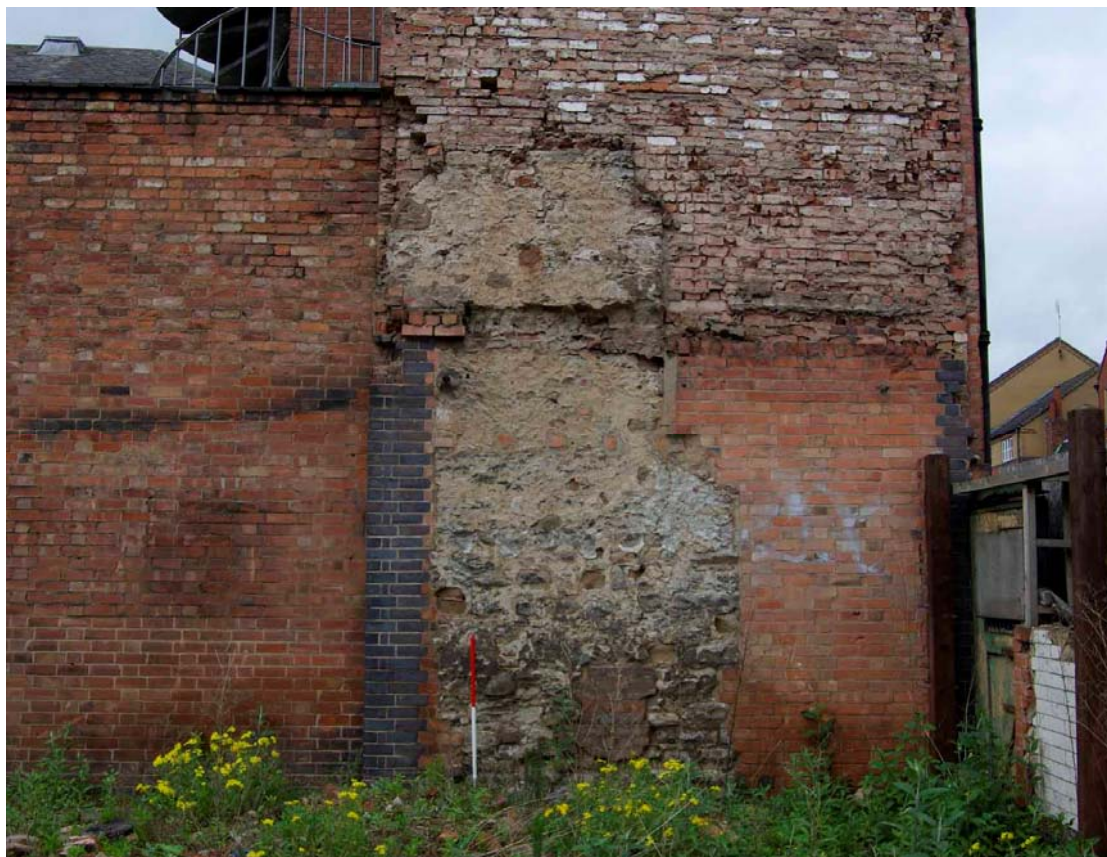
storey building with the remains of a possible fireplace in evidence (Fig. 12). The front range is slightly thinner at this end in order to create a slightly larger courtyard.

Figure 12 Scar of stone building on south west facing elevation
Looking north-east. 1m scale

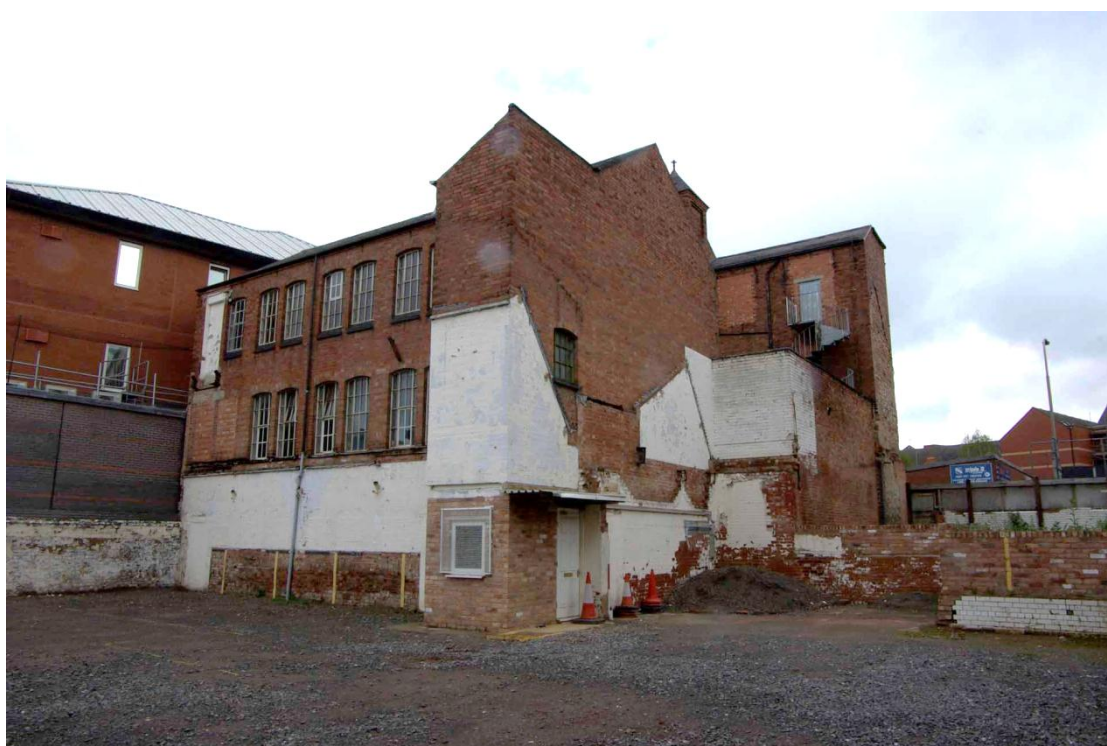
Figure 13 South-west and south-east facing elevations
Looking north. Note retaining wall on right of photograph showing difference in
ground levels

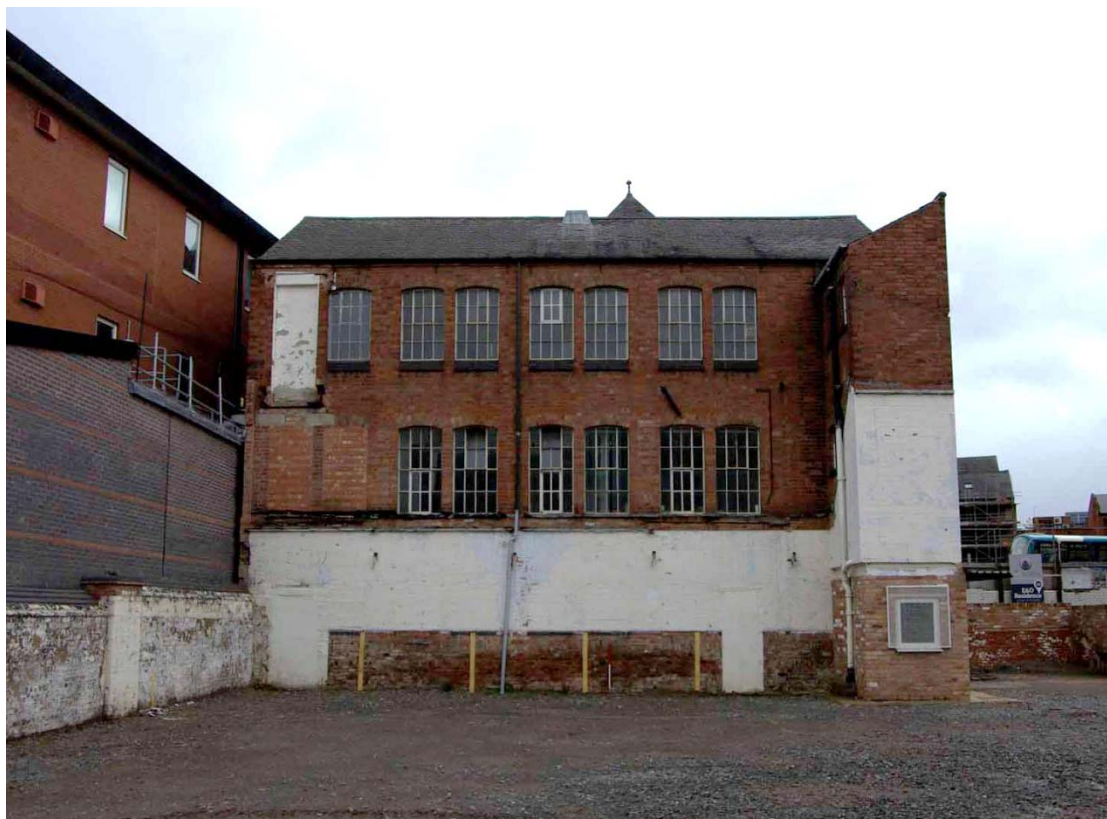
The south facing elevation faces the area of the site where a number of former buildings have been demolished (Fig. 14). This range has two storeys plus the basement. The basement has had its windows bricked up and the white painted wall suggests that a single storey structure was attached at this point (Fig. 15). There are also two inserted and now blocked doors at basement level. The windows on this elevation are metal-framed and not as ornate as on the front range. At the east end a number of windows have been modified into doorways on the two upper floors. These may have acted as fire escapes but are now blocked.

Figure 14 South-west facing elevation
Looking north-east

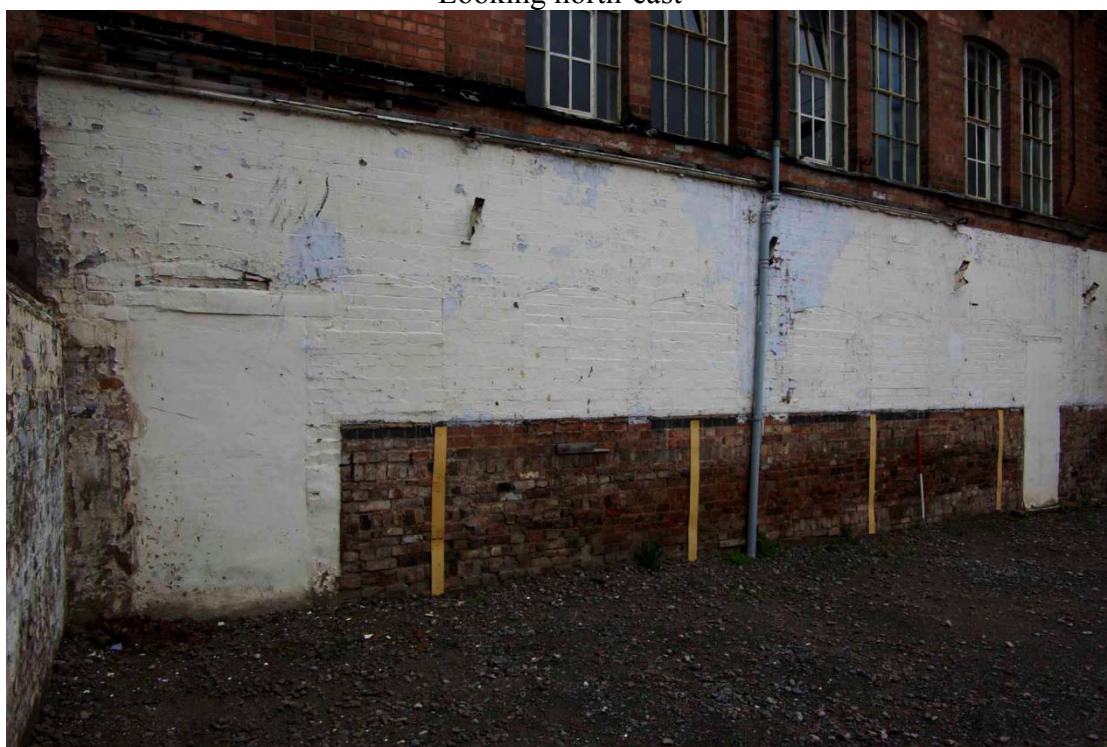
Figure 15 South-west facing elevation basement wall
Looking north-east. 1m scale. Note blocked windows

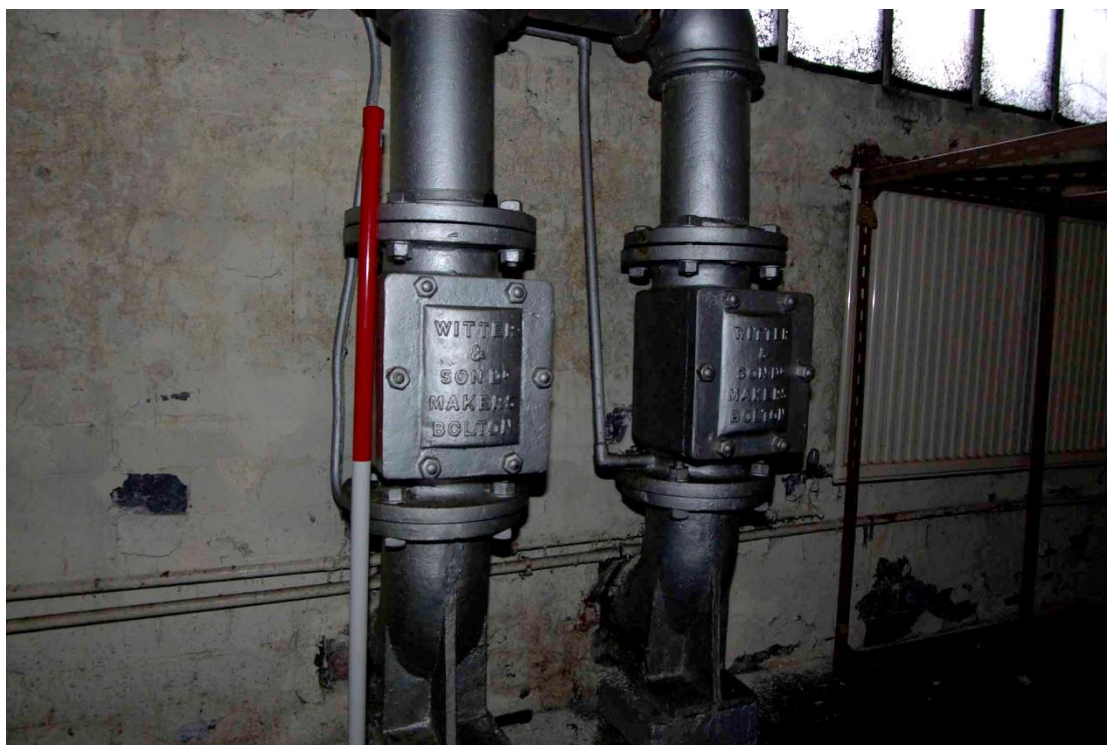
Figure 19 Heating apparatus, front range basement
Looking north east. 1m scale

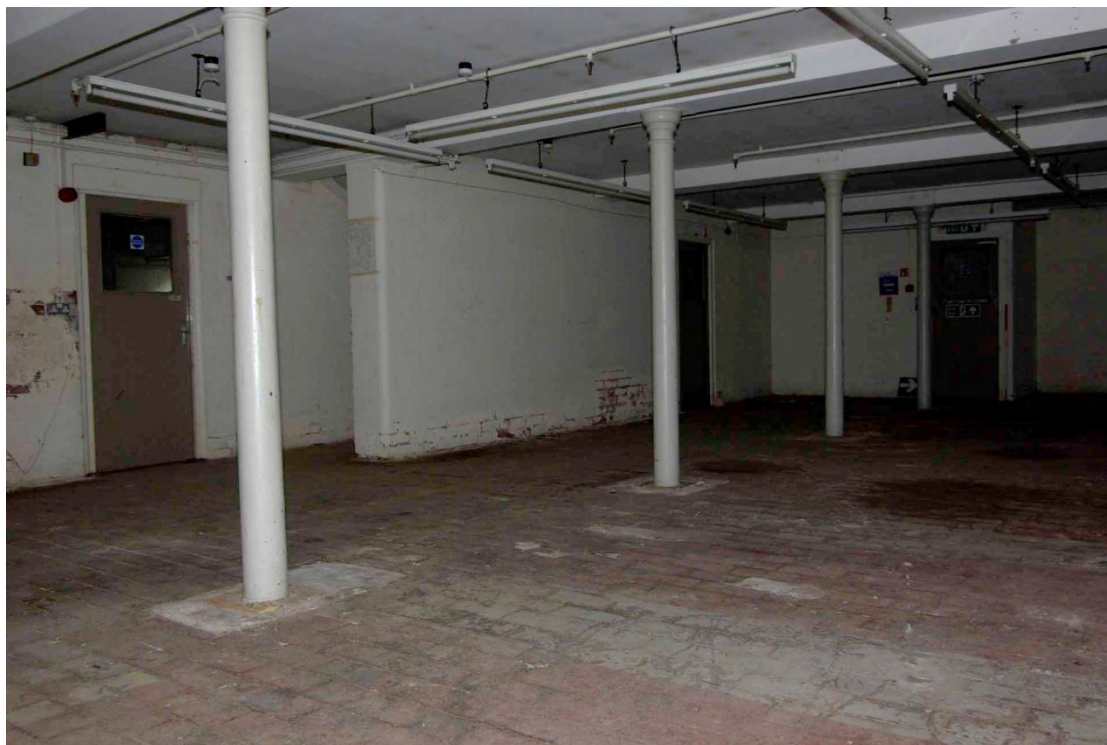
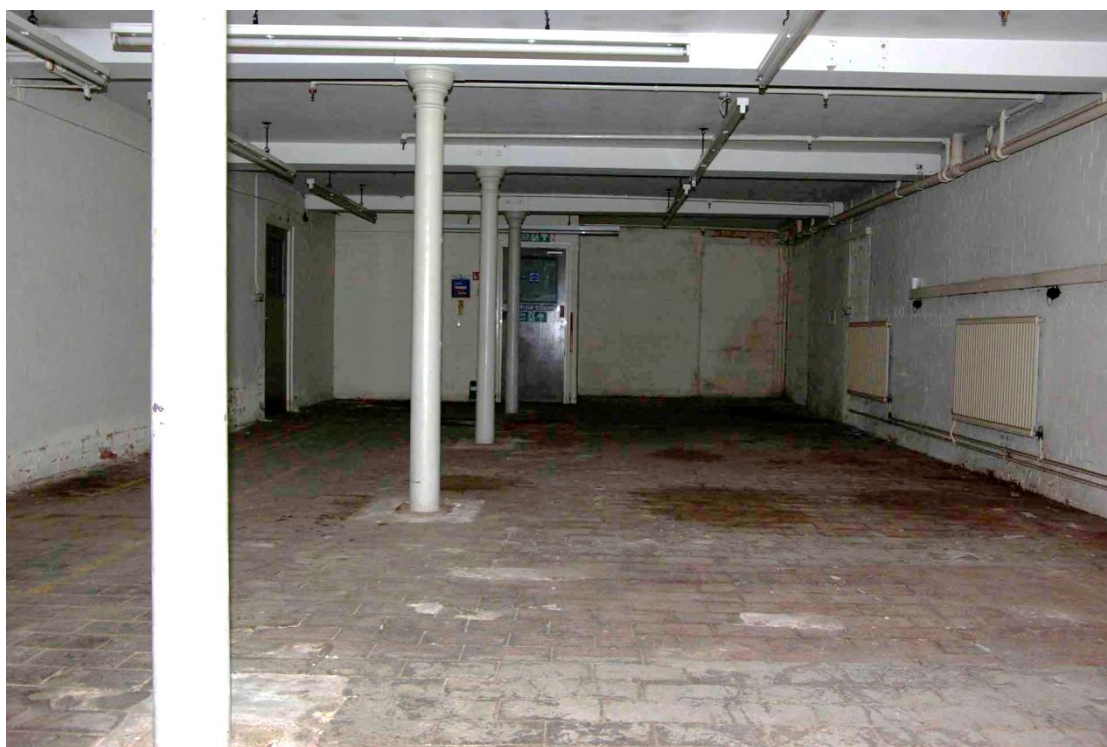
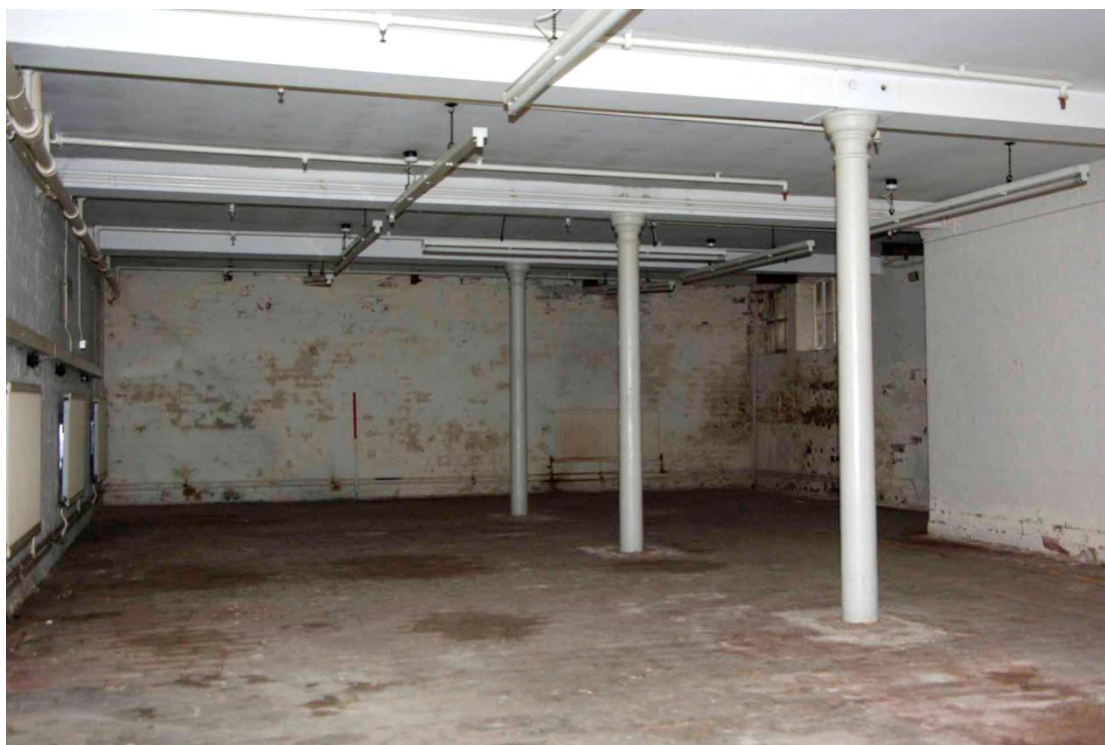
The south range ceiling is supported by four cast-iron columns (Figs. 21, 22 and 23). The floor has brick or quarry tiles in contrast to the concrete floor of the front range. The blocked windows and doors discussed above can be seen on the south west wall. Two windows in the north west corner let in light from a small light-well/courtyard which is on the western side of the cross range. At the south eastern end of the basement a dividing wall creates a corridor leading to a set of fire escape stairs in the north east corner of the range. The stairs lead up to the enclosed courtyard and then continue up to the ground floor. Another set of stairs in the middle of the north wall lead up to the first floor. There is no internal access to the south eastern corner toilet block.

Figure 21 South range basement
Looking east

Figure 22 South range basement
Looking south east. 1m scale

Figure 23 South range basement
Looking north west. 1m scale

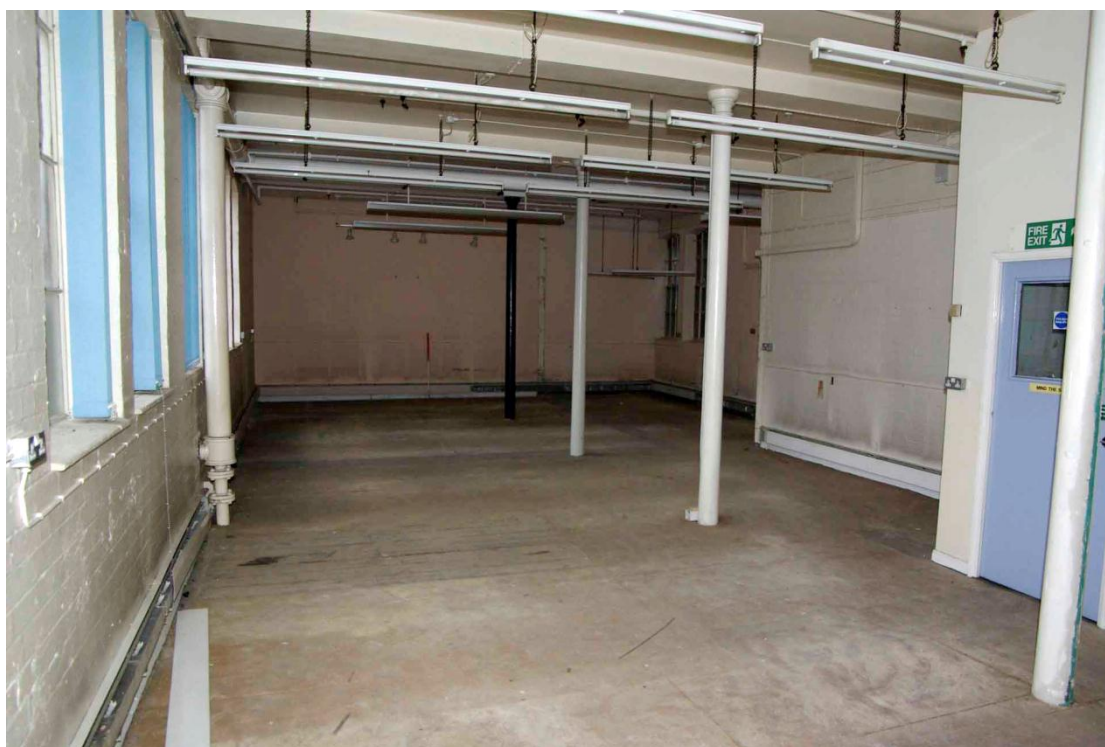
The south range is an open space with four cast-iron columns supporting the ceiling and floor above (Figs. 32 and 33). The western end wall has three flat headed windows which have been bricked up. Metal-framed windows run along the southern wall and in the north eastern corner (Fig. 34). Also in the north east corner is a wooden cover for the stairs below which consists of a stepped structure which appears to be a later addition as it partially cuts one of the windows (see Fig. 34). Doors on the

Figure 32 Ground floor south range
Looking north east. 1m scale

Figure 33 Ground floor south range
Looking north west. 1m scale

Figure 34 Ground floor south range, north east corner
Looking north east. 1m scale

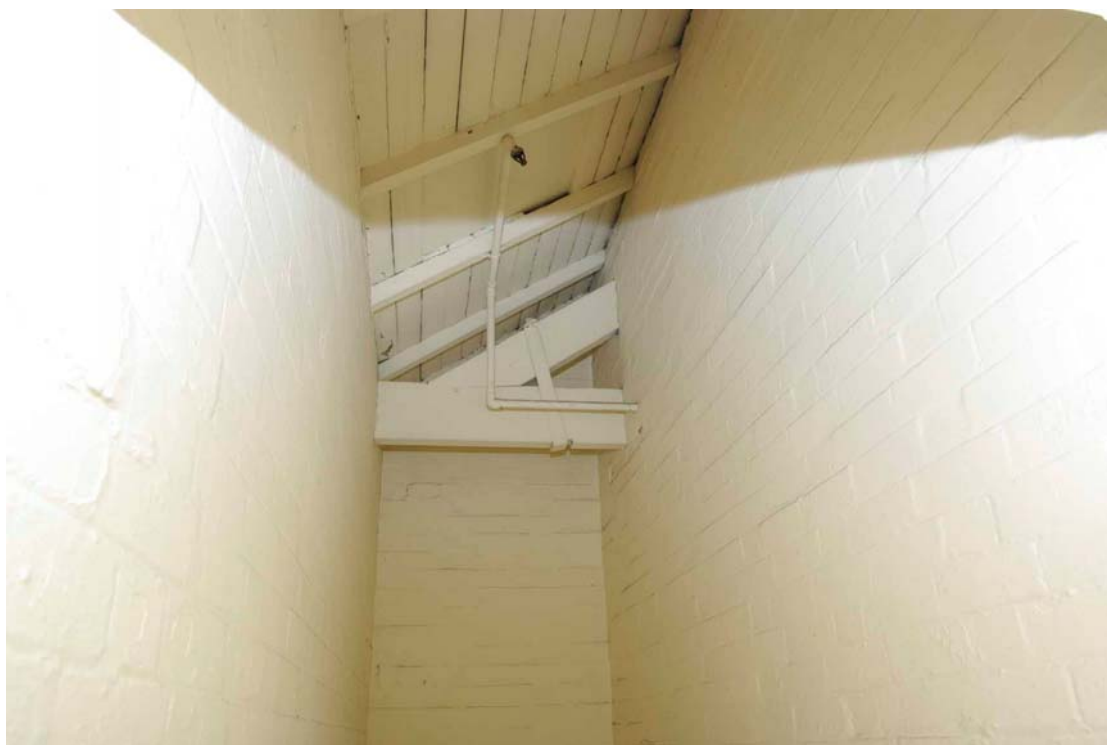
The south range is also a large open space although a new toilet block with plasterboard walls has been inserted into the north western corner (Figs. 38, 39 and 40). Only the stairs in the middle of the north wall are present on this floor. Originally the stairs were open to the room but have now been enclosed. A blocked doorway modified from a window is on the southern wall in the western corner. The south range only has a basement, ground and first floor unlike the front range which has a second floor. A false ceiling hides much of the roof structure but a small section of principal rafter and truss can be seen over the stairs (Fig. 41). The roof appears to be of typical late 19th century industrial design with metal stirrups holding the principals to the trusses.

Figure 41 South range roof detail
Looking south east over stairwell

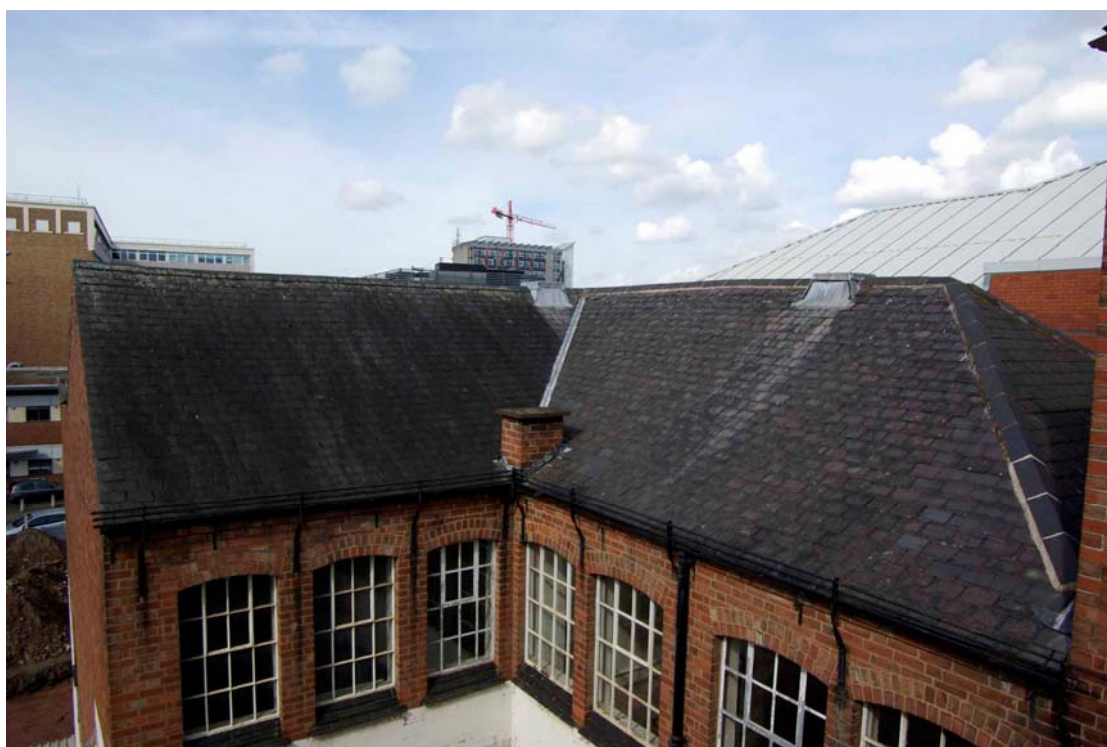
Only the front range has a second floor which has been subdivided into smaller offices by the insertion of plasterboard partitions. The main stairs lead up to a narrow corridor running across the front of the building (Fig. 42). As in the south range the roof is hidden by a false ceiling but the area over the stairwell shows that the structure is quite simple and consists of purlins supporting common rafters (Fig. 43). In the eastern end office the bottom of a truss can be seen showing that in this range, as in the south range, the principal rafters are held by metal stirrups (Fig. 44). The offices have no fixtures or fittings related to the hosiery industry (Figs. 45 and 46). The rear, south west facing, windows look out over the roof of the cross and south ranges (Fig. 47).

Figure 47 External roof detail of cross and south ranges
Looking south-west
