**A Second Phase of Archaeological Evaluation
at Friars Mill, Bath Lane, Leicester
NGR: SK 58002 04684**

ULAS Report No 2015-123.
©2015

For: Leicester City Council

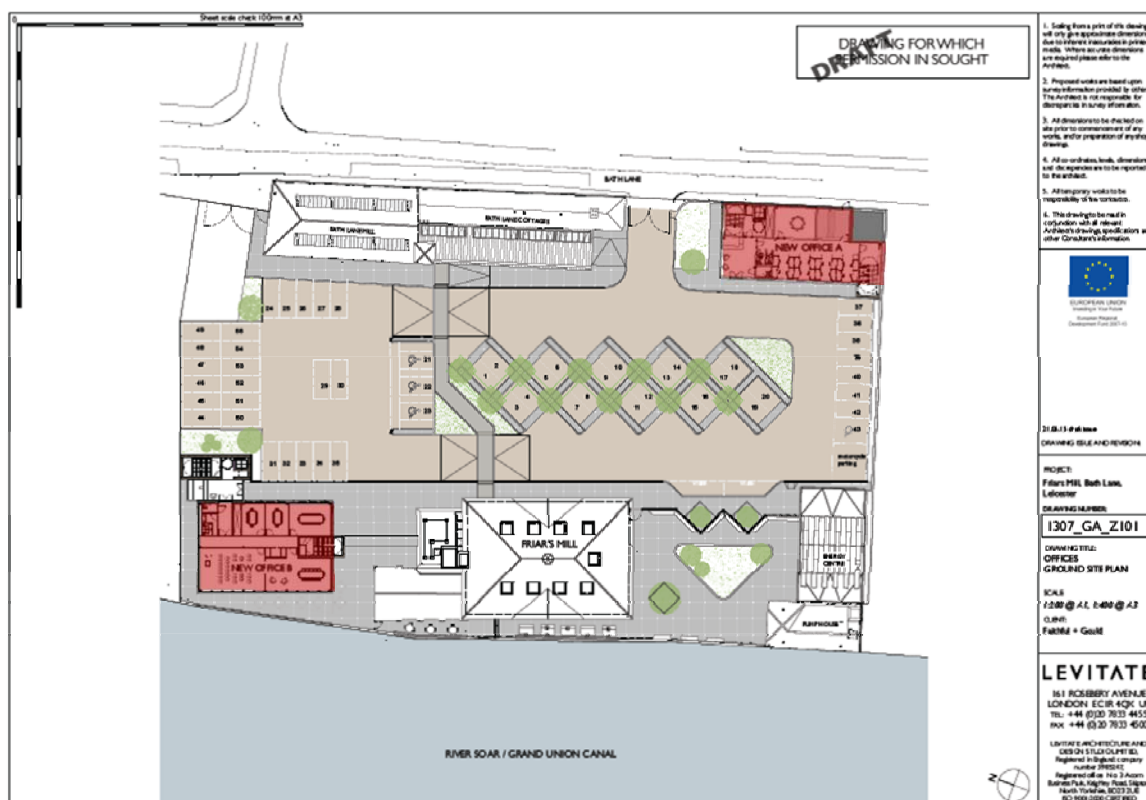
Figure 2 Friars Mill showing the location of the two proposed buildings (shaded red)

The current (second phase) evaluation was carried out in response to new development proposals by Leicester City Council for the construction of two additional buildings; one on the southern side of the site adjacent to the Bath Lane frontage and another in the north-western part of the site close to the river (Planning Application tbc) (Fig. 2).

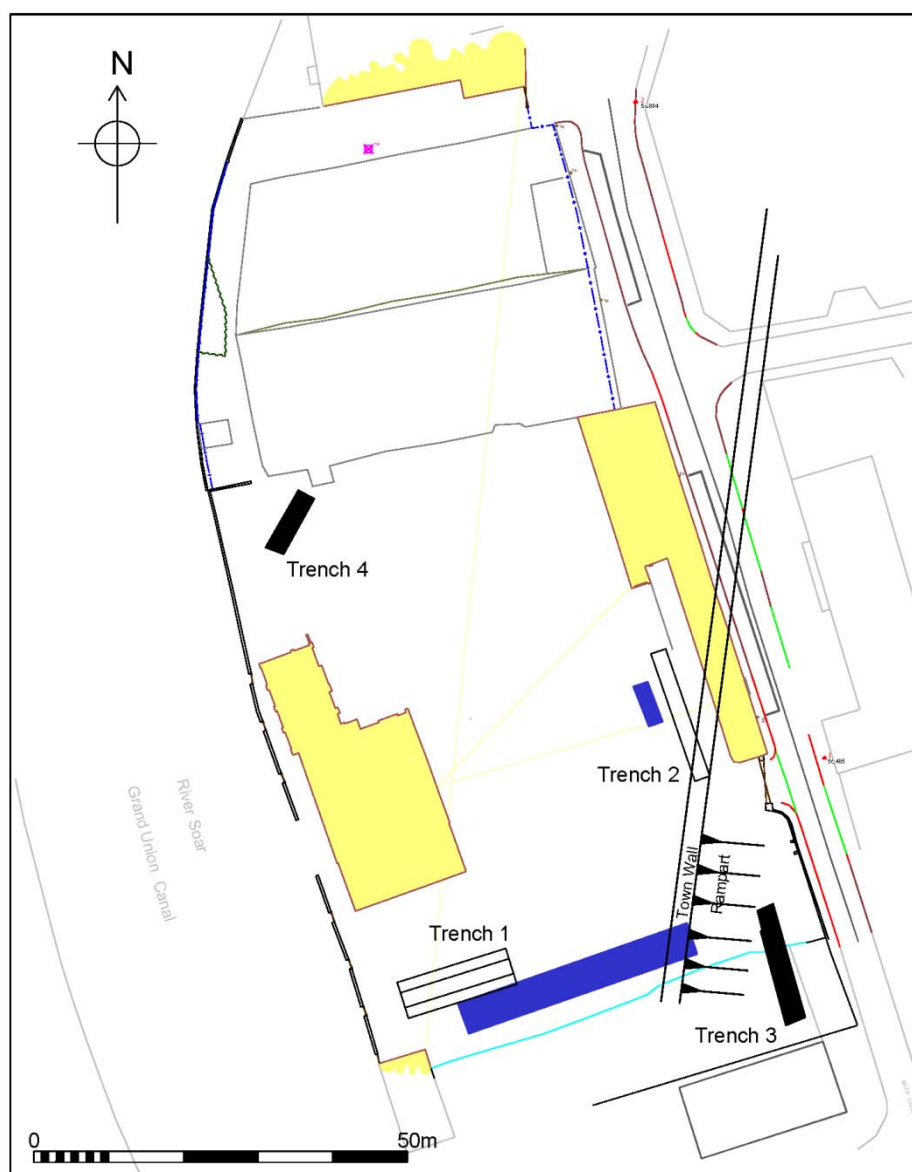
Figure 3 Trench locations in relation to earlier work

The evaluation consisted of two trial trenches located to coincide with areas threatened by the development proposals. The eventual positioning and dimensions of the trenches differed slightly to the details proposed in the WSI due to restrictions on access and available space in the two areas of interest (Fig 3). The location of both trenches was scanned with a CAT Scanner to determine the presence/absence of live services (none were found) and known live services were avoided.

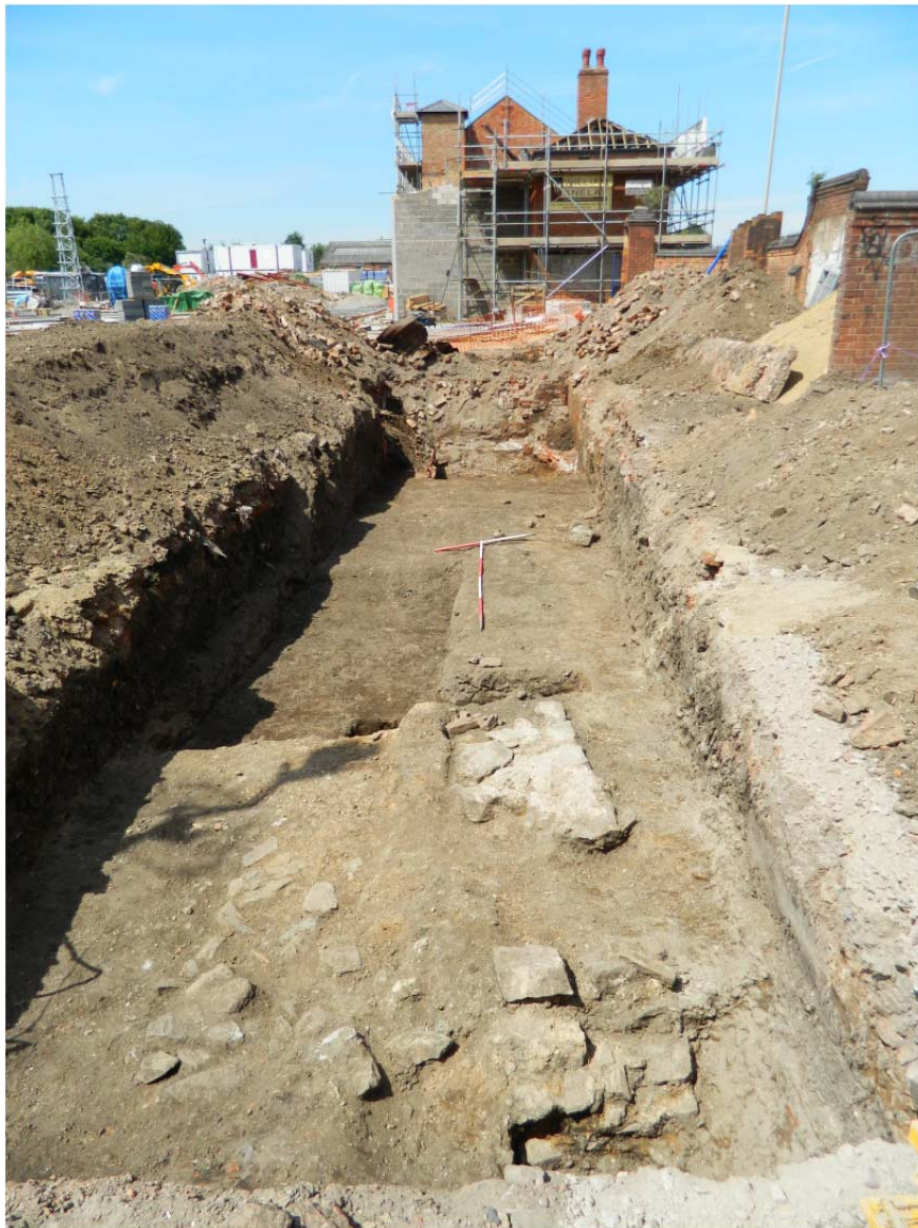
Figure 4 Trench 3 facing north with Roman wall footings in the foreground

Trench 3 was located in the south-east corner of the development area on a north-south orientation, adjacent to the Bath Lane frontage and slightly east of the eastern end of the earlier Birmingham Archaeology trench from 2003. Trench 3 measured c.17m long x 3m wide and was between c.0.70m and 1.30m deep (Fig 4).

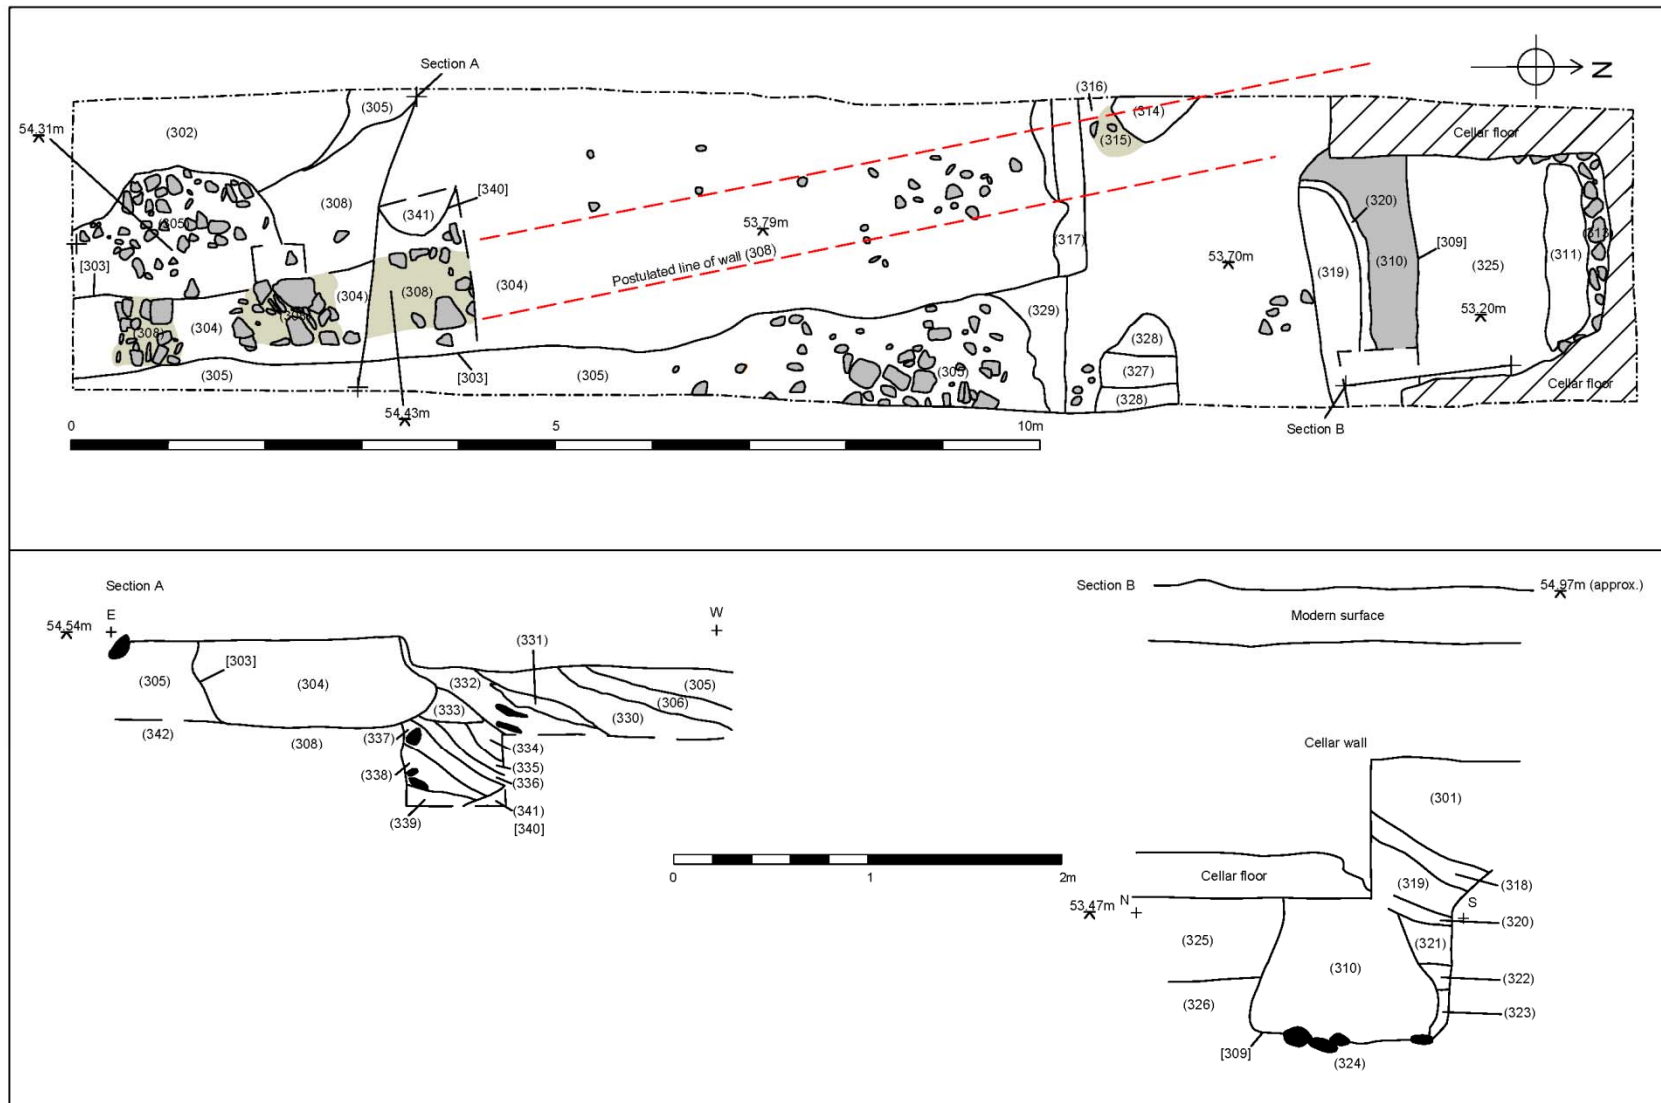
Figure 5 Trench 3 plan and section drawings

The upper c.0.30m of deposits in this trench consisted of a brick demolition rubble/yard surface layer (300). Beneath this was a c.0.40m thick layer of dark greyish brown silty clay (301) mixed with mortar flecks, pottery and stone & ceramic demolition rubble and a thinner layer (302) likely to represent the interface between (301) and (305) – see below. These layers were not closely dated but may have formed during medieval cultivation or garden-use of the site. They sealed the underlying archaeological remains that were predominantly Roman in date (Fig 5).

The central archaeological feature was a substantial Roman masonry wall (308) that crossed the trench diagonally on a SE to NW alignment. The wall had been partially robbed along its length but limited excavation indicated that the stone robbing had not been comprehensive and that survival generally was very good.

The wall measured *c.*0.60m-0.70m wide by at least 0.80m deep and was revealed over a length of *c.*13m. It survived best at the southern end of the trench where the uppermost courses existed only 0.70m below the current ground level. The wall was constructed of coursed granite blocks forming flat outer faces, with a coarse rubble 'infill' of smaller granite chunks, cobbles and tile fragments all bonded with a hard yellow/creamy brown mortar. There was a noticeable difference in width between the upper wall courses (*c.*0.60m wide) and the lower courses (*c.*0.70m wide) revealed, suggesting that there was a distinction between foundation and superstructure. The thickness of the wall courses (*c.*0.10m towards the top and 0.20m towards the bottom) also appears to reflect this distinction.

At the northern end of the trench a second robber trench [309] indicated the presence of another wall on a NE to SW alignment. It seems highly likely that the two walls/robber trenches are related as part of the same building, but further work would be needed to clarify this. Robber trench [309] was *c.*0.70m wide x 0.70m deep and was observed for *c.*3m before it ran beneath the eastern edge of the trench. It had similar characteristics and a similar fill to robber trench [303], also containing 12th-14th century medieval pottery. A concentration of granite rubble (324) revealed at the base of the robber trench may have represented surviving in situ footings of this wall (Fig 5 Section B).

To the west of the wall at the southern end of the trench the demolition layer (305) covered a series of layers possibly reflecting surfaces associated with the building (Fig 5 Section A & Fig 7). The uppermost was compact pebble surface (306), perhaps relating to a yard or floor.

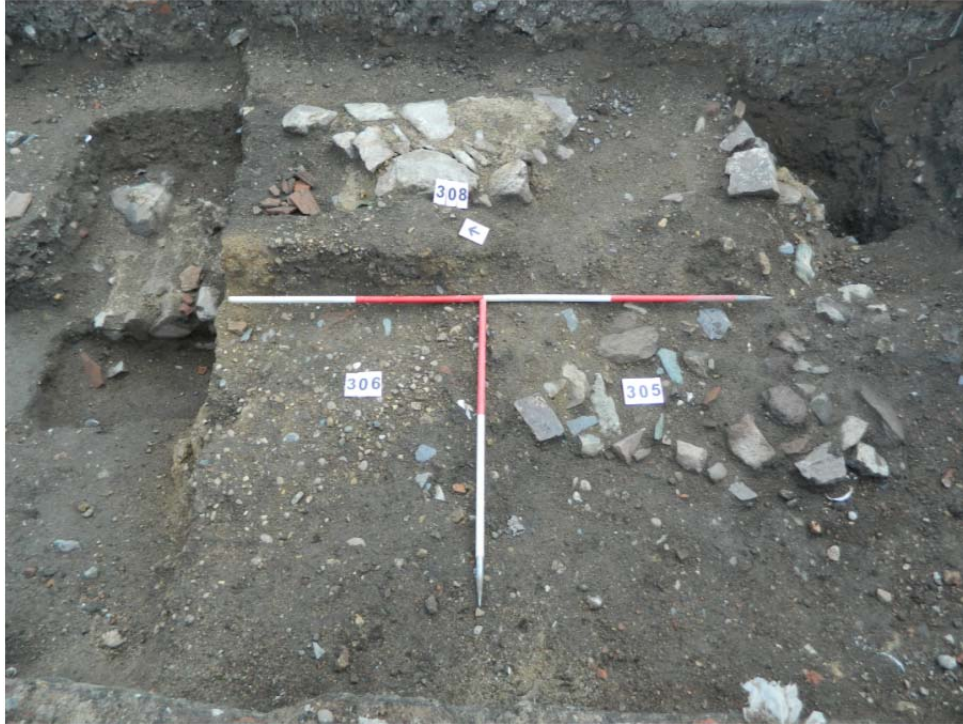
Figure 6 Roman wall remains with associated pebble surface (306) and demolition layer (305) in the foreground

A layer of demolition rubble (305) existed on either side of wall (308)/robber trench [303]. This consisted of mid-brown mortar-rich silty soil containing concentrations of granite rubble, Roman pottery and roof tile (Fig 6). On the eastern side of the wall layer (305) was *c.*0.41m thick and lay as a fairly even spread (as far as could be discerned within the trench confines). It overlay a deposit of mid yellowish-brown silty clay (342), the full extent of which was not established.

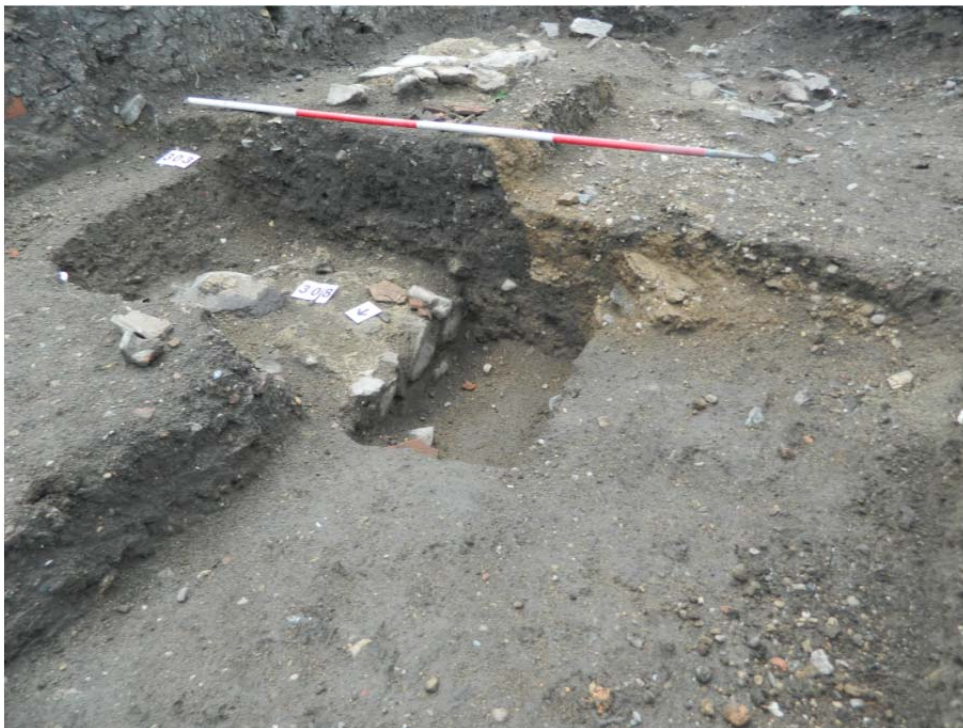
Figure 7 Roman wall remains and associated layers at the southern end of the trench

This surface overlay a sandy layer (330) that may have formed bedding for the pebbles. Below this was a compact mortar surface (331) supported by another possible bedding layer (332). A fragment of crushed mortar surface (333) survived close to the wall. Beneath this a series of sloping deposits (335-338) was associated with 2nd-4th century Roman pottery and painted wall plaster. These may have been fills of a cut feature such as a pit. Below these layers, excavation revealed the top of what appeared to be another demolition layer (339) consisting of mortar-rich silty soil containing stone, tile and painted plaster.

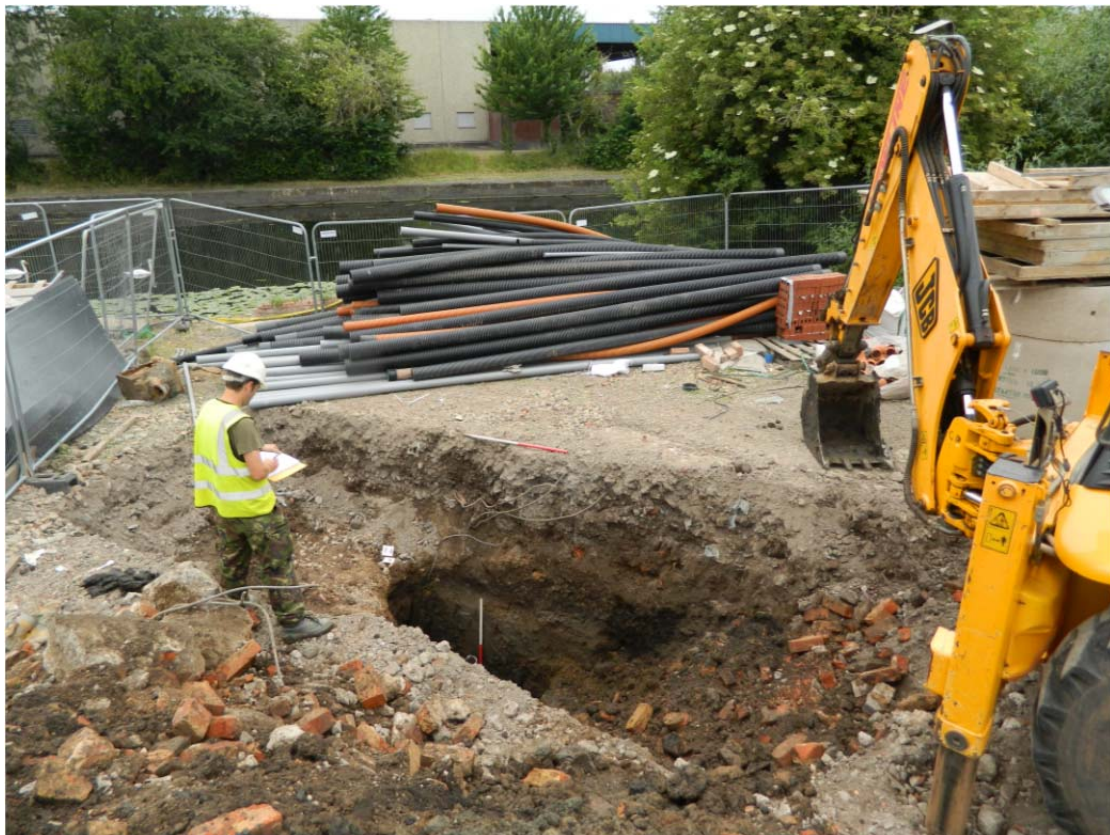
Figure 8 Trench 4 general view with river in the background

Trench 4 was located adjacent to the river on the north-western side of the development area. It measured *c.* 7.00m x 3.00m x up to 4.20m deep (Fig 8). Due to space restrictions the trench was smaller than originally intended and a number of large concrete footings from previous buildings further impeded the view of archaeological deposits. That said, a narrow window between areas of disturbance was accessible. This provided a view of soil layers up to 3.30m deep overlying compact natural gravels.

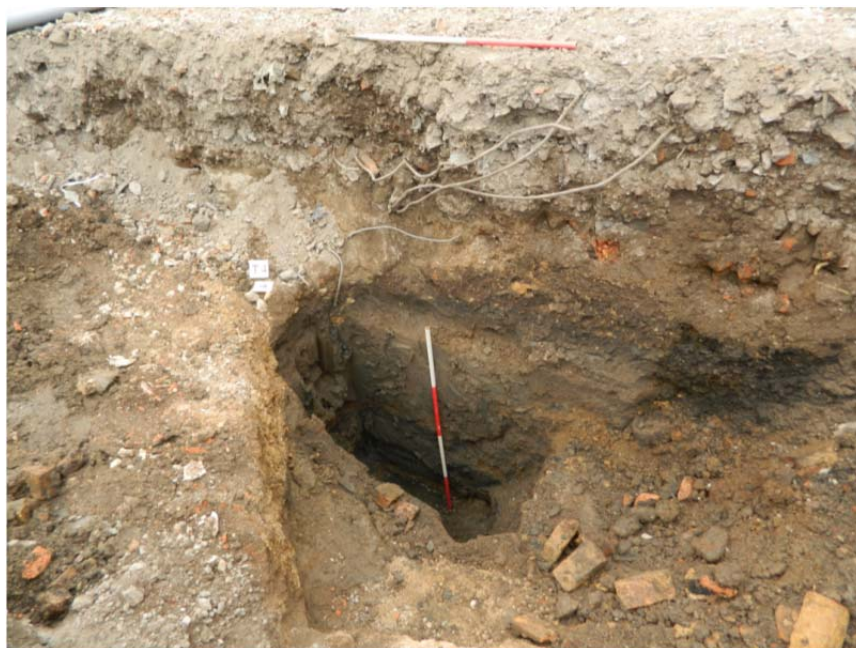
Figure 9 Trench 4 facing west

The overlying yard surface layer (400) accounted for the upper *c.* 0.90m of the sequence of layers in this area, below which was a series of archaeological layers (Fig 9 & Fig 10).

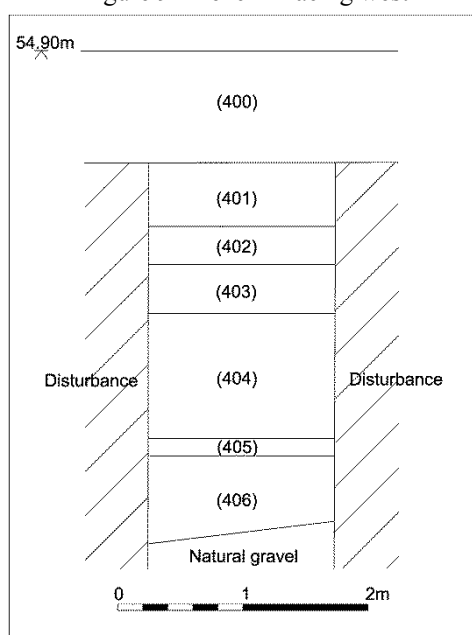
Figure 10 Schematic section drawing of layers recorded in Trench 4

The earliest of these deposits was a layer of blueish-green silty clay and organic matter (406) associated with large stone blocks and a large fragment of Roman tile (not retrieved). These

Above this was a thin (*c.*0.15m) layer of orange silty clay (405) and this in turn was covered with a *c.*1.00m thick deposit of greyish brown clay.

Overlying this was a *c.*0.40m thick layer of sandy gravel (403), and then a layer of grey clay (402 – *c.*0.30m thick) that contained a sherd of late 4th century Roman pottery.

Finally a *c.*0.50m thick deposit of mortar rich silty clay (401) completed the sequence.

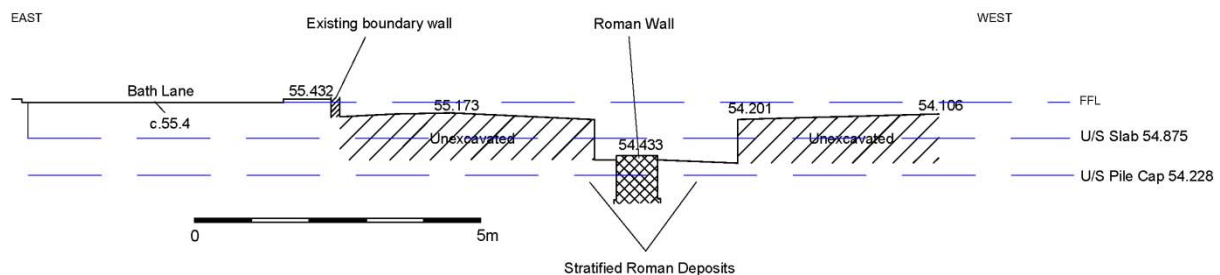
Figure 11 Cross section through Trench 3 archaeological deposits in relation to development proposals

The uppermost levels of archaeology within the trench were only 0.70m deep (c.54.43m AOD) and appear to have survived because of low levels of later intrusive activity such as pitting. A cellar at the northern end of the trench also seems to have caused only minimal disturbance to the Roman archaeology.

In association with the building remains was a series of intact layers, comprising compact mortar and pebble/cobble surfaces probably relating to contemporary floors and yards. Their stratigraphic relationship to the wall suggests that at least some of the building's superstructure may have survived *in situ*. Overlying these layers was a thick demolition deposit containing much roofing tile, painted wall-plaster and tesserae, providing information on the character of the building. Of particular note, the presence of painted wall plaster, mosaic fragments and the suggestion that hypocaust heating and bathing facilities were associated with the building provide a good indication of its status. Further work on this part of the development area would undoubtedly reveal more information about this building, but would also allow a clearer understanding of how it related to the other nearby contemporary buildings that have recently been discovered. Further excavation would also help understand the relationship of the building to the nearby town defences that have been postulated as existing less than c.10m to the north of Trench 3 (from the results of the Birmingham Archaeology trench).
