**An Archaeological Strip, Plan and
Sample Excavation at Manor Farm,
Main Street, Tugby,
Leicestershire
(SK 7632 0098)**

ULAS Report No 2015-173
©2015

For: Mulberry Property Developments Ltd.

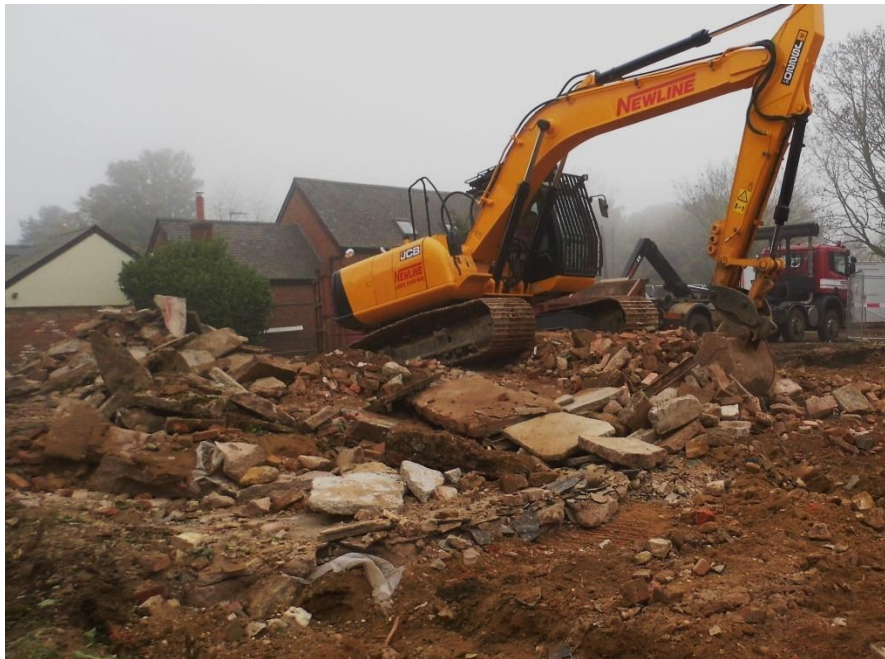
Figure 4: Demolition of the manor house in progress

Machine removal of concrete floors and footings associated with the recently-demolished manor house was firstly monitored (Figure 4) prior to the opening of a single open area totalling c.395m² by a 360° mechanical excavator fitted with a 1.3m wide toothless ditching bucket under continuous archaeological supervision.

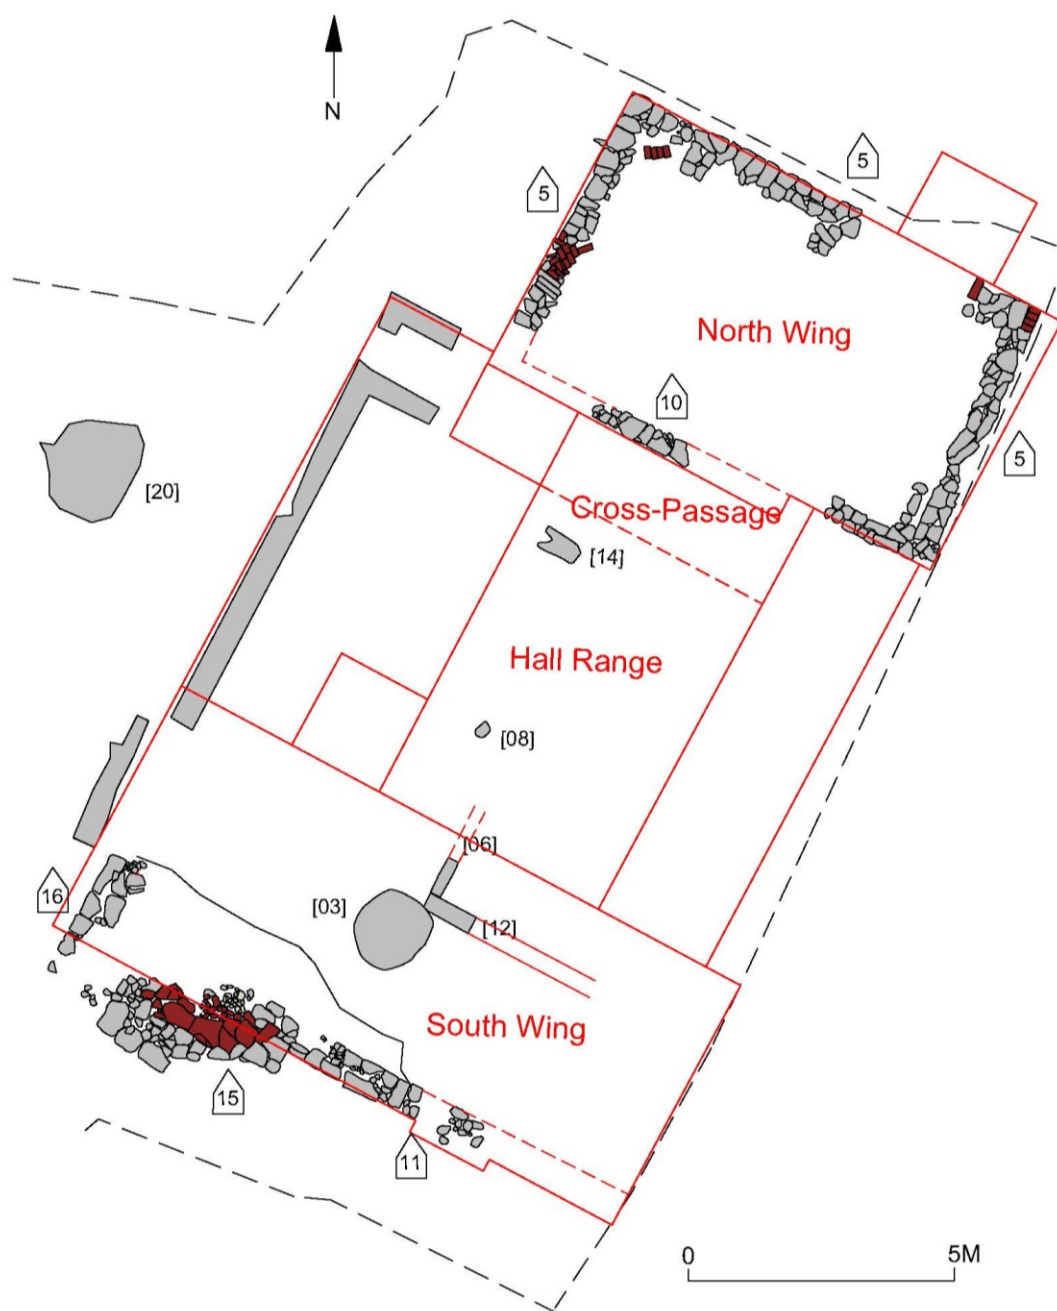
Figure 8: Excavation results overlaid on manor house outline plan

Two possible beam slots hinted at internal structural arrangements to the south hall. The first, [**12**] (0.8m x 0.35m x 0.05m deep) ran parallel with wall (**11**) at c.3m distance and may suggest the presence of a passageway. A second, 1m long slot [**06**] (**07**) ran north at right angles to the former (Figure 8, Figure 13, Figure 14, Figure 15).

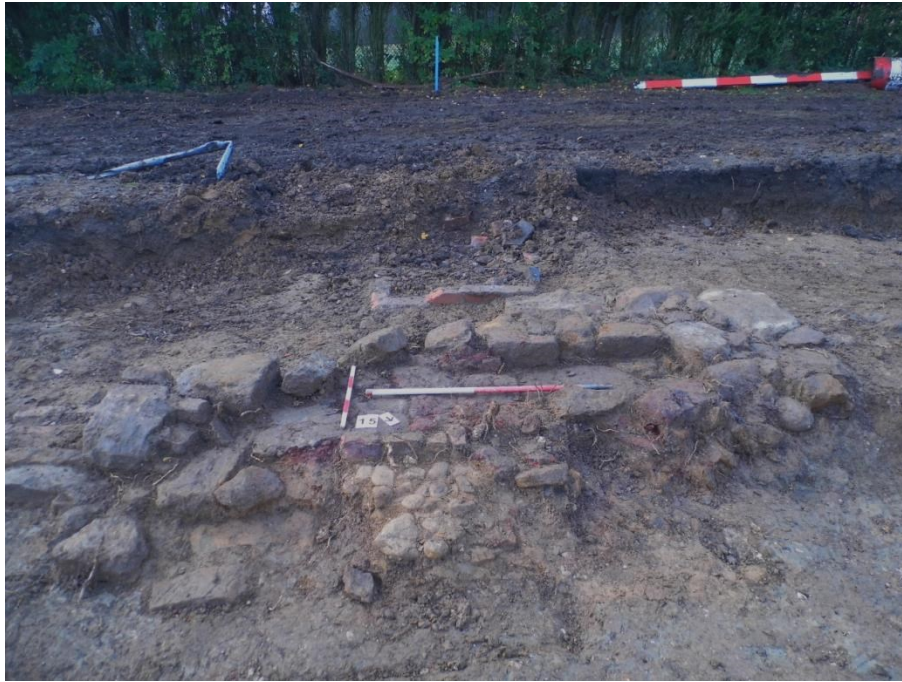
Figure 9: South wing fireplace (15)

A chimney and hearth base (**15**) was located at the western end of the wall, close to its junction with wall (**16**) (Figure 9, Figure 10). Flat ironstone slabs were laid as the hearth base, degraded from heat reddening, with a chimney built around it on three sides. A lip around the front of the hearth possibly represented a second hearth, and was associated with a fragment of cobbled flooring. The entire structure was set upon a rough rubble base and measured 3.4m x 1.2m and 0.26m in height. The wall overlay a 1.6m wide medieval plough furrow [**17**] (**18**) (Figure 15, Figure 17) which ran on the same alignment of the wall. A small undated pit [**03**] (**04**) measuring 1.5m in diameter and 0.49m deep lay 1.5m to the north (Figure 8, Figure 16). A second pit-like feature [**01**] measuring 1.7m in diameter and 0.3m deep lay to c.3m to the west of wall [**16**] (Figure 16) and likely represents a tree throw.

The west wall (**16**) lay directly to the west, consisting of a single surviving ironstone earth bonded course measuring 0.7m wide, 2.1m in length and 0.152m high (Figure 9).

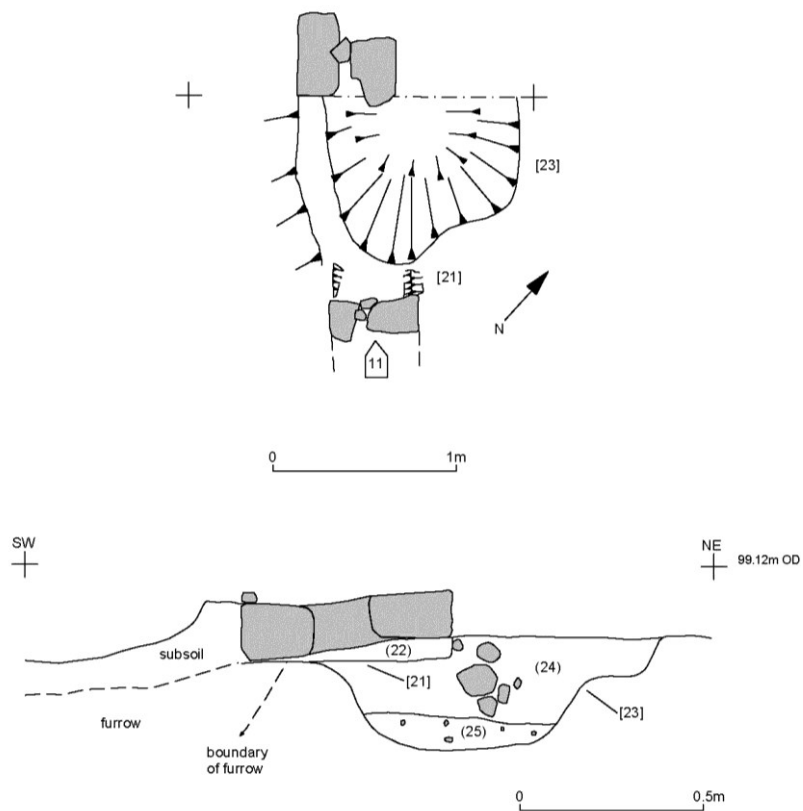
Figure 11: South wing wall (11) cross section

The surviving walls of the south wing of the manor house consisted of the footings of the principal external southern and eastern walls. The latter (**11**) consisted of earth bonded regularly coursed ironstone blocks with roughly squared outer faces, the base course of which was laid on a thin bed of gravel (Figure 9 - 12). The fabric was 0.56m wide and survived to a height of 0.13m and the wall set on a north-west – south-east orientation. The wall cut into the top of a small circular pit [**23**] measuring 0.95m in diameter and 0.30m deep (Figure 11, Figure 12). The later of the feature's two fills, a secondary mid grey silty sand (24), contained three mid-second century Roman pottery sherds (Cooper, this volume).

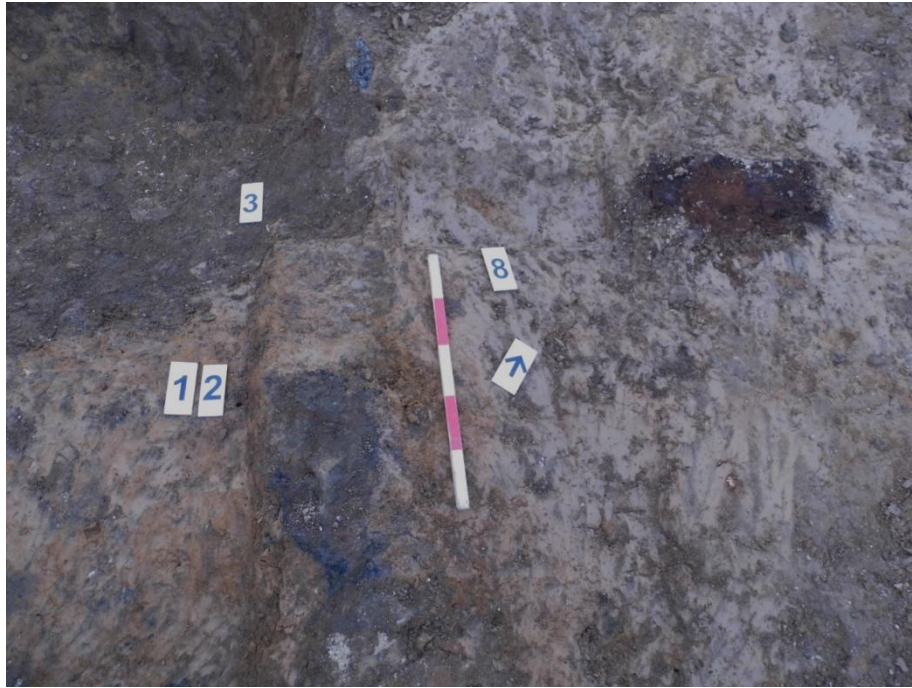
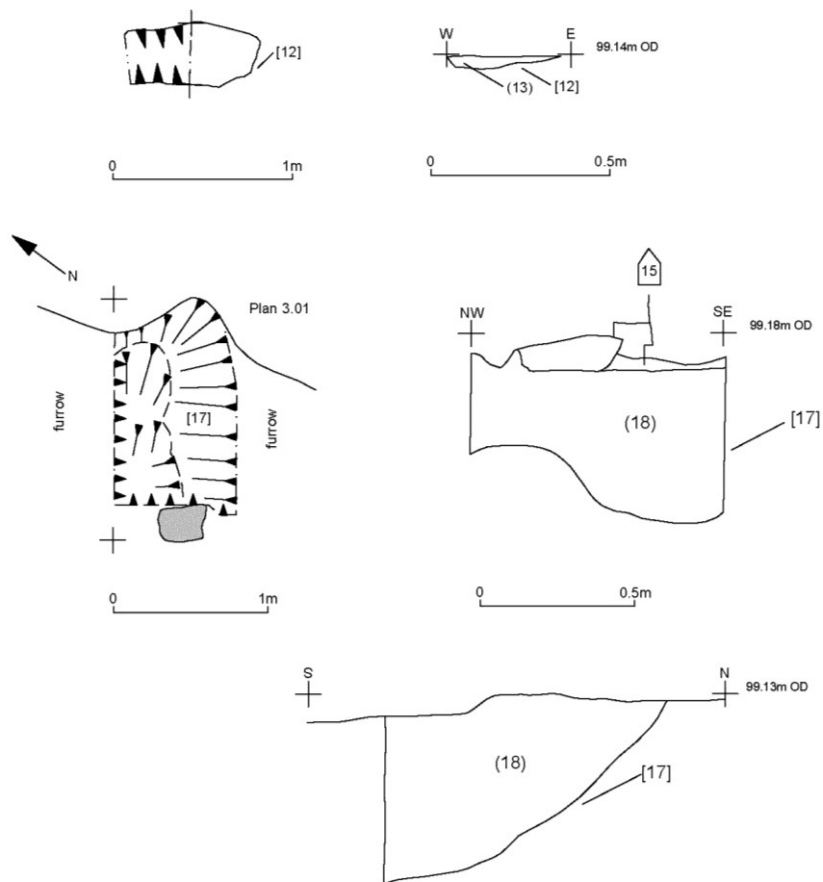
Figure 13: Beam slots [06] & [08]

Figure 14: Beam slots [08] & [12] (0.5m scale)

Figure 15: Beam slot [12] & plough furrow [17]

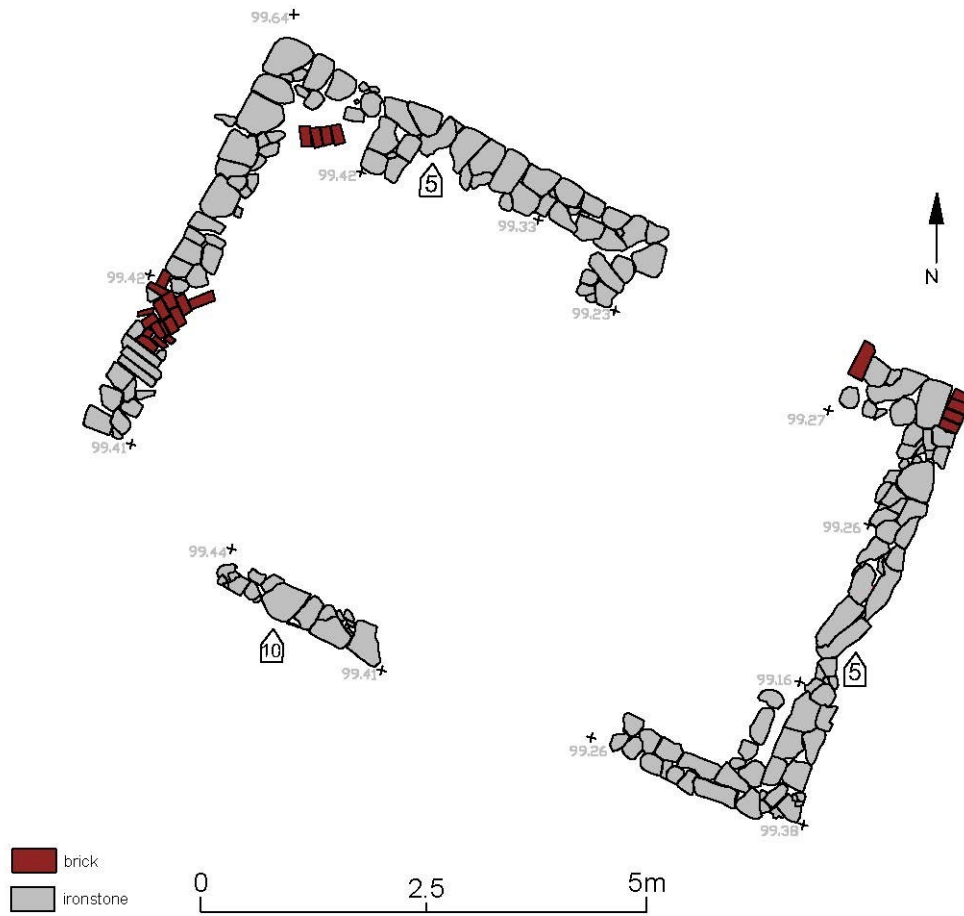
Figure 17: North wing

The north wing of the manor house appeared to have survived in a more intact state than its southern counterpart, with a full run of wall footings including its possible (southern) cross-passage wall remaining (Figure 17, Figure 18, Figure 19). The wall footings [05] comprised predominately faced rectangular ironstone blocks surviving up to three courses (0.34m) in height and 0.45m-0.5m wide with no core. The base course was bonded with yellowish grey clay, whilst greyish yellow lime cement had been used on upper courses. Small amounts of brick (repairs?) were evident within the western and eastern wall builds.

The wing measured *c.* 8m x 4.2m-4.8m internally and was devoid of internal features, with the exception of a possible fireplace set against the north wall, as represented by short masonry stubs measuring 2.3m apart and projecting 0.5m into the room. There was, however, no evidence of heat scorching on the stonework. An external doorway, as defined by a 2.4m wide opening with squared off wall ends, occupied the eastern end of the north wall.

A 2m length of narrow offset stone walling south of the southern wall of the wing [10], may represent an internal partition wall separating the north wing from the

central hall (Figure 17, Figure 19)). Alternatively, it may form the north wall of a cross passage at the northern end of the hall.

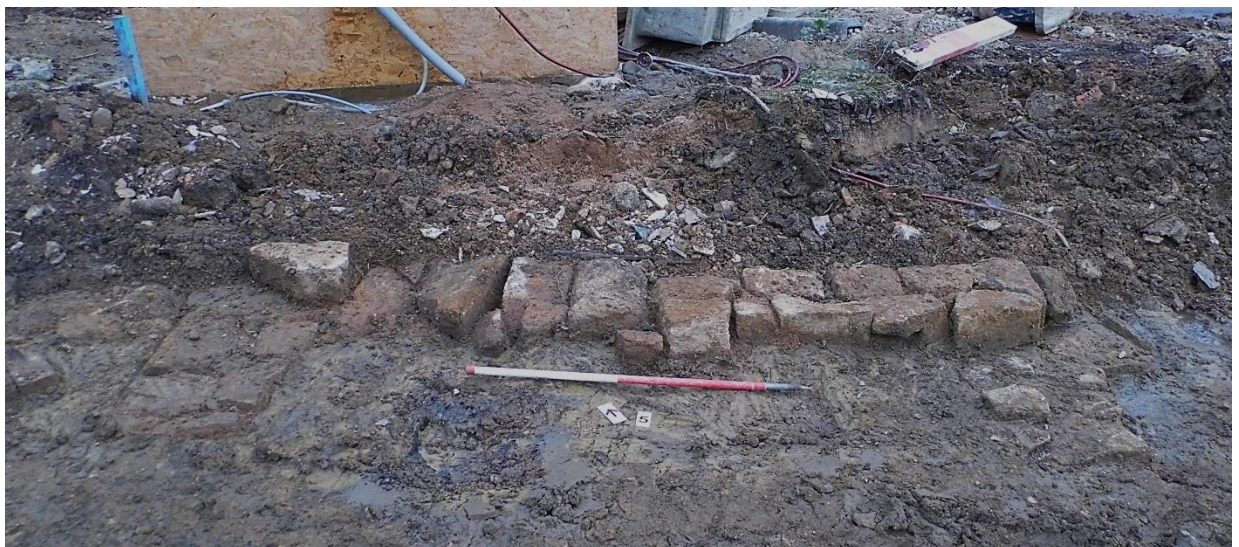
Figure 18: Wall (05), north wing; possible fireplace; view north-east (1m scale)

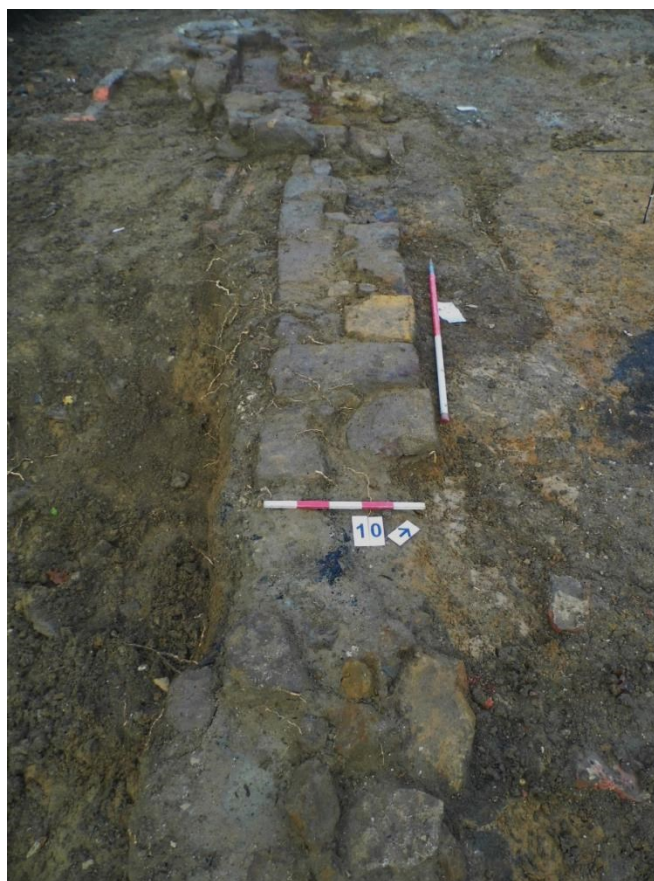
Figure 19: North wing, wall (10), view north-west (1m & 0.5m scales)

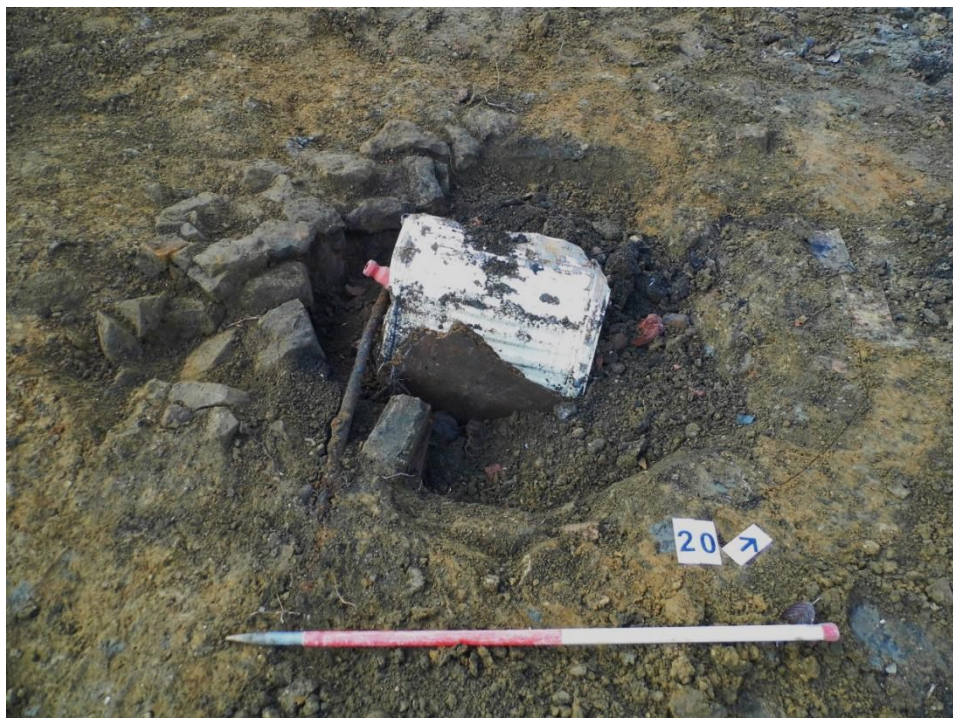
Figure 20: Well [20] view north-west (1m scale)

A stone-lined well and a stone culvert were located immediately west of the manor house. The former, [19] (20) (Figure 21), measured 2mx 1.4m and was lined with roughly faced ironstone stonework defining a c.1.2m wide shaft. The undated feature was filled with unstable modern material and was therefore not excavated on safety grounds.

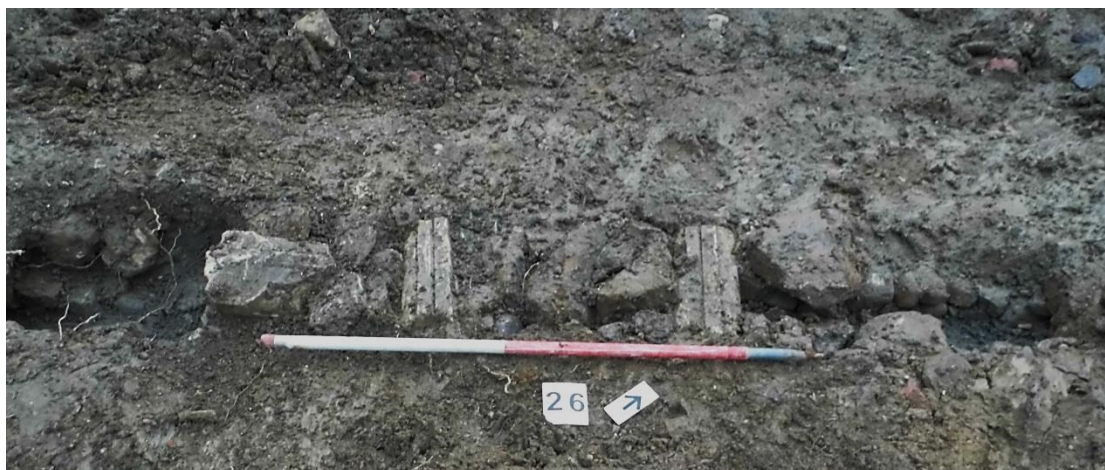
Figure 21: Stone culvert [27]; view north-west (1m scale)

The modern culvert [27] (26) flanked and ran parallel to the building's western external wall for 2.8m+ (Figure 21, Figure 22). The 0.4m wide and 0.2m deep channel cut was lined and capped with a combination of ironstone field stone and window tracery fragments forming a 0.12m wide drainage channel. The tracery has been identified as ovolo moulded mullions, regionally in use from the end of the 16th century and in use throughout the 17th and into the 18th centuries (N.Finn pers. comm.). Consequently the window from which this tracery derives is unlikely to have formed part of the original phase of the manor house.

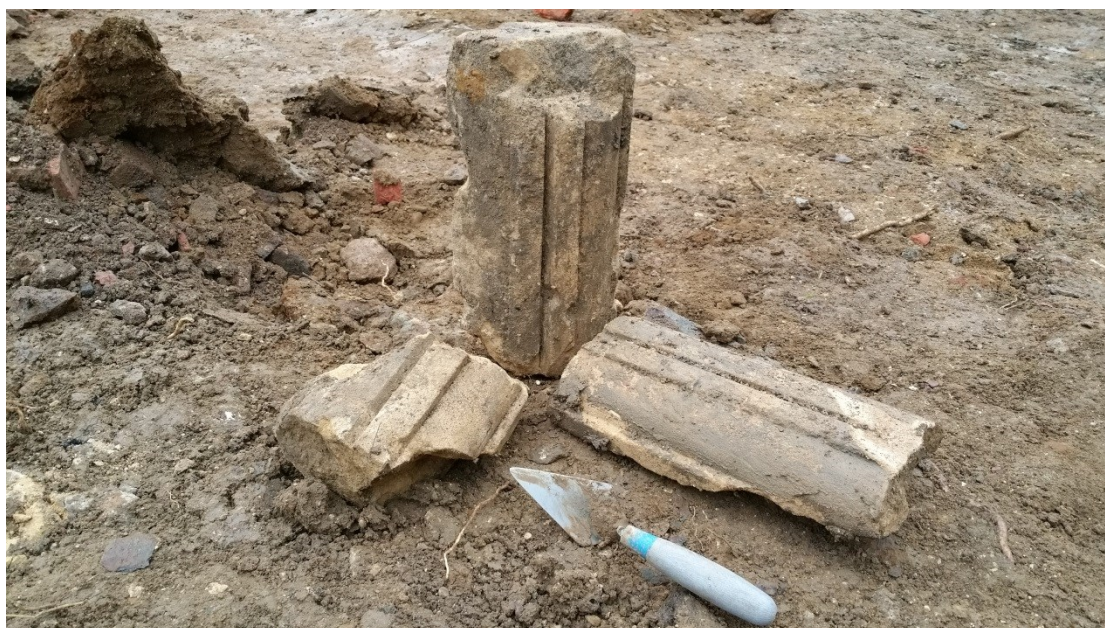
Figure 22: Window tracery fragments from stone culvert [27] (26)

Seven fragments of moulded architectural stonework were recovered from the capping (26) of the stone-built drain [27].

All seven pieces, nominally identified by the letter codes A-G, are from a mullioned and transomed window (or windows). Mullions and transoms are, respectively, the vertical and horizontal members dividing a window into a series of lights.

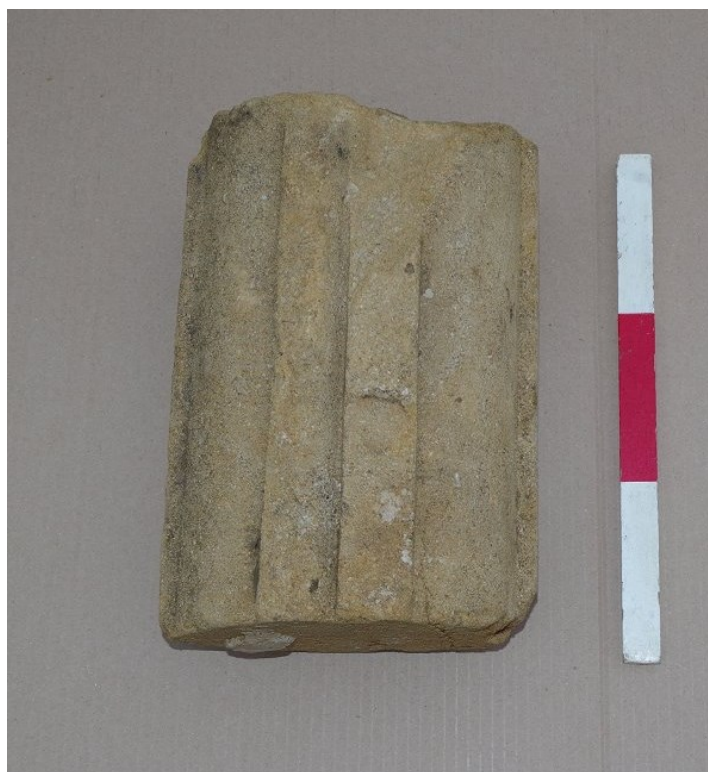
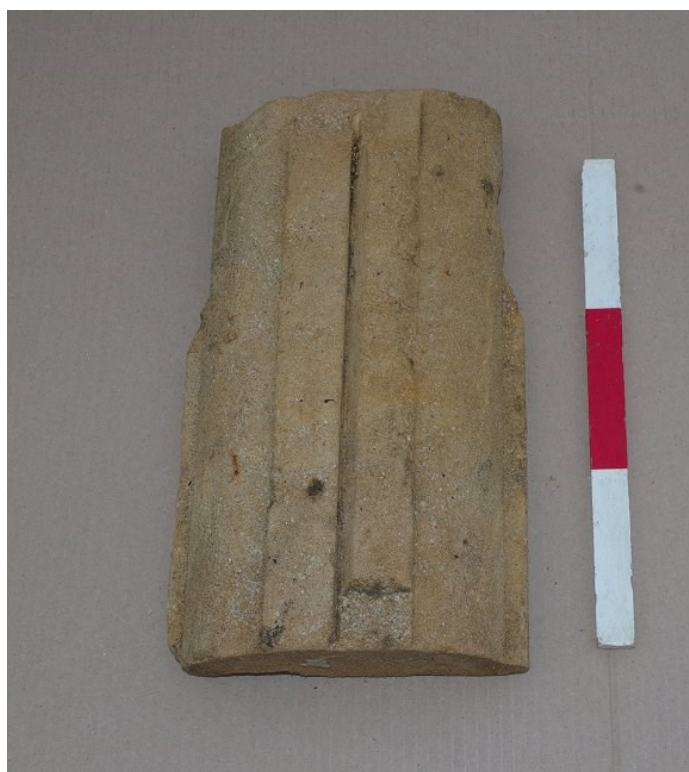
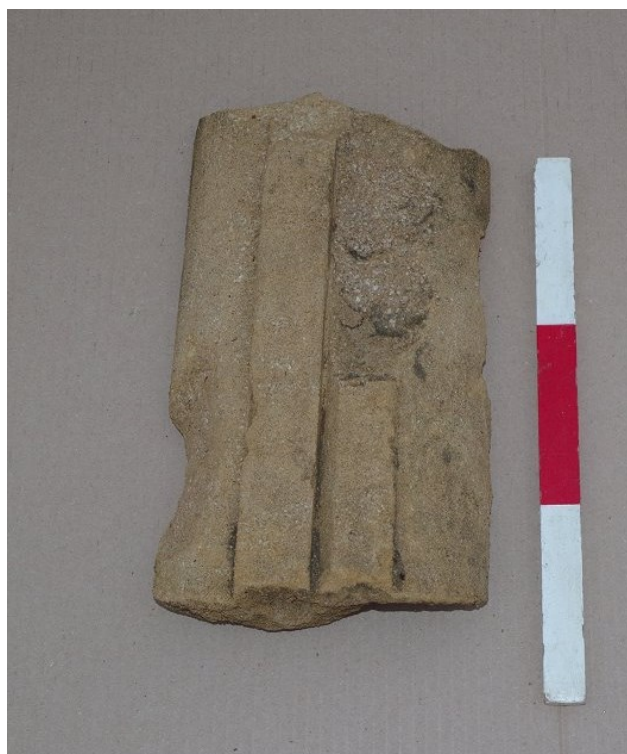
Fragments A, B and C are window mullions of similar form, with ovolo mouldings to their external and internal faces, and rebates for glazing; B and C may be two halves of the same mullion split along its length (Figures 23-25). The complete profile of fragment A is illustrated in Figure 31.

Figure 23. Window mullion A, ovolo-profile. Scale 300mm.

Figure 24. Window mullion B, ovolo-profile (incomplete). Scale 300mm.

Figure 25. Window mullion C, ovolo-profile (incomplete). Scale 300mm.

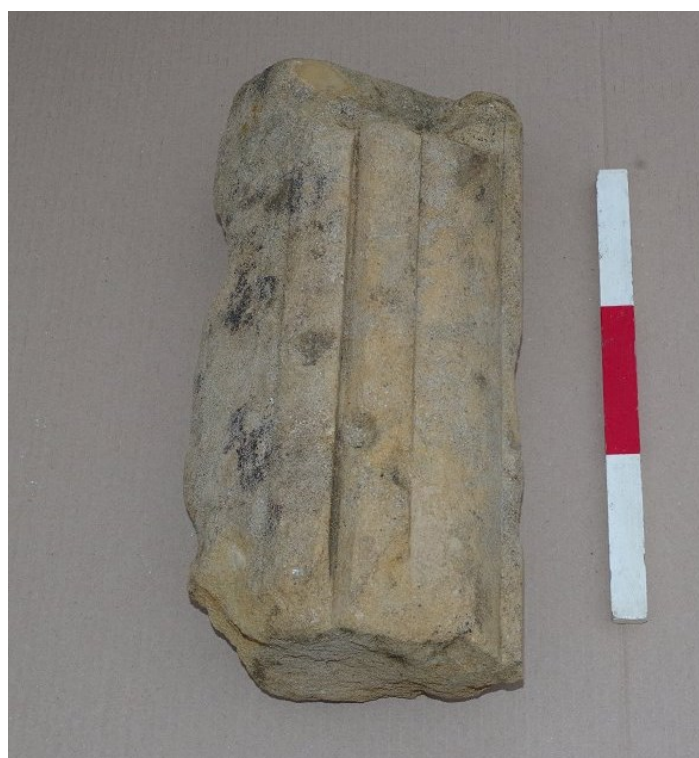
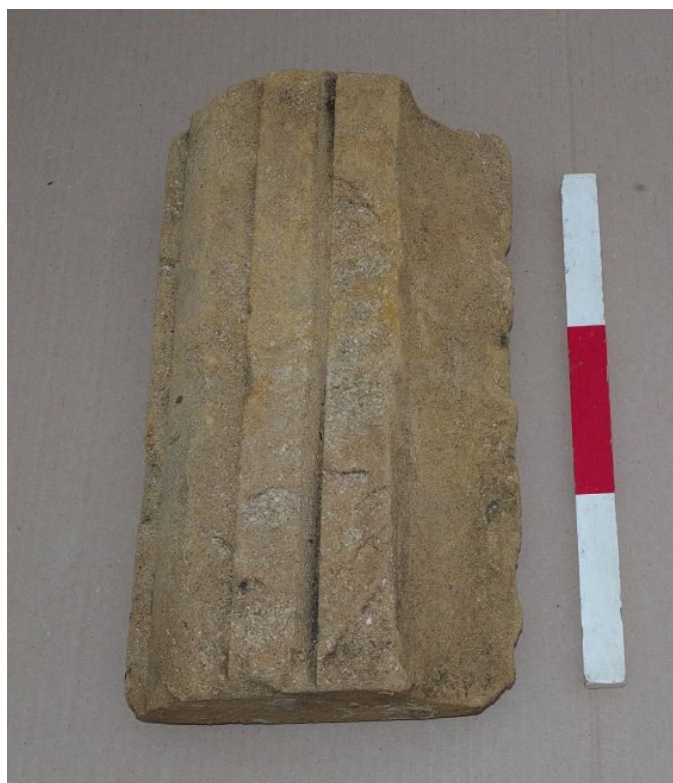
Fragments D and E probably had matching profiles, though E is incomplete (Figures 26-27). These appear to be transoms, having ovolo mouldings internally and externally a chamfered upper surface and hollow chamfered underside. The upper and lower faces are rebated for glazing. The profile of fragment D is illustrated in Figure 31. The variation in profile between D/E and F/G may indicate that these are from two different windows.

Figure 26. Window transom D. Scale 300mm.

Figure 27. Window transom E (incomplete profile). Scale 300mm.

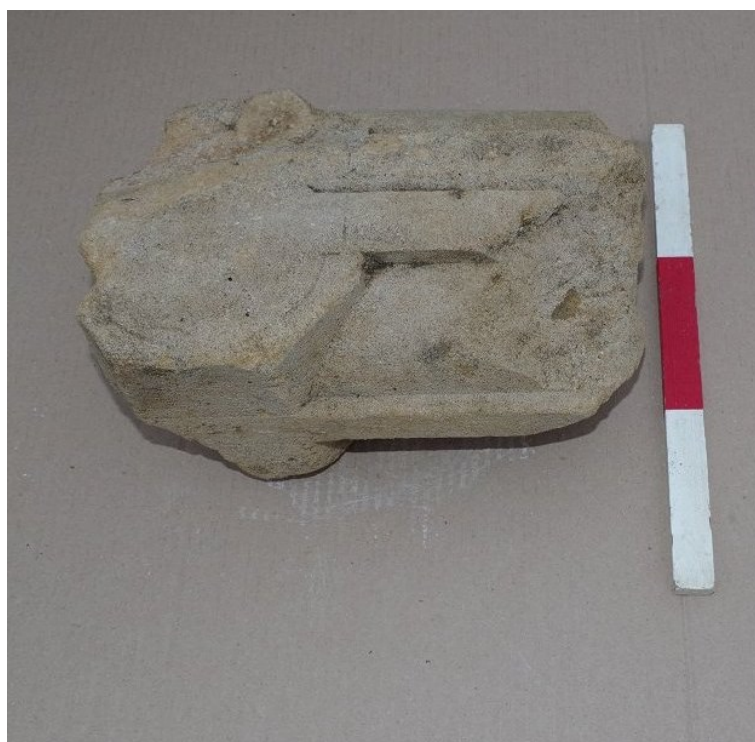
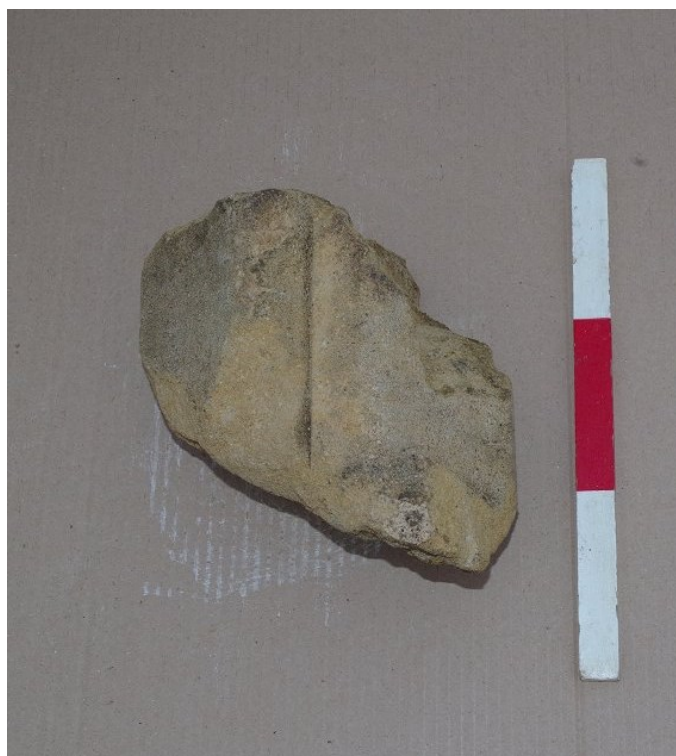
F and G are two joining fragments of a transom, with chamfered upper arrises and ovolo mouldings to the underside (Figures 28-29). There are seatings on the upper and lower faces for mullions with profiles matching that of A. There are glazing rebates in the upper and lower faces. The profile of fragment F is illustrated in Figure 31.

Figure 28. Window transom F. Note scribed mark on upper surface for ovolo mullion. Scale 300mm.

Figure 29. Window transom G, joins fragment F. Scale 300mm.

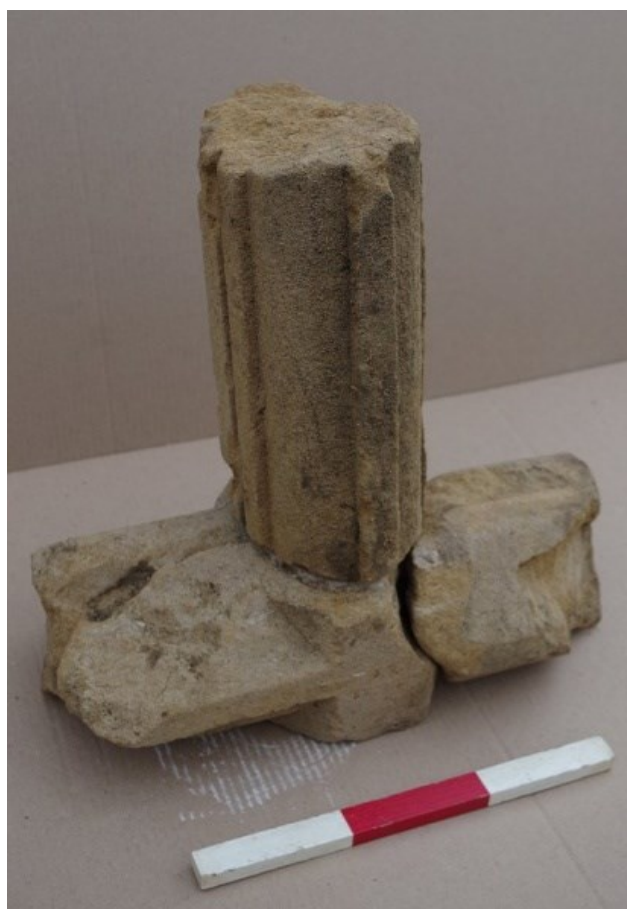
Figure 30 illustrates the relationship between transom fragments F and G and mullion A above. A mullion of corresponding profile would also have been located below the transom.

Figure 30. Reconstruction showing arrangement of mullion (A) and transom (F and G). Scale 300mm

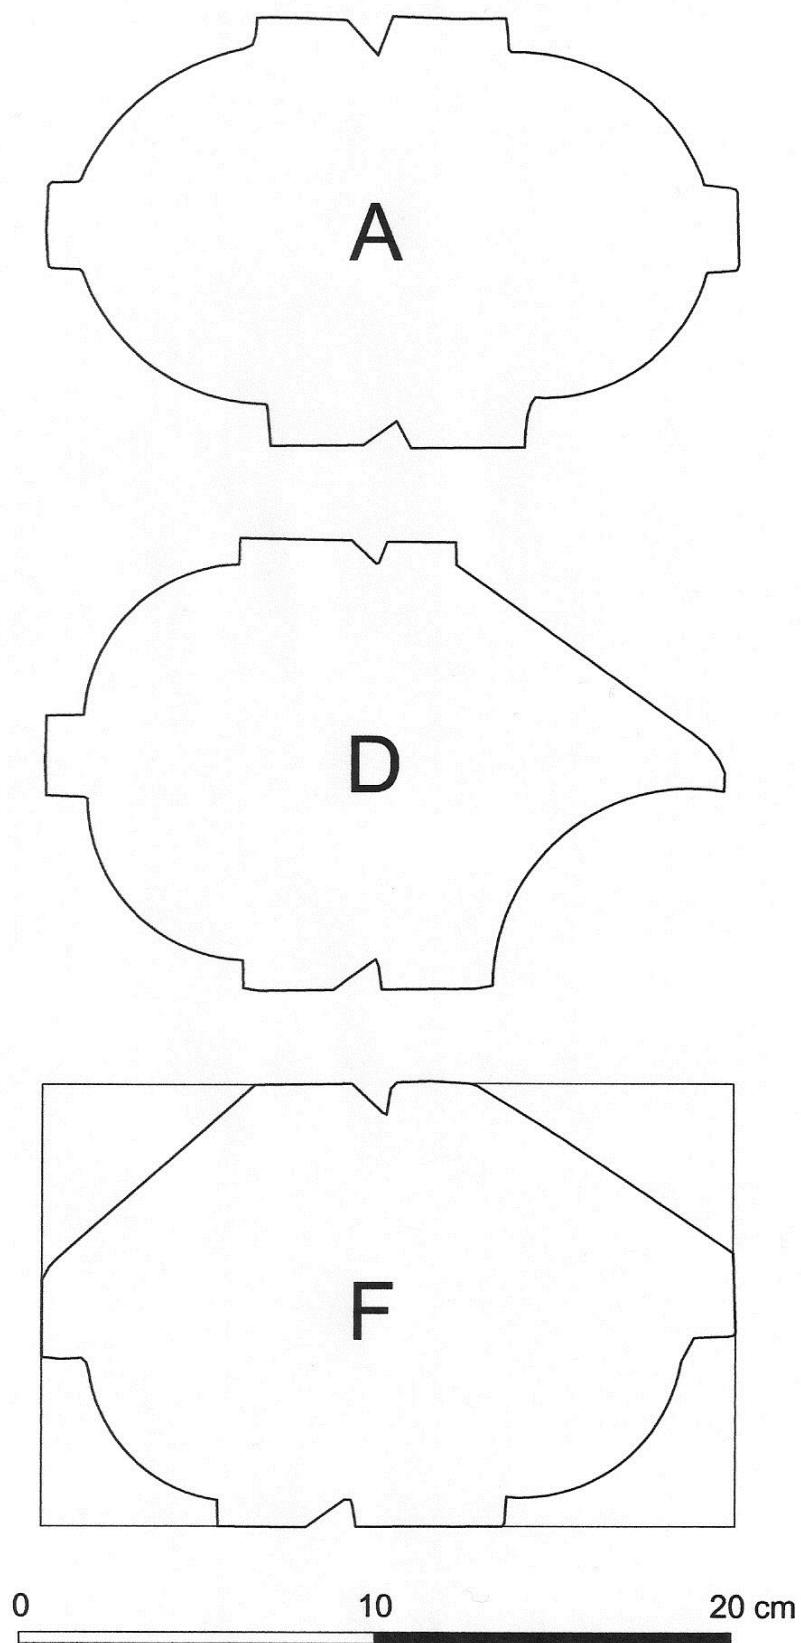
On all of the fragments the glazing rebates have an asymmetrical profile, with one side being near vertical and the other having a shallower angle (Figure 31).

Figure 31. Profiles of window fragments A, D and F.
