**Archaeological Trial Trenching At  
The Coach House, 9b Misterton Way,  
Lutterworth, Leicestershire  
NGR: SP 54525 84362**

ULAS Report No. 2015- 056

**Planning Authority: Harborough District Council  
Planning Consent: 14/01667/FUL**

**For: Life Space Design Studio Ltd**

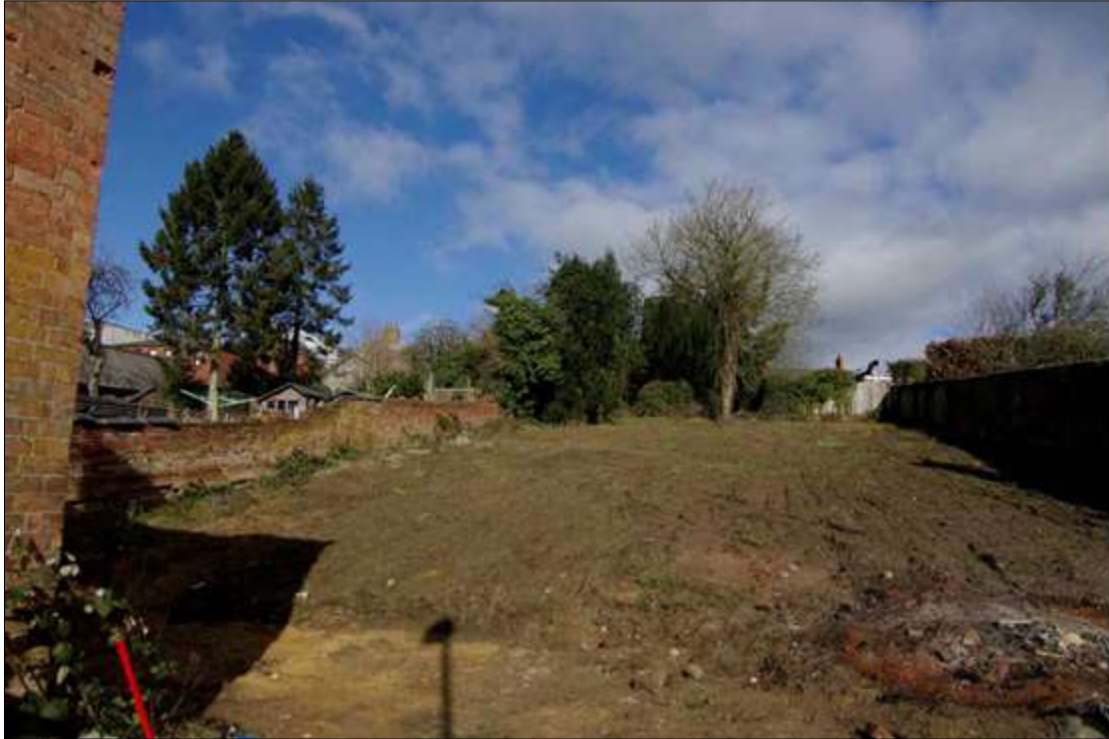
Figure 4: Site prior to trenching facing north

As noted the Coach House sits alone in the south-western corner of the plot. Brick-built boundary walls run along the eastern and western edges of the plot and appear to be of similar age to the building. The northern site boundary is heavily overgrown with a number of trees and large bushes. The southern site boundary is open to the road although a scar on the south east corner of the coach house shows where a boundary wall used to exist. A row of four terraced houses dating to the earlier part of the 20th century have been built against the western gable end of the Coach House.

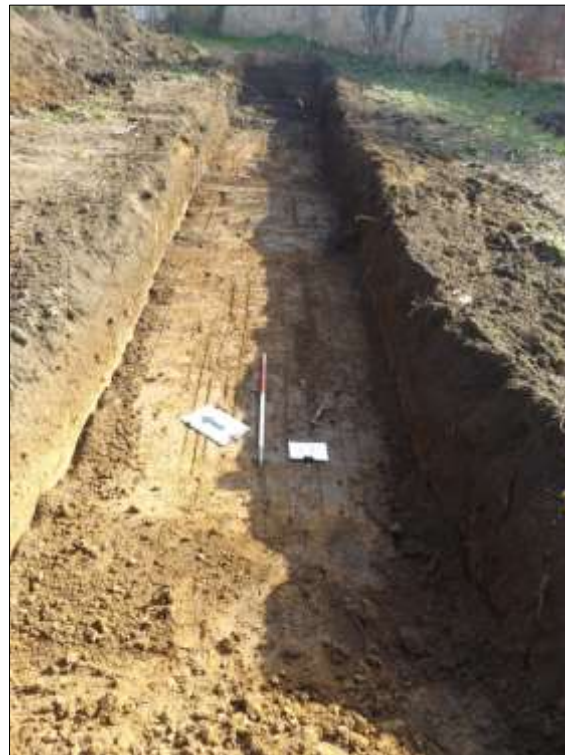
Figure 5: Trench T1 facing north-east

Trench T1 was excavated under archaeological supervision down to the natural sub-stratum of a yellow brown sand. The sub-stratum was overlain by a grey brown silty-sand subsoil and the subsoil was overlain by a grey brown silty sand topsoil. In the north-east end of the trench a modern pit was observed but no further investigation was required as the pit contained

modern garden clearance debris. No archaeological features or finds were located in this trench.

Interval	SW 0m	4m	8m	12m	16.5m NE
<b>Topsoil Depth</b>	0.30m	0.43m	0.58m		
<b>Subsoil Depth</b>	0.11m	0.13m	0.13m		
<b>Top of Natural</b>	0.41m	0.56m	0.71m		
<b>Base of Trench</b>	0.52m	0.70m	0.77m	0.67m	0.71m

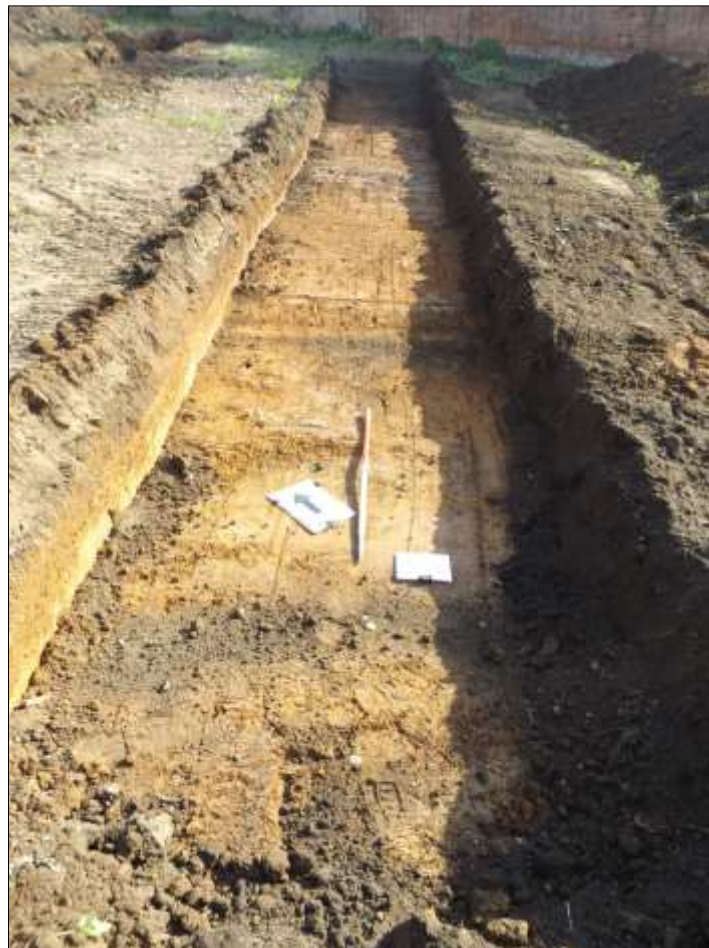
Figure 6: Trench T2 facing north-east

Trench T2 was excavated under archaeological supervision down to the natural substratum comprising a yellow brown sand. The substratum was overlain by a grey brown silty-sand subsoil and the subsoil was overlain by a grey brown silty-sand topsoil. No archaeological features or finds were located in this trench.

Interval	SW 0m	3m	6m	9m	12m	15m NE
<b>Topsoil Depth</b>	0.23m	0.29m	0.28m	0.31m	0.36m	0.38m
<b>Subsoil Depth</b>	0.24m	0.13m	0.19m	0.13m	0.18m	0.20m
<b>Top of Natural</b>	0.47m	0.42m	0.47m	0.44m	0.54m	0.58m
<b>Base of Trench</b>	0.52m	0.56m	0.49m	0.51m	0.64m	0.67m

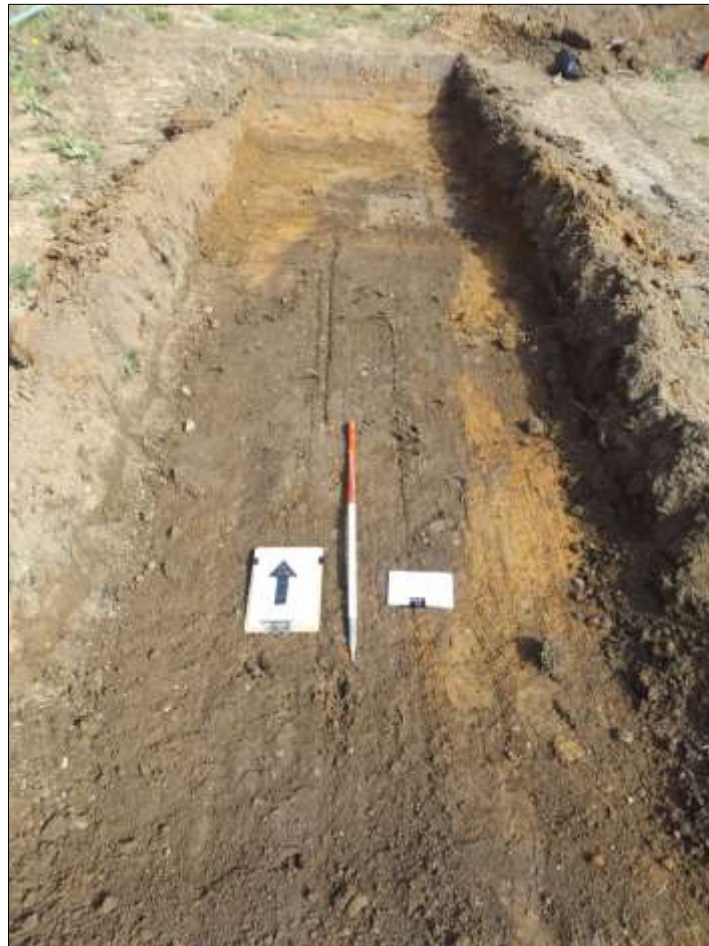
Figure 7: Trench T3 facing north

The trench was excavated under archaeological supervision down to the natural substratum of a yellow brown sand. The substratum was overlain by a grey brown silty-sand subsoil and the subsoil was overlain by a grey brown silty-sand topsoil. An elongated pit or possible linear feature (Fig.6) was discovered, hand excavated and recorded to a safe depth of 0.8m. This

was steep sided with sharp edges and may have been a modern cut feature. It contained a dark grey brown silty sand fill from which medieval pottery was recovered (below p. 9).

Interval	S 0m	2m	4m	N 8m
Topsoil Depth	0.21m	0.19m	0.24m	0.22m
Subsoil Depth	0.10m	0.07m	0.14m	0.12m
Top of Natural	0.31m	0.26m	0.38m	0.34m
Base of Trench	0.36m	0.31m	0.49m	0.43m

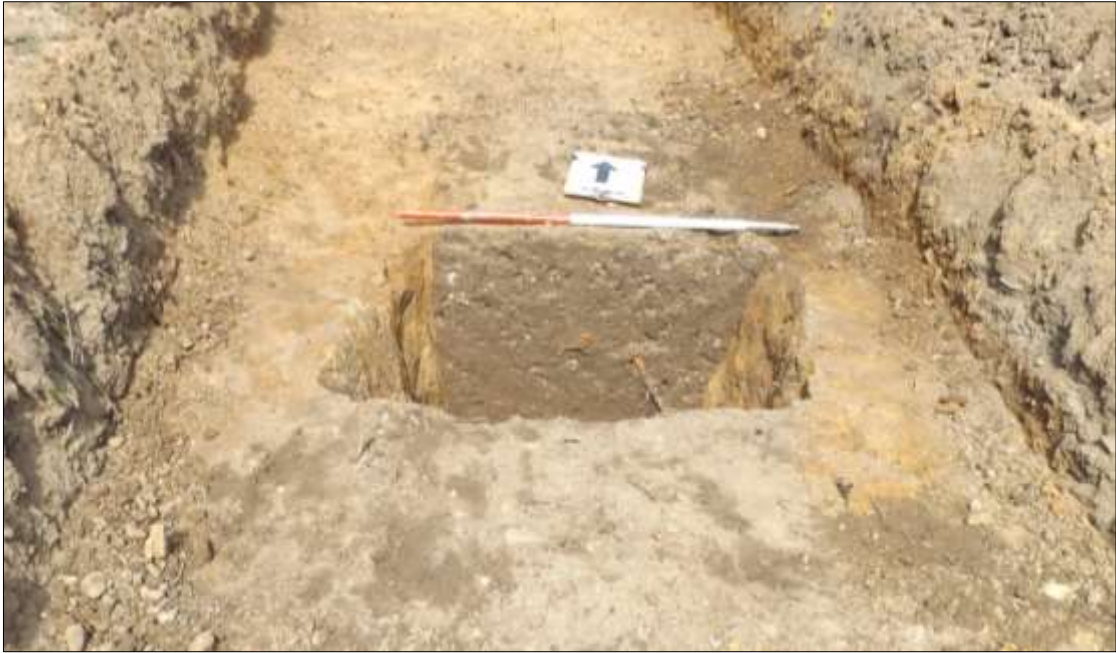
Figure 8: Post-medieval pit in T3

Archaeological trial trenching was undertaken on the land north of the demolished Coach House on the site of 9b Misterton Way, Lutterworth, Leicestershire. Three trenches were excavated, two of which contained no archaeological deposits while one (T3) revealed an elongated pit. The sharp edged form of the pit suggested a modern origin although the only material recovered was of a late medieval date – post-medieval date (above p.9).
