**An Archaeological Evaluation and Strip, Map and Record Excavation
on Land at Country House, Coleorton, Leicestershire, LE67 8JJ**

ULAS Report No 2016-049
©2016

**An Archaeological Evaluation
and Strip, Map and Record Excavation on
Land at Country House, Coleorton, Leicestershire**

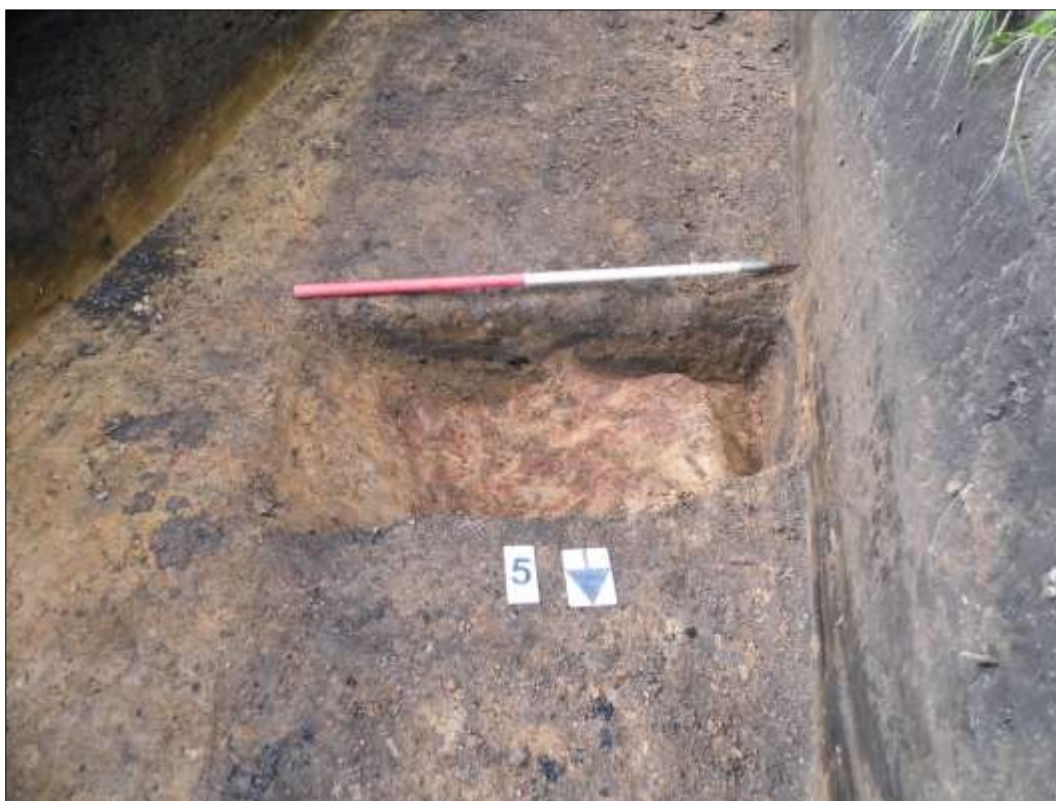
One edge of a double linear feature **[05]** ran along Trench 04 at its southern end on a north-south orientation for approximately *c.* 6.50m. It was 1.13m wide, 0.30m deep and had moderately sloping sides and a concave base. There was no obvious relationship between the features and both contained the same dark grey silty-clay with charcoal **(06)**. It was also devoid of finds.

Figure 6: Gully [05], Trench 2, looking south

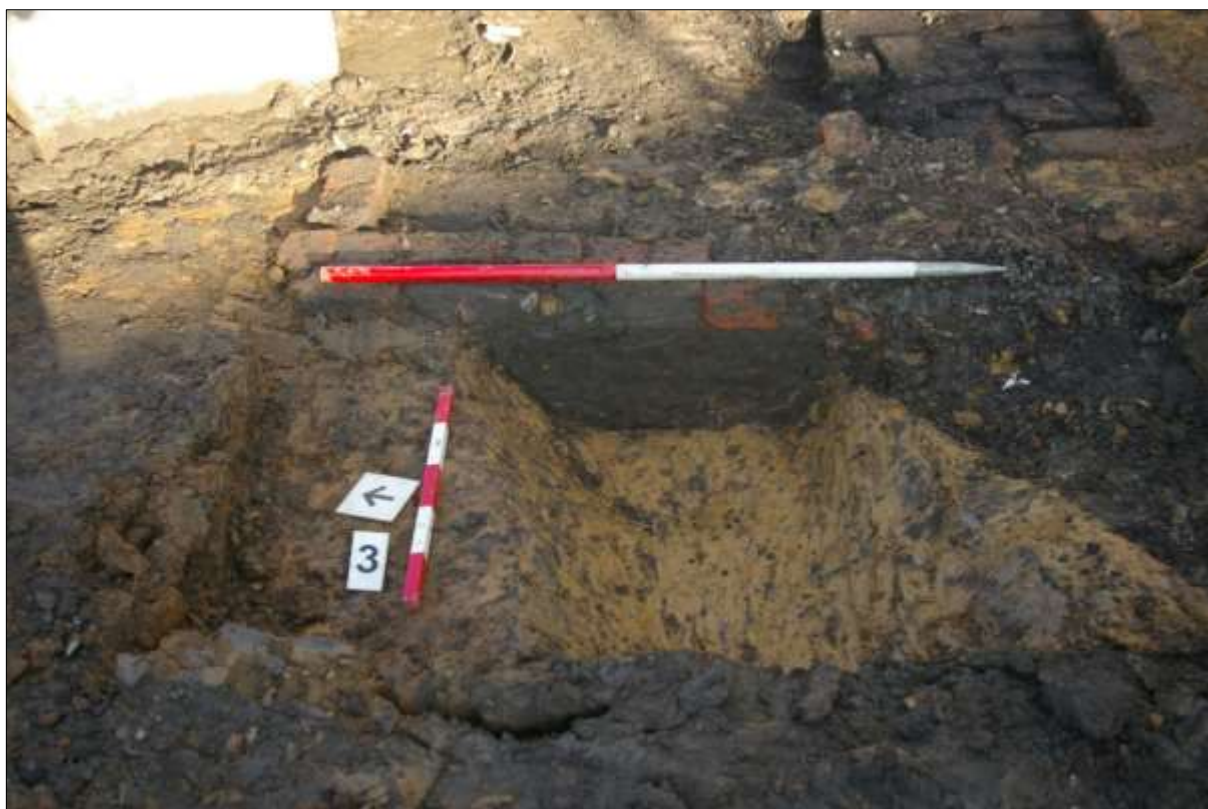
Ditch [3] had a broad flat base with steep sides and was recorded as 0.75m wide and 0.21m deep (Fig. 15, Section 3.02). A length of 1.60m was visible during the excavation but the ditch was seen to continue beneath the sections to the south-west and north-east (Fig. 16) and was clearly visible running beneath the cottage walls. Within ditch [3] the fill (4) was recorded as very dark grey silty clay with small amounts of yellow clay included and a large amount of charcoal or coal residue was observed. Pottery was found within fill (4) and this has been identified as 17th or 18th century pancheon ware (Appendix 1).

Figure 16: Ditch [3] continuing beneath cottage remains, looking east

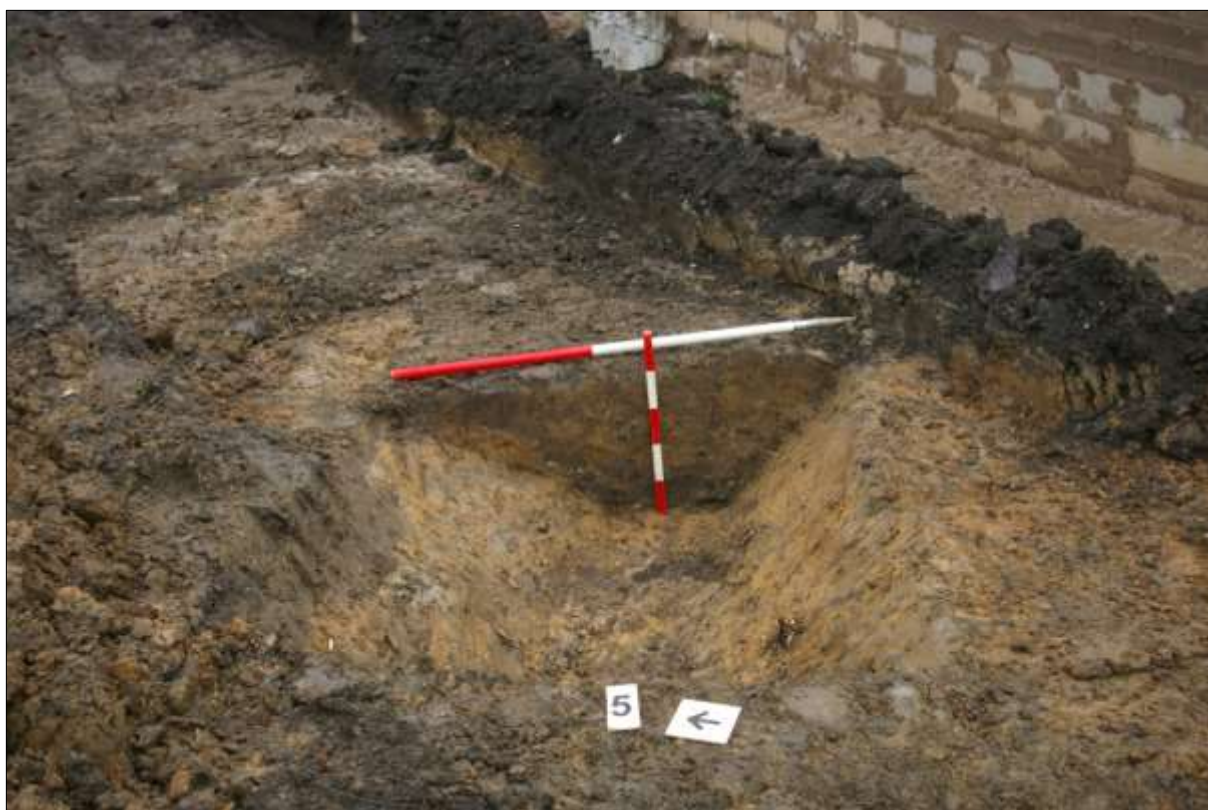
Ditch [5], although narrower than the base of ditch [3], also had a flat base with sides of approximately 45 degrees. It was 1.18m wide and 0.40m deep (Fig. 15, Section 3.01). A length of 2.80m was visible during the excavation and the ditch continued beneath the sections to the south-west and the north-east (Fig. 17). Within ditch [5] the fill (6) comprised a light grey, silty clay with small amounts of yellow clay mottles and contained large amounts of charcoal or coal residue. Pottery was found within fill (6) and this has been identified as 17th or 18th century pancheon ware (Appendix 1).

Figure 17: Ditch [5] continuing beneath garage footings, looking north-east

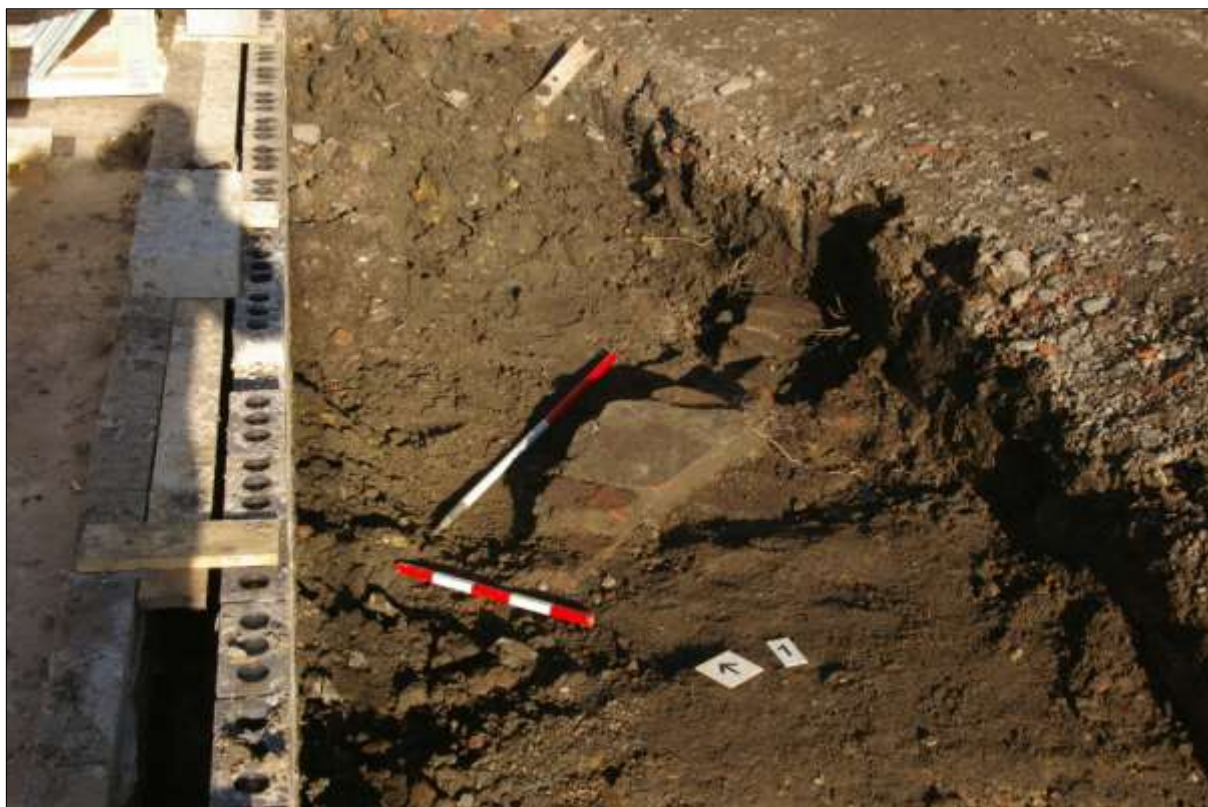
The portion of wall [1] measured 1.70m in length and 0.30m wide, the height was irregular ranging from 0.24m to 0.52m., the highest measurement was recorded where three courses of brick remained (Figs 15, S3.03, 18). Pottery fragments associated with the remains of the cottage have been described as 17th/18th century mottled ware (Appendix 1).

Figure 18: Cottage wall [1] looking north-east

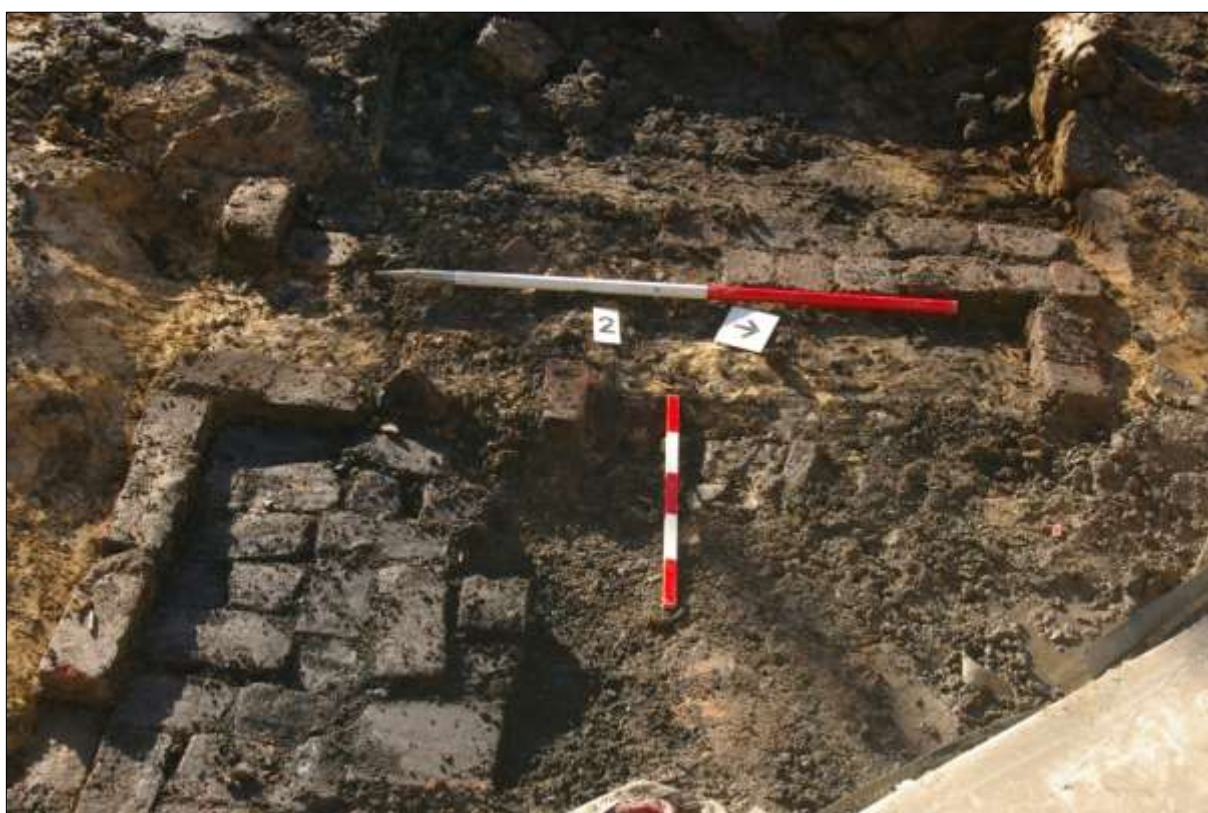
The 1888 1st edition Ordnance Survey Map (1:10560) shows a building visible in the north-east corner of the site in the approximate location of the new garage (Fig. 20). However, the area was very disturbed and the fragmented remains of the 18th-19th century cottage were only visible in two areas of the excavation [1] and [2]. In both of these areas the cottage was represented by a small amount of brickwork, in area [1] by a wall and in area [2] by a small portion of flooring (Figs 14, 18-19).

Figure 19: Cottage floor looking south-west
