**An Historic England Level 2 Historic  
Building Recording at 54 to 58 London  
Road, Leicester**

ULAS Report No. 2016-083  
©2016

**Planning Application PA 20150338**

**For: Abode London Road Ltd**

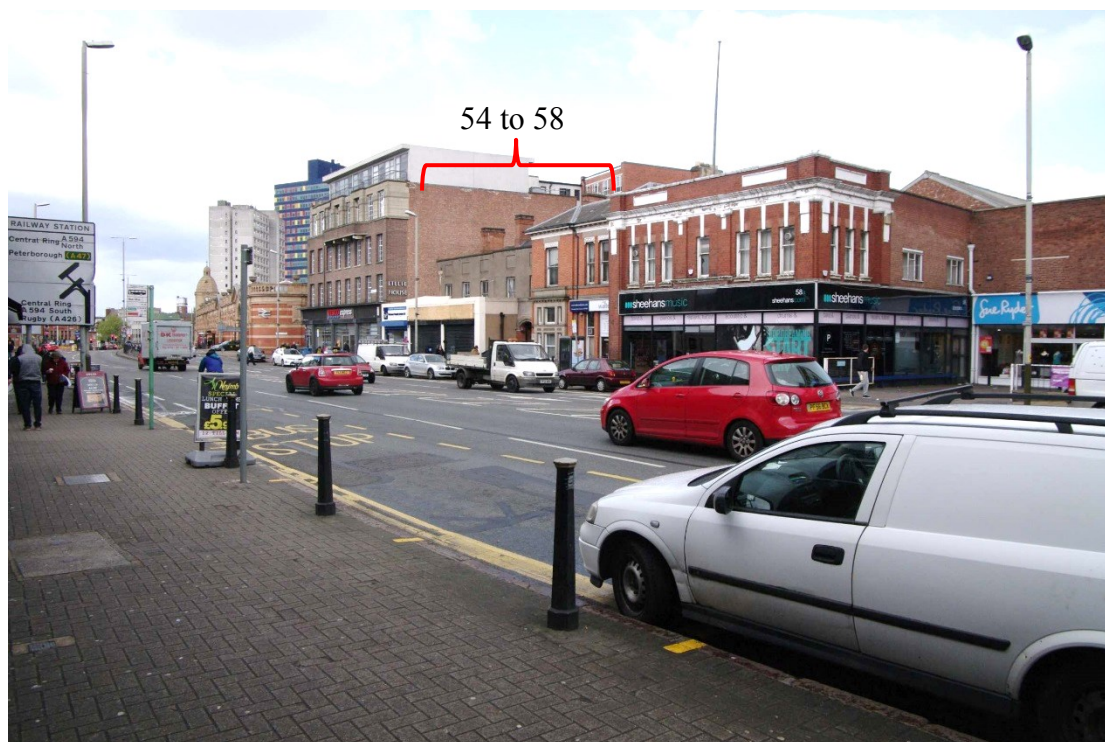
Figure 8 54 to 58 London Road  
Looking north across London Road. Buildings highlighted

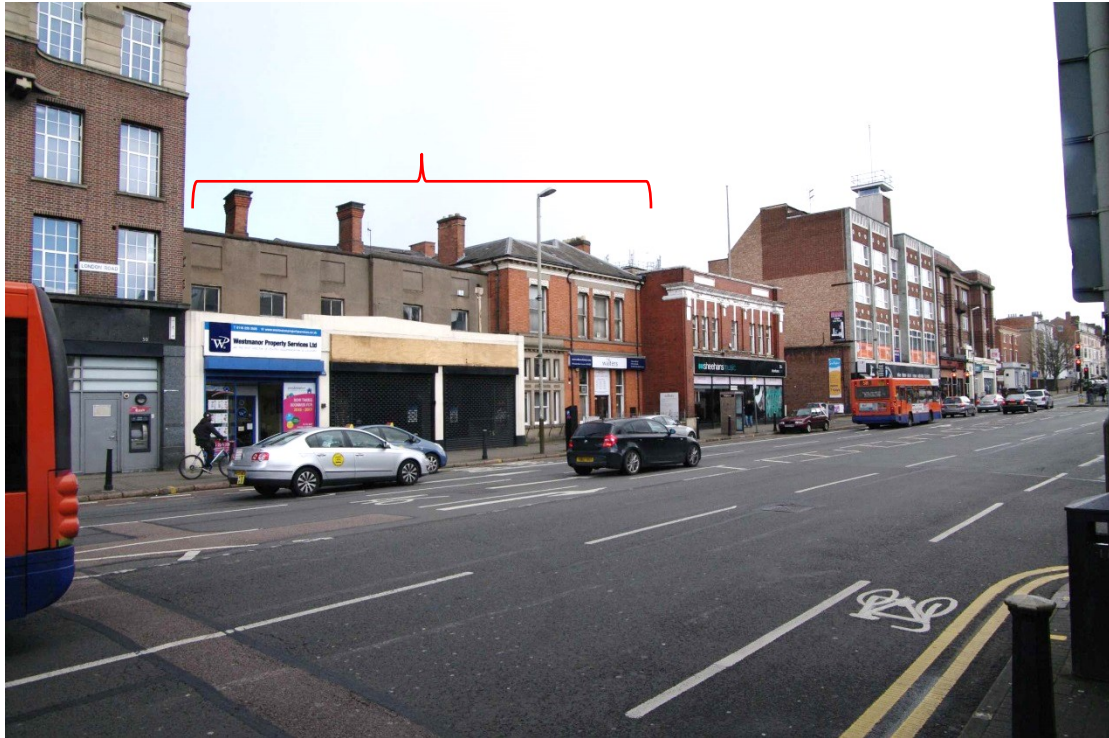
Figure 9 54 to 58 London Road  
Looking east across London Road. Buildings highlighted. Note step in frontage of 54 and 56 beneath central chimney stack

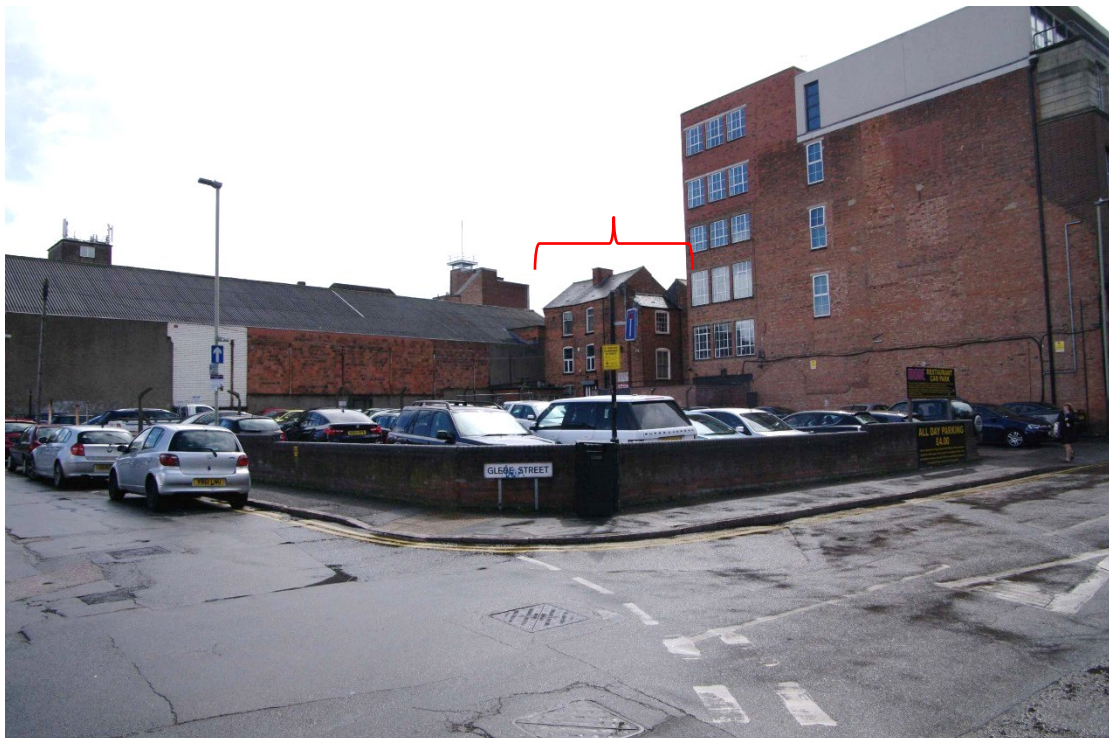
Figure 10 Rear of 54 to 58  
Looking south-east from the corner of Conduit Street and Glebe Street (part of Number 54 obscured by building on right of picture)

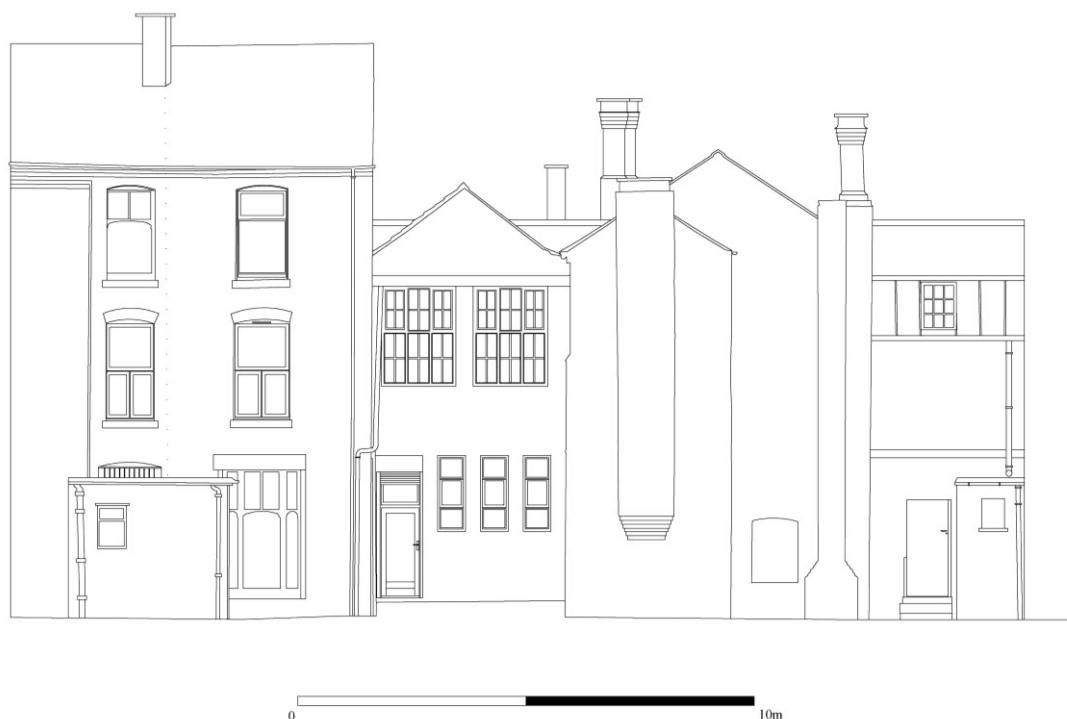
Figure 12 North-east facing elevation  
Modified from client's drawings

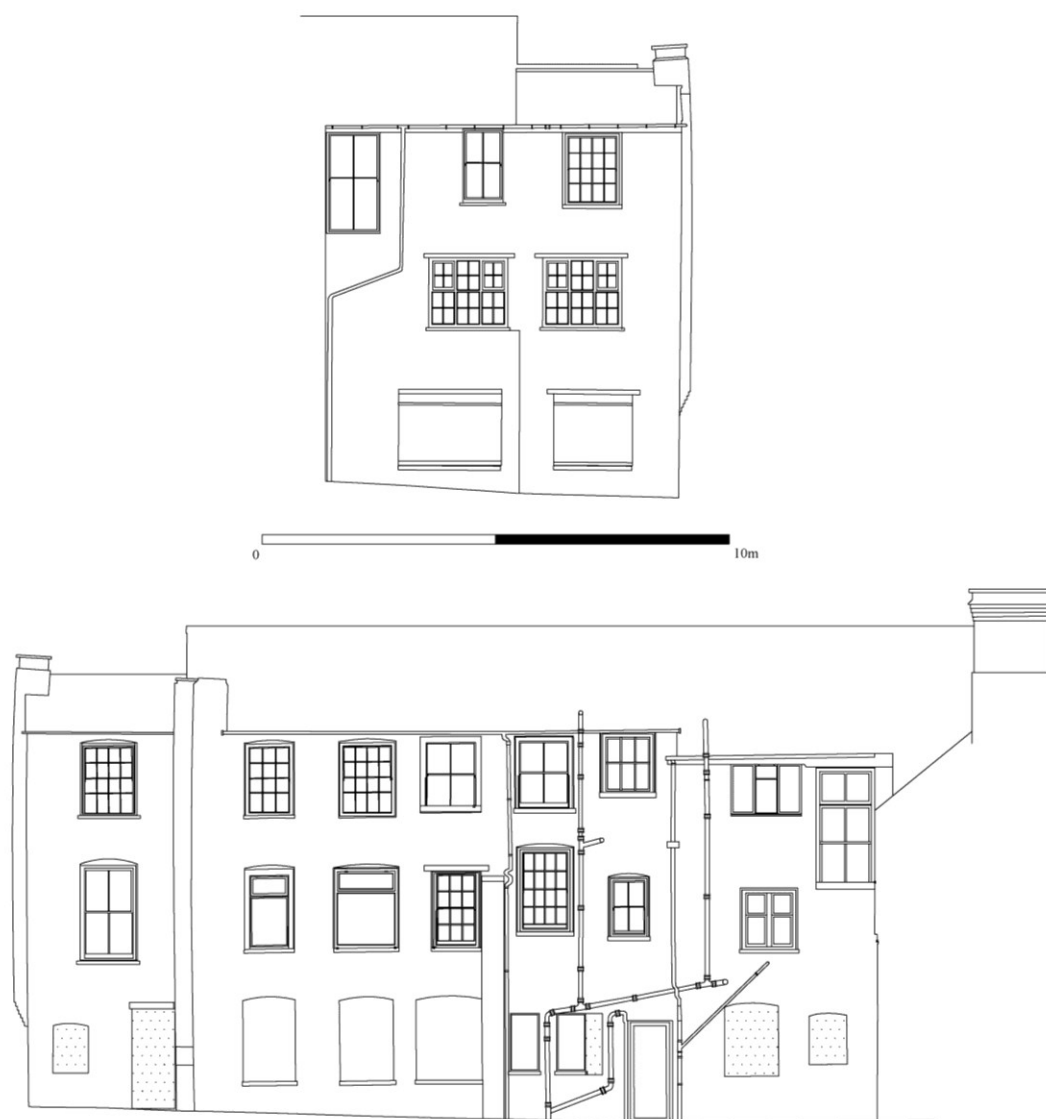
Figure 13 Rear range extension elevations  
Top: south-east facing, bottom: north-west facing

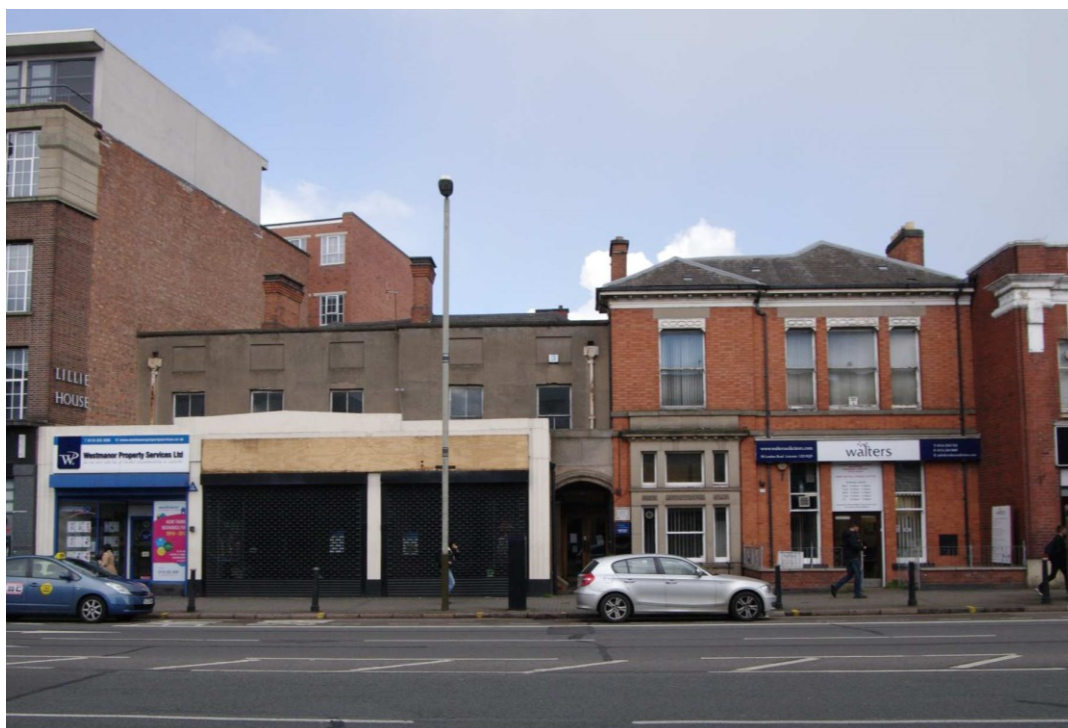
The south-west facing elevation looks out onto London Road and is dominated by the ground floor shop frontages added in the 1930s (Fig. 14). The columns at either side of the extensions have a fluted decoration and match the Art Deco style of the parapet which is mostly obscured by modern name boards. On the eastern side of the shop fronts a stone-built archway has been constructed at the same point as the front wall of Number 58 (Fig. 15). This archway leads into the ground floor hallway of 56 where stairs lead to the first and second floors of all three buildings. Above the double doors the fanlight has *56 & 58* painted in gold lettering. The style of the doors and their Art Nouveau handles (Fig. 16) suggests a pre 1930s, if not earlier, date. If this is the case then it seems likely that the buildings were used as commercial premises from this date.

Figure 14 South-west facing elevation  
Looking north-east. 54 to 58 from left to right

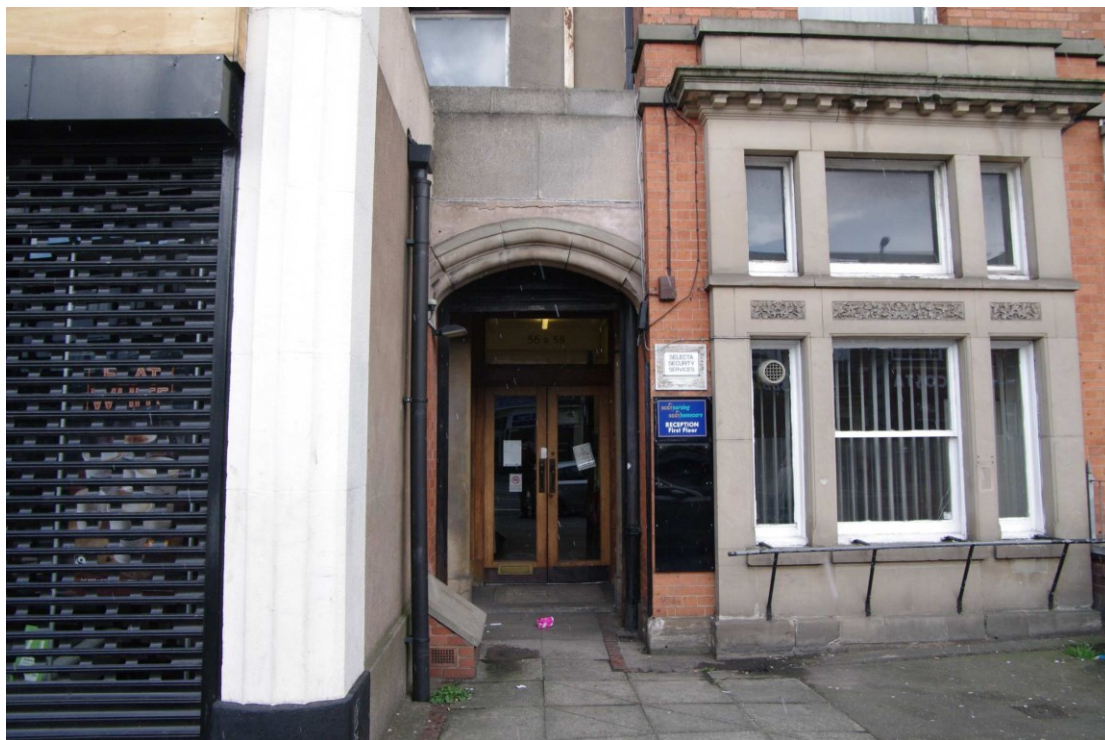
Figure 15 Doorway between 54 and 58  
Looking north-east. Note fluted column decoration on shop front to left

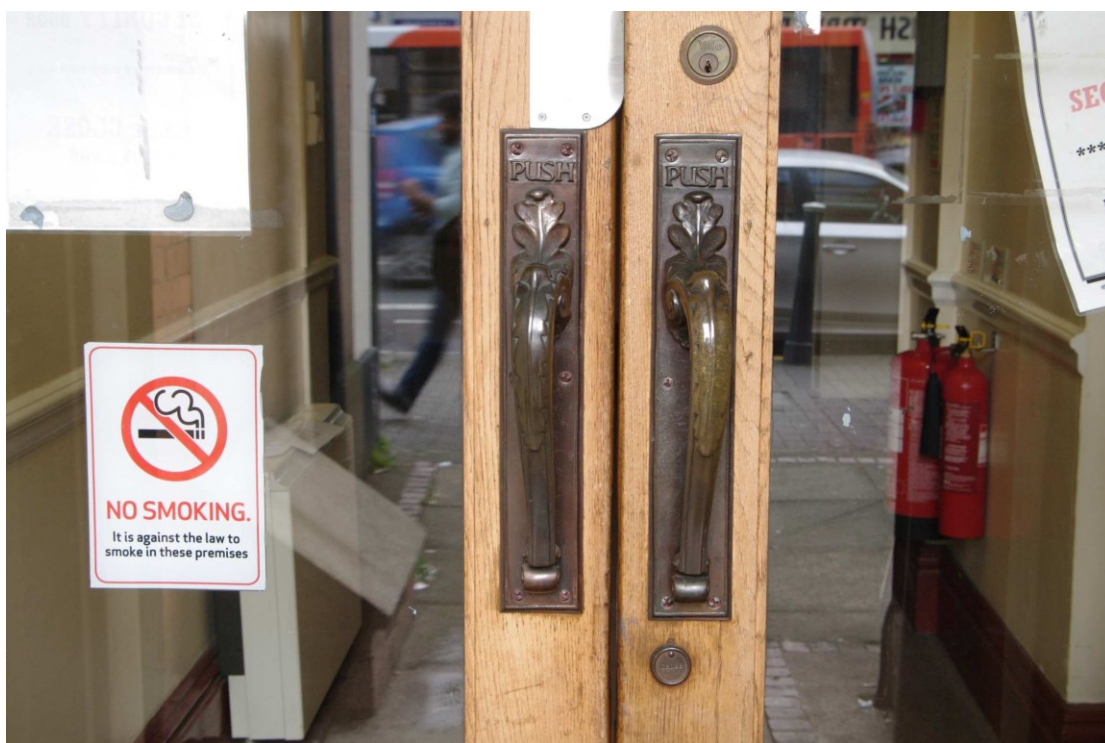
Figure 16 Door handles on main doorway, south-west facing elevation  
Looking north-east

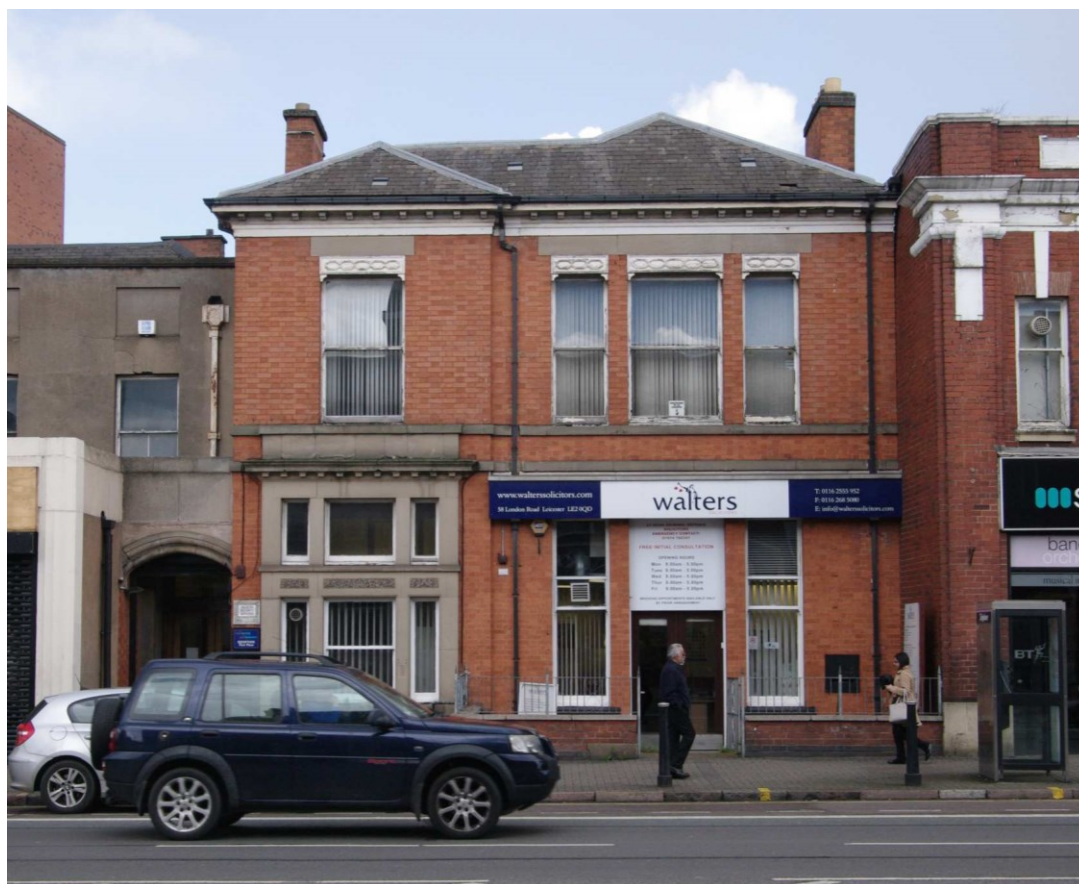
Number 58 is a brick-built, slate-roof building with a slightly prominent side bay which is built against the eastern side of 56 (Fig. 17). The ground floor of the bay is built front limestone with carved, or possibly cast, floral decoration on the central transom. To the east of the bay two ground floor sash windows flank the entrance doorway. A stone string course marks the division of ground and first floors. The first floor sash windows match the pattern of the ground floor but have decorative wooden panels attached to their heads (Fig. 18). With the exception of the modern signage the south-west facing elevation of this building appears to be relatively unchanged since construction.

Figure 17 Number 58 south-west facing  
Looking north-east

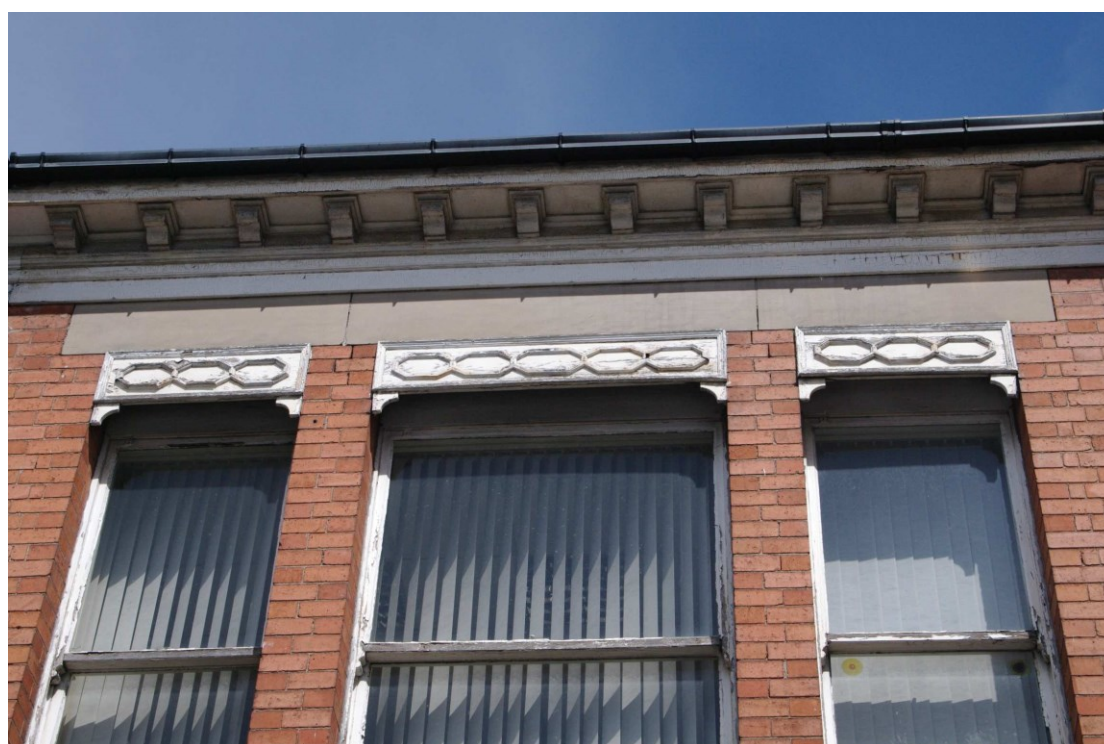
Figure 18 Number 58 south-west facing first floor window detail  
Looking north-east

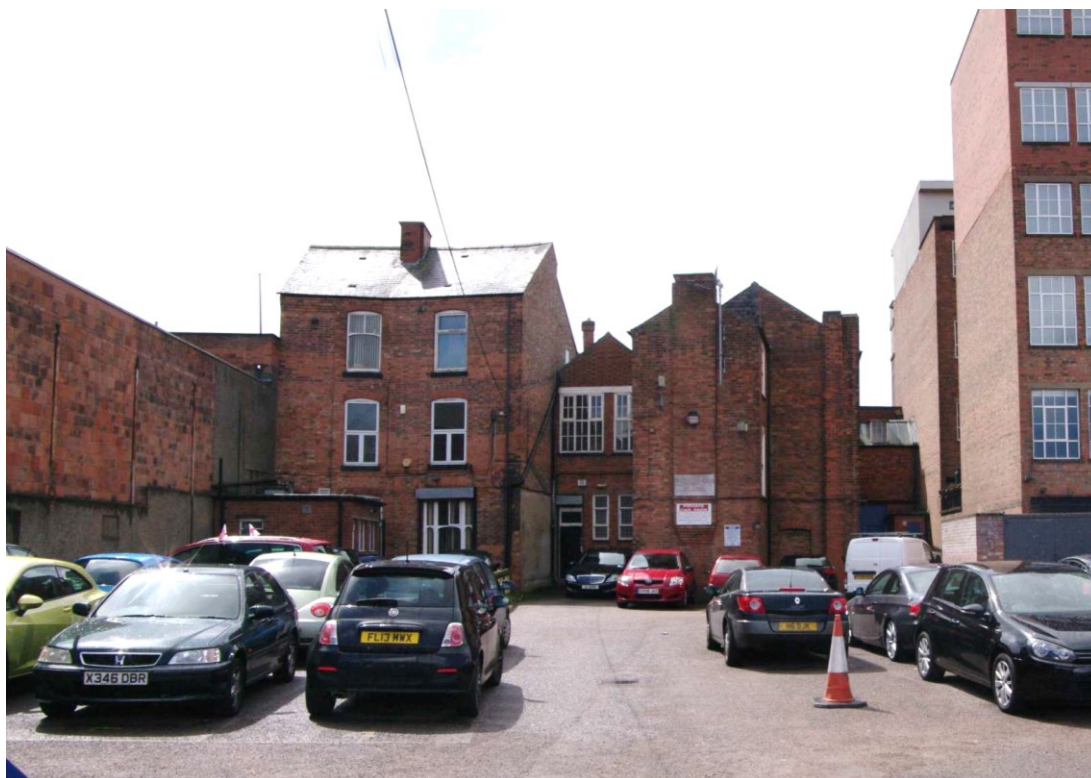
The north-east facing elevation is an amalgamation of extensions running out from the north-eastern side of the main buildings (Fig. 19). The rear of Number 58 has a large three storey extension which has a kink in the middle to allow it to follow both the property boundary to the east and the line of the extensions extending from 54 and 56 (Fig. 20). The extension to 58 has arched lintels over sash or modern windows at first and second floor level. A mid-20th century single storey building housing a toilet block has been attached to the former ground floor back door of the extension. To the west of the back door is a large picture window which once, presumably, looked out into the garden. Much of the north-west facing elevation is obscured by a shorter two storey extension from the rear of number 56 which has two large multi-paned windows set below a wooden lintel at first floor height. This extension has a flat gable end and has three narrow toilet windows and a doorway leading into the hallway behind the doors shown in Figure 15 above. The style of the multi-paned window suggests a late 19th century date.

Figure 19 North-east facing elevation and extensions  
Number 58 on left of picture

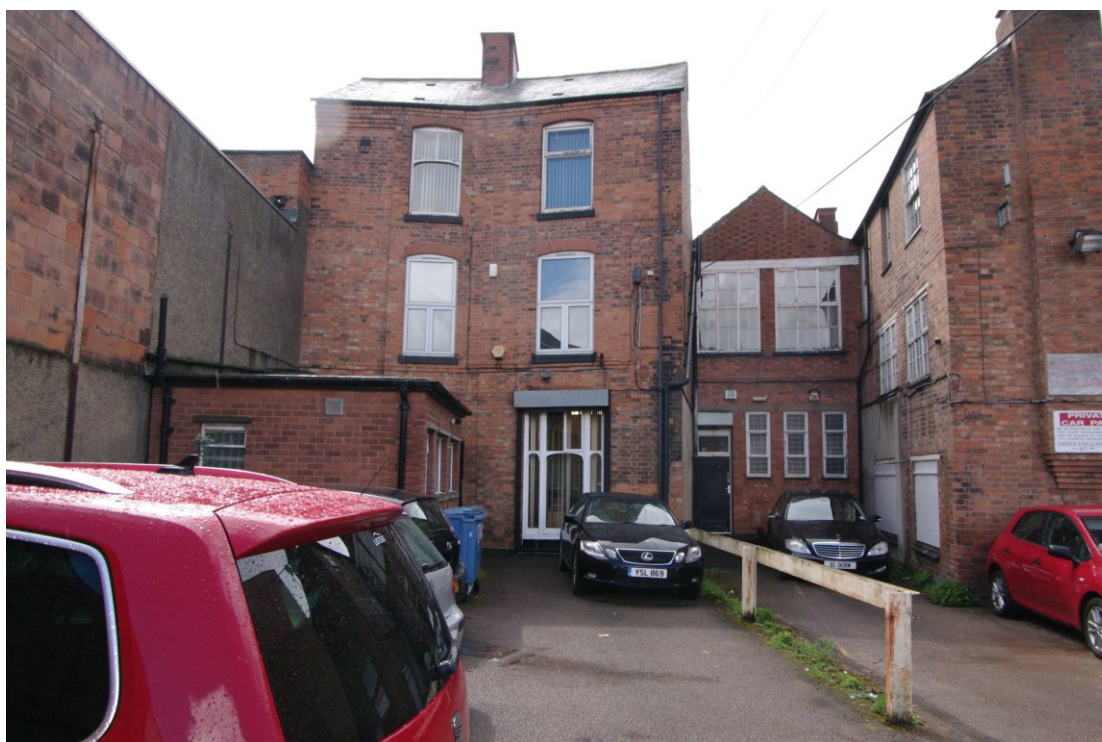
Figure 20 Rear extension of Number 58  
Looking south-west. Note kink in building line running down from the chimney stack

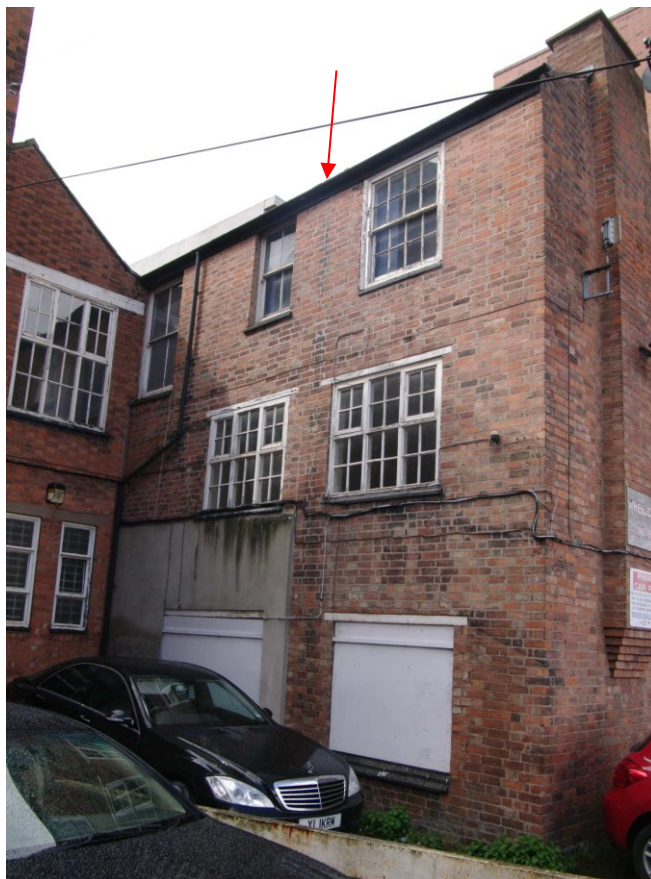
Figure 21 South-east facing elevation of extension to rear of Number 56  
Looking west. Arrow indicates joint of two phases

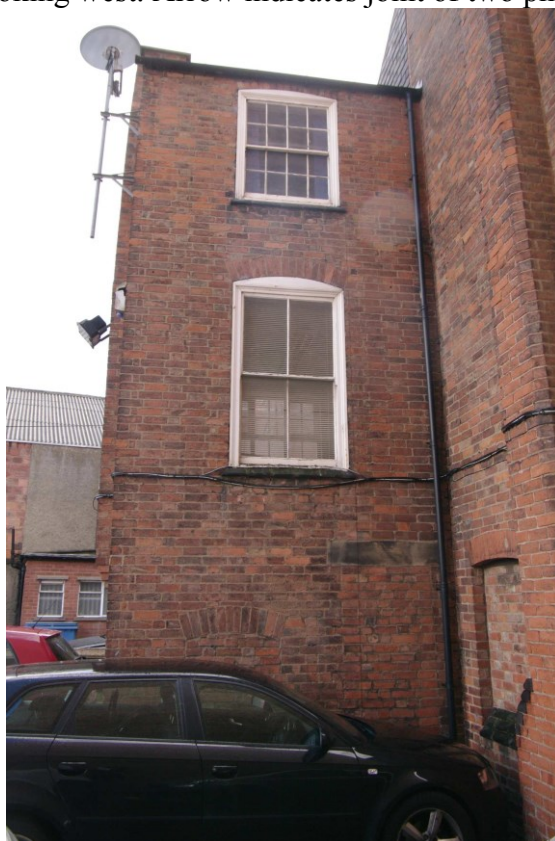
Figure 22 North-west facing elevation of second phase extension to rear of No 56  
Looking south-east. Note blocked door and window at ground floor

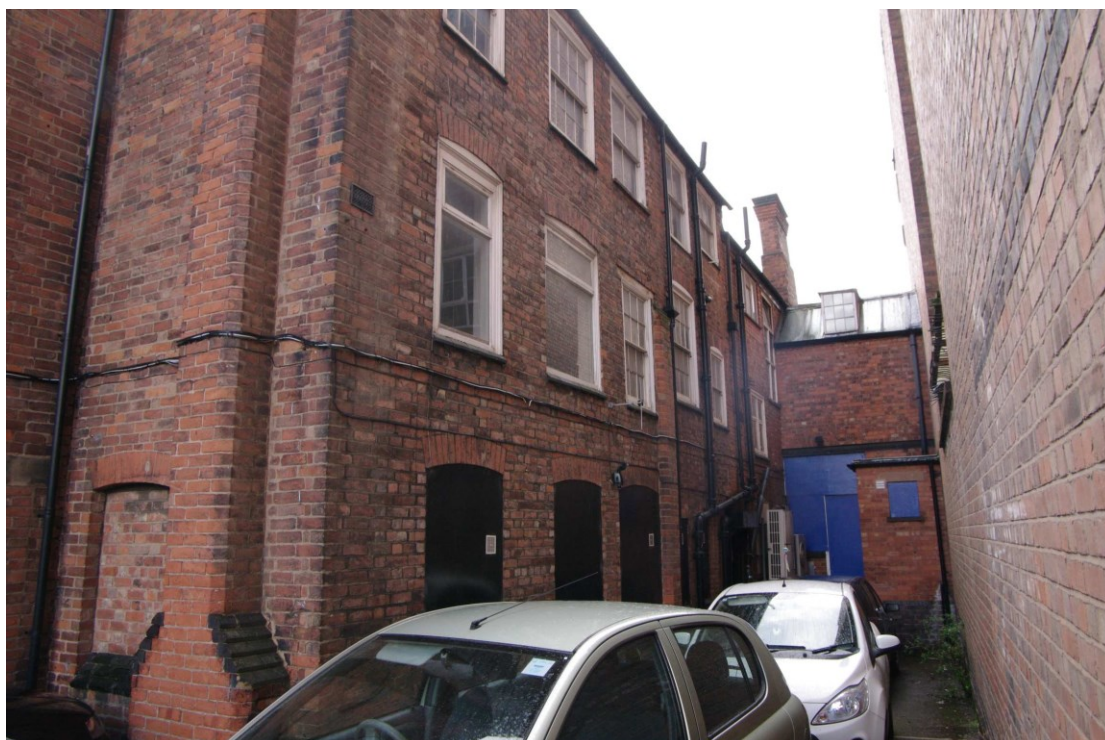
The back wall of Number 54 can be seen at this point as a flat brick wall with steps leading up to the ground floor doorway (Fig. 23). Above the doorway is a steel supporting beam with the manufacturer's name of Frodingham Iron and Steel Co. Ltd England. This Scunthorpe company appears to have changed its name at some time between 1910 and 1930. A modern single storey toilet extension has been added to the west of the doorway. At this point it is clear that Number 54 infills the original gap between 56 and the adjacent property now occupied by Lillie House. There are no first floor windows but the sloping roof is made of large panes of glass with a metal-framed glass dormer window set into it.

Figure 23 North-west facing elevation of first phase extension to rear of No 56  
Blue doorway belongs to Number 54. Note glass roof and glass dormer of 54

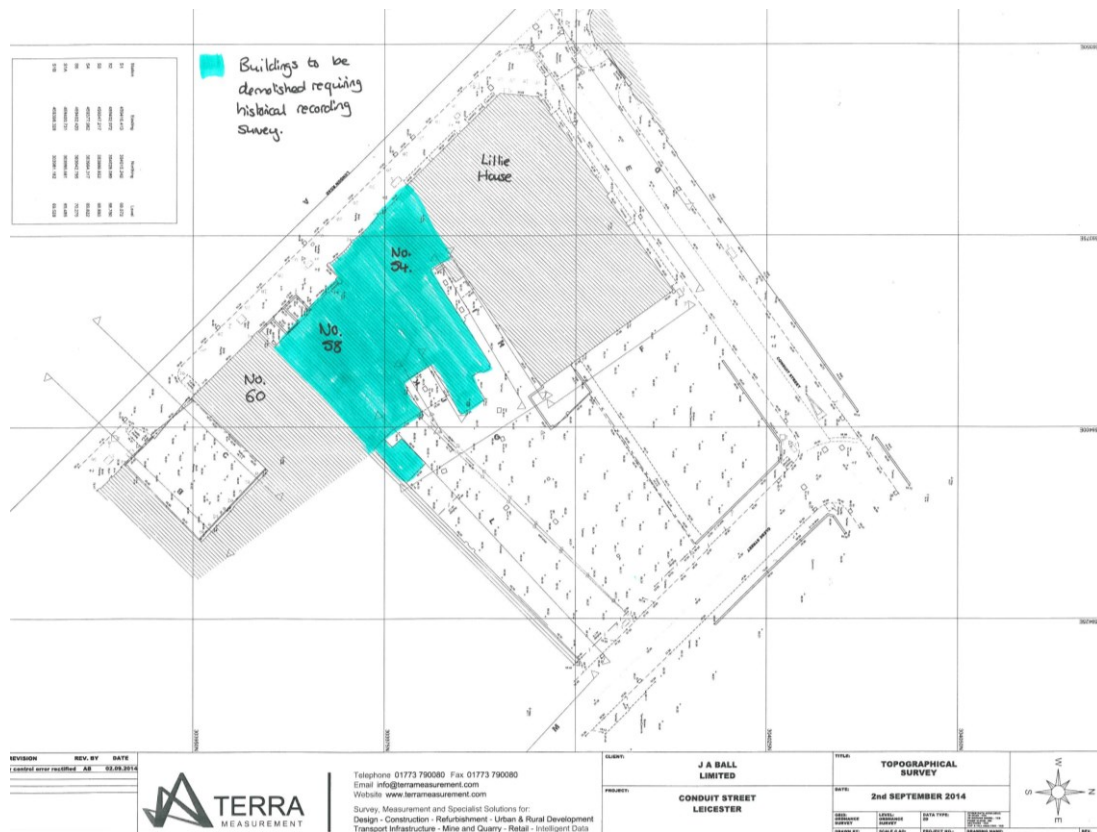
Figure 24 Overall plan of buildings  
Supplied by client

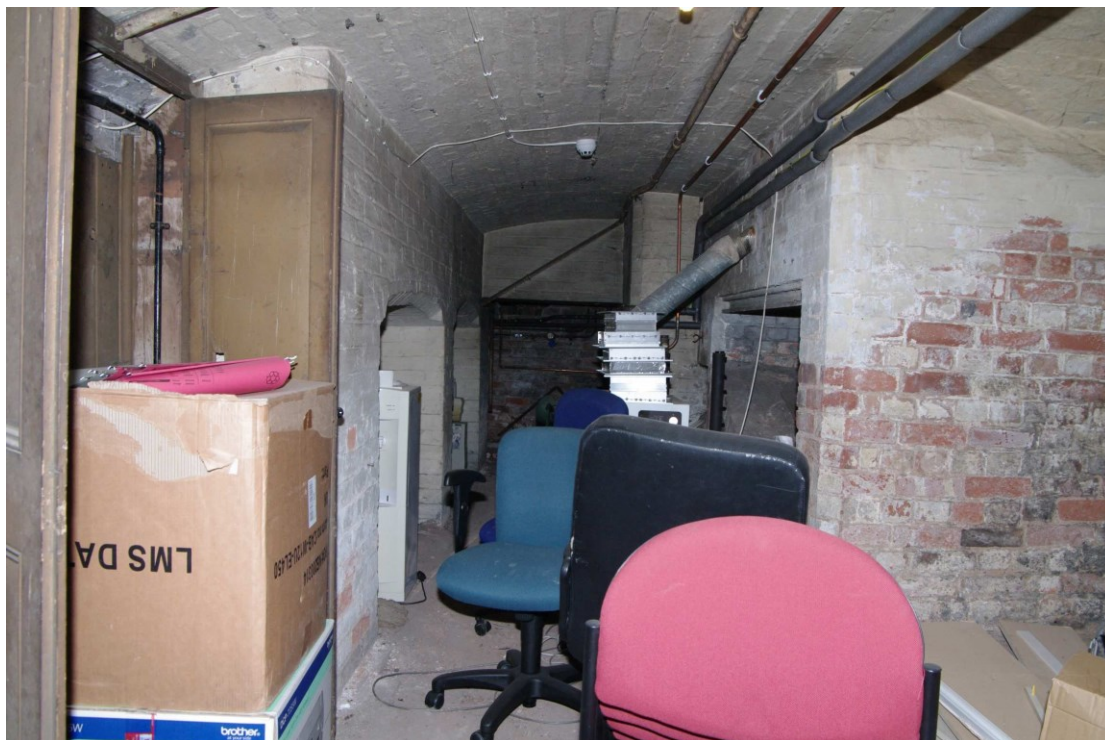
C1 is a long narrow room with a vaulted brick ceiling and blind supporting arches along the side walls (Fig. 26). The floor is paved with brick. Along the western wall are the remains of the old boiler system including the cast iron door and the coal chute from the pavement on London Road (Fig. 27). A doorway in the north-east corner leads into Room C2. The door is made from vertical planks and has two substantial latches at top and bottom and three locks which suggests that something important was being stored in C2 (Fig. 28).

Figure 26 Cellar C1  
Looking south-west

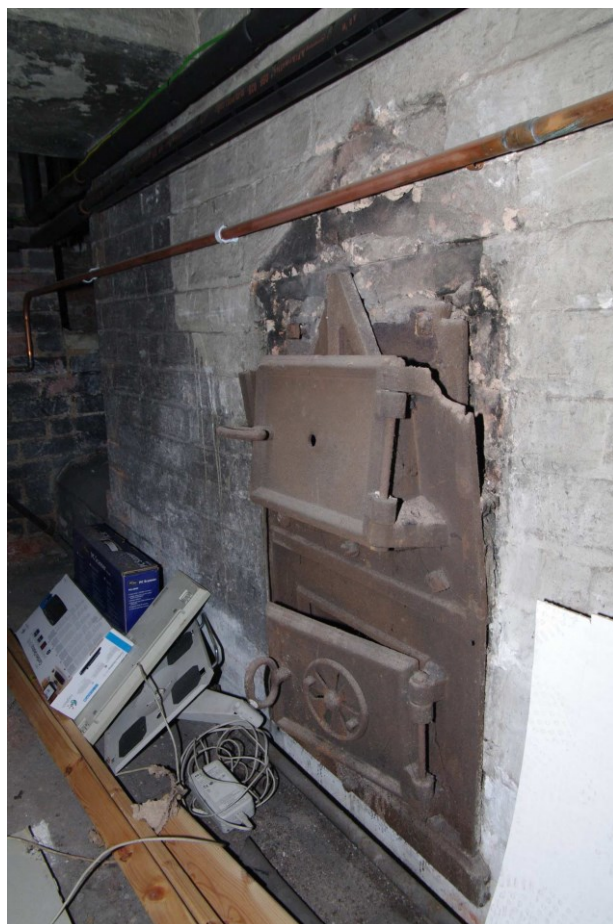
Figure 27 Cellar C1. Boiler door at southern end of room  
Looking west

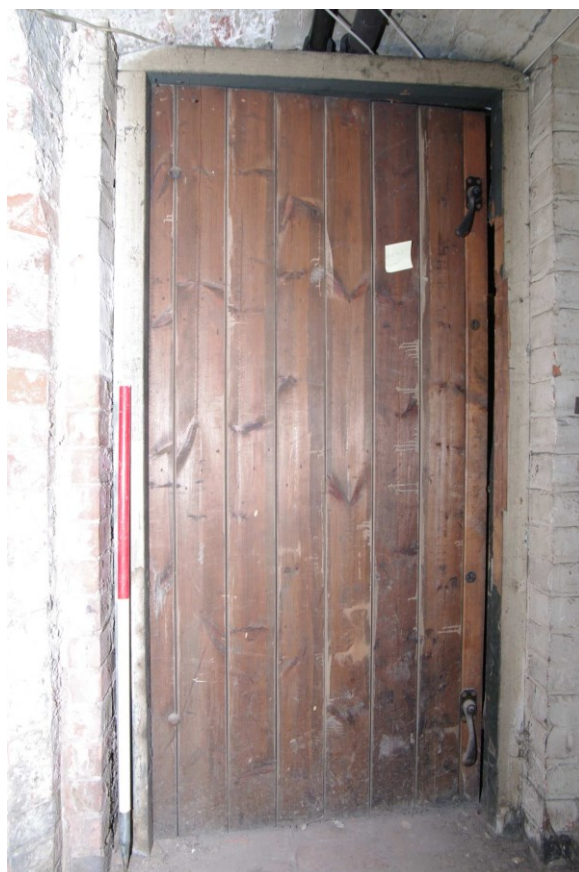
Figure 28 Door from C1 to C2  
Looking south-east. 1m scale

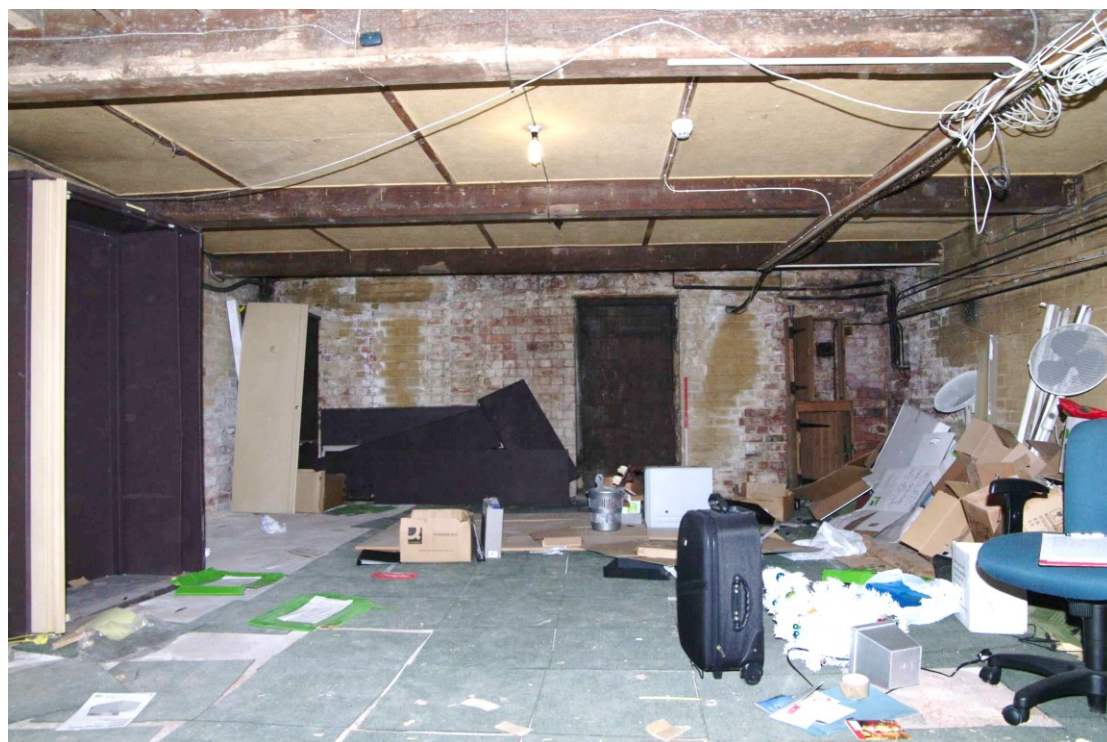
C2 is a large rectangular room with a ceiling formed by three large chamfered north-west to south-east beams above which can be seen the floorboards of Room G10 (Fig. 29). A supporting arch on the eastern wall supports the chimney breast on the ground and first floors. A plank doorway on the south-western wall leads into Room C3. The door has the same latches and locks as the door from C1 to C2.

Figure 29 Cellar C2  
Looking south-west. 1m scale adjacent to doorway into C3

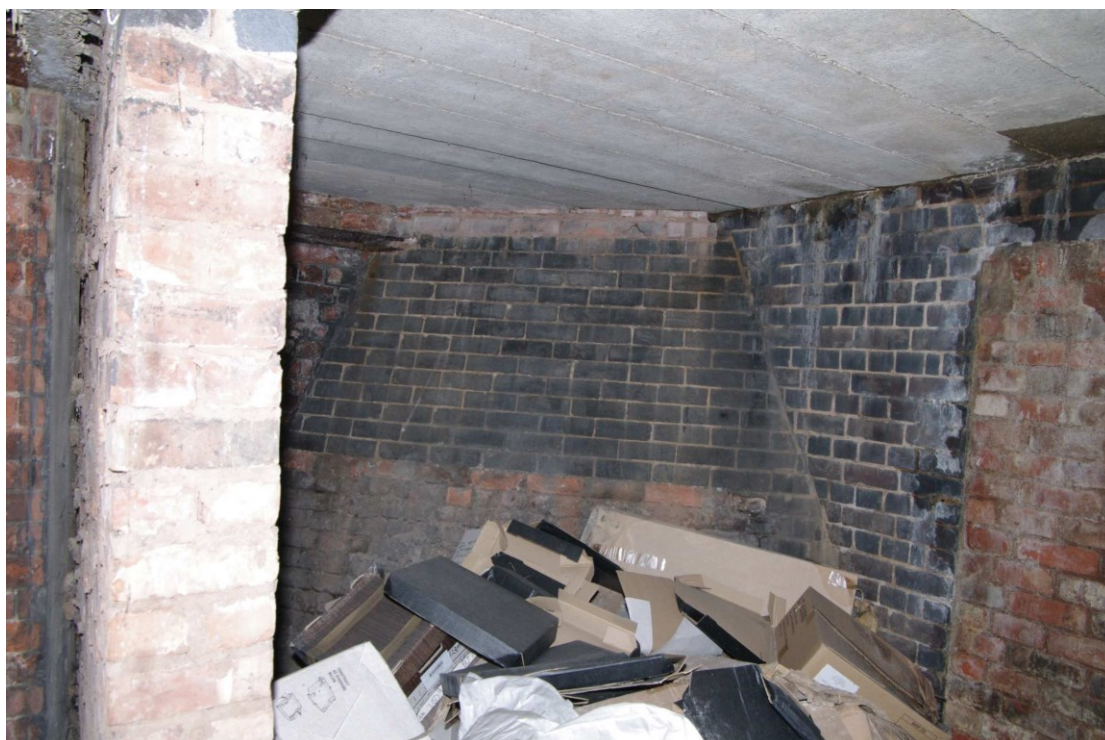
C3 has clearly been truncated and modified as it has a blue brick south-west wall which curves in the southern corner (Fig. 30). There is also double skinned wall between C2 and C3. In the south-west corner of the room is a set of concrete stairs which would have led up to the front garden of Number 58 (Fig. 31). The stairs have now been capped off which probably took place when London Road was widened. It seems likely that the end wall of the cellar was also truncated and filled in to allow heavy traffic to use the pavement rather than collapsing into the cellar. The ceiling is supported by concrete beams which is also likely to be a later modification.

Figure 30 Cellar C3  
Looking south. Note sloping wall and double skin of south-east wall on left of picture

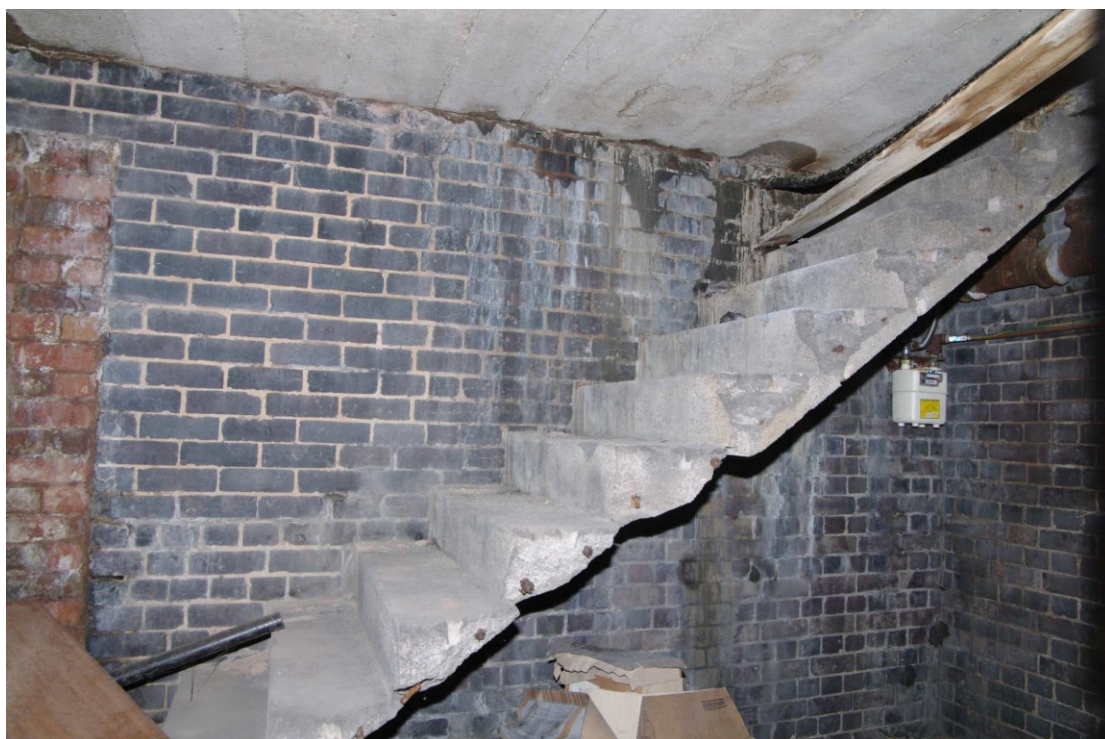
Figure 31 Cellar C3 steps to London Road  
Looking south-west

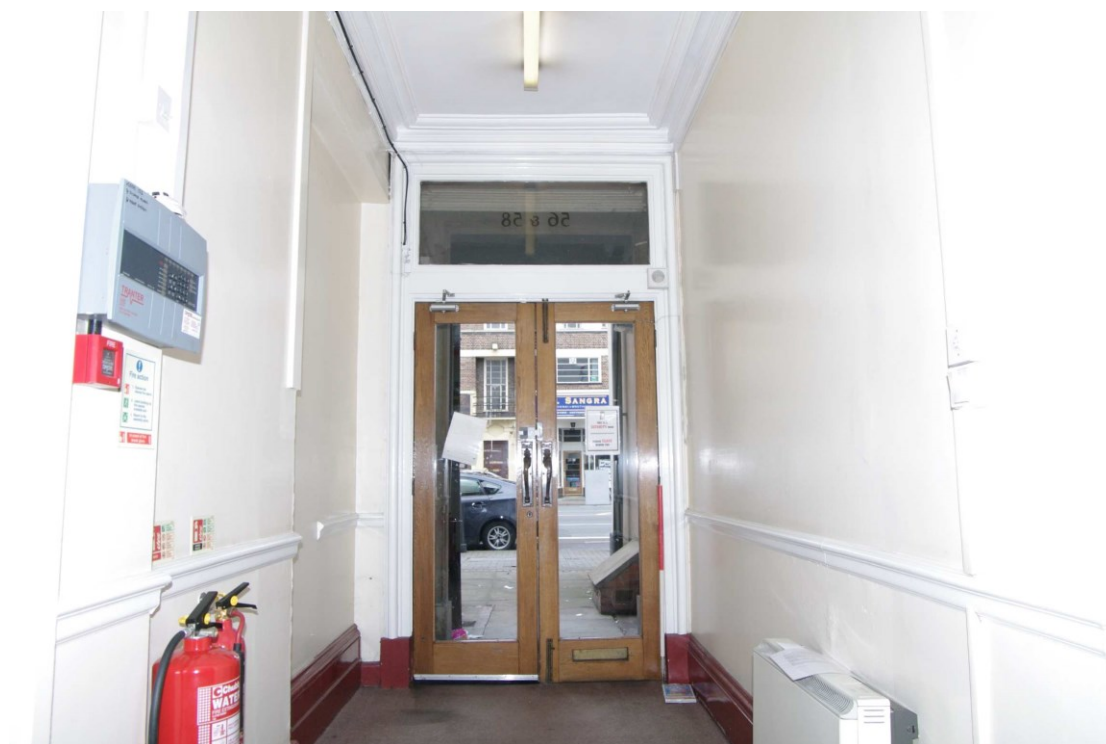
Figure 33 Ground floor G1  
Looking south-west. 1m scale

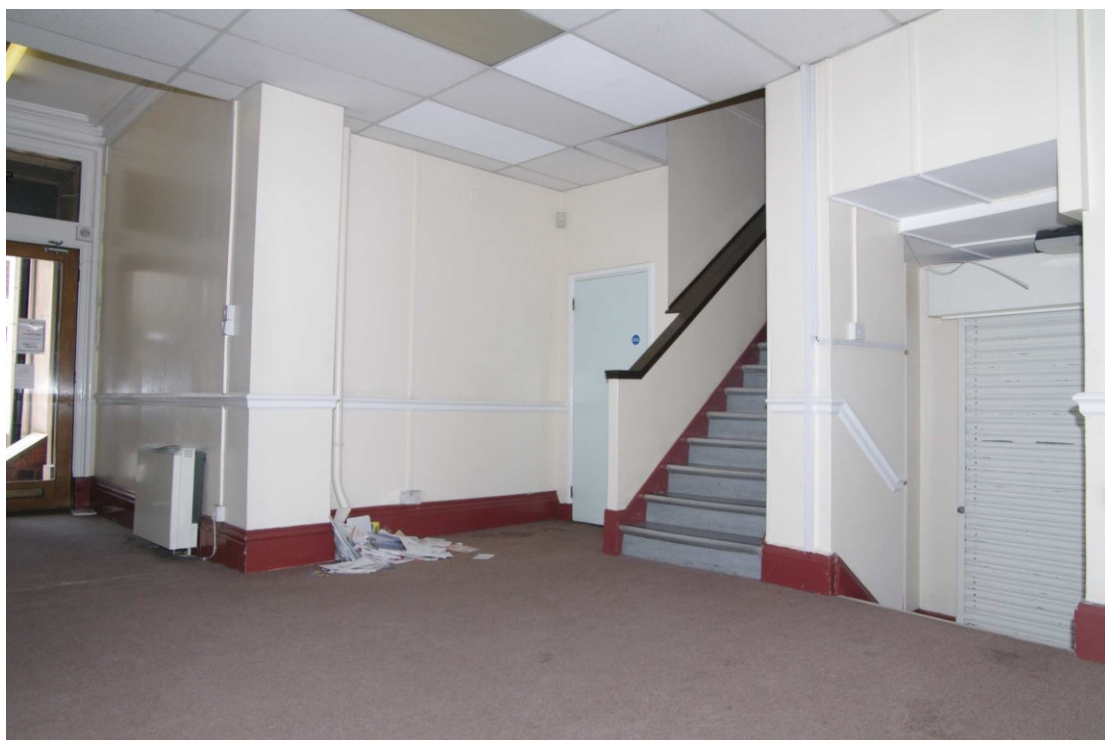
Figure 34 Ground floor G2  
Looking west. Entrance G1 on left, stairs to first floor of 54 and 56 centre right, steps down to stairs to rear extension on right

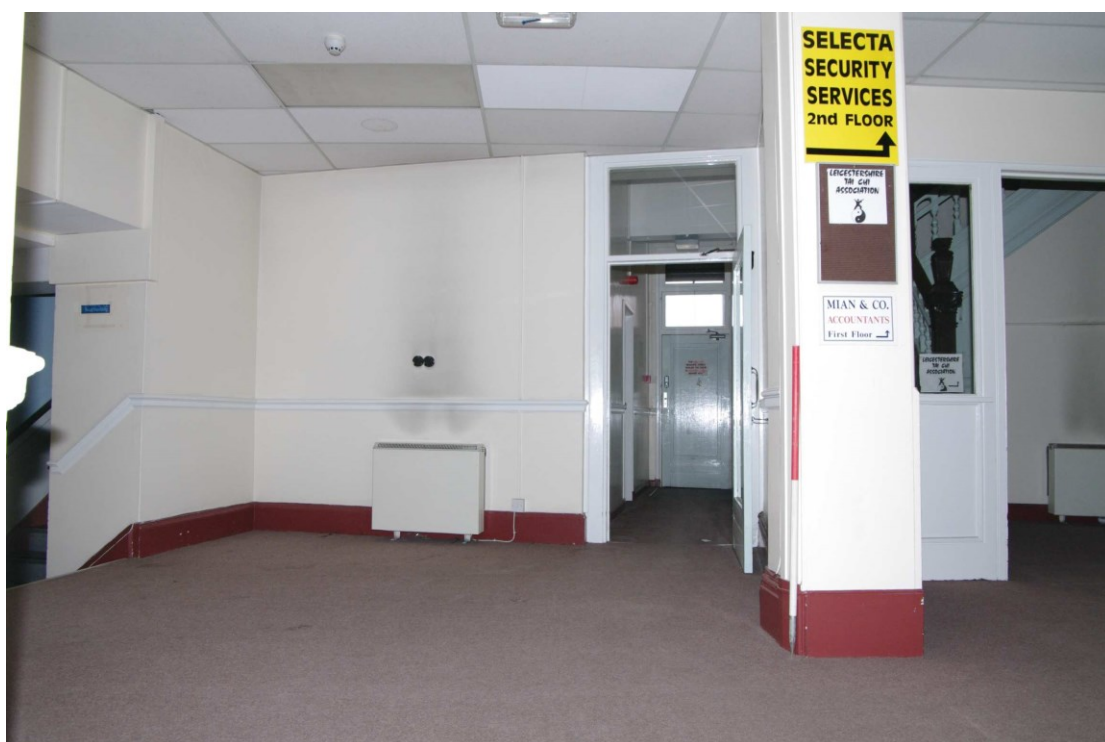
Figure 35 Ground floor G2  
Looking north-east. 1m scale. Stairs to rear extension on left, doorway to rear carpark in middle, G3 and stairs on right

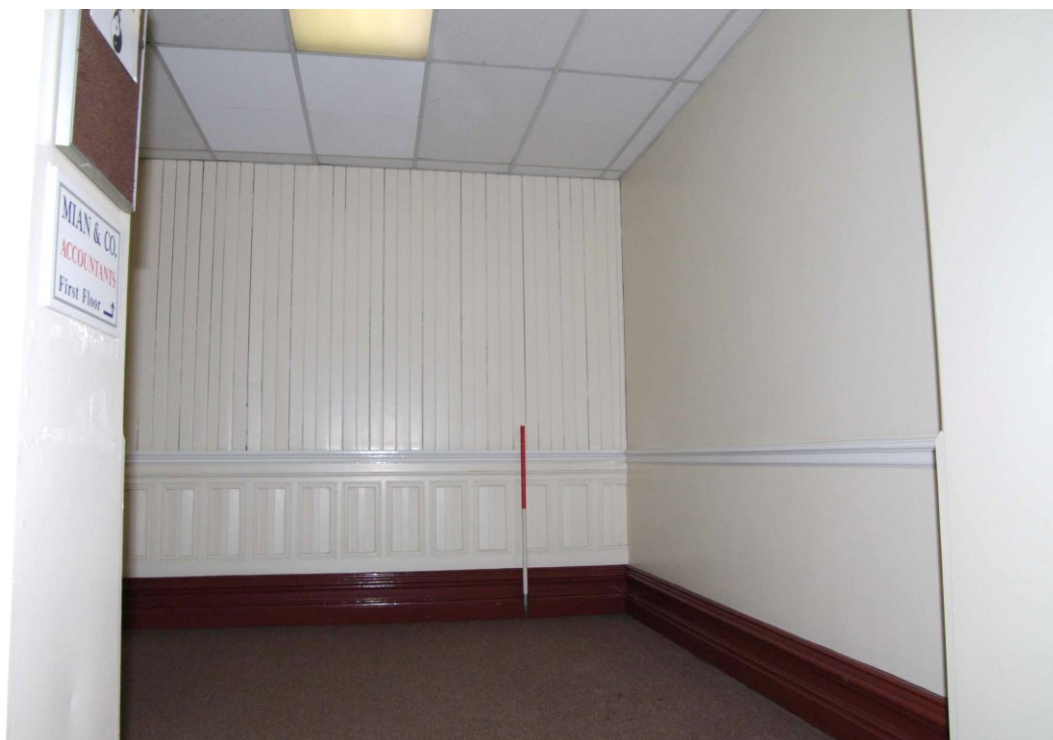
G3 has wood panelled walls which have been truncated by the insertion of a wall across the south-west side separating this room from the rest of Number 58 (Fig. 36). At the north-eastern side of the room is a wood and glass partition with an arched head leading to a flight of High Victorian stairs up to the first and second floors (Figs 37 and 38). The stairs are highly decorated with a carved newel post and urn decoration at each turn. Beneath the newels are pendant decorations. The balusters have an arch and rail decoration below the moulded handrail. The stairs lead up to narrow landings at first and second floor levels.

Figure 36 Room G3  
Looking south-east. 1m scale. Note inserted wall on right of picture
