**An Historic England Level 2 Historic  
Building Recording at 54 to 58 London  
Road, Leicester**

ULAS Report No. 2016-083  
©2016

**Planning Application PA 20150338**

**For: Abode London Road Ltd**

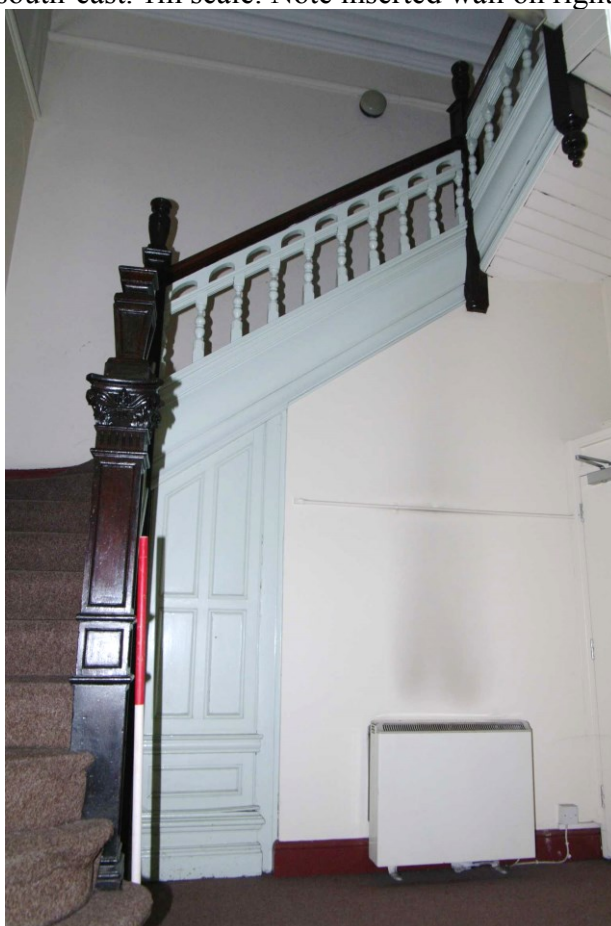
Figure 37 G3 stair case leading up to first floor  
Looking north-east. 1m scale. Possible blocked entrance to Room G18 behind heater

G3 has wood panelled walls which have been truncated by the insertion of a wall across the south-west side separating this room from the rest of Number 58 (Fig. 36). At the north-eastern side of the room is a wood and glass partition with an arched head leading to a flight of High Victorian stairs up to the first and second floors (Figs 37 and 38). The stairs are highly decorated with a carved newel post and urn decoration at each turn. Beneath the newels are pendant decorations. The balusters have an arch and rail decoration below the moulded handrail. The stairs lead up to narrow landings at first and second floor levels.

G18 is a large room with irregularly angled walls to accommodate the changes in alignment between the original house and the rear extension. The room has deep moulded architraves but modern skirting boards with no evidence of a fireplace. On the north-eastern wall is a large decorative window which once looked out into the garden (Fig. 48). This room was clearly of some importance but at present its only doorway is from room G17. As G17 was part of the service area it seems likely that this would be the main doorway for the household. It is possible that there used to be a doorway from Room G3 which passed beneath the main stairs (see Fig. 37).

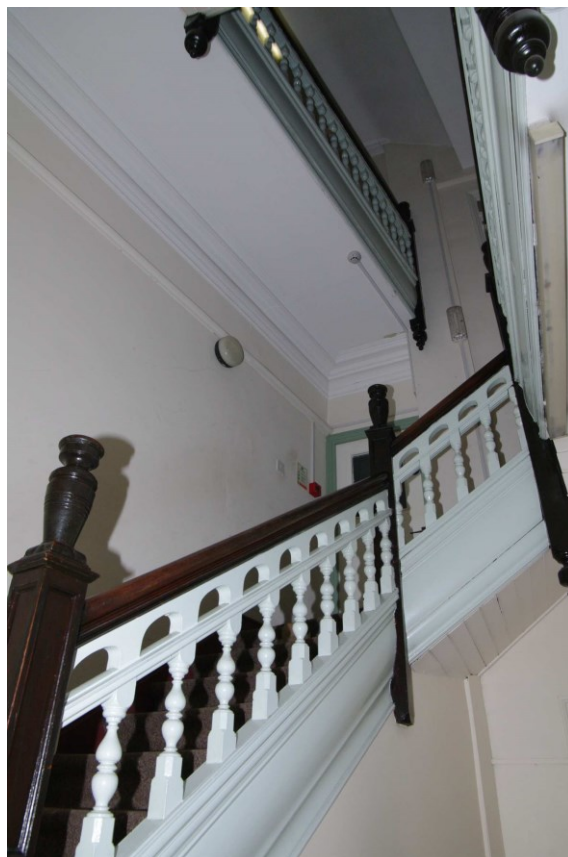
Figure 38 G3 stairs and landing up to first and second floors  
Looking east

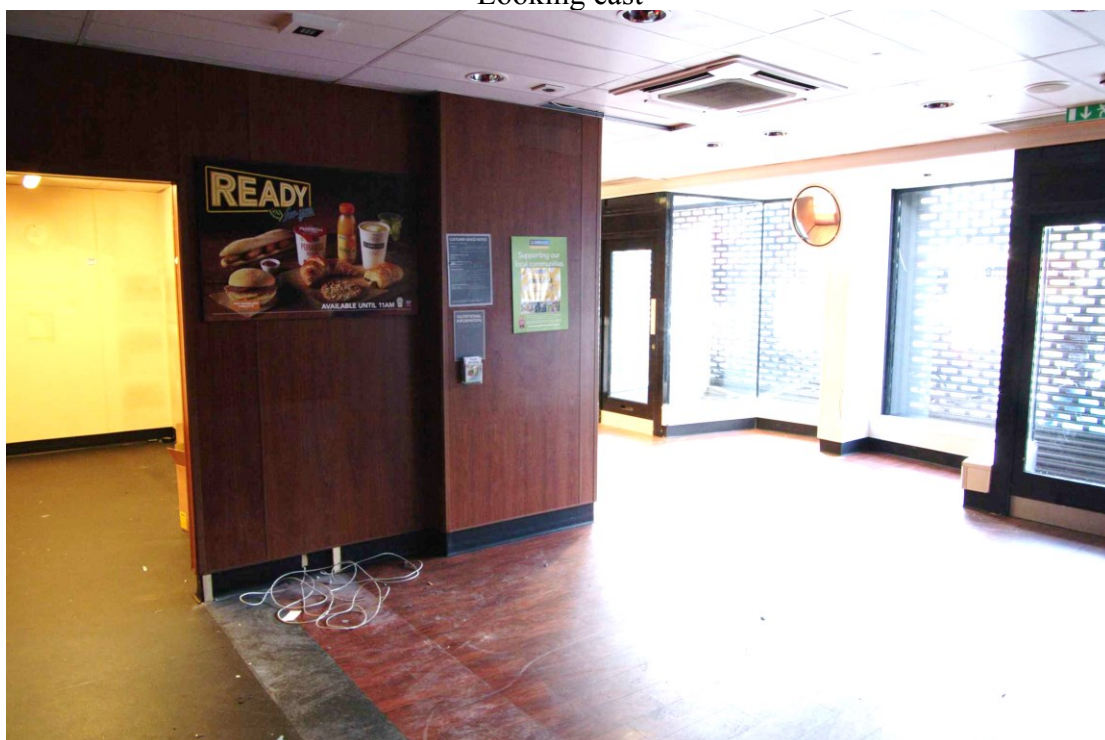
Figure 39 G6 former Greggs shop  
Looking south-east. Stub of original supporting front wall behind the brown panel in  
centre of picture

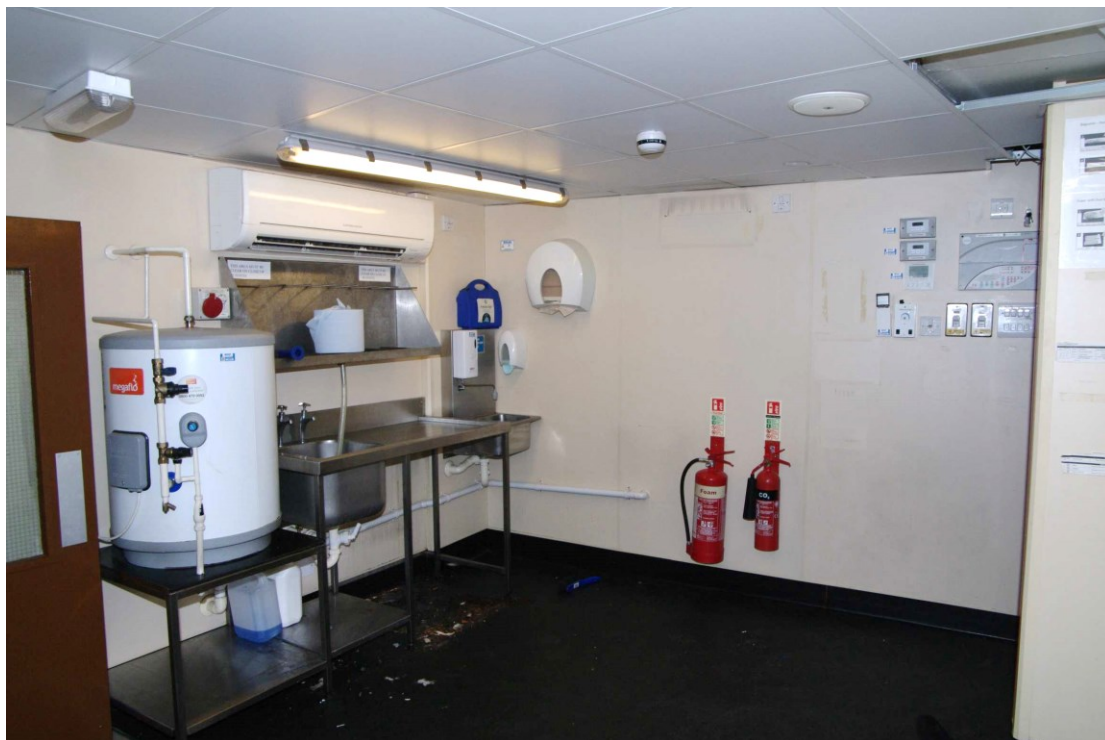
G7 is a small rectangular room presently used as a kitchen (Fig. 40). It has modern ceiling and wall coverings which mask any architectural phasing details. A set of steps follow the natural drop in ground level down to Room G8.

Figure 40 G7 food preparation area  
Looking south-east

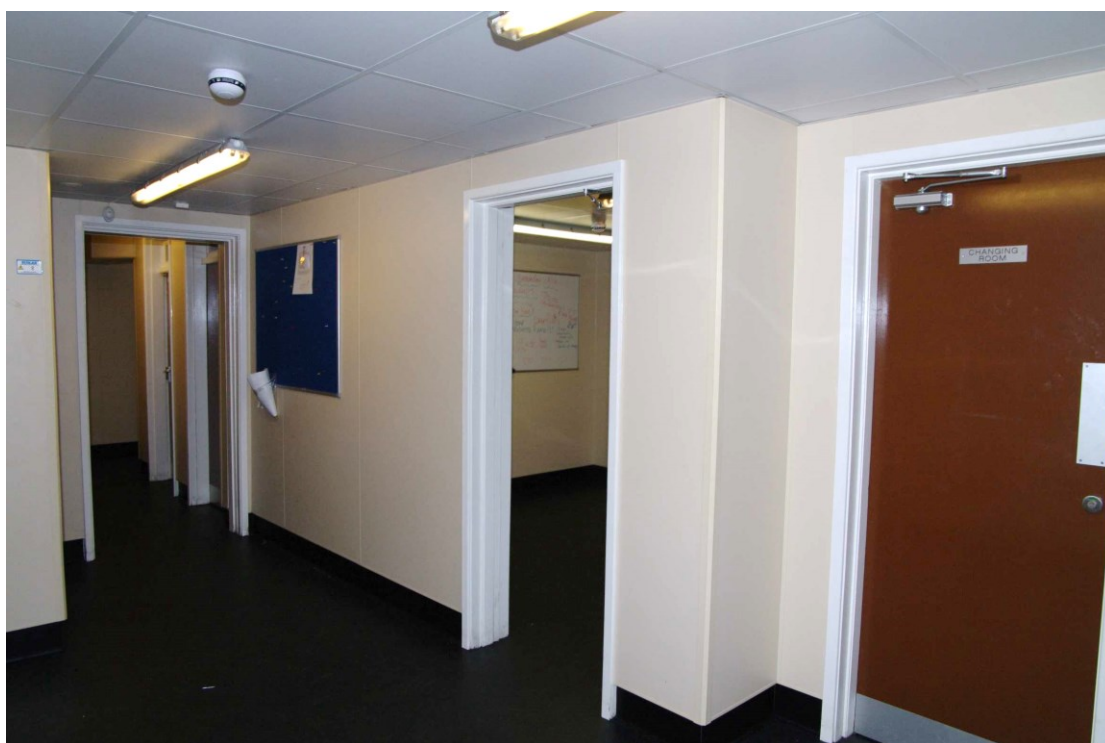
G8 forms a long room with modern side rooms off to the north-west (Fig. 41). This forms the ground floor of the north-westernmost rear extension. All rooms have been modernised and nameplates on the door show that they have been used most recently as a toilet, store, staff room and changing room. A larger store room at the north-eastern end of the extension has painted brick walls but no other details.

Figure 41 G8 and side rooms  
Looking south-west

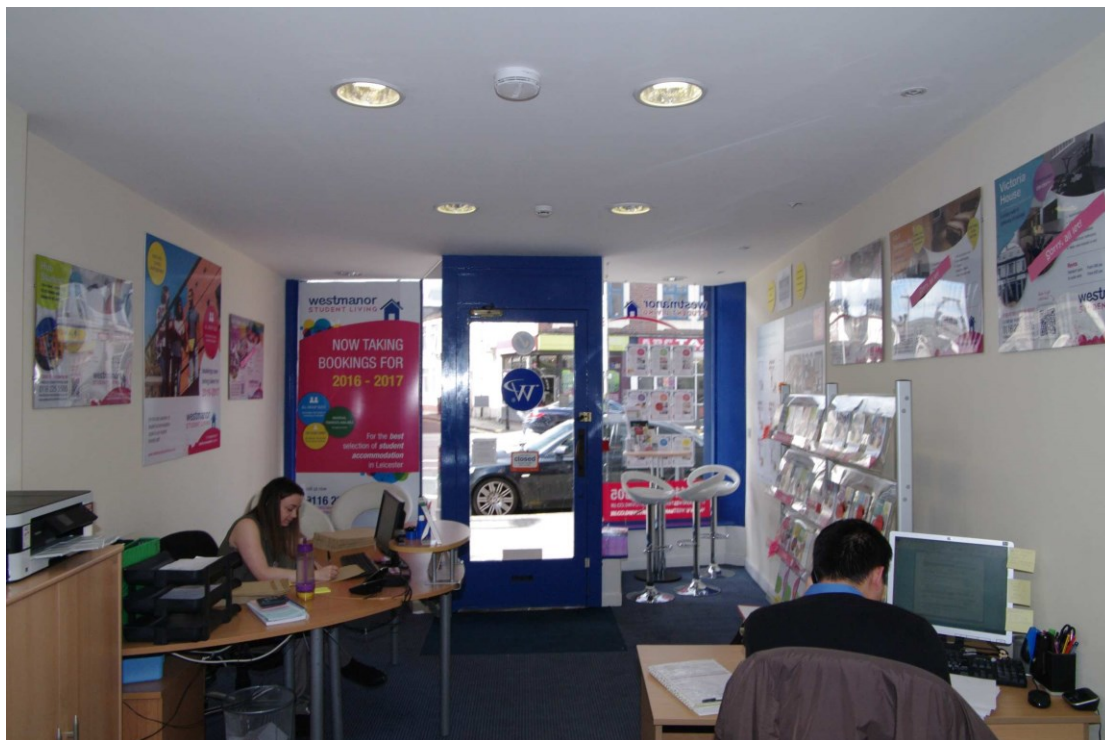
G9 forms a separate long room currently occupied by a lettings agency. It is built into the ground floor of the linking structure between Number 54 and Lillie House (Fig. 42.) The frontage is formed by the 1930s shop front extensions which continue through from next door. Because of the alignment of the buildings this room tapers slightly to the north. A modern low ceiling hides any details and the walls are plain and undecorated.

Figure 42 G9  
Looking south-west

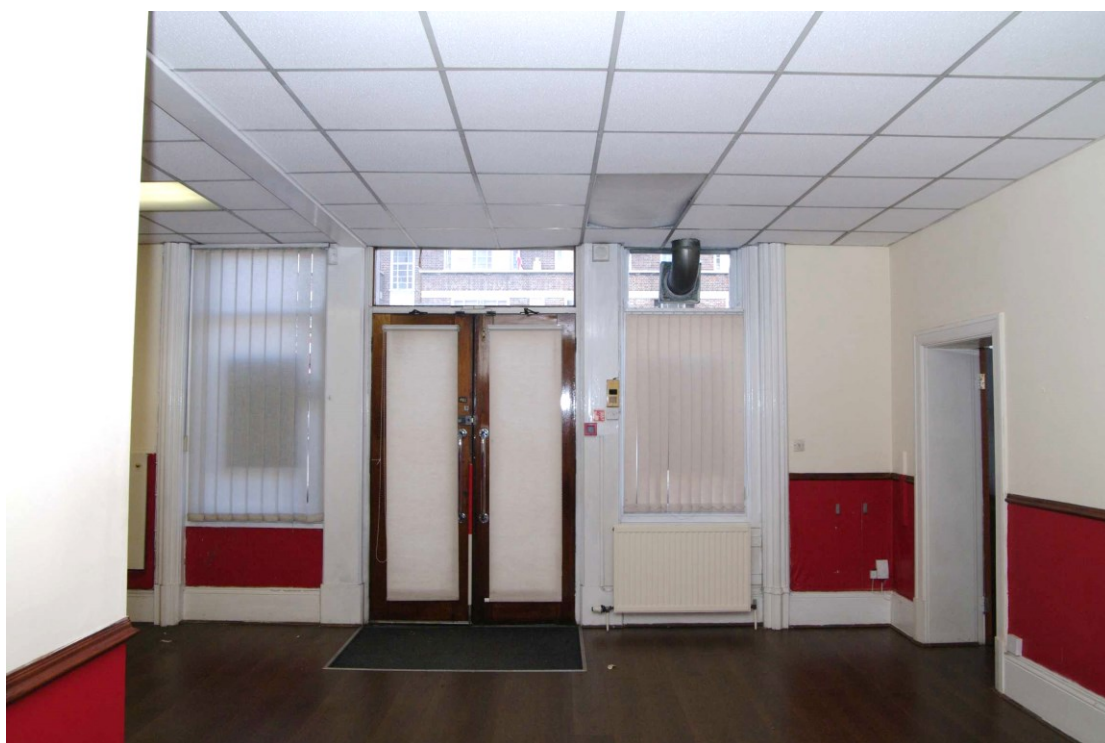
G10 is the main front room of 58 and is entered via the main front double doors on London Road (Fig. 43). It has been subdivided with plasterboard partitions to incorporate rooms G13, 14 and 15 (Fig. 44). Above the doorway is a glass panel with traces of the painted name ESG Developments Ltd scratched off. The doors are more consistent with a commercial premises rather than domestic doors and appear to be of a 1930s style. The flanking sash windows either side of the door have full height mouldings from floor to ceiling on their outer edges. The false ceiling hides the tops of the windows and the original ceiling height. The skirting boards are quite high but relatively plain.

Figure 43 G10  
Looking south-west. 1m scale

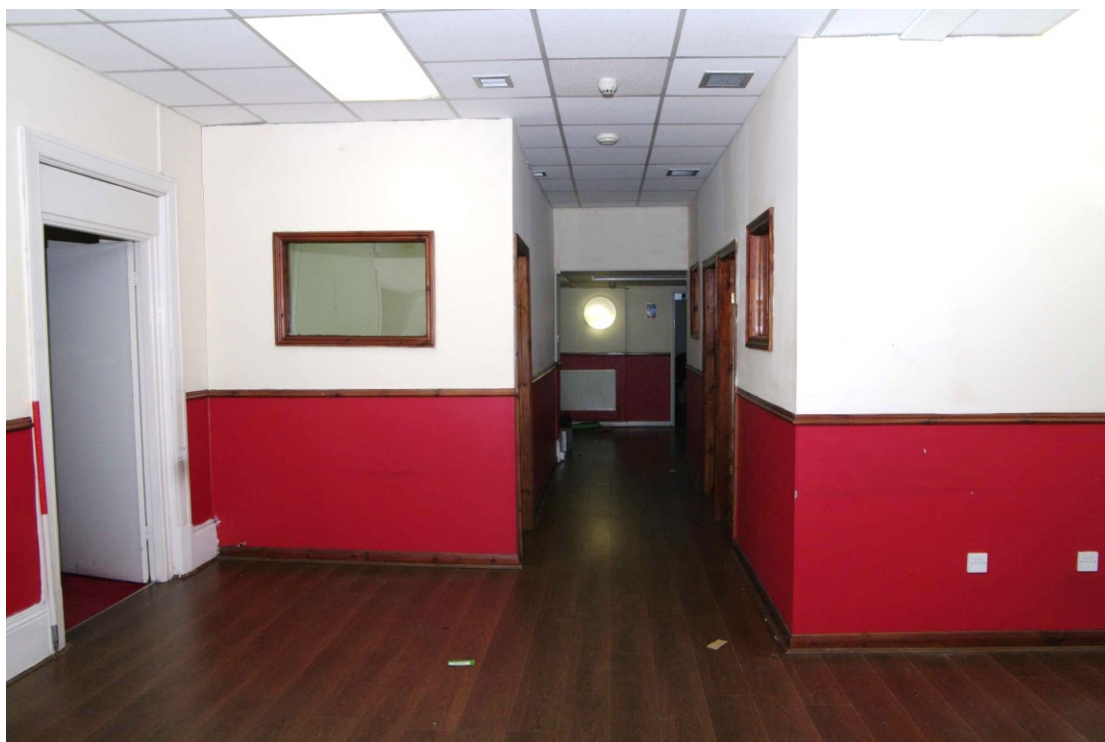
Figure 44 G10

Looking north-east. 1m scale. Plasterboard walls flanking corridor to rear of building

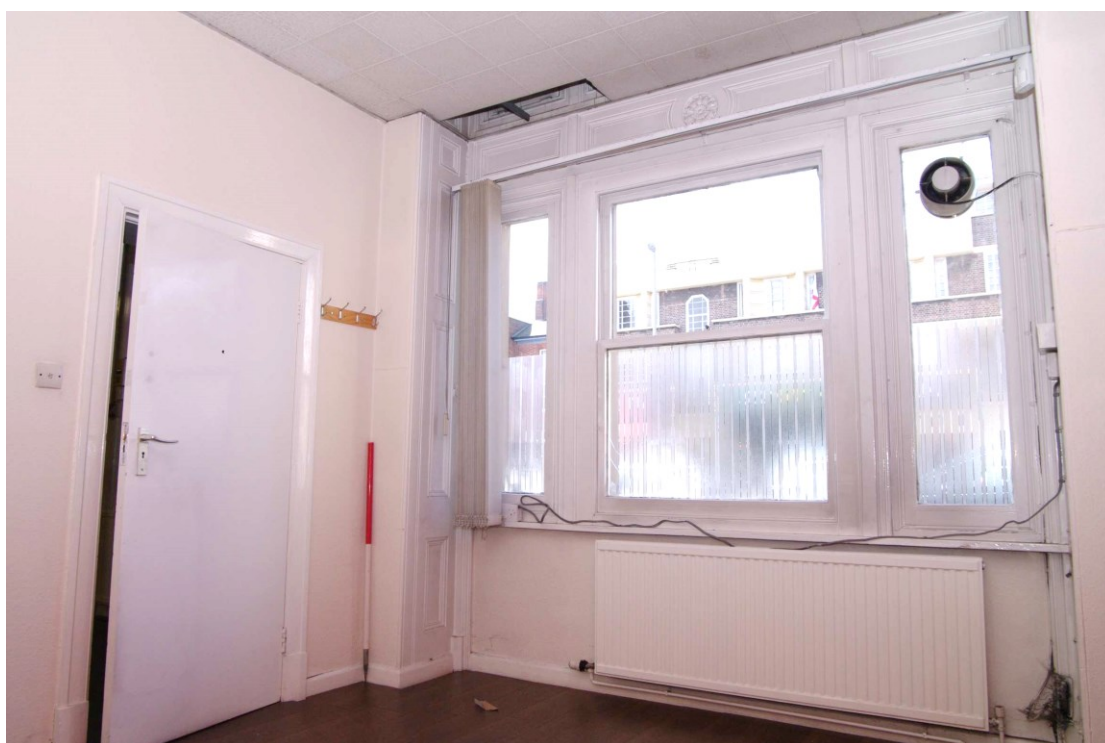
Figure 45 G11

G11 is a side room with the stone-built bay window on its south-western side (Fig. 45). The upper part of the bay window has been partially cut by the insertion of the false ceiling which appears to be decorated with a floral design. The window has flanking wooden panels extending down to floor level. There is no evidence of any window shutters. The doors into rooms G10 and G12 are plain modern replacements. The skirting boards are low and plain and are likely to be mid to late 20th century.

Looking south-east. 1m scale. Note hole in ceiling showing upper window detail

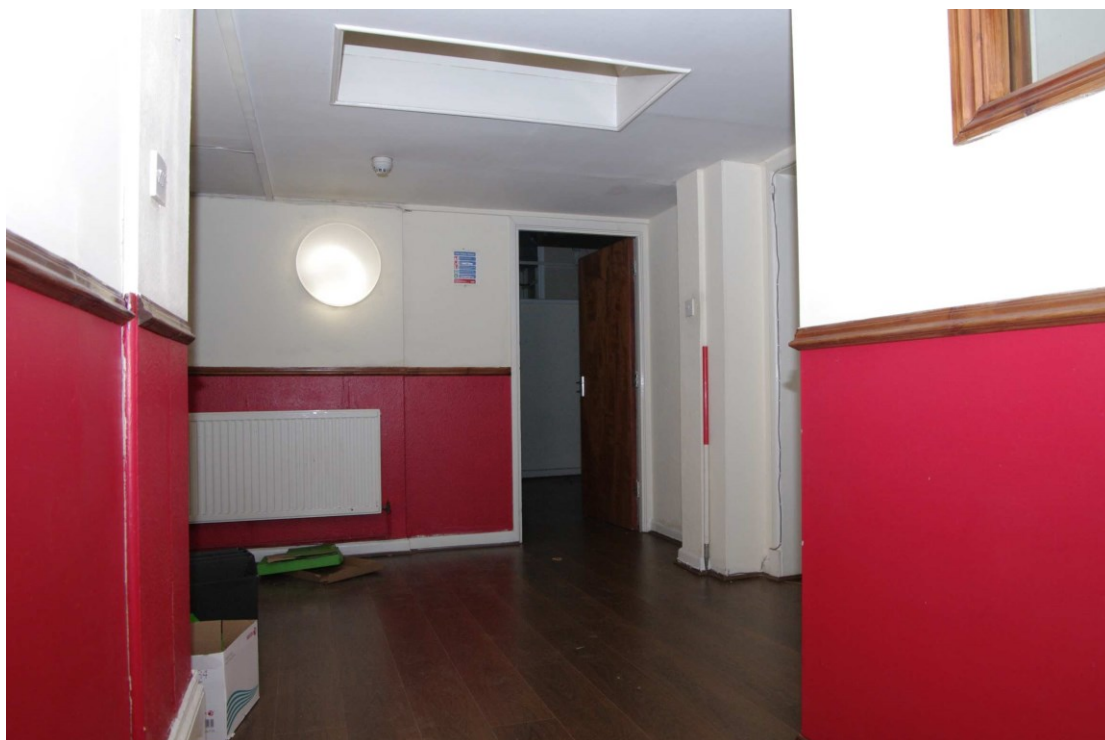
G16 is a small space which appears to have been made larger by the partial removal of much of the rear wall of the original Number 58 (Fig. 46). A small side room to the east currently houses computer and communication equipment. On the north-western side of G16 is the short corridor leading to the stairs down into the cellar.

Figure 46 G16  
Looking north-east. 1m scale. Note truncated wall behind ranging pole

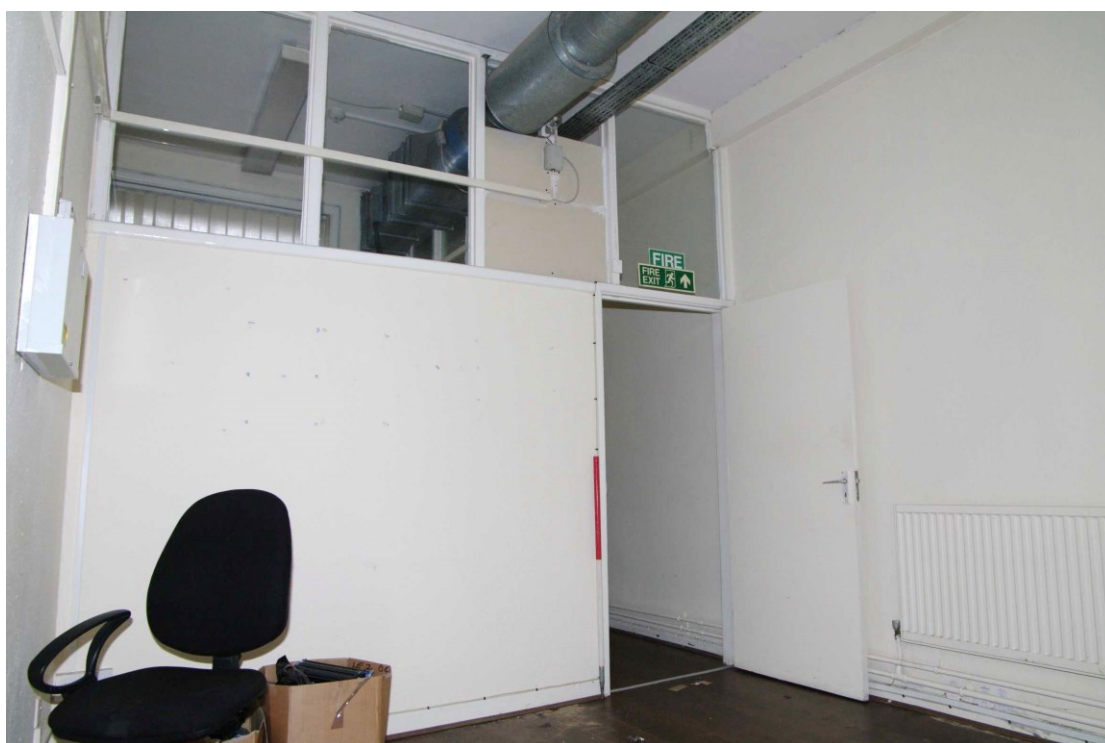
Figure 47 G17  
Looking north-east. 1m scale. Note window lights into adjacent room G19

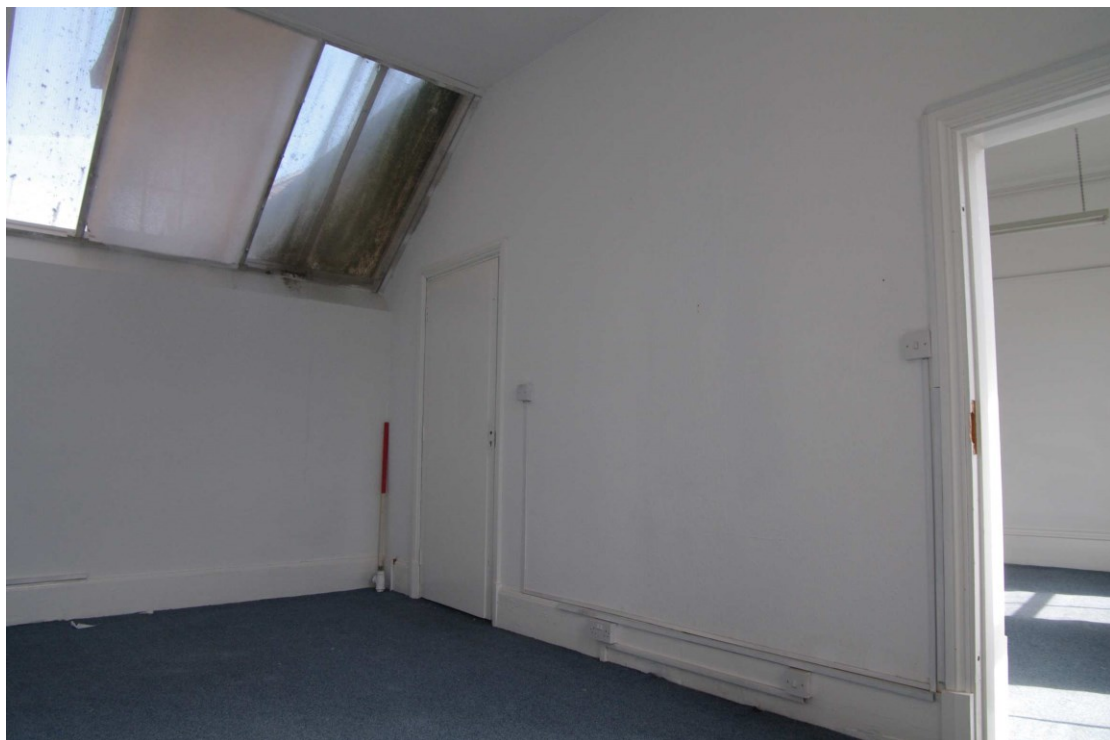
Room F1 is located at the north-western end of Numbers 54 and 56. It is built within the connecting building between 54 and Lillie House and above G9. Because it is a connecting building it has a slightly trapezoidal shape. Most of the ceiling is flat except for a sloping glass portion on the north-eastern side (Fig.50).

Figure 50 F1  
Looking north-east. 1m scale

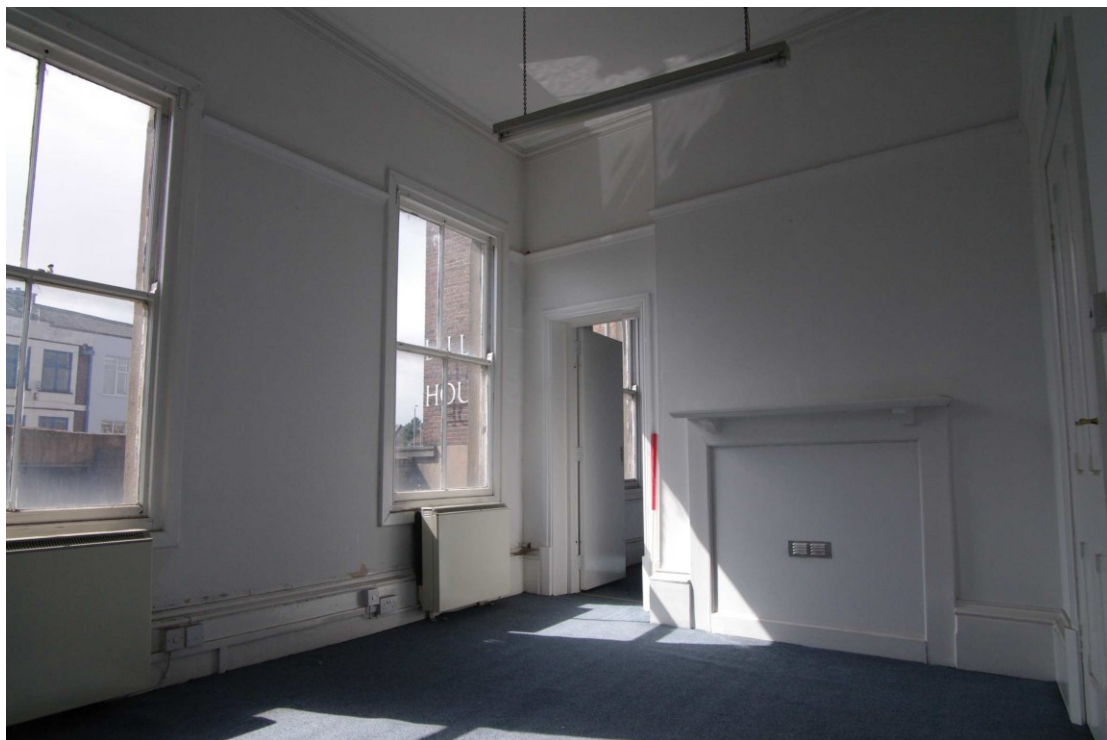
Figure 51 F2  
Looking west. 1m scale. Doorway to F1 to left of fireplace

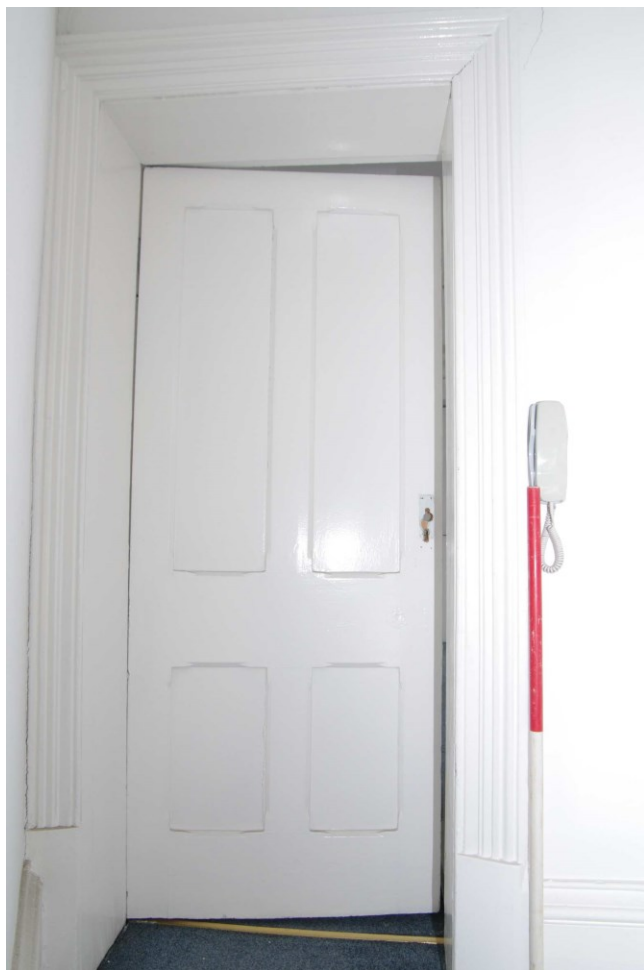
Figure 52 F2  
Looking east. 1m scale. Doorway to corridor on left, door to F3 in centre. Note kink  
in north-east wall

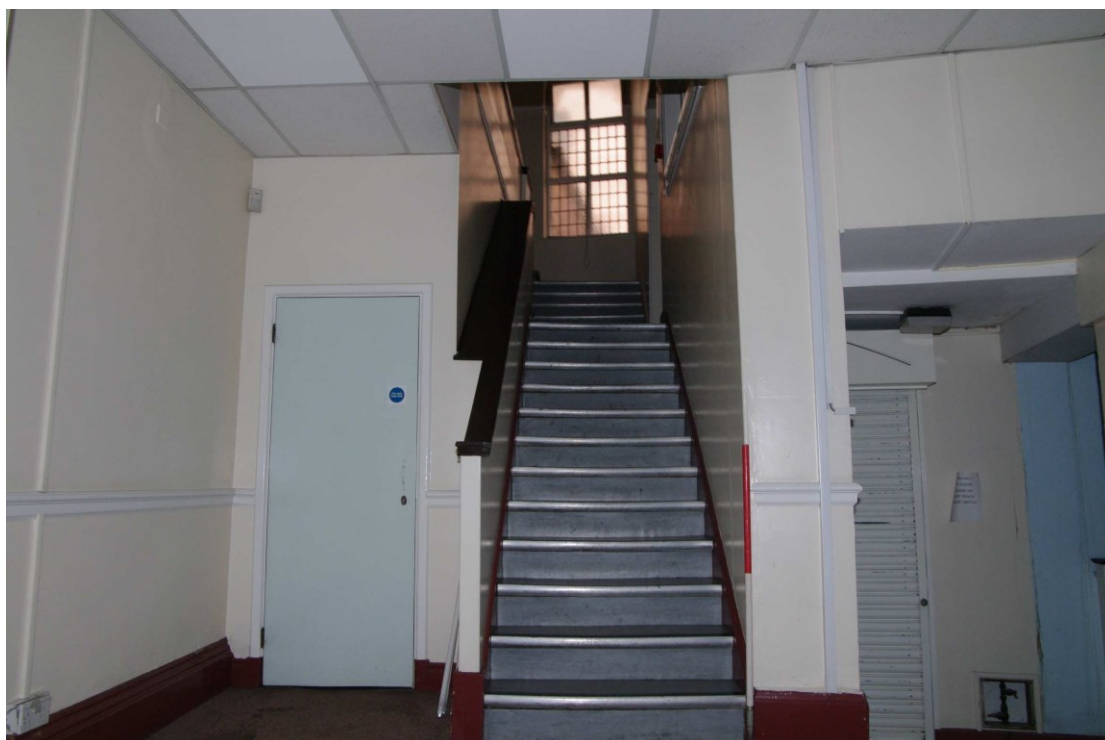
F4 is the landing and stairs serving this part of the building. The stairs lead up from hallway G2 (Fig. 56). The stairs appear to be 1930s replacements judging by their plain appearance and materials used. They are formed from two shorter flights with a small landing in the middle which leads to the first floor of the rear extension. The alignment of the stairs kinks slightly to accommodate the change in angles of the buildings. These stairs sit outside the original building line of 54 and 56. The upper landing follows the sharp kink in the wall of Room F2 and may actually be the location of the original staircase before the extensions were built (Fig. 57).

Figure 56 Stairs from G2 up to first floor  
Looking north-west. 1m scale

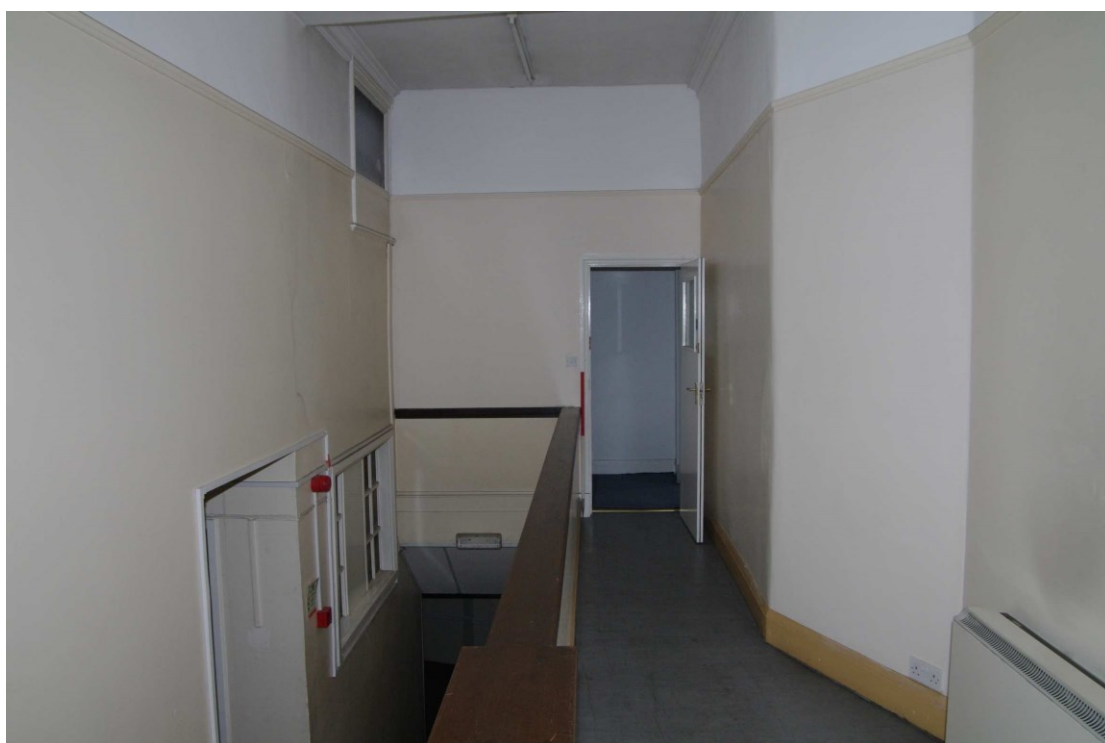
Figure 57 F4 landing and stairs  
Looking east. 1m scale

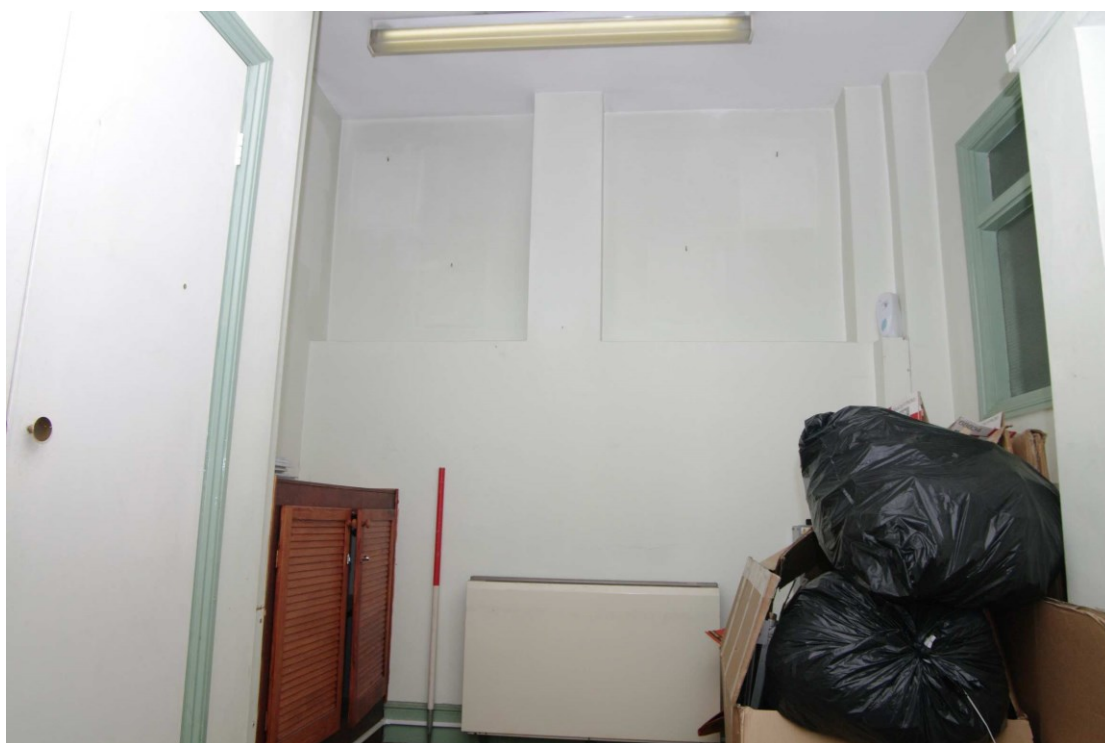
Figure 63 F12  
Looking west. 1m scale. Note possible blocked windows

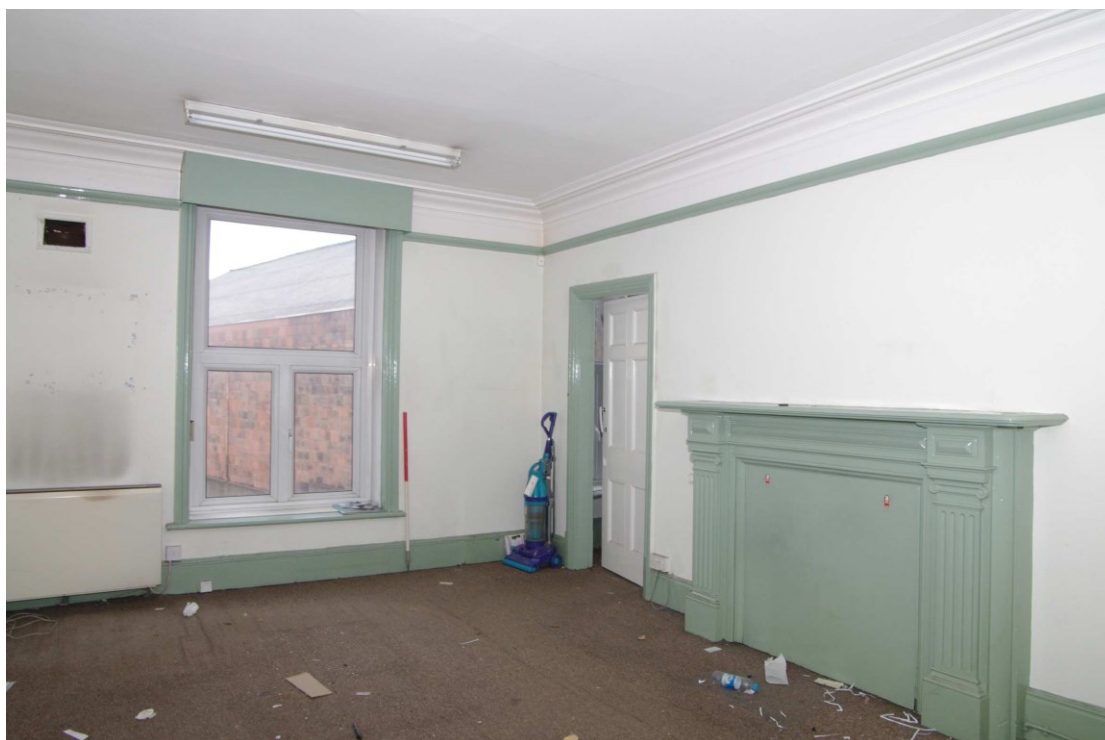
Is a large trapezoidal room with a large window at the north-eastern end (Fig. 64). The window is a modern uPVC replacement. The room has moulded architraves and a high picture rail and a high skirting board. The wooden fireplace surround and mantelpiece is crisply carved in wood and appears to match the style and date of the late Victorian staircase. A bell-push for calling a servant is located to the left of the fireplace. The door out to F12 is modern but the connecting door to Room F14 is a late Victorian six-panelled door.

Figure 64 F13  
Looking east. 1m scale. Doorway into F14 in centre of picture

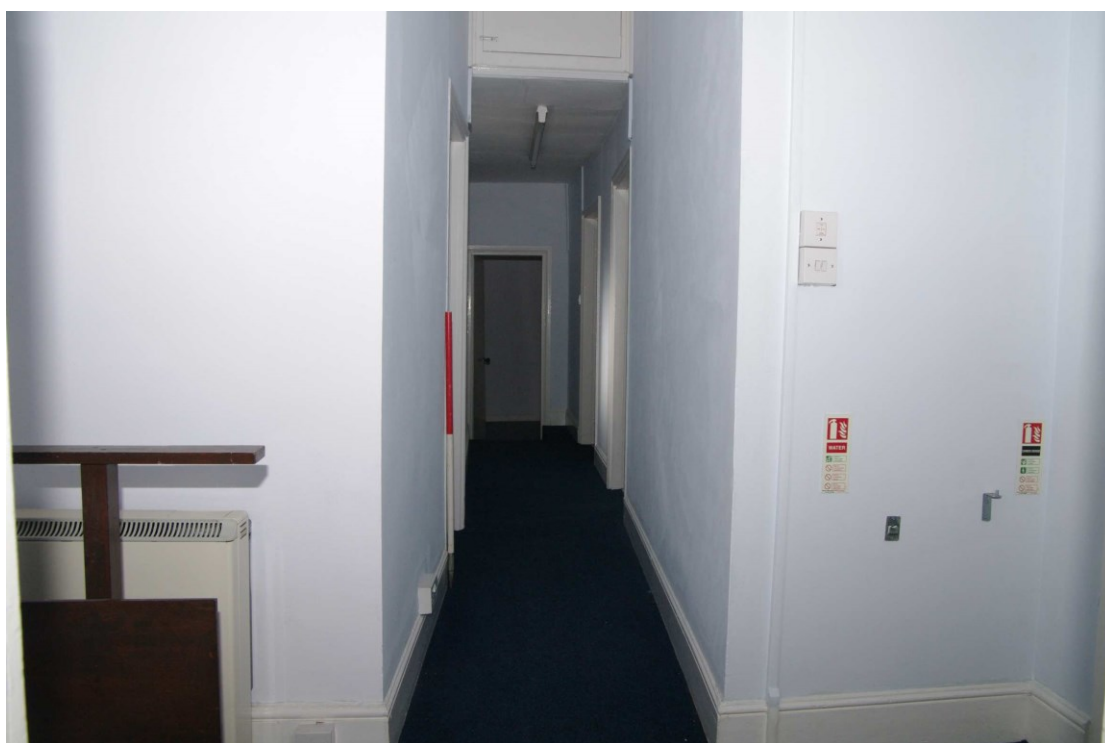
Figure 70 Second floor corridor  
Looking south-west. 1m scale. Note bend in corridor

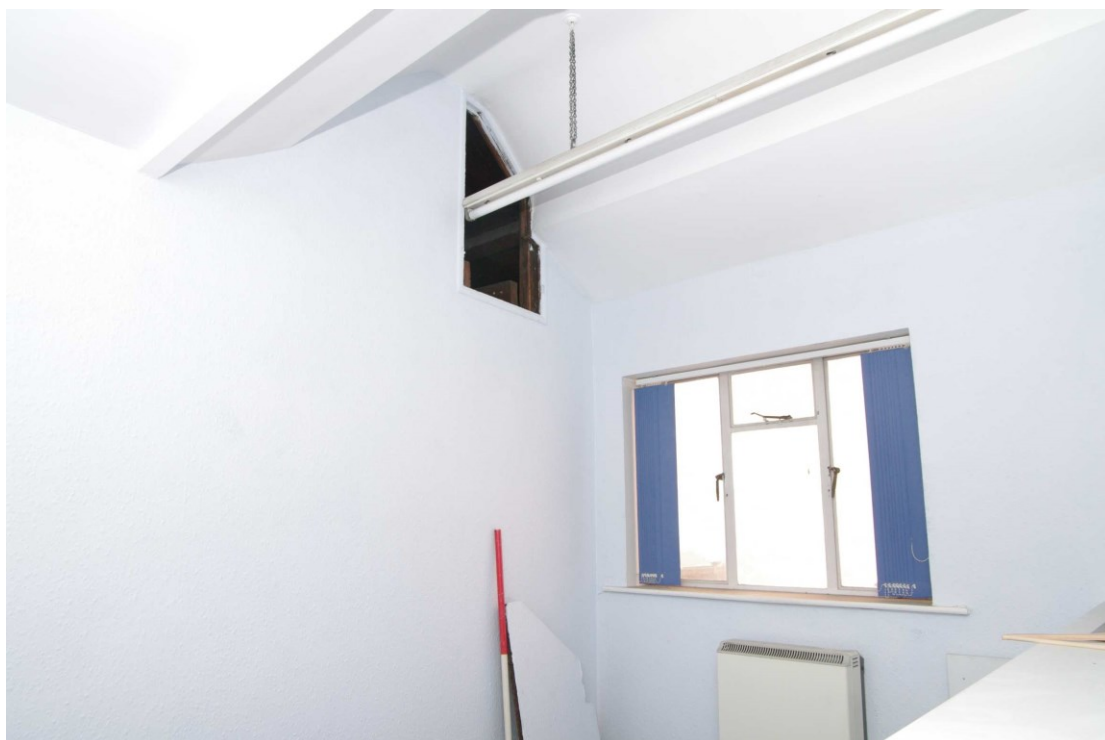
Figure 71 S1  
Looking west. 1m scale. Note pitched ceiling

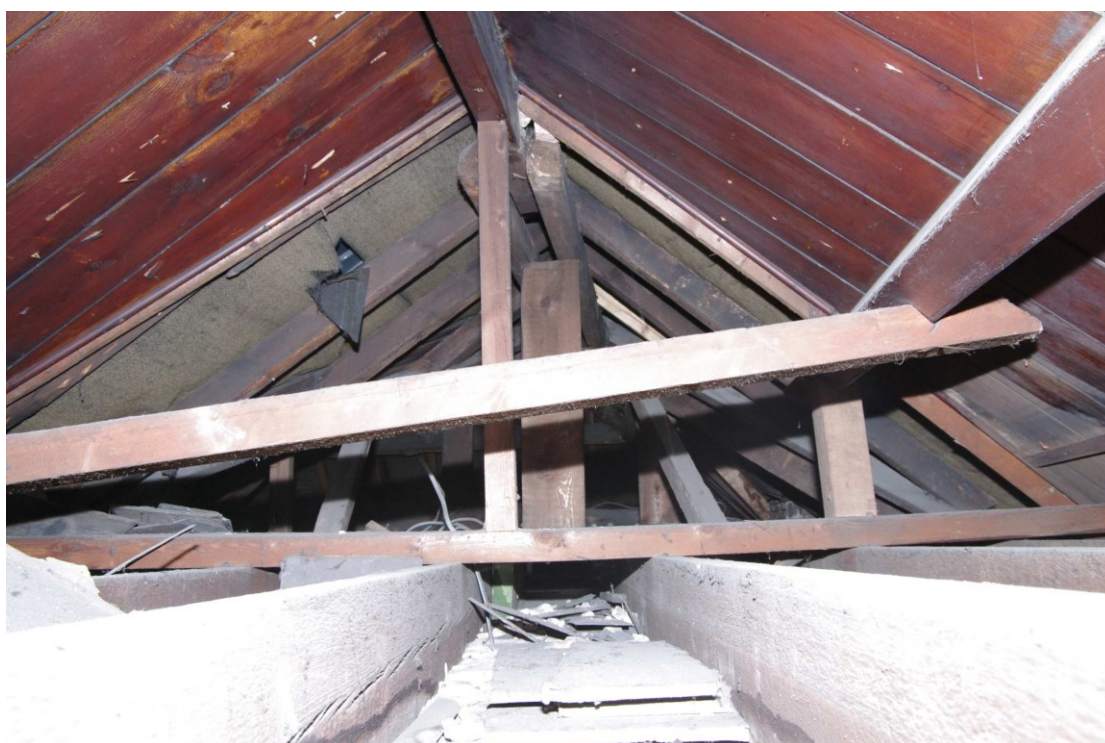
Figure 72 Roof space into Room S1  
Looking west through hole in wall of S1

Room S1 is at the south-west end of the corridor and is built against a narrow gabled extension on the rear of Number 54 (Fig. 71). The western half of the ceiling is pitched following the roof of the gable whilst the eastern side is flat. The floor is approximately 0.25m lower than the rest of this floor which gives an indication of the extent of this original gable extension. A hole in the wall gives a glimpse into the gable roof structure which has varnished sarking boards which were clearly meant to be seen (Fig. 72). The room has a modern Crittall window. The door has four panels which have been covered over with a sheet of hardboard on the corridor side, as have all doors on this floor. The doorknobs are of Bakelite.

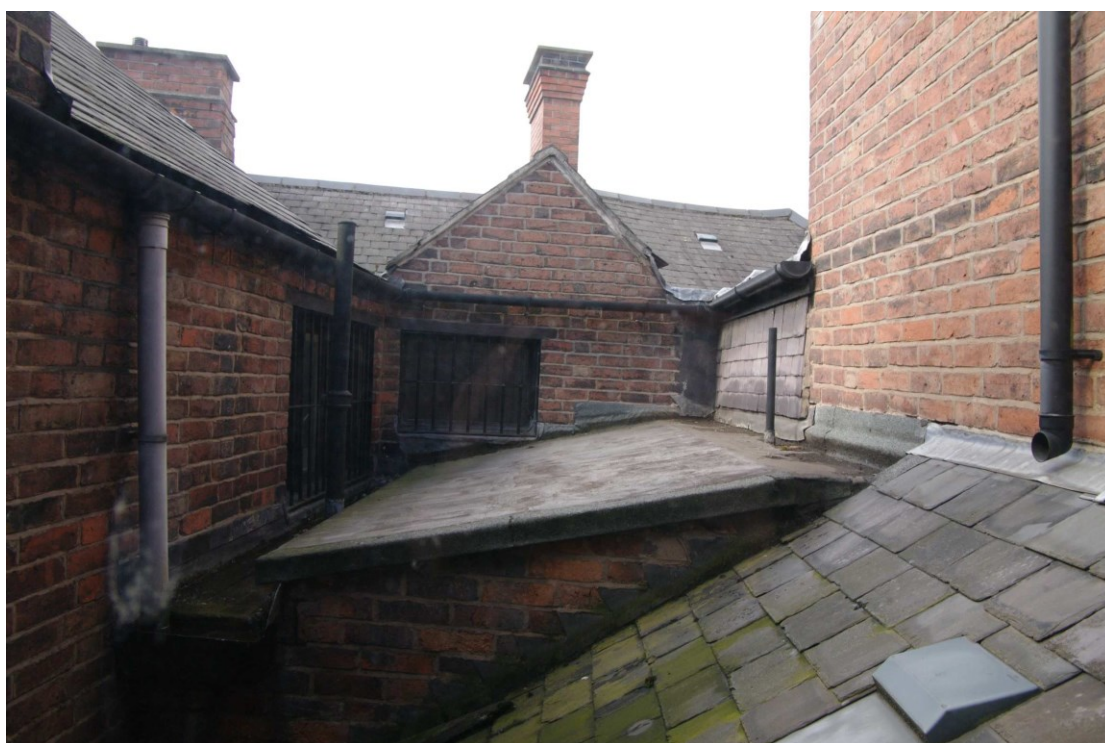
Figure 74 View of roof from S5  
Looking west

Room S5 is a square room on the south-east side of the corridor. To the south-west is a window which looks out across the roofscape of 54 and 56 (Fig. 74). Through the

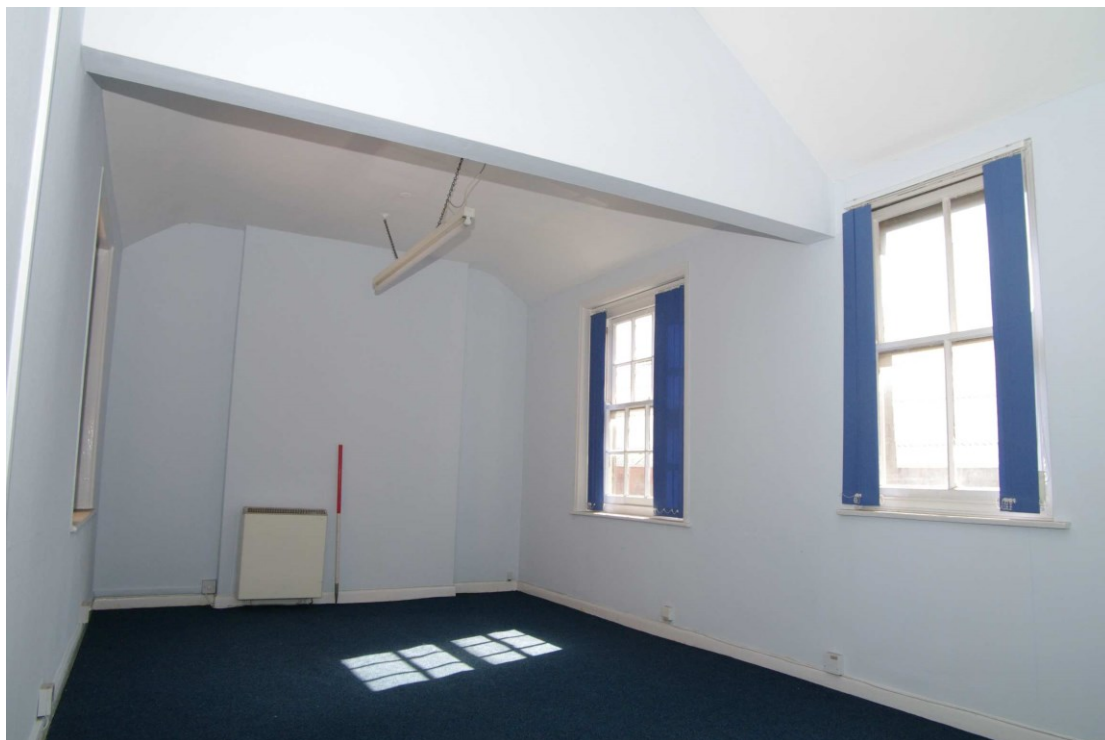
Figure 75 S7

Looking north-east. 1m scale. Note original end wall cutting across the ceiling. Also note the two different styles of window

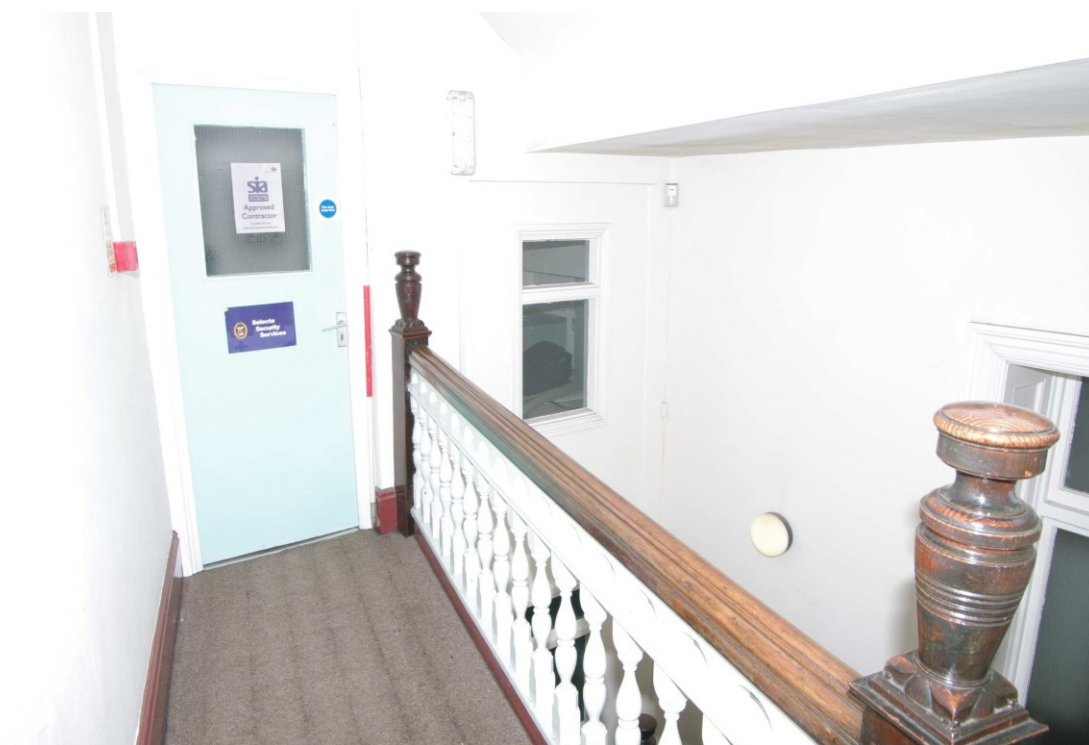
Figure 76 S9

Looking south-east. 1m scale

Rooms S9 to S13 form the second floor of the extension to the rear of Number 58. S9 is the narrow landing at the top of the Victorian staircase which descends down to ground floor Room G3 (Fig. 76). The door to the rest of the rooms is modern but there is also a window into Room S10. The ceiling height of the landing is varied but the reason is not clear.

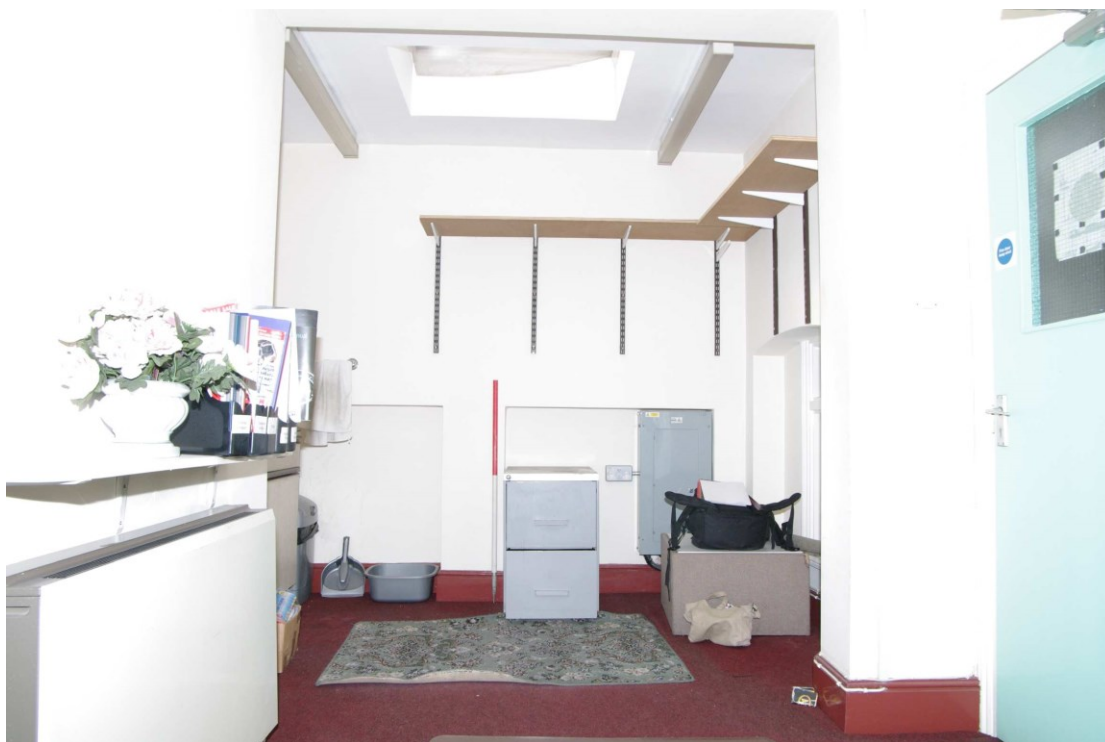
Figure 77 S10  
Looking south-west. 1m scale. Note tops of blanked windows either side of ranging pole
