An archaeological field
evaluation at
All Saints' Church,
Main Street,
Cossington,
Leicestershire
(SK 603 136)

ULAS Report No 2016-090
©2016

**An archaeological field evaluation at
All Saints' Church,
Main Street, Cossington,
Leicestershire
(SK 603 136)**

for
Cossington PPC

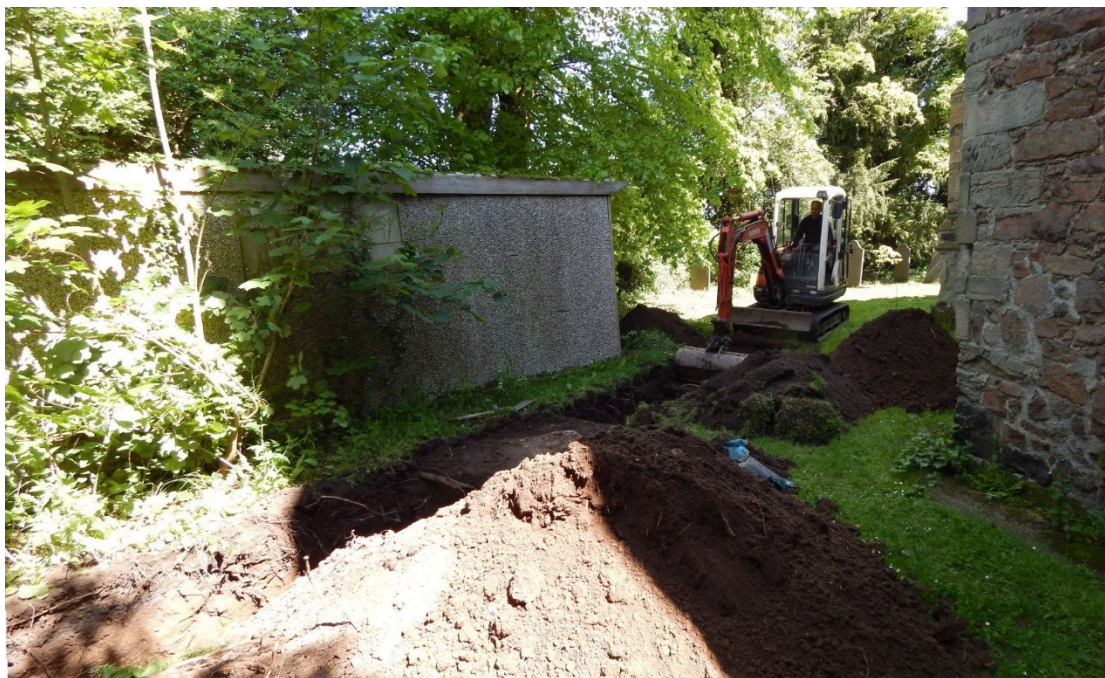
Plate 1: Work in progress on T P 07

A c.5% sample of the area of the proposed meeting room and external store was to be evaluated by trial trenching, the equivalent of one 10m by 1.6 m trenches and three 5m by 1.6m trenches (c.32m²). It was proposed that any burials encountered would be left *in situ*. Large roots, service pipes and a manhole were encountered, as well as having to fit the trenches between the gravestones, and so the trenches were shortened or lengthened to fit around these obstacles (Plate 1).

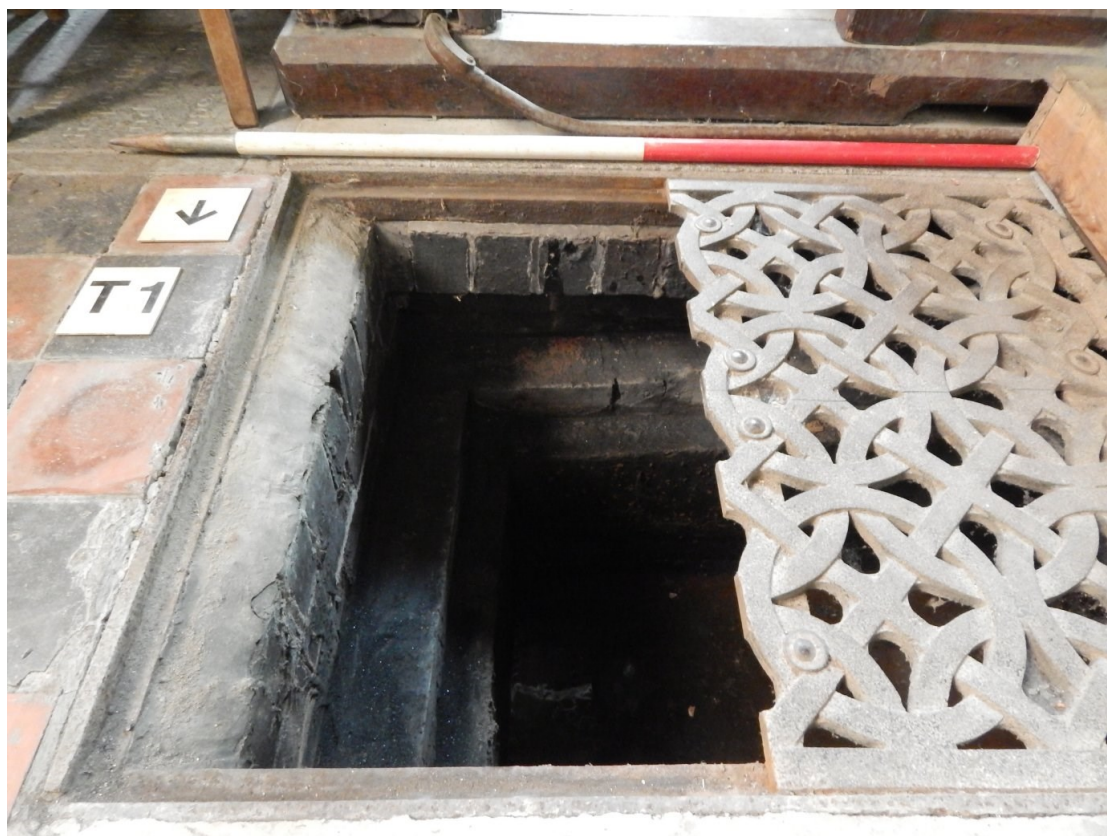
Plate 2: Test Pit 01; western end of heating system, with grille part removed

This test-pit consisted of the investigation of the eastern end of the heating system and no excavation was undertaken save the cleaning of the area under the grille for recording. The space under the grilles appeared to run the whole length of the north aisle and was constructed of blue bricks of 0.21m x 0.11m x 0.08m with an edging of concrete (Plate 2; Figures 4 & 5). The visible area of the space measured around 0.74m by 0.95m and was around 0.95m deep, although the space was filled with water to a depth of around 0.5m. The space ran for around 2m until blocked by an iron door, leading into the next space to the west (Plate 3).

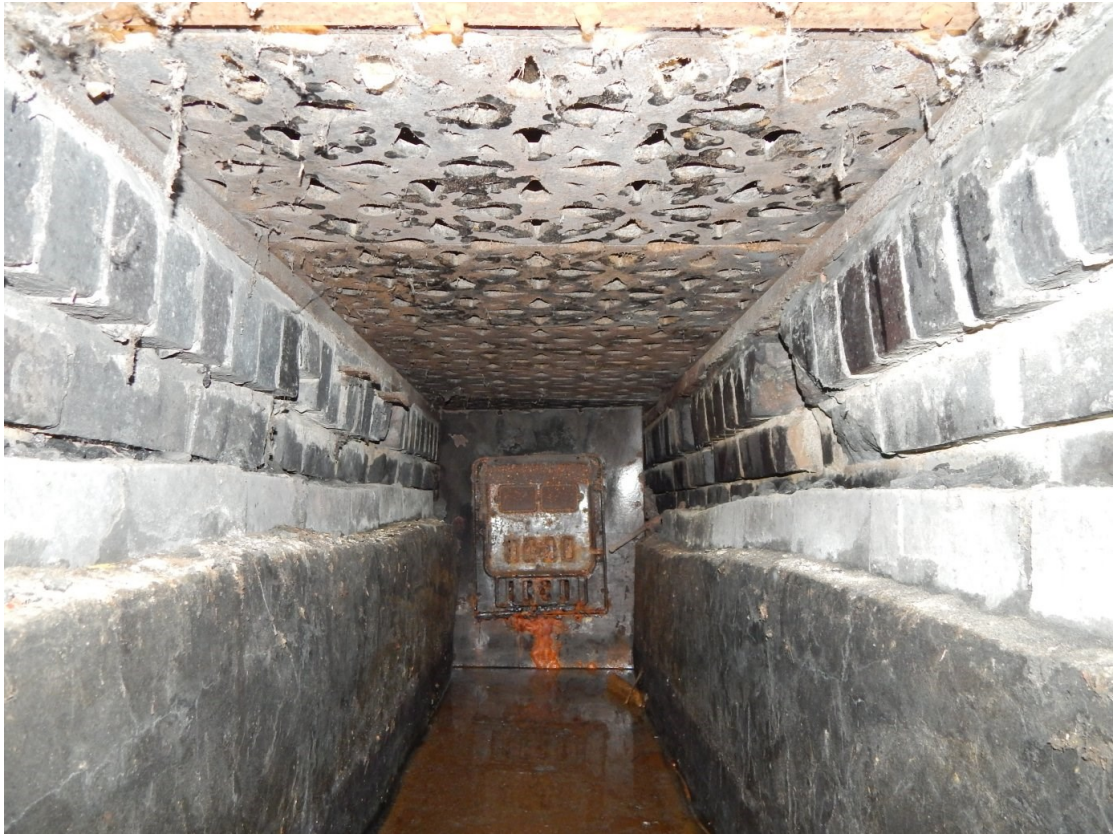
Plate 3: The interior of the heating system at eastern end (T.P 01) looking west

Some coal pieces and dust was removed during cleaning.

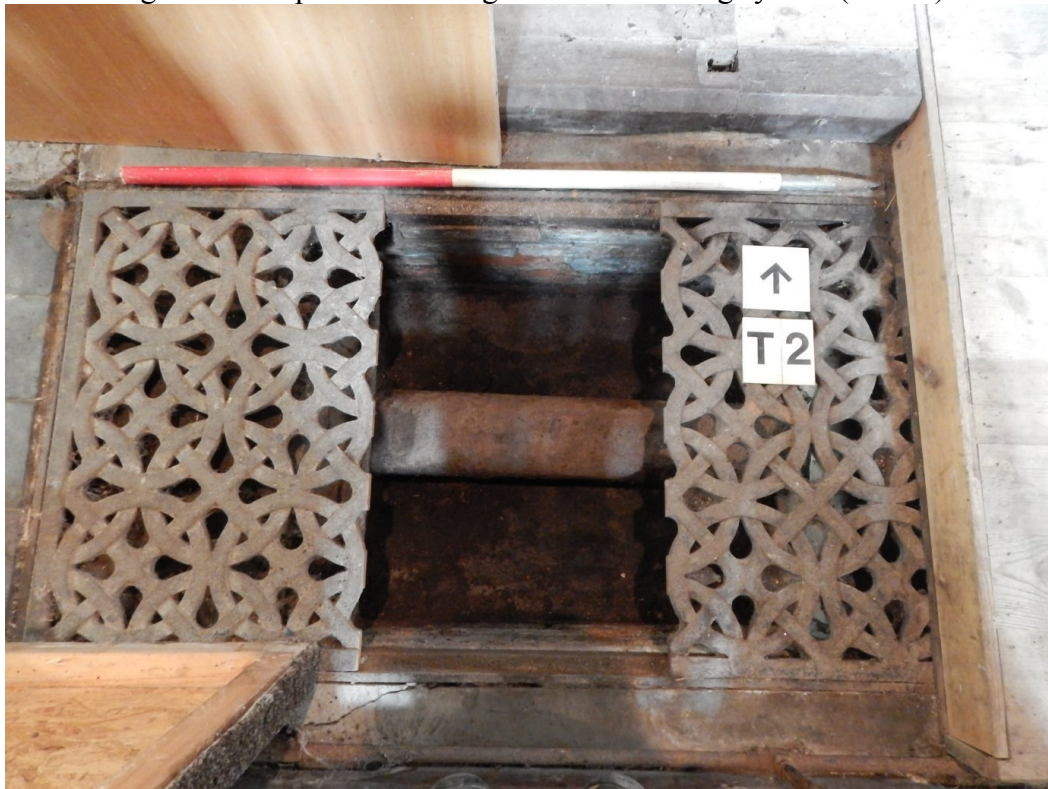
Plate 4: Second section of heating system with central grille removed (T.P 02)

This test pit was the next section of the heating system to the west of Test Pit 01. This space measured 1.30m by 0.74m and was around 0.42m and was also constructed of bricks and tile with a metal pipe running through it. The space around the pipe was filled with debris and soil, which was extracted before the pit was recorded (Plate 4; Figure 6).

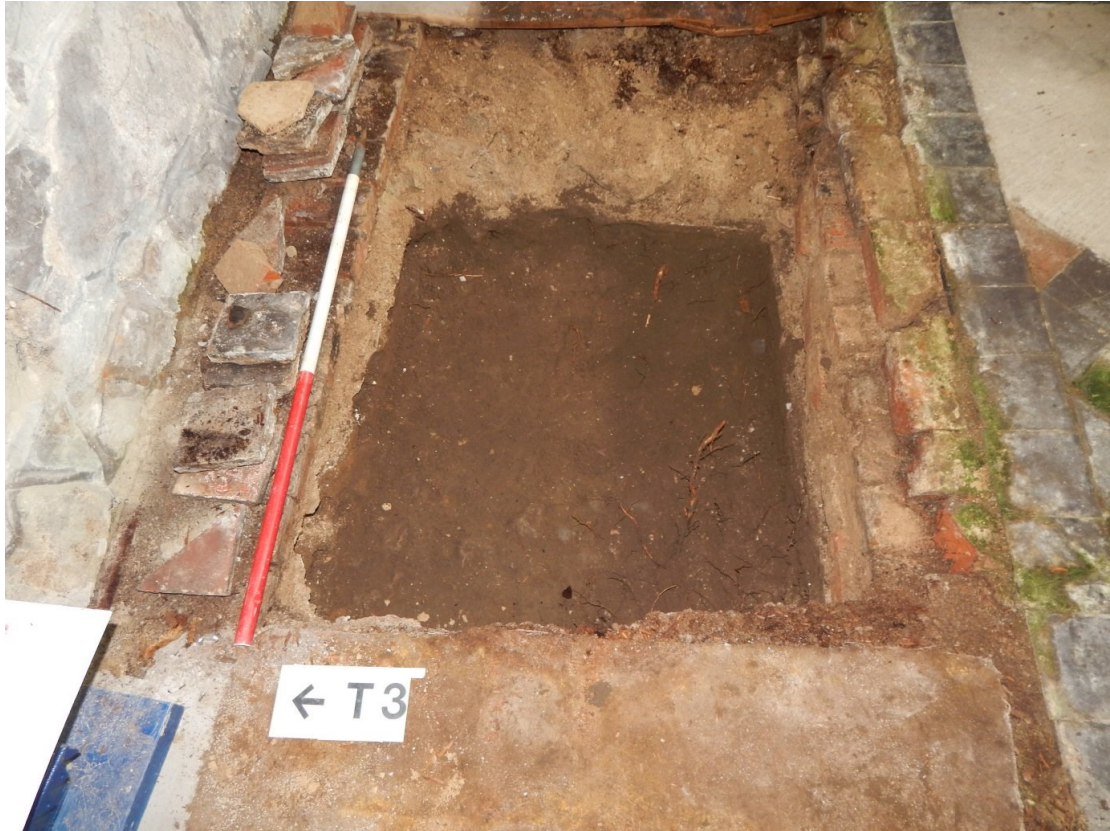
Plate 5: Post excavation view of T.P 03, looking east

This test pit measured 1.5m by 1m and was excavated through an area of floor that was already damaged along the northern side of the north aisle close to the sealed north door. It was excavated to a depth of 0.4m; the maximum depth of excavation for the proposed new floor (Plate 5; Figure 7A). The east and west facing sections showed 0.11-0.15m of rubble hardcore over a very dark sandy silt soil containing small pieces of ceramic building material (CBM), tile and medium sized cobbles (Figures 7B & 7C).

There was a row of bricks, laid as a course of stretchers, along the edge of the north wall of the church, each measuring 0.24m x 0.12m x 0.06m and all heavily degraded. Under these was a mortar/ rubble layer and then the aforementioned soil, with some root action visible. On the north facing section lay a course of similar bricks, which were loose and lay on top of two mortar courses of brick with the upper laid as stretchers and the lower as headers.

A sherd of 12th century pottery was recovered from the soil layer.

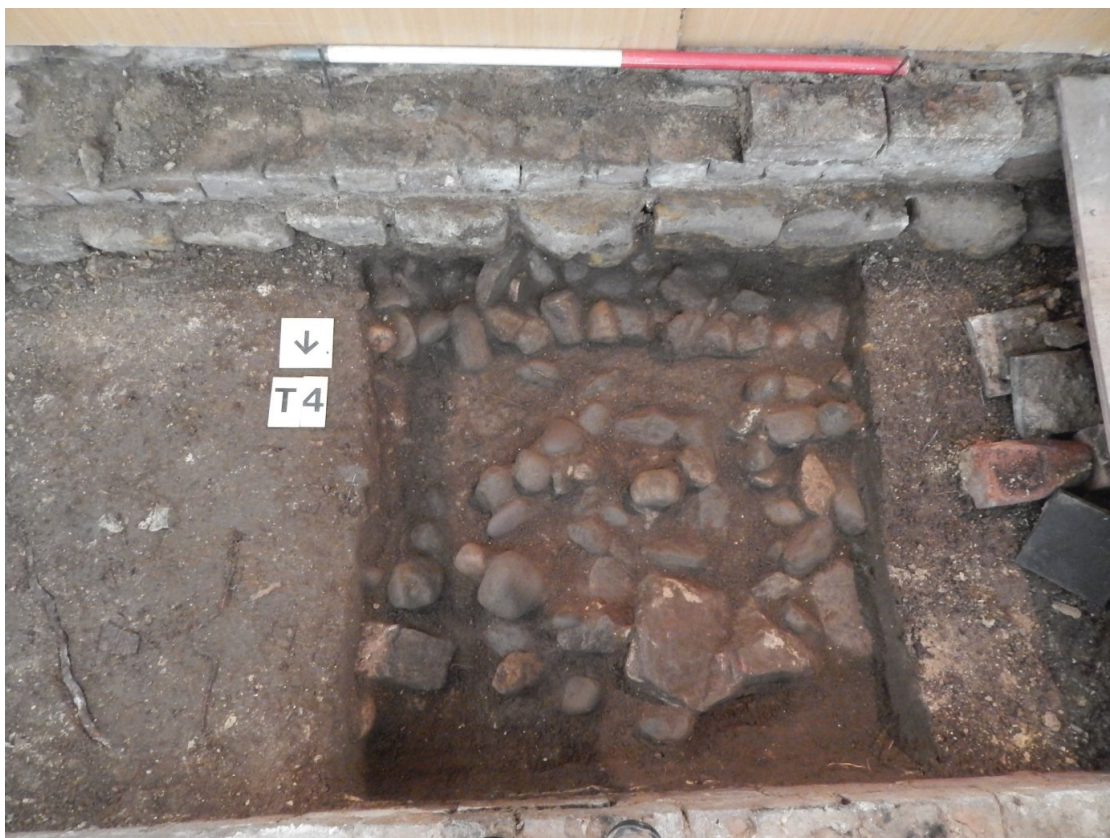
Plate 6: Post excavation view of T.P 04, looking south, showing stonework and cobbles

This test pit also lay along the north wall where the floor had collapsed. This was 1.32m long and 1m wide and was excavated to 0.40m depth (Plate 6; Figure 8A). The southern facing section had two courses of red bricks with a stretcher above a header course as in Test Pit 03. Below these bricks on the north facing section was a course of ironstone, roughly faced and seemingly the continuation of the lower course seen in Test Pit 03, but of stone. The bricks were mortared in but the stone seemed earth bonded (Figure 8B).

To the north the brick courses lay upon mortar and then the soil layer, but with medium sized cobbles roughly set into the matrix. These seemed to continue under the stonework on the southern side.

A sherd of 13th century pottery was retrieved from the soil layer.

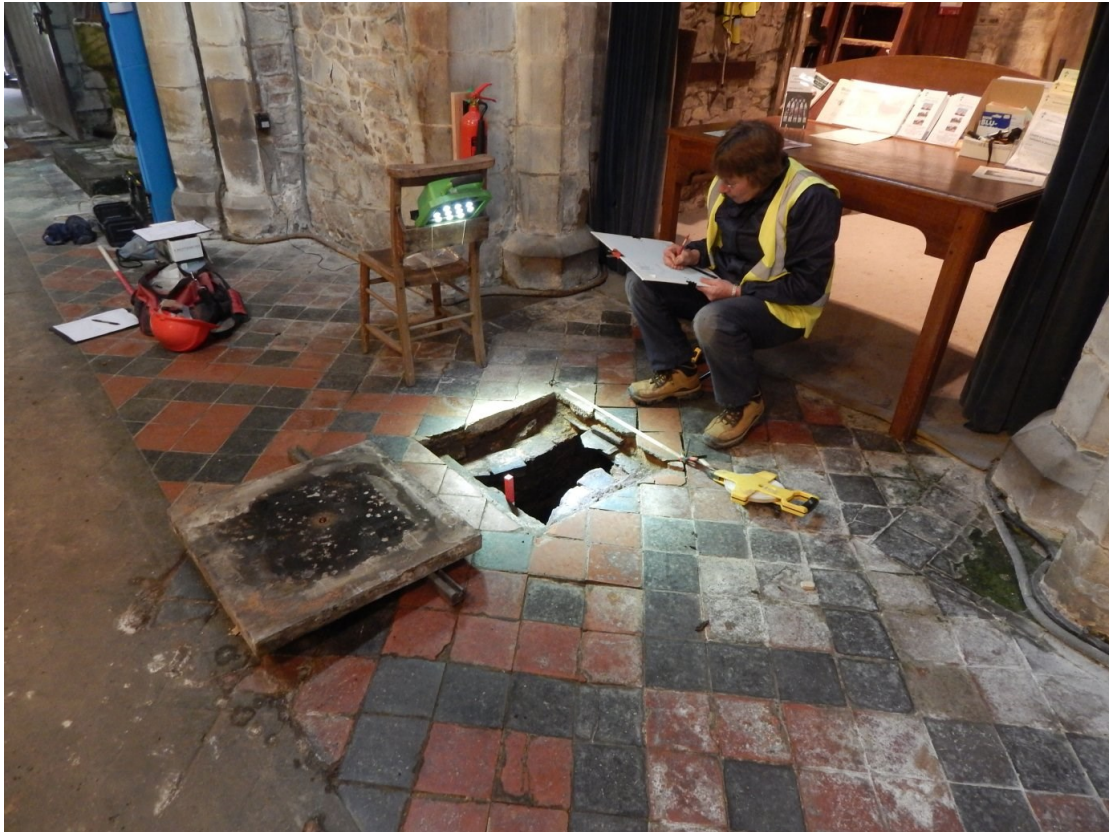
Plate 7: Work in progress recording T.P 05, looking south-west

This was the space under the concrete inspection slab at the western end of the nave close to the base of the west tower. The space measured 0.60m by 0.60m and was around 0.50m deep. Within this space was a Y-shaped chamber of red brick construction, some of which were voussoirs to provide a curve. The bricks were of a visible size of 0.23m x 0.08m, of unknown width. The voussoirs were 0.10m x 0.12m x 0.05m. The chamber was capped with slate, with a slab to the east and fragments to the west. The chamber was blackened but there was actual piping as in Test Pit 02.

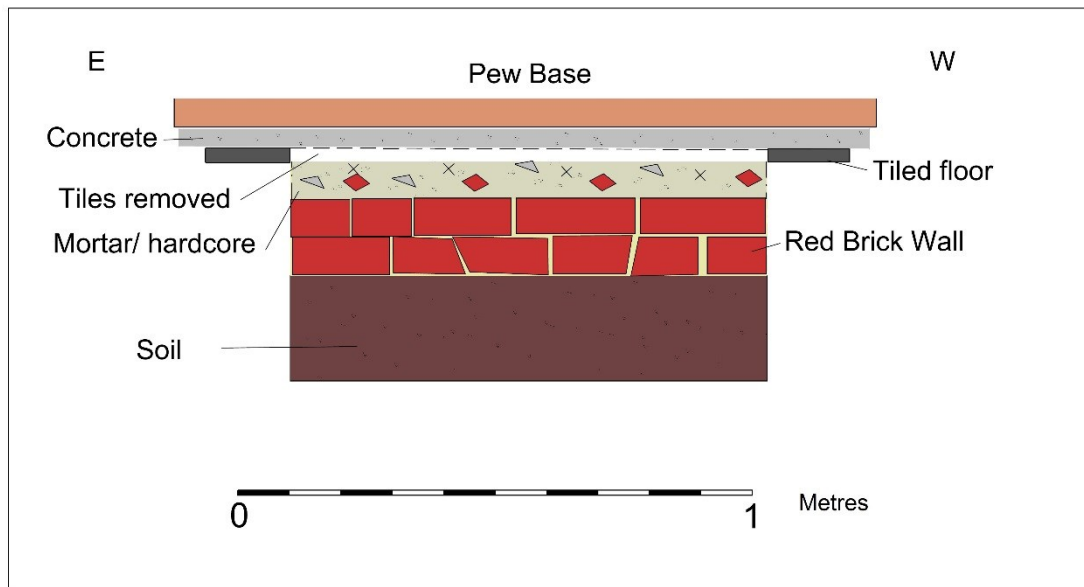
Figure 11: T.P 06 north facing section

When the tiles were removed along the southern edge of the test pit, a layer of concrete could be seen underlying the pew base along here. This overlay two courses of a brick wall that supported the pew base (Figure 11).

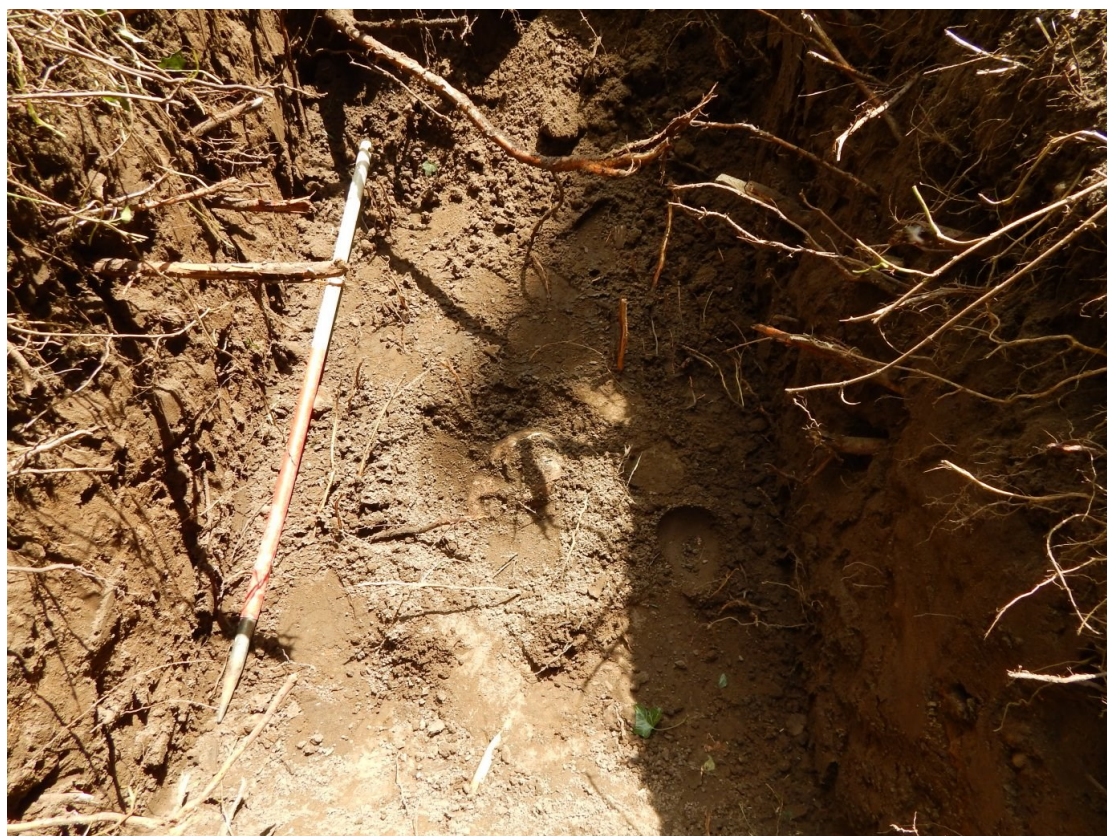
Plate 11: Base of T. P 08 showing skull *in situ*, looking south

This was oriented north-west to south-east and was excavated between two lines of gravestones to the north of the north-west buttress of the north aisle of the church. Large tree roots also foreshortened this trench to around 4m in length. The soils were very similar to those encountered in Test Pit 07, with around 0.30m of topsoil lying over a more mixed layer to the base of the trench at between 0.40m-0.90m depth. An articulated skeleton, with the exposed skull lying to the left, was encountered at 0.88m depth.

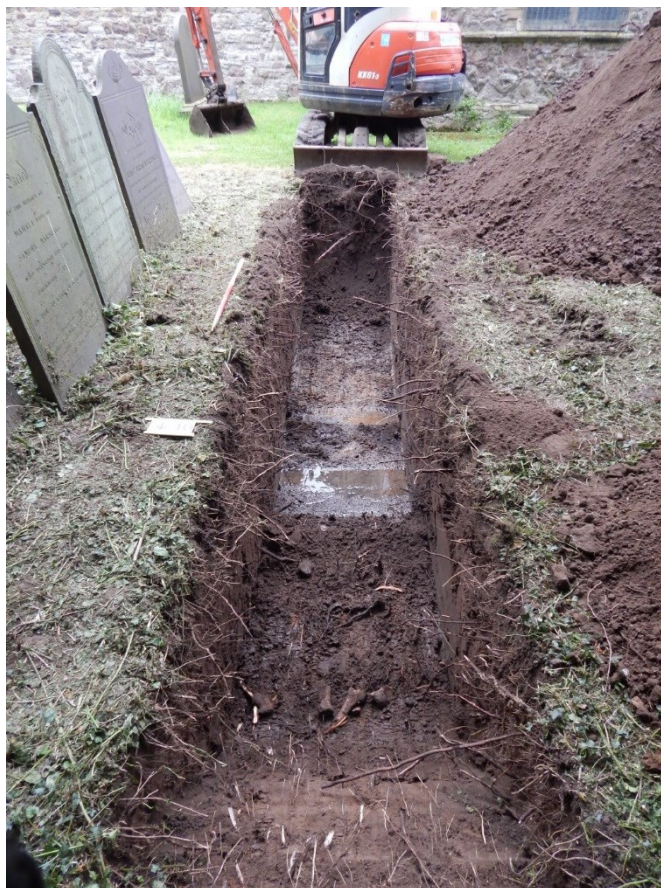
Plate 12: T.P 10, post excavation, looking north

The final trench was oriented north to south and lay to the north of the north-east buttress of the north aisle. The trench was 6m long and as fewer large roots were encountered, it was possible to excavate the trench down to the natural sub-stratum of brownish orange sand at between 0.92m and 1.30m depth. Articulated bone was encountered around 0.80m – 1m depth (Plate 12).
