**An Archaeological Topographic and
Historic Building Photographic Survey
at Land west of Stanton Road, Sapcote,
Leicestershire
(SP 489 939)**

ULAS Report No 2015-039
©2015

An Archaeological Topographic and Historic Building Photographic Survey at Land west of Stanton Road, Sapcote, Leicestershire (SP 489 939)

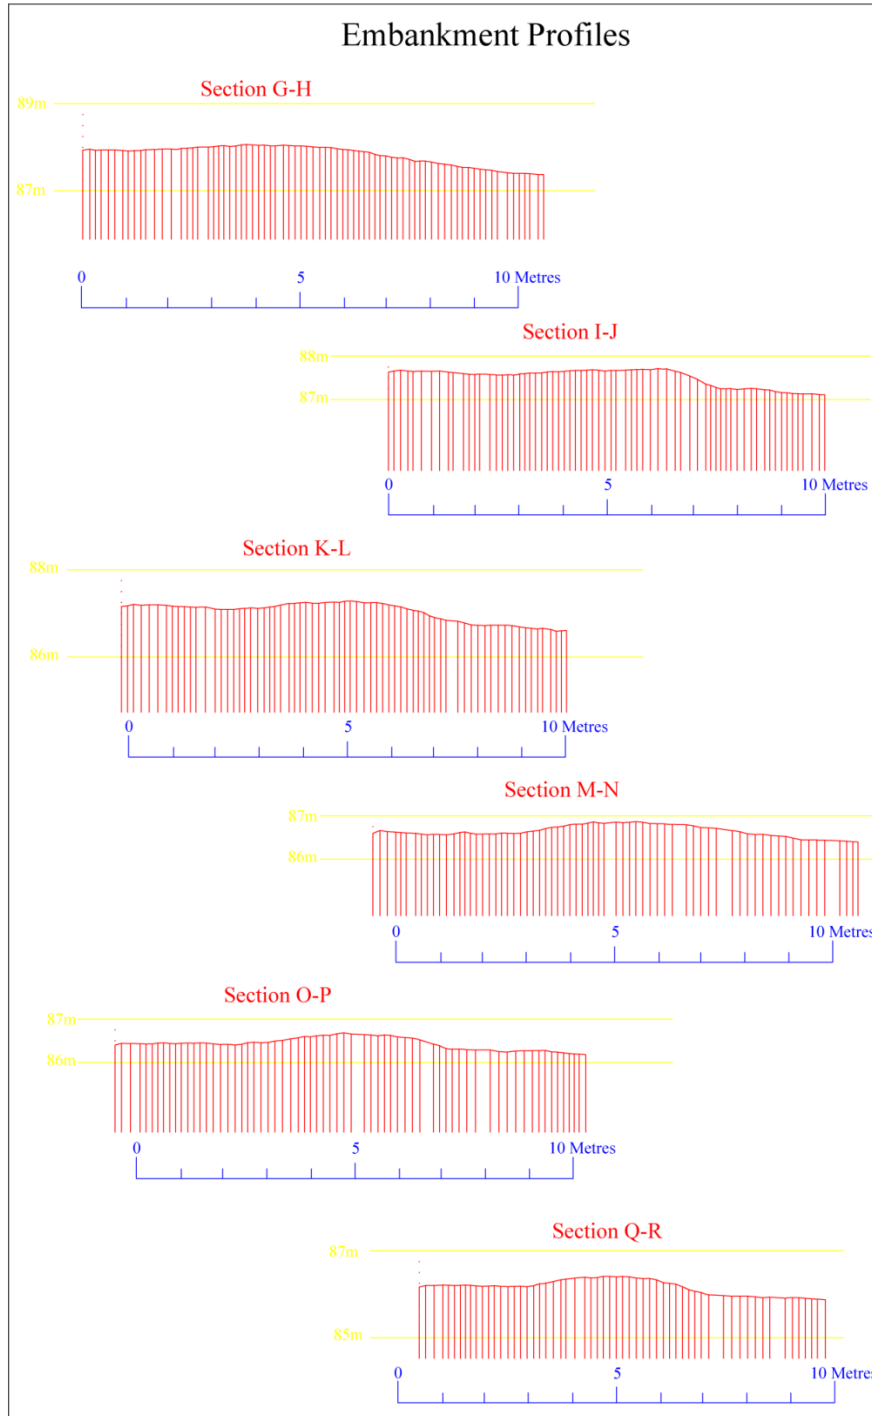
Figure 5 Recorded Profiles of the linear embankment

A linear earthwork was recorded that extended from the south-eastern edge of the northern terrace (close to the gated entrance) to the south-east edge of the southern terrace (fig.3; Appendix 4, photo 4). The earthwork measured 165m long and varied in width between 3.85-6.36m. It was noticeably straight along the majority of its extent, curving immediately before reaching the southern terrace. The form of the earthwork is best described as an embankment that has been deliberately constructed in order to create a level plane, now measuring between 1.43-2.11m in wide. This means the embankment itself is quite varied in profile depending on the localised slope of the topography (fig.5 Profiles **G-H**, **I-J** and **K-L**, **M-N** and **O-P**; Appendix 4, photos 51-55). However it was recorded that generally the north-west side of the embankment exhibited a steeper slope to compensate the fall in ground level in that direction. The embankment has been constructed obliquely to the natural contour of the ground in order to create an inclined plane that gradually descends from 88.28m OD at its north-eastern extent to 85.79 at its south-western extent. The gradient of this slope is approximately 1 in 68 (fig. 6).

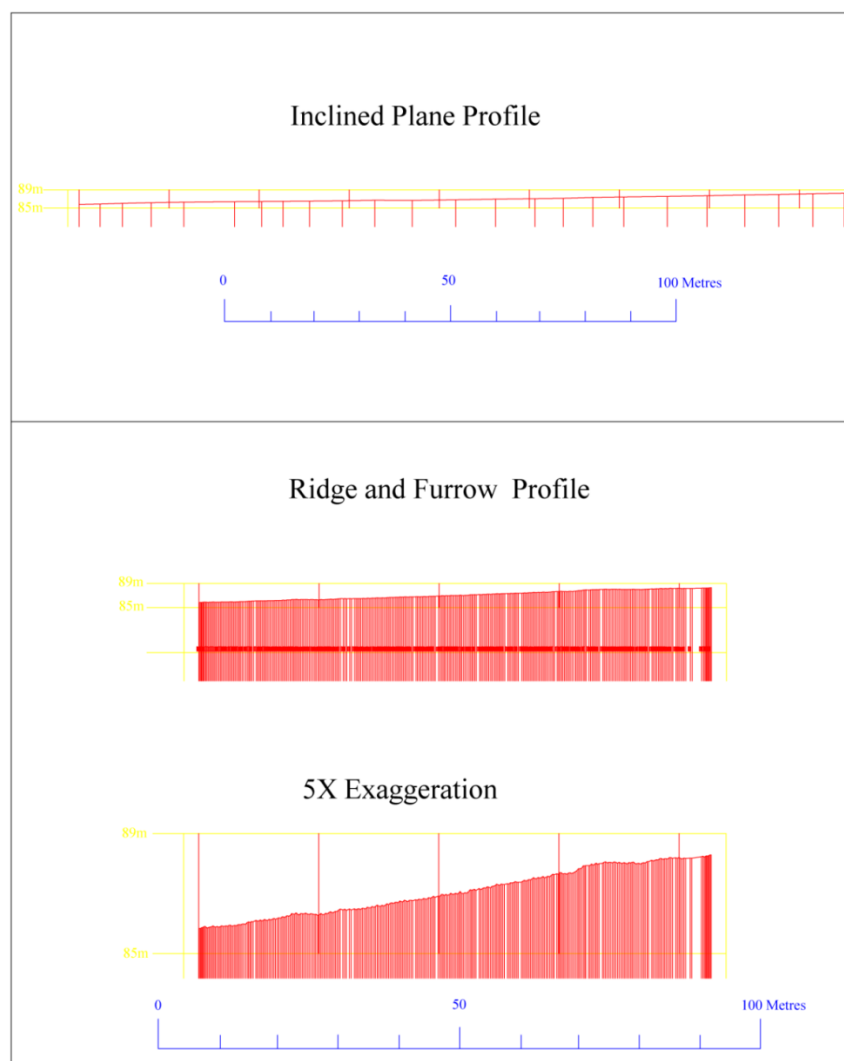
Figure 6 **Above:** Profile of the inclined plan (top of embankment). **Below:** Profile across area of faint ridge and furrow (includes 5x exaggeration)

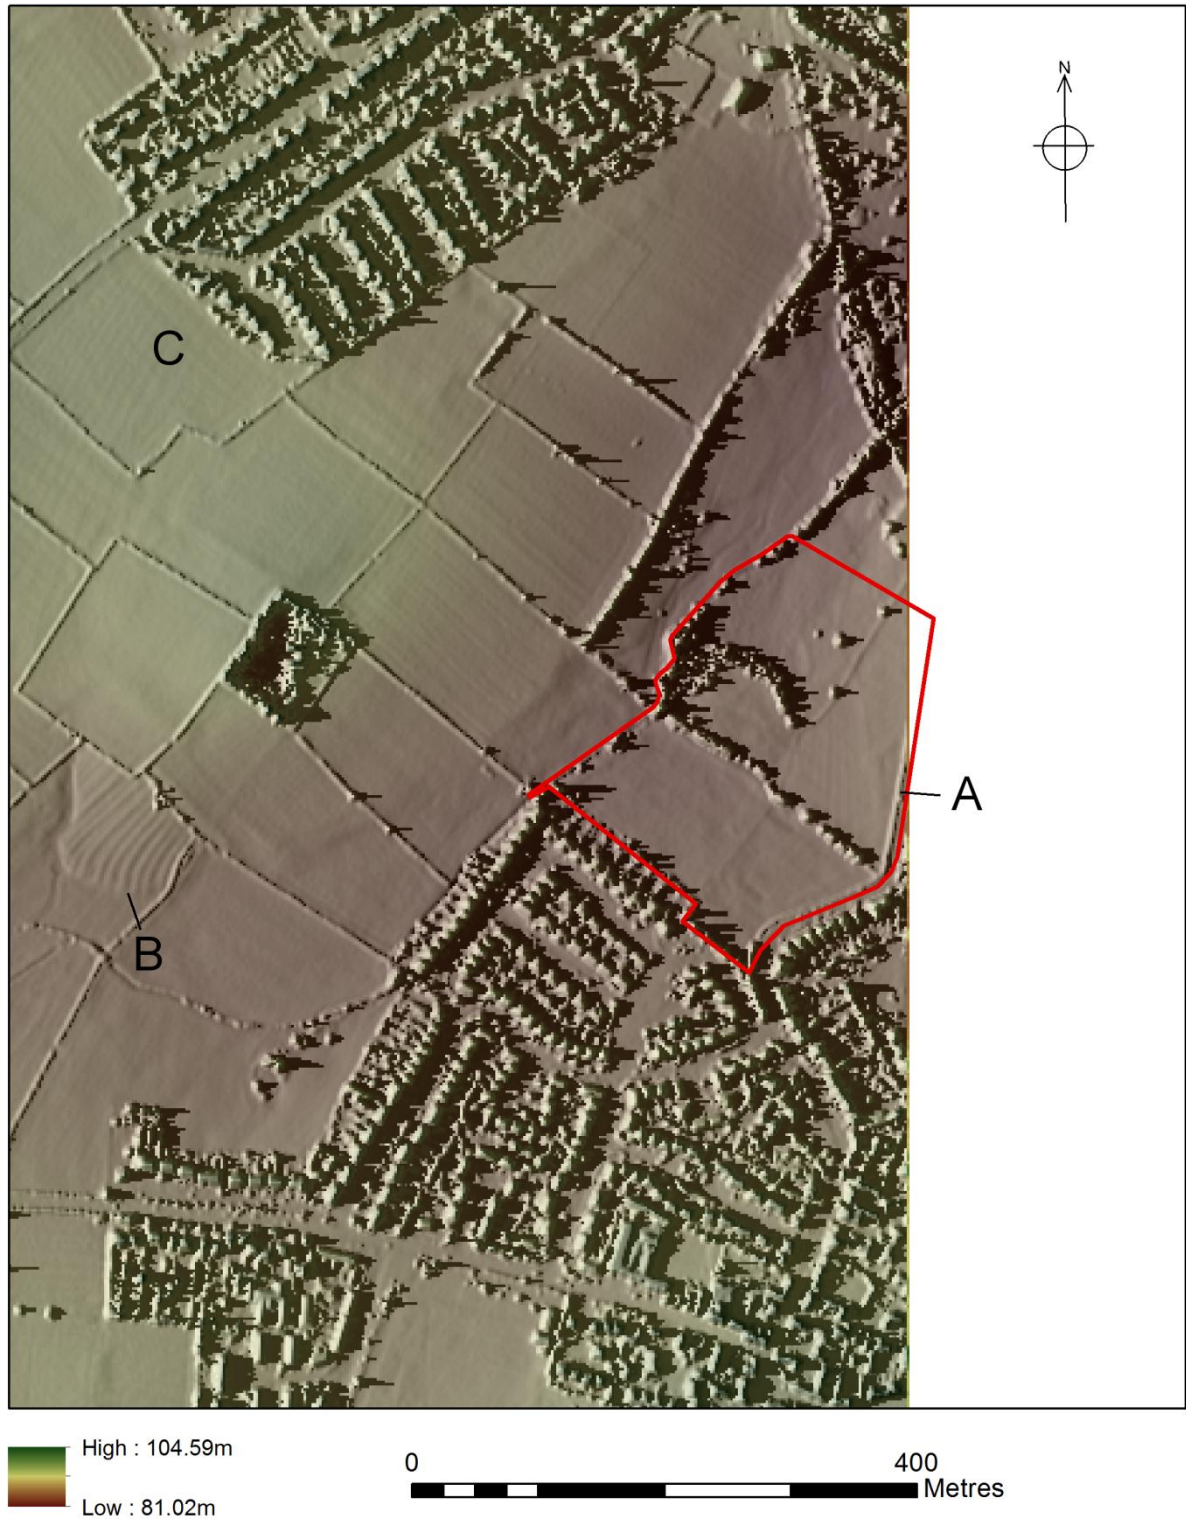
Figure 7 Composite hillshade plot of LiDAR 2m DSM data. DEM overlain by hillshade (HS270302)

The aerial LiDAR recorded very faint vestiges of north-south aligned ridge and furrow earthworks in the south of the site (fig. 7, A). A group of five furrows/ridges in all *c.* 40m wide, can be traced for *c.* 80m north from the north-west to south-east field boundary that bisects the site. Slight breaks of slope indicate the location of the eroded furrows in a profile drawn across the LiDAR data (fig. 8, D-E and fig. 9).

More strongly surviving ridge and furrow earthworks are visible in the data to the west (B). Some of the patterning in the data is a result of data processing e.g. the linear forms north-west of the site (fig. 7, C) (cf. Crutchley & Crow, 2009, 27).

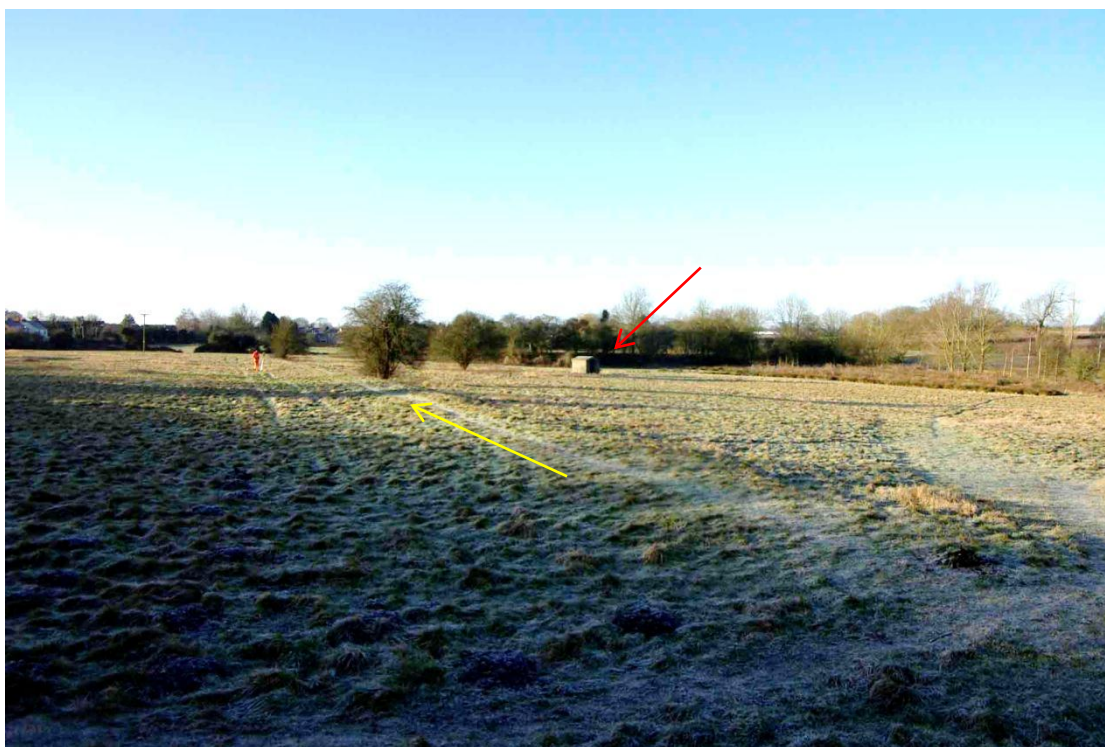
Figure 11 Building location

Looking south-east. Building shown with red arrow. Yellow arrow indicates line of linear earthwork

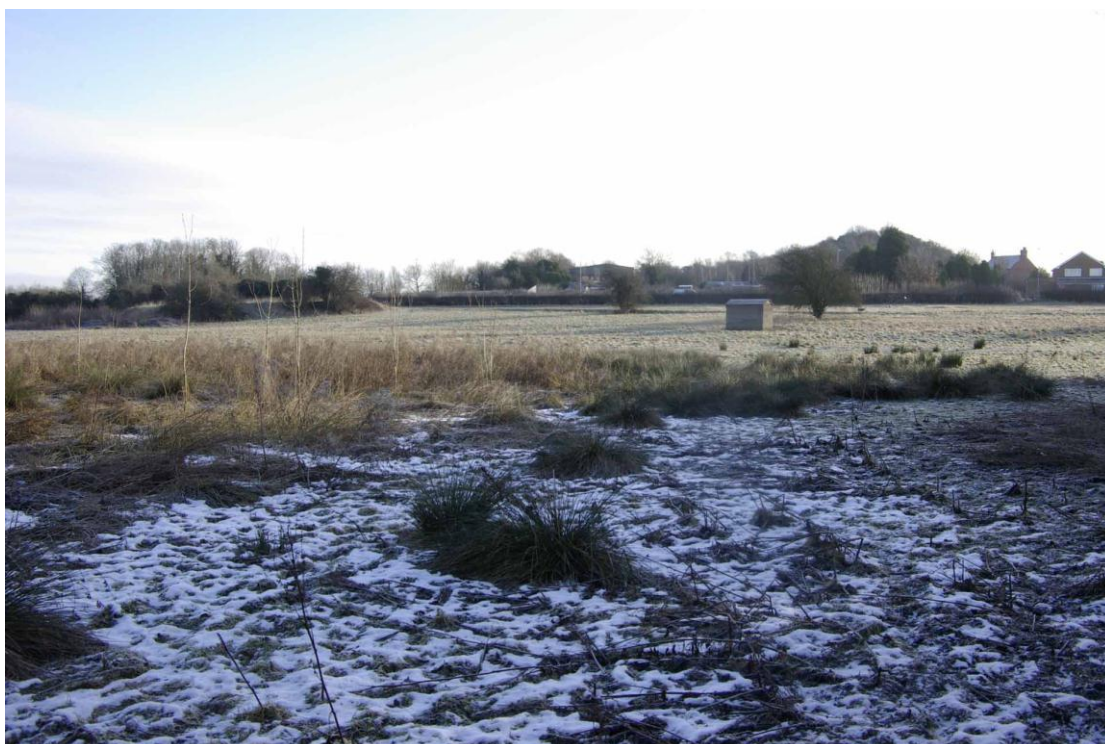
Figure 12 Building location

The building is constructed entirely of concrete with large lumps of granite visible within the walls (Fig. 12). The walls are 0.32m thick. It has a single entrance on the north-east facing elevation and has stop chamfered corners on each elevation which is an unusual decoration on an otherwise utilitarian structure (Figs. 13 to 17). The building sits on a small plinth of concrete and granite rubble (Fig. 18). The north-east and south-west facing elevations have a series of drilled holes to which something was attached to the walls. It is not clear what this was although is unlikely to have been a downpipe for a gutter as they are on the shortest sides of the building (see Figs. 12, 14 and 16). Evidence of casting marks from wooden shuttering can be seen on both the inside and outside walls. The building was cast in a number of pouring episodes as there are at least two clear lines where different batches of concrete were used. The large number of granite lumps used within the concrete probably necessitated a number of pouring lifts in a similar fashion to flint walls are constructed. The roof is cast in a single curving piece which also shows the casting lines from the timber shuttering.

Looking north-west

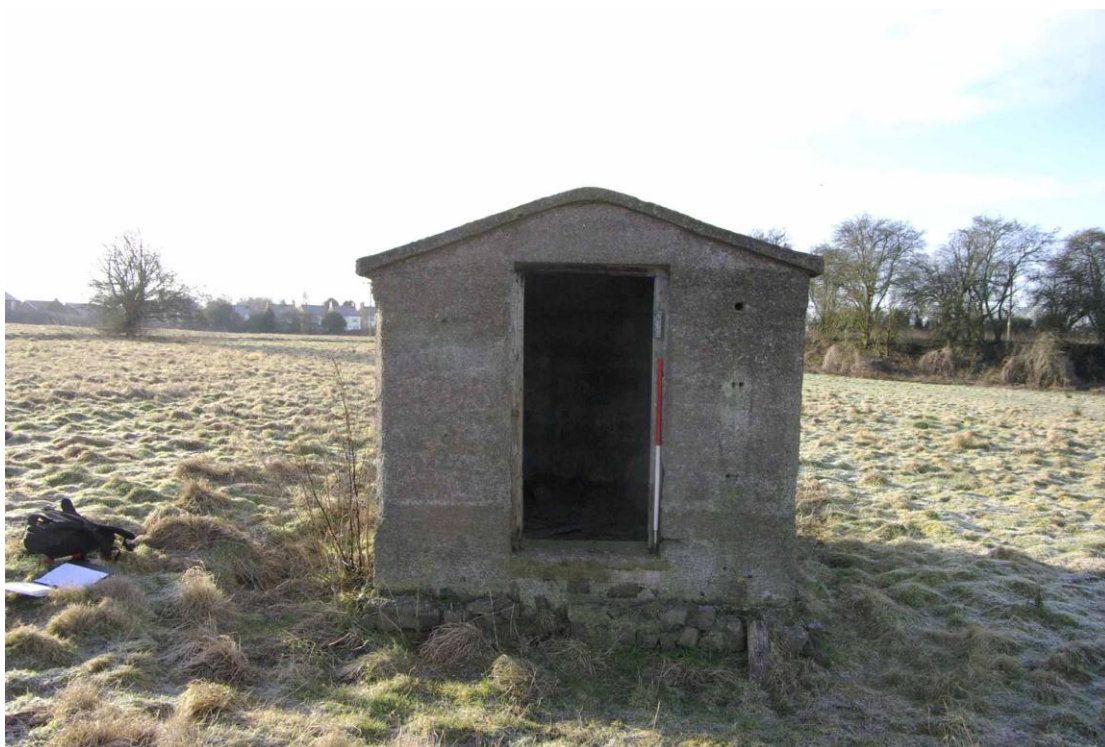
Figure 13 North-east facing elevation
Looking south-west. 1m scale

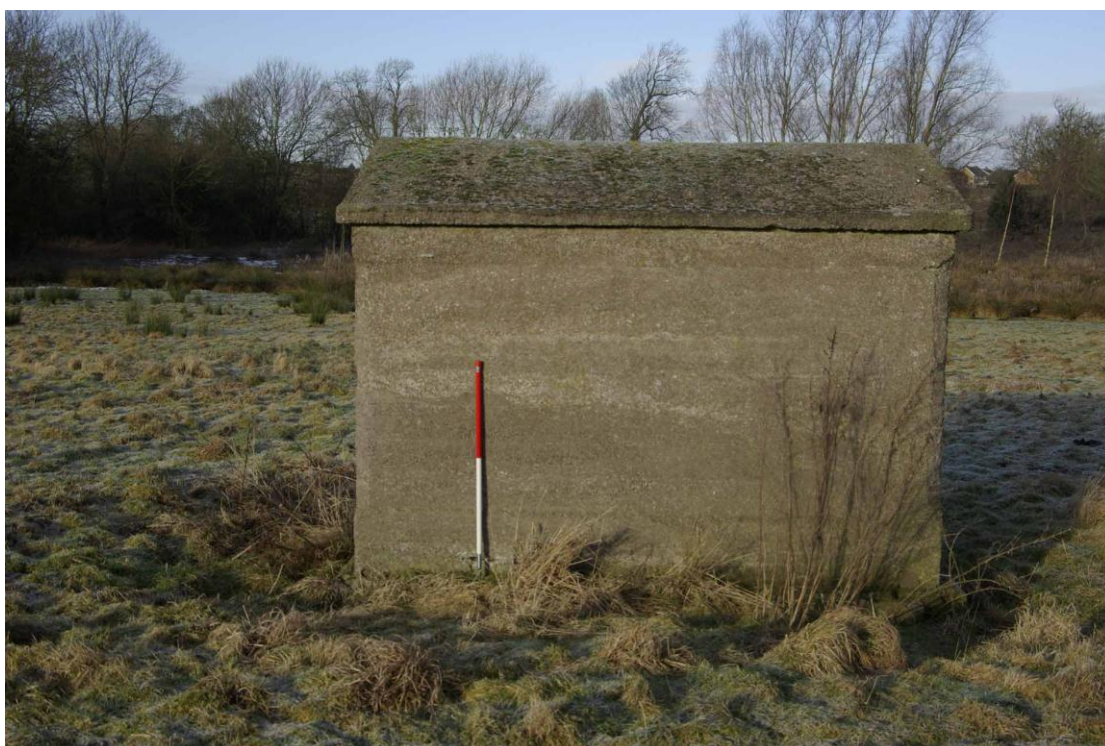
Figure 14 South-east facing elevation
Looking north-west. 1m scale

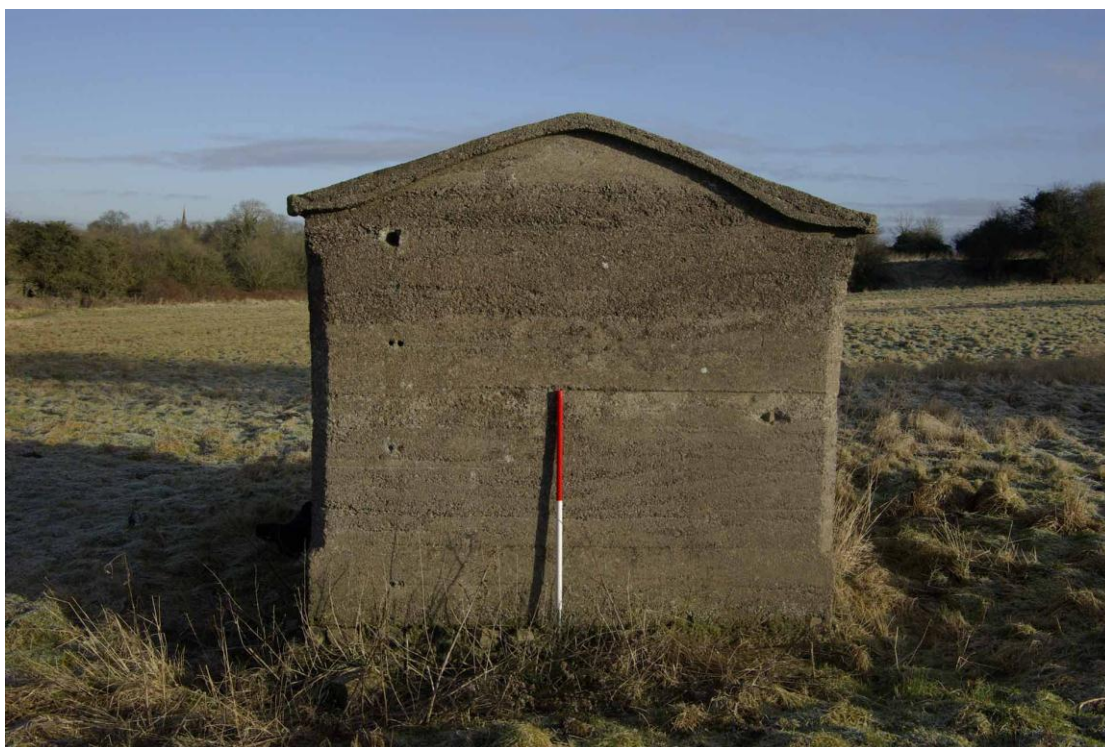
Figure 15 South-west facing elevation

Looking north-east. 1m scale. Note the horizontal shuttering lines cast into the concrete

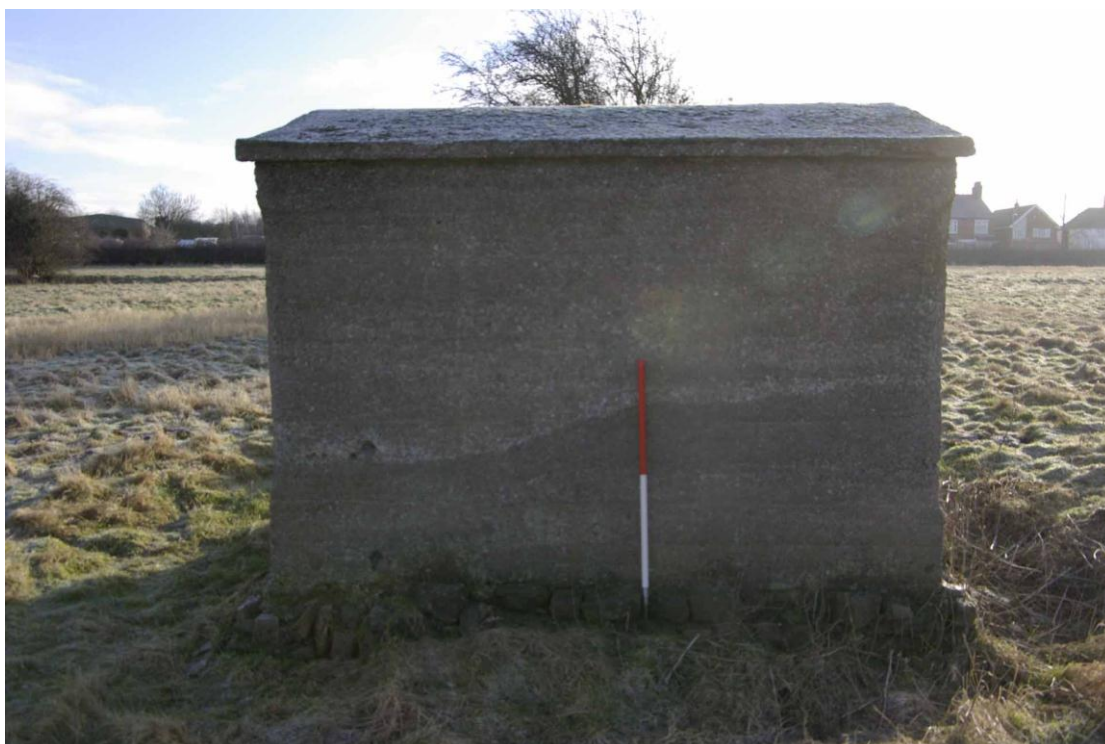
Figure 16 North-west facing elevation

Looking south-east. 1m scale. Wavy line shows separate pours of concrete

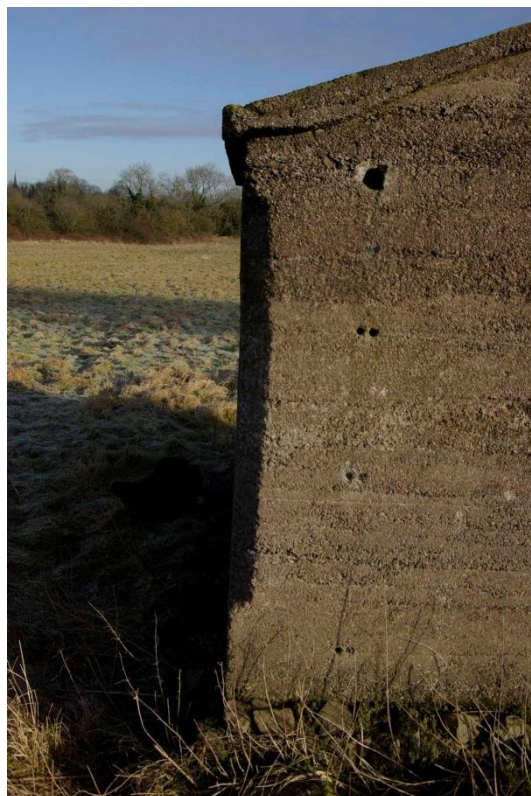
Figure 17 Corner chamfer detail

Looking north-east. Note drilled holes for unknown attachment

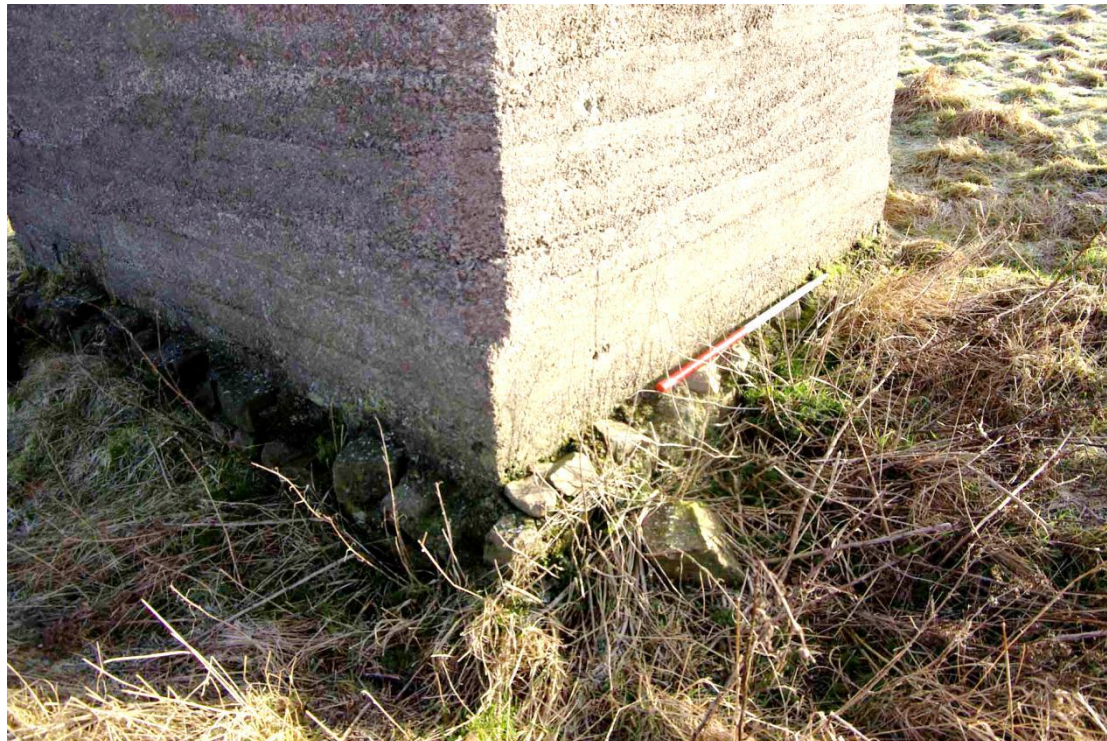
Figure 18 Plinth detail

Looking north-east. 1m scale

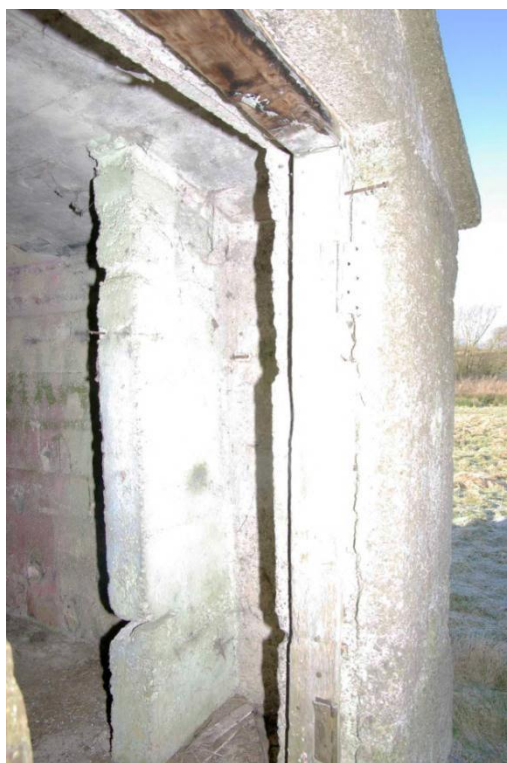
The single doorway, which is on the north-east facing elevation, has the remains of a wooden door frame but the door has been removed. The hinges are still present and are made of brass which would normally be unusual in a simple agricultural building. Brass however is often used where it is necessary to prevent sparks, such as when dealing with explosives. Inside the doorway is a second doorway created by a wall built from concrete blocks (Fig. 19). There is evidence of wooden shelving being inserted between the block walls and the outer walls and is seen as stubs of planking built into the walls (Fig. 20). No trace of a secondary internal doorway can be seen.

Figure 19 Internal wall
Looking south-west

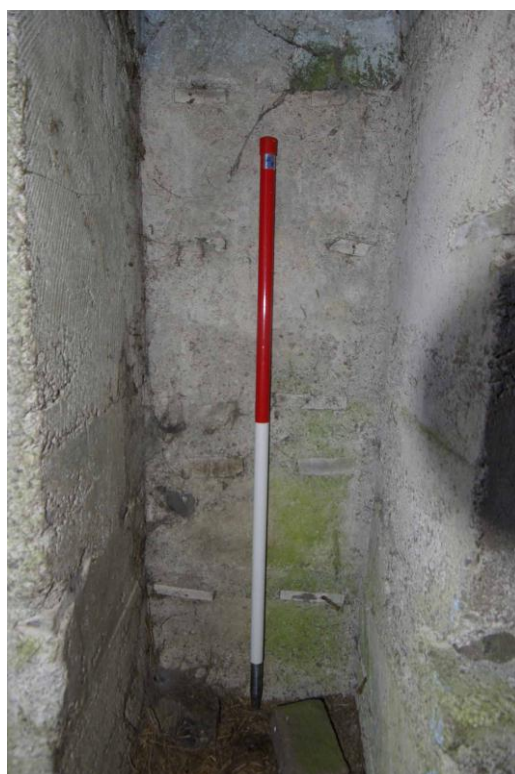
Figure 20 Alcove between inner and outer walls
Looking east. 1m scale. Inserted stubs of wooden planking can be seen either side of scale

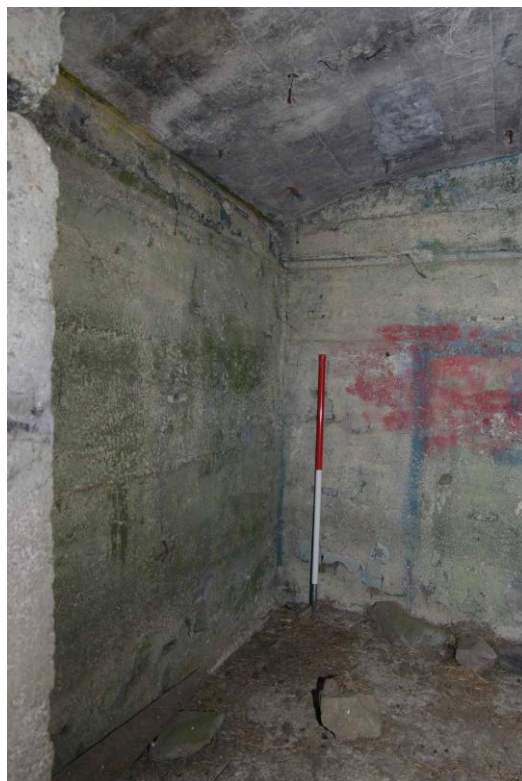
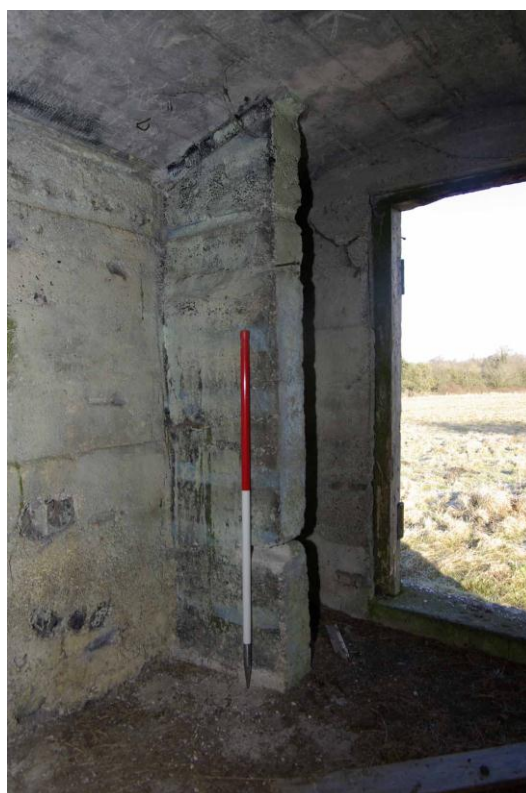
The main room of the building is open with no evidence of any fixtures and fittings surviving (Figs. 21 and 22). The inner faces of the walls have large lumps of granite visible in the matrix of the concrete which act as reinforcement and also indicate that the builders had a relatively easy access to granite rubble (fig. 23).

Figure 21 Internal view
Looking south. 1m scale

Figure 22 Internal view
Looking north. 1m scale

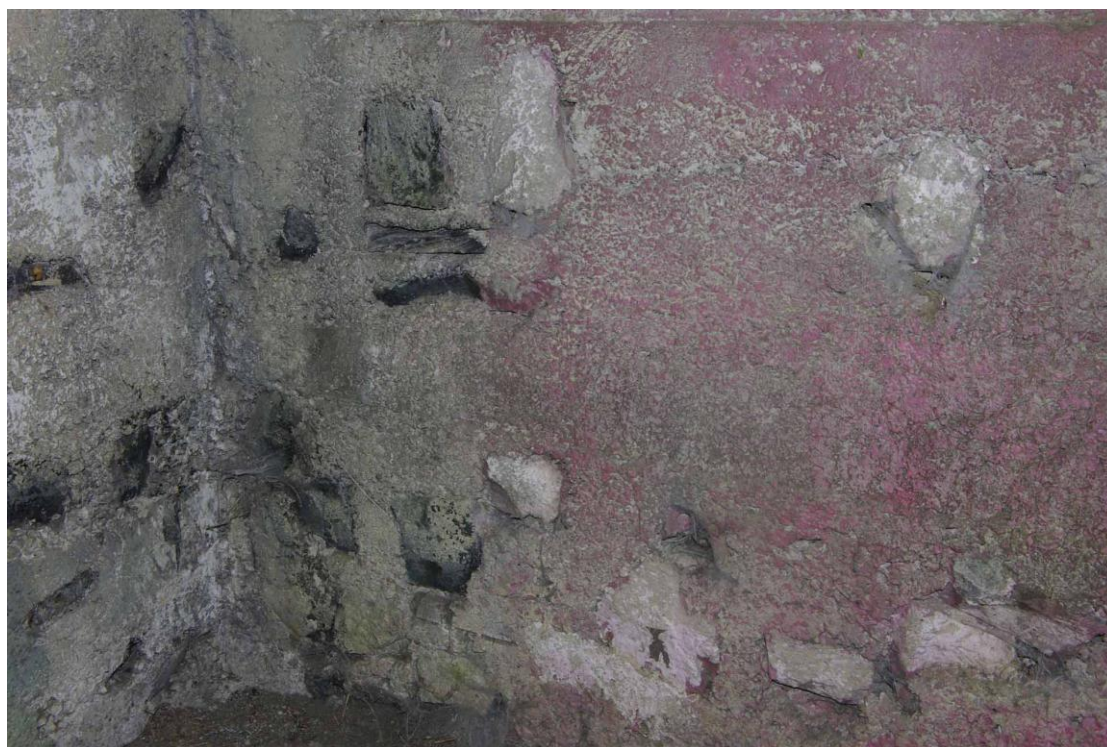
Figure 23 Granite blocks visible within wall fabric
