**A Level 2 Historic Building Recording:
The Granary,
Rodbaston Campus,
South Staffordshire College,
Rodbaston,
South Staffordshire**

ULAS Report No. 2015-182
©2015

For: South Staffordshire College

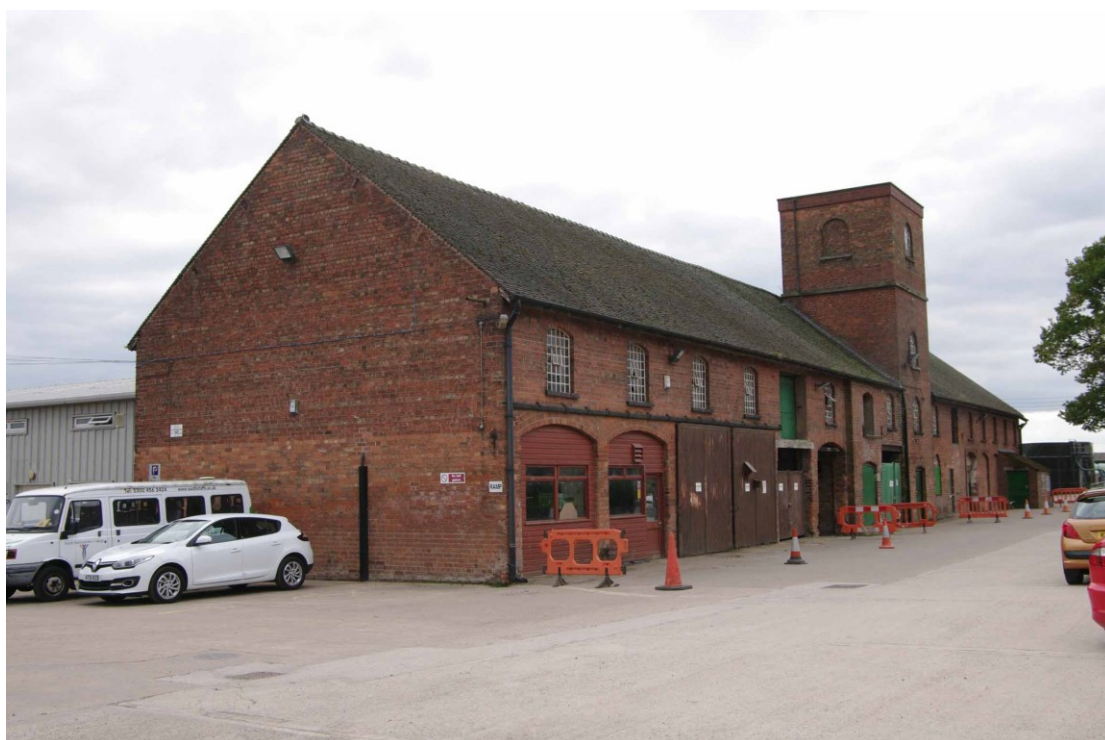
Figure 6: General view of the Granary
Looking south-west. South-eastern range of Granary buildings on far left of picture

The main two storey Granary building is built from red brick and has a roof covering of plain tiles which may be original. The bricks are laid in English Garden Wall bond consisting of a single course of headers separated by three courses of stretchers.

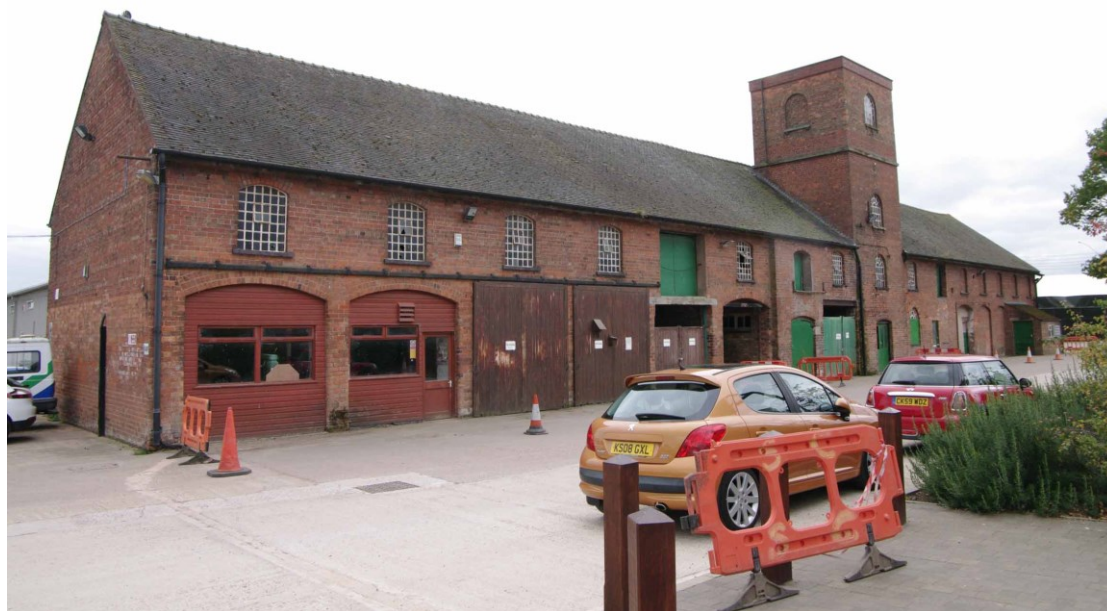
Figure 12: Granary, north facing elevation, eastern end
Looking south-west

When viewed from east to west at ground floor there are four wide arches in the eastern section. Two have been filled in with glazed wooden panels to create the front wall of a large workshop (Figs 12 and 13). Two more arched openings have sliding wooden doors covering the opening. The tracks for the sliding doors run above the arches close to the eastern corner of the building. To the west of the four arches is a rectangular double gateway with a concrete lintel leading into an open room. The 1964 Past Track photograph indicates that this used to be a fifth archway with a small hayloft type door above it. To the west of the modified doorway with the concrete lintel is another archway and passage which leads all the way through the building to the space between the rear ranges. The first floor has iron-framed multi-paned windows which have tilting central panels (Fig. 14). The window sills are made from blue bricks. The 1964 photograph suggests that the existing square doorway over the concrete lintel was originally a much smaller hayloft door which matched the size and shape of its neighbouring windows.

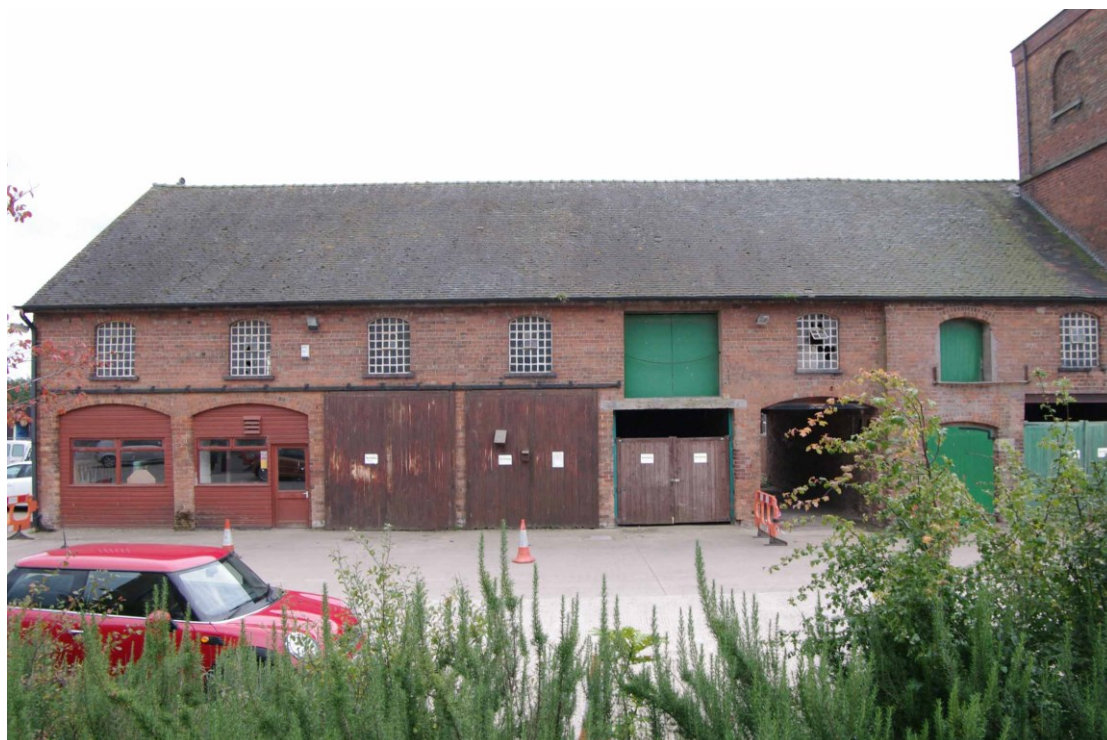
Figure 13: Granary, north facing elevation, eastern end
Looking south. Note inserted concrete lintel next to the sliding doors

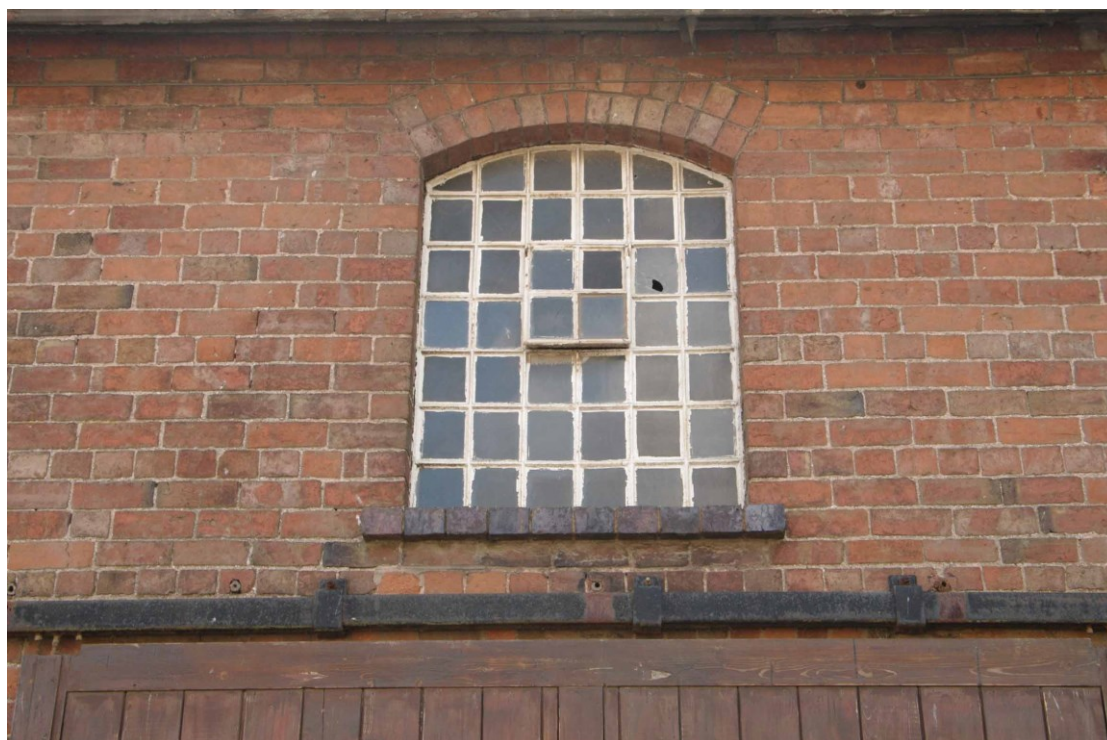
Figure 14: East facing elevation, first floor eastern end window detail
Looking south

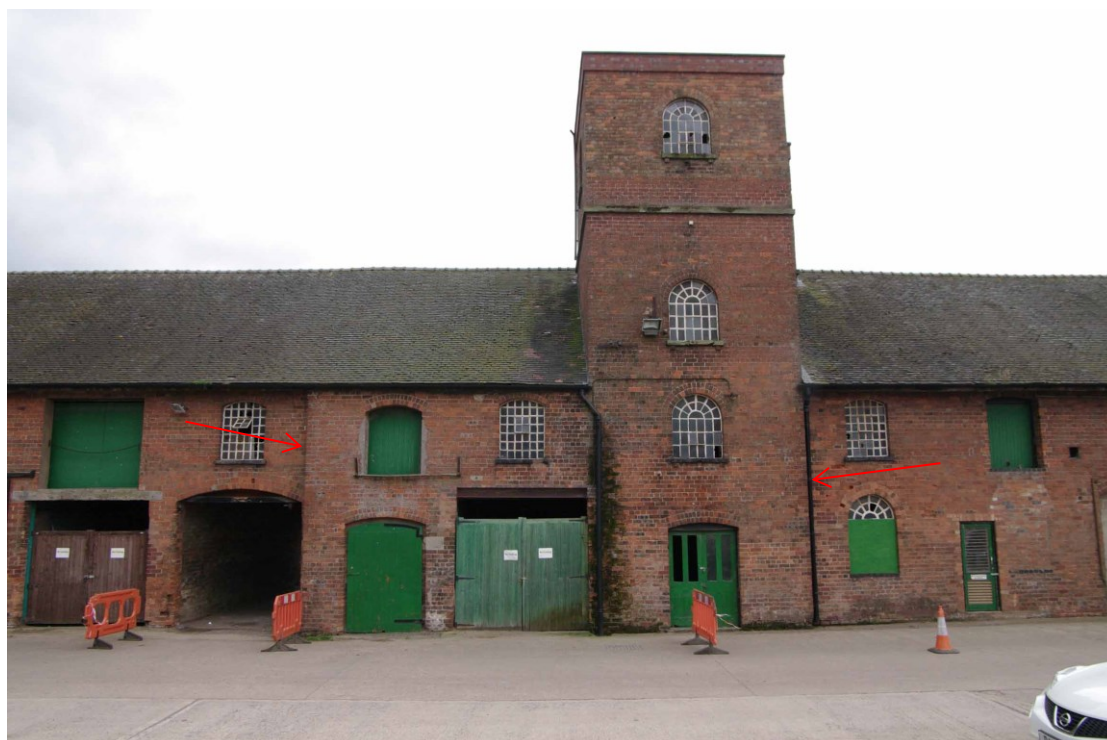
To the west of the passageway through the building the elevation steps outwards by 0.25m to create a slightly projected central section which includes the four storey tower (Fig. 15). The line of the eaves remains unbroken until it meets the side of the tower itself. At ground floor level there is a wide arched doorway with a double width gateway to the west. The gateway has a modern steel lintel and appears to post-date the 1964 photograph which shows a lower arched opening. At first floor level is a hayloft type door and a multi-paned window of the same pattern as those to the east.

Figure 15: Granary north facing elevation, central tower section
Looking south. Note steps in wall (arrowed)

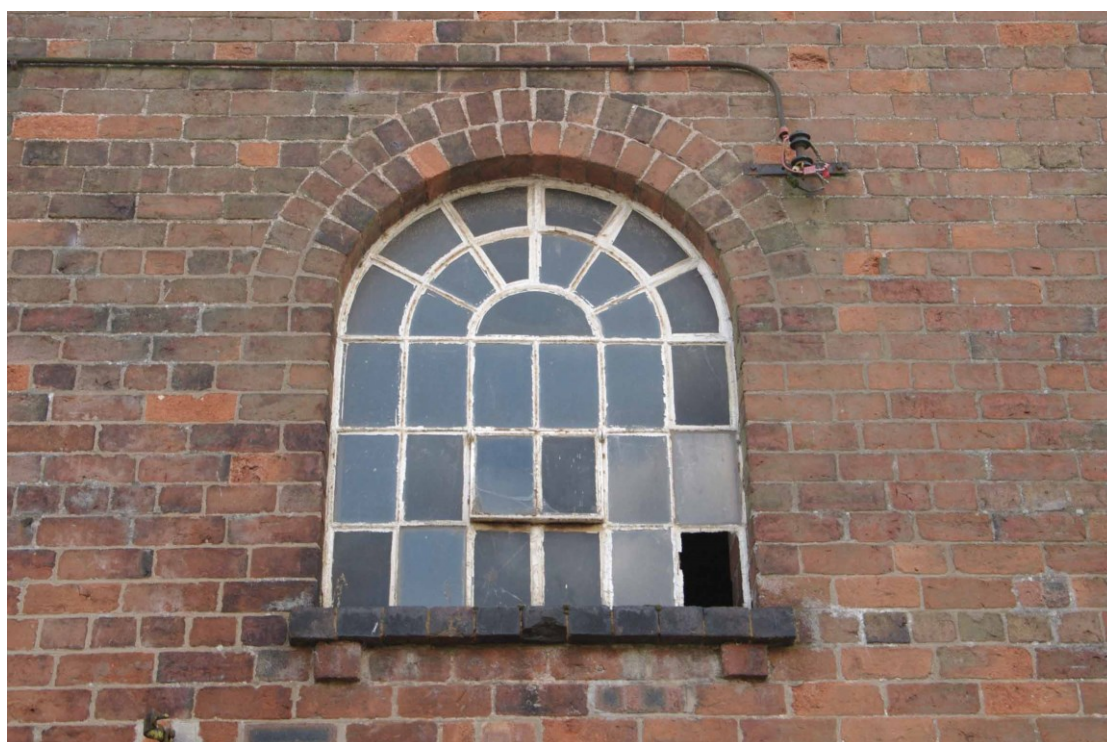
Figure 16: Granary tower window detail
Looking south, First floor

The main part of the rectangular tower sits on the north side of the granary roof ridgeline. Attached to the south-west corner of the tower is a small chimney-like square structure which sits astride the ridgeline. The main tower has a ground floor doorway with three Romanesque style arched windows on the floors above. The windows have cast-iron multi-paned frames with larger panes than those used on the eastern section (Fig. 16). The first floor window has a blue brick sill but the higher floors have limestone sills which match a decorative limestone band which runs around the east, west and north sides at the height of the roof ridgeline (Fig. 17). The window sills are supported by projecting brick headers which are present for decorative purposes only. The east, west and south faces of the tower have blind arches with sills to match those used on the glazed windows. The blind arches do not appear to have ever been open windows. On the west facing elevation of the tower is a small window which breaks the line of the stone banding and was presumably placed to light a stairwell. Just above the stone band the brickwork changes colour from red to a slightly more yellow colour which extends upwards just above the second floor window arch to a brick string course where the colour changes back to a darker red. The top of the tower is finished with projecting limestone coping stones. The reason for the change is not entirely clear and may be due to the tower being raised although

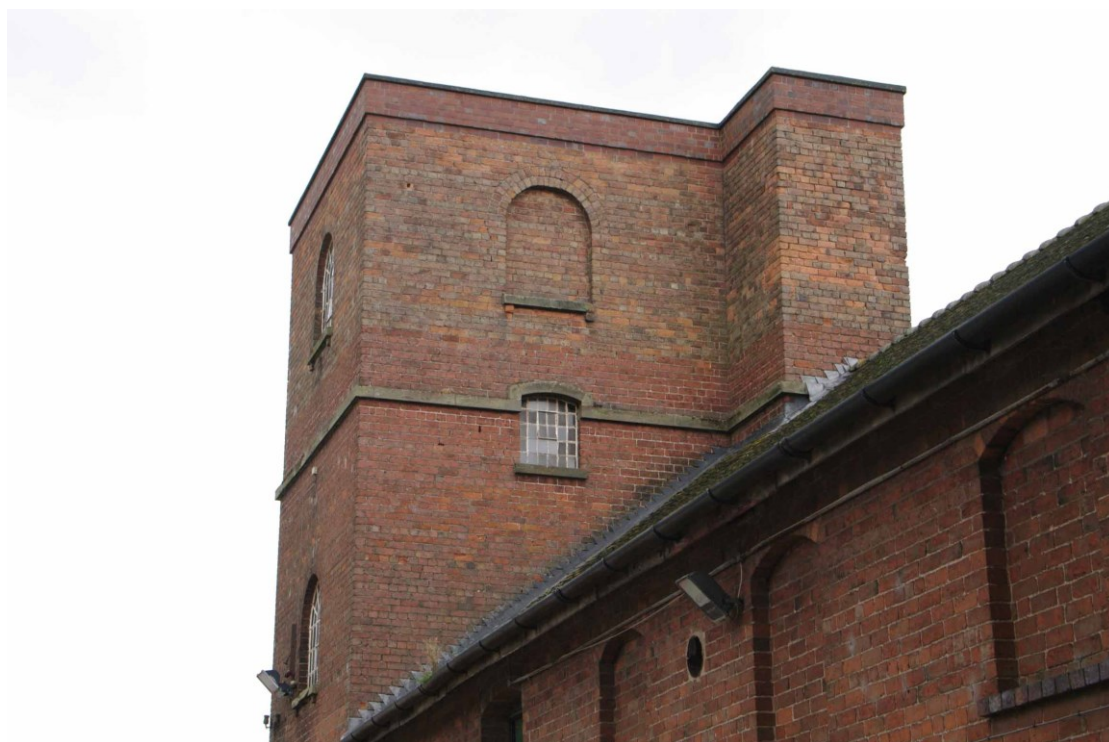
Figure 17: Granary tower, west facing elevation
Looking south-east

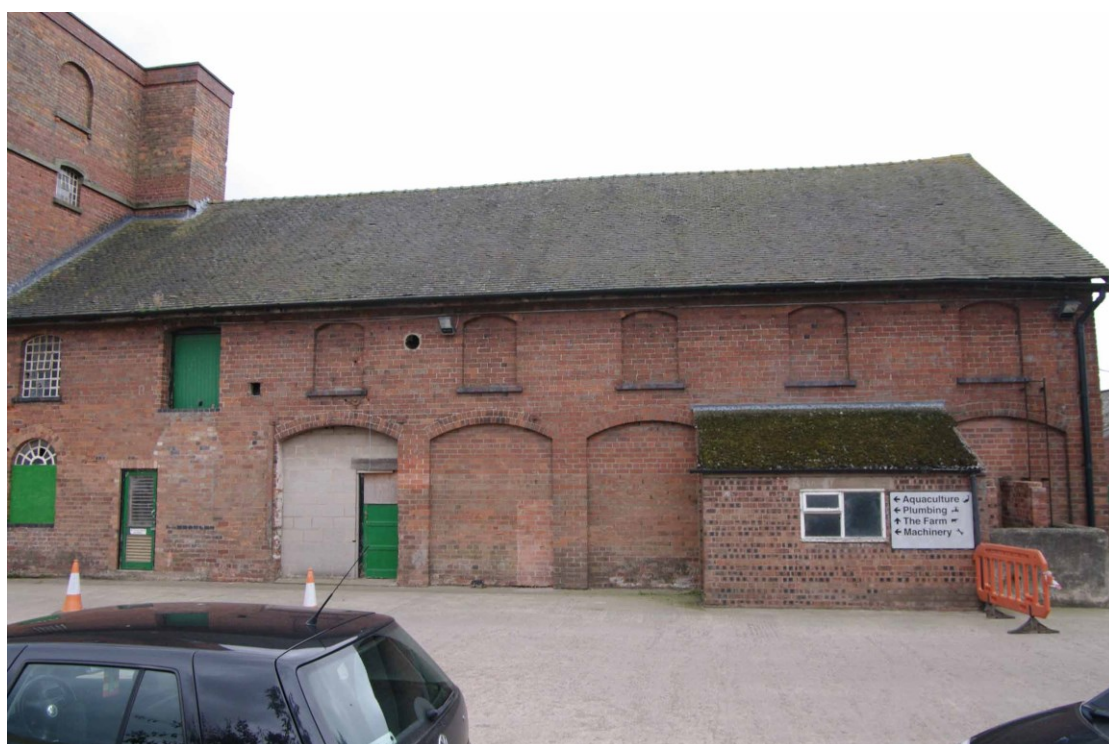
Figure 18: Granary north facing elevation, western end
Looking south

Immediately to the west of the tower the building steps back again to the same line as the eastern end of the building. At ground floor level two Romanesque windows of the same style as seen on the tower are present although one has been blocked by brickwork and replaced by a single width doorway (Fig. 18). To the west of the windows are five blind arches creating a decorative arcade design. The easternmost of the arches has been blocked by modern breeze blocks and a doorway inserted into it. The 1964 photograph shows this blocking as an open archway with a sliding door covering it in the same way as seen at the eastern end of this elevation. The fixings for the sliding door trackway are still present. The rest of the arches are blocked with the same bricks as used on the rest of the building and appear to have always been blind. A modern lean-to brick-built structure has been built against this part of the elevation and partially obscures one of the arches. At first floor level there is a single multi-paned window of the same design as used at the eastern end of the elevation and a rectangular hayloft style door. The remaining five recesses to the west give the impression of blocked windows but were never open and are for decorative purposes only.

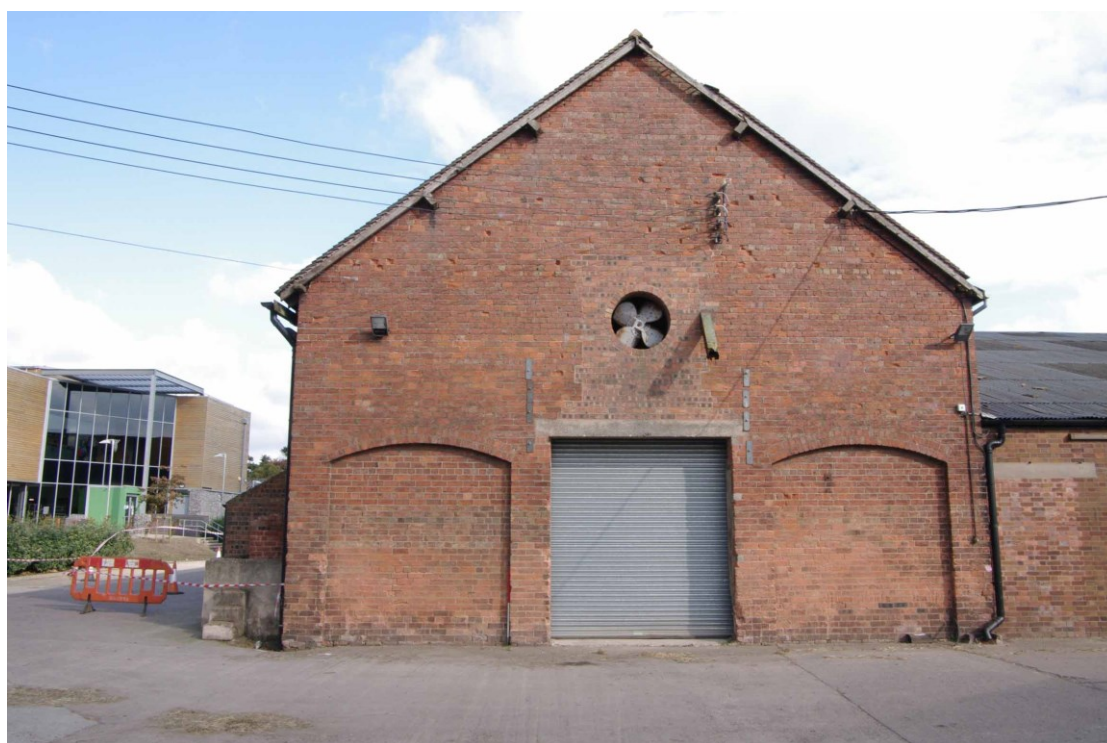
The flat gable-ended west facing elevation has two ground floor decorative blind arches to match those used on the north facing elevation (Fig. 19). There is no evidence that the arches were ever intended to be openings. There are courses of lighter coloured bricks running across the recesses of the arches and across the supporting pilasters on either side indicating continuous contemporary brickwork. Between the two blind arches is a rectangular entrance with a steel roller shutter door and a concrete lintel. The lintel is modern and may have replaced an earlier archway. Above the lintel is a rectangular patch of later brickwork indicating the location of a blocked opening which may have been a window. Within the patched brickwork is a circular ventilation fan and a narrow chute extending out from the wall.

At eaves level the brickwork appears to change from a lighter red to a slightly darker red which extends up to the ridgeline. The darker bricks have also been affected by frost which suggests that the gable may have been rebuilt. The modern southern range building is not flush with the west facing elevation of the Granary but is set slightly back to accommodate the guttering.

Figure 19: Granary, west facing elevation
Looking east. 1m scale

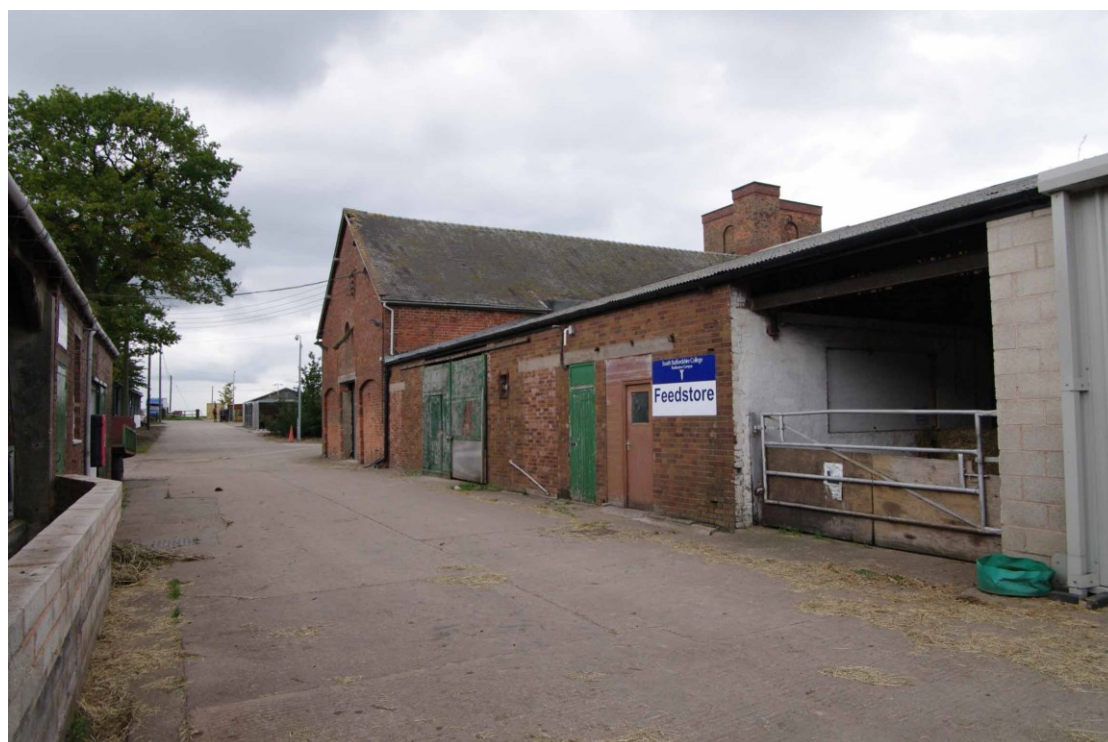
Figure 20: Granary, east end of south facing elevation
Looking north-east

Much of the south facing elevation is obscured by the two rear (south) ranges of buildings (Figs 20 to 22). The tiled roof of the Granary has two glass roof lights close to the tower and is broken at eaves level by the rear ranges. The main part of the tower can be seen on the northern side of the ridge and has a blind arched window as seen on the eastern and western faces. Between the rear ranges is the access passageway through the building to the north side (Fig. 21). The lintel is concrete with blue brick supports and shows evidence of being rebuilt.

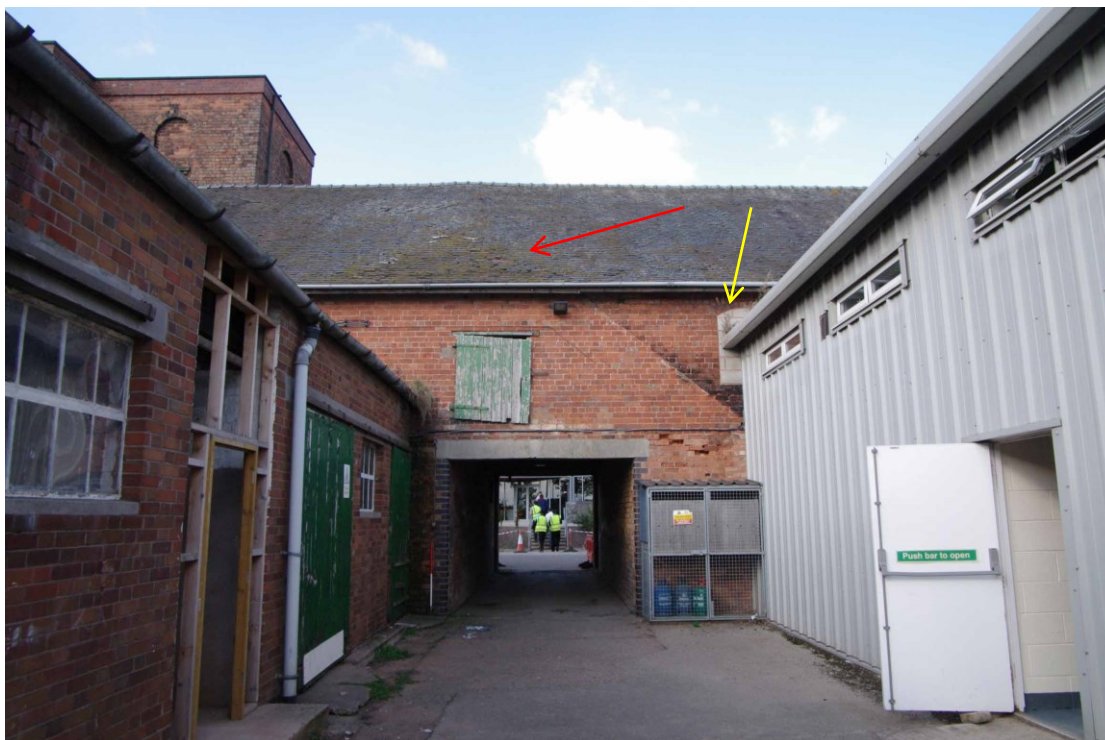
Above the concrete lintel can be seen a scar left by the gable end of an earlier rear range. This must be one of the three rear ranges shown on the early Ordnance Survey maps and in the 1964 photographs. The roofline of this earlier building can also be seen in an area of disturbed roof tiles which have been laid to fill the gap left by the building. The scar left on the bricks shows that the brickwork was not keyed and therefore indicates that the demolished range was built at a later date than the main granary. A rectangular hayloft doorway sits within the apex of the scar on the brickwork. Either side of the scar are two blocked windows which are partially obscured by the roof lines of the present rear ranges.

Figure 21: Granary, centre of south-facing elevation
Looking north. Note scar on brickwork and roof (red arrow) from earlier rear range
and blocked window (yellow arrow). 1m scale

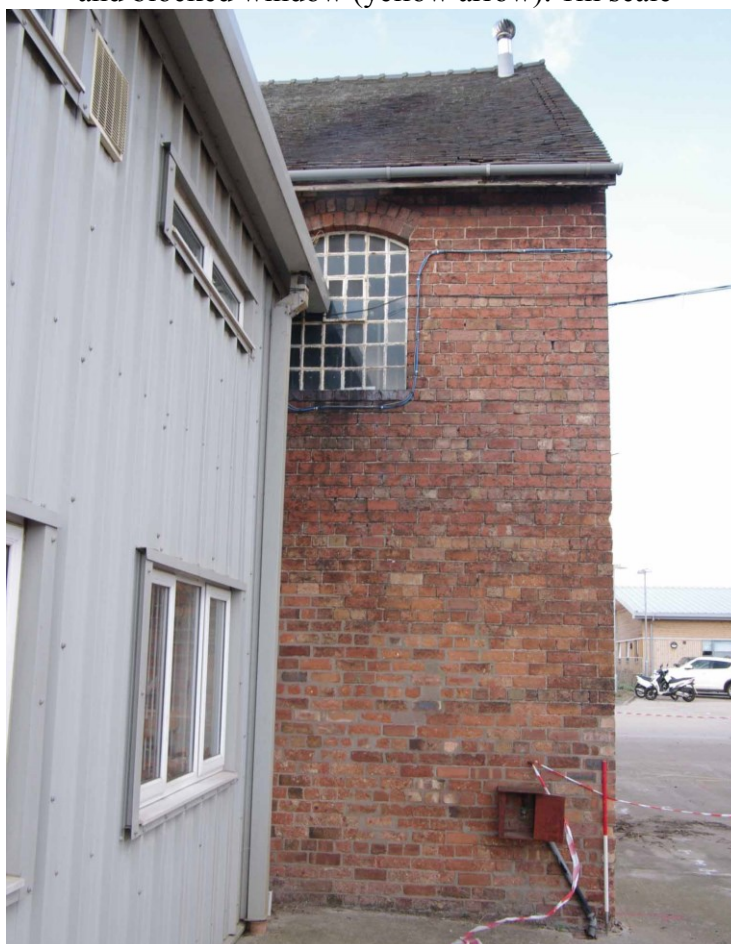
At the eastern end of the south facing elevation is a single first floor multi-paned window which is adjacent to the eastern edge of the easternmost of the southern range buildings (Fig. 22). The modern south range is so close to the window that the guttering partially obscures the window. The ground floor brickwork is slightly lighter and yellowish than the darker brickwork of the first floor suggesting that some form of rebuilding or extension has taken place.

Figure 22: Granary, east end of south facing elevation
Looking north. Note difference in ground floor and first floor brickwork. 1m scale

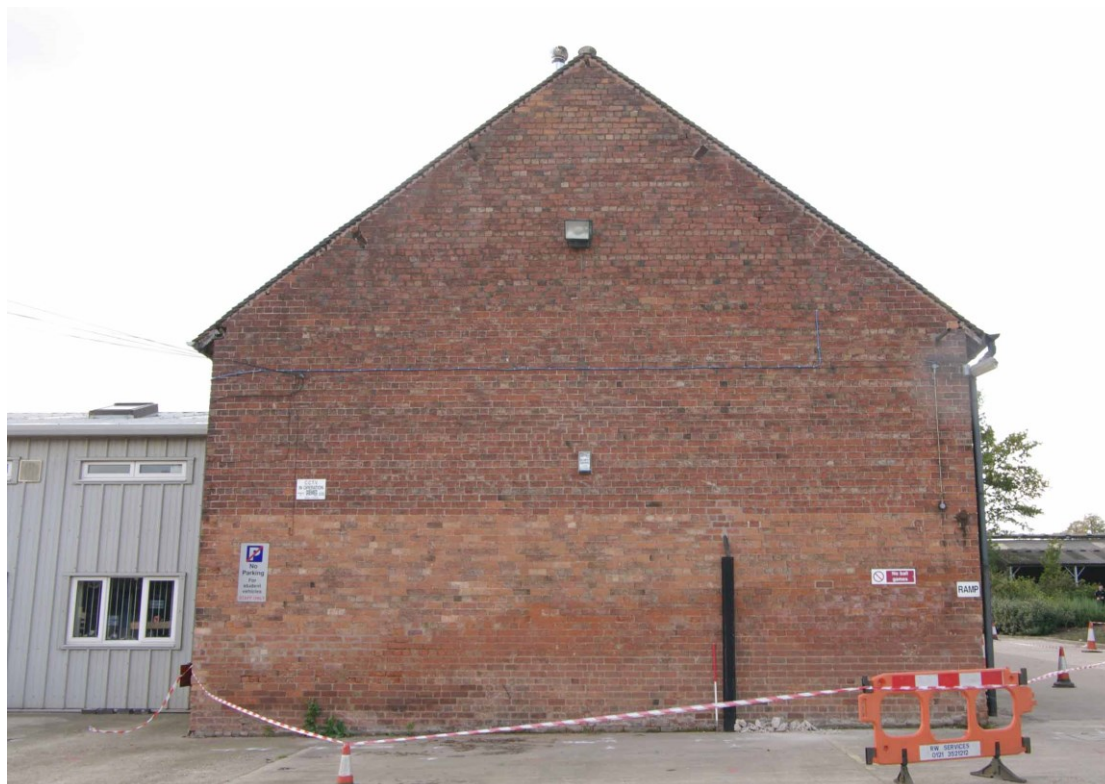
The east facing gable end of the Granary is plain without any openings or blind arches. Of greatest significance however is a clear change in the brickwork at the top of ground floor level (Fig. 23). The brickwork at ground floor level has a slightly lighter appearance than the first floor and gable brickwork which suggests a rebuild or extension.

Figure 23: Granary, east facing elevation
Looking west. 1m scale

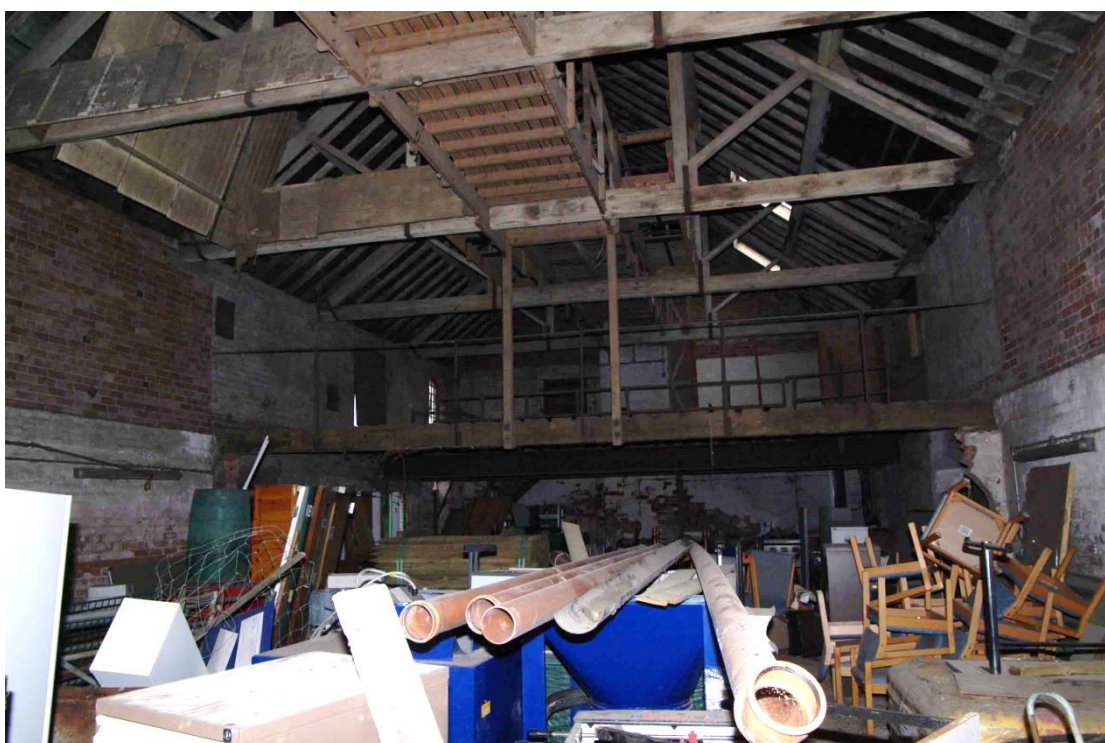
Figure 27: Granary, ground floor Room G1
Looking east

Room **G1** is the westernmost ground floor room of the main Granary building. It is open to the roof with a small wooden mezzanine floor at the eastern end. The north wall has two single doorways at ground floor level and one archway blocked with breeze blocks as noted on the north facing elevation description. Two windows at the north-east end of the room light a set of wooden stairs leading up to the mezzanine and the rest of the first floor rooms. There is no internal structural evidence of any of the blind arches or windows on the north wall showing that they were built for external decoration only. The western end wall of **G1** has the large roller shutter door as seen on the outside elevation. Above the roller door is the patched brickwork with the remains of a brick arch at the top indicating that this was once a window rather than a hayloft type door.

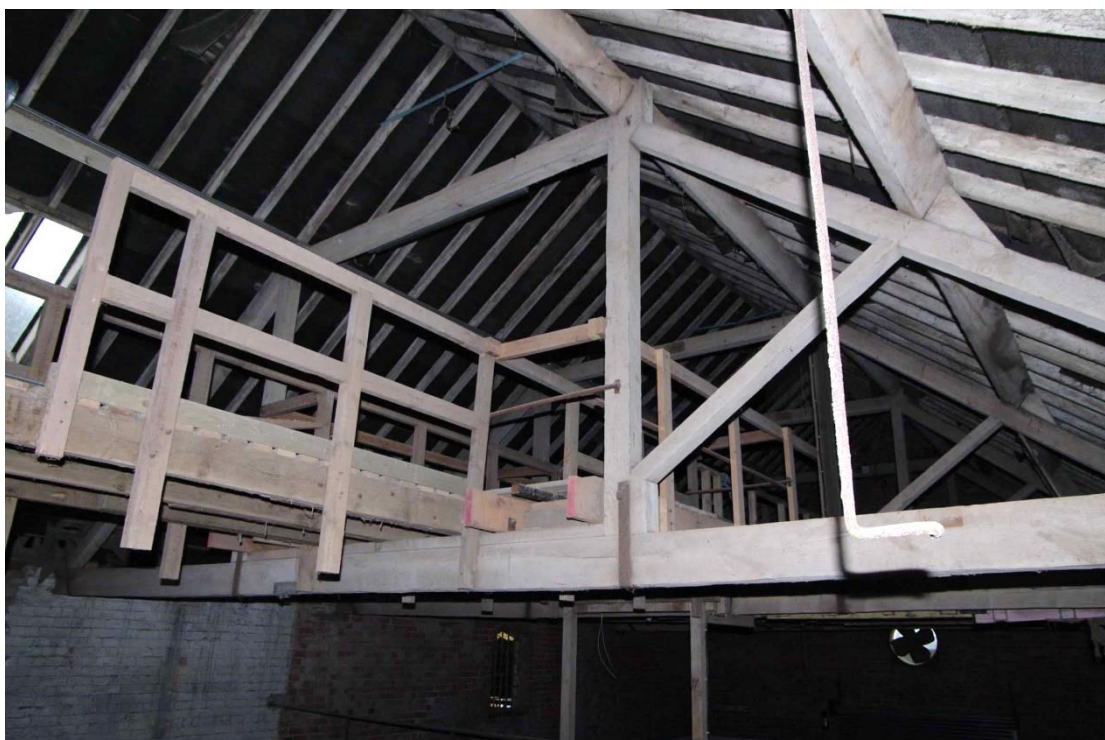
Figure 31: Granary roof structure at west end of building
Looking south-west

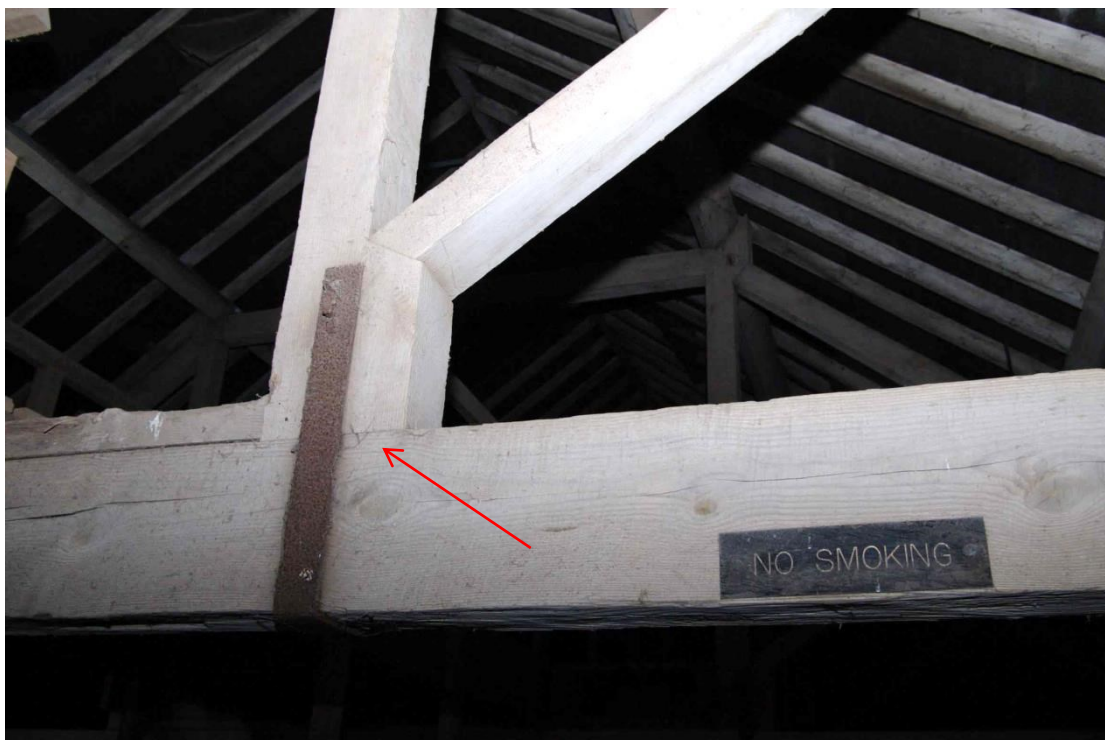
Figure 32: Granary, Room G1 roof detail and carpenter's mark "V" mark indicated by arrow at junction of queen post and truss

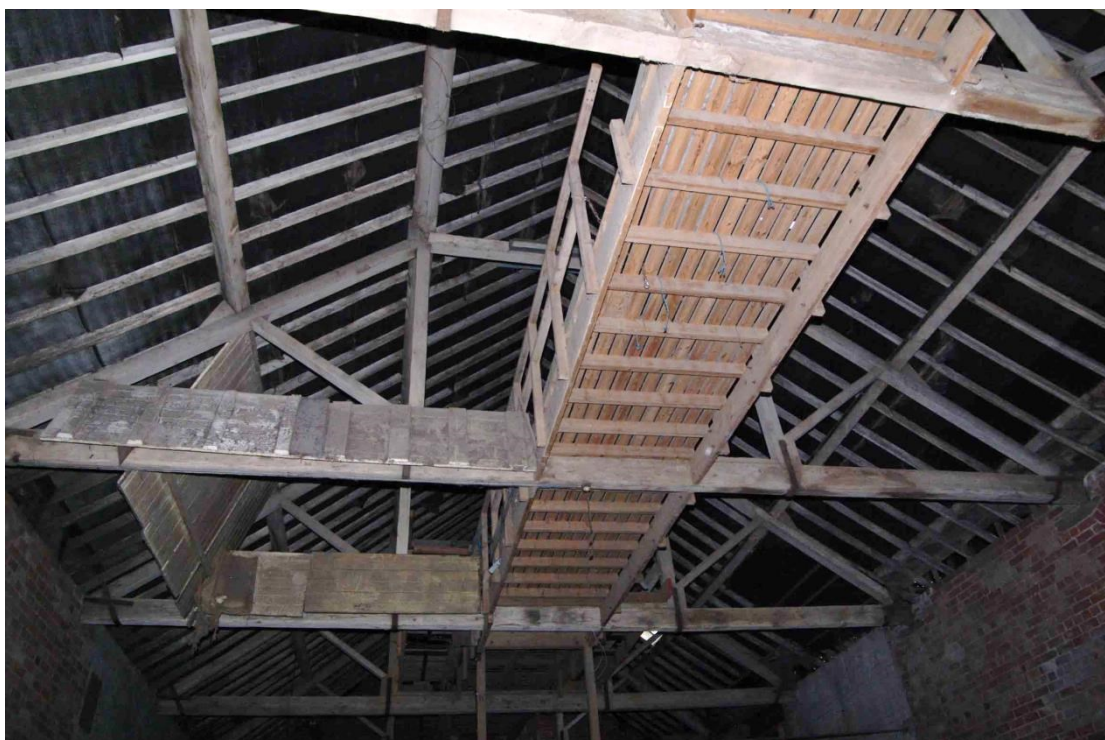
Figure 33: Granary, Room G1 walkway in roof
Looking east. Note baffles and other timber structures on left

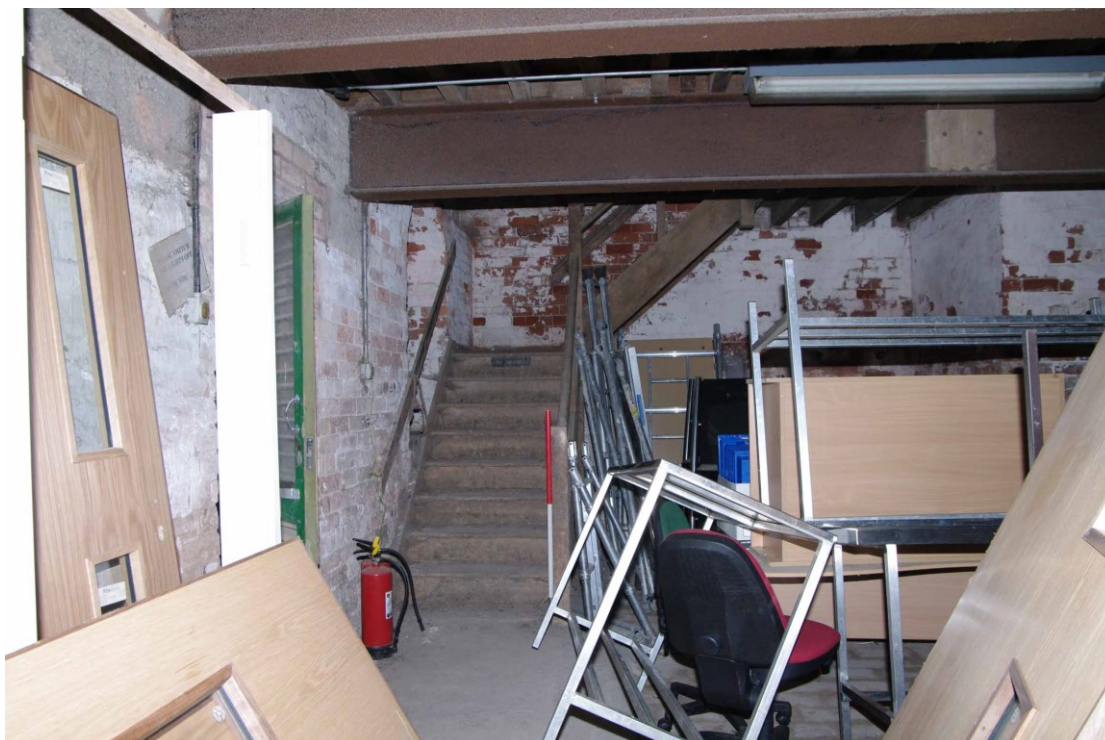
Figure 34: Granary, Room G1 stairs to mezzanine
Looking east. 1m scale. Note modern steel beams supporting mezzanine

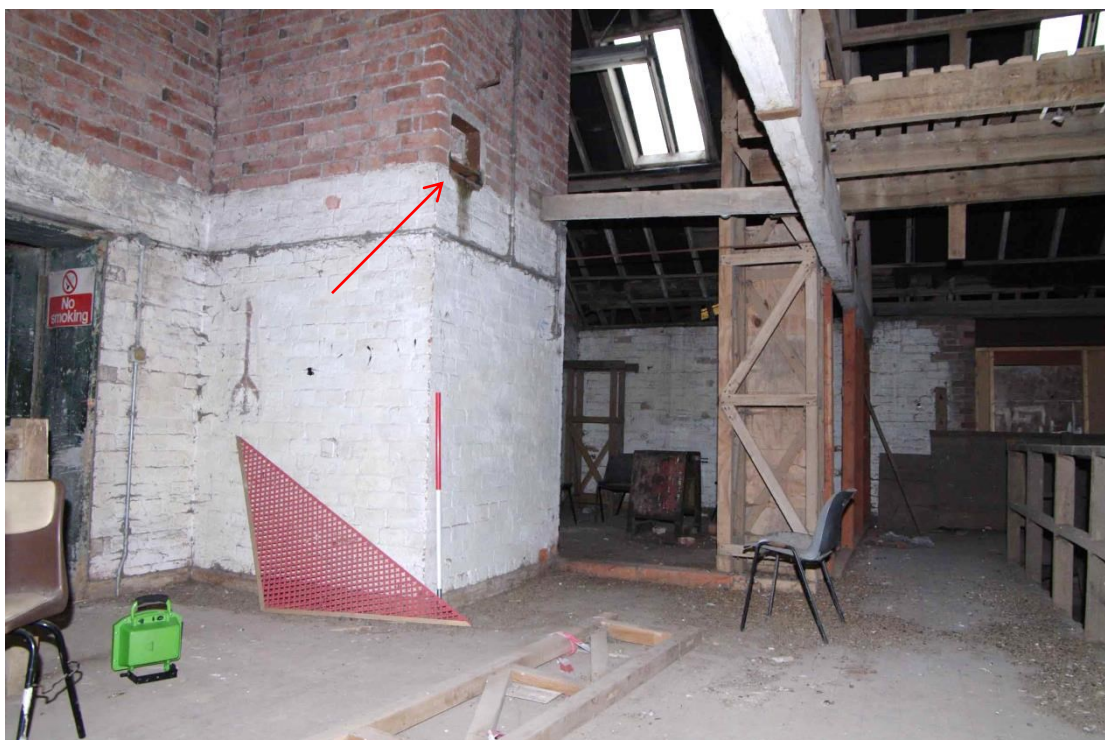
The mezzanine floor, although it is part of the first floor and has been identified by the reference **F1**, is part of the larger room and so will be discussed in this section. The mezzanine is reached by the wooden stairs in the corner (Fig. 34). As noted the smaller rectangular chimney-like portion of the tower extends into the room but there are no indications of any openings on it. However, there is the hole for a bearing box on the west side of this structure showing that a drive shaft extended out into the main room at the height of the walkway (Fig. 35). No trace of this shaft or the drive equipment survives. Where the walkway ends is a timber latticework structure of unclear purpose has been attached to the mezzanine floor (see Fig. 35).

Figure 35: Granary, Room F1 mezzanine
Looking south-east. Arrow shows location of bearing box. 1m scale

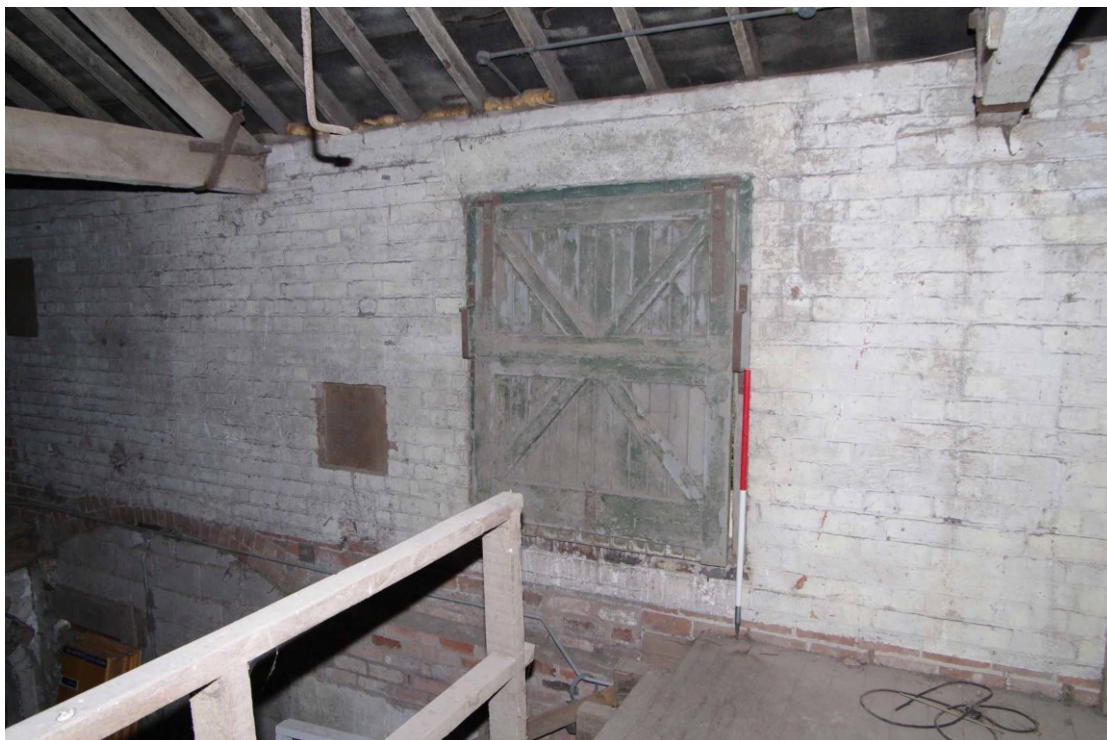
Figure 36: Granary, Room F1 north wall loading door
Looking north-west. 1m scale

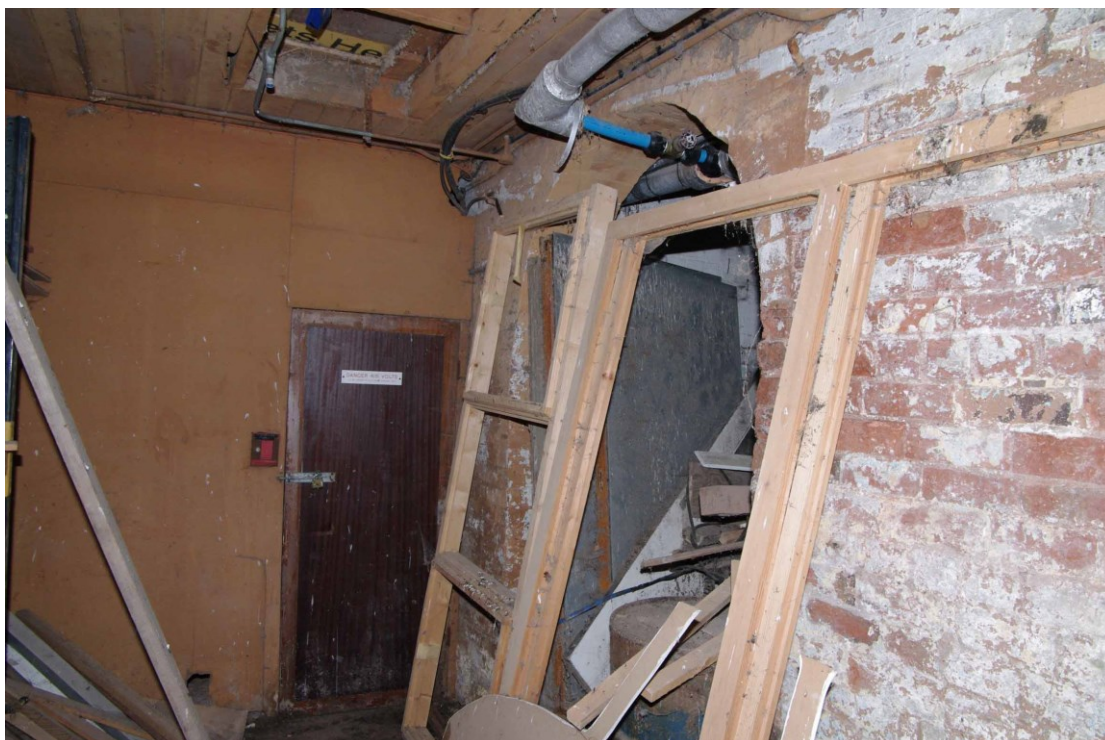
Room **G4** is a long narrow room running across the width of the Granary building. It has a boarded eastern wall with a modern timber partition dividing the room into two (See Fig. 38). The boards on the east wall are wide and are beaded and appear to be late 19th century in origin if not a little earlier. To the south of the modern partition the boarded wall gives way to a brick wall. A small arched fanlight window looks into the south range building (Fig. 39). On the west wall of **G4**, as noted, is the open arch into **G3** along with a low brick arch which has been blocked with later brickwork. This lower arch corresponds with the hole in the east wall seen in Room **G2**.

Figure 38: Granary, ground floor. Entrance to Room G3 on right
Looking south-west. Photograph taken from Room G4 with modern partition on right

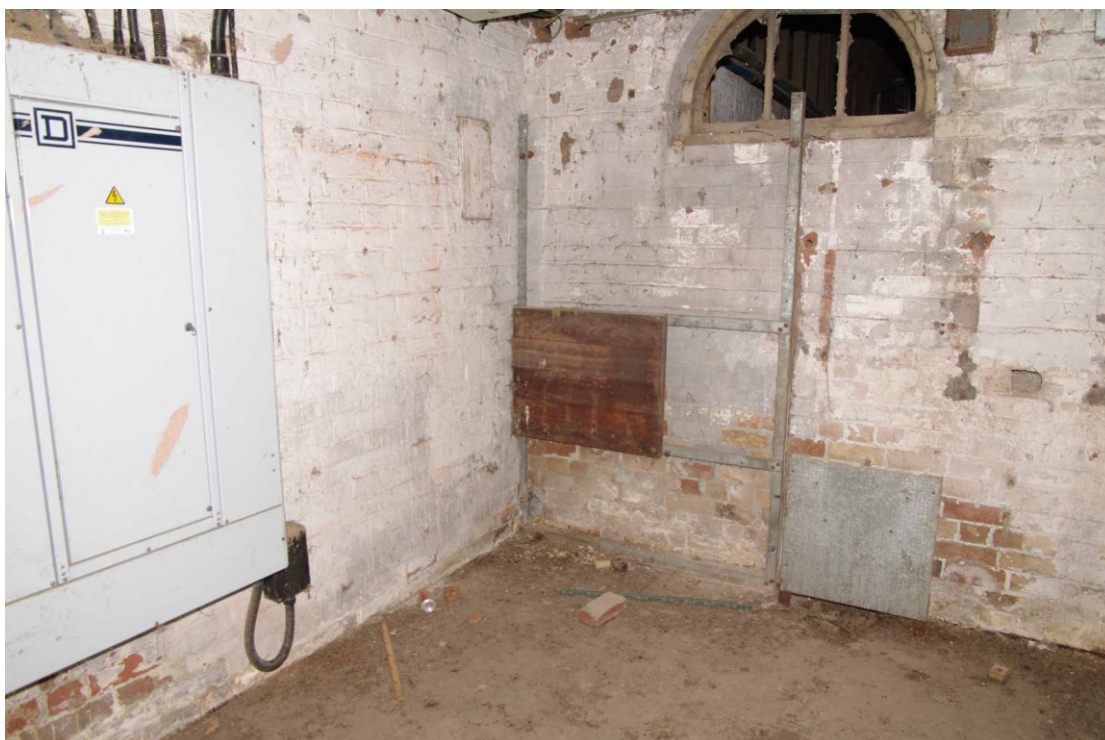
Figure 39: Granary, ground floor. South end of Room G4
Looking south-east

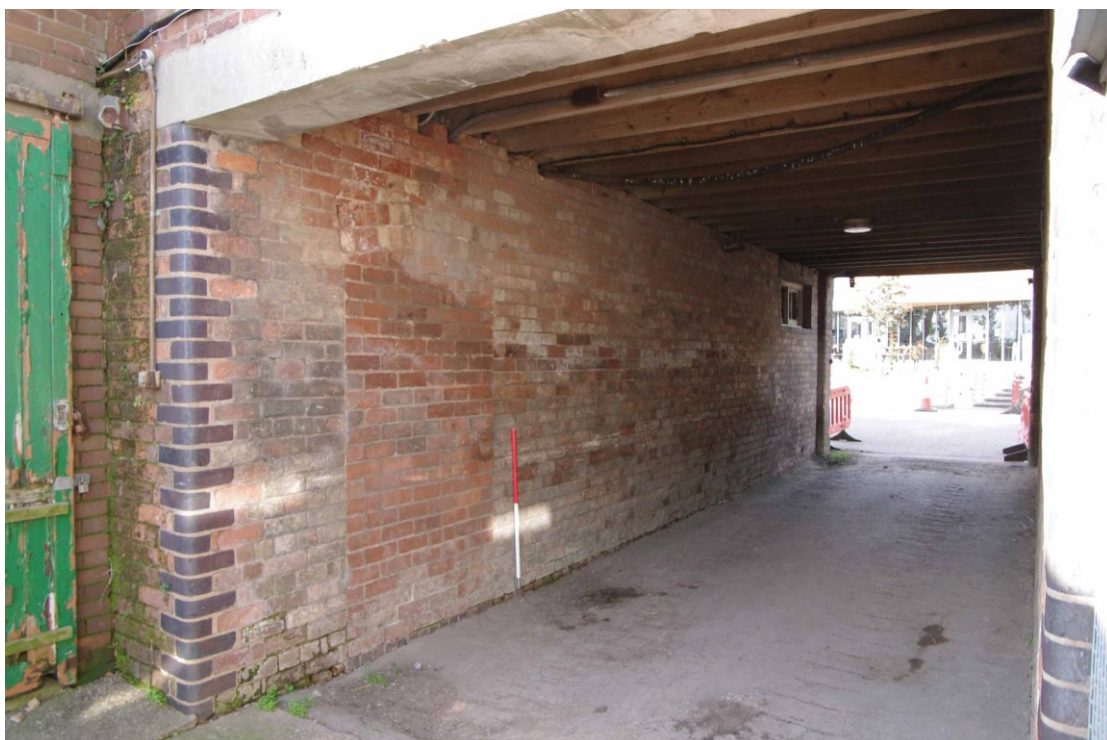
Figure 41: Granary, passageway and outside wall of Room G5
Looking north-west. 1m scale. Blocked doorway to left of scale
