**A Level 2 Historic Building Recording:
The Granary,
Rodbaston Campus,
South Staffordshire College,
Rodbaston,
South Staffordshire**

ULAS Report No. 2015-182
©2015

For: South Staffordshire College

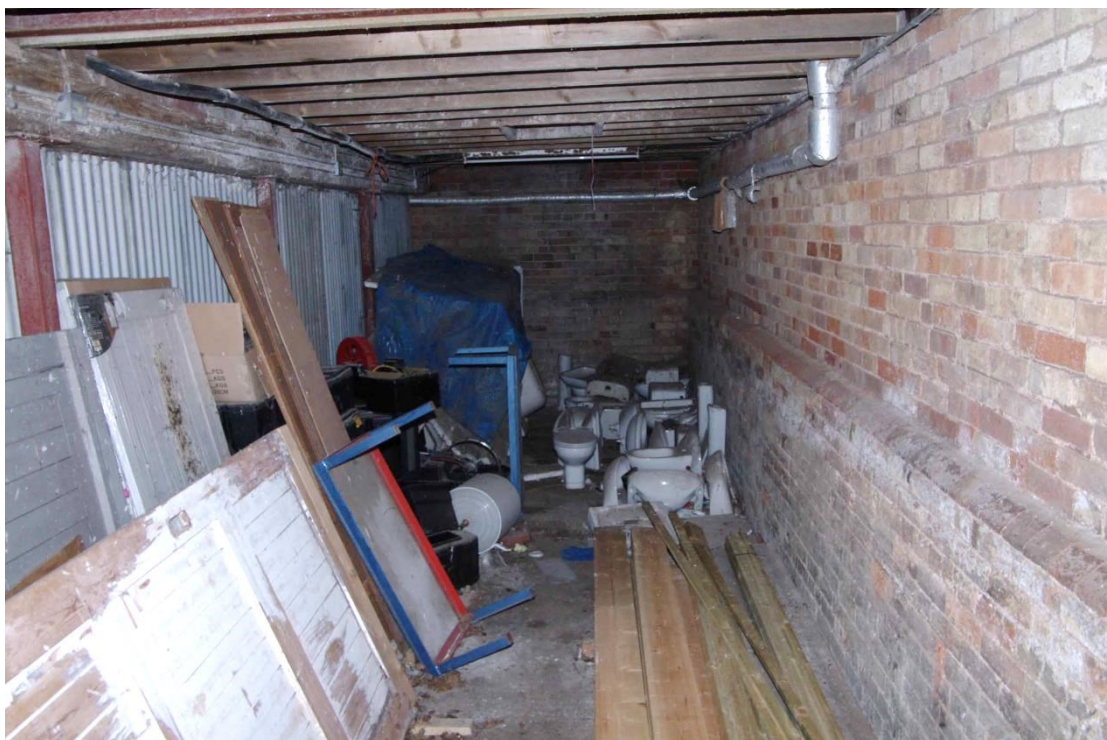
Figure 42: Granary, ground floor Room G6
Looking south

Room **G6** is located on the eastern side of the passageway through the building and, at the time of the survey, was used as a store. It has a brick west wall unbroken by any openings or former openings and a corrugated sheet metal east wall (Fig. 42). The corrugated sheet is attached to the side of a substantial north to south timber beam which is supported (or propped) by square section steel posts. The temporary nature of the sheet walling suggests that this room was originally part of the adjacent room **G7**. As noted during the description of the north facing elevation this room has a modern concrete lintel above the entrance. The ceiling joists are modern steel beams with timber inserted along their length which is a modification that probably took place at the same time as the insertion of the lintel. It may also indicate that heavy equipment might have been present on the floor above.

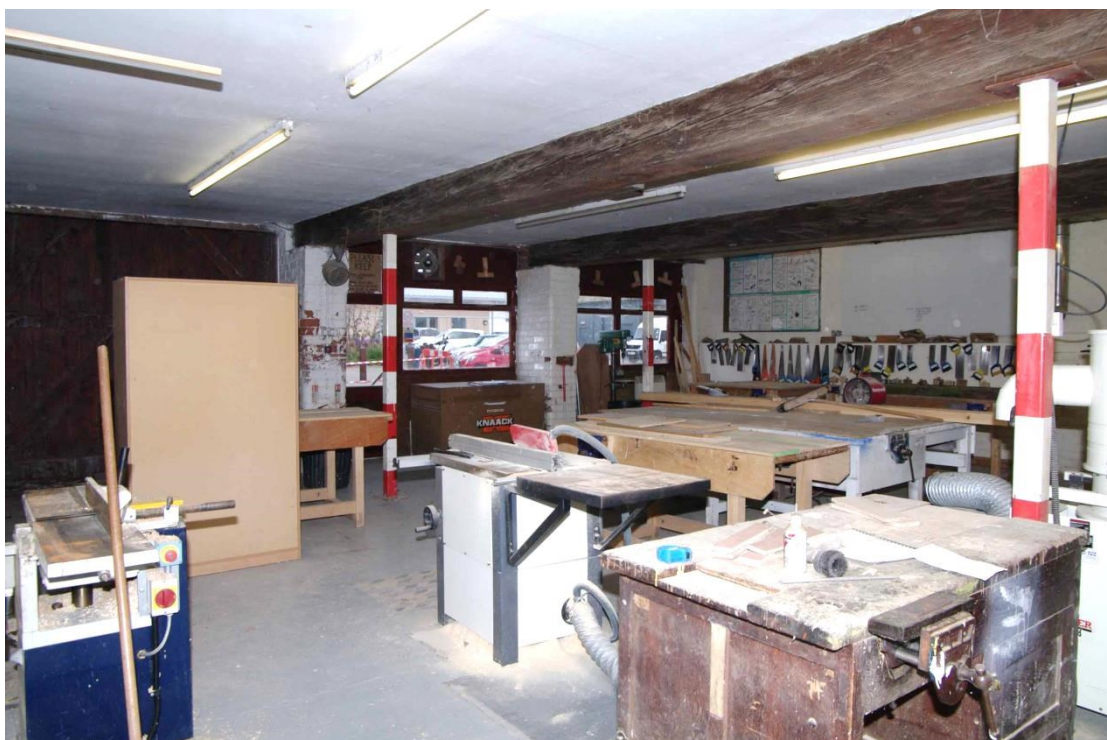
Room **G7** forms a large open carpentry shop at the eastern end of the Granary (Fig. 43). At the time of the survey it was the only room still in regular use in this building. The two arches on the north wall are infilled with modern wood and glass as discussed earlier. From the inside the arches with the sliding wooden doors can be seen to be of the same design as the others suggesting that this whole area was built as an open four-bayed room or possibly a five-bay room if Room **G6** had an arch before its rebuild. This is probably what is shown on the 1958 Ordnance Survey map. The ceiling is supported by substantial north to south timber beams which have been supported by modern square section steel posts. Many of these beams have a variety of raze marks in the form of incised slashes or recognisable numbers (Figs 44 and 45). The ceiling has been boarded with modern plasterboard so it is not possible to inspect the first floor joists to see if they have been strengthened as in Room **G6**.

Figure 43: Granary, ground floor Room G7
Looking north-east

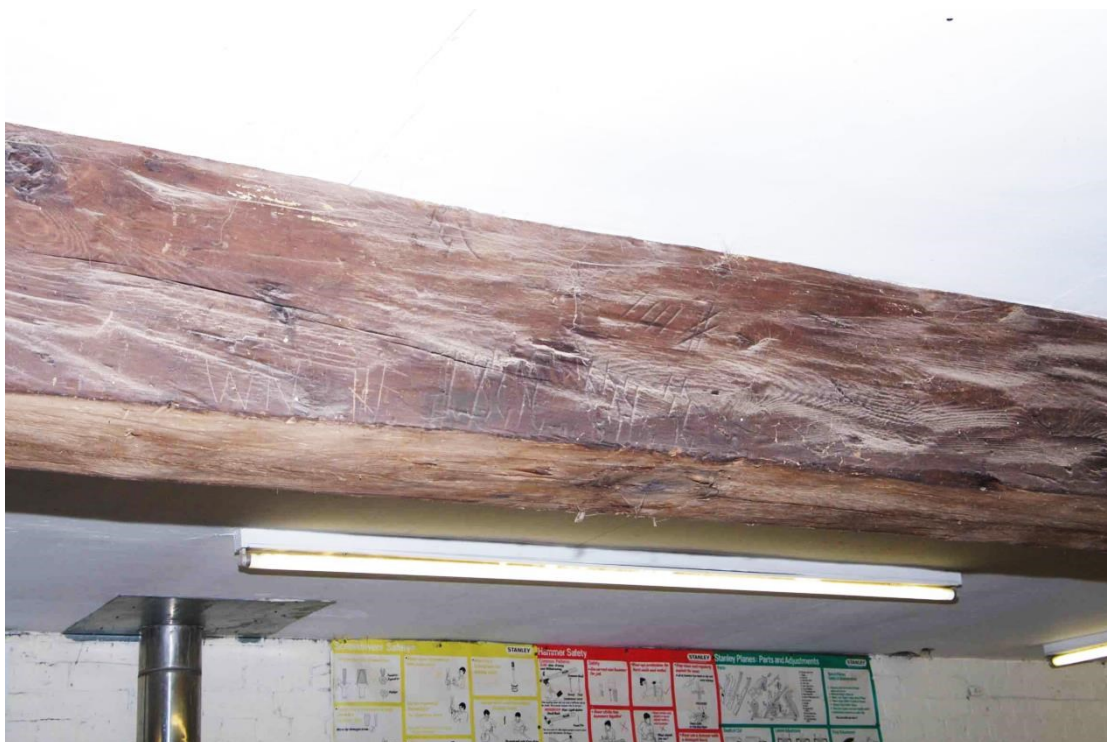
Figure 44: Granary, ground floor Room G7. Raze marks on beam

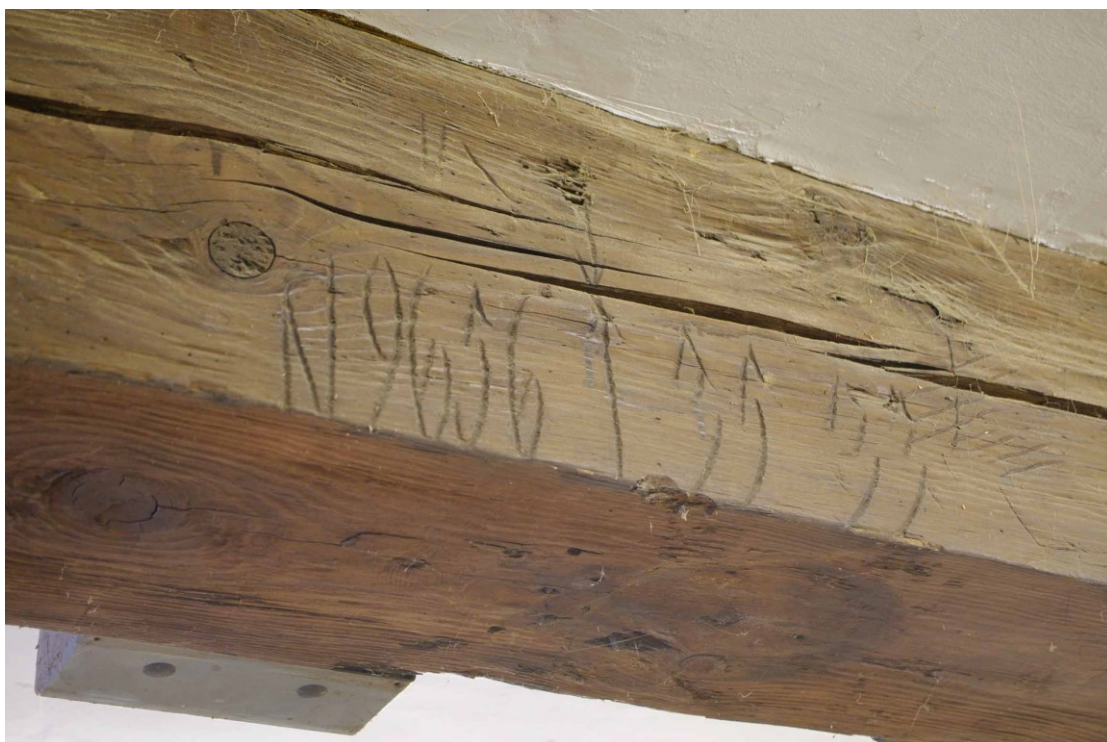
Figure 45: Granary, ground floor Room G7. Raze marks on beam

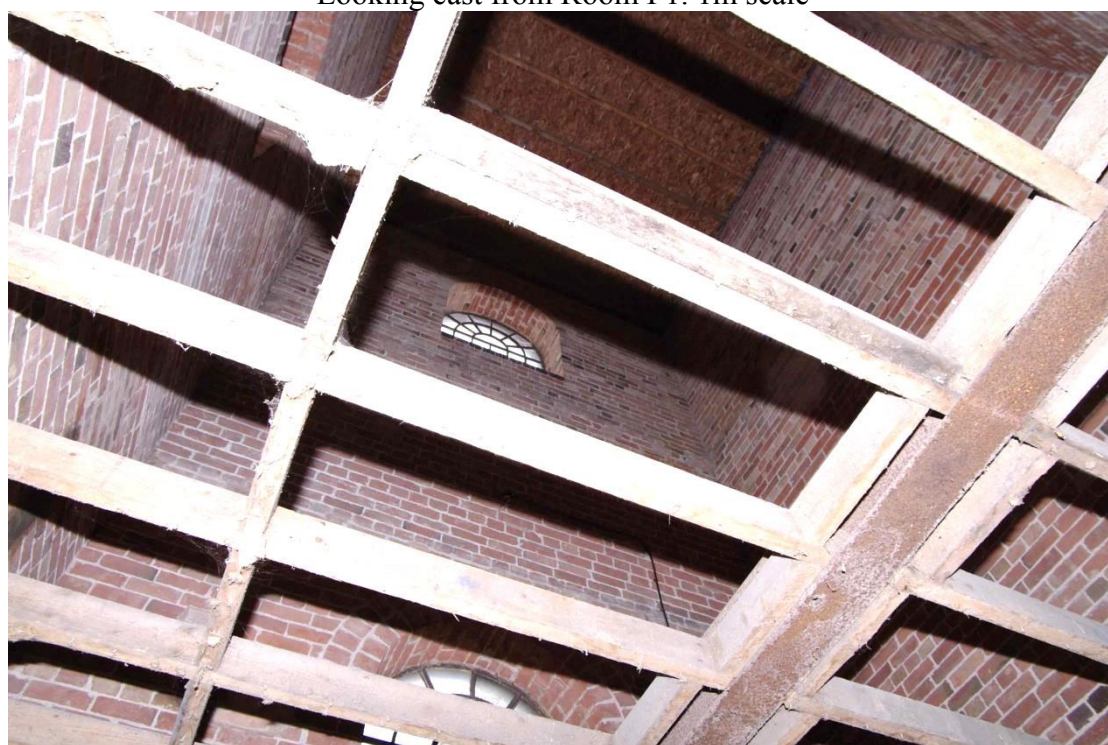
Figure 47: Inside of tower from Room F2
Looking north

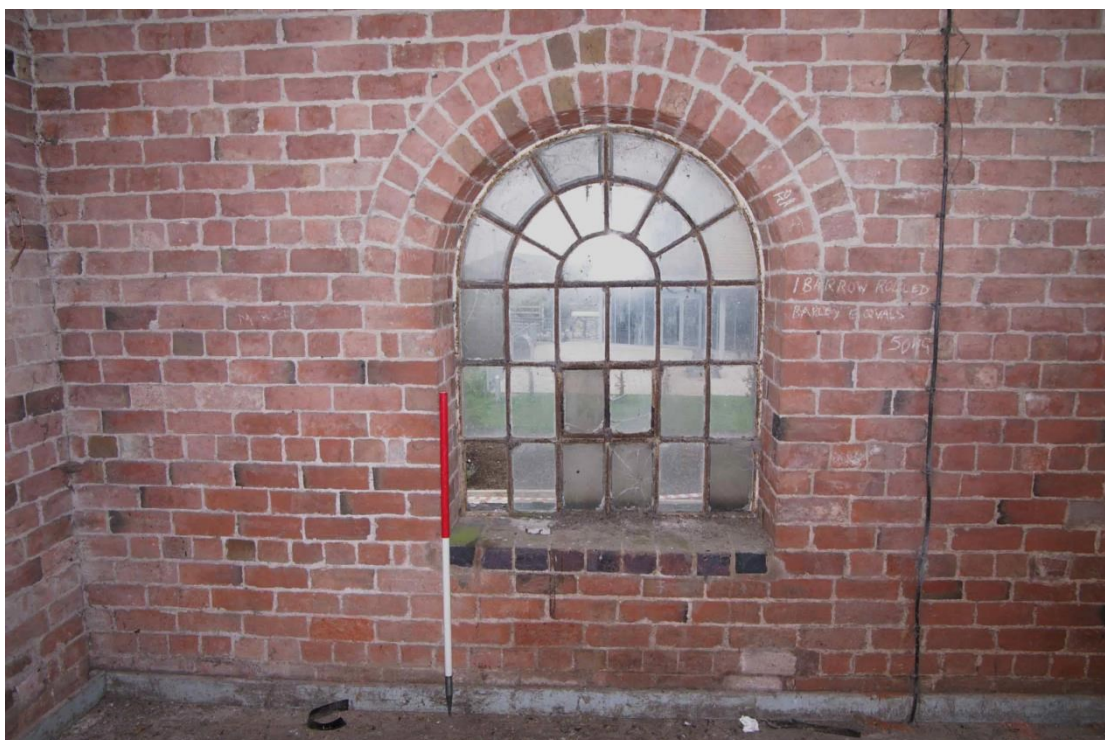
Figure 48: Granary, first floor Room F2. Window detail
Looking north. 1m scale. Note chalked graffiti to right of window

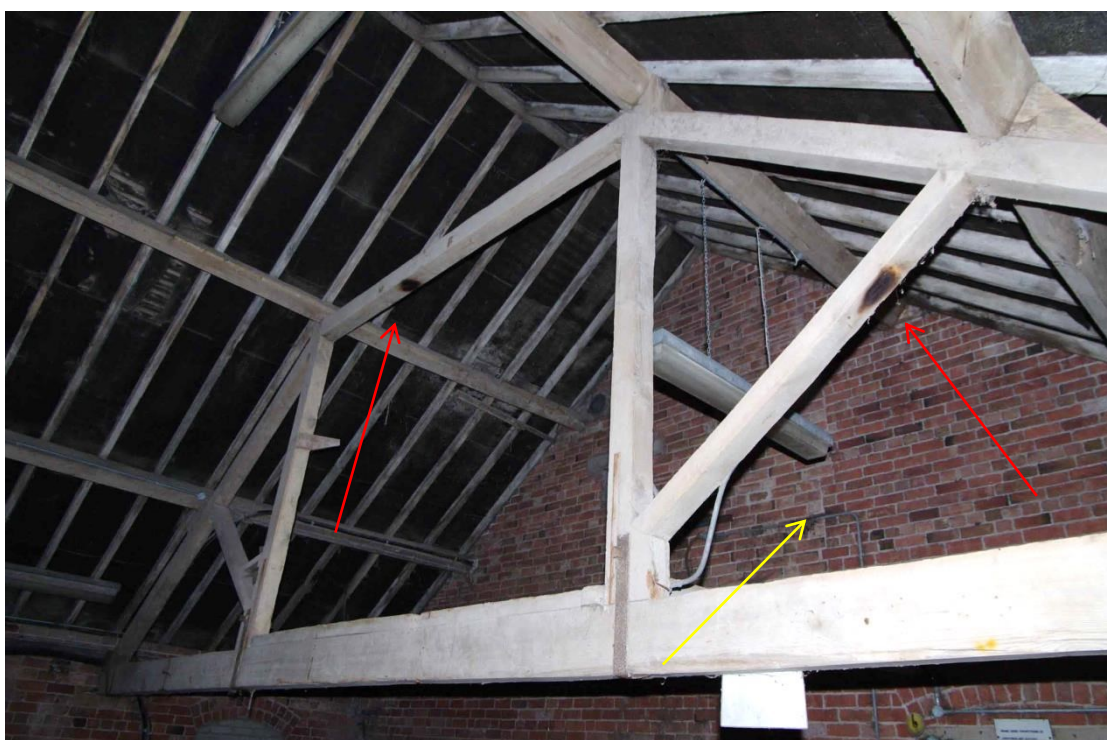
As noted in Room **F3** a joint in the brickwork can be seen on the south-east corner of the tower wall where it joins the dividing wall of Rooms **F3** and **F4** (Fig. 53). The tower wall is built using an English Garden Wall bond whereas the dividing wall uses three courses of stretchers and one course of alternating headers and stretchers. The different bonds suggest different times of construction. The north and south walls of the room use English Garden wall as seen elsewhere in the building. More chalk markings on the wall indicate where materials were stored and show: “*BEEF RATION, STORE RATION, HEIFFER No 2, CALVES ONLY DO NOT USE*”. The

The roof structure is the same as that seen in Room **G1** which suggests that the entire roof of the Granary was built at the same time (Fig. 53). Modern roofing felt can be seen between the rafters and the tiles which indicates that the tiles have been re-hung or replaced. There are several scorch marks that can be seen on the roof timbers (Fig. 53). It is not clear if these were caused by hot machinery located nearby or if they are apotropaic marks. Scorch marks can often be seen in earlier buildings to ward off fires and evil spirits. A granary would represent a significant fire risk which may encourage the workers to take extra precautions but such marks are not often seen in late 19th century roof structures.

Figure 53: Granary, first floor Room F4 roof detail
Looking north-west. Red arrows point to scorch marks, yellow arrow at brick joint of
tower wall and room wall

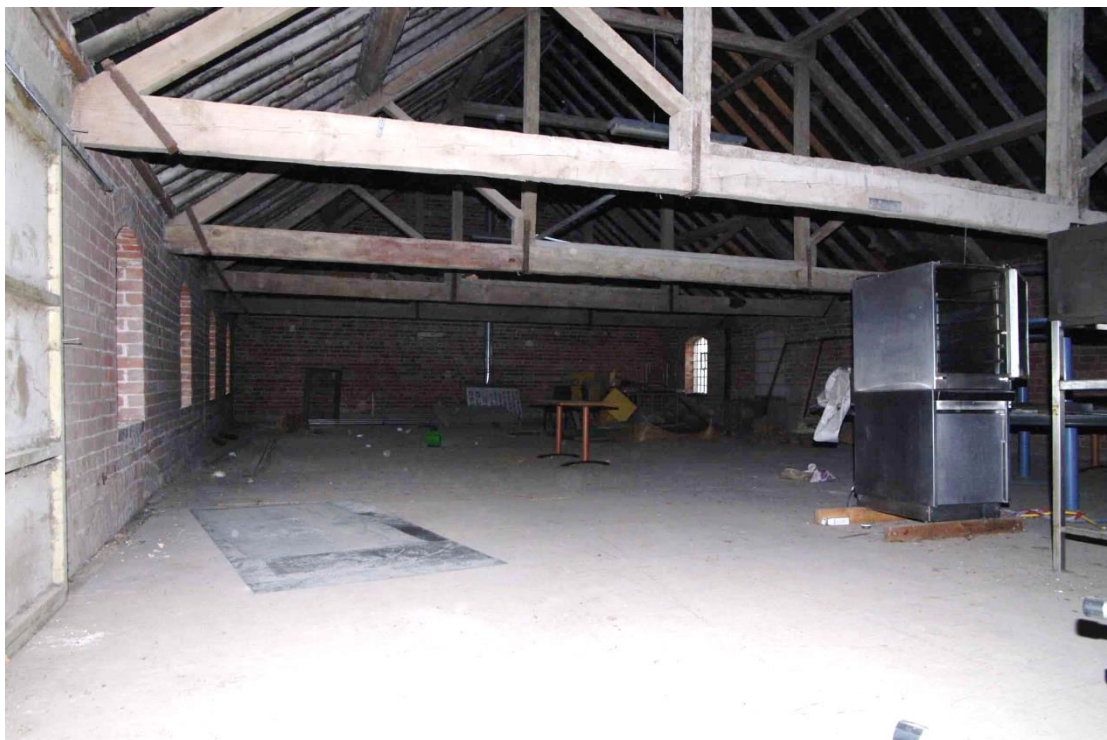
Figure 54: Granary, first floor Room F5
Looking east

Room **F5** is a large open room covering the whole of the first floor to the east of the ground floor passageway (Fig. 54). Two windows on the south wall have been blocked using breeze blocks, an event which presumably happened when the south ranges were added. One window remaining window on the south wall is left intact but even this is partially obscured by the guttering of the south range building (Fig. 55). On the same wall, in the south-western corner, is a rectangular hayloft style door. This door is the one that is located within the scar of the older gable end discussed above and shown in Figure 21. No evidence of the gable or the former range can be seen from within this room. The north wall still retains all of its multi-paned windows with the exception of the modified loading door above room **G6** with its modified concrete lintel. The tops of the ground floor arches can also be seen at floor level (Fig. 57).

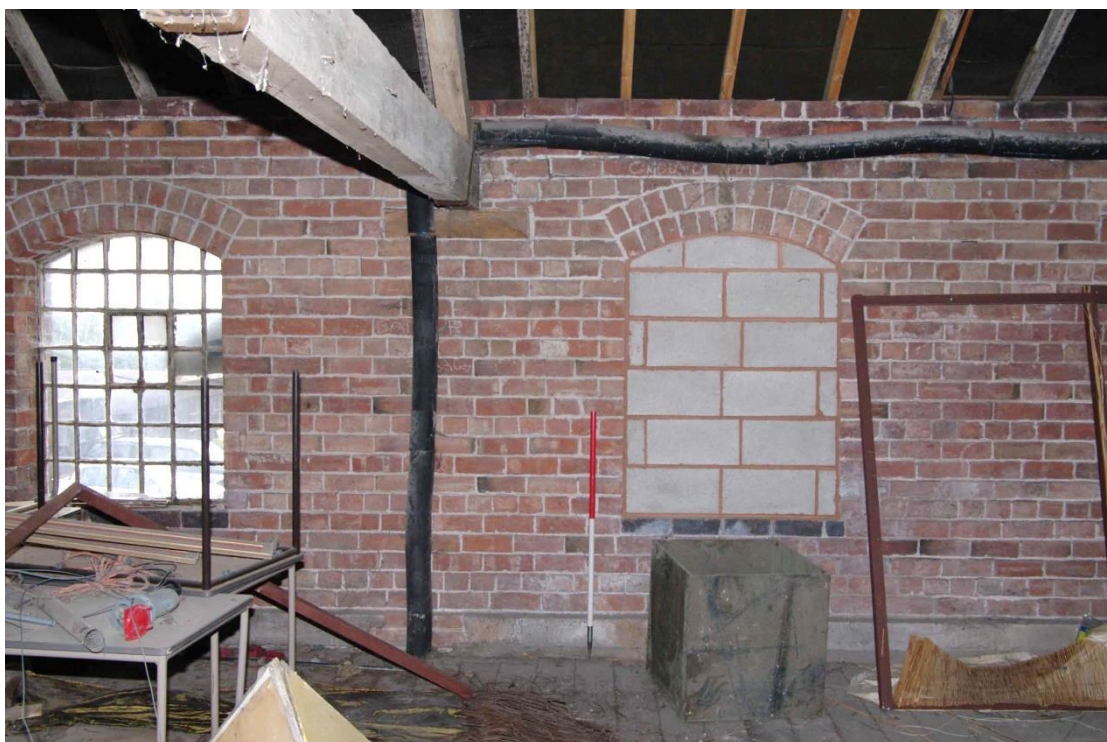
Figure 55: Granary, first floor Room F5. Windows in south-east corner
Looking south. 1m scale

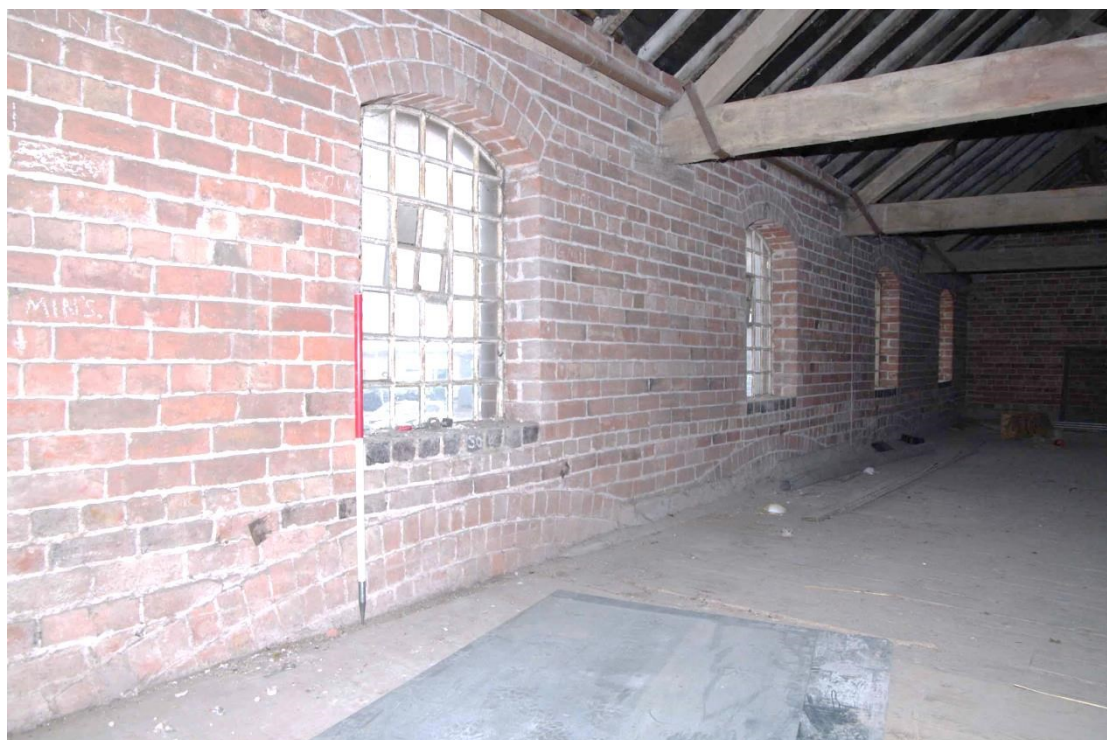
Figure 56: Granary, first floor Room F5 north wall
Looking north-east. 1m scale

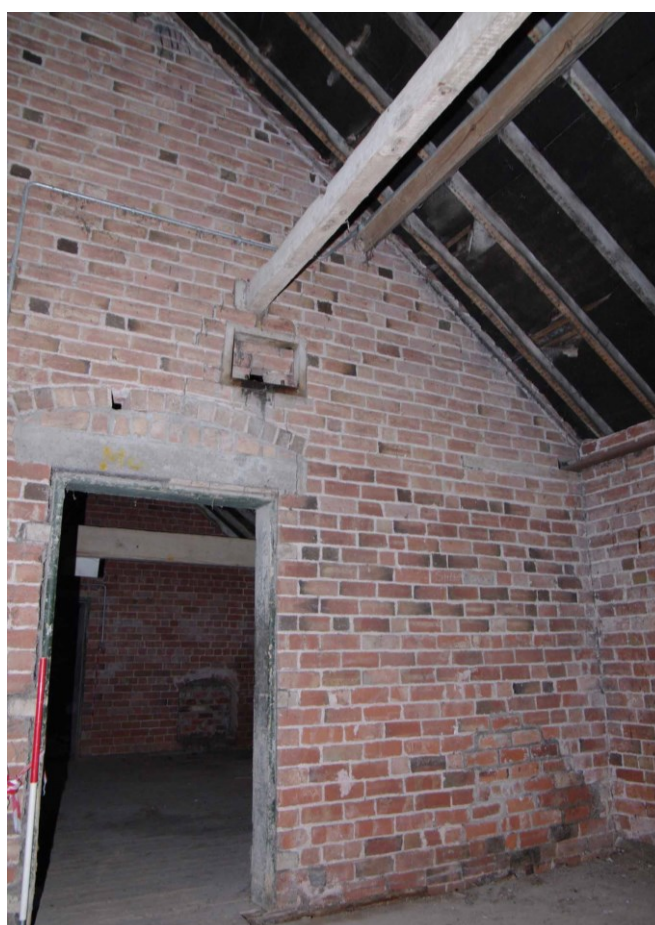
Figure 57: Granary, first floor Room F5
Bearing box on west wall (above door). Looking north-west. 1m scale

On the western wall is a bearing box to the north of the doorway with a timber beam above it (Fig. 57). There is no indication of an opposing bearing box anywhere within the room or of any associated driveshaft equipment. In the south-western corner of the room is a small timber platform which has a metal rail set into the roof structure above it (Fig. 58). This may be the remnant of the superstructure for a bagging hopper but this is not clear. No other processing equipment relating to the Granary can be seen in this room.

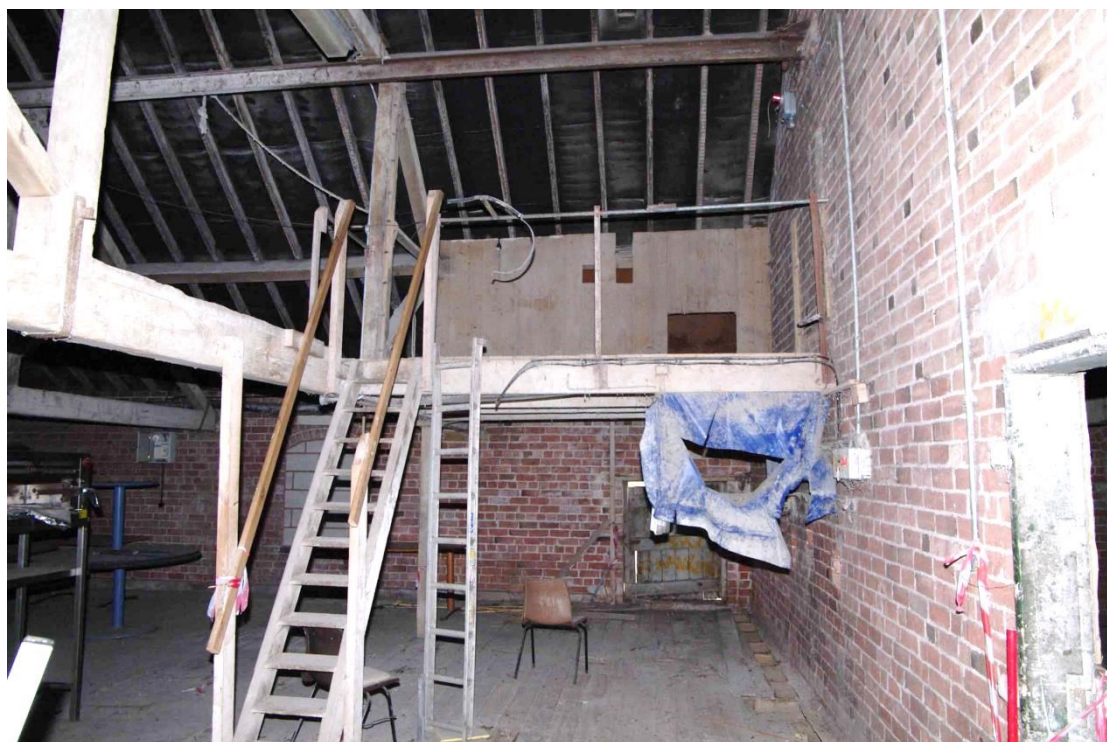
Figure 58: Granary, first floor Room F5
Looking south into north-west corner of room

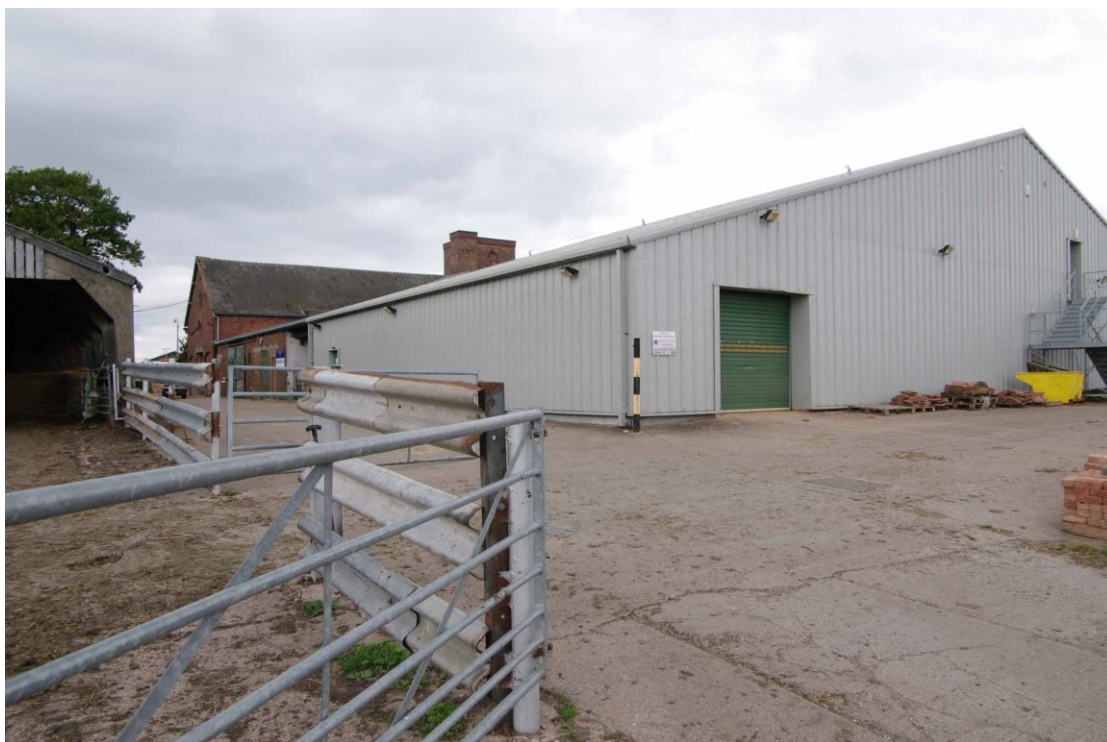
Figure 59: South-western rear range
Looking north-east

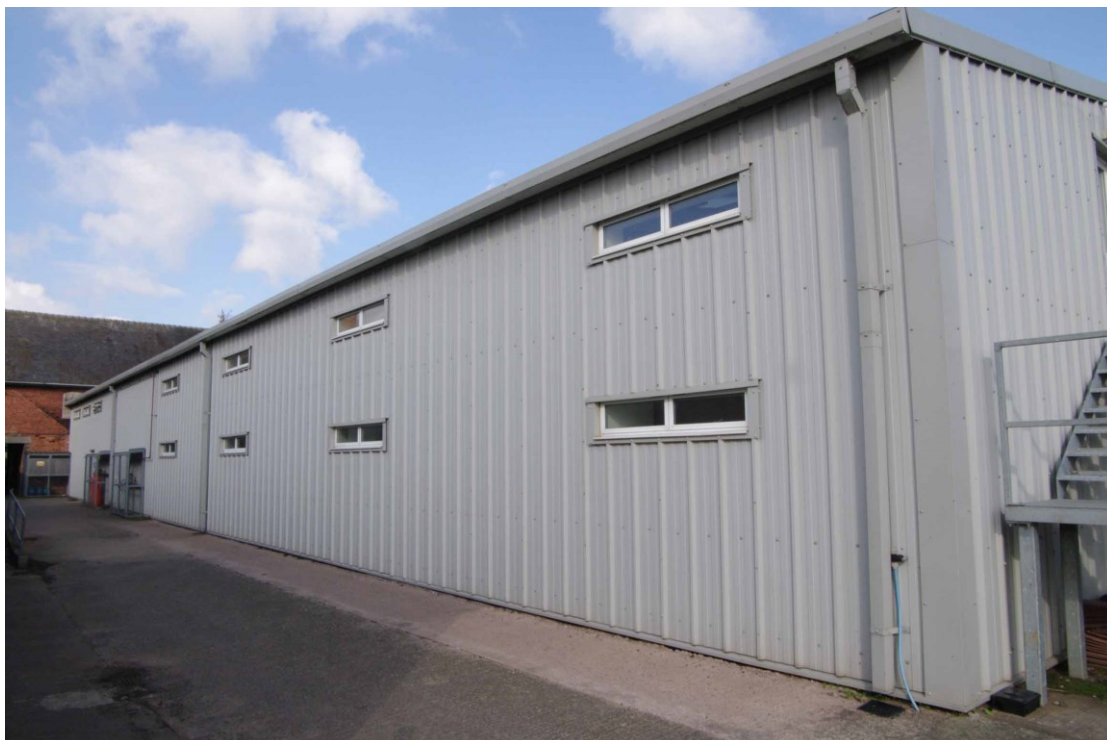
Figure 63: South-eastern rear range. West facing elevation
Looking north-east

The south-eastern range is lower and less than half the width of the south-western range. The difference in sizes of the two ranges is likely to be their ability to fit against the rear of the Granary and leave a space for the passageway running through it. This range has a steel frame and is clad entirely with sheet steel of the same type used in the south end of the south-western range which suggests a similar construction

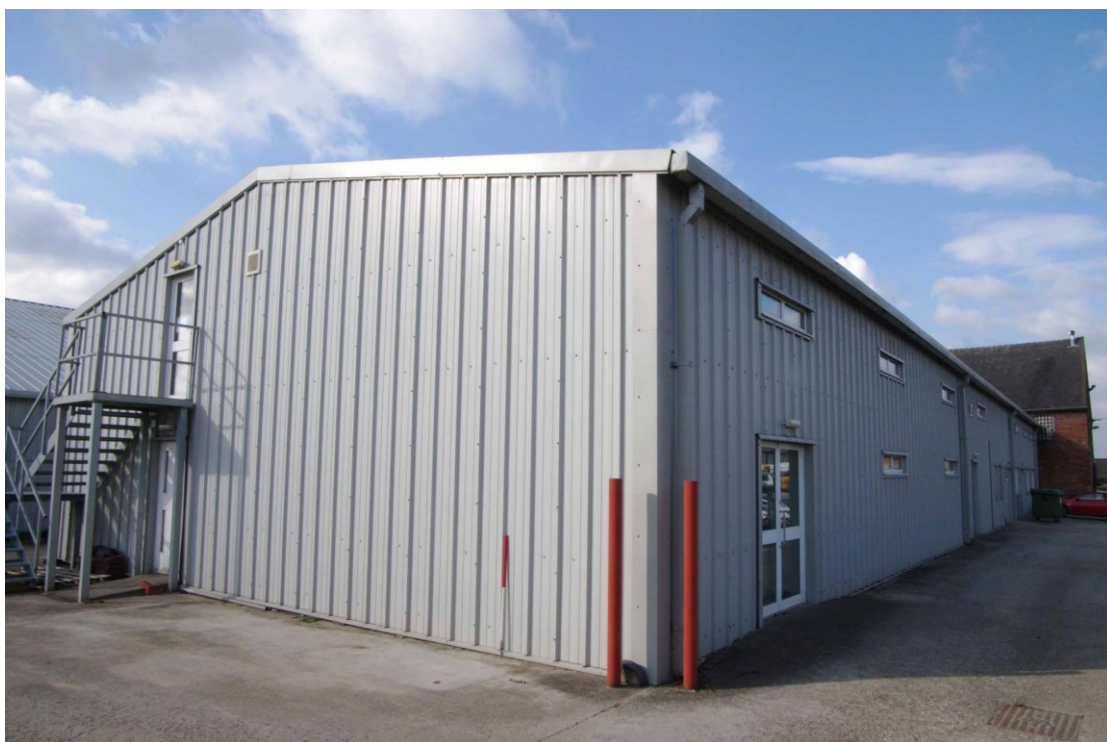
Figure 64: South-eastern rear range. South and east facing elevations
Looking north-west. 1m scale

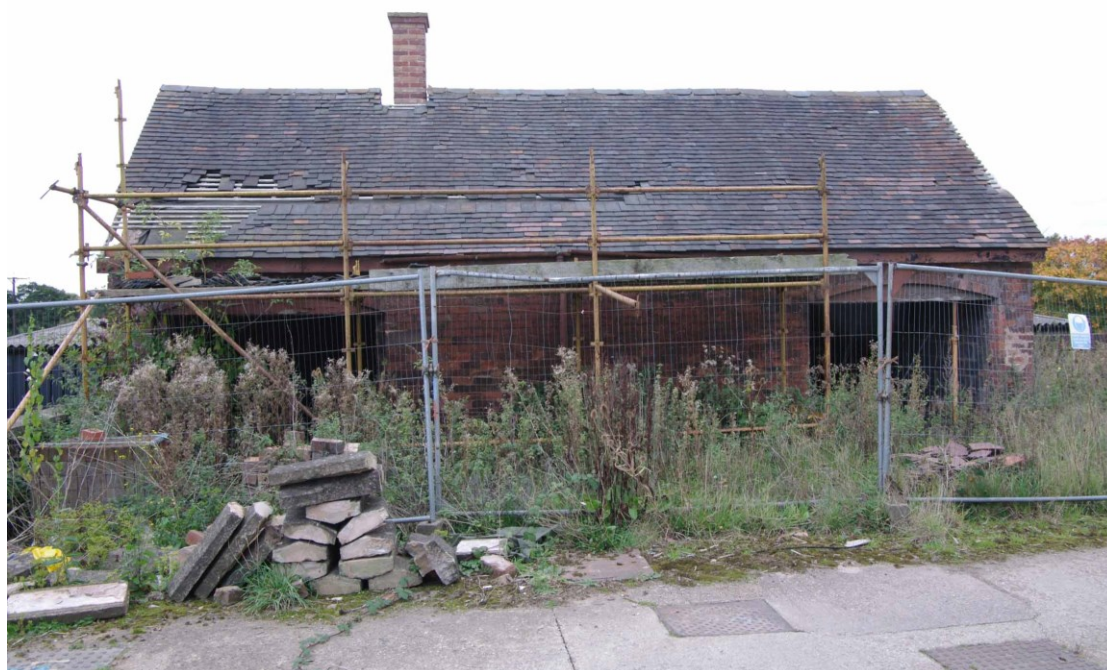
The principal elevation of the building faces northwards towards the south-east corner of the Granary buildings (Fig. 66). This elevation appears to be built in a similar English Garden Wall bond as used on the main Granary building. However, the brick coursing is quite variable and may reflect a number of rebuilding phases along with other modifications. There are two wide arched openings at each end of the north facing elevation. The ridgeline is broken by the hole for a chimney but a much smaller chimney has been rebuilt within the hole leaving a significant gap between it and the roof. A low brick wall butts against the eastern corner of the elevation and runs northwards alongside the south-eastern rear range to create a boundary wall to the Granary site.

Figure 66 Gasometer building, north facing elevation
Looking south

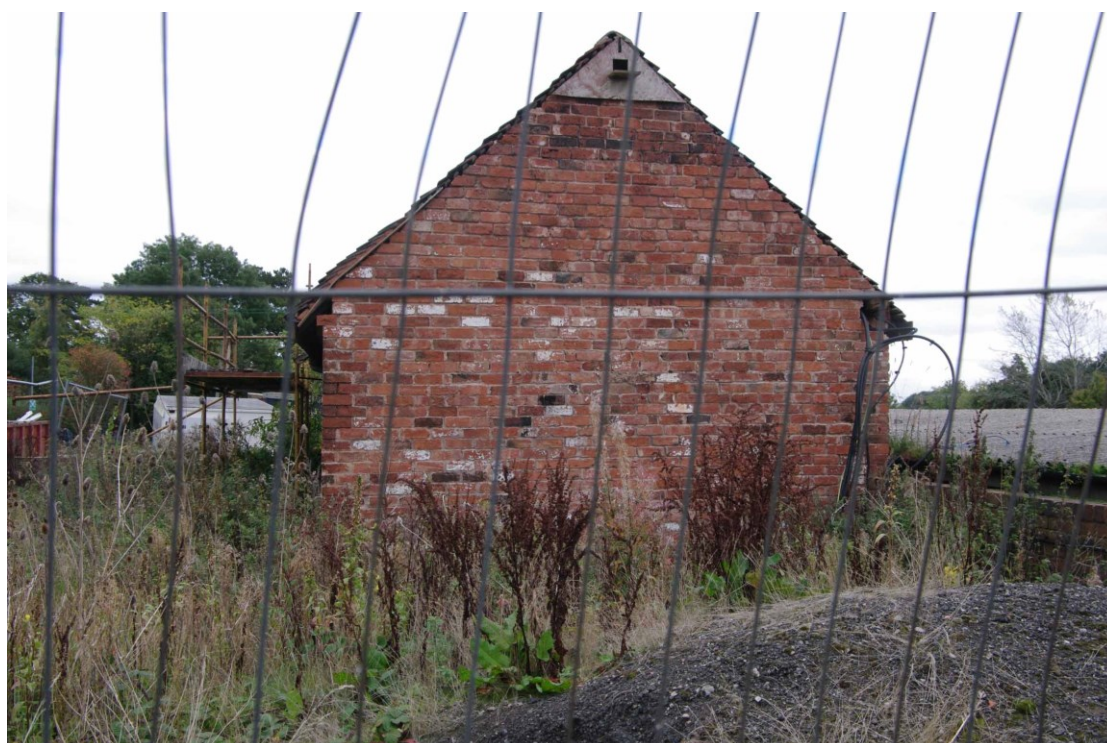
The west facing elevation is a plain gable end laid, for the most part, in a stretcher bond (Fig. 67). The bricks are possibly re-used and may be a new wall added when the building was truncated. The 1958 Ordnance Survey map suggests that this structure was a much longer building consisting of a number of elements which are now no longer present. The ground in front of this elevation is overgrown so it is not possible to inspect it for evidence of wall foundations or floors of demolished buildings.

Figure 67 Gasometer building, west facing elevation
Looking east

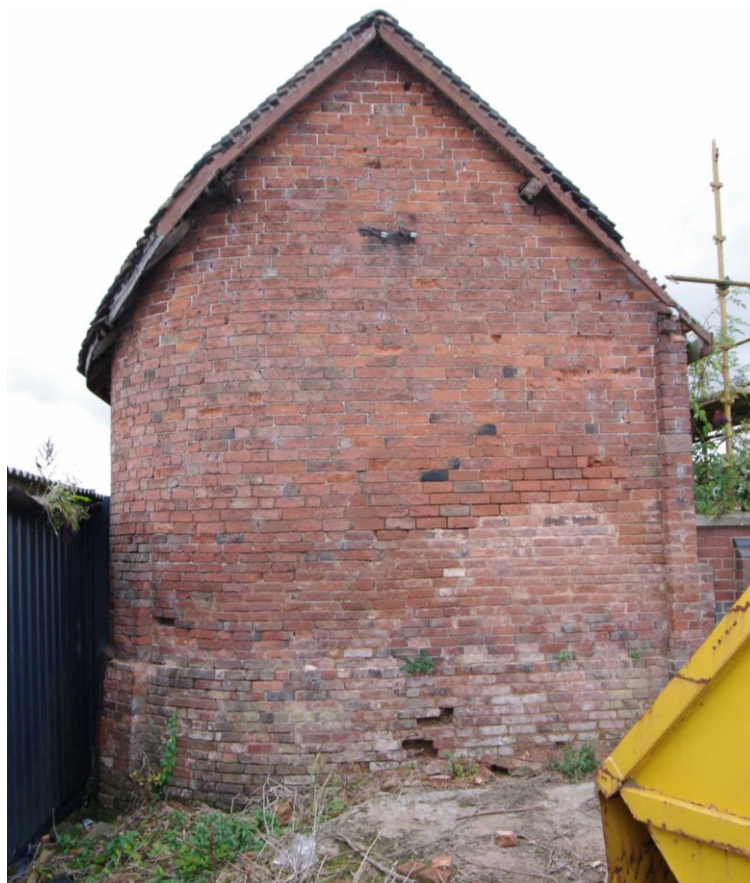
Figure 68 Gasometer building, east facing elevation
Looking west

The building consists of a single storey structure with a tile roof using similar bricks and tiles to those used on the main Granary building. The similarity of the bricks and tiles may suggest a similar construction date. At the time of the survey the roof and walls appeared to be in a poor state of repair and the entire building was fenced off preventing access and detailed inspection. Weeds and undergrowth obscured much of the north facing elevation. The building is located on the edge of a terrace which drops down to the south.

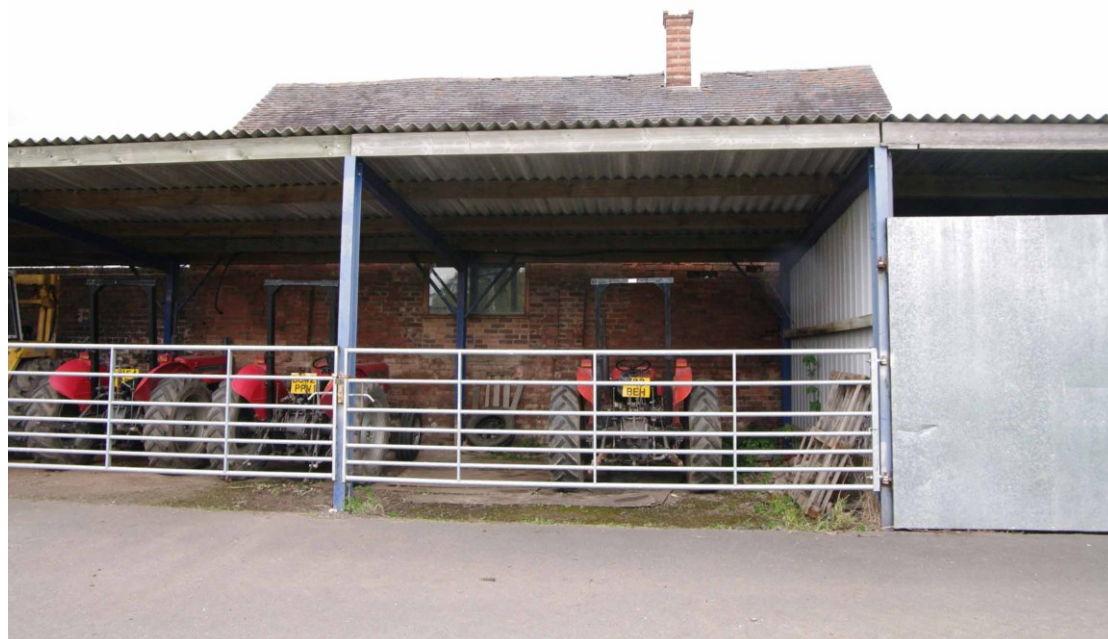
The south facing elevation is partially obscured by a modern tractor shed built against, but not joining, the wall (Figs 9 and 69). This wall appears to have a large window which may have been modified from a larger opening which was perhaps used as a loading bay for coal. There is evidence for repointing of the brickwork which may suggest other openings. Two small buttresses help to prevent the wall from sliding downhill.

Figure 69 Gasometer building, south facing elevation behind tractor shed
Looking north
