**An Archaeological Field Evaluation
At the rear of 30, Markfield Road,
Groby, Leicestershire
(SK 522 077)**

ULAS Report Number 2007-059 ©2007

An Archaeological Field Evaluation At the rear of 30, Markfield Road, Groby, Leicestershire (SK 522 077)

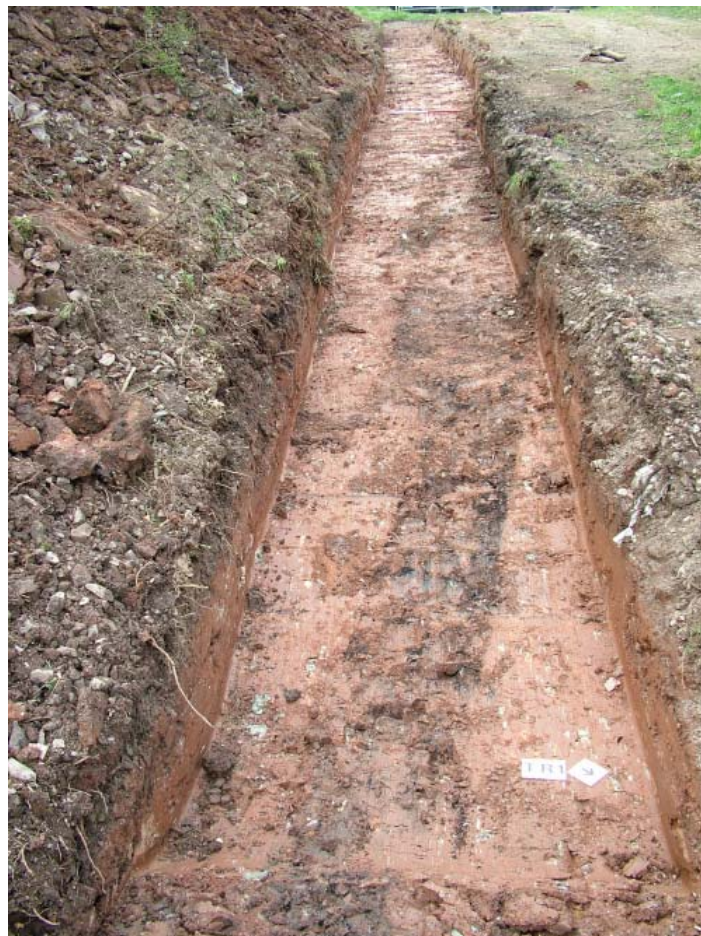
This trench was oriented north-east to south west between the site of the old mineral railway and the church wall. Topsoil was only in evidence at the north east end of the trench and this lay over a layer of a hardcore consisting of grey mill waste. Throughout the rest of the trench the mill waste was the upper layer. The mill waste lay directly over compacted re-deposited Mercia Mudstone clay, which in the upper layers contained large amounts of broken ceramic building material.

Several silted up manholes could be seen in this area, which were associated with a sewer serving the church. The cut for the sewer trench was uncovered in the base of trench 1 towards the north east end and ran approximately north to south across the trench. A further two manholes were seen to the south of the trench with a further one in the far north east corner of the field. All these appeared to have fallen out of use.

No archaeological features were discovered in this trench. The topsoil, the debris and the surface contained sherds of modern pottery and tile, mainly white or willow pattern.

Plate 1: Trench 1 with sewer trench at north east end, looking south west

Trench 1, which was placed on the site of the dismantled mineral railway showed that the cutting for the railway was in-filled with Mercia Mudstone clay to some significant depth. The desk-based assessment had not highlighted that the railway ran under the Markfield Road and in retrospect the placing of a trench in an area known to have been in-filled to such a depth was largely irrelevant to an evaluation of the area. However, it does prove the eye witness reports of the cutting being in-filled with Groby clay during the 1960s (Alison Coates pers. comm.).

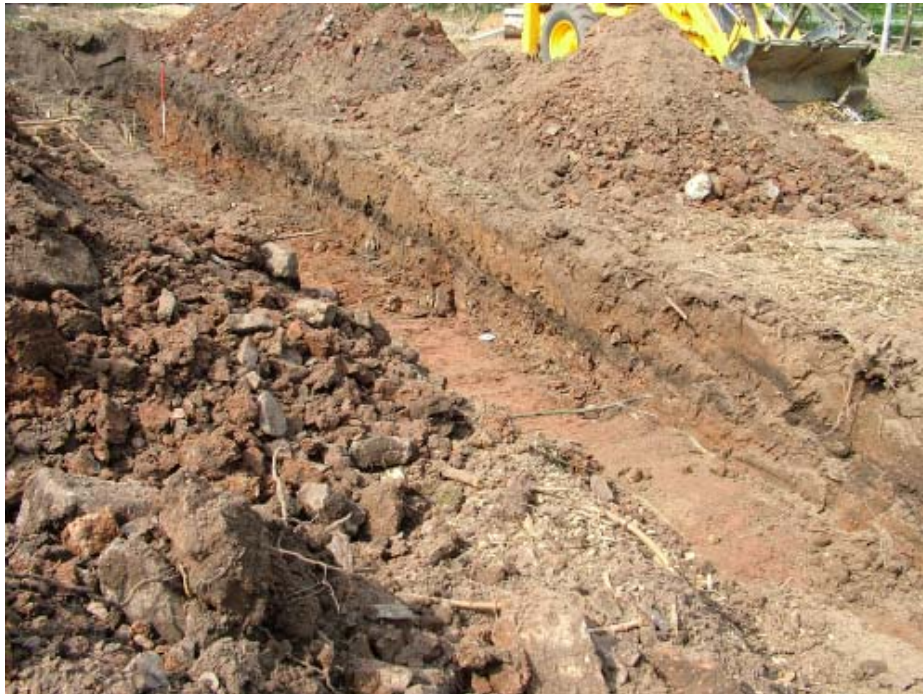
This trench was oriented east-south-east to west-north-west and was placed close to the northern wall of the nearby building. At the south east end the topsoil was quite shallow and directly overlay the Mercia Mudstone sub-stratum. As the trench progressed north west the topsoil became much deeper and appeared to consist of two separate types: one a pale brown clayey silt and the other a dark grey sandy silt, with the pale brown one overlying the darker in most places, but not exclusively. In the south east end of the trench the darker topsoil overlay brick, tile and other demolition debris.

No archaeological features or finds associated with archaeological features were discovered in this trench. All the pieces of tile, brick and pottery discovered in the occupation debris were modern in date.

Plate 2: Trench 2, showing topsoil variation in south west facing section. Looking north west

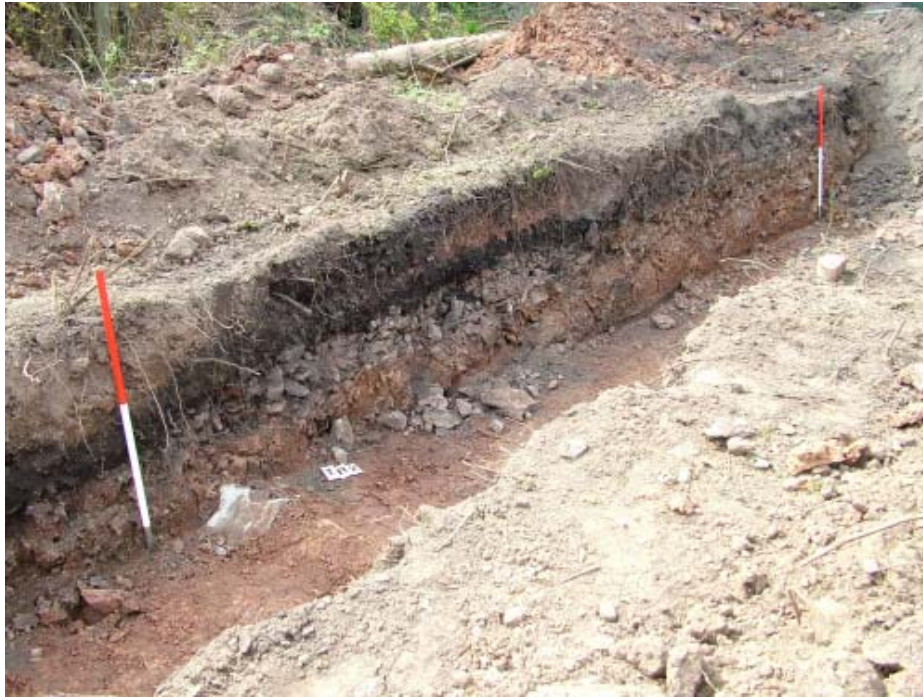
In the west-north-west end of the trench the topsoil overlay a surface, which consisted of large and medium-sized grey slate and, towards the western extent of the trench, mill waste overlying brown modern hardcore.

Plate 3: North east facing section of trench 2, showing surface. Looking south

The surface seen in the western end of trench 2 is known to have been a trackway, which led from the back of the outbuildings to the fields to the west and served as the landowner's access (Liz Emerson pers. comm.). This is shown on some later maps of the area (Figure 5). It would appear that the trackway was widened and consolidated at some point by the addition of the hardcore area to the west of the area that was comprised of slate.

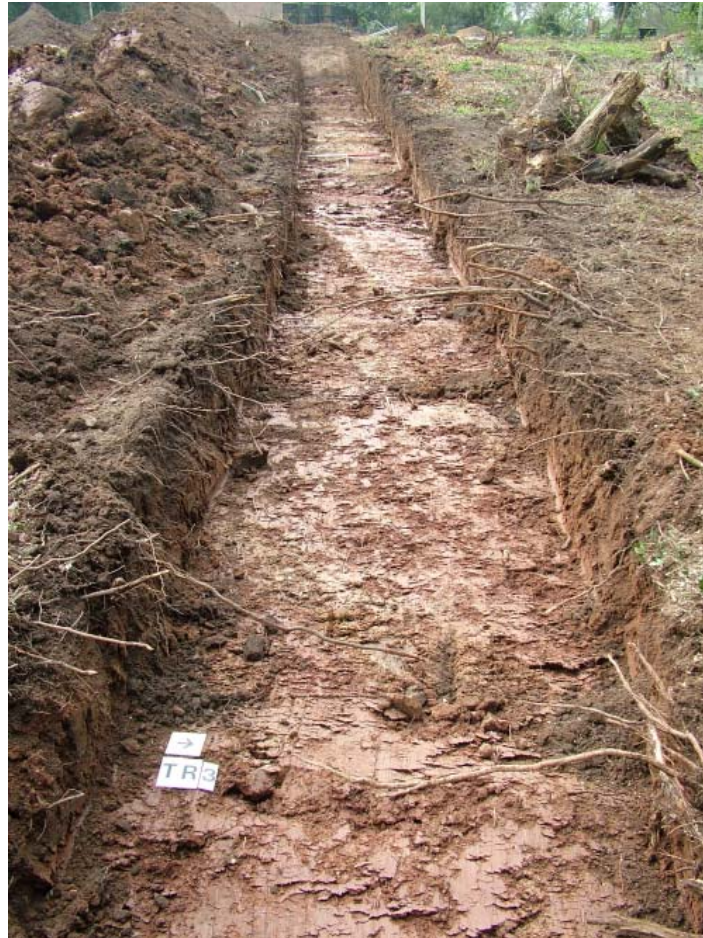
This trench was placed at the eastern side of the site to the north of trench 2 and on a similar alignment. The sequence was very similar to trench 2, with two types of topsoil, one overlying the other in places. As in trench 2 the soil was shallower in the eastern end of the trench. The topsoil overlay a narrow layer of brown clayey subsoil, which was only visible in places.

The sub-stratum was Mercia Mudstone with pieces of granite therein. No archaeological features were discovered during the excavation of this trench. The topsoil contained small pieces of modern brick and modern pottery.

Plate 4: Trench 3, post-excavation, looking west

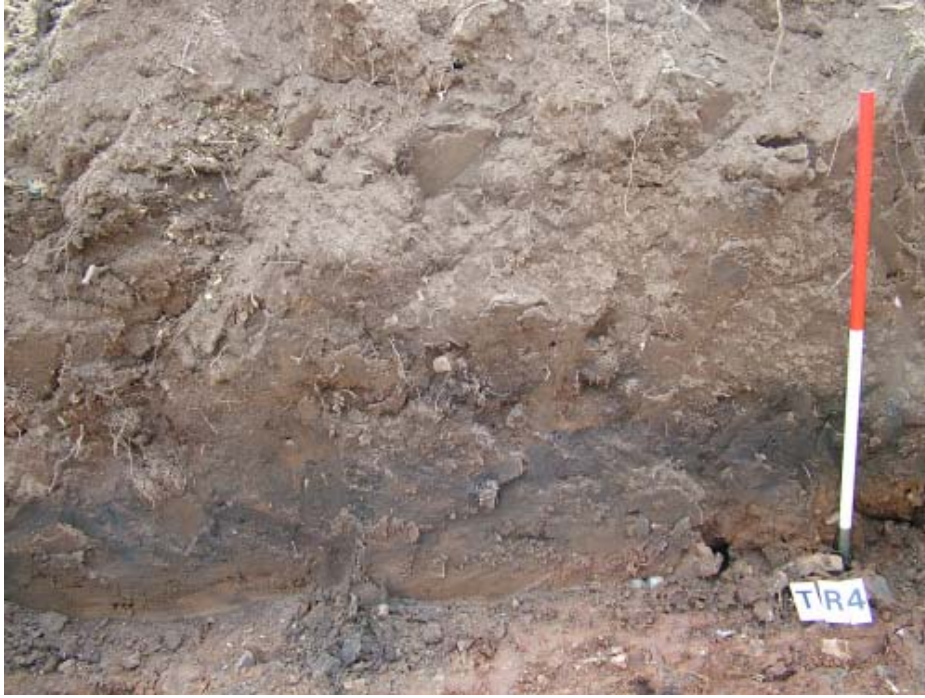
The trench also showed evidence for two soils, although in this case the main topsoil was very thick (up to 1.1m deep) and overlay very compacted older topsoil throughout most of the trench. In the middle of the trench the brown topsoil directly overlay the Mercia Mudstone sub-stratum.

There were no archaeological features located in this trench and there was little evidence of the demolition debris seen in trenches 2 and 3, although the compacted buried soil contained small pieces of modern brick and tile.

Plate 5: South facing section of trench 4, showing thick loose topsoil overlying earlier compacted soil layer. Looking north

Throughout trenches 2-4 there is evidence that a modern layer of loose topsoil overlay a compacted darker layer of buried soil. In some areas this darker layer is nearer the surface and this would suggest that topsoil may have been brought into the site at some point to level it, or to provide extra topsoil for cultivation. The site was recently used as a Christmas tree farm so it is possible that the deep topsoil was brought in to build up the otherwise quite shallow soil layer.
