**Archaeological work at  
The Stable Block,  
Nevill Holt Hall,  
Nevill Holt,  
Leicestershire  
(SP 816 937)**

ULAS Report No 2016-142  
©2016

Rural Solutions Planning Consultants

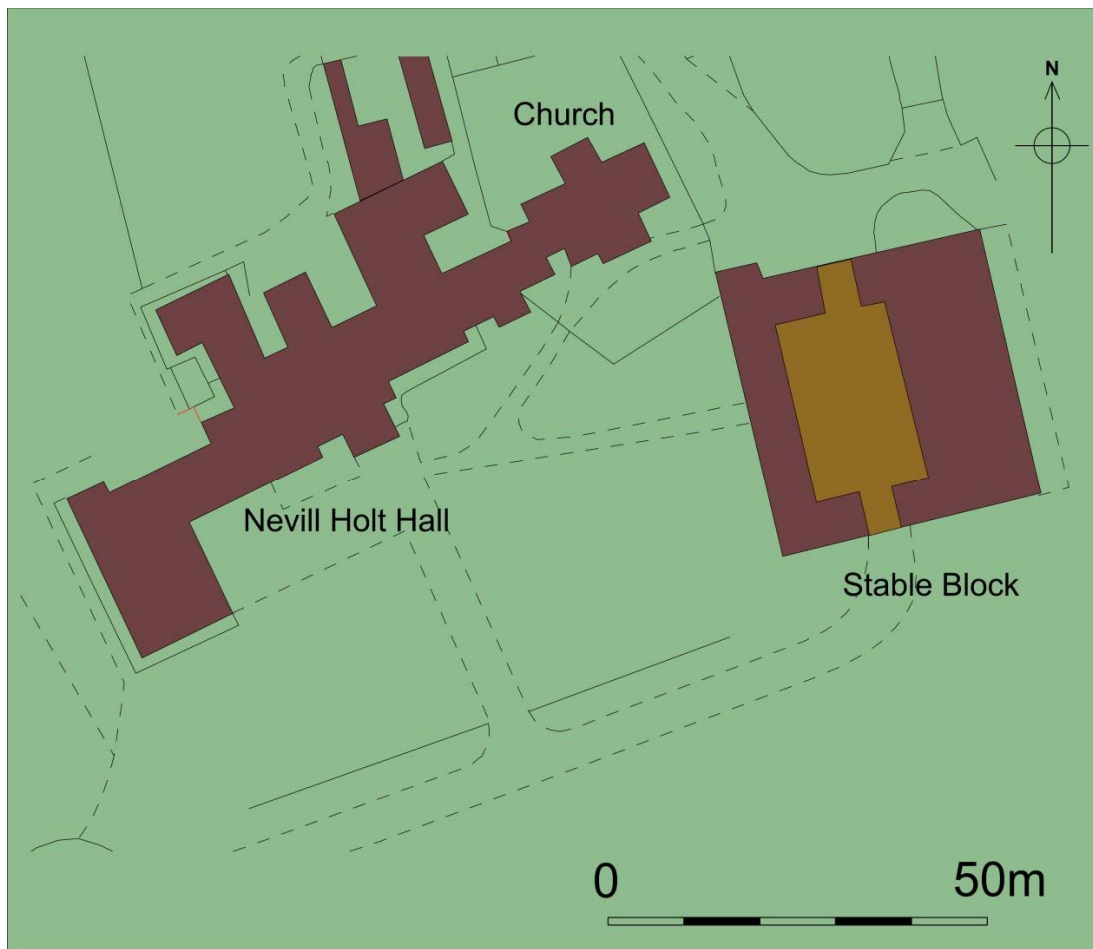
Figure 2: Plan of Nevill Holt Hall and Stable Block

The Hall and church, both dating from the 13th century, stand on a hilltop, dominating the cluster of houses that make up the village. The Hall itself is a complex building, covering many periods (Figure 2).

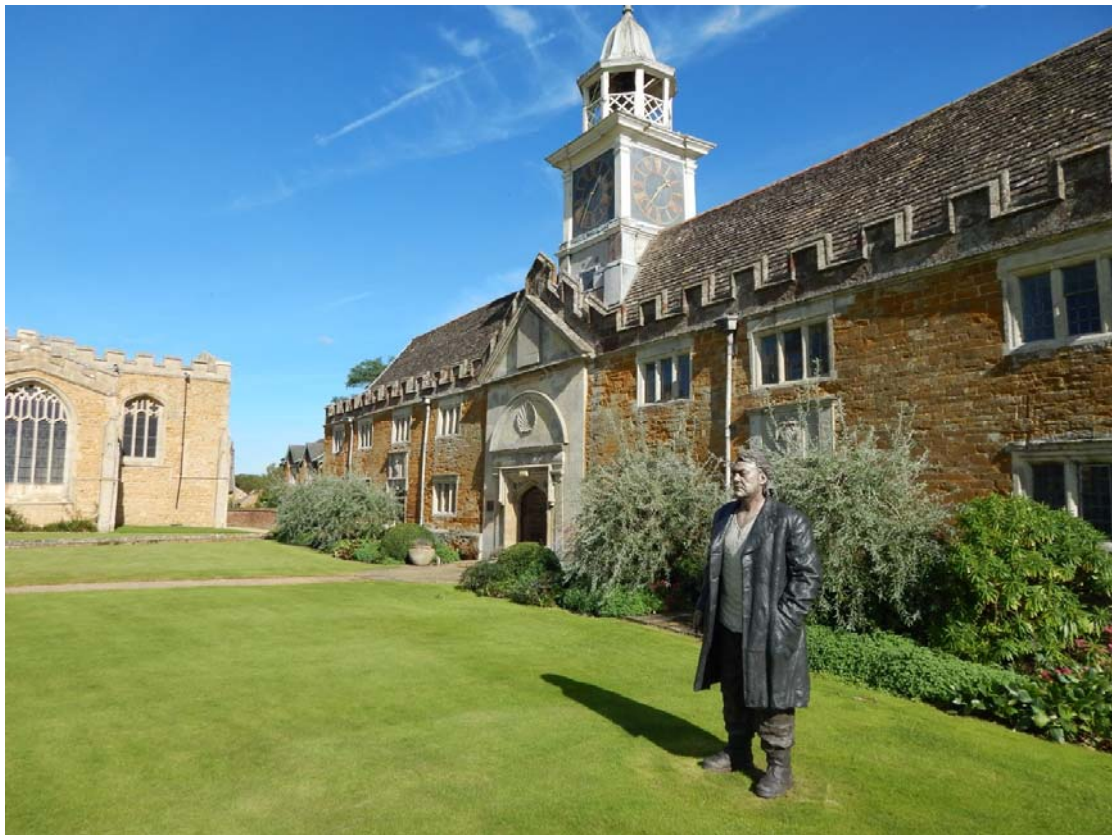
Figure 4: The west wing of the stable block, with statue of Bryn Terfel, from the south-west, looking north

The stable block also covers many periods (Figure 4). The west wing dates from the 1661 when it appears to have been built on top of the ruins of an old medieval ‘Hospital’; an almshouse of unknown date and origin (Hill 1997). The previous stables, which lay to the south of the Hall, according to the 1661 plan, were demolished (Figure 5). The remainder of the current stable building dates from the late 19th century, after the Hall passed into the hands of Sir Bache Cunard in 1877. Sir Bache was Master of Fox Hounds from 1878 to 1888 and expanded the stables in line with his new position.

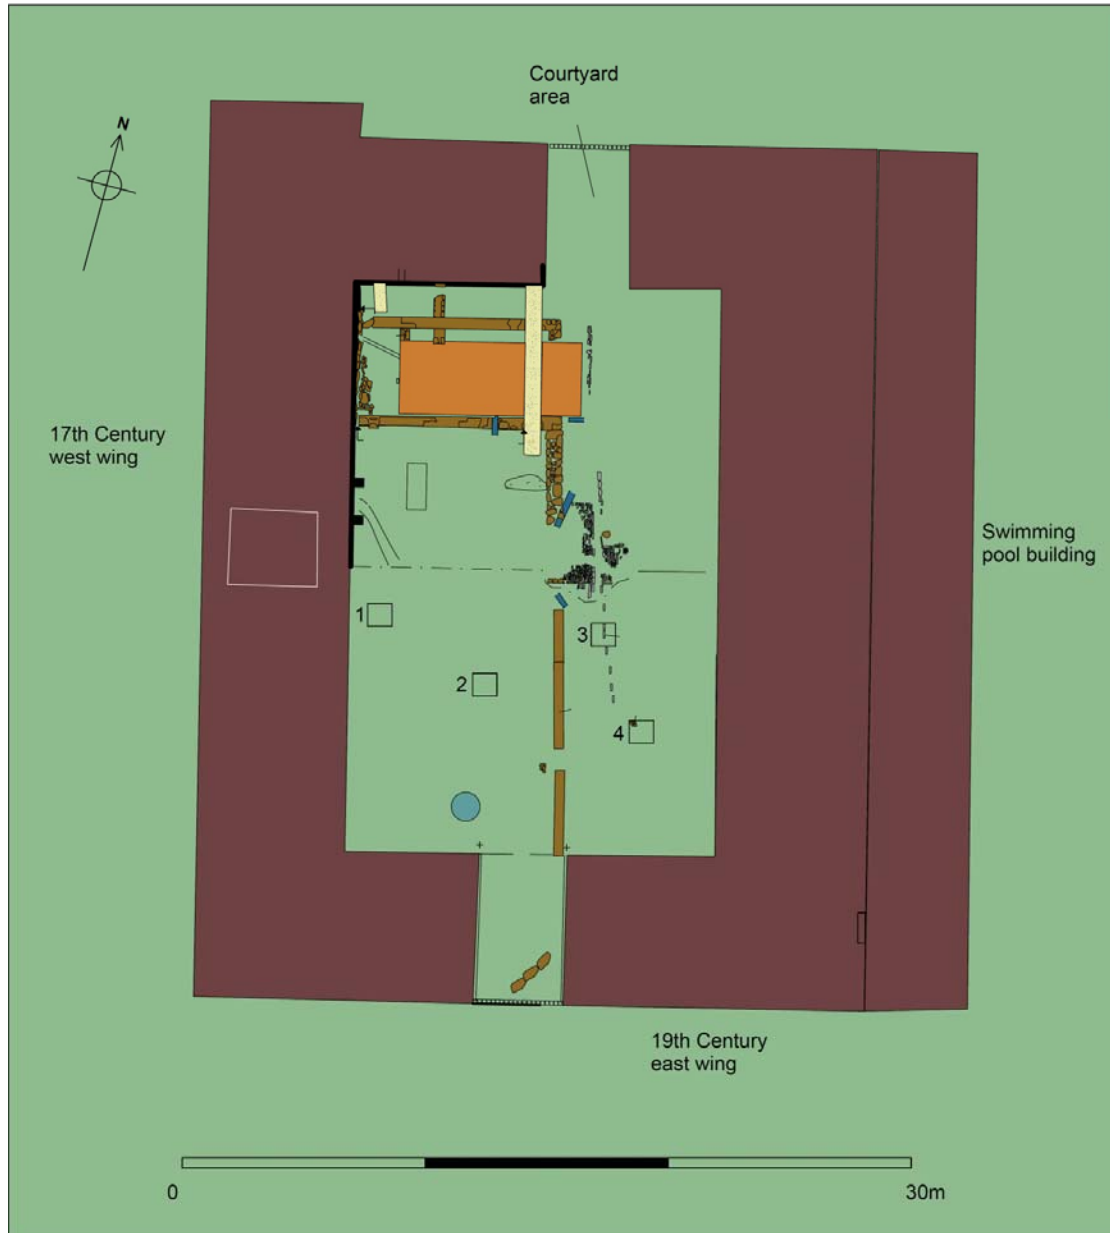
Figure 6: Plan of stable block with archaeological remains and test pit locations from the 2006 work (from Hunt 2006)

Test pit three contained a stone feature (45) that consisted of two pitched blocks of Weldon stone, lying broadly north-south across the pit (Fig.7). To the west of these was a light grey mortar spread (5), which may have been a floor make-up layer.

Test pit four also contained a thin mortar layer (17), similar to (5), along with a group of large sub-rounded cobbles (46), which may have represented a former courtyard surface. Test pit two contained no archaeological features.

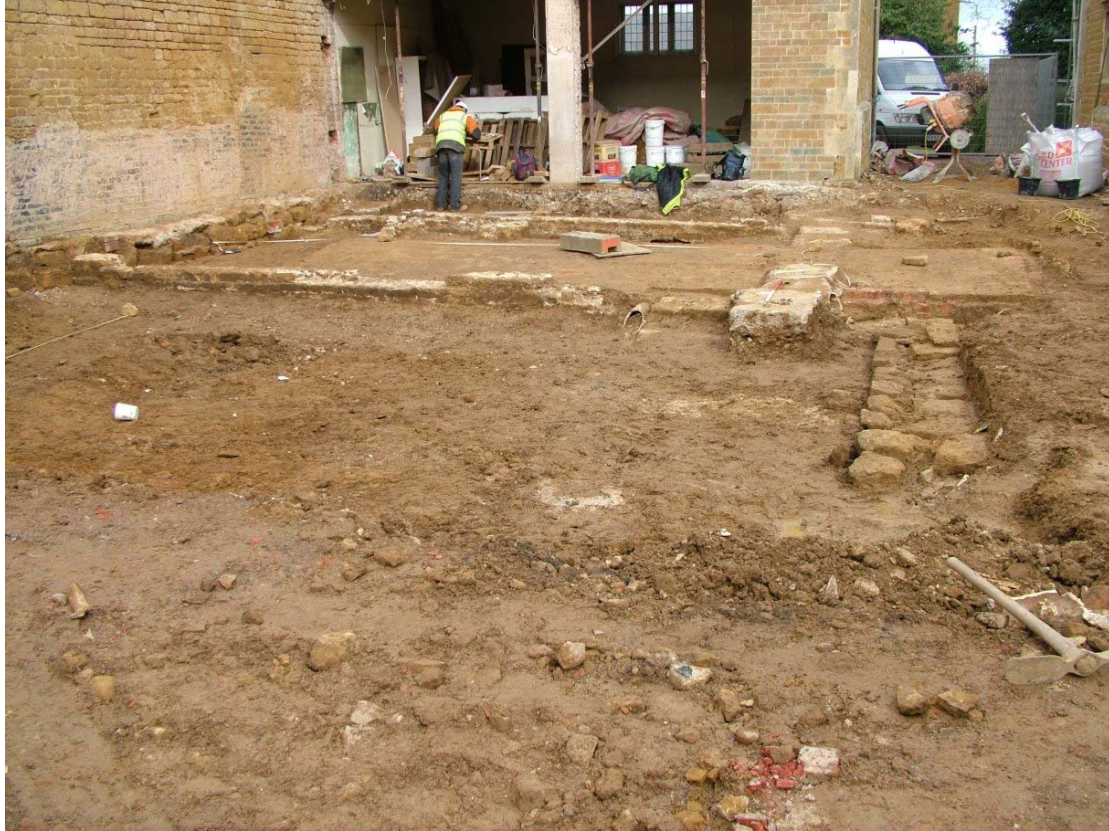
Figure 7: Work in progress on northern end of courtyard from 2005-6, looking north-west

The evaluation within the northern end of the stable block courtyard area revealed a series of walls and other features (Figures 7 & 8). A large brick built cess-pit or water tank (32) was situated at the northern end of the stable block a few metres from the northwest wing.

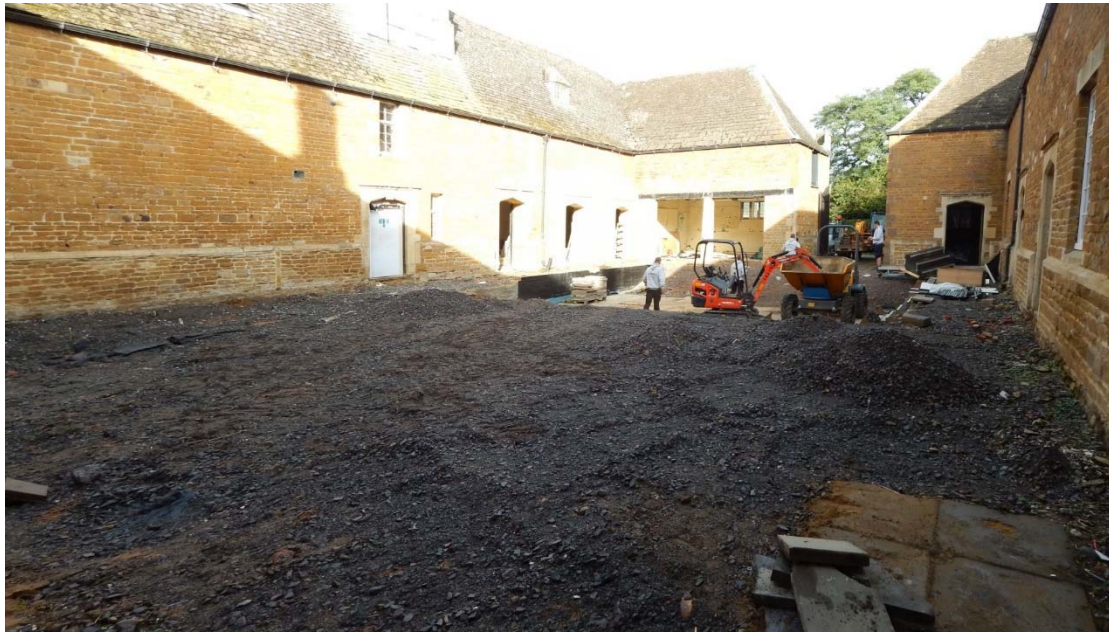
Figure 12: The courtyard area during removal of mill waste, looking north-west

Prior to the site being visited by an archaeologist, the temporary structure and stage had been removed and the internal seating dismantled leaving the courtyard of the stable block largely covered in granite mill waste, with areas covered in flagstones at the base of the orchestra pit and the entranceways. Much of the mill waste had been removed prior to the visit and had lain across the courtyard in a layer around 0.20m thick (Figure 12).

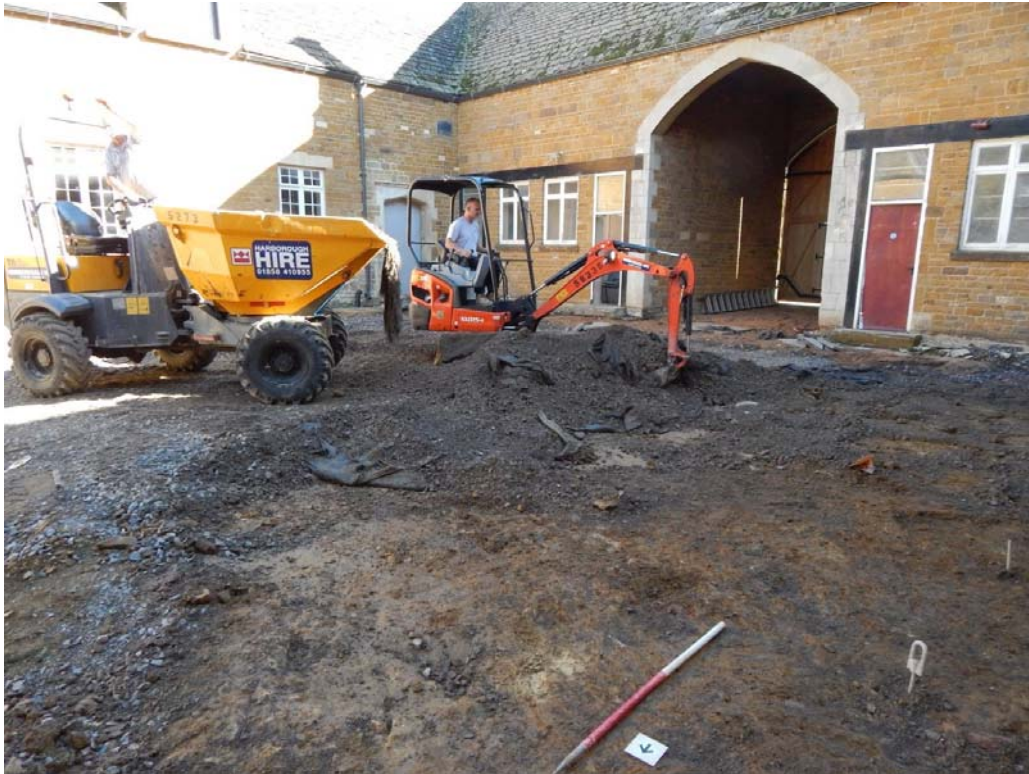
Figure 13: Work in progress, looking south-east, note anchor points in foreground

At the edges of the courtyard were a series of anchor points, mainly in pairs 2.3m apart or closer, which had been driven into the natural sub-stratum and had held the temporary roof in place. All proved to be impossible to remove with the machines available at the time of the archaeological supervision (Figure 13).

The stripping mainly moved from north to south, but after archaeological features were revealed at the southern end of the courtyard, the southern area was stripped more lightly moving broadly south to north, with changes of direction to avoid the steel anchor points (Figure 13).

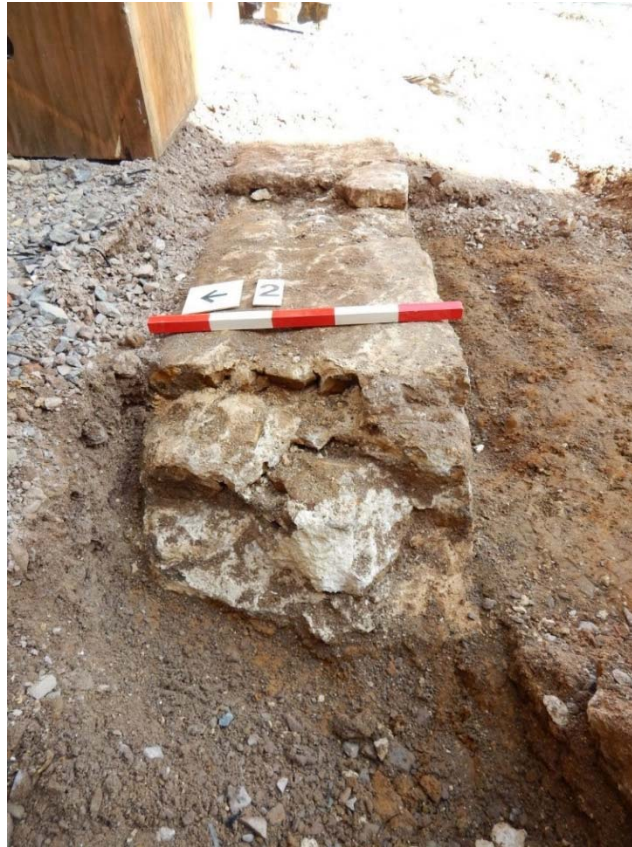
At the northern end of the courtyard part of the stone wall found in the evaluations of 2005 was revealed. Originally recorded as (25), this wall was renumbered (2) for this current work (Figures 8 & 14). A section was excavated by hand through the western end of the wall in order to ascertain its construction. Lying east to west, with a gap at the western end, where it had been damaged, it consisted on 3 courses of very rough ironstone blocks of varying sizes (typically 300mm x 200mm x 100mm, but many were smaller). The outside surfaces had been better finished and they had been mortared together very firmly with creamy grey lime mortar. Although the mortar had obscured much of the stonework, it appeared that it had a rubble core of varying sized pieces of ironstone. The total visible depth was 0.28m and the width was 0.28m long (Figure 14). Its remaining length was obscured by overburden and rubble to the east. As this wall had been recorded during the previous work, no new illustrations were made.

Figure 14: Western end of wall (2) revealed during courtyard strip. Previously recorded as (25), looking east

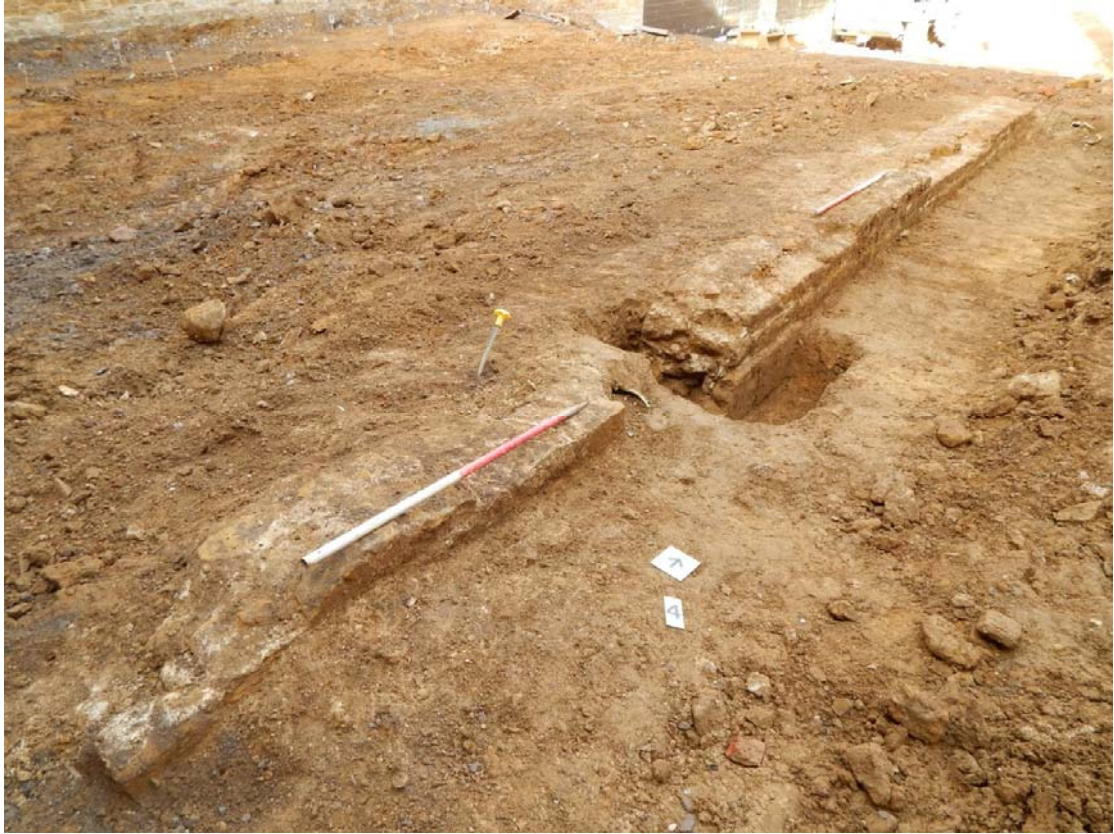
There were three courses in total including the foundations, which consisted of a single course of well finished rectangular ironstone blocks, around 450mm x 260mm x 150mm in size. These were clay bonded. The section through the wall appeared to show a clay bonded ironstone rubble core set within the larger lime mortar bonded blocks (Figures 17, 18, 20).

Figure 16: Section of wall (4) revealed in southern part of courtyard, looking north-west

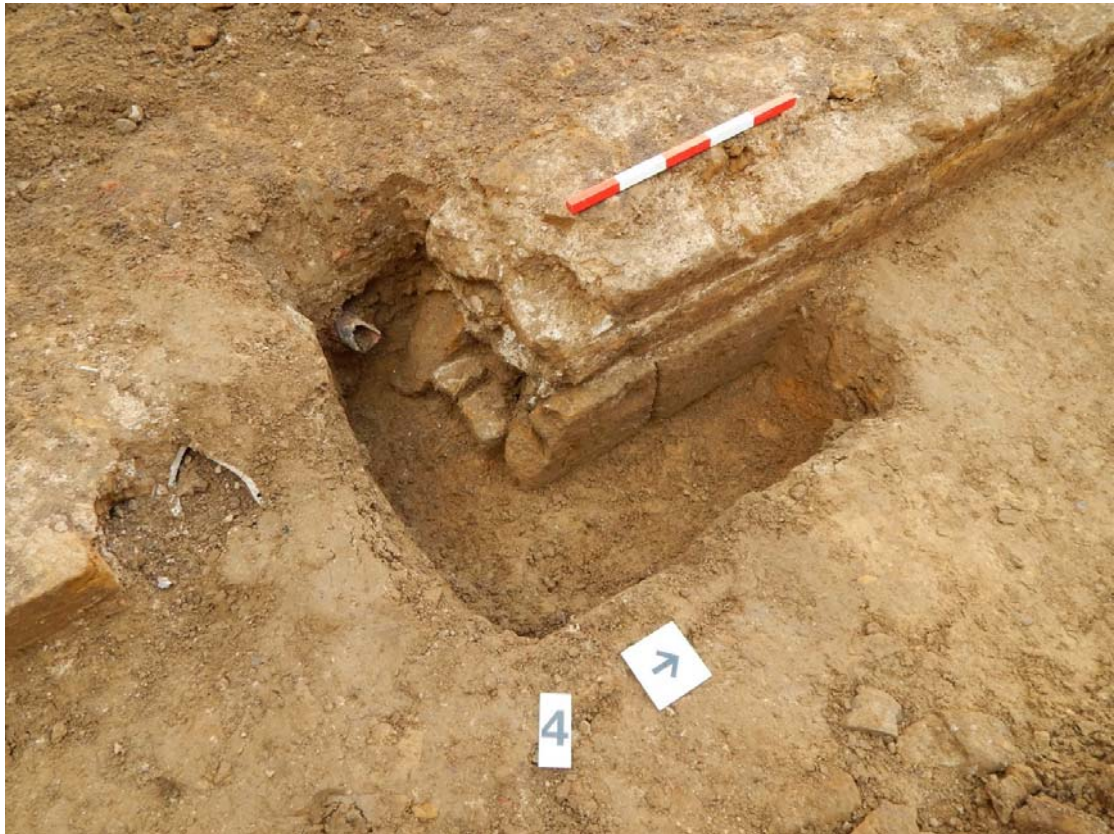
The two courses of the superstructure were of a more roughly finished ironstone, measuring approximately 400mm x 120mm x 240mm bonded with lime mortar. The foundations were 0.49m wide and the superstructure around 0.42m wide. The section revealed was 0.58m high (Figure 17 and 20a & 20b). No construction cut for the foundations was identified.

Figure 17: Section through damaged part of wall, showing foundations, looking north-west

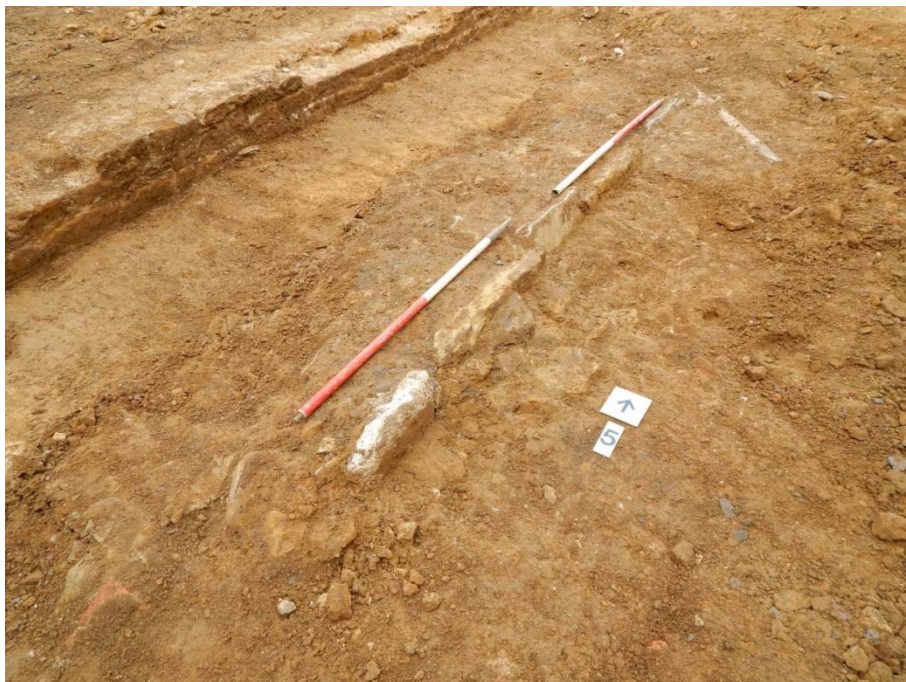
Around 1.5m east of the wall (4) was another linear stone feature, running broadly parallel with the wall, but aligned slightly more westwards (Figures 15 & 19). This feature (5) consisted of a line of pitched stones of various types, including ironstone, limestone and slate, of varying sizes and pitch. They varied between 350mm x 100mm x 90mm to 630mm x 80mm x 90mm in size and were all roughly finished. The feature as a whole was 2.6m long and around 100mm wide (Figures 15, 19 & 20c). This feature appears to be a continuation of the stone feature (45) seen in Test-pit 3 (Figure 9) that consisted of two pitched blocks of Weldon stone, lying broadly north-south across the pit and possibly continuing to the south.

Figure 19: Pitched stone feature, looking north-west

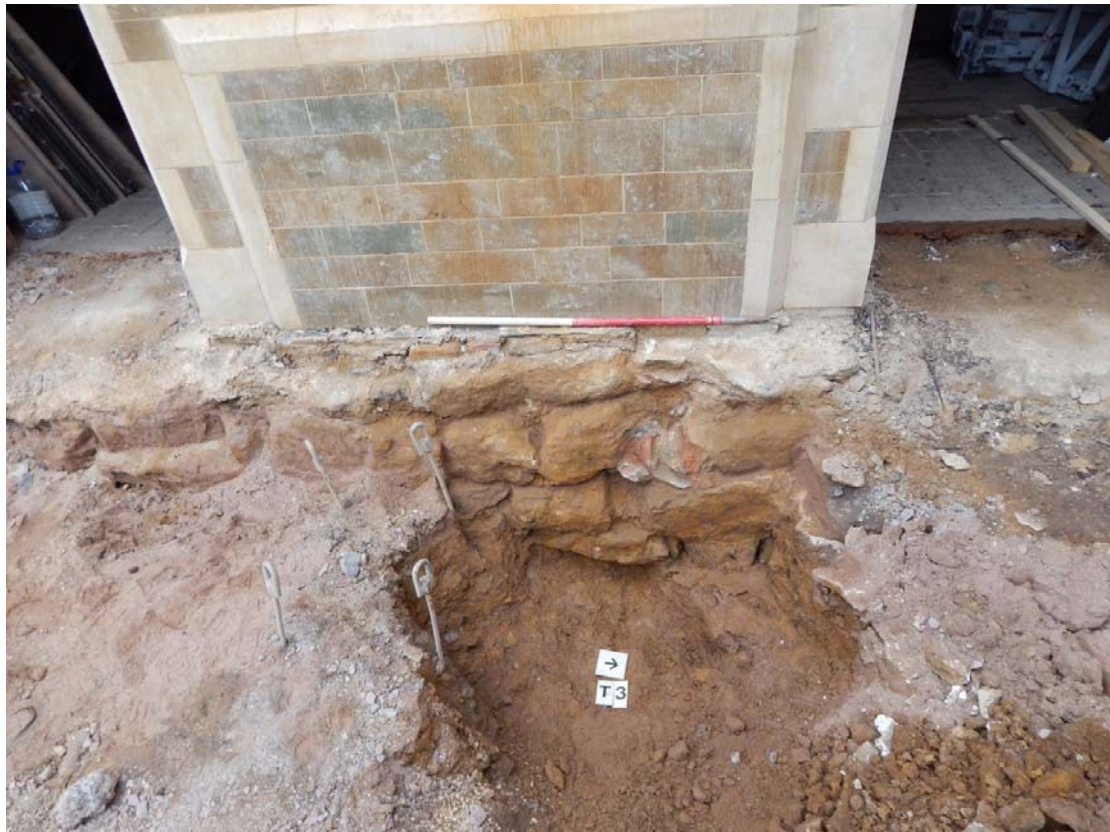
The test pits revealed that the west and north-west wings of the stable rested on simple rough ironstone foundations such as the section (wall (3)) recorded in TP 03 (Figures 21 & 23a). Wall (3) consisted of 4 courses of large and medium roughly finished ironstone blocks of a maximum size of 580mm x 300 mm, bonded together with clay, and were 0.82m deep. The foundations lay beneath a layer of slate, with the mortared superstructure of ironstone above. Although along this part of the wall new ironstone doorways had been recently been inserted, as during the visits of 2005-2006 the wall here was of modern brick.

Figure 21: Test Pit 03, post excavation showing foundations (3)

The test pits against the stable walls show that the simplest foundations are those of the 17th century west wing, consisting of rough ironstone blocks. These also seem to be in evidence under the south facing side of the north-west wing, suggesting that this section of the stable is also fairly early, or possibly built using earlier structures as foundations. The foundations of the southern and eastern wings are mainly of limestone construction and far more sophisticated, if not more substantial, than the west wing. The southern inner walls appeared to have been underpinned with concrete in recent times, possibly due to deterioration of the original structure.

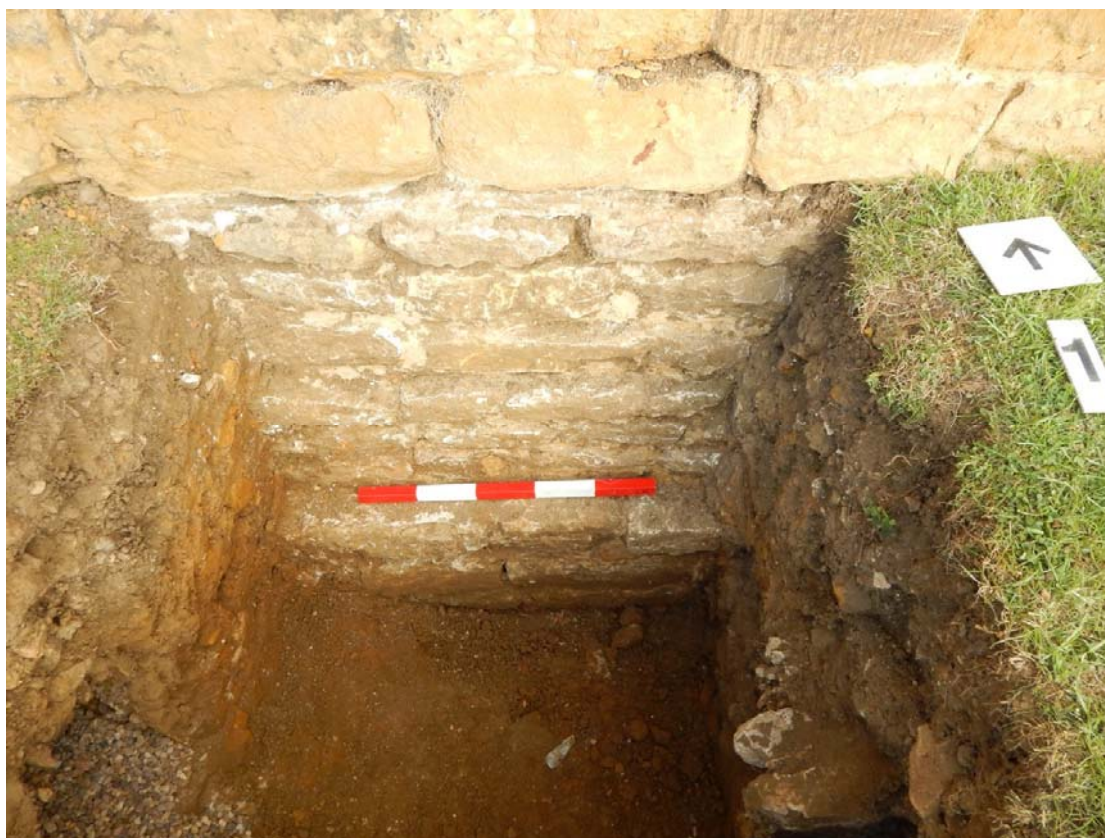
The external walls of the southern wings appeared to have foundations of smaller but better finished limestone blocks, with some ironstone, which were mortared. In TP 01 the wall here (1) consisted of 9 courses in 3 sets of 3, each projecting slightly out from the course above, first by 30mm and then 90mm. The limestone blocks were of varying sizes; typically between 200mm x 80mm and 300mm x 100mm. The courses were around 0.35m deep and the entire foundation was 0.92m deep (Figures 22 & 23b).

Figure 22: Test Pit 01, post excavation showing foundations (1)

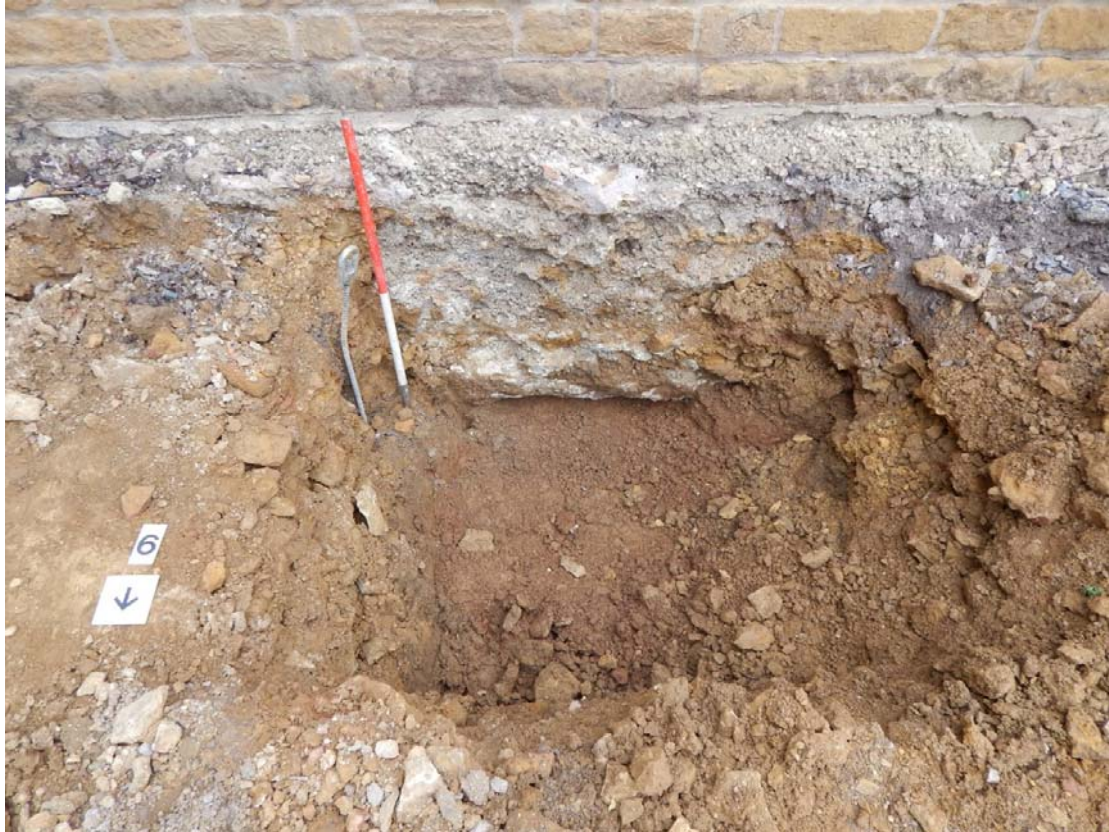
Test pits 05 and 06 were excavated against the walls within the courtyard of the southern wings and showed the foundations here as being underpinned by concrete (Figure 24).

Figure 24: Test Pit 06, post excavation showing concrete underpinning

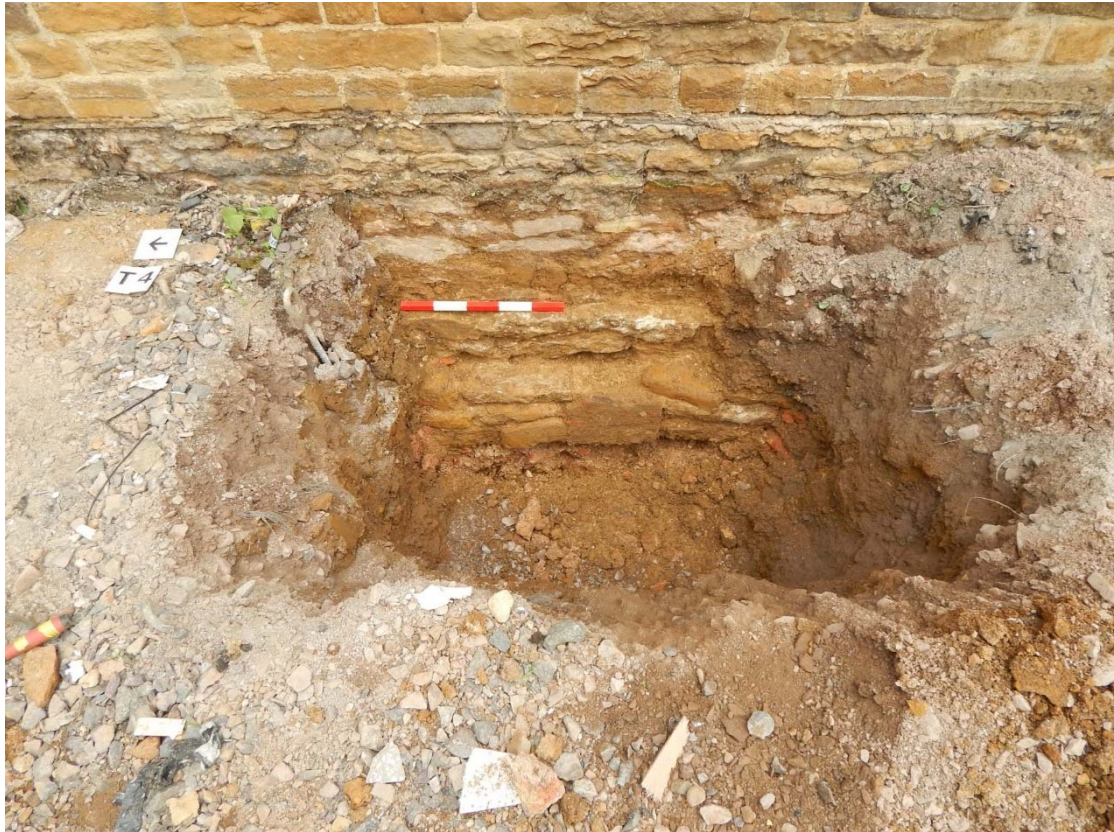
The test pits along the courtyard walls of the eastern wing (Test Pit 04 and the west facing elevation of Test Pit 09), showed the foundations here comprised rough limestone and ironstone blocks of very variable sizes (Figures 23c & 25). The west facing elevation revealed in TP 04 showed that the foundations here consisted of 13 courses of sizes varying from 150mm x 60mm to 330mm x 250mm. All were very roughly finished apart from a single large well- finished square block of ironstone, which resembled that used in the foundation of wall (4) within the courtyard. All were mortared with creamy grey lime mortar. There were three sets of courses; the first of 8, the next of 2 and the final lower course of 3, with a step between each group. The total depth of the foundation was 1.13m.

Figure 25: Test Pit 04, post excavation showing foundations (6)

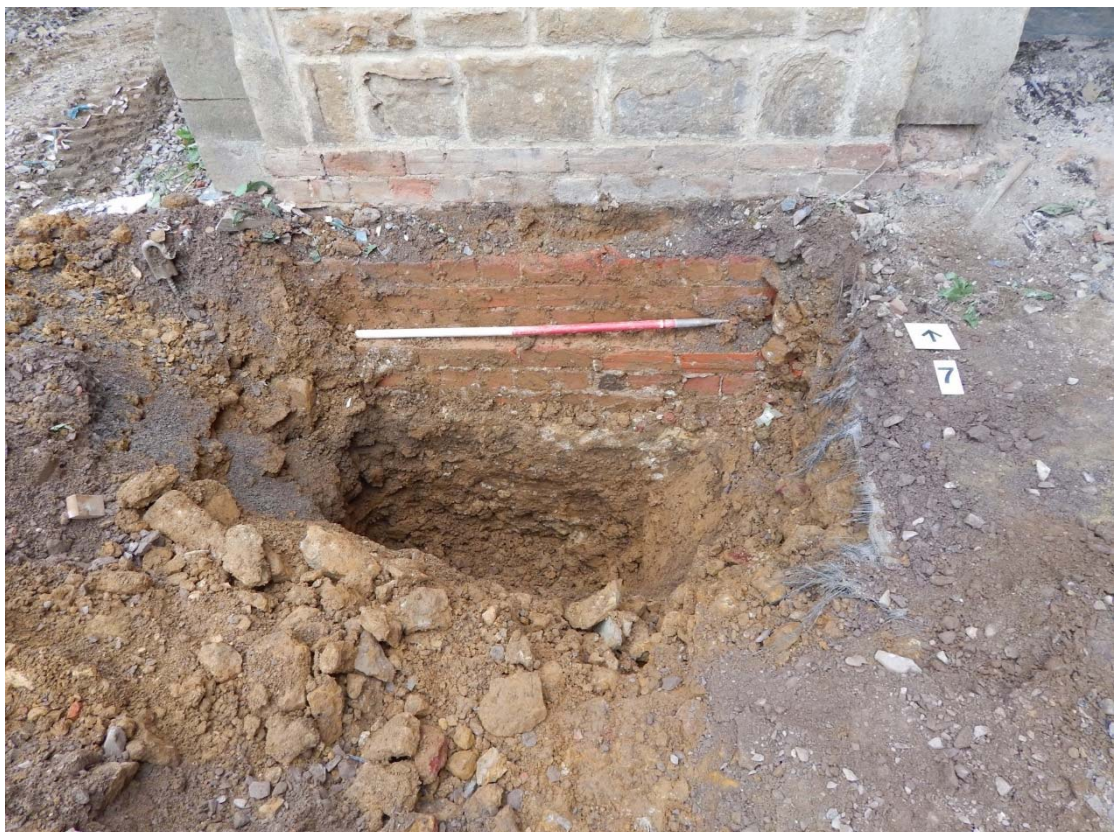
The foundations of the north-east wing, as seen in Test Pits 07, 10, 11 and the south facing elevation of TP 09 were of brick, below a brick plinth. The foundations were in 2 sets of 3 courses with projections between each course (Figure 26).

Figure 26: Test Pit 07, post excavation showing brick foundations

The most modern of the foundations are the brick courses under the north-eastern wing, which also contains a large metal water tank.

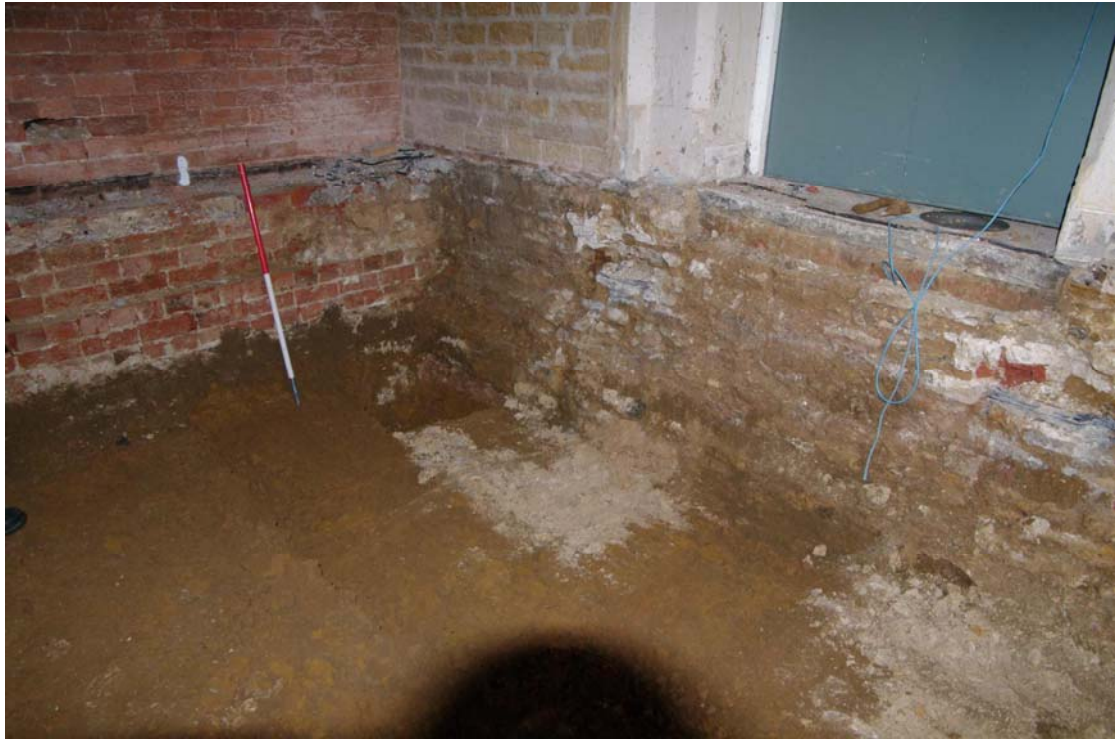
A 0.2m layer of cement flooring was removed to reveal a mixed layer of sandy clay extending down to approximately 0.6m below the cement floor level. After breaking through the brick threshold doorway and removing approximately 0.5m of the concrete wall foundation a mini digger fitted with a ditching bucket reduced the ground within the room to 1.1m below the cement floor level. This revealed a clean mid yellowish brown silty sandy clay which appeared to be undisturbed apart from a modern cut on the eastern side of the room. There was also evidence of the foundation cut for the walls. Two small test pits, one in the north-east corner and one to the west were excavated to 1.6m below floor level continued to expose the undisturbed silty sandy clay (Figure 27).

Figure 27: Reduced floor level in G.01. Looking north-east

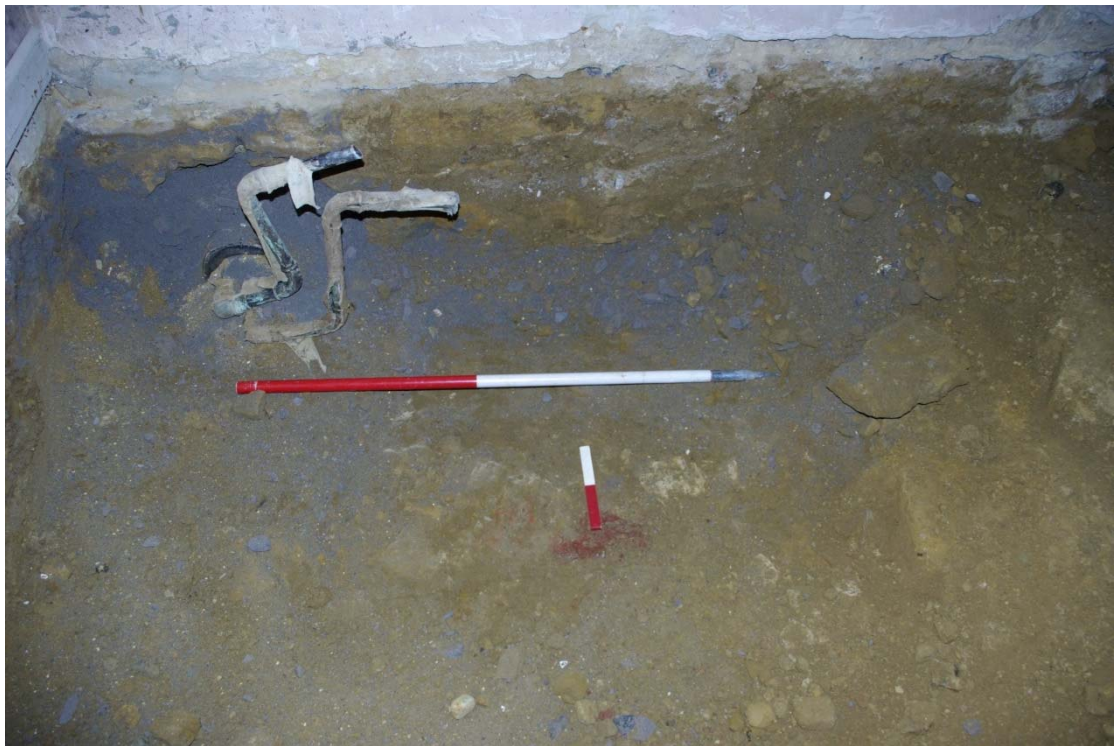
The eastern room (G.08,09) had already had the modern flooring removed and required a further reduction to bring it down to the same level as in the western room. The stub of an ironstone wall running from north to south was seen in the south-west corner of the room approximately 0.4m from the west wall. Only the bottom two courses survived, both of which partially cut into the natural. The wall was extremely insubstantial and petered out approximately 3m from the south wall of the room. This wall was not as wide as the stepped foundations of the present building so is likely to be earlier (Figure 28). No other features or dating evidence was observed.

Figure 28: Wall remnant in south-east room (G.09), looking west

A further small section of wall was discovered in Room G.09 during the watching brief. This appears to be on a similar alignment to (42), running north to south but does not appear to be continuation of it. Very little of this wall survived and no dating evidence was found for this section of wall.
