**An Archaeological Evaluation at the  
Former Ambulance Station,  
Leicester Road,  
Melton Mowbray,  
Leicestershire.**

**NGR: SK 74693 18825**

ULAS Report No. 2016-114  
©2016

**For: ALDI Stores Ltd**

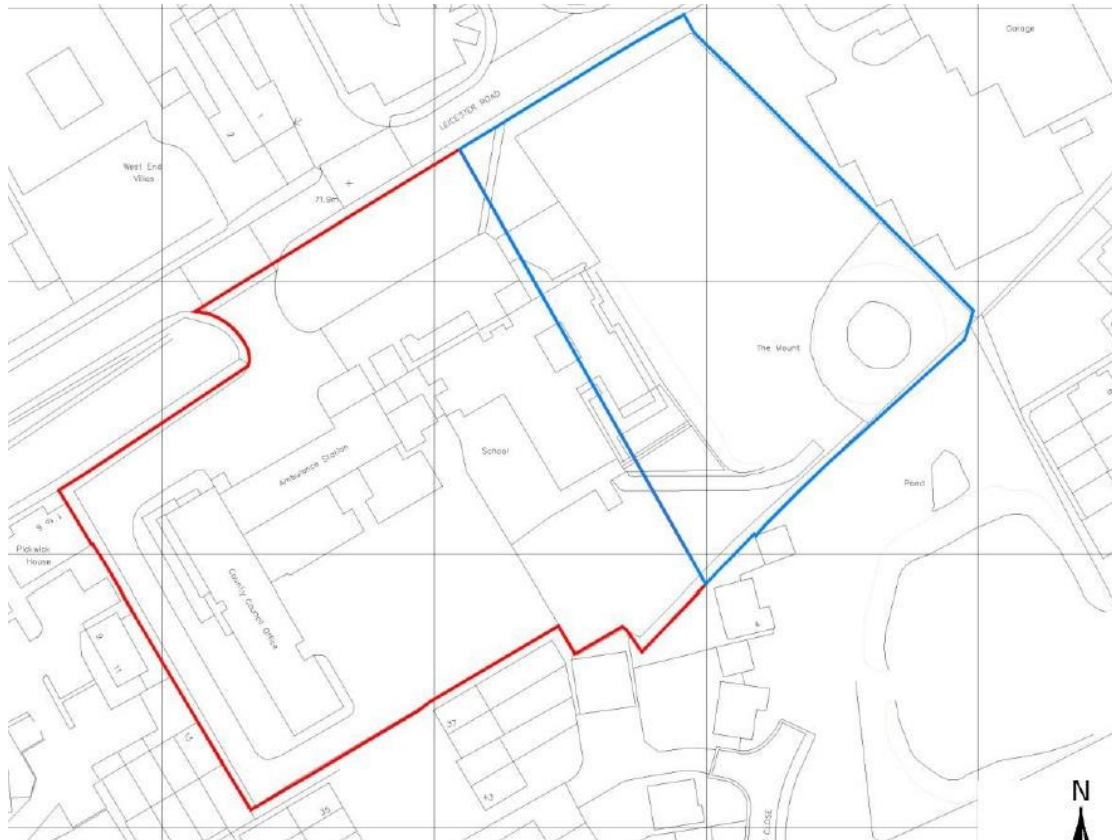
Figure 2 Site layout  
Red outline shows evaluation area. Blue outline shows Site B which was not evaluated.  
Plan supplied by Client

areas for car parking surrounded by small grass verges. To the east of the buildings is a large garden area covered in grass and, for the purposes of this work, identified as Site B (Fig. 2). To the south-west of the garden lies the possible post-medieval windmill mound known as The Mount. The development area covers an area of approximately 7500m<sup>2</sup> and is at a height of around 71m above OD. A recently completed housing estate runs around the south-eastern and south-western site boundaries. A number of light industrial workshops and adapted buildings line the north side of Leicester Road.

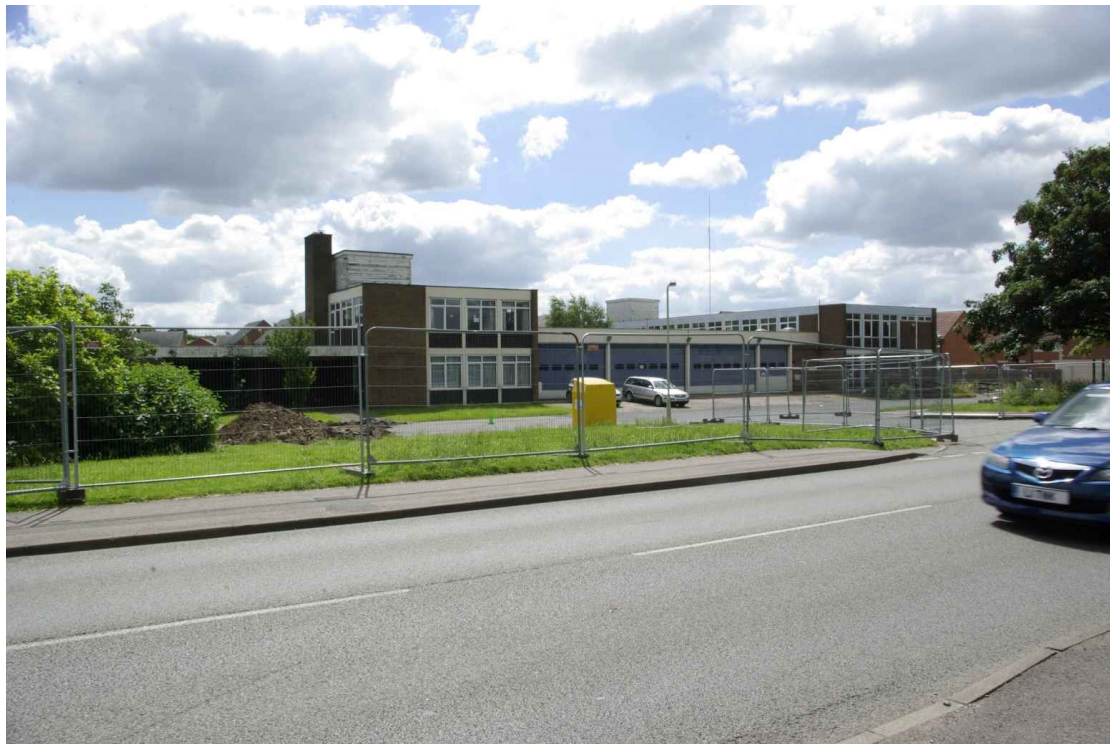
Figure 3 Site seen from Leicester Road  
Looking south-west

At the time of this evaluation all of the buildings had been out of use for a number of months although none appeared to be suffering from deterioration or vandalism. The surrounding roads and car parks were also in a reasonable state of repair. Some fly-tipping had taken place over the southern boundary fence from the recently built housing estate (Figs 3 and 4).

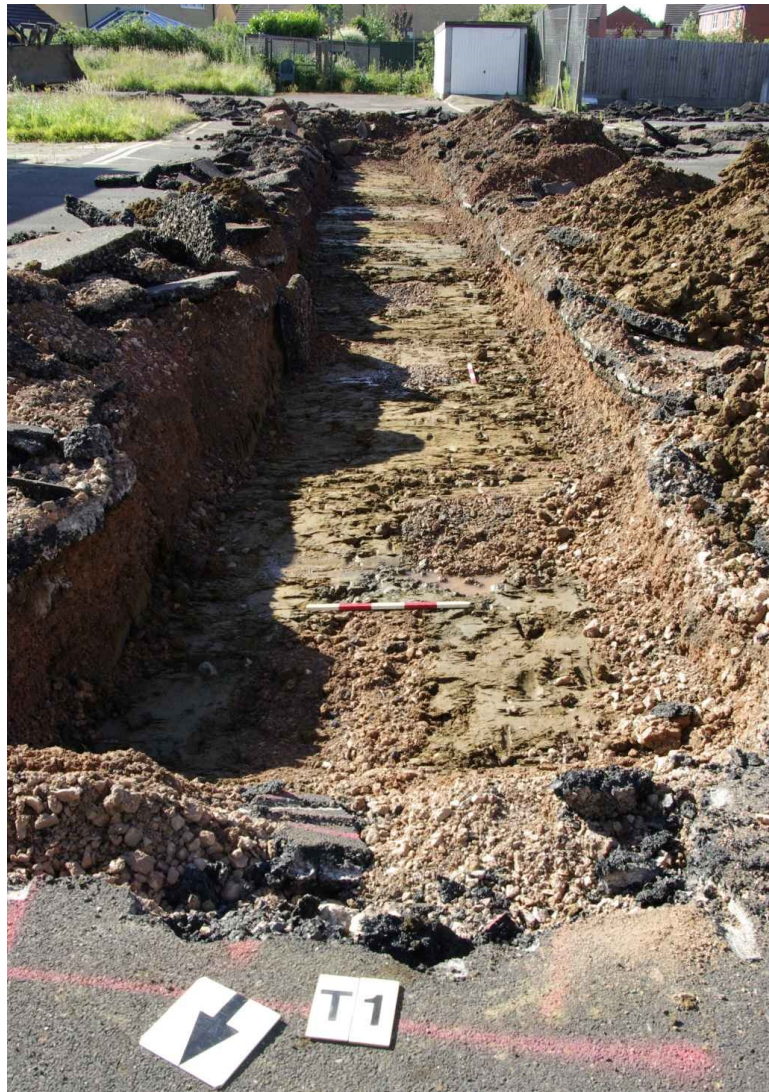
Figure 7 Trench 1

Trench 1 was located within the angle of the day care centre and the rear of the ambulance station (Fig. 6). It was excavated on a north-west to south-east alignment and had a total length of 17.3m. Beneath the tarmac layer was a thick layer of mill-waste stone and hard-core giving a total depth between 0.4m and 0.5m. Removal of these modern layers exposed the natural mid greyish brown sandy clay substratum (Fig. 7). There was no evidence of any topsoil or subsoil. Running along the centre of the trench were six rectangular 0.4m wide post-holes, five of which were full of modern building debris. The sixth post-hole still contained its concrete base showing that all were very modern. Other modern disturbances were present in the centre of the trench.

No archaeological features or deposits were present in this trench.

Looking south-east. 0.5m scale. Modern post holes seen as areas of stone either side of scale and extending down the length of the trench

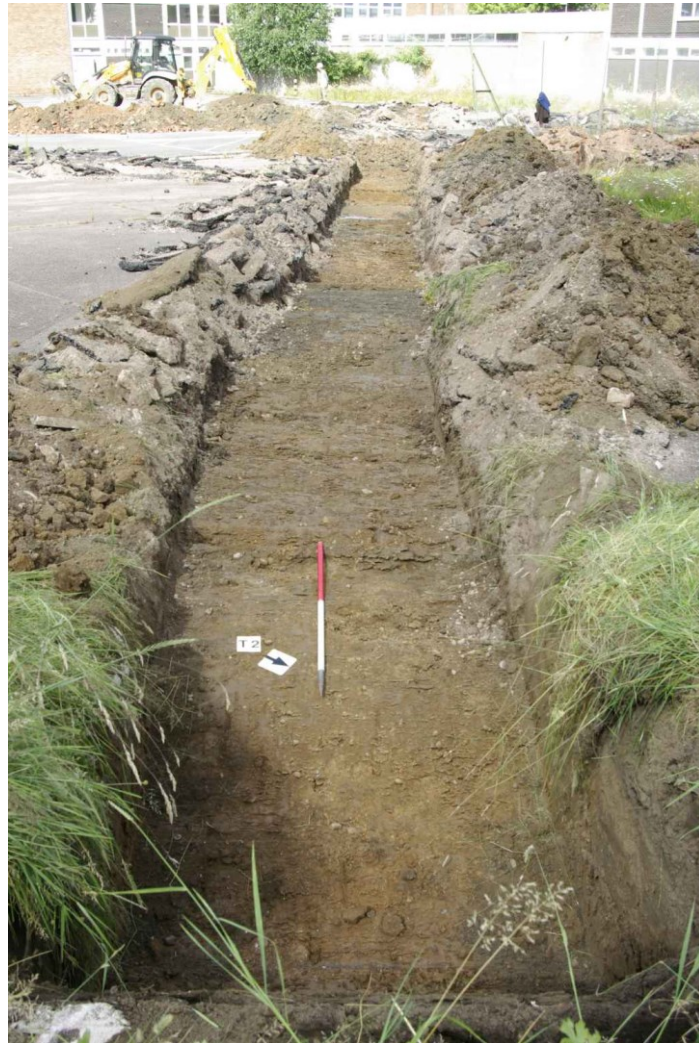
Figure 8 Trench 2

Trench 2 was placed in the south-eastern corner of the site partially on the tarmac and extending 3m into a large turf bank to the south-east. The trench was laid out on a west-south-west to east-north-east alignment and was 28.2m long. Excavation of the bank showed it to consist almost entirely of clean mid grey brown silty-sand with a thickness of 0.6m. Beneath this was a 0.2m thick layer of mid-red brown sandy-clay subsoil. Elsewhere along the trench the tarmac car park surface had been laid on a bed of sand and gravel with building rubble mixed in. Between 0.2m and 0.12m of subsoil survived beneath this area. The natural substratum consisted of mid-orange brown clay-sand with occasional gravel pockets (Fig. 8). A large area of apparently contaminated natural substratum smelling strongly of diesel was encountered half way along the trench. Beneath the car park the trench depth varied between 0.4m and 0.45m increasing to 0.95m beneath the bank material.

No archaeological features or deposits were present in this trench.

Looking south-west. 1m scale. The dark patch is the contaminated area

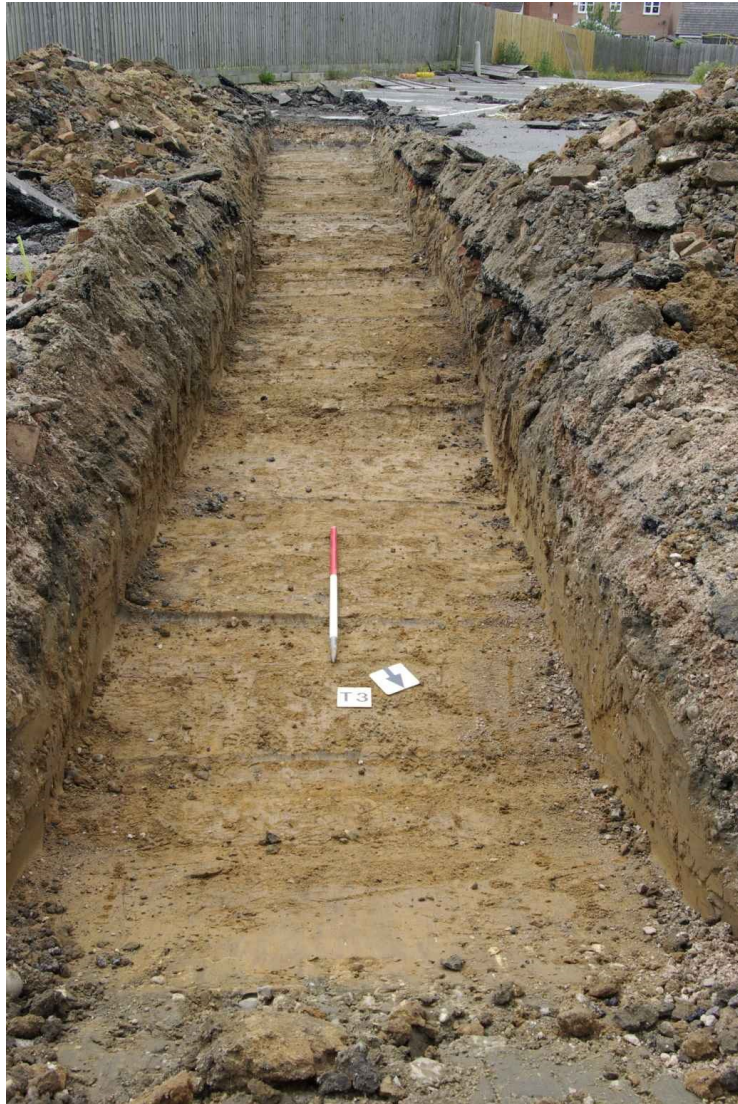
Trench 3 was placed towards the southern boundary of the site but had to be shortened due to the presence of a live cable running along the edge of the car park. The trench followed a north-north-east to south-south-west alignment and was 16.8m long. Removal of the tarmac layer exposed a make-up and rubble layer over a disturbed mid red brown subsoil which contained a large amount of brick rubble. Between 0.55m and 0.6m below the car park surface was the natural substratum consisting of a mid-orange brown clay-sand (Fig. 9).

No archaeological features or deposits were present in this trench.

Figure 9 Trench 3  
Looking south-west. 1m scale

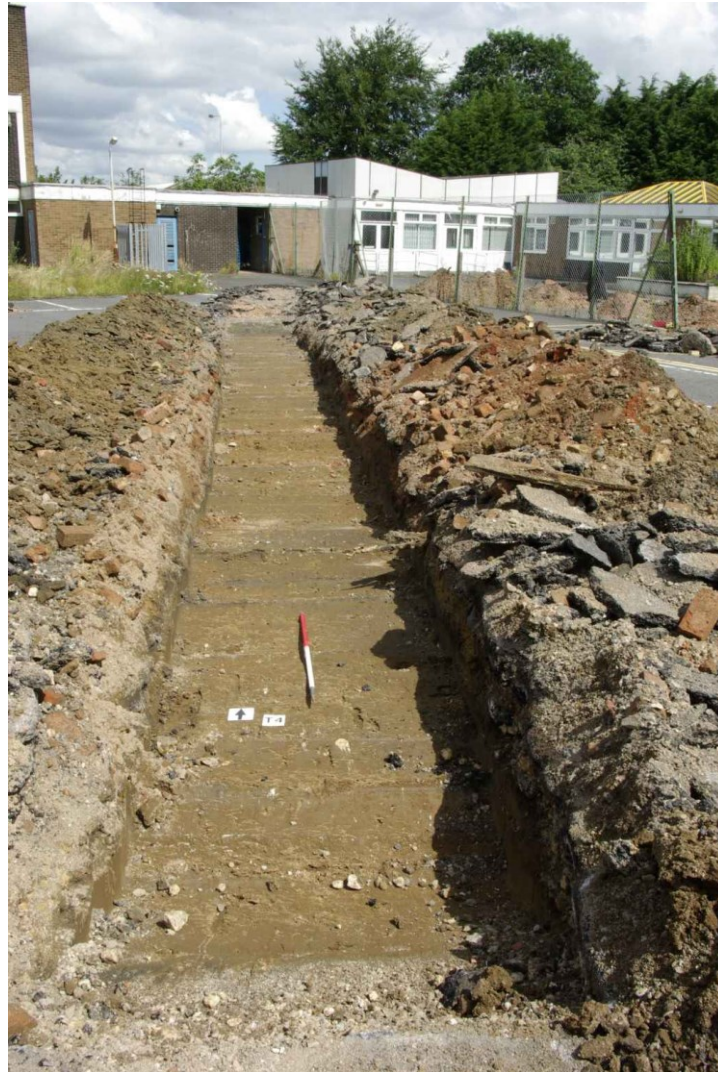
Trench 4 was placed towards the eastern edge of the main car park on a north to south alignment. A total length of 29.5m of tarmac was removed but when the trench area was CAT-scanned for a second time a live cable was detected near to the north end. This area was therefore left unexcavated leaving a 19.6m long excavated trench (see Fig. 6). Removal of the tarmac revealed a thick layer of bricks creating a domed surface for the car park to allow water runoff. Below the bricks was a layer of make-up and rubble extending down to the natural substratum between 0.4m and 0.65 below present ground surface (Fig. 10).

No archaeological features or deposits were present in this trench.

Figure 10 Trench 4  
Looking north. 1m scale

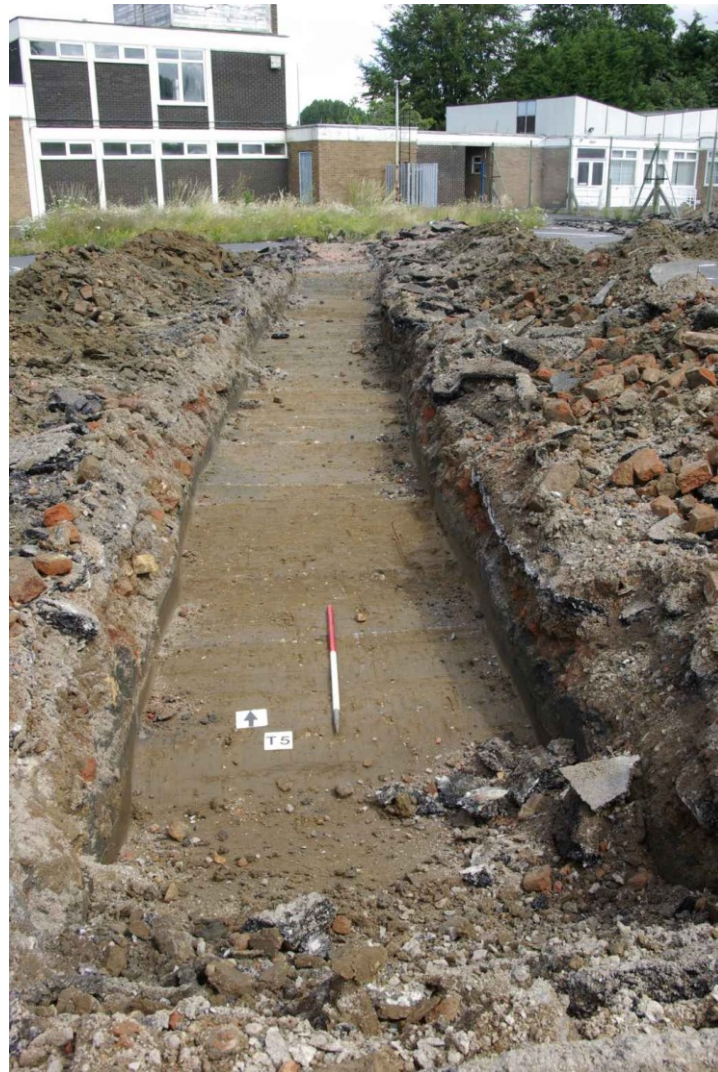
Trench 5 was placed on a parallel alignment to the west of Trench 4. Once again the removal of the tarmac revealed a live cable running across the northern end of the trench. It had been intended to extend this trench northwards into a grass area beyond the tarmac but the presence of at least two live cables prevented this. The eventual excavated trench length was 16m. The same layering of brick rubble over make-up on top of the natural substratum observed in Trench 4 was present in this trench although there was a trace of disturbed subsoil 5m from the southern end of the trench (Fig. 11). The trench depth from surface down to natural varied between 0.45m and 0.70m.

No archaeological features or deposits were present in this trench.

Figure 11 Trench 5  
Looking north. 1m scale

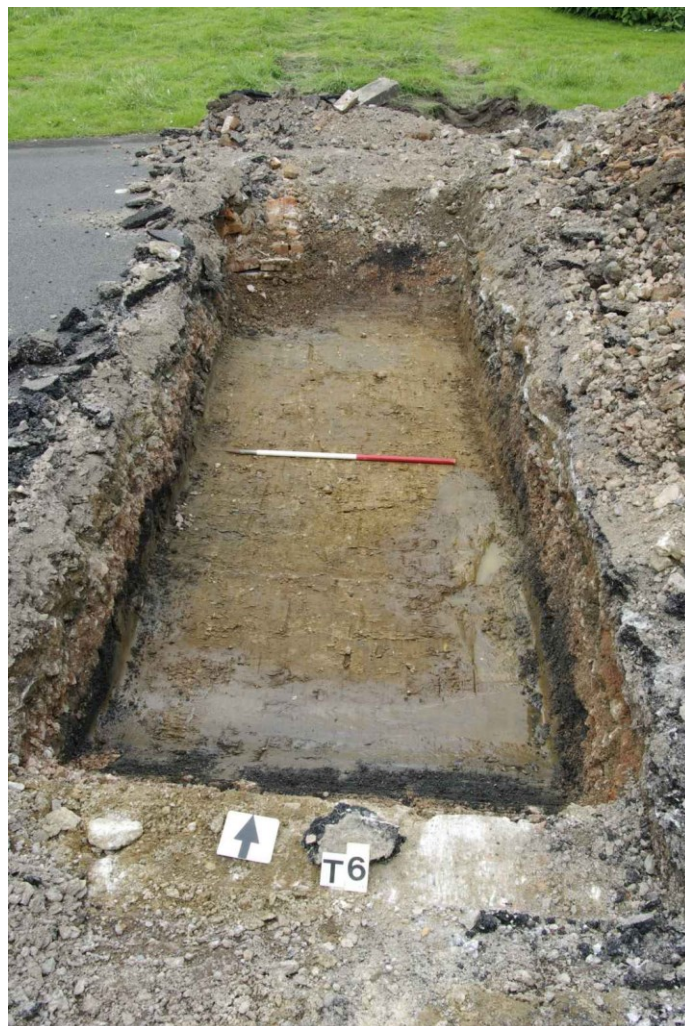
Trench 6 was placed on the northern side of the ambulance station across the perimeter roadway on a north to south alignment. The original intention was to run the trench into the grass verge or to run along the road on a north-east to south-west alignment but a live cable was detected running along the edge of the verge and roadway and a probable sewer or drain was thought to run across the road to the west. The main gas supply ran across the road to the east. The tarmac was removed which appeared to be laid on a thin bed of concrete. Layers of rubble and make-up were removed to expose a thin layer of mid-red brown sandy clay subsoil approximately 0.07m thick which may be redeposited material. A brick-built culvert made with later 20th century bricks was encountered at the northern end of the trench. This was left in-situ as it may contain services. A thicker band of concrete below the curb on the southern side of the trench was also left in place as it was getting quite close to the drain or sewer. The natural substratum consisted of mid-yellowish brown clayish sand (Fig. 12).

No archaeological features or deposits were present in this trench.

Figure 12 Trench 6  
Looking north-west. 1m scale. Brick structure in top left corner
