**An Archaeological Evaluation on
Land at Hamilton Lane,
Leicester**

NGR: SK 64206 06771 (centre)

ULAS Report No. 2016-155v3
©2016

For: Bellway Homes East Midlands Limited

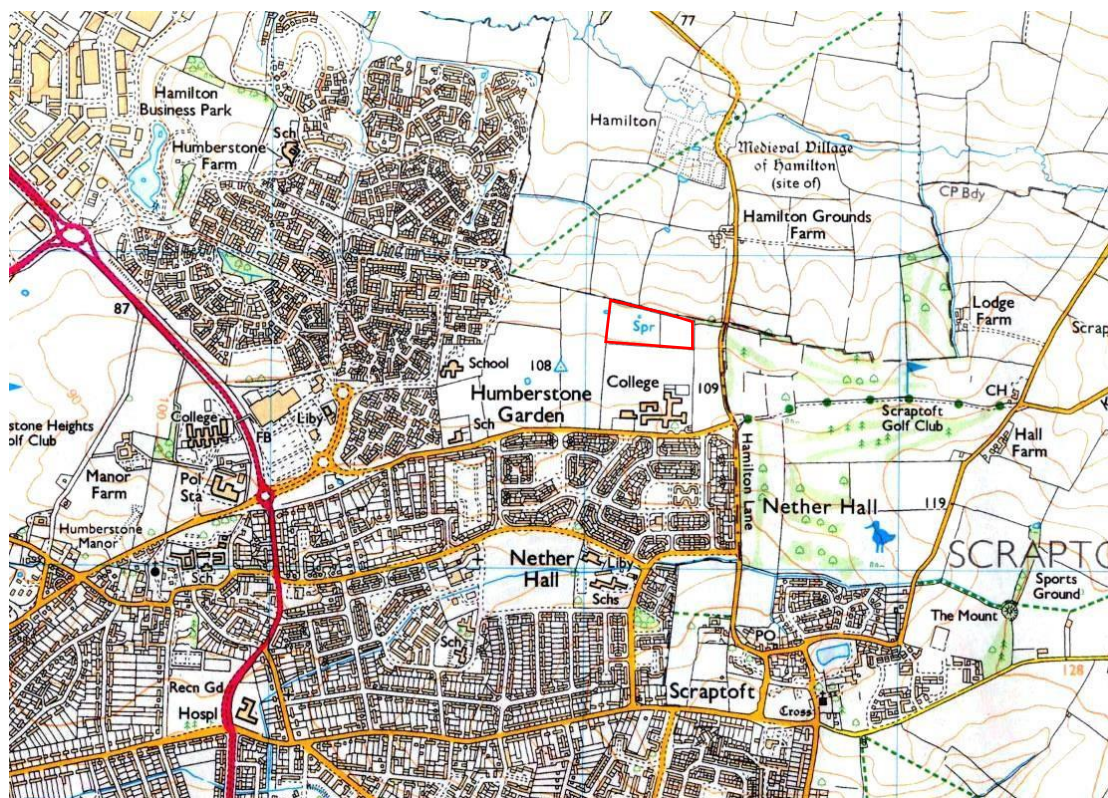
Figure 1 Site location

Note that the entire area to the west of the site is now a housing estate

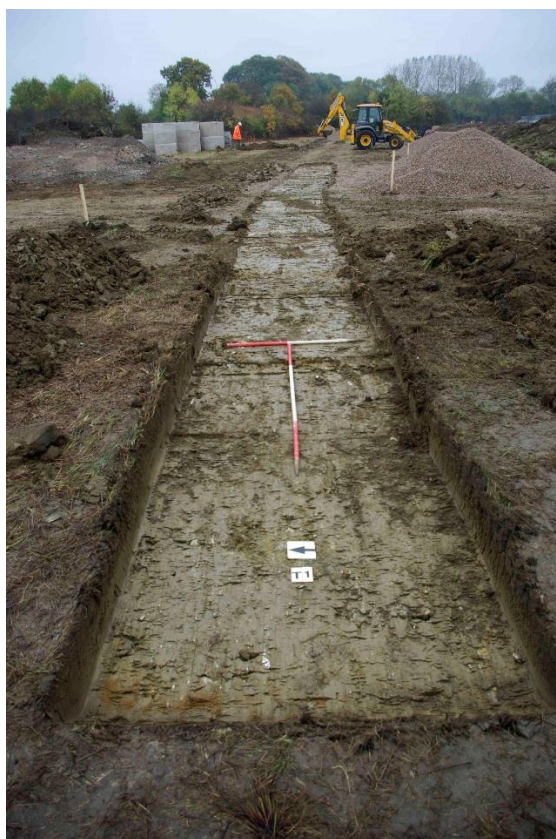
Figure 4 Trench 1
Looking east. Trench 2 being excavated in background. 1m and 2m scales

Trench 1 was located towards the south-west corner of the development site and placed to investigate the area for the proposed estate road (Fig.4). As already noted the road had been stripped down to the natural substratum shortly before the start of the evaluation although this stripping had, in fact, only removed approximately 0.25m of overburden. At the west end of the trench 0.1m of dark grey brown silty-clay material roughly equivalent to topsoil was removed to expose a similar but slightly lighter subsoil with an average depth of around 0.15m. Both of these layers appeared to be disturbed. The natural substratum consisted of a mid-greenish brown clay with chalky inclusions and some flint nodules. The same substratum was present across the whole site. Because the roadway had already been stripped by site contractors the eastern end of the trench was scraped clean with the JCB bucket by removing the upper 30mm of natural substratum.

No archaeological features or deposits were present within this trench.

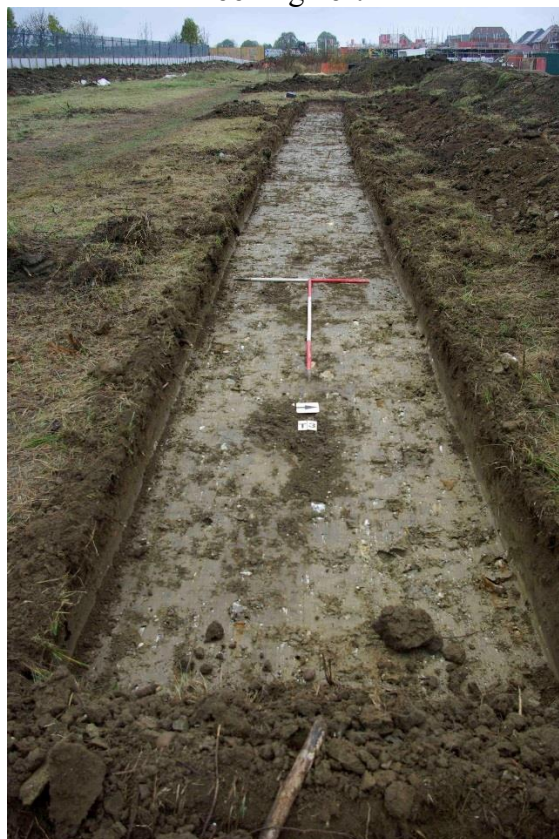
Figure 6 Trench 3
Looking west. Note height of adjacent school playing field on left

Running on an east to west alignment to the south of the roadway Trench 3 topsoil and subsoil appeared to be quite mixed and disturbed (Fig. 6). Another field drain was observed close to the west end of the trench. Interestingly the school playing field which is 20m to the south of this trench is around 1m higher than the development site. This may suggest that some landscaping may have taken place either by reducing this site or raising the playing field.

No archaeological features or deposits were present within this trench.

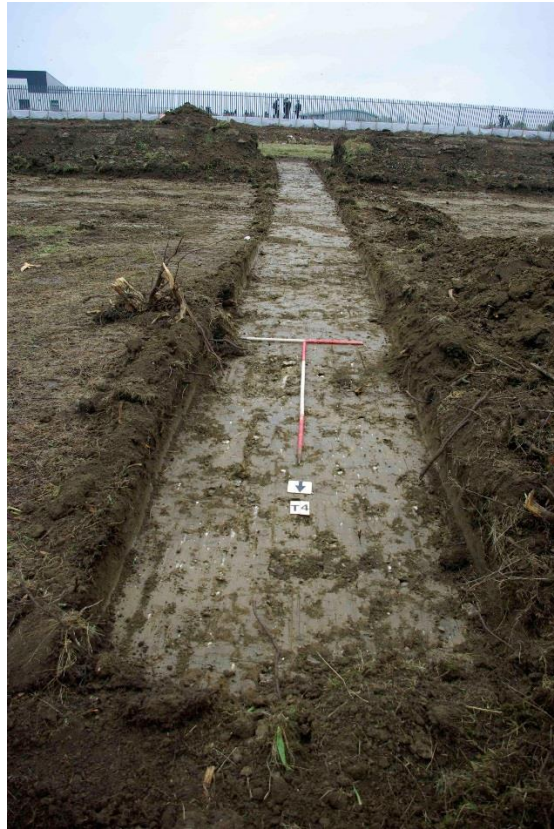
Figure 7 Trench 4

Looking south across site roadway towards school playing field

As with Trench 2 this trench cut across the site roadway (Fig. 7). Another gravel-filled land drain was observed running across the otherwise empty trench

No archaeological features or deposits were present within this trench.

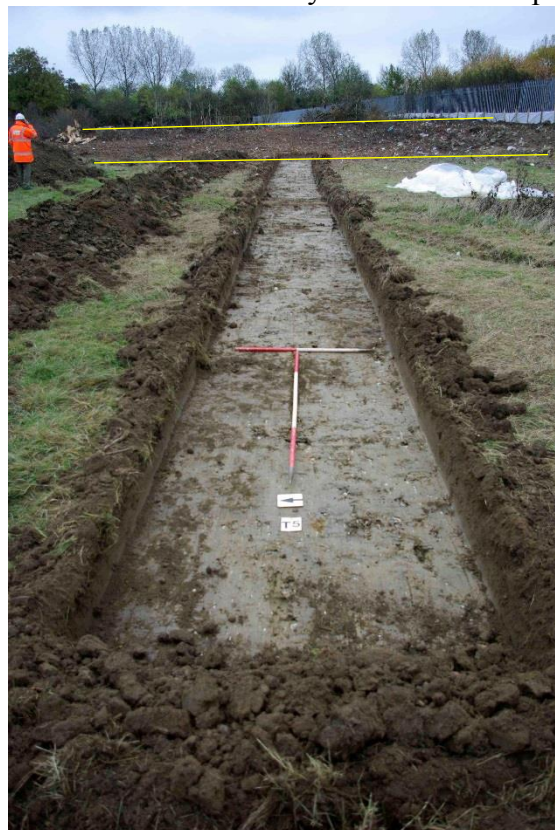
Figure 8 Trench 5

Looking east towards hedgeline running across centre of site (top and bottom of bank highlighted)

The eastern end of Trench 5 partially cut into the north to south bank and former field boundary running across the site (Fig. 8). The bank sits almost 0.8m higher than the surrounding land and is only slightly lower than the school playing field. It may be possible that this represents the original ground level of the site which has since been reduced hence the lack of any real topsoil or subsoil.

No archaeological features or deposits were present within this trench.

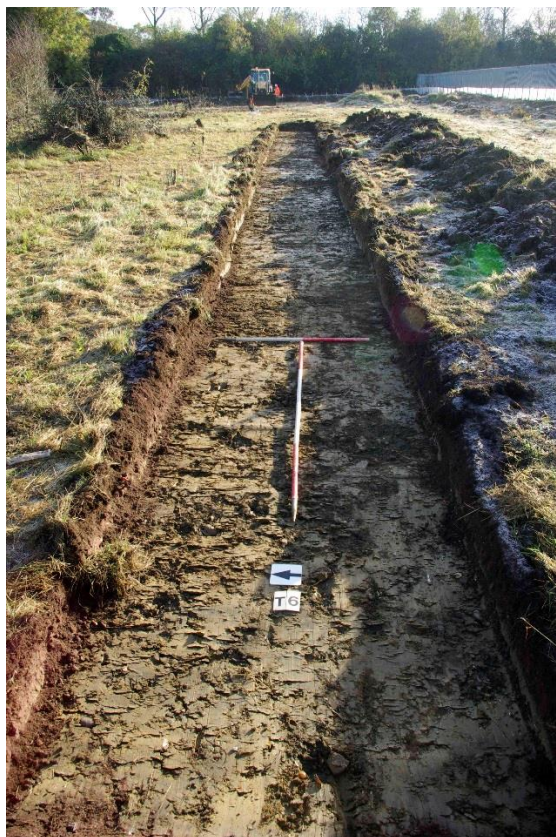
Figure 9 Trench 6
Looking east. Trench 7 being excavated in distance

Very little distinction could be seen between the topsoil and subsoil in the trench (Fig. 9). Disturbed ground around the topsoil of this trench and around Trench 7 appeared to be full of modern rubbish which once again indicates that the area has undergone a high degree of disturbance.

No archaeological features or deposits were present within this trench.

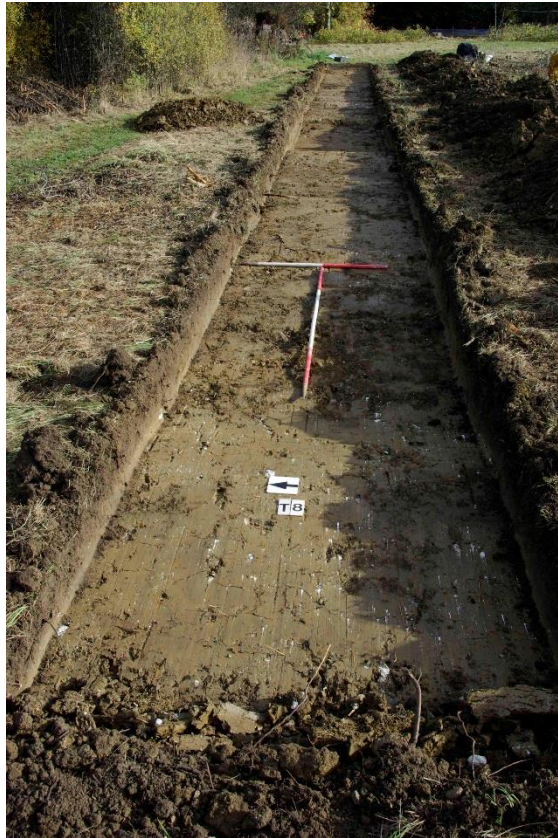
Figure 11 Trench 8
Looking east. The dip in the natural can be seen adjacent to the spoil heap on the left

Trench 8 was located near to the north-east corner of the site (Fig. 11). Only a very thin layer of subsoil with a depth between 0.05m and 0.1m was observed. A slight shallow sided dip in the level of the natural substratum was observed close to the centre of the trench running from north to south. The dip measured approximately 4m in width and was 0.1m at its greatest depth. There was no difference in the subsoil above it and a single sherd of heavily abraded late medieval pottery was recovered from the base. It is probable that this was a remnant of a plough furrow although no other furrows were found across the rest of the site. It may be a remnant of an earlier field boundary although it does not match any boundaries shown on the first and subsequent editions of the Ordnance Survey.

No archaeological features or deposits were present within this trench.

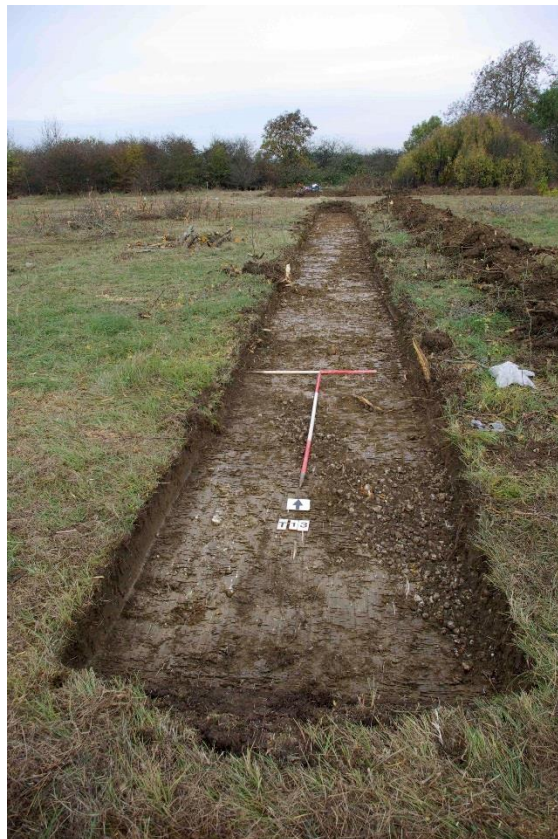
Figure 16 Trench 13

Looking north. Gravel covered land drain in foreground

Three gravel covered modern ceramic land drains were observed running from south-east to north-west across this otherwise blank trench (Fig. 16). As with almost all of the other trenches the difference between the topsoil and subsoil was quite indistinct and the excavated trench depth was quite shallow.

No archaeological features or deposits were present within this trench.

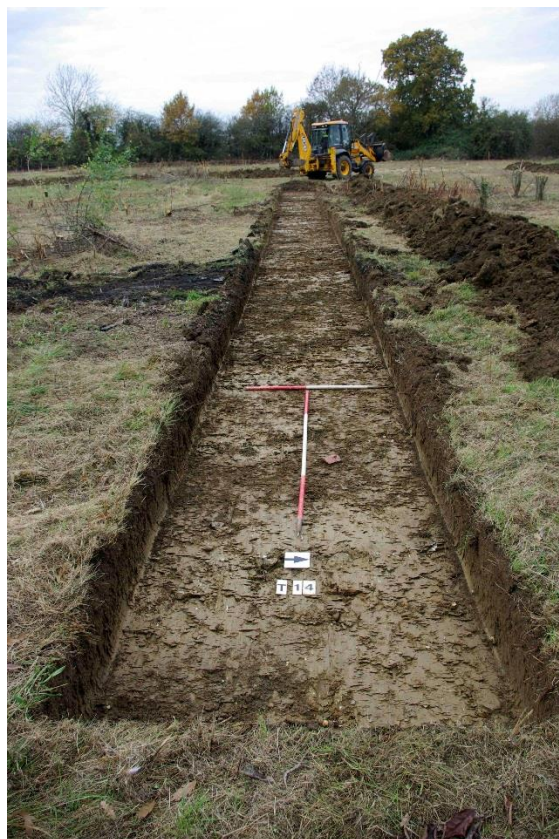
Figure 17 Trench 14
Looking west. Burnt area in centre of trench

The area around Trench 14 appears to be quite boggy in wet conditions as there were a number of deep wheel ruts running across this area. Excavation of this trench revealed the wheel ruts to cut into the natural substratum in several places (Fig. 17). A large bonfire area had stained the soil down to the natural substratum. Elsewhere the natural remained undisturbed.

No archaeological features or deposits were present within this trench.

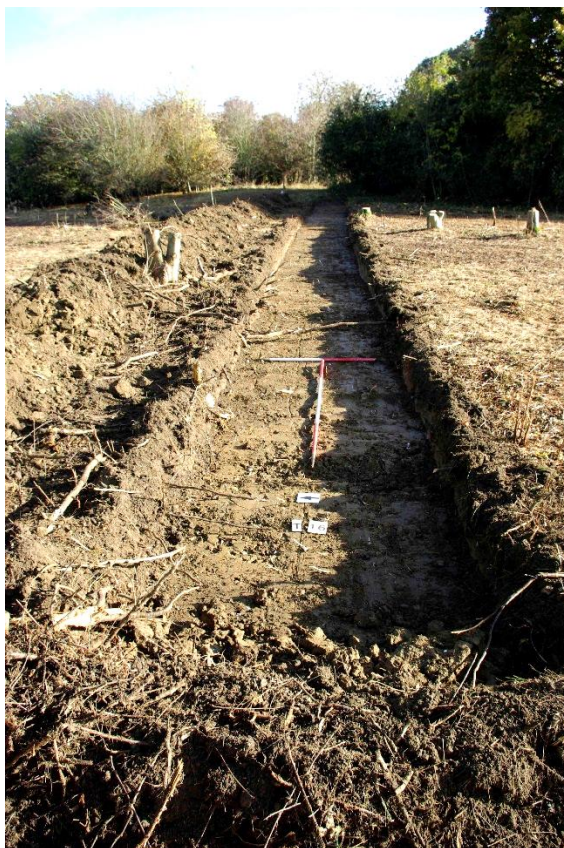
Figure 19 Trench 16
Looking east. Banked hedge line at far end of trench

Trench 16 was placed across the northern end of the banked hedge line running across the middle of the site (Fig. 19). At this point the surrounding land was at a similar height to the bank. Once again the natural substratum was heavily disturbed by root action.

No archaeological features or deposits were present within this trench.

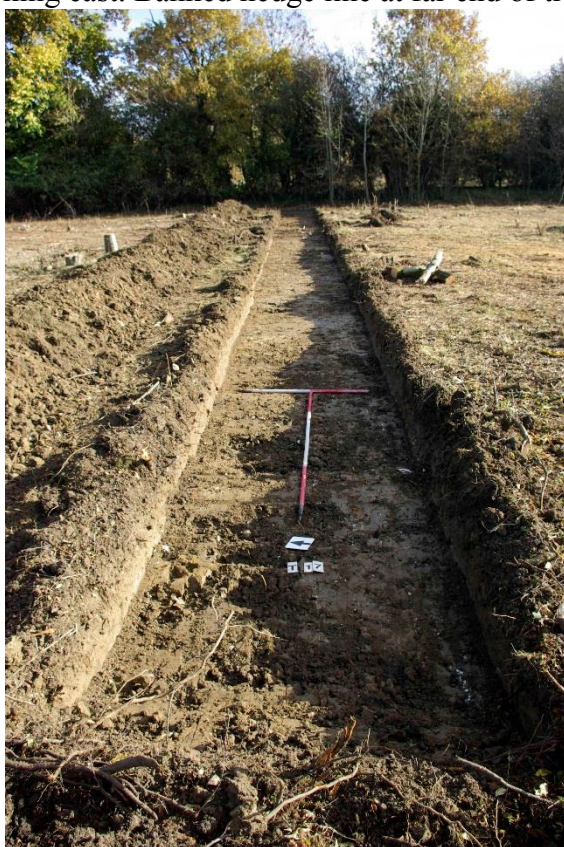
Figure 20 Trench 17
Looking east. Banked hedge line at far end of trench

Trench 17 also butted against the banked hedge line (Fig. 20). Heavy root disturbance was encountered from recently felled trees in this part of the site.

No archaeological features or deposits were present within this trench.

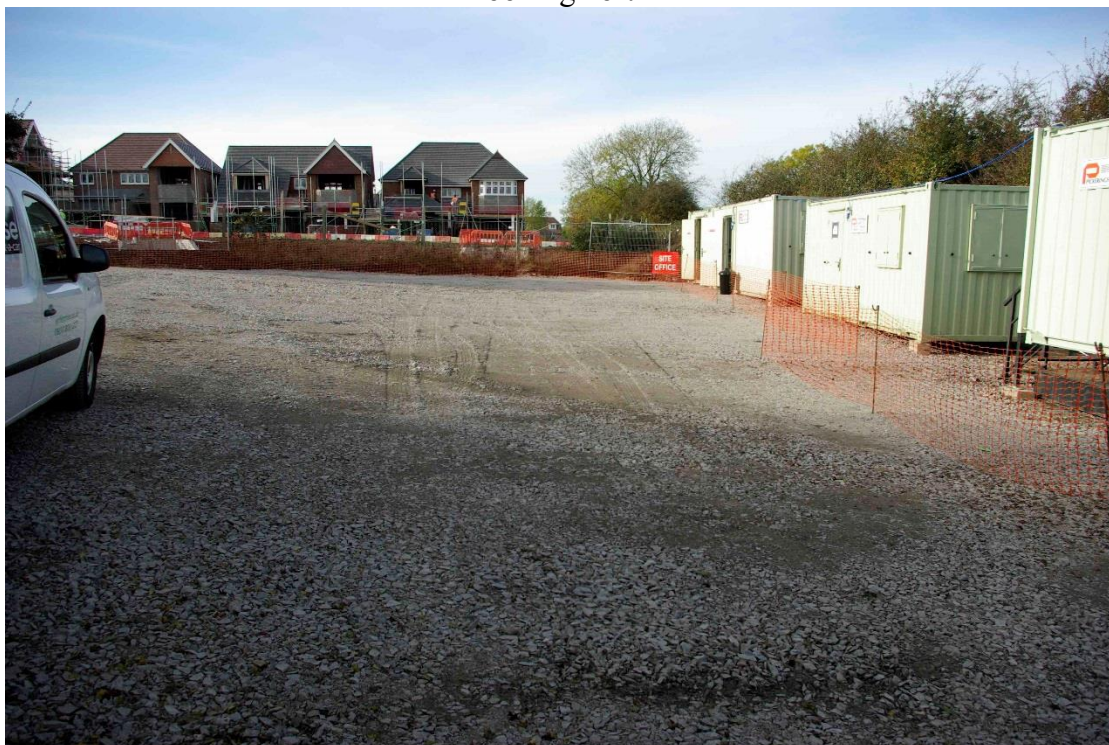
Figure 22 North-west corner of site and site car park
Looking west

Three trenches were specified in the WSI to be located in the north-western corner of the development site. Prior to arrival on site most of this area had been cleared and stoned to accommodate the site offices and car park thus preventing any further excavation in this area (Fig. 22). The ground appears to have been stripped of overburden and seems likely to have exposed the natural substratum.

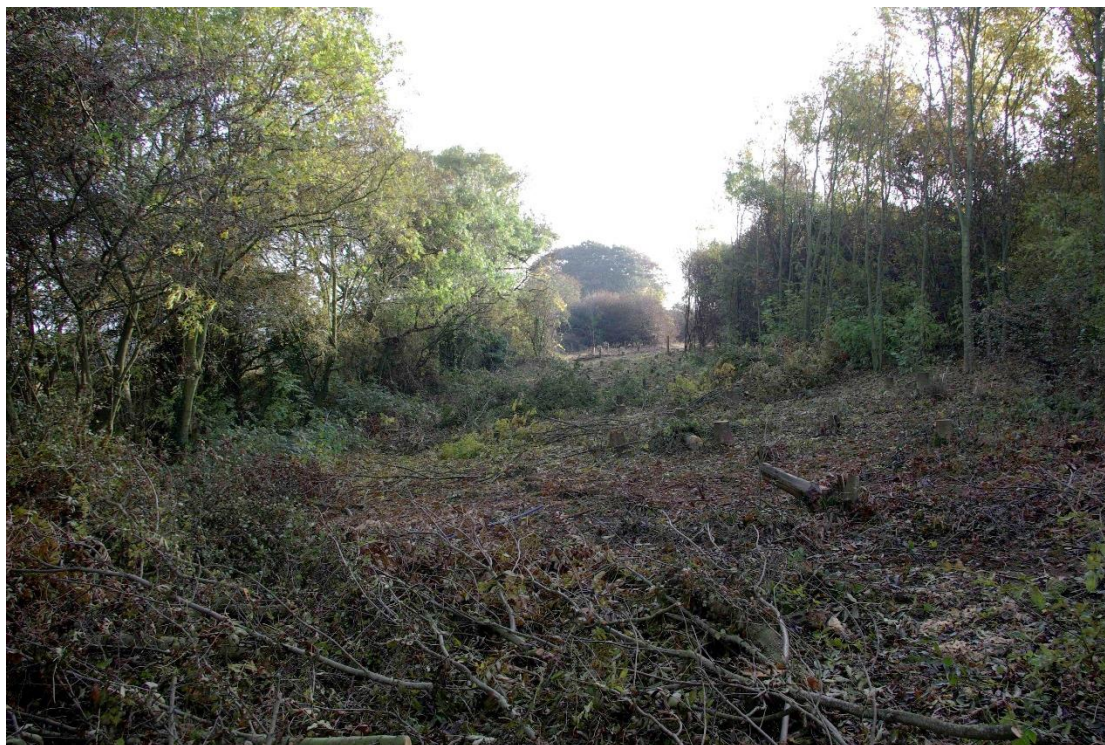
Figure 23 Unexcavated trench location
Looking east. Trench was to be located within tree line on right of photo

Another trench was to be excavated to the east of the site car park but at the time of the evaluation was still covered with semi-mature trees which are likely to have caused a great deal of root disturbance (Fig. 23). A final trench should have been excavated in the south-west corner of the site but a large rectangular pond was in this position which had already disturbed the area. The pond appears to have been present for a number of years.
