**An Historic Building Assessment at
Taylor's Farm,
Casterton Lane,
Pickworth, Rutland**

NGR: SK 99702 12489

ULAS Report Number 2016-036
©2016

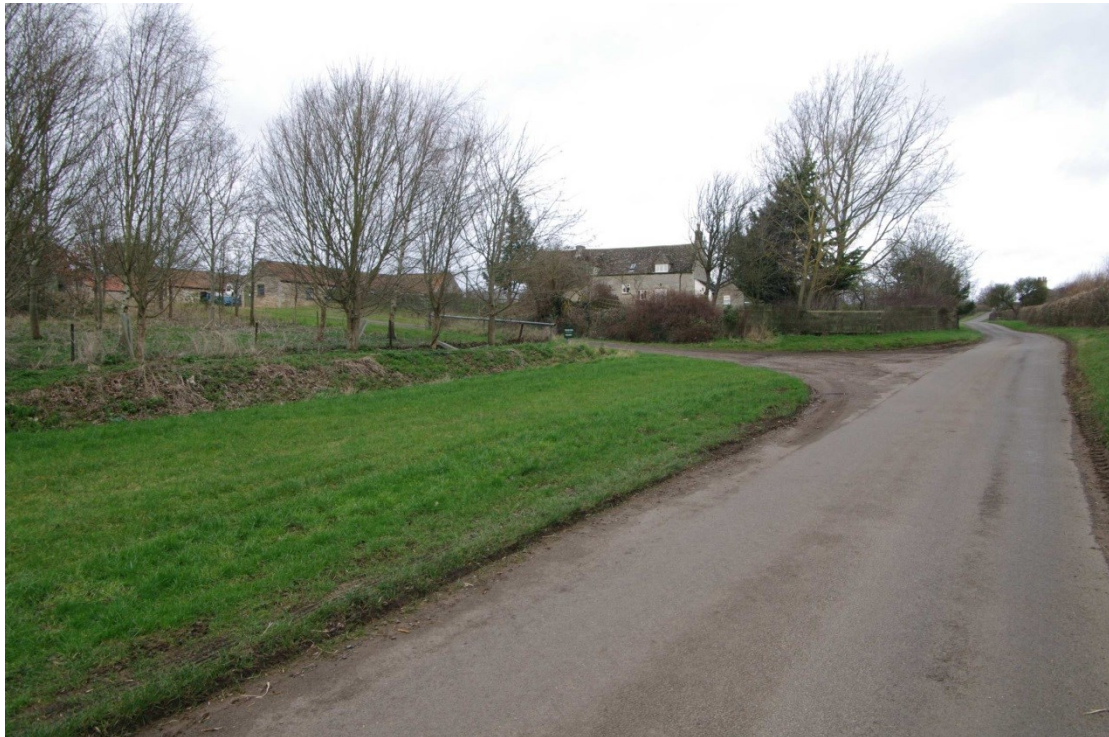
Figure 2 Taylor's Farm from Casterton Lane
Looking north-west. Farmhouse in centre of picture, surveyed buildings to left

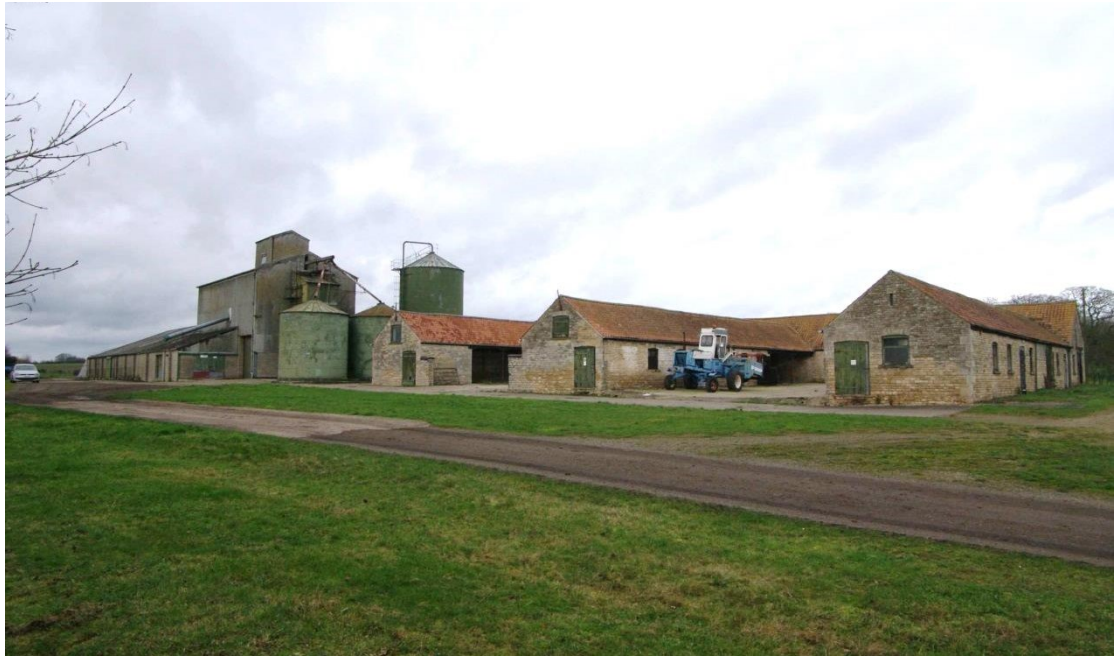
Figure 7 Barns and modern buildings
Looking north-west

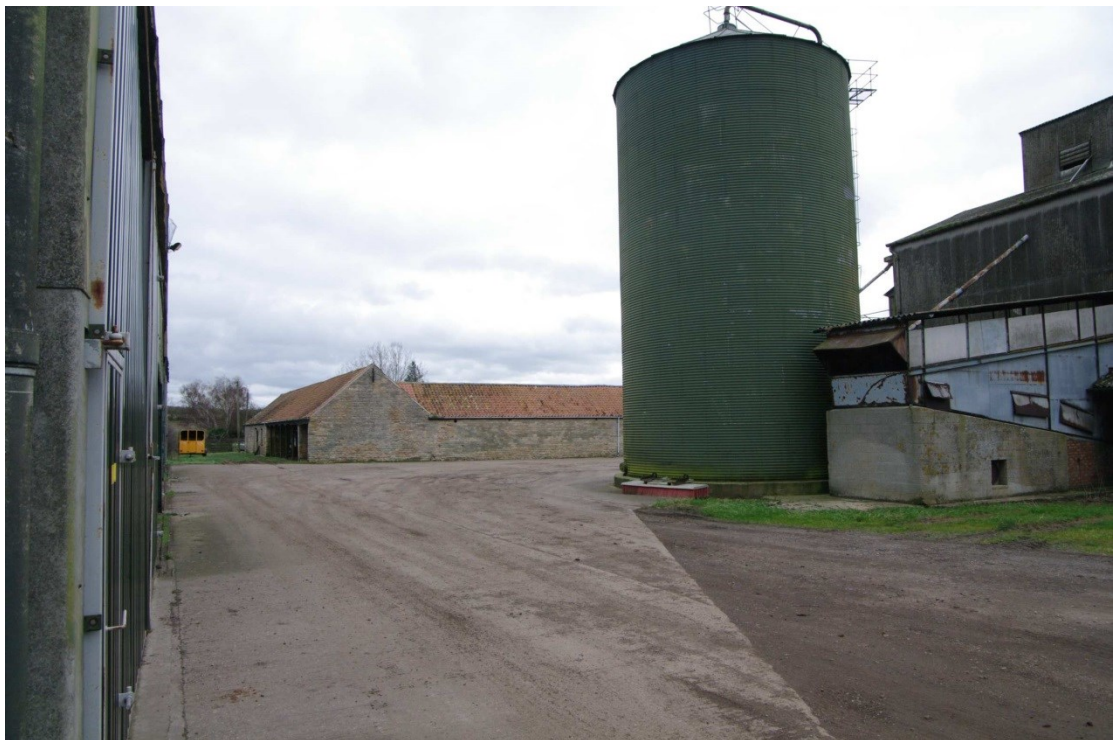
Figure 8 Barns and modern buildings
Looking south-east. Farmhouse behind yellow trailer

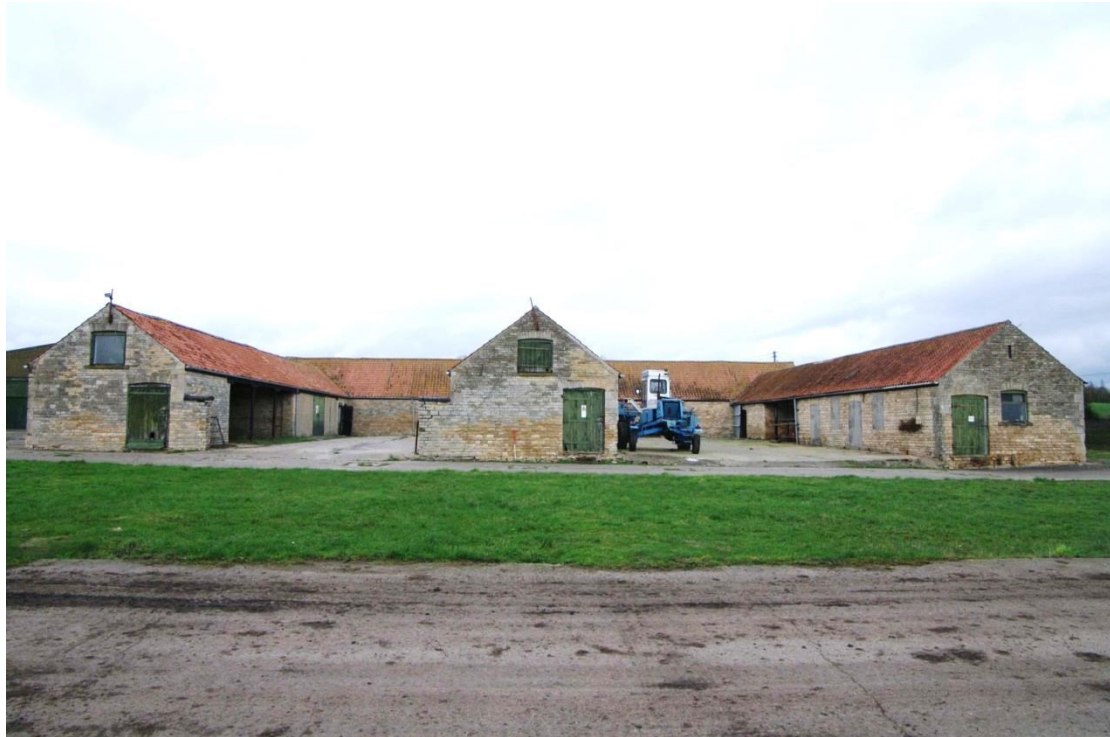
The principal elevation is the south facing elevation and has three gable ends of the three ranges which create two rectangular courtyards, or foldyards (Fig. 9). The ranges are not evenly set apart so that the east yard is slightly wider than the west yard. The western range has a flat gable end with a stable door and a window set in

Figure 9 South facing elevation
Looking north. 1m scale

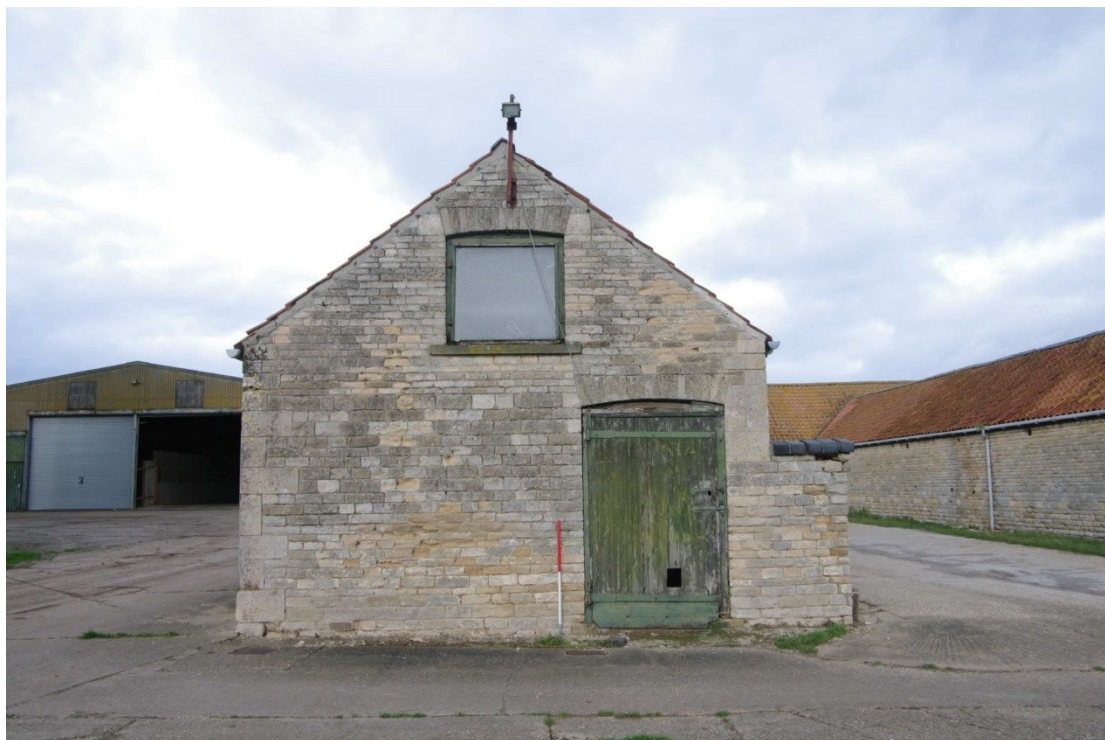
the gable apex (Fig. 10). The window has a single pane of glass and is likely to be a modern replacement for a hayloft door as the pintles for strap hinges are still present. A stub of wall on the eastern side of the gable forms part of the wall and gateway into the western yard.

Figure 10 South facing gable end of western range
Looking north. 1m scale

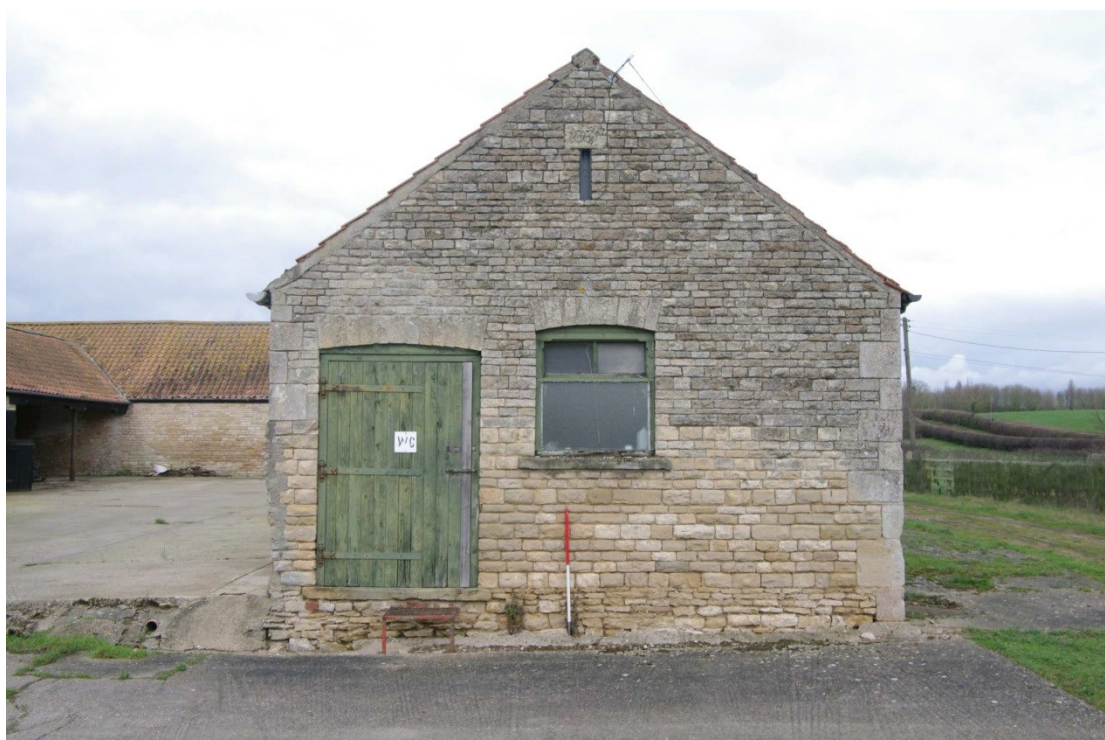
The central range gable end is virtually the same as the west range with the exception of the wooden hayloft door still being in place in the apex. This range is also slightly wider than the west range. Another stub of wall extends into the west yard. Both wall stubs into the west yard are bonded to the main gable walls indicating that they are part of the original plan. The wall on the east side of the gable has been removed leaving a scar in the stonework. This was probably done when the modern metal barn was inserted within the east yard.

The eastern gable end is slightly lower than the other two gables as the building follows the gentle downward slope to the east. There is a door and ground floor level window with a slit vent set into the gable apex (Fig. 11). Above the vent is a rectangular block of limestone with the date 1880 carved onto it.

Figure 11 South facing gable end of eastern range
Looking north. 1m scale. Note date stone above vent and scar left by removal of yard wall to the left of the door

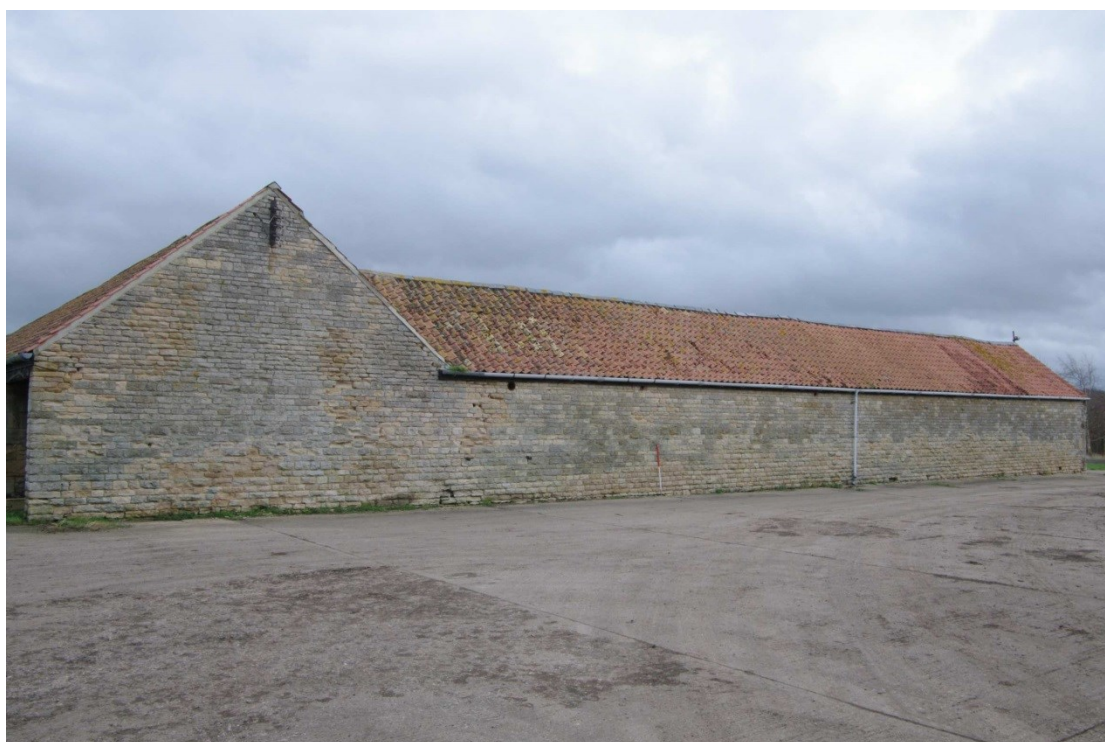
The west facing elevation is a continuous wall running from north to south (Fig. 12). There is no evidence of any blocked doors or windows. The stonework of the gable end of the north range bonds with the wall of the west range showing that both were built at the same time.

Figure 12 West facing elevation
Looking south-east. 1m scale

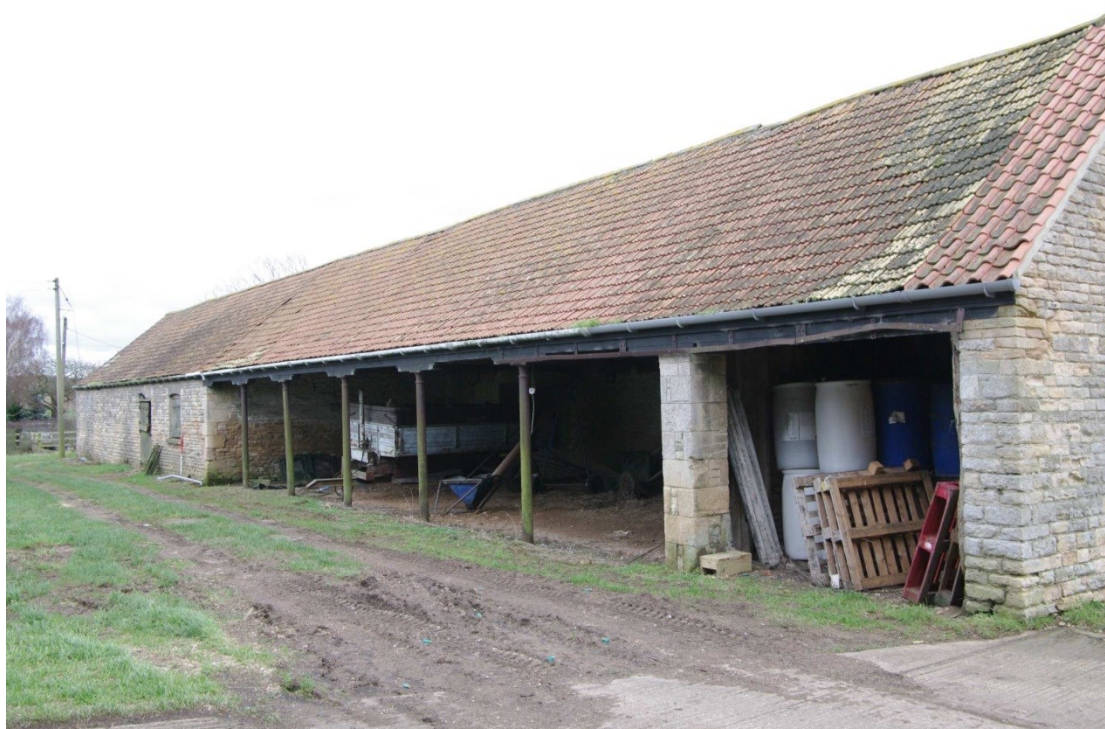
The north facing elevation consists of a six-bay open shed with a separate bay at the west end and a large room accessed by a doorway at the east end (Fig. 13). The roof tiles at the western end have been replaced by modern pan tiles. The open shed, presumably a former cart shed is supported by a series of cast iron columns. At the top of each column is a shaped piece of timber with scroll work at each end (Fig. 14). This decoration is seen above all of the columns on all of the open sheds throughout the building.

Figure 13 North facing elevation
Looking south-east. 1m scale

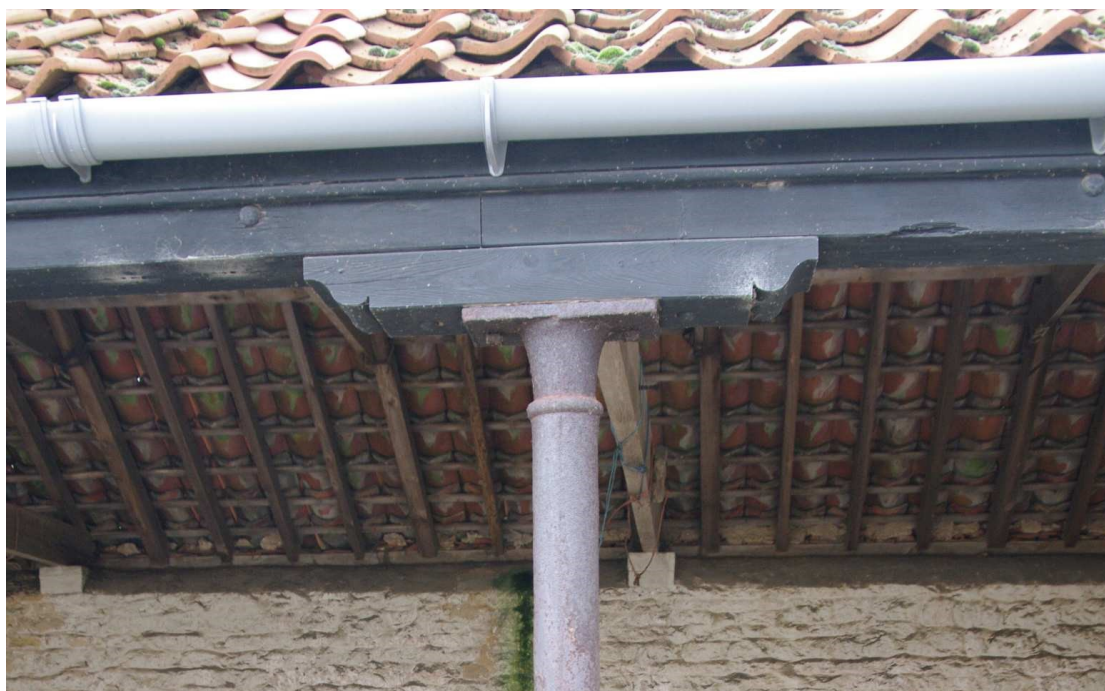
Figure 14 Column detail and woodwork on the open sheds

The preliminary proposals are to convert the barns into dwellings which will retain the same roofline and overall plan. This could have the beneficial effect of preserving what are otherwise redundant structures albeit in a slightly different but still recognisable form. Original features where they survive should be incorporated into the new proposals. Worthy of retention are the cast iron pillars, door furniture and the coat hooks with the Taylor family names on.

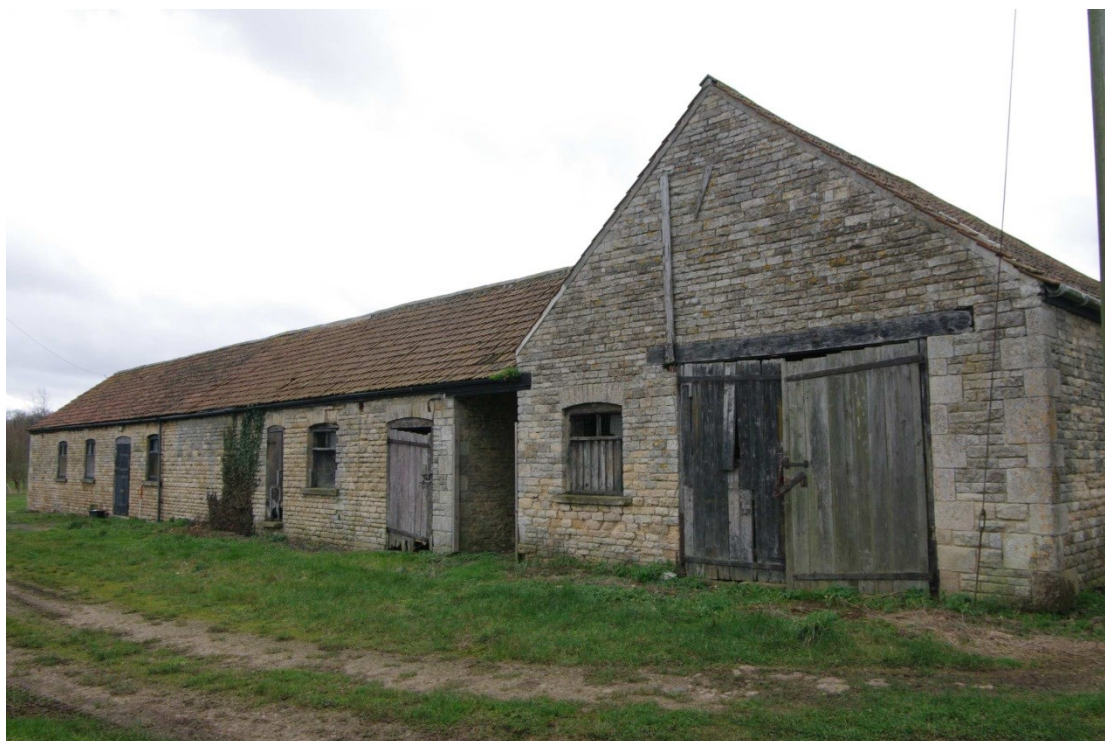
The east facing elevation faces across to the farmhouse and contains a number of doors and windows (Fig. 15). The north range gable end has a double door opening with a substantial timber lintel above. A passageway leads through the range into the eastern yard to allow greater ease of movement from the farmhouse. This elevation has a number of doorways leading into the rooms of the building which can also be accessed from the yard. A narrow doorway leads into a small chicken coop. At the southern end of the elevation three windows have had their glass replaced by modern clear glass to allow more light into the modernised rooms. The wooden frames may also be later replacements.

Figure 15 East facing elevation
Looking south-west. 1m scale

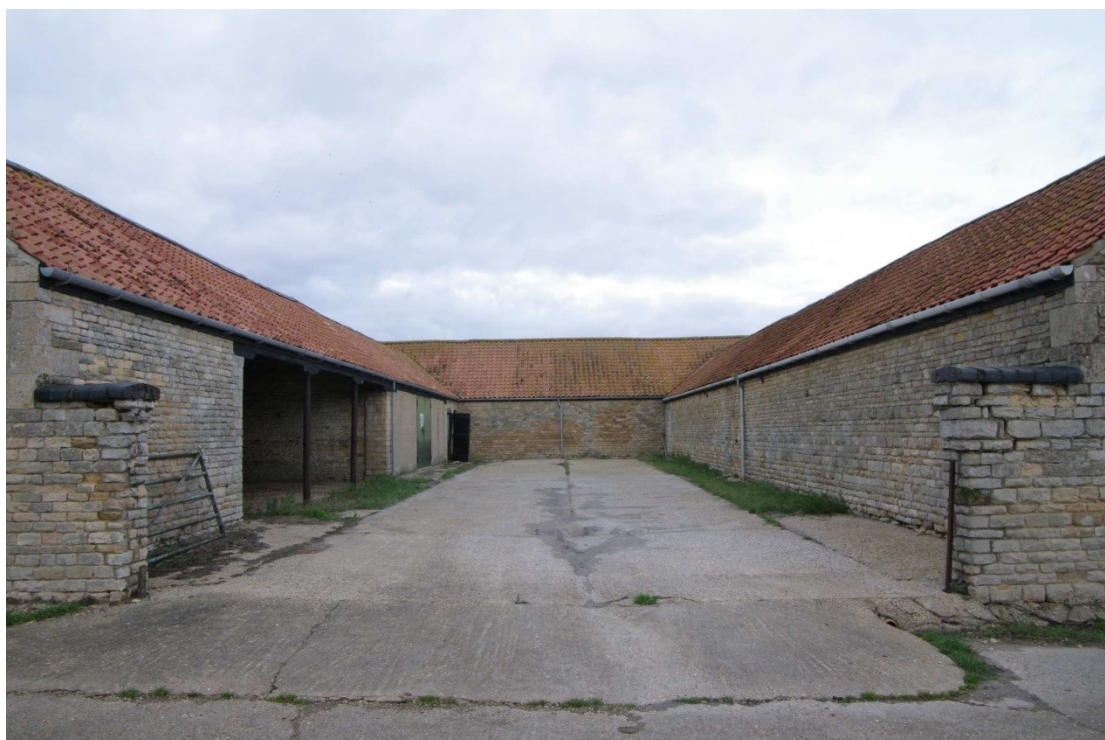
The west yard is the smaller of the two yards and when first built was dominated by two three-bay open sheds running along the western range (Fig. 16). They have the same cast iron pillars as used on the north range cart shed. The northernmost of the two sheds has been blocked by modern breeze blocks to create a chemical store (Fig. 17). There is no access into the north range from this yard. A doorway into the central range has been blocked with modern breeze blocks. The yard has a concrete surface.

Figure 16 West yard
Looking north. Blocked doorway into central range in top right corner

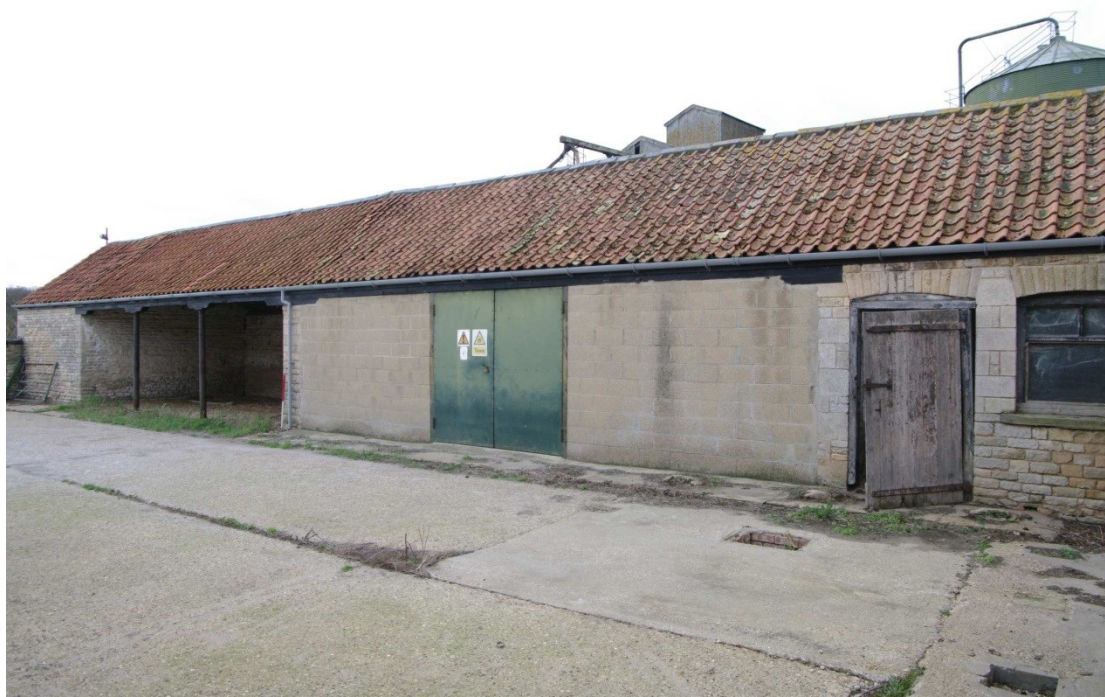
Figure 17 West yard, east facing elevation of west range
Looking south-west. 1m scale

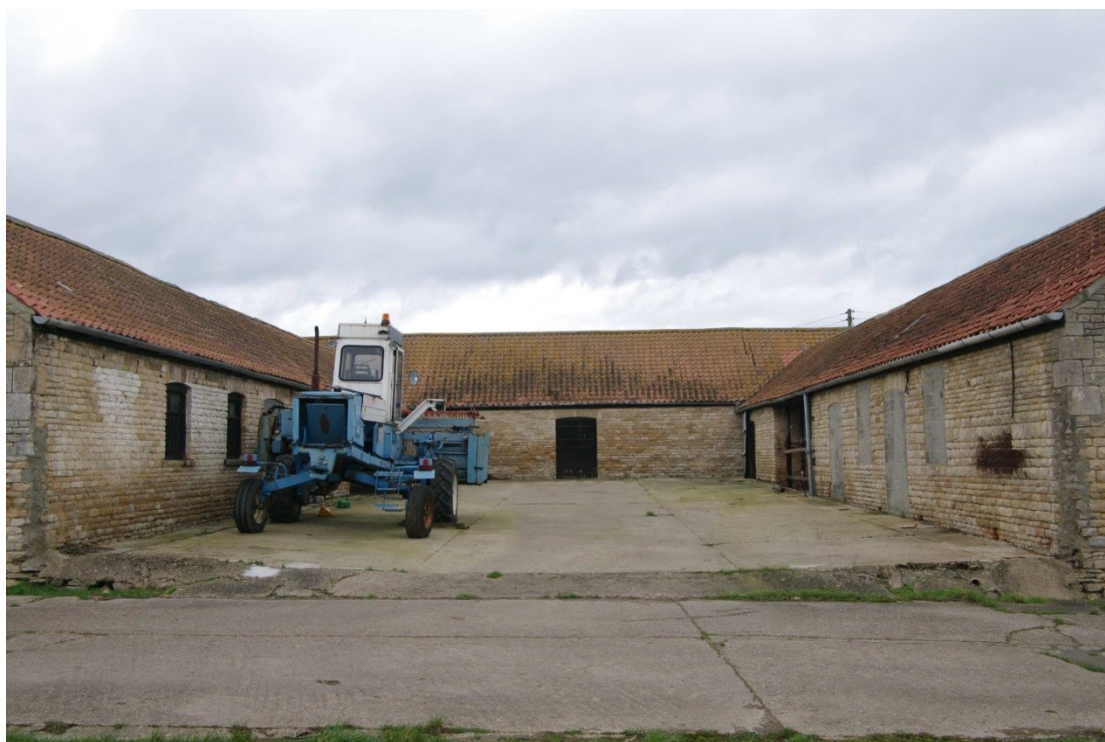
The east yard was until recently filled with a metal-skinned barn structure but this has been removed leaving only the cut-off steel I-beam bases (Fig. 18). The central range has two large barns or stables with vented windows using hit-and-miss boards rather than glazing. A two-bay open shed is at the north end of the central range and has the blocked doorway into the west yard as already noted. A single doorway which leads into the north range is the only access into this range from any of the yards or south ranges. The door and fittings are present but it is boarded over on the inside. As noted earlier the eastern range has a passageway leading out towards the farmhouse. A set of three open pig styes face into the yard (Fig. 19). The styes have sloping ceilings to accommodate the chicken coop above. The remaining rooms to the south have had their windows and frames removed and are blocked with modern breeze blocks.

Figure 18 East yard
Looking north. Note cut off yard wall stubs either side of the yard

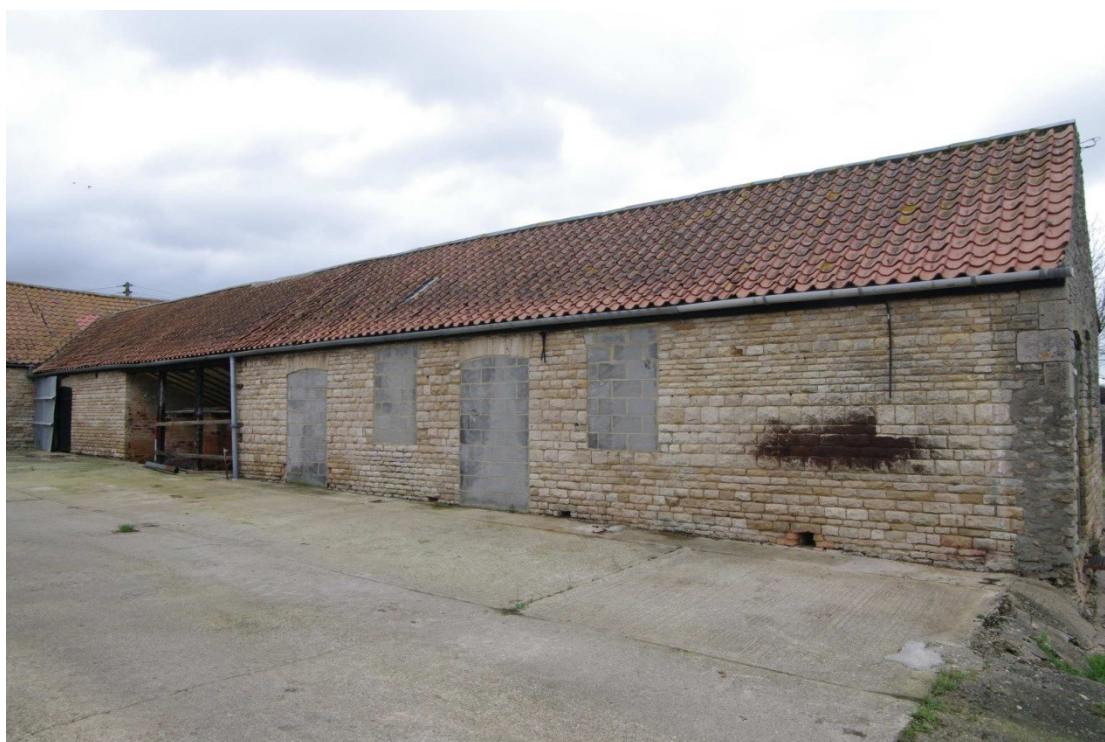
Figure 19 East yard, west facing elevation of east range
Looking north-east

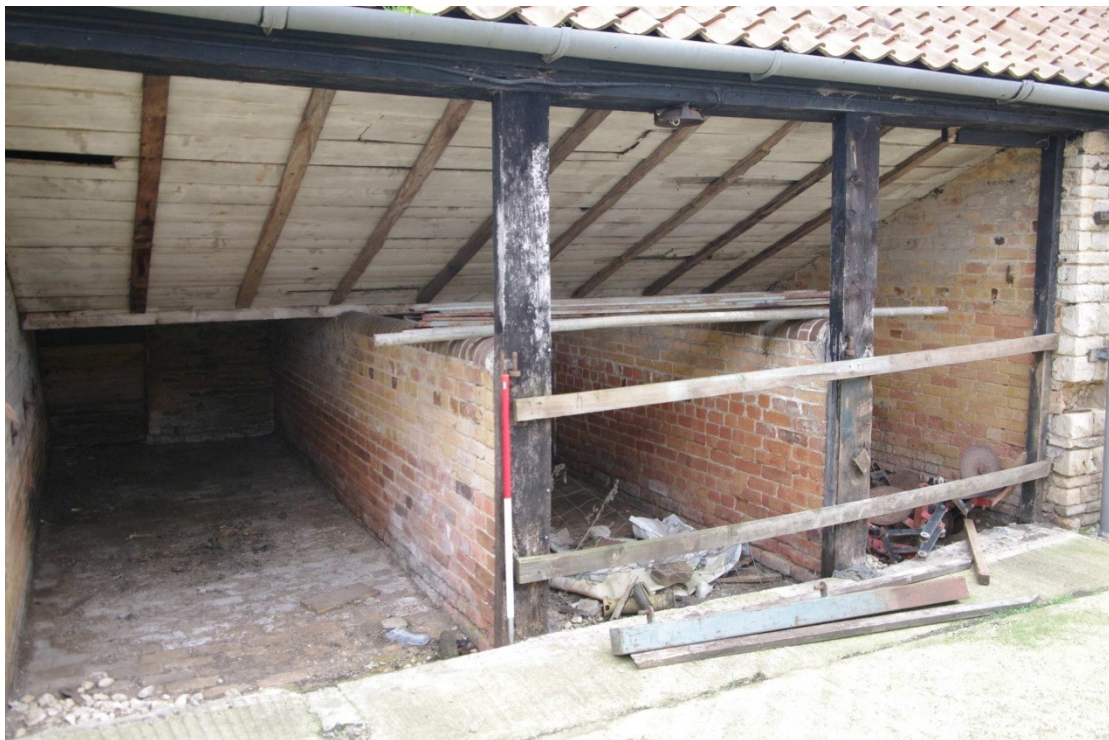
Figure 20 East yard, sties west facing elevation of east range
Looking south-east. 1m scale

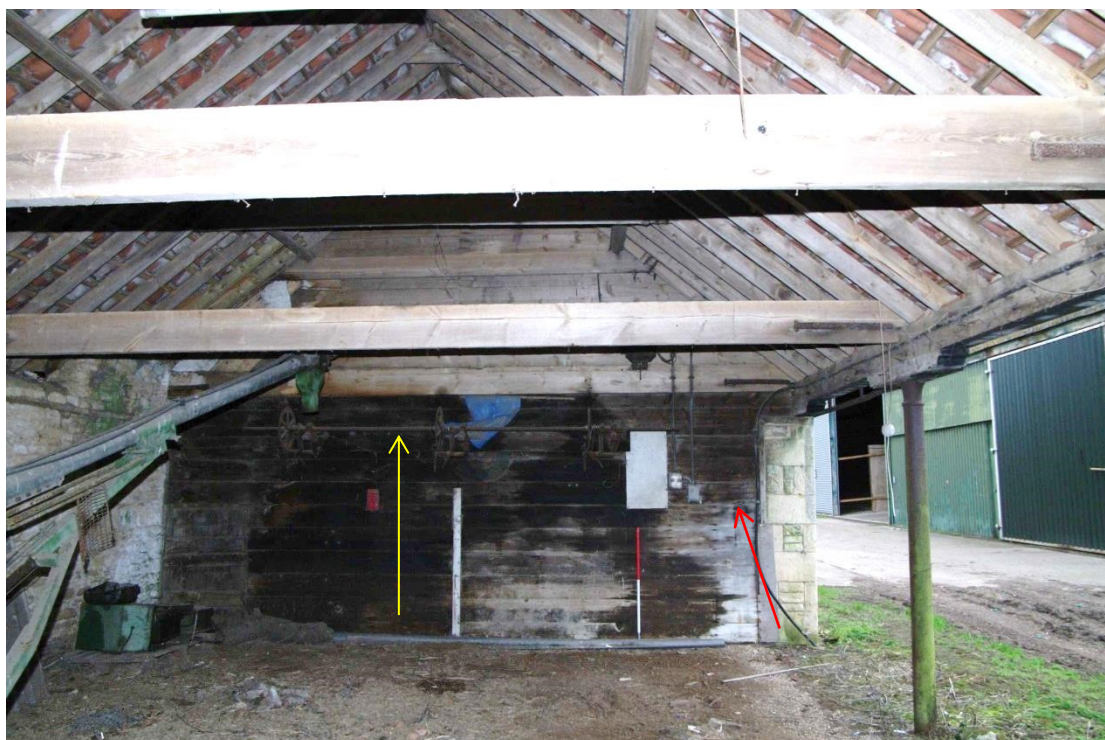
Half of the north range is occupied by the open cart shed which has a floor made from small rounded pebbles. A wooden partition made from wide boards separates the west bay from the main open shed (Fig. 21). This is likely to be original as it butts against a stone pillar rather than against a cast iron post. The partition has a drive shaft and electric motor attached to it (Fig. 22). The electric motor is clearly a later addition and the driveshaft covers an earlier painted-on bull's eye target. Close to the machinery is the carved name of A ROGER and a Chi-Rho symbol (Fig. 23). The style of the carving suggests a reasonably early date, possibly pre 1914.

Figure 21 North range cart shed
Looking west towards wooden partition wall. 1m scale. Machinery shown with yellow arrow. Location of graffiti shown with red arrow (see figs. 17 and 18)

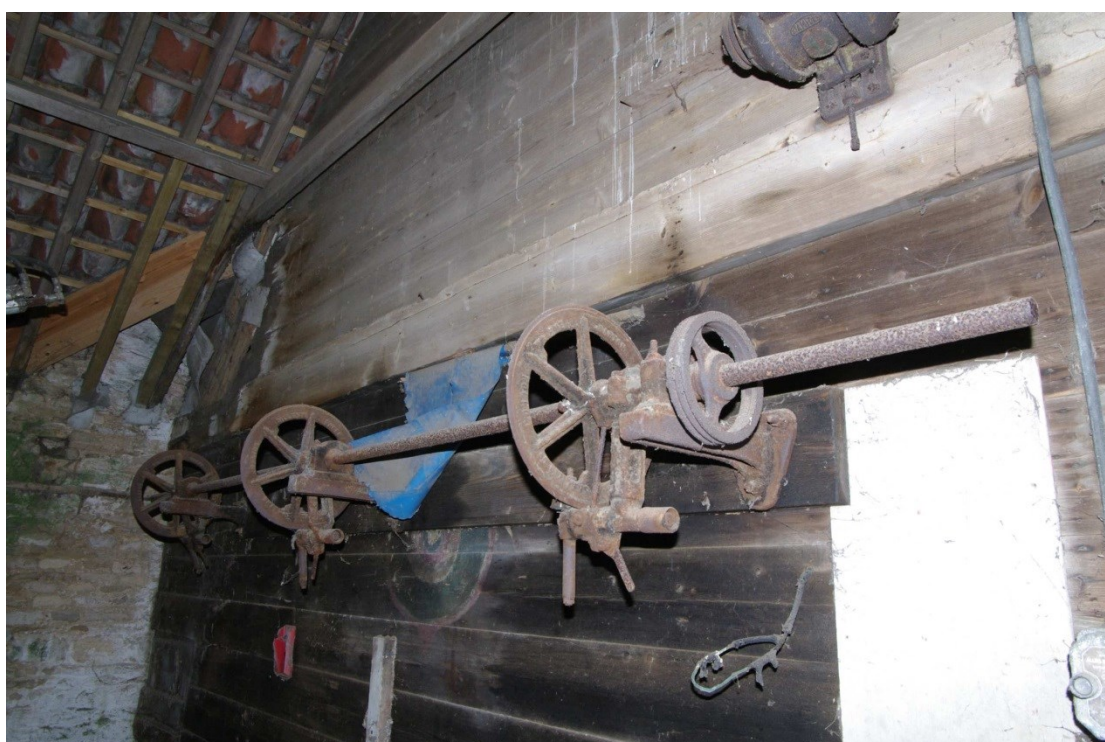
Figure 22 Machinery on west partition wall of cart shed

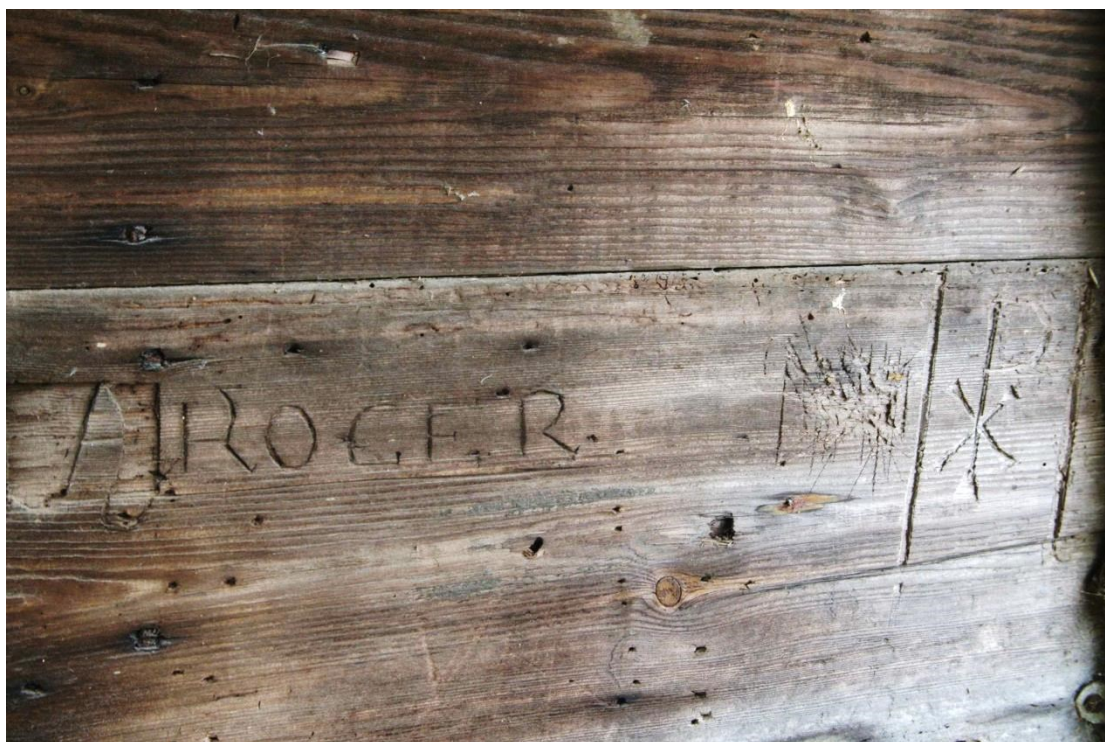
Figure 23 Graffiti on west partition wall of cart shed

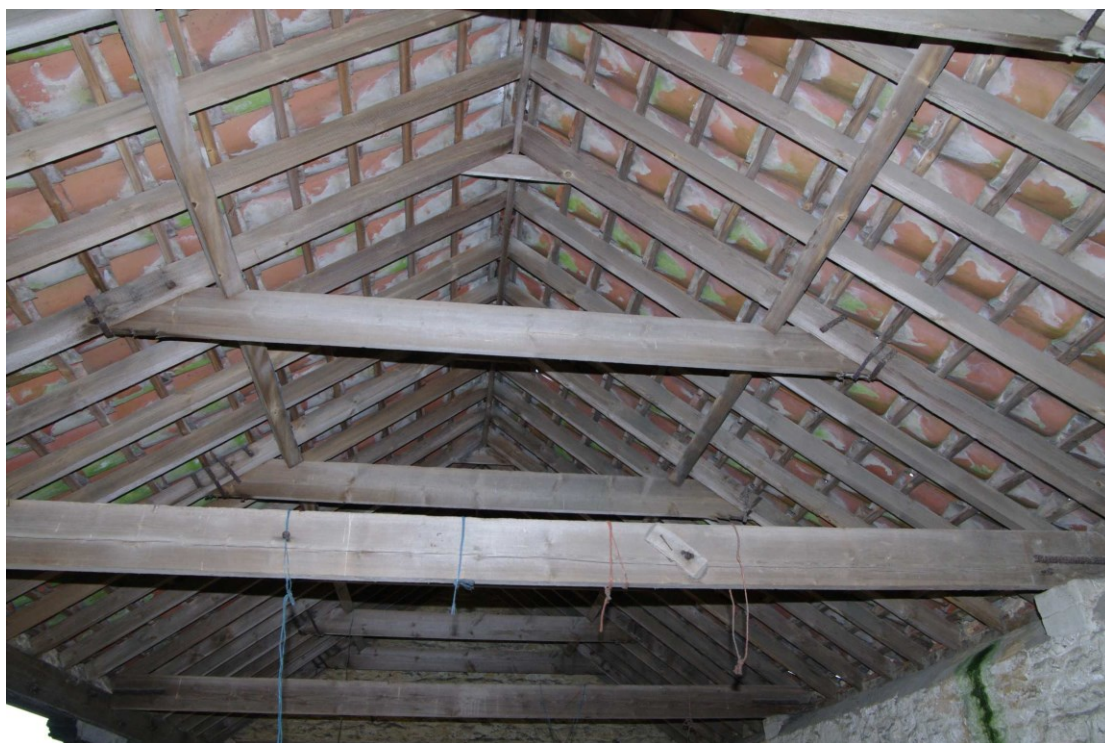
The cart shed roof structure is relatively lightweight and consists of trusses over each post with narrow tie-beams held to the principals by thin iron strips or stirrups. The tie-beams also support the purlins in a birds-mouth joint (Fig. 24). The same roof structure can be seen throughout the barn buildings.

Figure 24 Barn roof structure
The style is common throughout the building

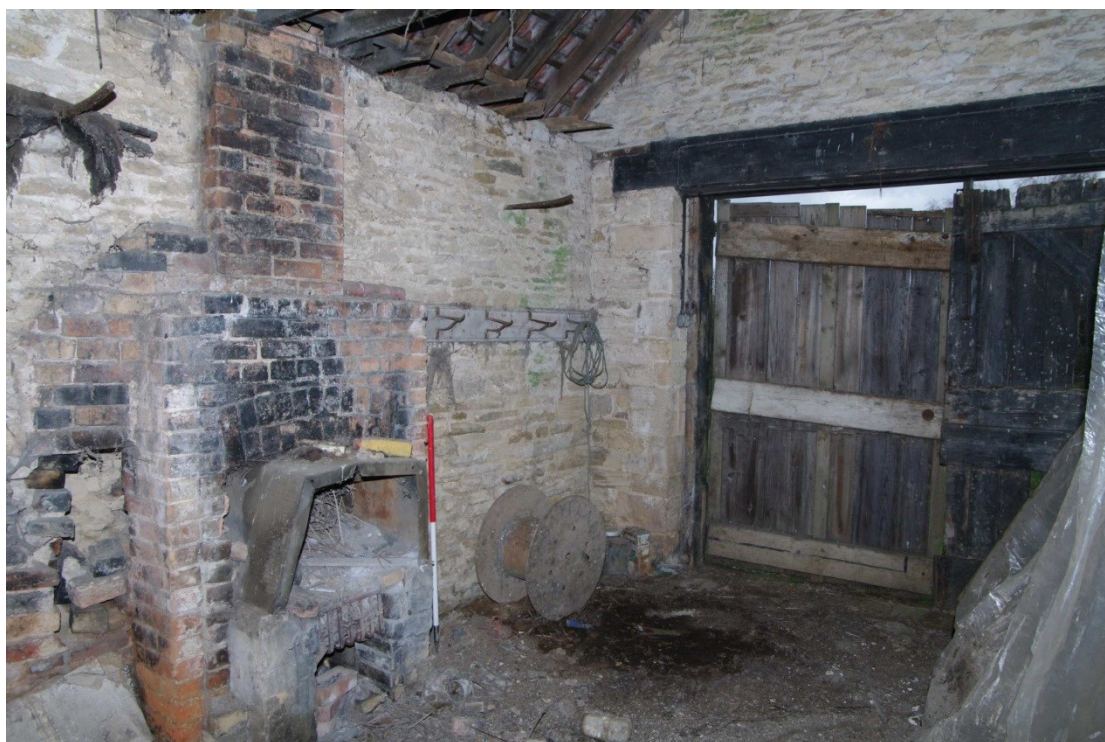
the cart shed. Partial inspection through a gap in the locked door showed this room to be mostly empty but with a row of ascending perches used as a chicken house. The eastern end room of the north range is entered through the wide double doors on the gable end. The room has the remains of a plastered ceiling and a fireplace on the north wall (Fig. 25). The chimney has been truncated and no longer passes through the roof tiles. On the north wall, to the east of the chimney is a row of metal coat hooks with the names W. TAYLOR, E TAYLOR, G. TAYLOR, N. TAYLOR (Fig. 26). Presumably these are the Taylors of Taylor's farm. To the west of the chimney are two racks for saddles. A small room accessed from the passageway from the west yard is located to the south of the room with the fireplace and appears to have been used most recently as an animal pen.

Figure 25 East room of north range
Looking north-east. 1m scale

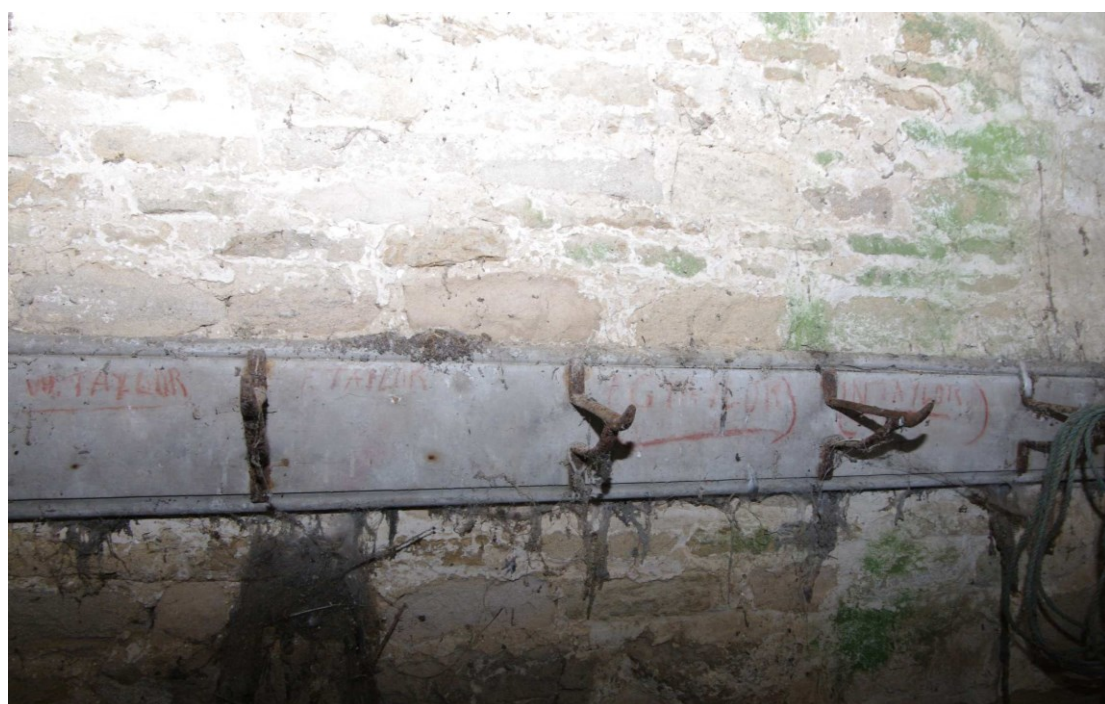
Figure 26 Coat hooks with the Taylor family names
East room of north range

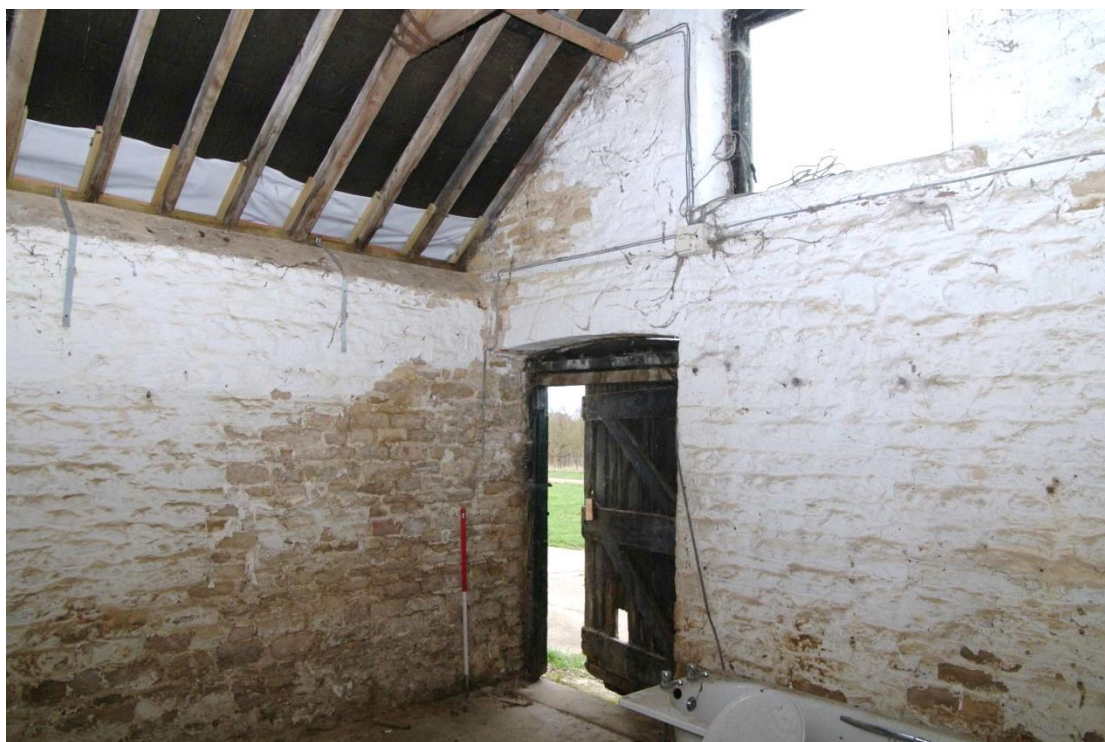
The west range has a small rectangular room at the south end which has a concrete floor (Fig. 27). There is no evidence of any former uses and no clear evidence of a hayloft floor which would be served by the door in the gable apex. The arched lintels over the door and over the window are constructed from two courses of brick headers. This brick reinforcement is seen on all doors and windows throughout the building.

Figure 27 South room of west range
Looking south-east. 1m scale

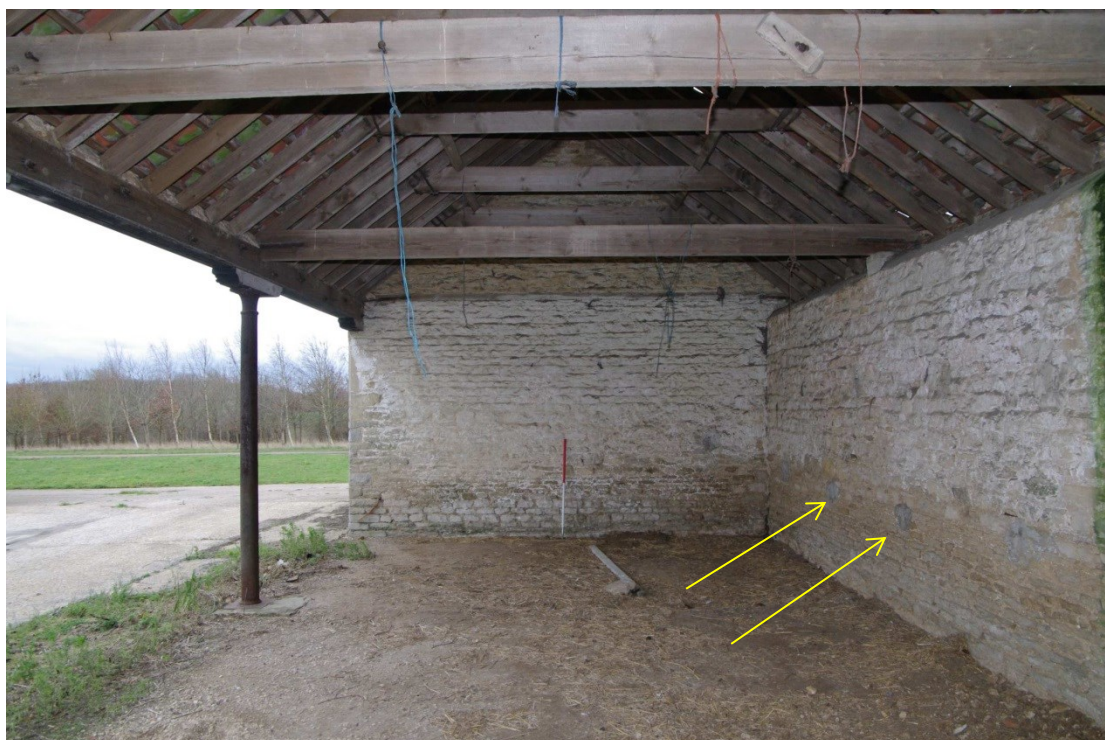
When first built the west range had two three-bay open sheds facing east into the yard but the northern shed has been blocked to create a chemical store as discussed above. The remaining open shed has traces on the west wall where wooden byres or troughs were attached (Fig. 28). The chemical store is a large empty room with a concrete floor. A small stable room is located at the northern end of the range.

Figure 28 Open shed of west range
Looking south. 1m scale. Yellow arrows point to locations of byres or stalls

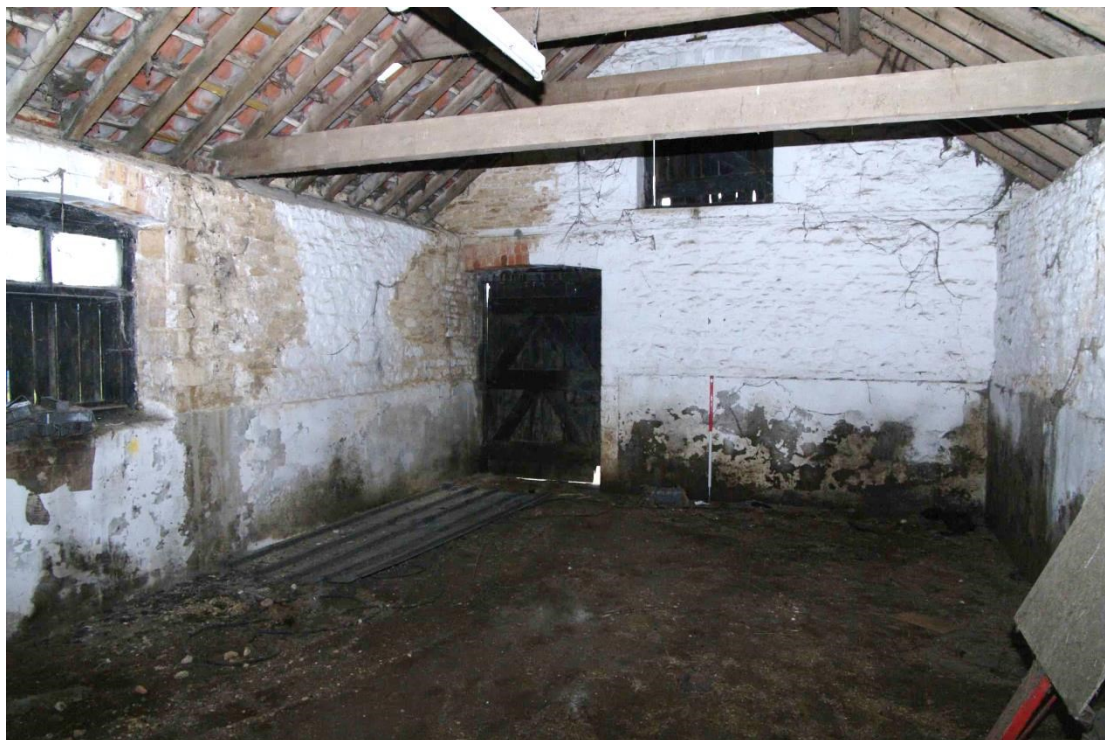
Most of the central range is filled by two large enclosed animal sheds. The southern room has a mortar floor and has evidence of stalls and byres along the western wall. The walls have been lined with plaster or mortar up to window sill height to prevent animals from rubbing against the bare stonework (Fig. 29). There is no evidence of a floor or mezzanine which would be served by the hayloft door on the gable end. The adjacent room the north has stable paviments and has two doors to allow for easier movement of animals. The northern segment of the central range is occupied by a two bay open shed which has a blocked doorway into the west yard as discussed above.

Figure 29 South room of centre range
Looking south-east. 1m scale

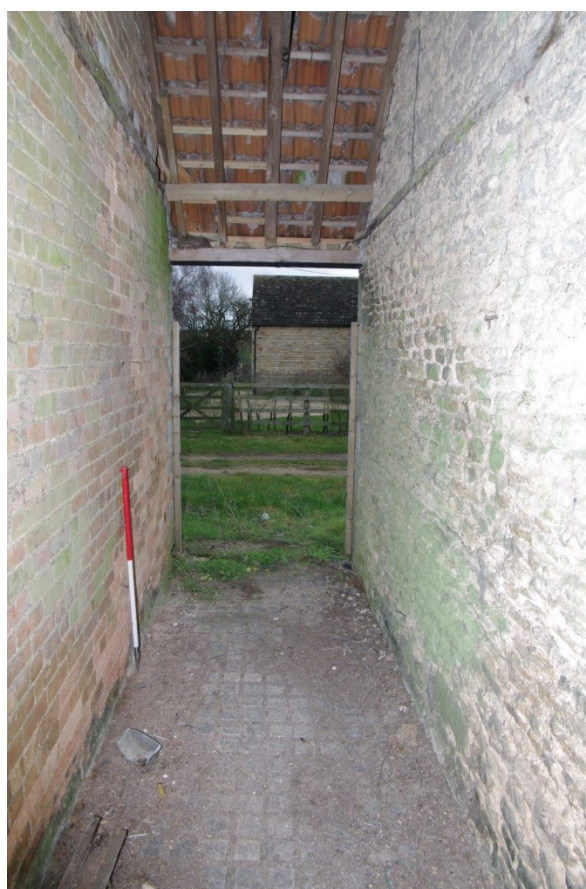
As noted a passageway runs from the east yard towards the farmhouse (Fig. 30). A room to the south of the passageway has doors both into the yard and out to the east. It appears to have been a room of some importance as it has a plaster and lath ceiling. A set of three cages, probably kennels has been built against the south wall (Fig. 31). A narrow doorway to the south of the kennels leads up a set of wooden steps into the chicken house (Fig. 32). The remaining rooms were locked although a cursory inspection through the clear glass windows indicates that they have been partially modernised so that no original fixtures or fittings appear to have survived.

Figure 30 East range passageway from east yard
Looking east towards farmhouse. 1m scale
