**An Historic Building Assessment at
Taylor's Farm,
Casterton Lane,
Pickworth, Rutland**

NGR: SK 99702 12489

ULAS Report Number 2016-036
©2016

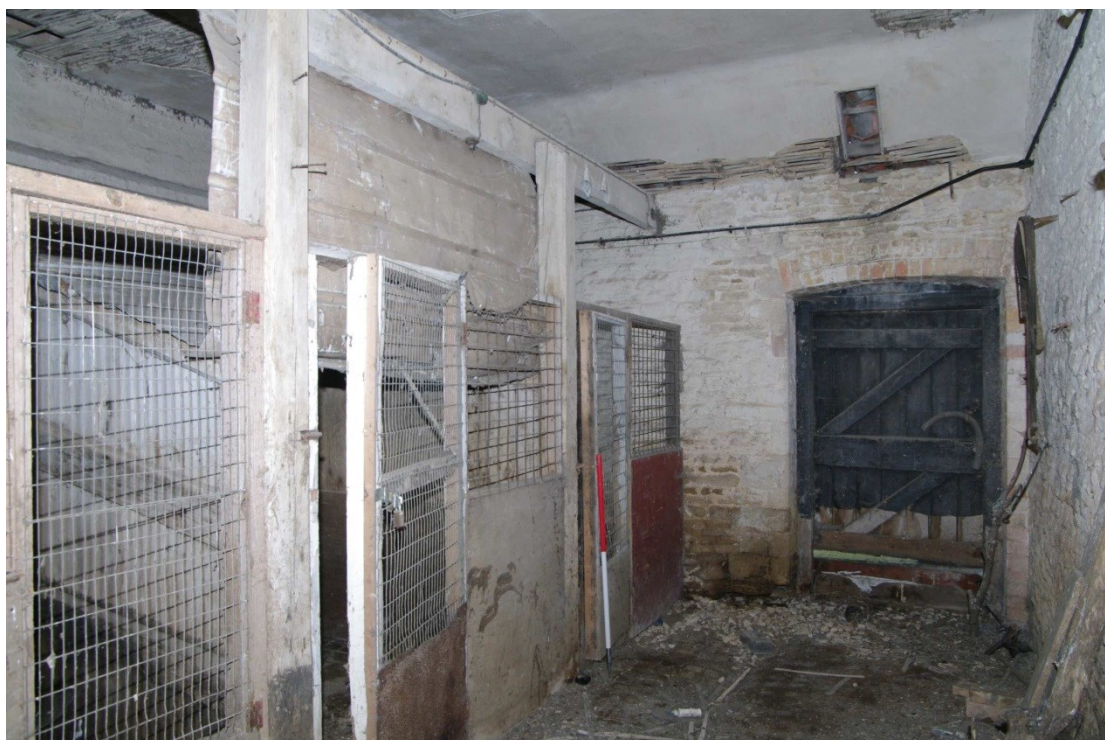
As noted a passageway runs from the east yard towards the farmhouse (Fig. 30). A room to the south of the passageway has doors both into the yard and out to the east. It appears to have been a room of some importance as it has a plaster and lath ceiling. A set of three cages, probably kennels has been built against the south wall (Fig. 31). A narrow doorway to the south of the kennels leads up a set of wooden steps into the chicken house (Fig. 32). The remaining rooms were locked although a cursory inspection through the clear glass windows indicates that they have been partially modernised so that no original fixtures or fittings appear to have survived.

Figure 31 East range kennels
Looking west. 1m scale

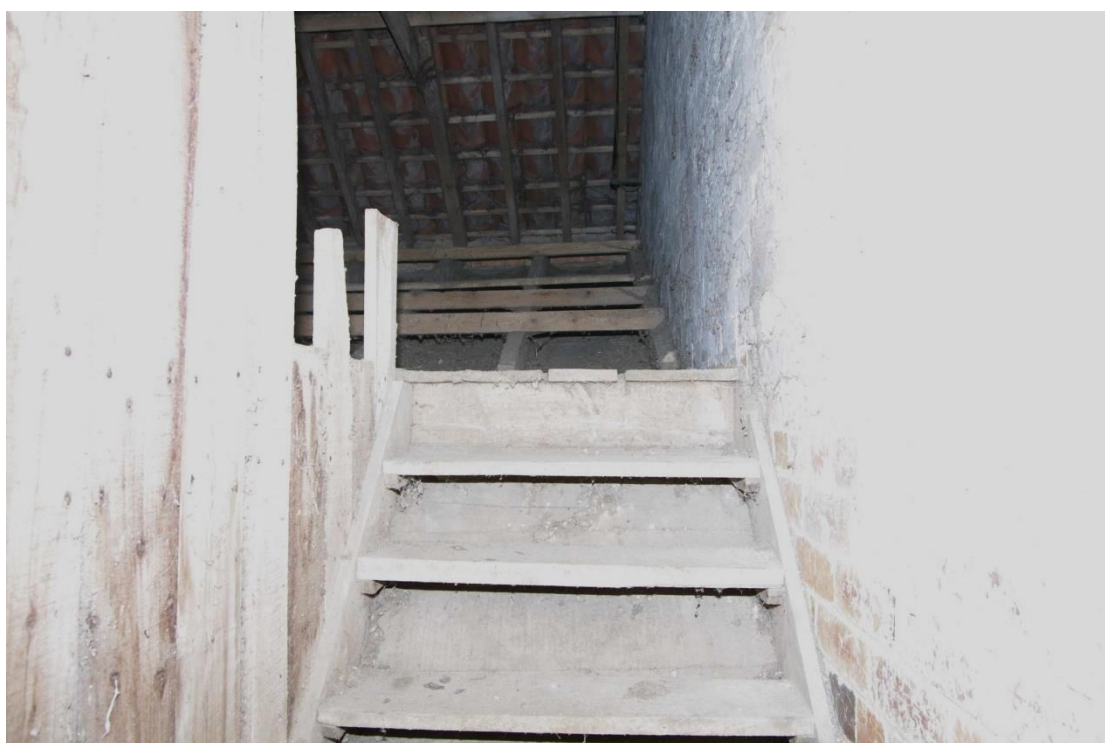
Figure 32 East range, steps up to chicken coop
Looking west
