An Archaeological Evaluation For land adjoining Narborough Parish Centre, Desford Road, Narborough, Leicestershire NGR: SP 53913 97482

An Archaeological Evaluation at Narborough Parish Council, Desford Road, Narborough

For: Narborough Parish Council

ULAS Report Number 2017-027 ©2017 X.A12.2017

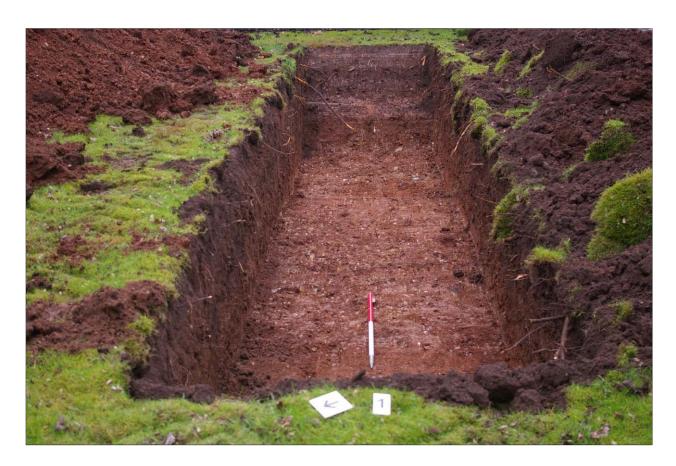
Figure 4: Trench 1 looking south east

Trench 1 measured 9.80m in length and 1.6m in width and was orientated south-east to north-west. Initially it had been planned to excavate the trench 0.40m further to the south-east but this was not possible due to live services. The natural undisturbed substratum was recognised at a depth of between 0.74m and 1.01m within the trench. Overlying the natural was a subsoil which consisted of a sandy layer of redeposited clay. It is likely that the area had been previously disturbed and there was a notable height difference between the level of the site and the road level.

Interval in metres from NW end	0m	5m	9m
Topsoil depth	0.38m	0.43m	0.40m
Subsoil depth	0.36m	0.58m	0.57m
Top of natural	0.74m	1.01m	0.97m
Base of trench	0.90m	1.02m	1.16m

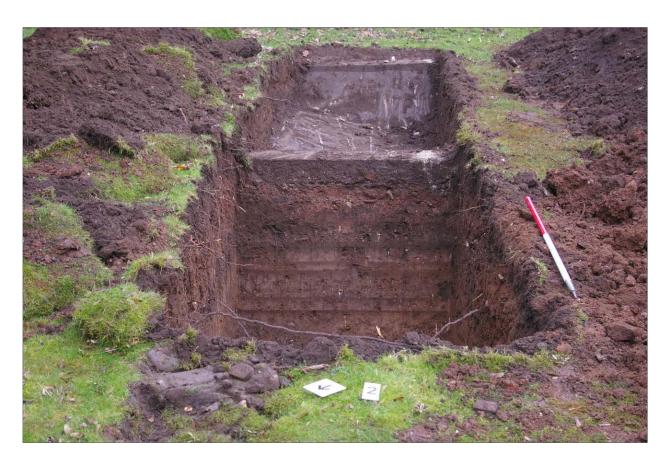
Figure 5: Trench 2 looking south-east

Trench 2 measured 8m in length and 1.6m in width and was orientated south-east to north-west. Initially it had been planned to excavate the trench perpendicular to Trench 1, but this was not possible due to the presence of a large tree. The natural undisturbed substratum was not seen, even at a depth of 1.85m, within the trench at the north-west end. Within the south-east half of the trench, a large concrete unidentified structure was uncovered 0.15m beneath the surface, this made further investigation within the trench impossible.

Interval in metres from NW end	0m	4m	8m
Topsoil depth	0.43m	0.21m	0.15m
Base of trench	1.85m	0.21m	0.15m

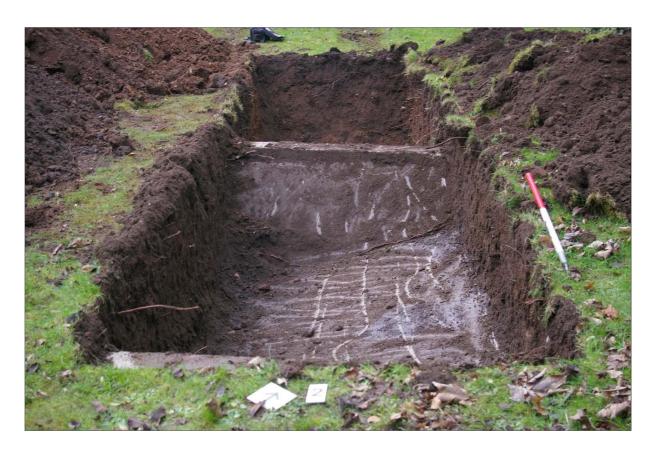
Figure 6: Trench 2 looking north-west, concrete structure

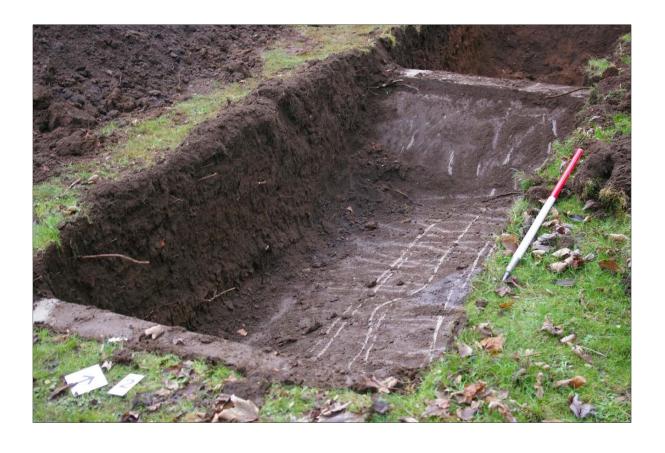
Figure 7: Trench 2 looking west, concrete structure
