An archaeological field evaluation at The Cedars, 29-33 London Road, Kegworth, Leicestershire (SK 48819 26496)

ULAS Report No 2017-043 ©2017

An archaeological trial trench evaluation was carried out by University of Leicester Archaeological Services (ULAS) at The Cedars, 29-33 London Road, Kegworth, Leicestershire (NGR: SK 48819 26496) in advance of the development of the associated land for two new detached dwellings.

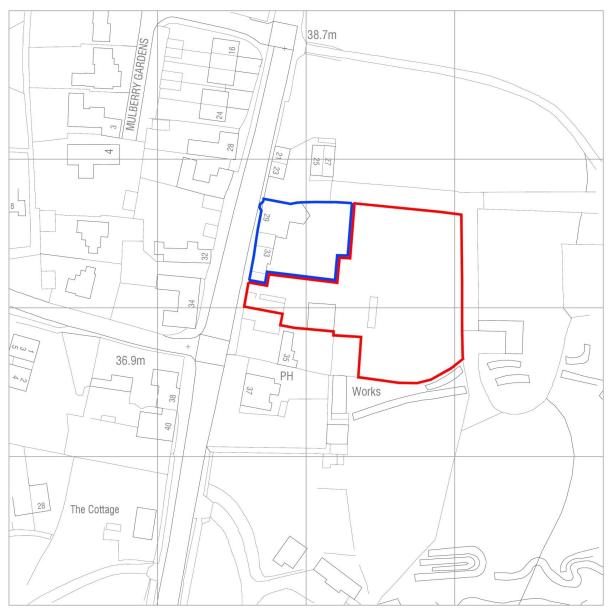
Figure 2: Plan of the site showing the house and area to be retained (blue) and the proposed development area (red)

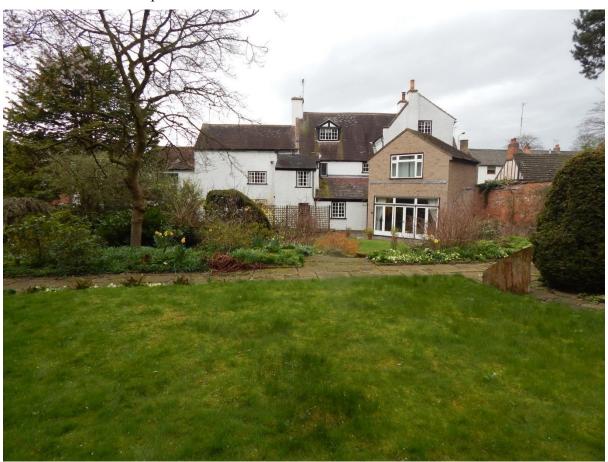
The proposed development area comprises an approximate area of 860 square metres at a height of 37m aOD. The garden is situated on slightly varying levels, but the land broadly falls slightly to the south and east (Figure 3).

Figure 3: The site from the western lawn, looking west

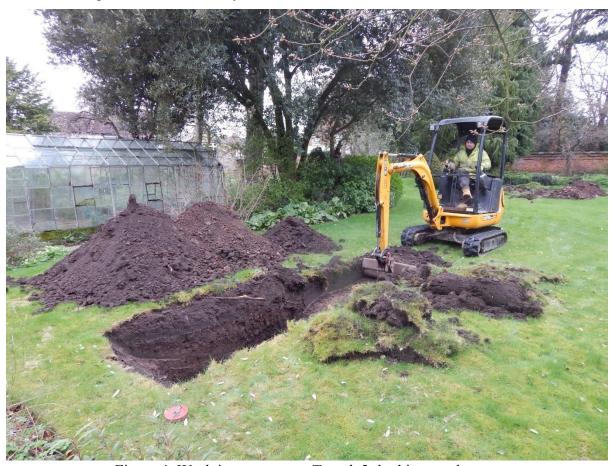
Figure 4: Work in progress on Trench 2, looking north-west

The work was carried out by a 1.5 tonne mini digger fitted with a 0.9m wide ditching bucket under archaeological supervision at all times (Figure 4).

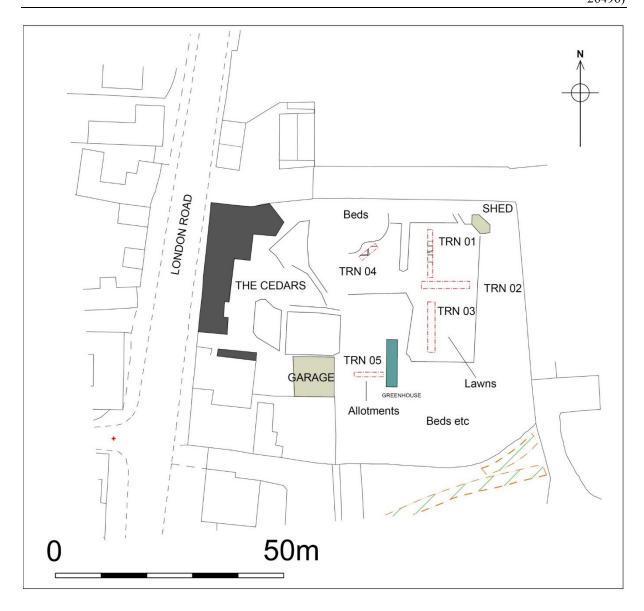
Figure 5: Plan showing trench locations

Trench 01 was situated at the northern end of the eastern lawn (see Figure 5 for positions).

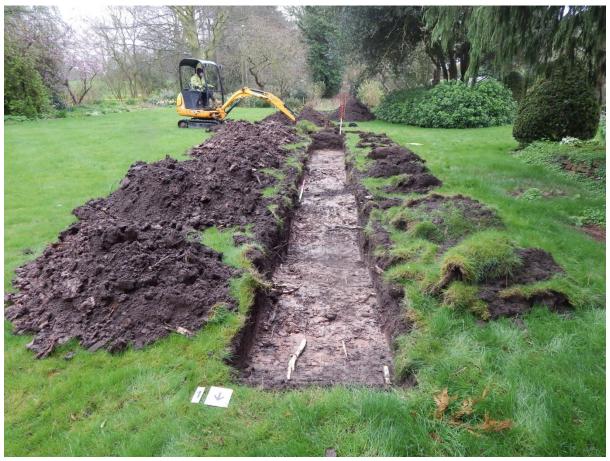
Figure 6: Trench 01, post excavation, looking south

There were two apparently linear features within this trench, running east to west across the trench. The northern one was 1m wide and shallow and the southern was 1.5m wide and around 0.40m deep. The northern one contained topsoil almost to the base and the other contained subsoil to the base. Both contained modern brick.

Between them lay a stone filled field drain running north-east to south-west.

The topsoil contained a lot of roots from adjacent trees, some very large, which made excavation difficult, and so the trench was limited to 1m wide (Figure 6).

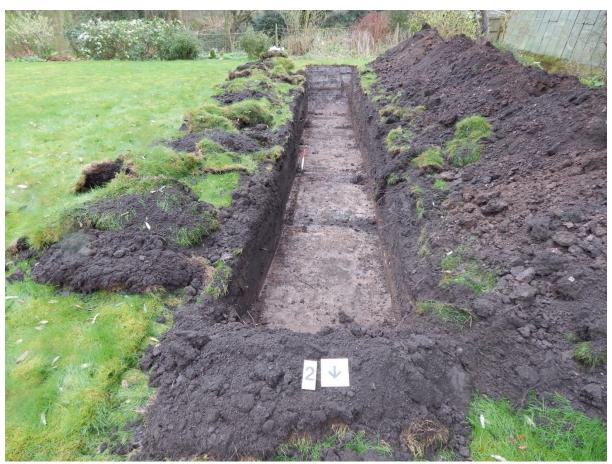
Figure 7: Trench 02, post excavation, looking south

The trench contained deep topsoil throughout the length of the trench. At the southern end the upper soil consisted of layers of dark topsoil and other mixed material suggesting made-up ground. There were patches of brick and rubble within this matrix for around the first 4-5m from the southern end. The ground here was easier to excavate and so the trench was excavated to the 1.6m width.

No archaeological features were identified within the trench (Figure 7).

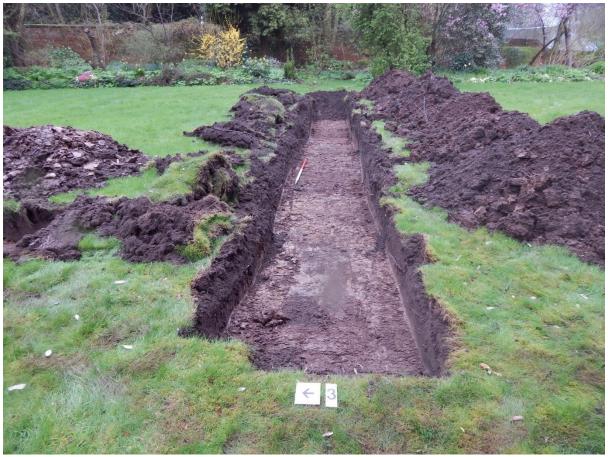
Figure 8: Trench 03, post excavation, looking east

No archaeological features were identified within the trench (Figure 8).

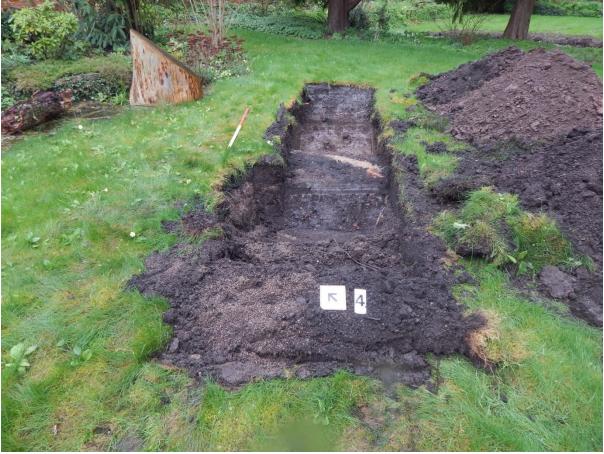
Figure 9: Trench 04, post excavation, looking north-east

At the north-east end of the trench was an apparent feature of the same form and alignment as the northern linear in Trench 01, and contained a small piece of modern pottery.

Most of the rest of the trench contained a brick and concrete structure, with a green glaze on its internal surfaces that could not be excavated with the small machine. The current house owners had described the area as originally containing an ornamental pond (David Leadsam pers. comm.).

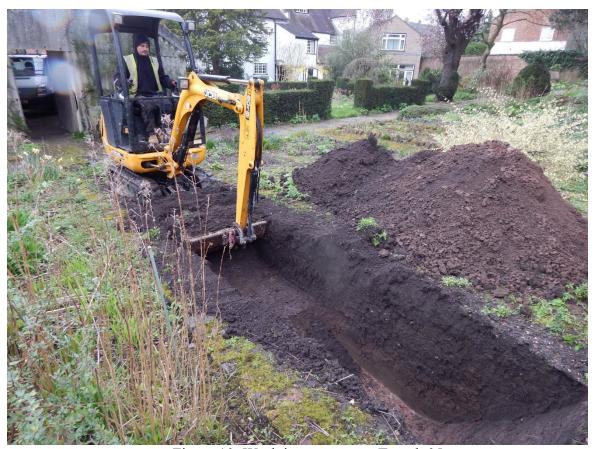
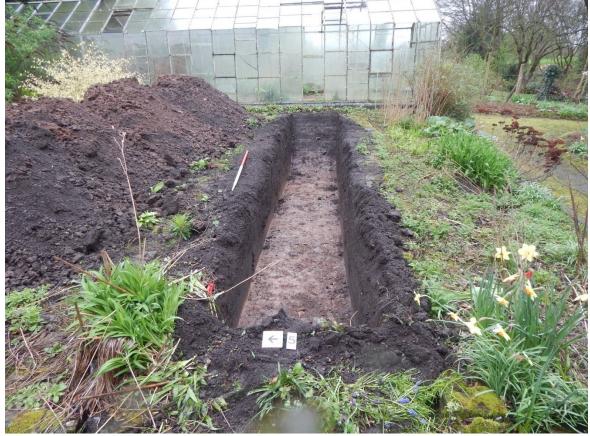
Figure 10: Work in progress on Trench 05

Figure 11: Trench 05, post excavation, looking east

Trench 05 was situated within the vegetable garden area to the direct west of a large greenhouse (Figures 10 & 11). Space was somewhat limited here and so the trench was only 1m wide. The trench was made 6.4m long to compensate for some loss of area due to the width restriction.

No archaeological features were identified within the trench (Figure 8).

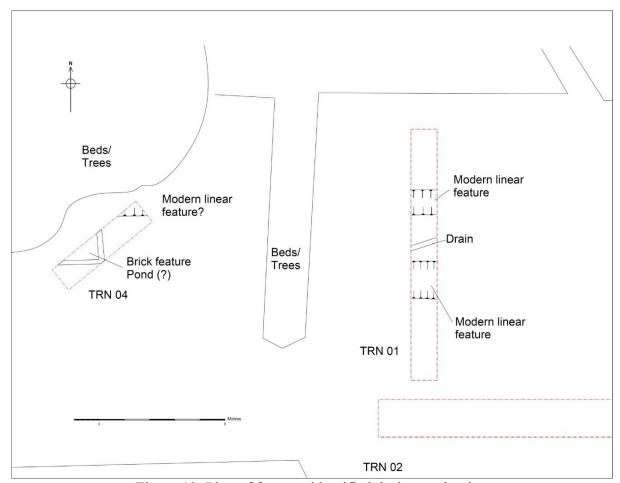
The two linear features seen in Trench 01 (and possibly picked up in Trench 04), were parallel to one another and a few metres apart, running east to west at the northern end of the eastern

lawn. One contained topsoil virtually to the base and both contained modern brick within their fills (Figure 12).

These features, along with the infilled pond feature in Trench 04 most likely represent the infilling of modern garden or agricultural features. Trench 02 at the southern end of the lawn shows evidence of significant deposits of soil and made up ground to build the land up at this end of the garden against the natural fall of the land to provide a level surface for the lawn, which was once used as a tennis court.

Figure 12: Plan of features identified during evaluation
