**An Archaeological Evaluation
on Land at Atherstone Road, Measham, Leicestershire**

NGR: SK 333 112

ULAS Report No. 2015-115

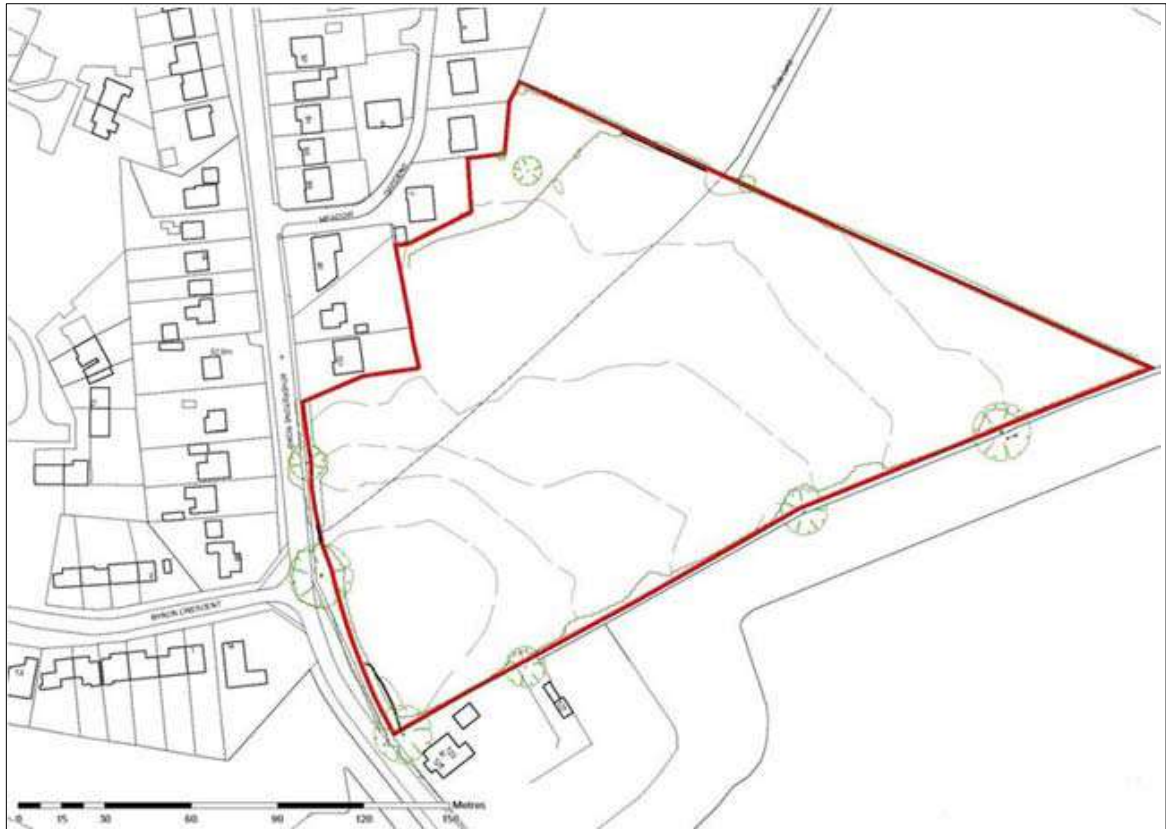
Figure 2: Proposed development area (supplied by client).

The site lies on the north-eastern side of Atherstone Road, south of the town centre of Measham, North-West Leicestershire (Fig. 1). The site is a sub-triangular area of arable land, bisected by a public footpath, which rises slightly to the east from around 82m OD to around 88m OD (Fig. 2).

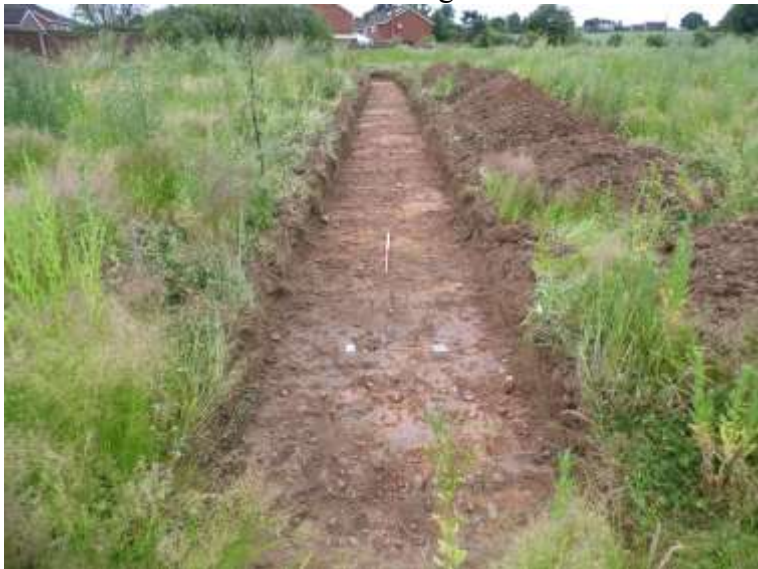
Trench 7 looking north

A public footpath crosses the site and trenches were located to avoid this. There were no other physical constraints to the excavation of the trenches. Trench 7 was slightly relocated on site to avoid a nearby boundary.

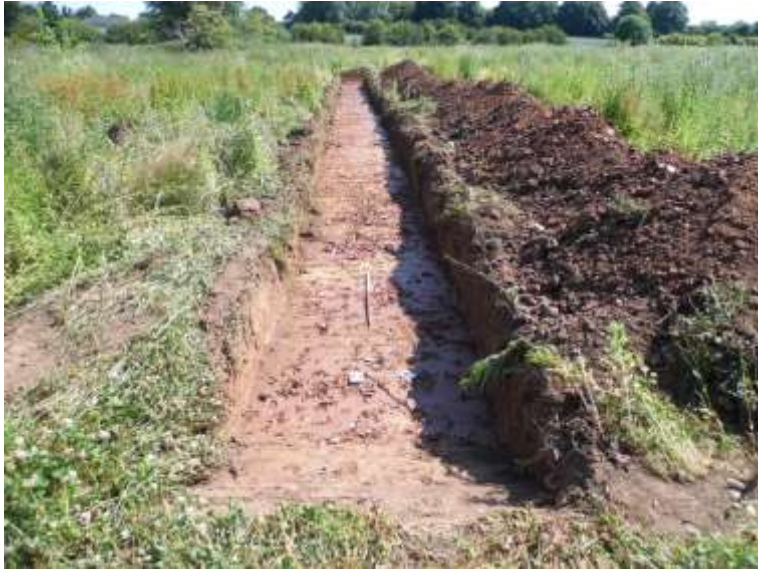
Trench 13 looking north-east

No archaeological features were identified. Plough scars, the remnants of furrows and field drains were seen in all of the trenches. A modern dump of material was identified in Trench 13. The results are shown in the table below and photographs of each trench are shown in Appendix 1.
