An Archaeological Watching Brief conducted during groundworks at 54, Main Street, Houghton on the Hill Leicestershire.

NGR: SK 67872 03420

October 2016

Client: Mr Patric Phelan

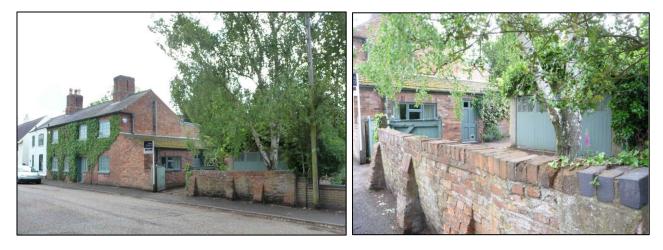
Figure 8. Photographs of the development site taken in 2011

None of these more recent maps show either the lean-to or the rear extension which clearly pre-date the 1959 map. These features can be seen in two photographs taken in 2011 (Figure 8) and show the site before conversion of the lean-to extension and garage, as well as landscaping and partial removal of the boundary wall. Figure 9 shows the present layout of the development site and after these changes had been made.

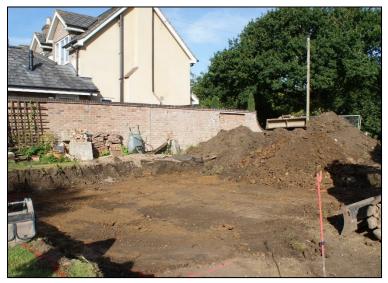
Notwithstanding the removal of the concrete garage plinth, stripping of overburden for the footprint of the new building revealed a previously well disturbed area. Drainage pipes and manholes had been inserted in the area close to the house in the recent conversion of the lean-to extension. A large soakaway had also been inserted running from the conservatory to the southern corner of the new building plot (Figures 10 and 11).

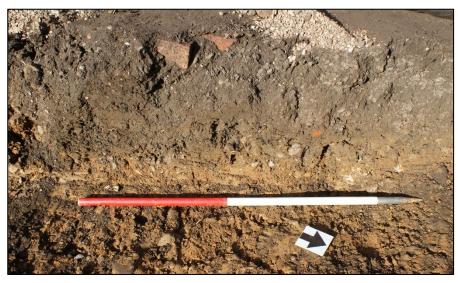
Figure 12. The western edge of site showing topsoil and subsoil layers.

The topsoil was generally a dark greyish brown mixed deposit with frequent limestone, flint and sandstone fragments. The subsoil, a mid-greenish brown silty clay with frequent pebbles and limestone fragments, varied in depth across the site. Removal of these soil layers revealed a mixed natural geology, there being bands of a reddish brown sandy clay, a greenish brown clay with chalk and ironstone components and a yellowish brown clayey sand with frequent occurrence of limestone, chalk and flint (Figure 12).

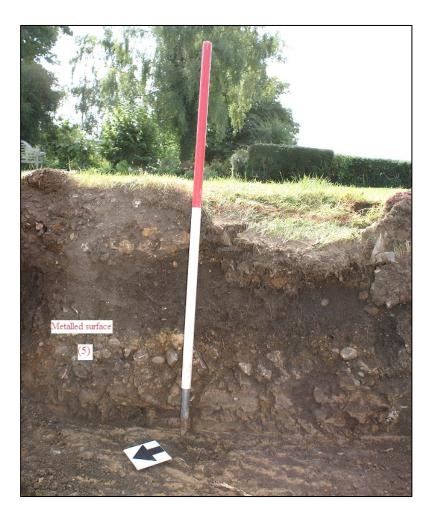
Figure 15. Section (1.06) across metalled surface (5) looking south-east

Trenching for the foundations of the new building was executed to an average depth of 0.85m. Trenching revealed, on the boundaries of the site, two further features that had been truncated by the modern drainage works. On the south-eastern boundary truncated by the soakaway, a metalled surface was visible in section (Figure 15).

The surface was absent on the eastern boundary and continued visible for 2m, dipping to the south-west. The deposit comprised a mid-greenish brown silty-clay with frequent rounded pebbles and limestone chunks to an average depth of 0.20m. A single sherd of pottery was found within the silty-clay matrix.

The pottery from the matrix of the metalled surface (5) was of early medieval date. As a small isolated sherd from section only, it is difficult to draw any meaningful conclusions from this. The surface does appear, however, to be outside the yard boundaries of the early cottage as identified on the 1902 map and so may relate to occupation earlier than this building.

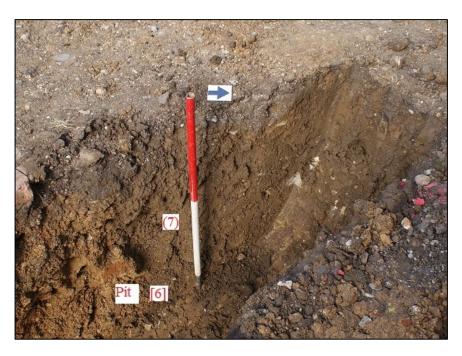
Figure 16. Pit [6] visible in the east facing trench section close to the house.

In the north-eastern corner of the plot, at the junction of the house and extension, trenching revealed a pit [6] truncated by a manhole and drainage pipe. This feature had not been visible in plan as removal of all overburden had not been possible close to these drains (Figure 16).

The medieval pottery recovered from the pit [6] (7) was from a secure context and suggests medieval activity within 10 metres of the present Main Street. The pit lay on

a geological boundary, where large limestone pieces were available. As the pit was relatively deep and not significantly filled with refuse, it may be that material was being quarried here.
