Archaeological attendance on land at Rose Cottage, 23 Main Street, Swadlincote, Snarestone, Leicestershire DE12 7DB (SK 34562 09365)

ULAS Report No 2017-105 ©2017

Planning Ref: 16/01160/FUL

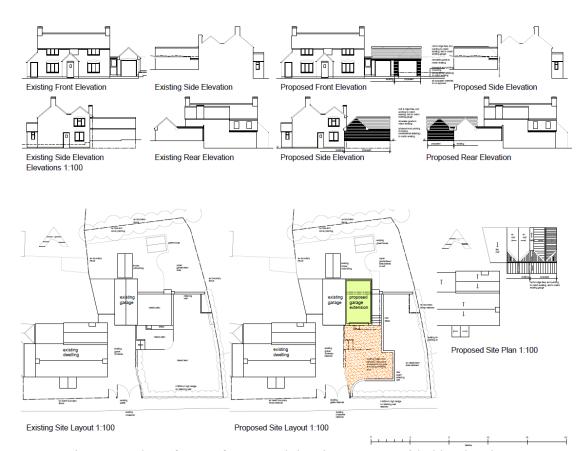
Figure 3: Plan of area of proposed development provided by developer.

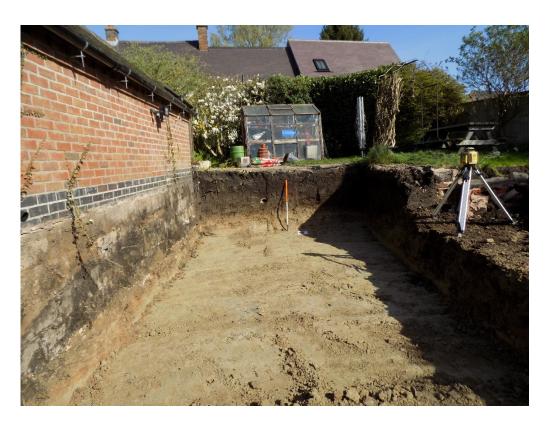
Figure 4: Prepared area of land for the garage extension to the east of the existing garage, looking north. The view shows the stripped area prior to the foundation trenches being dug. Land drains are visible in section.

The excavation began at the northernmost point of the development, to the eastern side of the existing garage. The land was clearly disturbed and likely to have been redeposited from the southernmost part of the site creating a slope.

This soil was removed to a depth of 0.14m at its deepest part, (0.95m redeposited / disturbed topsoil) with 0.55m being dug directly into the natural yellowish grey clay/sandstone mix substratum. There were land drains clearly visible in section within the disturbed topsoil.

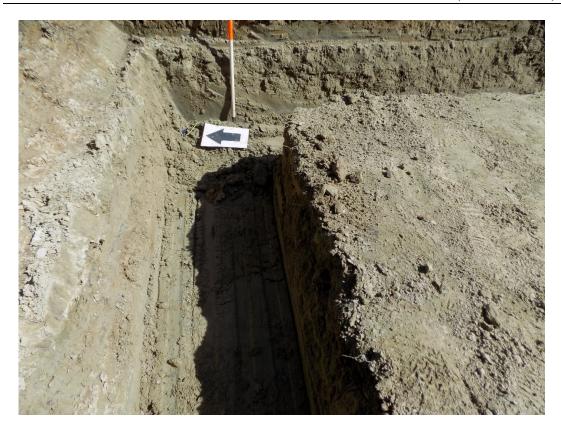
Figure 5: View looking east, showing north-eastern area of the foundation trench for the garage extension.

The foundation trenches were approximately 0.6m wide. For the proposed garage extension, they were excavated to a depth of approx. 1.0m. For the small retaining wall, the foundation trenches were dug to approx. 0.3m

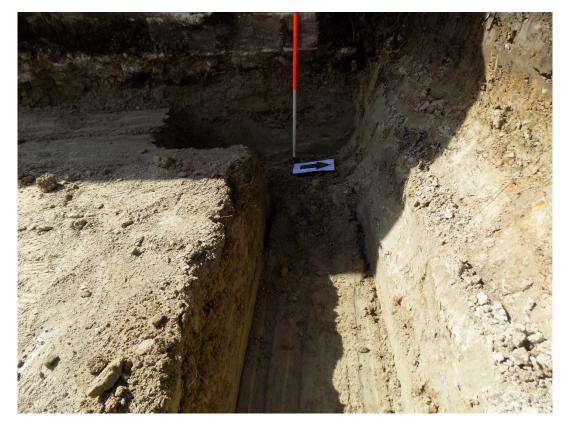
Figure 6: View looking west, showing north-western area of the foundation trench for the garage extension.

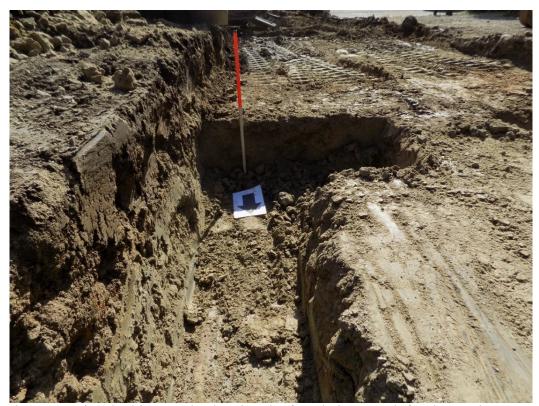
Figure 7: View looking south, showing the foundation trench for the south-eastern footing for the garage extension.

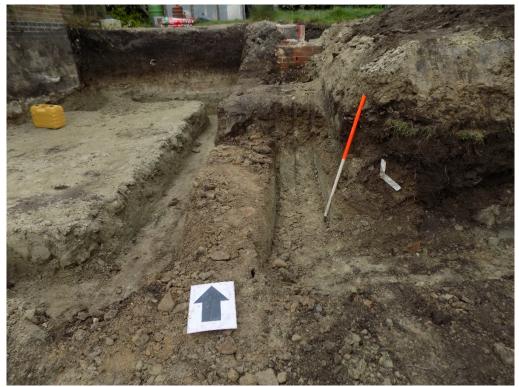
Figure 8: View looking north showing the foundation trench for the new retaining wall which will surround the new driveway and to the east of the proposed garage.

The work was delayed due to the amount of spoil that had to be completely removed from site. Agreement was made that the area that lay beneath the spoil (the proposed driveway) could be levelled after removing the spoil heap. On returning to site the following day, the area discussed had been levelled, and the foundation trenches had also been dug. They were not deep enough however, to have disturbed the natural substratum.

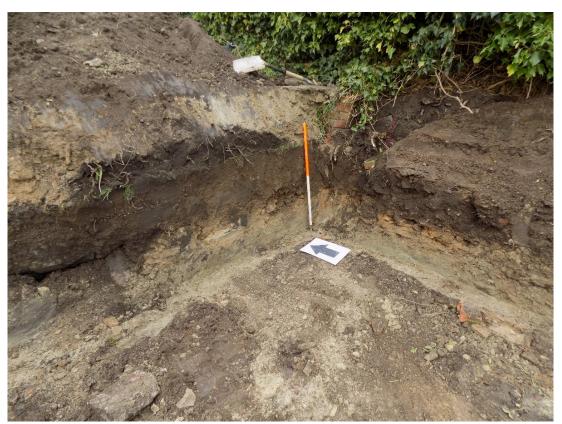
Figure 9: View looking north-east showing the foundation trench for the proposed retaining wall for the driveway.

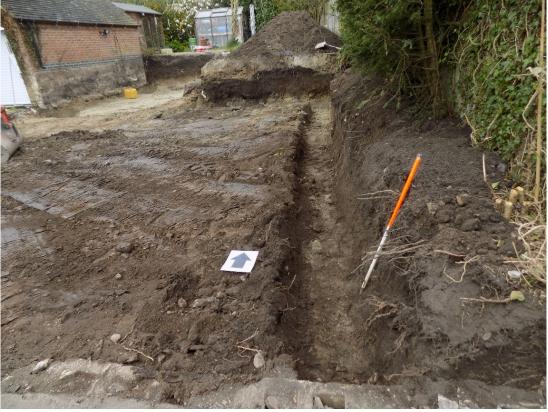
Figure 10: View looking north along the easternmost boundary of the development showing the foundation trench for the retaining wall surrounding the driveway.

No archaeological features or finds were identified or recovered from the trenches. The foundation trenches to the retaining wall surrounding the proposed driveway had previously been excavated and filled prior to the visit.

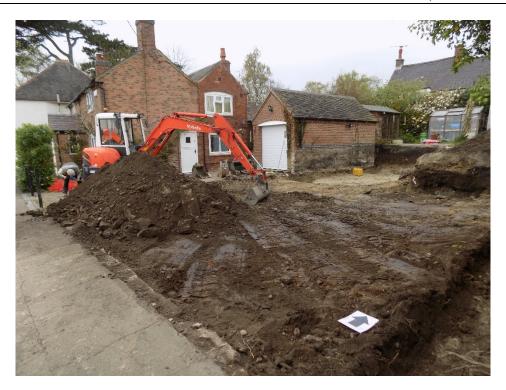
Figure 11: View post-excavation waiting for excess soil to be removed in preparation for the arival of the ready made concrete.

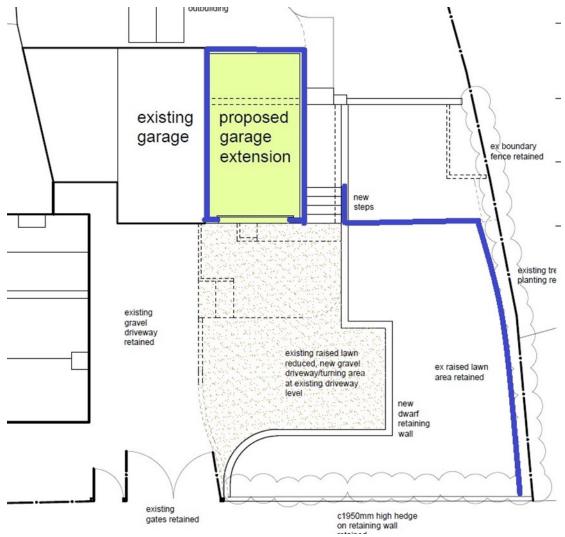
Figure 12: Position of excavated foundation trenches highlighted in blue.
