**An Archaeological Field Evaluation on  
gardens adjacent to the North-west  
elevation of Radbourne Hall,  
Radbourne Lane, Radbourne,  
Derbyshire (SK 428634 335683)**

ULAS Report No 2017-125  
©2017

The Trustees of The Radbourne Settlement

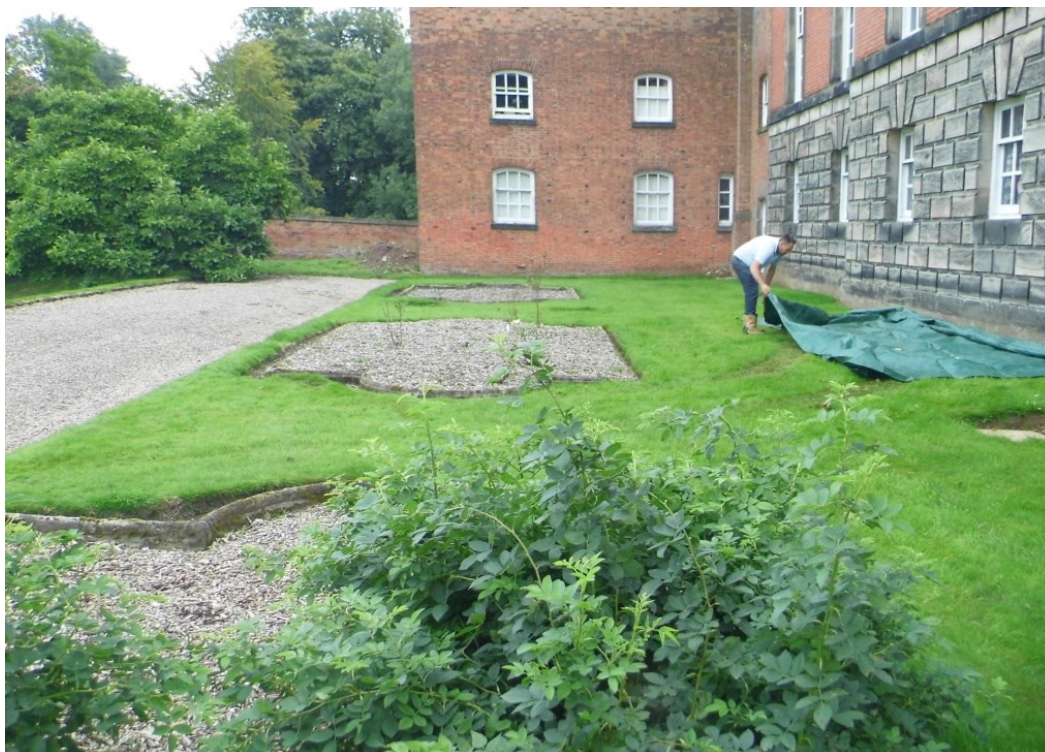
Figure 4: Application area prior to evaluation, looking North-east.

The application area is situated on gardens directly to north-west elevation of the Hall and covers a rectangular shape of approximately ninety six square metres (Figs.2 &3).

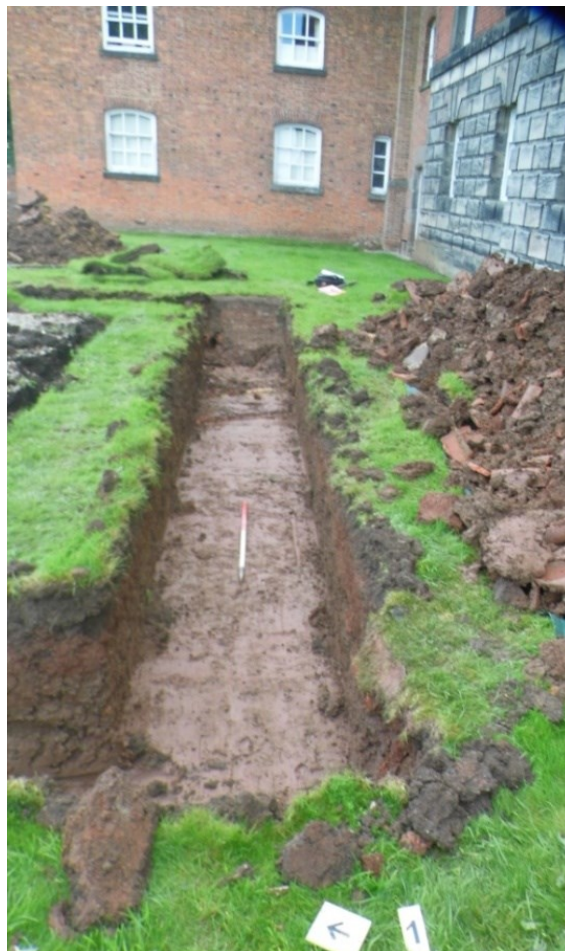
Figure 7: Trench 1 looking north-east

**Orientation:** South-west to north-east.

Length: 8.50 m Width: 0.90 m

No Archaeological remains identified

Interval	SW 0m	2m	4m	6m	8.50m
<b>Topsoil Depth</b>	0.20	0.18	0.20	0.16	0.15
<b>Subsoil Depth</b>	0.46	0.60	0.20 0.26	0.15 0.42	0.22 0.07
<b>Top of natural</b>	0.66	0.78	0.66	0.67	0.44
<b>Base of Trench</b>	0.73	0.78	0.74	0.75	0.77

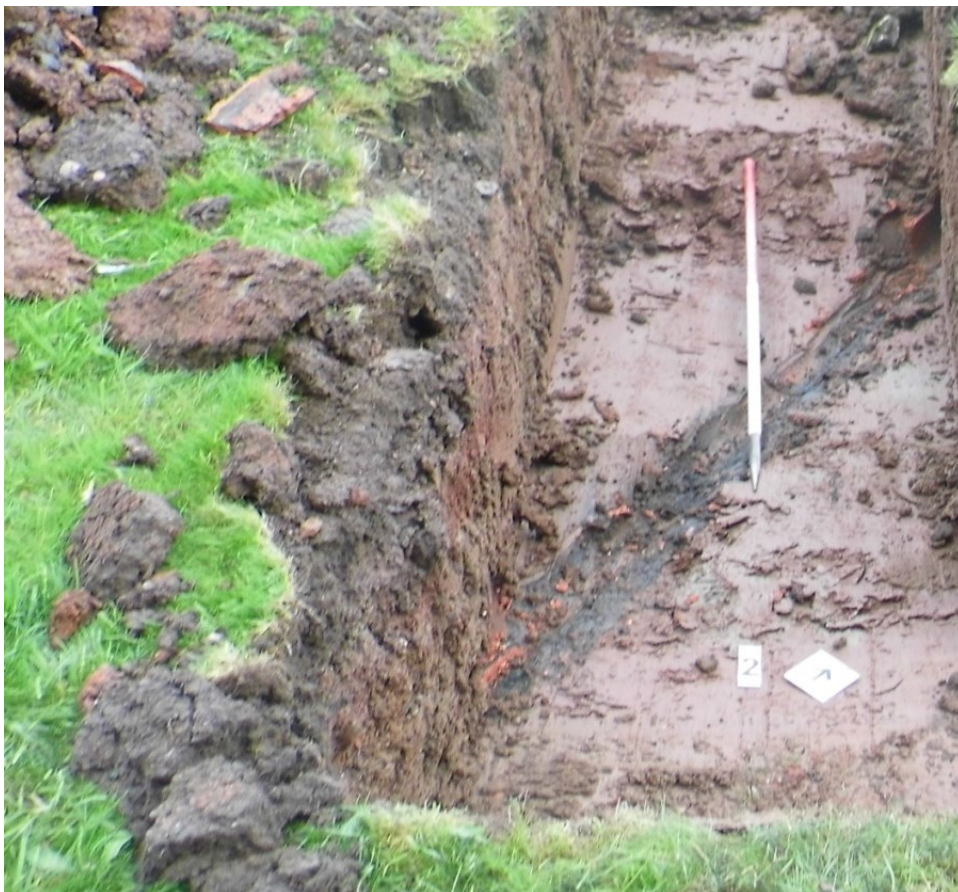
Figure 8: Trench 2 looking north-west

Orientation: South-east to North- west

Length: 4.50m Width: 0.90m

No Archaeological remains identified

Interval	SW 0m	1m	2m	3m	4.5m
Topsoil Depth	0.20	0.20	0.18	0.20	0.25
Subsoil Depth	0.16 0.38	0.20	0.20 0.28	0.16 0.25	0.30
Top of natural	0.74	0.40	0.64	0.61	0.55
Base of Trench	0.74	0.80	0.80	0.75	0.70

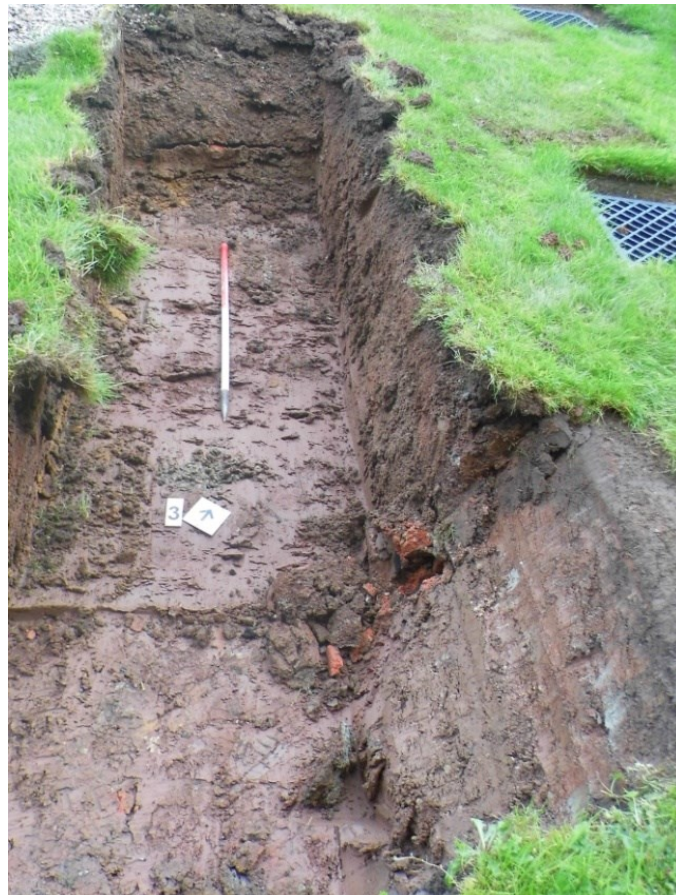
Figure 9: Trench 3 looking north-west

Orientation: North-west to south-east

Length: 4.50 m Width: 0.90m

No Archaeological remains identified

Interval	NW 0m	1m	2m	3m	4.50m
Topsoil Depth	0.20	0.20	0.20	0.10	0.10
Subsoil Depth	0.56	0.60	0.24 0.30	0.30 0.26	0.30 0.26
Top of natural	0.76	0.80	0.74	0.66	0.60
Base of Trench	0.80	0.80	0.80	0.80	0.80

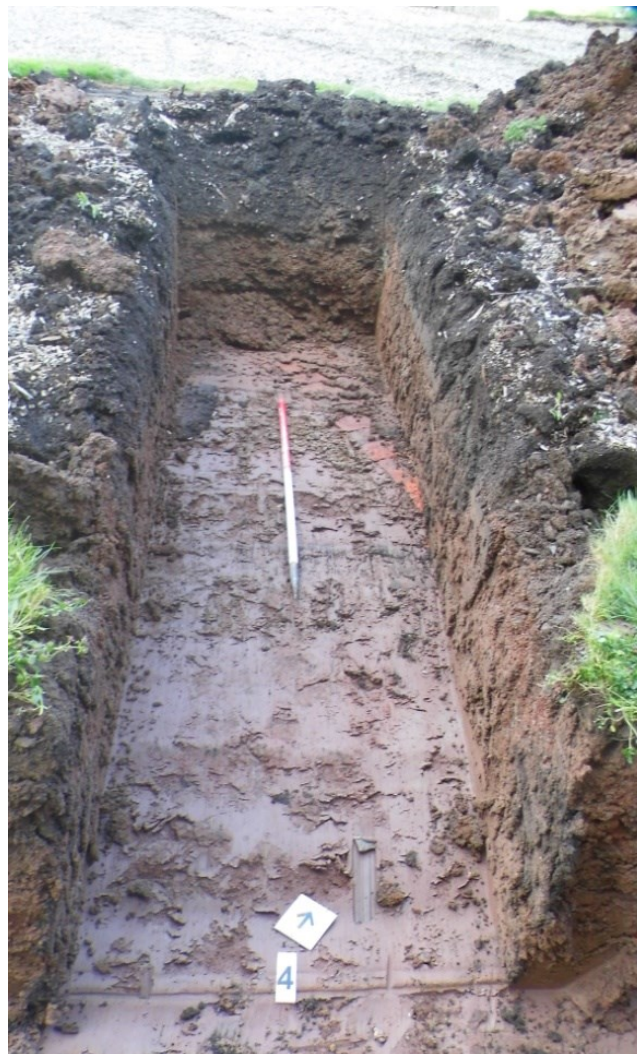
Figure 10: Trench 4 looking north-west

Orientation: North-west to south-east

Length: 3.5m Width: 0.90 m

No Archaeological remains identified

Interval	SE 0m	1m	2m	3.5m
Topsoil Depth	0.14	0.30	0.40	0.40
Subsoil Depth	0.30 0.20	0.24 0.18	0.40	0.40
Top of natural	0.64	0.72	0.80	0.80
Base of Trench	0.68	0.76	0.80	0.80

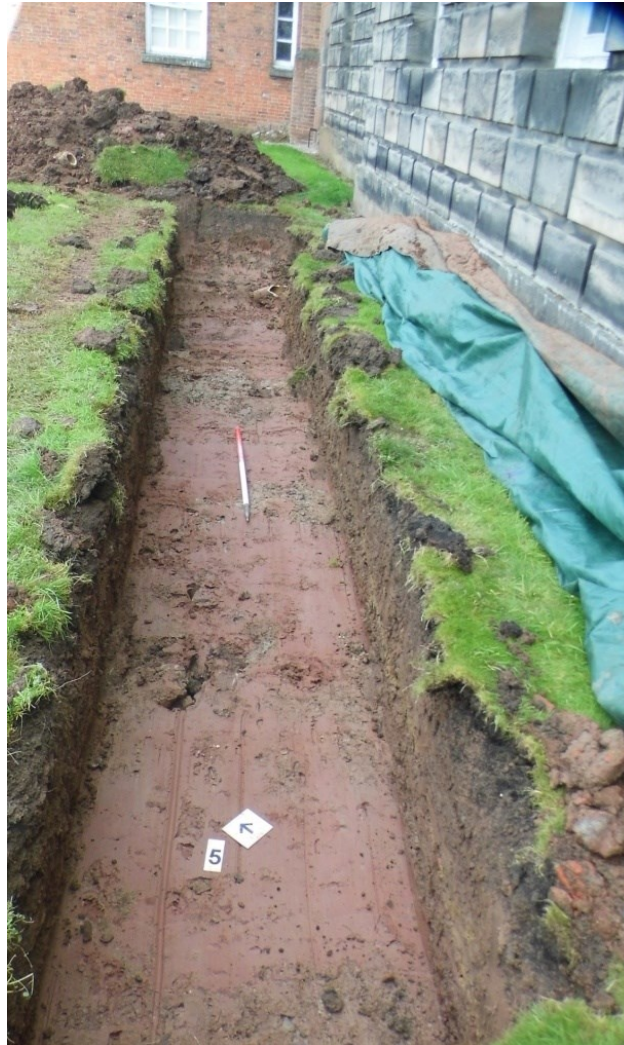
Figure 11: Trench 5 looking north-east

Orientation: North-east to south-west

Length: 8.50 m Width: 0.90 m

No Archaeological remains identified

Interval	NE 0m	2m	4m	6m	8.50m
Topsoil Depth	0.10	0.10	0.15	0.20	0.14
Subsoil Depth	0.40	0.60	0.47	0.40	0.50
Top of natural	0.50	0.70	0.62	0.60	0.64
Base of Trench	0.50	0.70	0.62	0.66	0.68

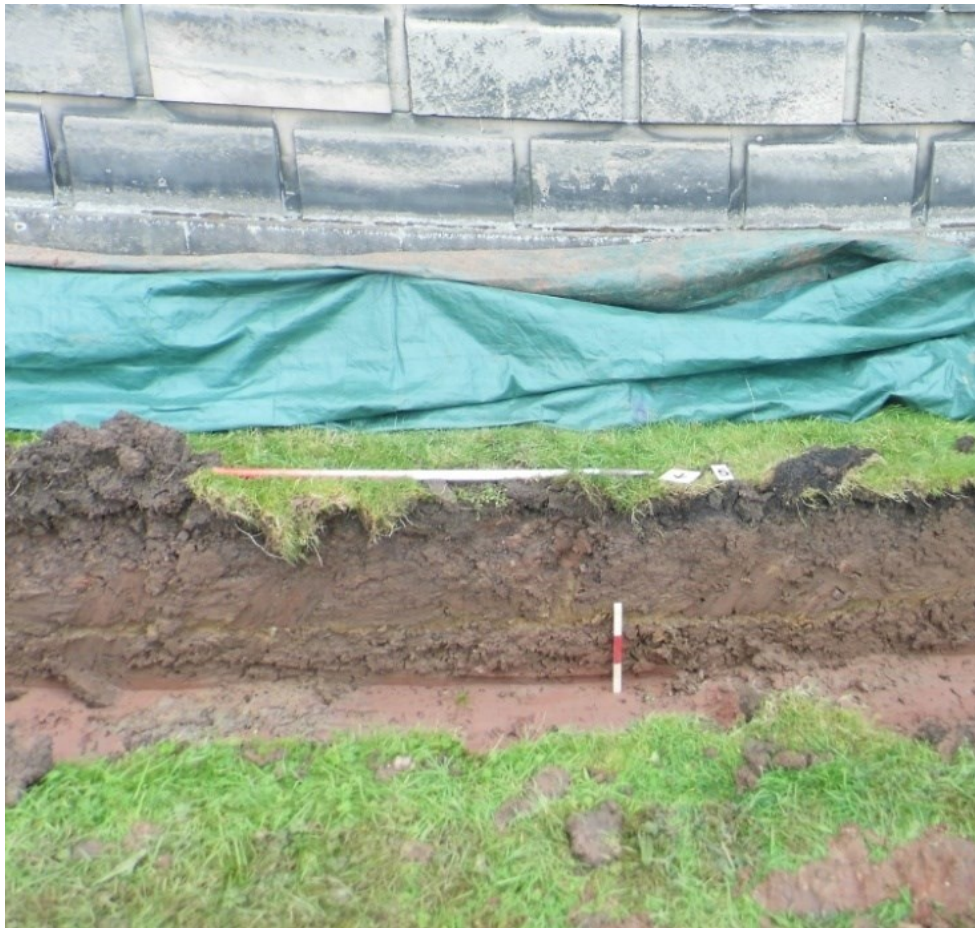
Figure 12: Trench 5, section looking south-east

Present below the re-deposited natural substratum layer was a lower subsoil consisting of a thick layer of soft mid yellow brown silty-clay with occasional charcoal flecks and pebbles. This probably represented deposits from earlier landscaping. Directly below this was a generally undisturbed compacted red clay natural substratum averaging up to a depth of 0.70m below ground level.
