**An Archaeological Field
Evaluation at Fairfax Street
Coventry
NGR: SP 33808 79211**

ULAS Report No. 2016-136

**An Archaeological Field Evaluation
At Fairfax Street, Coventry
(SP 33808 79211)**

**Nathan Flavell
For: CODE Student Accommodation**

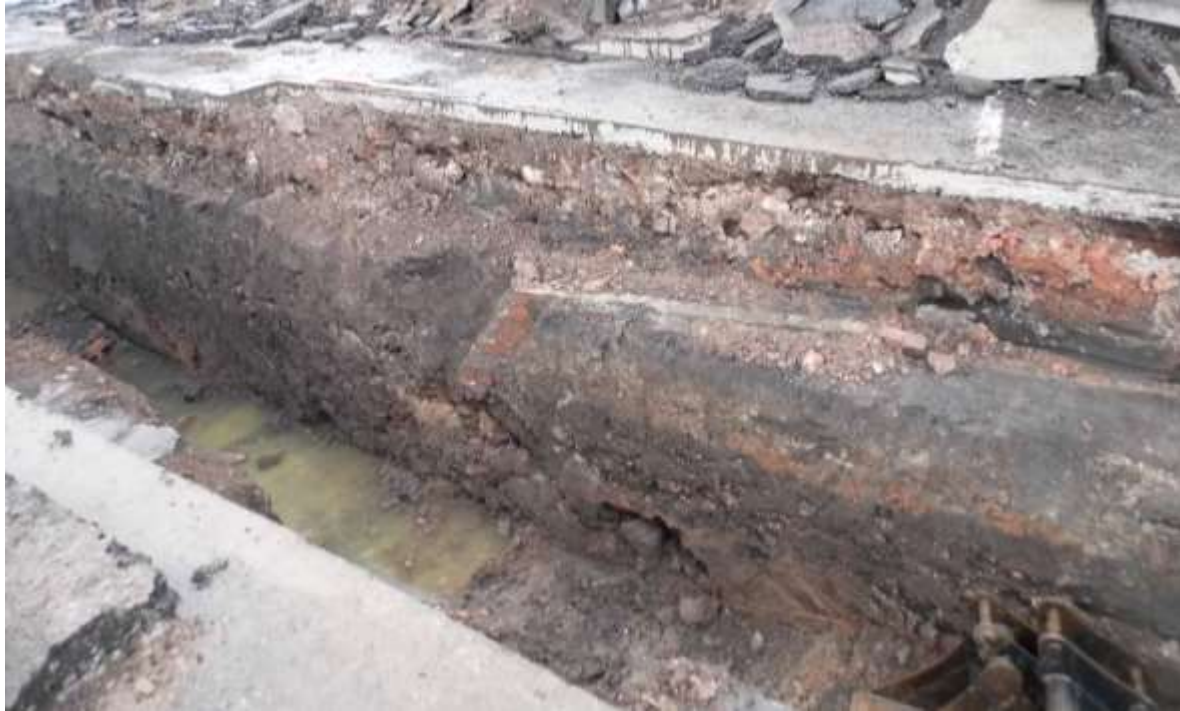
Figure 5: Trench 1: Terraced house boundary wall, looking north

Trench 1 was aligned roughly west to east. The natural substratum consisting of yellow-grey river-type gravels was only encountered at the east end of the trench at a depth of 2.88m. At 2.5m (the general machined depth), was a contaminated black-brown silty-clay soil. An organic silty sand covered this. Above these layers were at least two post-medieval levelling layers. Cut into these was a brick boundary wall, a single-brick-thick, aligned approximately east-west, 1.4m deep, from the northeast corner of the trench to 11m along the southwest side of the trench (Fig. 5). There were also remnants of a garden path. There also what appeared to be a linear pit under the path which may have been associated with the terraced house.

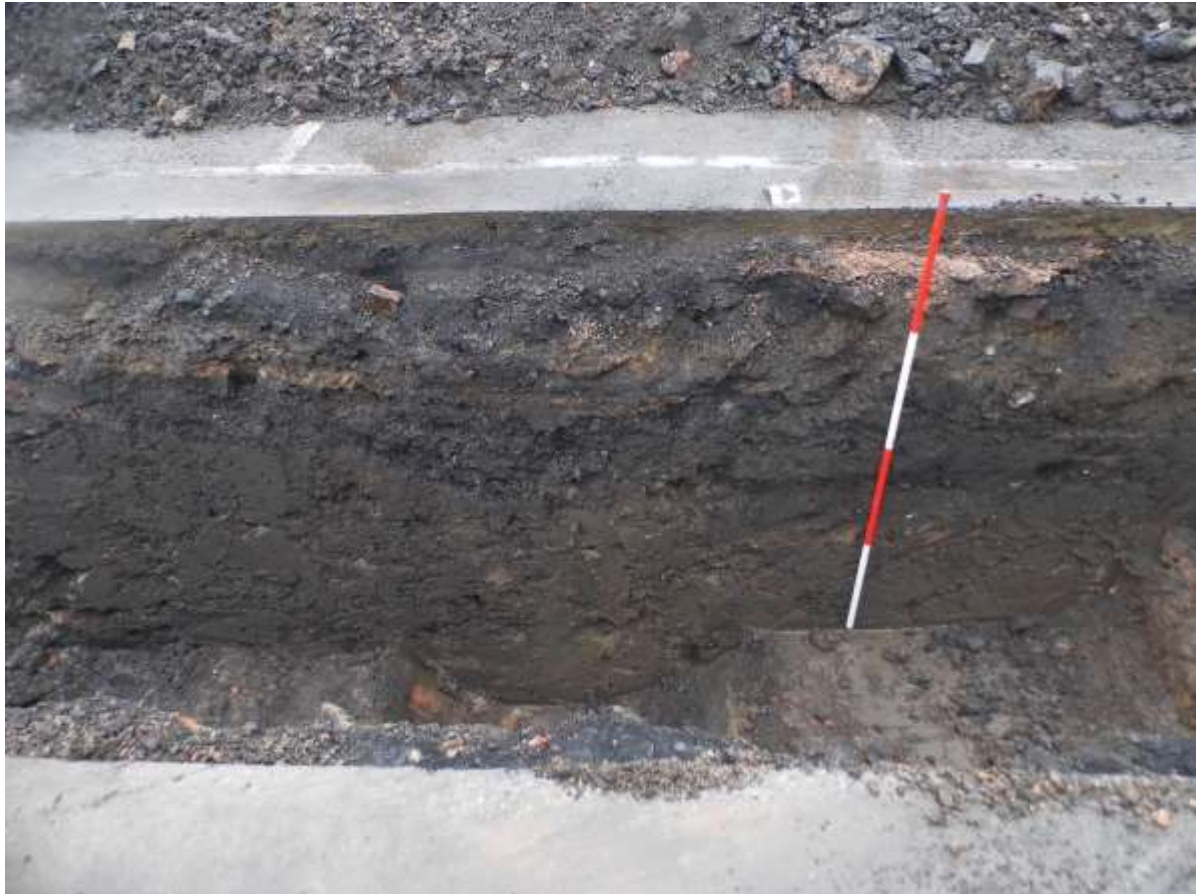
Figure 6: Trench 2 sondage looking west

Trench 2 was aligned north to south. The natural substratum consisting of light yellow-brown silty clay was only encountered at the east end of the trench, 2.7m deep. Possible pits were observed at the west end of the trench at a depth of 2.25m (Fig. 7). These were truncated by other pits with fills that were similar to the levelling layers that were in trench 1. These also appeared to be the same levelling layers within this trench, very dark brown-grey-black silty clay with CBM and charcoal inclusions. A sondage was excavated through these layers 28m from the west end of the trench (Fig. 6). This uncovered an earlier fill/layer of a black-brown organic clay (1), with remnants of leather to at least a depth of 3m. A number of drains and services were also noted.

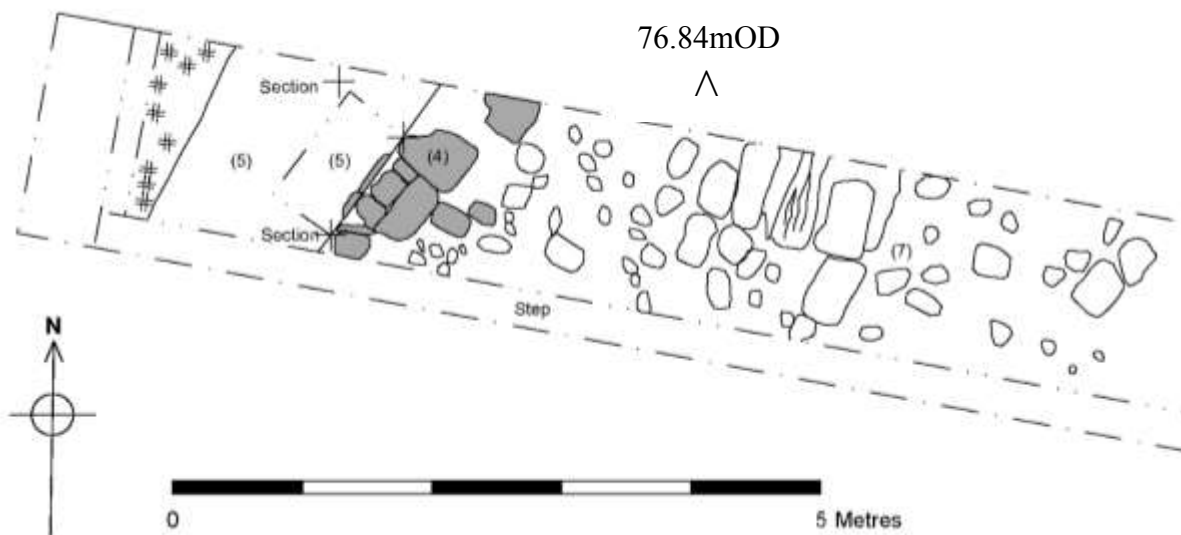
Figure 8: Trench 3 partial plan

Trench 3 was aligned approximately east to west (Figs. 8 & 10). The medieval town wall (4) was encountered near the west end of the trench, aligned north to south, 0.98m deep (Fig. 9). It was made up of large pink sandstone blocks, with rough facing on the outer edge, with a rubble core. A small sondage was excavated 0.5m into the west edge, into pink-red clay sand with charcoal flecks (5), which is mostly likely to be the backfill of the construction trench [10] (Figs. 11 & 12). Two fragments of roof tile dating from 13th to 15th centuries were recovered from this context. This showed two distinct courses of dressed sandstone blocks with a rubble foundation underneath. It was clear that the wall had been demolished to the east as the tumbled

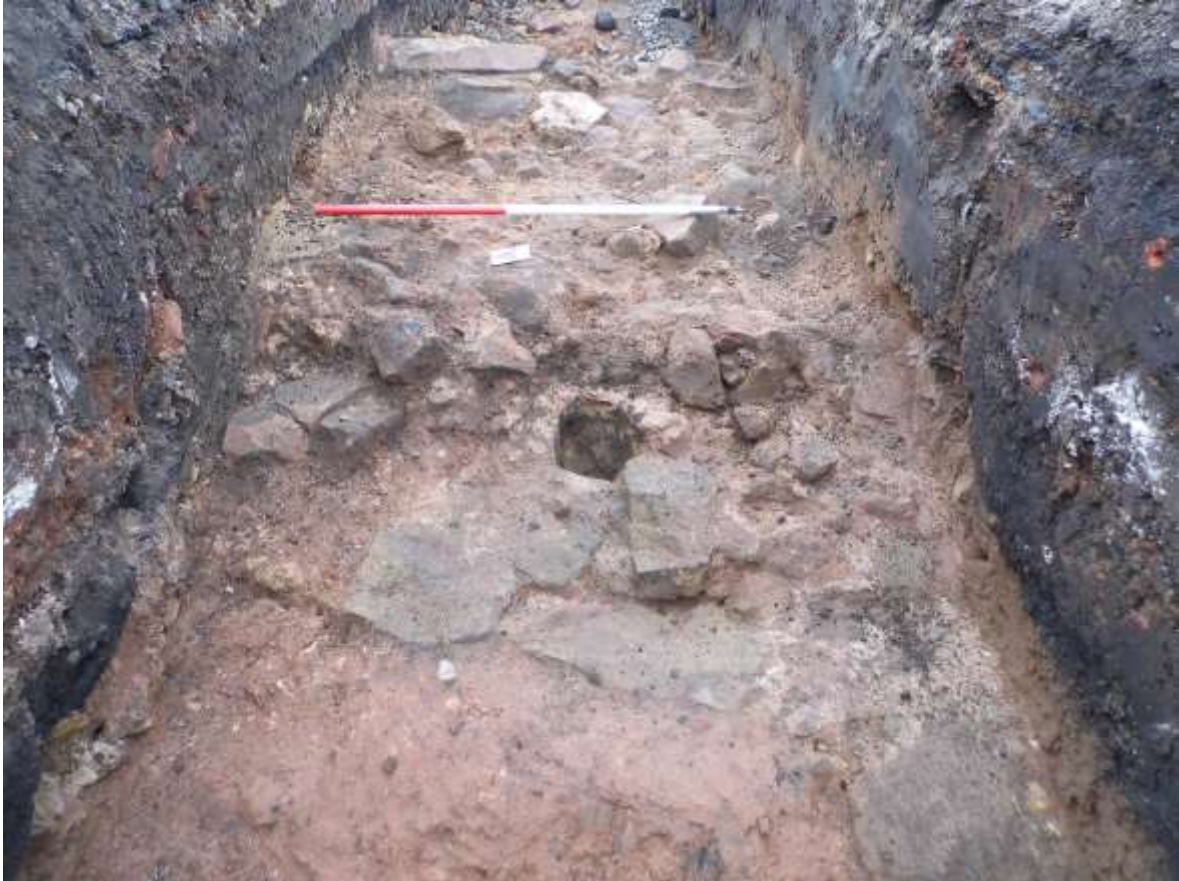
Figure 9: Trench 3: Town wall (4) looking west

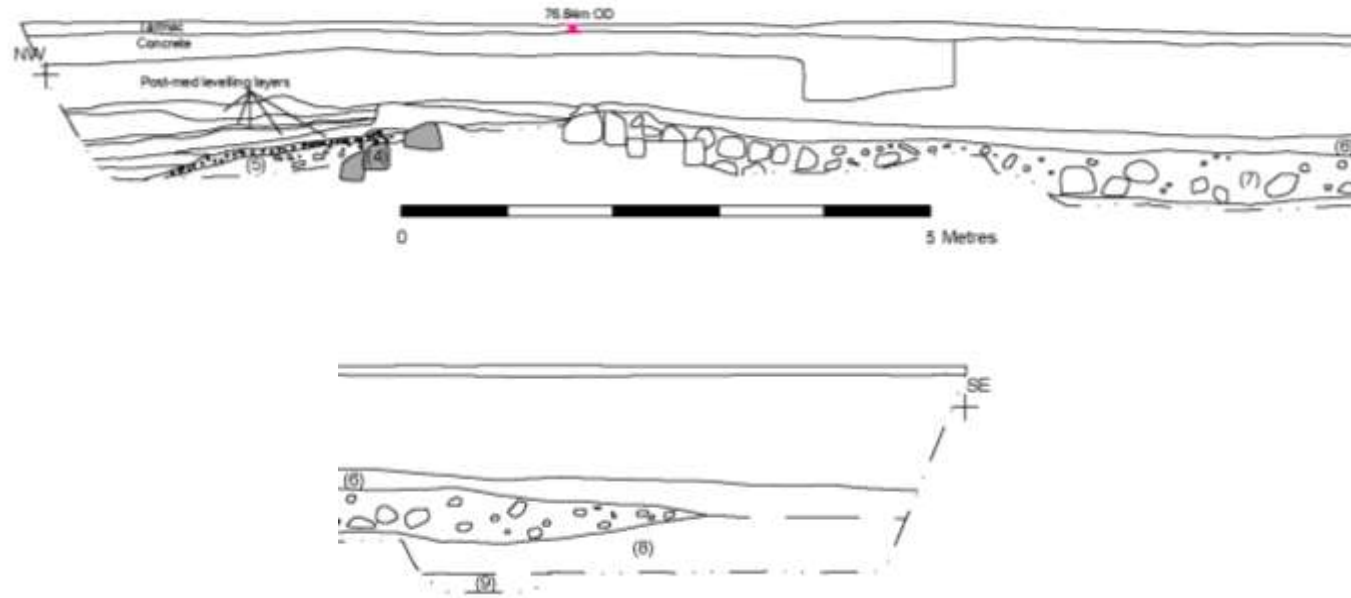
Figure 10: Trench 3 section

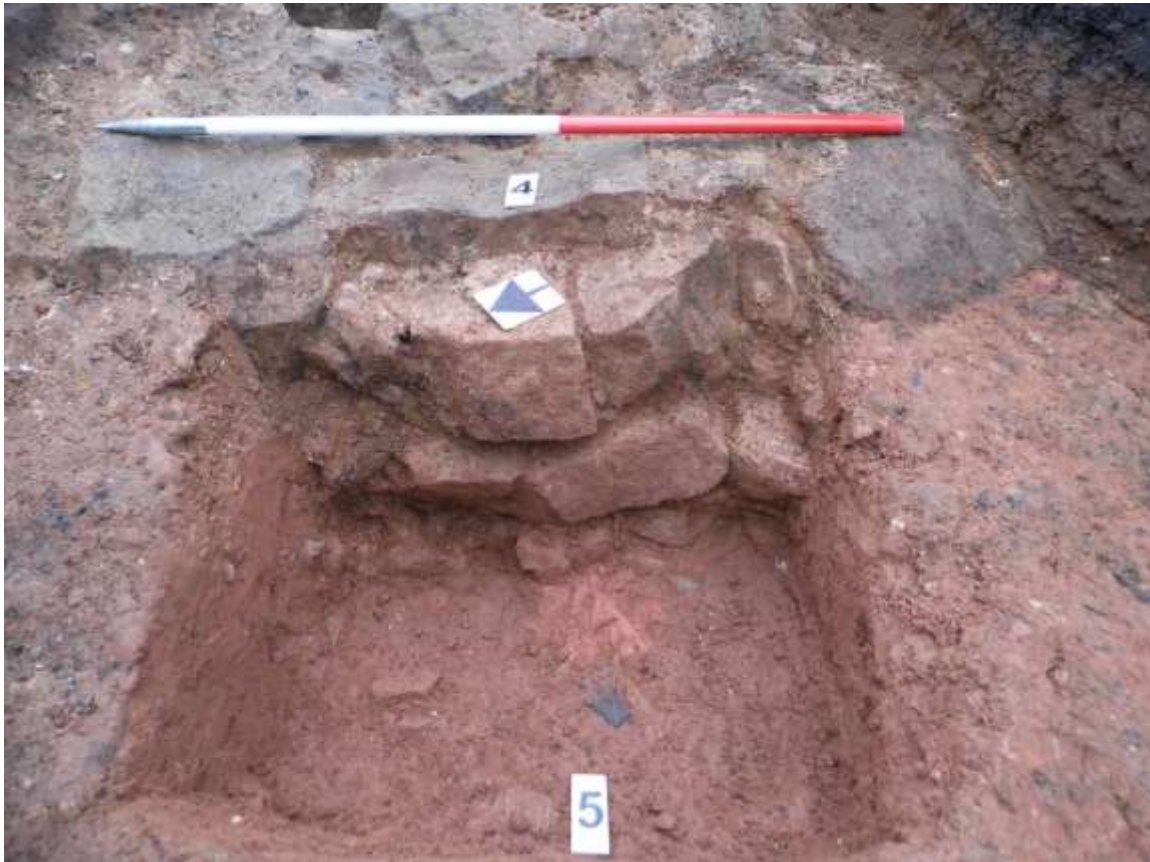
Figure 11: Wall (4) with foundations & backfill (5) looking east

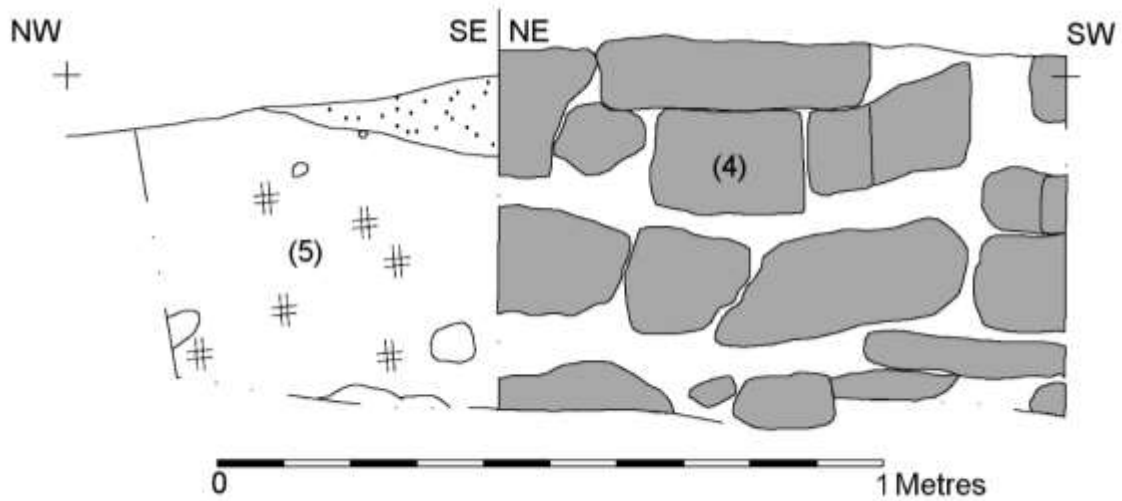
Figure 12: Wall foundation section

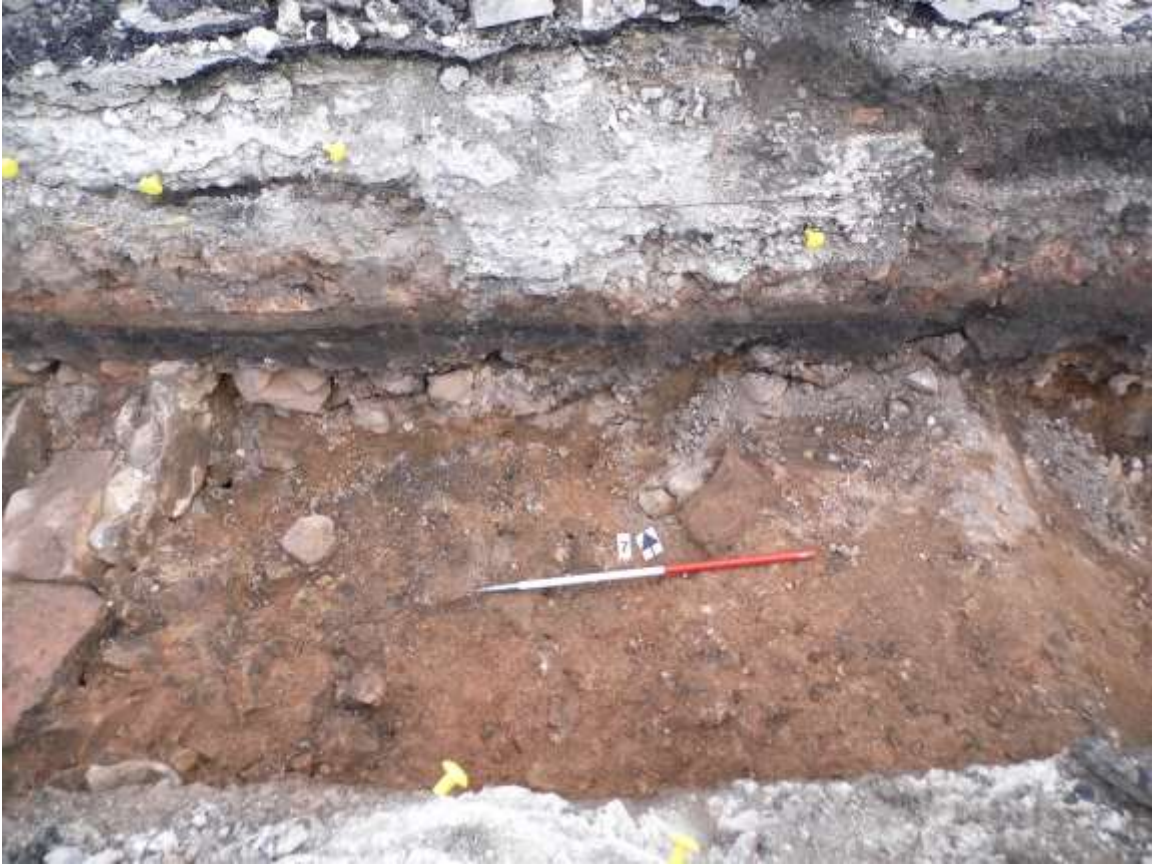
Figure 13: Wall demolition rubble looking north

stones were clearly visible. The rubble layer (7) was 0.25m thick, and continued for at least 10m along the trench (Fig. 13). It overlaid mid brown-grey silty sand with brick, mortar and tile inclusions (8), at least 0.35m thick. Above this and the rubble was dark brown-grey clay sand (6) with CBM inclusions, 0.45m thick. At least seven different post-medieval/modern levelling layers were above this 0.25-0.5m thick, with a re-enforced concrete foundation above that. On the north-west side of the wall there were eight make-up/levelling layers different to those in the rest of the trench. These were overlying the wall in stratigraphic sequence, and so post-date the 17th-century demolition. To avoid services, a gap was left, and the rest of the trench was excavated. This revealed the same levelling layers (6) and (8), somewhat similar to those in trenches 1 and 2. At 28.3m from the west end of the trench was a single course of sandstone blocks, 1.8m deep (Fig. 14). The wall, aligned north-northeast to south-southwest appeared to be quite roughly made, and at least cut into layer (6).

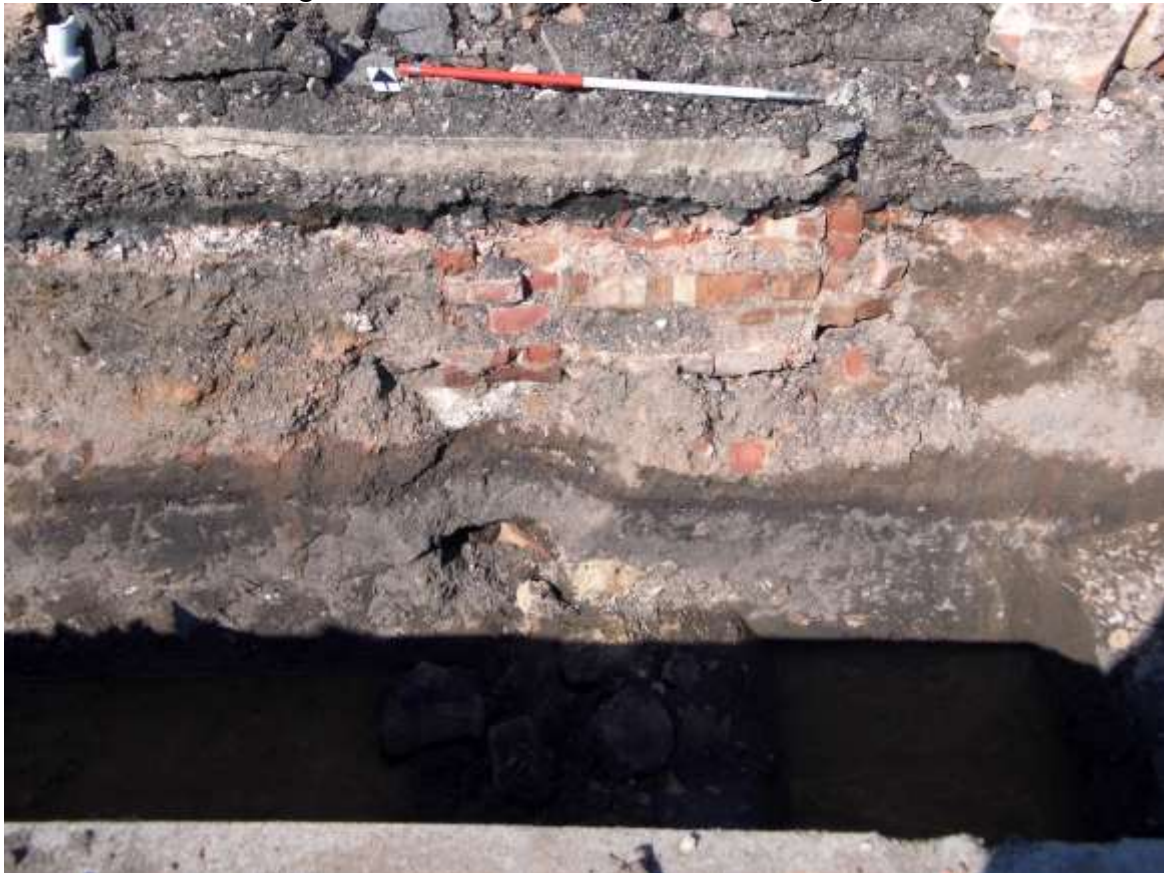
Figure 14: Trench 3 single course sandstone wall looking north

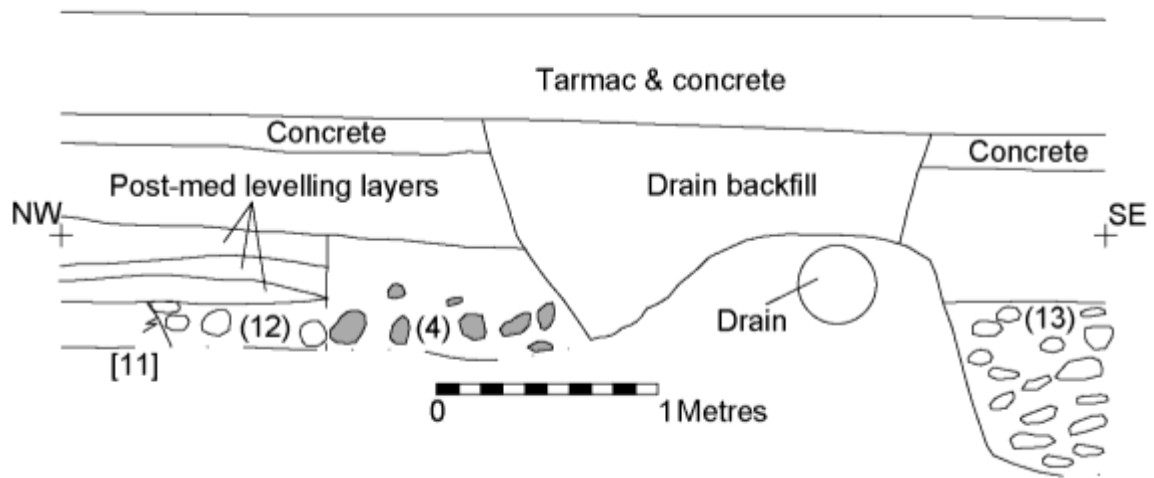
Figure 16: Trench 4 partial section

Trench 4 was aligned west to east (Fig. 15). The town wall (4) was further uncovered 10m from the east end of the trench at a depth of 1.04m (Figs. 16 & 17). No dressed sandstone blocks were present, only the rubble foundation remained. Immediately on the west side was a deposit of orange-brown silty-clay with mortar inclusions (12) which was most likely to be the backfill of the construction trench [11] (Fig. 18). To the east side there was a similar layer of sandstone rubble (13) as found in trench 3. This continued to the end of the trench, 0.8m thick. The same levelling layers were observed covering the rubble as in trench 3. To the west of the wall were different levelling layers. These were somewhat similar to those in trench 3 on the same side of the wall.

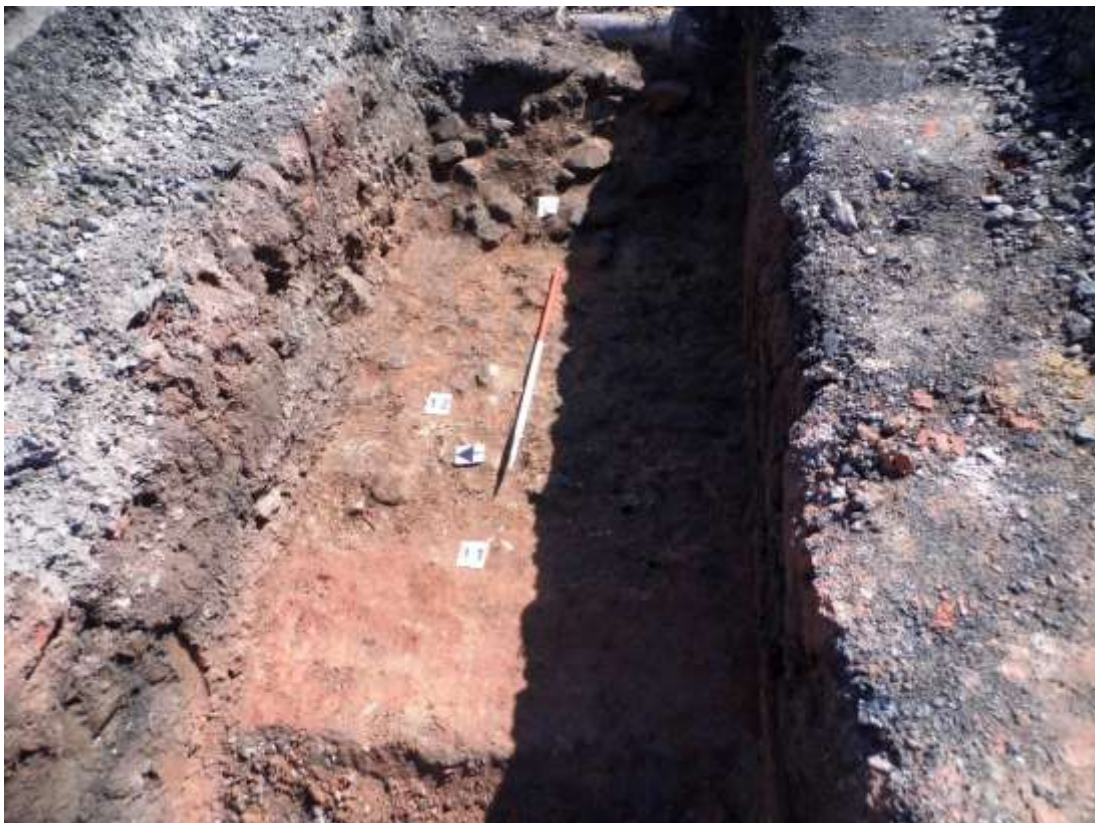
Figure 17: Wall (4) in trench 4 looking east

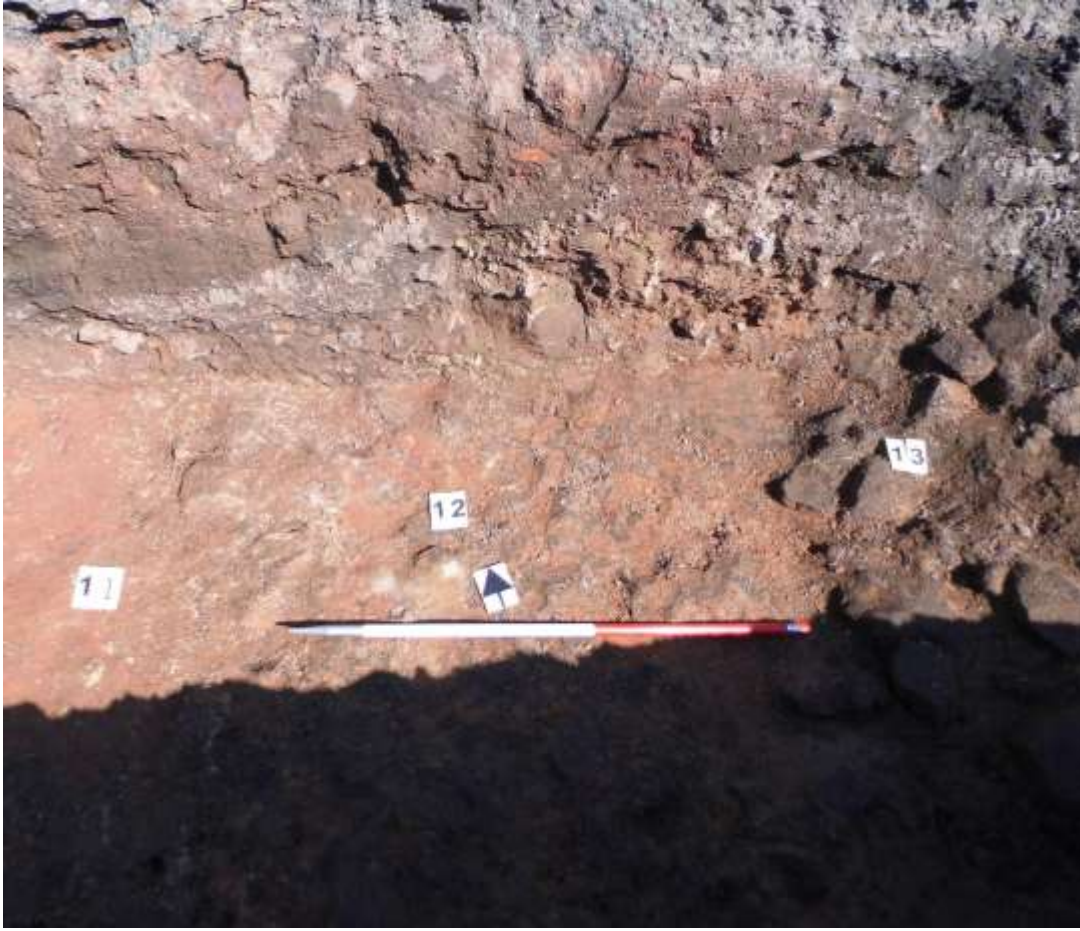
Figure 18: Wall (4) with construction cut [11] looking north

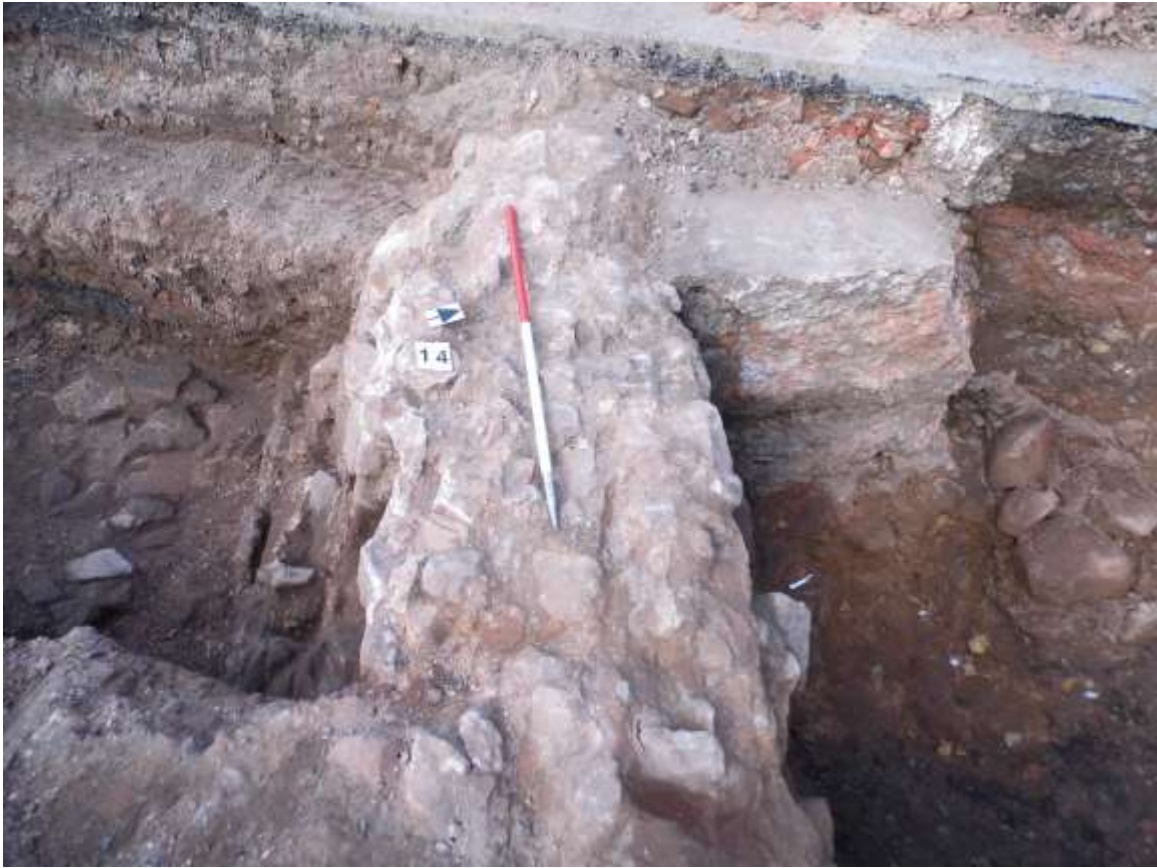
Figure 20: Town wall (14) looking west

Trench 5 was aligned north-east to south-west. A further section of town wall (14) was uncovered, aligned approximately east to west, 0.28m deep (Figs. 19 & 20). All the outer dressed stones seem to have been removed, leaving the rubble core as noted by the shapes of mortar left. It was 1.4m high, and 2.35m wide, including 0.8m of rubble foundation (15) on the north side of the wall. On the south side of the wall was a small layer of roughly shaped sandstone blocks, lying flat, and 0.9m wide (Fig. 21). These may have been removed from the wall but not taken away for reuse. On the north side of the wall there was a partial square sandstone foundation (16) uncovered, 1.6m deep, measuring 1.05m by 1.6m continuing into the east side of the trench (Figs. 22 & 23). The sandstone was partially dressed on the outside with a fine mortar bonding. This could be part of the tower where the walls meet, or a buttress for the tower. Part of the trench was unexcavated due to services to the south-west. The south-west end of the trench was excavated down to a depth of 3.8m to the natural substratum of pink clay. Above this was a layer of mid brown-grey silty clay with an organic component full of oyster shells. This was covered by various levelling layers similar to those seen in trench 6 (Fig. 24).

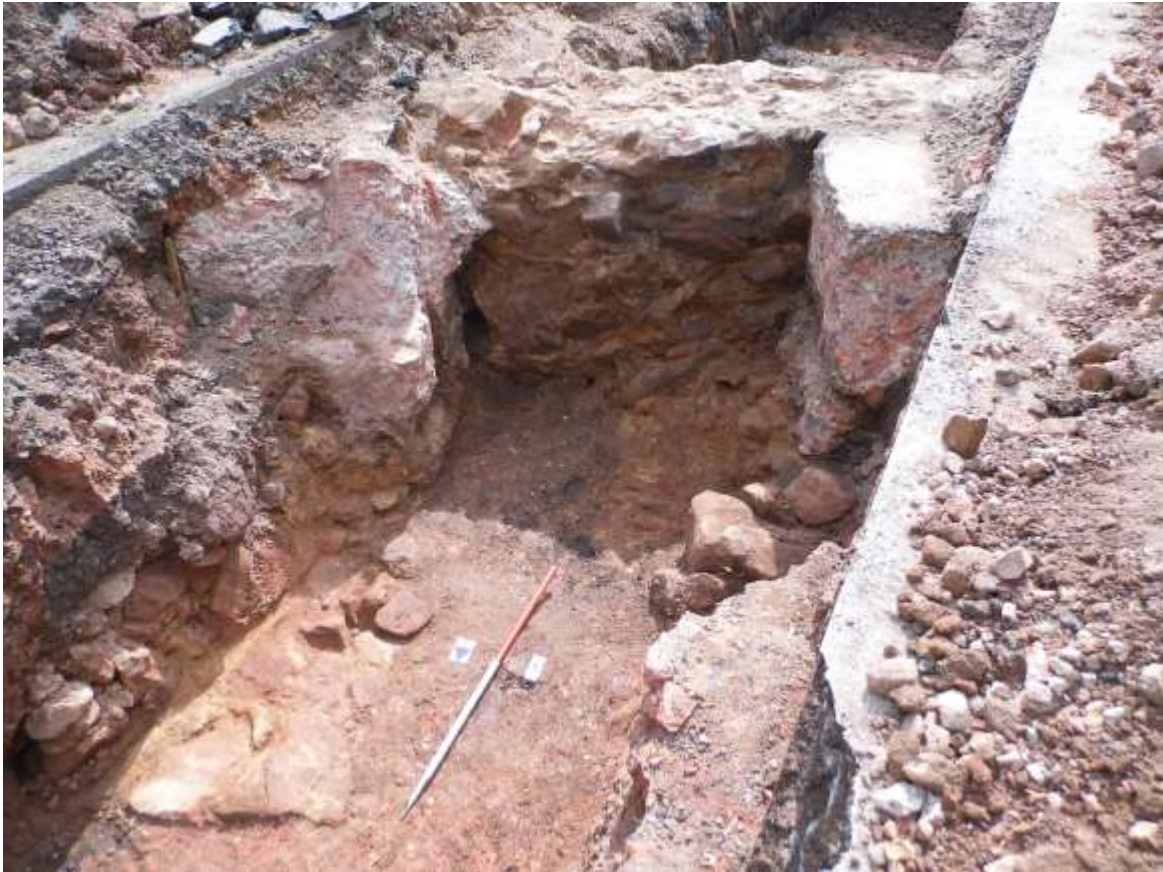
Figure 22: Butters/tower (16) & wall (14) looking south

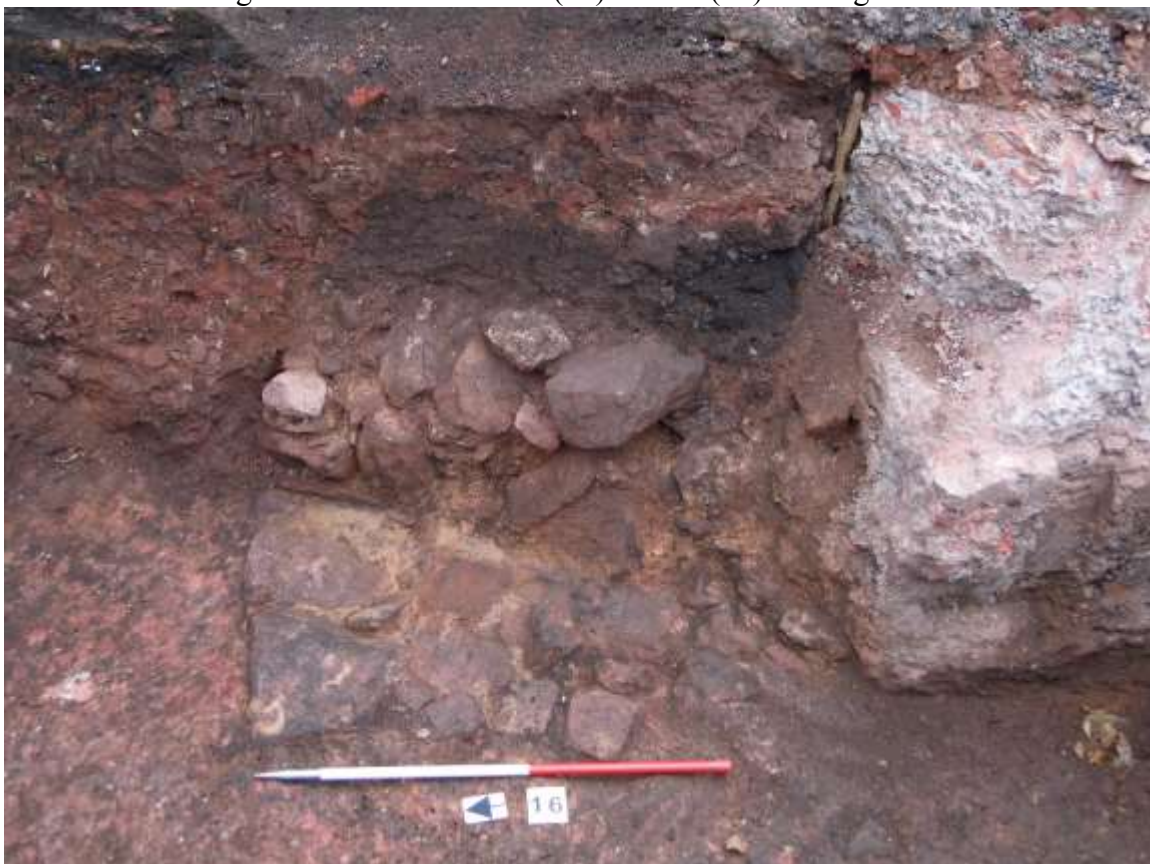
Figure 23: Butters/tower (16) looking east

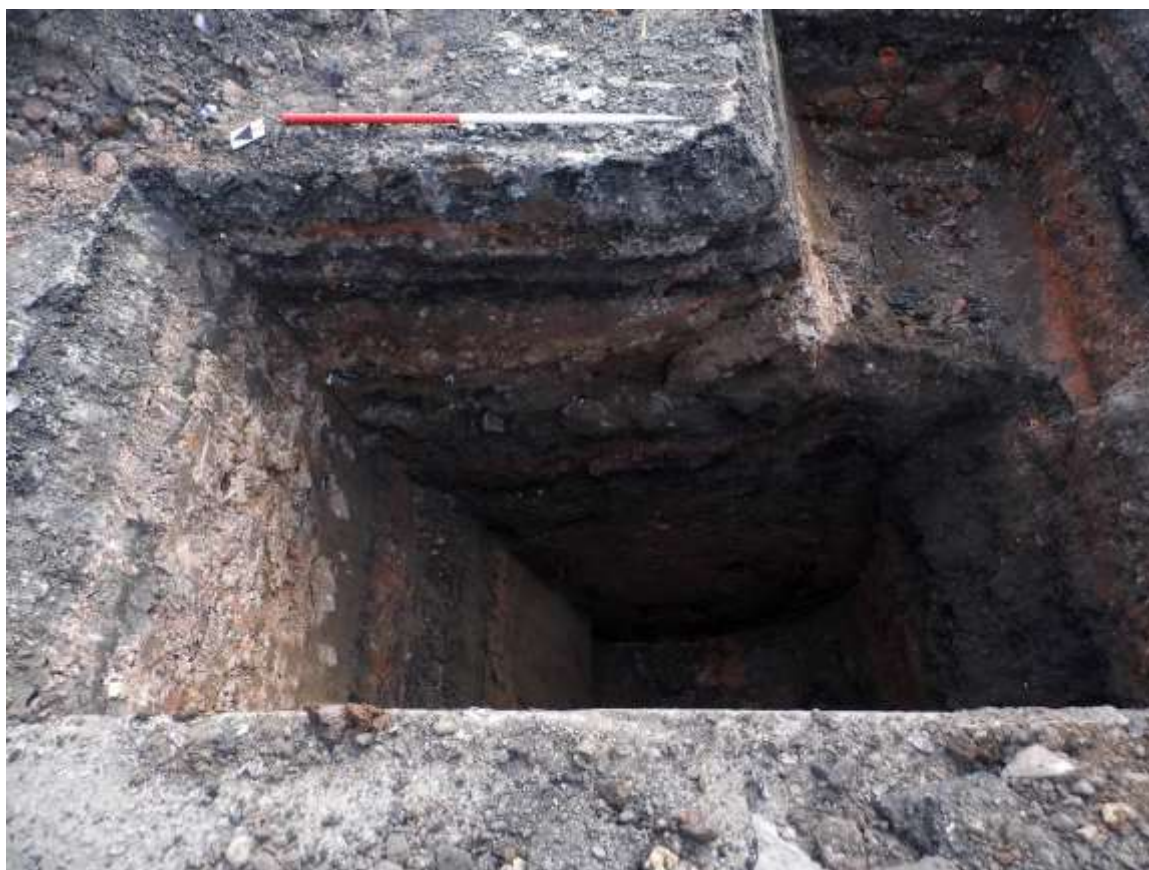
Figure 24: trench 5 sondage looking south-east

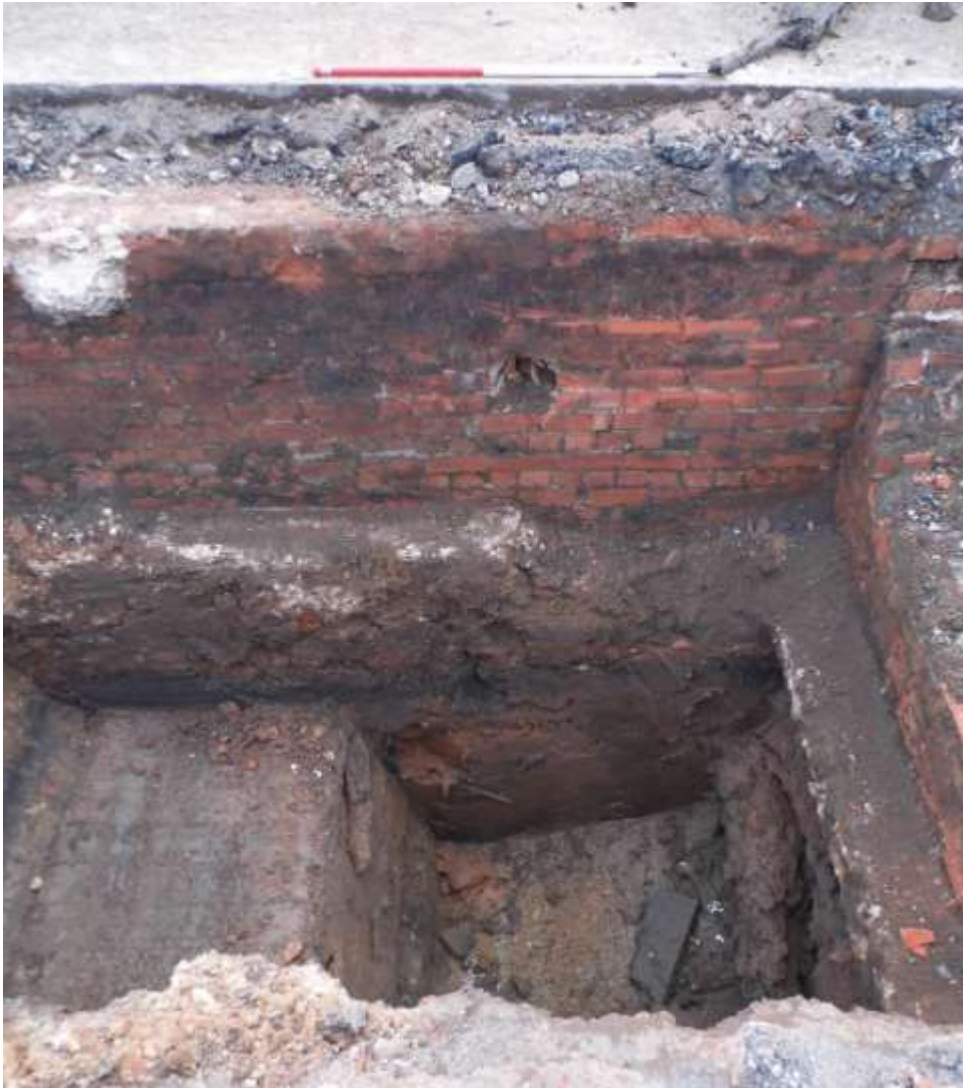
Figure 25: Trench 6 sondage looking south-east

Trench 6 was aligned north to south. The natural substratum of yellow-brown silty sand was uncovered in a sondage at the south end of the trench, 3.4m deep (Fig. 25). Above this was mid brown clay silt (20) with oyster shell and an organic component, 0.4m thick. This was overlain by mid brown red silty clay (19) with wood and stone fragments, 0.48m thick. Both have such an organic nature to their fill, it seems likely they might be fills of a pond. These layers are sealed by pink-red silty sand (18), 0.42m thick. Within the rest of the trench are post-medieval levelling layers 1.68m thick. There was also truncation by a cast iron pipe 0.7m deep, and brick foundations for a demolished building, 1.52m deep.

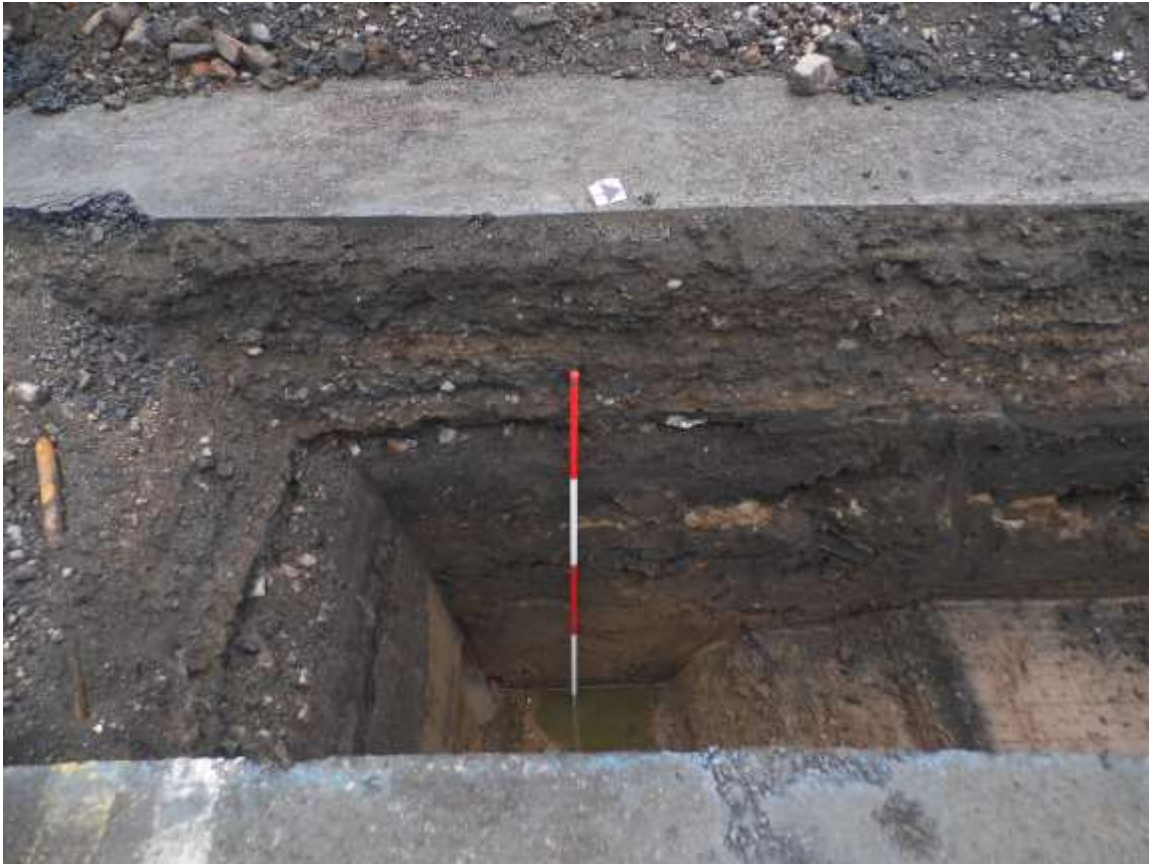
Figure 26: Trench 7 sondage looking west

Trench 7 was aligned north to south. The natural substratum was observed in a sondage 9m from the south end of the trench (Fig. 26). It was yellow brown sand, 2.7m deep. Above this was mid brown silty sand (9) with charcoal flecking, 0.7m thick. This was similar to that observed at the base of trench 3 (14m from the north end). Above this was layer (8), 0.6m thick. This was overlain by the same demolition rubble layer (7), 0.4m thick (Fig. 27). Layer (6) was above this, 0.4m thick. There were various make-up/levelling layers 0.7m above this. Again these were similar to those observed in other trenches.

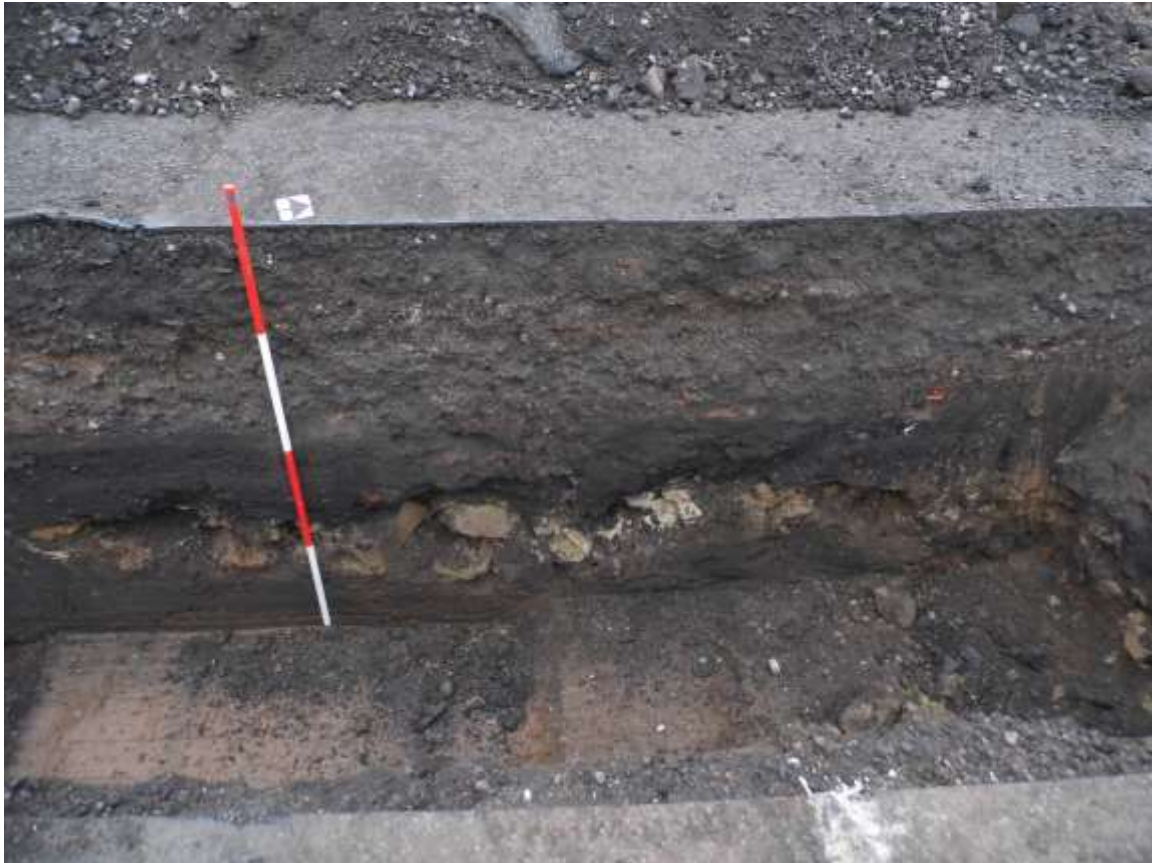
Figure 27: Trench 7 demolition rubble (7) looking west

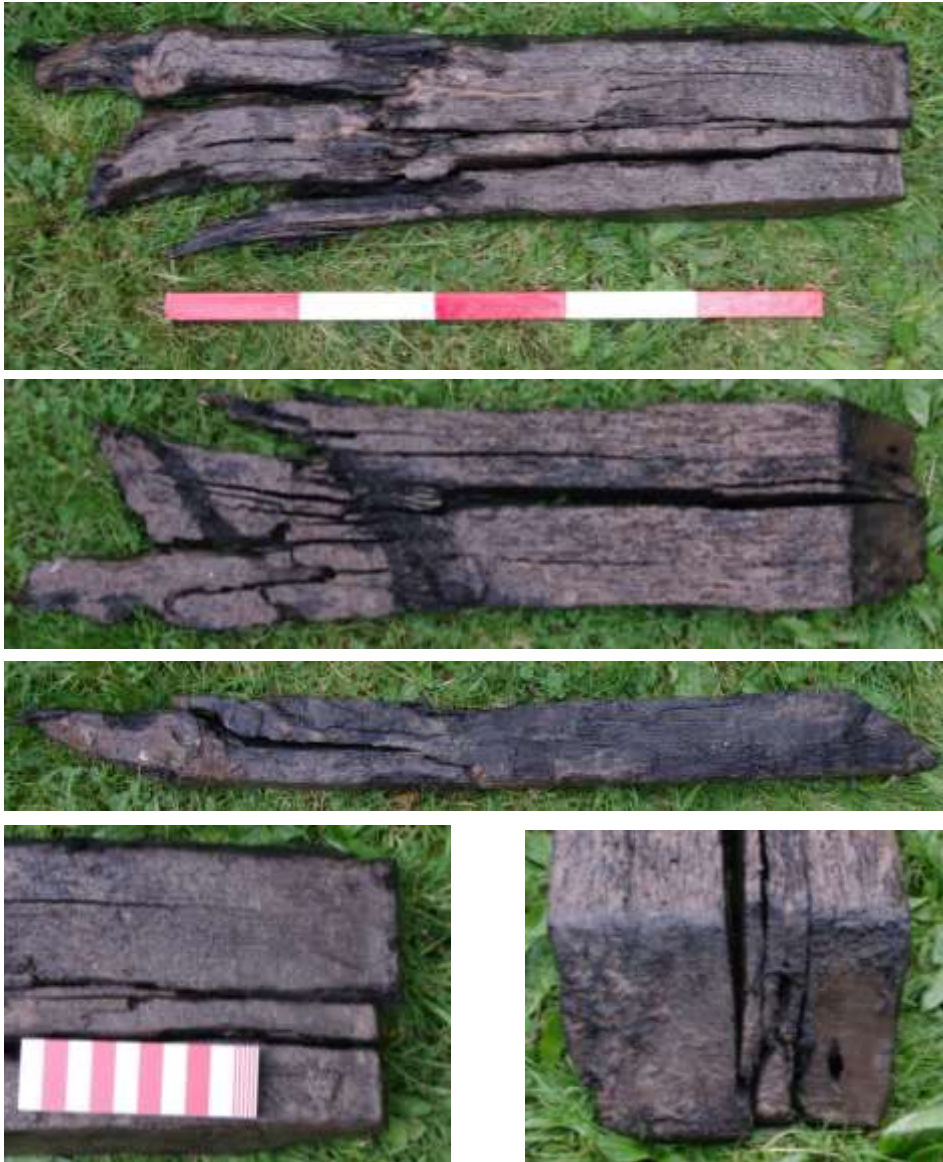
All pieces were of different lengths, but similar section, and were found to join together to form a single piece that had split into three. The piece is 680mm long (incomplete), 140mm wide (incomplete) and 55mm thick (complete).

The conversion is tangential: the piece has split apart along the lines of the rays. The piece is of rectangular cross section, although it is incomplete across its width as the faces of the piece have split recently, perhaps during excavation. The unsplit faces of the piece are eroded and are probably original. No tooling was observed. The wood is poor to fair condition with tooled surfaces eroded.

Figure 28: Waterlogged wood from Trench 6, (19). Nail head lower left, joint face with fibres visible low

The incompleteness of the timber precludes an interpretation with much certainty. The piece would appear to be a brace, and is therefore part of a larger structure. The angle of the cut face to the profile and the lack of a bird's mouth joint suggests that the timber is not a rafter.
