Archaeological Attendance and recording

St Mary the Virgin Church,

Coleorton, Leicestershire LE67 8FB

Report No 2017-139

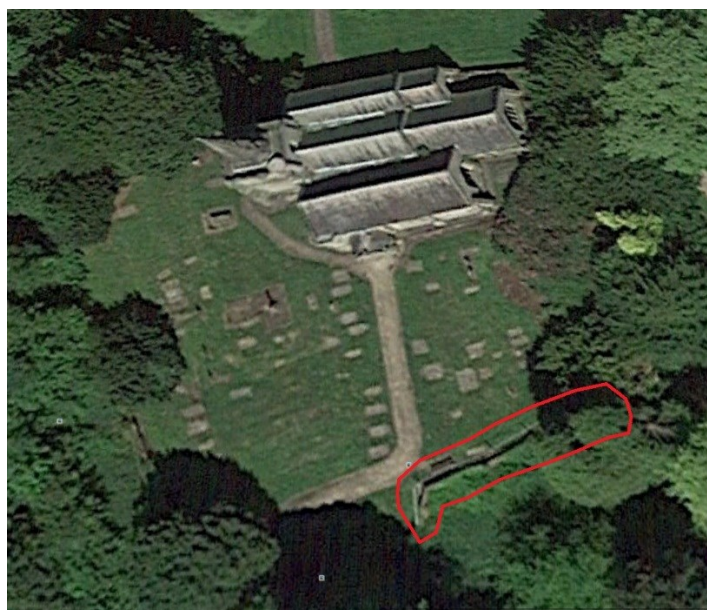
Figure 3: Approximate location of wall outlined in red (Google Earth data)

North West Leicestershire District Council (the client) proposes to undertake groundworks in the form of trial holes against the boundary retaining wall of the churchyard (Figures 2 & 3). The purpose of the trial holes is to confirm the causes of movement of the boundary retaining wall. The DAC has granted a faculty for work with a condition that 'no works shall take place until the PCC, after consultation with the Diocesan Archaeological Adviser, has secured the implementation of a programme of archaeological works in accordance with a written scheme of investigation which has been submitted by the PCC and approved by the DAC'.

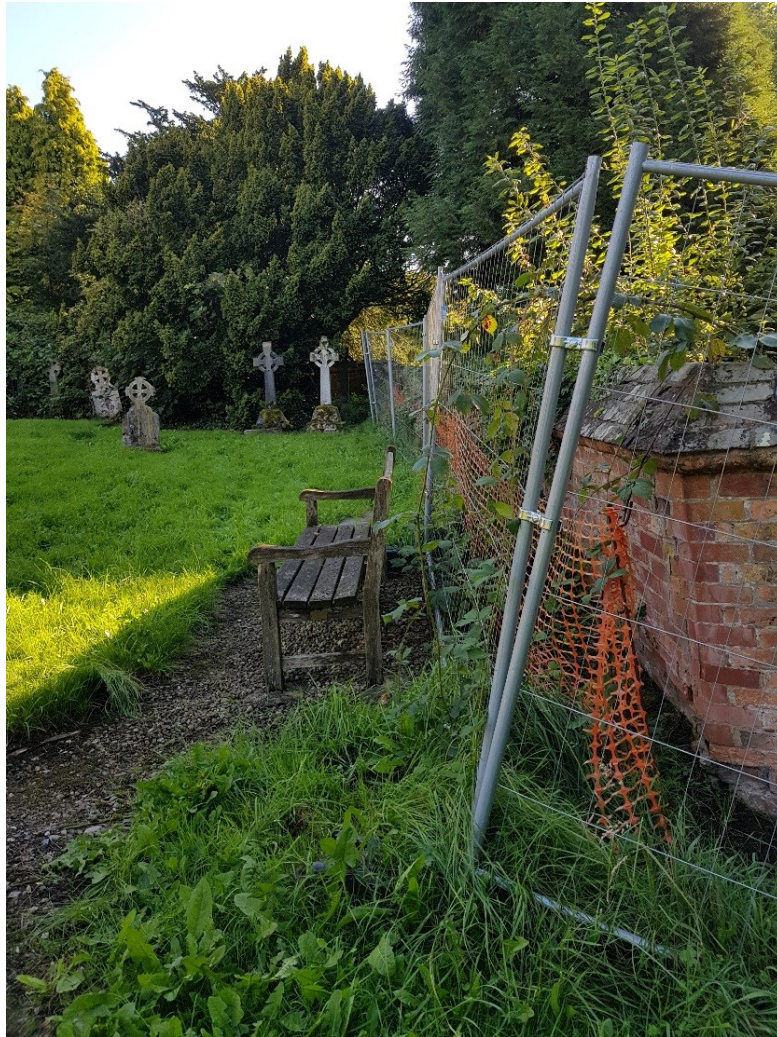
Figure 4: Looking East along the northern elevation of the wall.

Prior to arrival, the wall had been fenced off to prevent public access directly to the wall, which was in a poor state of repair (Figures 4 & 5). The first investigation pit (T1) was positioned approximately 2.5m from the western corner of the wall, just to the east of the bench. The dimensions of the hole was 0.6m x 0.5m and it was dug to a depth of 2.65m (Figures 7 & 8). The second investigation pit (T2) was positioned approximately 12m

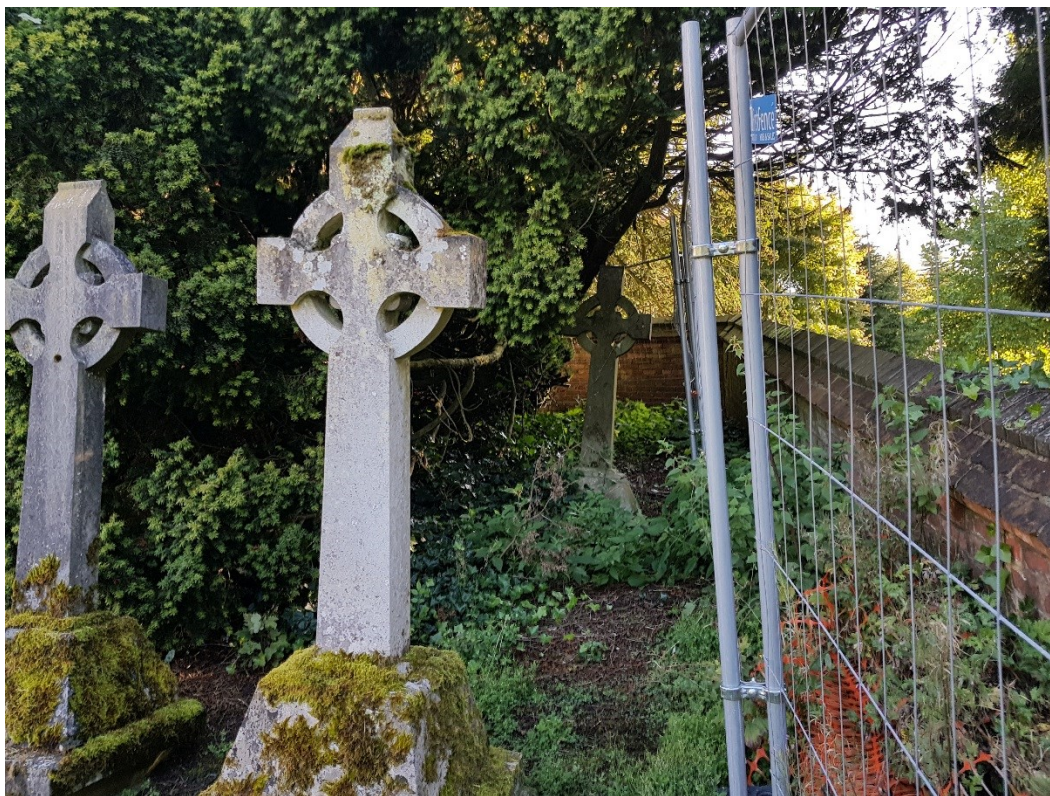
Figure 5: Looking east from the edge of the trees on the northern elevation of the wall at the point where T2 will be dug (between the two headstones against the wall).

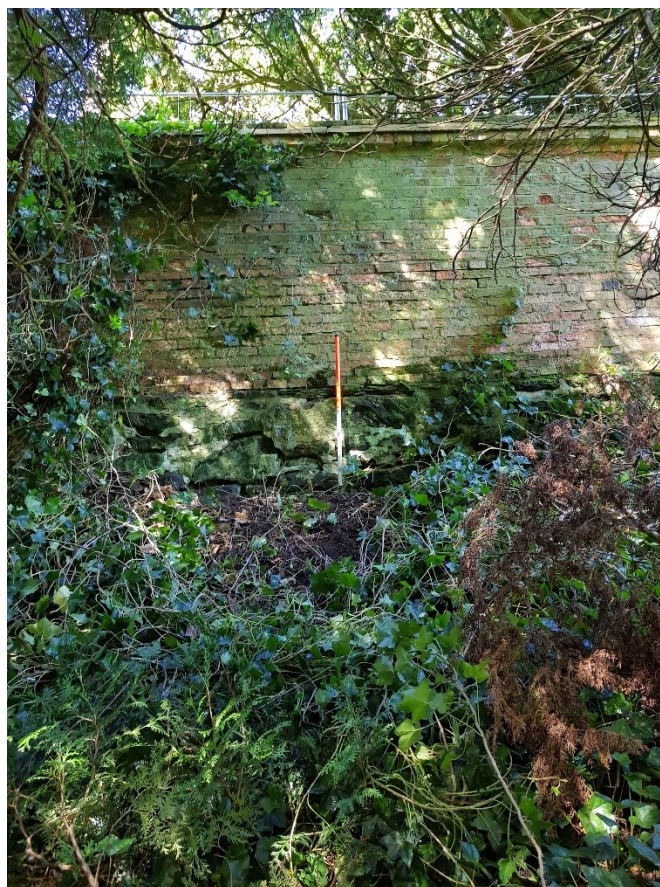
Figure 6: Photograph showing the southern elevation of the retaining boundary wall and the steep slope covered in vegetation leading up towards it.

The southern side of the wall had to be accessed by climbing over the boundary wall to the eastern side of the church and walking round through the overgrown foliage to the other side of the wall. The height of the land here was considerably lower than the church yard with the wall being built at the top of a steep embankment (Figure 6). At the base of the embankment, there was temporary fencing, separating the overgrown ivy and nettle covered mound from the gardens of Coleorton Hall and preventing access to the wall.

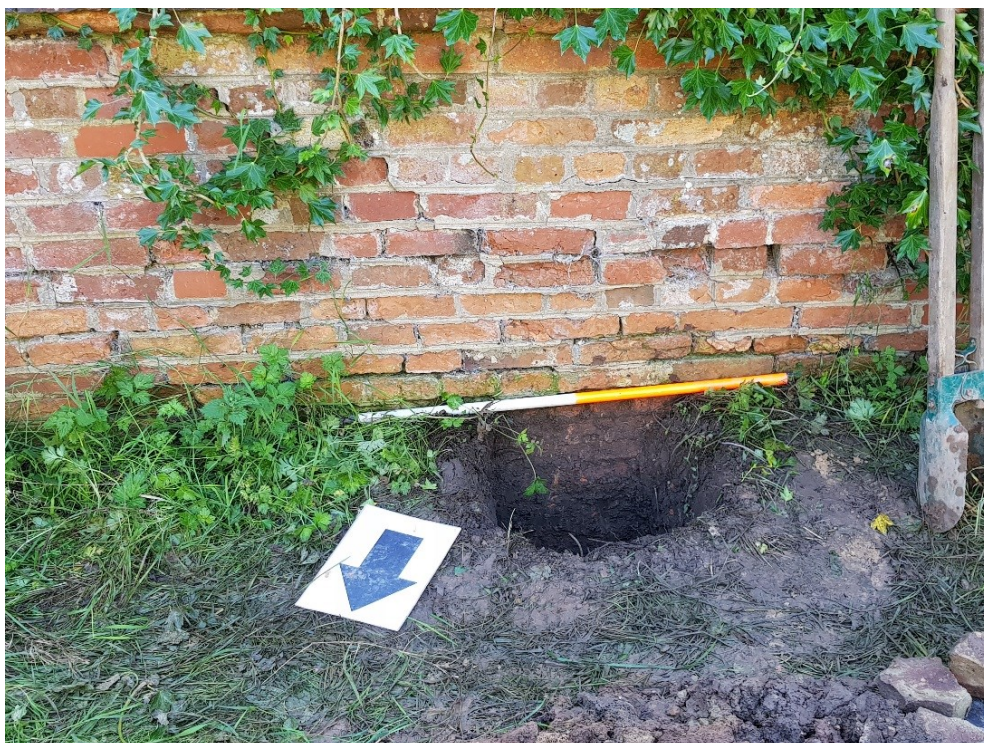
Figure 7: T1 – Investigative pit after excavation. Shows the brickwork of the wall running down to the base of the pit where the stonework of the old wall is visible.

Both investigation pits had approximately 0.2m of topsoil, which consisted of very dark and fertile soil, moving down onto a subsoil layer of mid – light brown sandy subsoil which had <10% red clay and sandstone inclusions. There were also some small fist size pieces of red brick and tile mixed within the subsoil. Close to the bottom of the pits, the sandstone became more concentrated and some pieces were rather large and cobble sized.

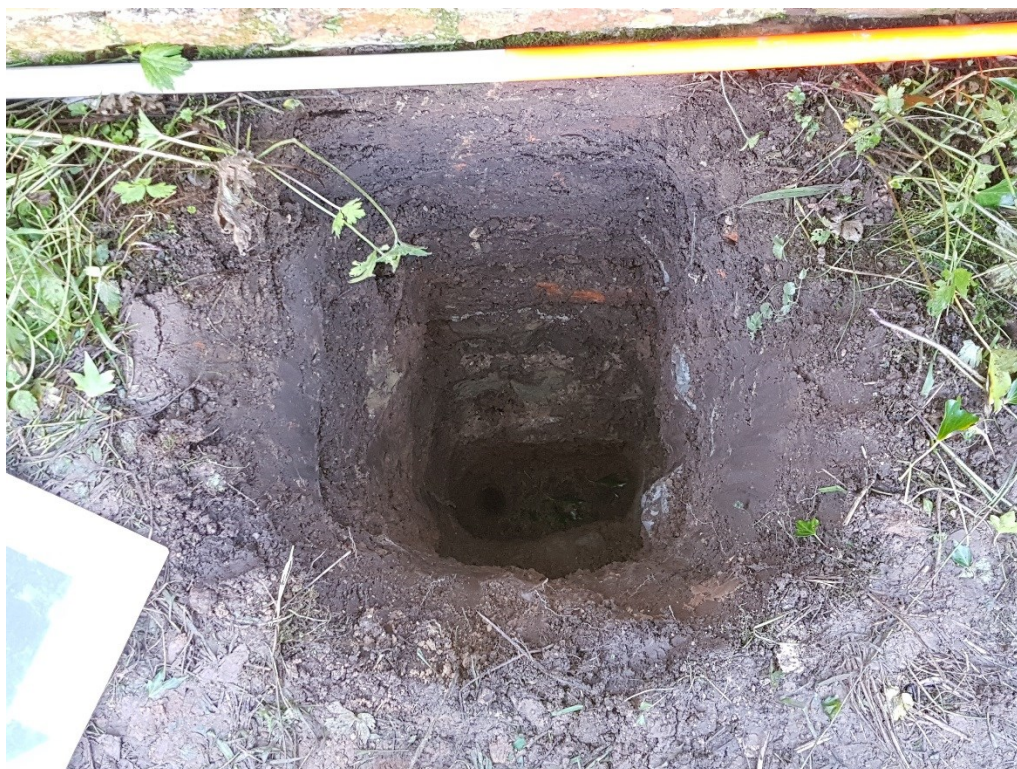
Figure 8: T1, Looking into the investigation pit. The stonework of the original wall is visible close to the base.

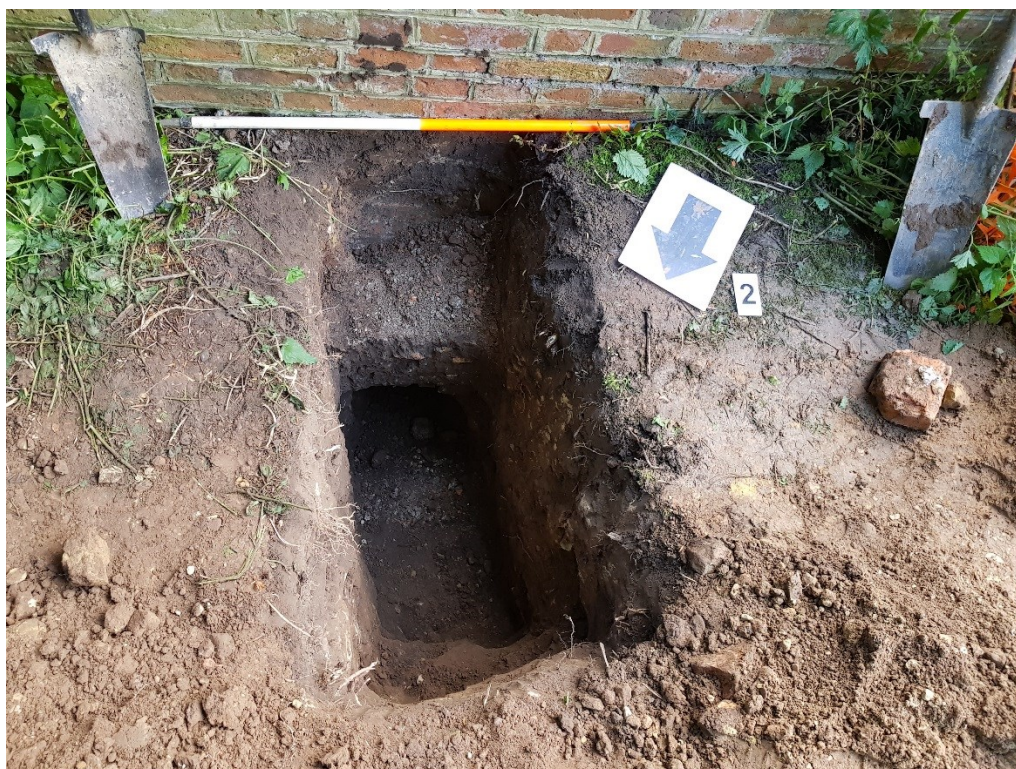
Figure 9: T2, Looking down into the investigative pit. Wall shows signs of repair.

further east along the wall with dimensions of 1.2m x 0.7m and dug to a depth of 1.5m (Figure 9).

T1 produced no archaeology. T2 produced some small disarticulated human bone fragments within the topsoil and very close to the surface. Further down the investigative pit at approximately 0.5m – 1.0m more disarticulated bone was found within the subsoil. Approximately eight small human bones / bone fragments were recovered. These were reburied with due respect as the pit was filled in.

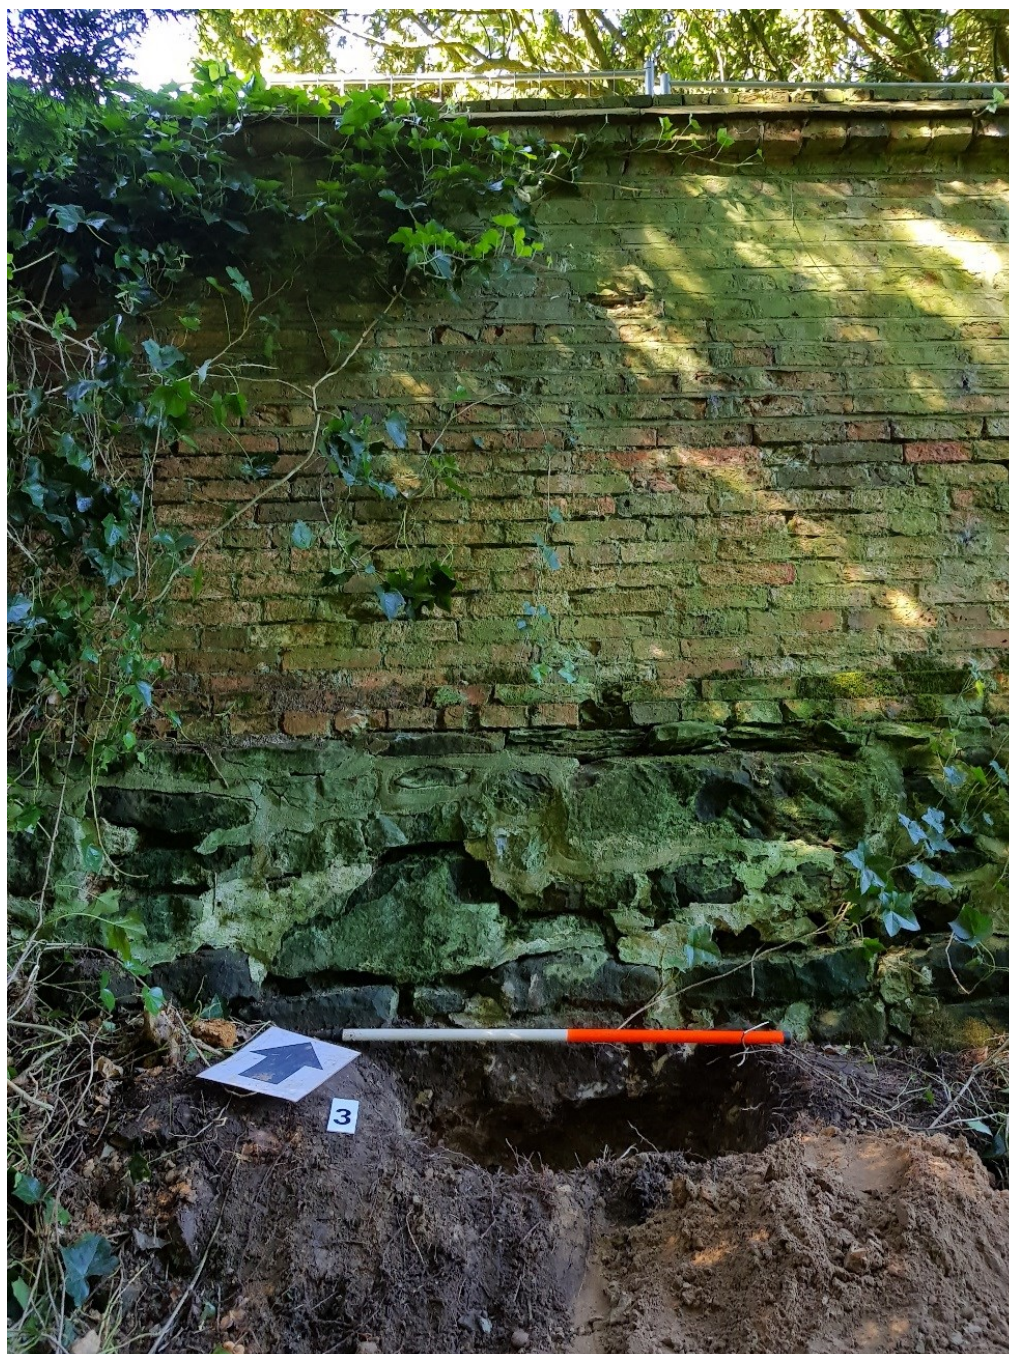
Figure 10: T3, Looking at the investigative pit surface. Photograph shows the lack of footing to the wall.

The third investigation pit (T3) was positioned roughly the opposite side of the wall to T2 (0.4m x 0.85m – Figures 10 & 11)). This could not be precisely located, as access to measure the wall was restricted by overgrowth. Likewise, the fourth trench (T4) was positioned the opposite side of the wall to T1 (0.5m x 0.5m – Figures 12 & 13).

T3 and T4 both had a minimum depth of topsoil (approximately 0.1m) going down onto light brown sandy subsoil with >10% sand stone inclusions. Close to the bottom of the pits, the sandstone became more concentrated and some pieces were rather large and cobble sized. T3 was dug to a depth of 1.7m and T4 was dug to 1.35m. No finds or archaeological features were recovered in either of these investigative pits.

The southern face of the wall is largely covered by Ivy and other creeping foliage and stands at approximately 2.5m in places from ground level. The base of the wall sits on top of a very steep embankment and appears to have very little footing. The original stone boundary wall of the church can be seen in Figure 6 standing at approximately 0.75m high. It is constructed out of local stone and has been mortared together. The brick built wall which sits on top of

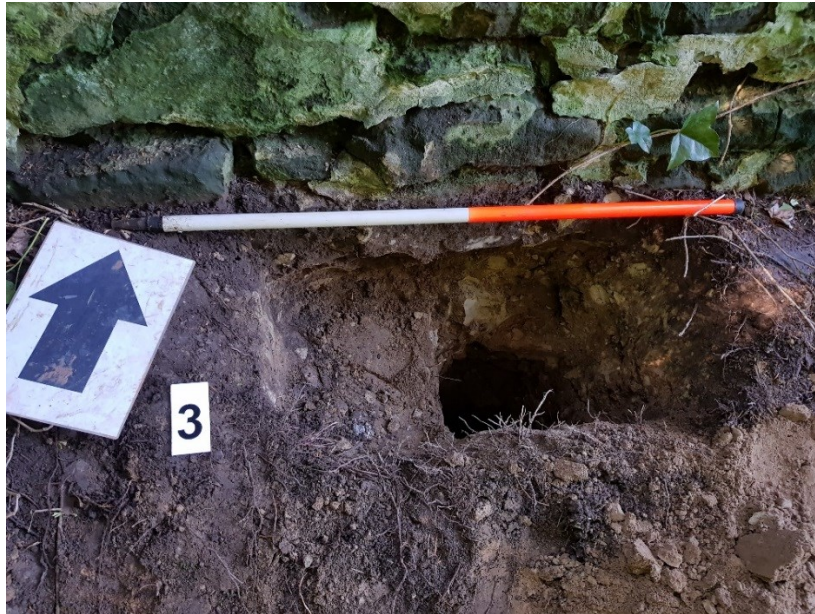
Figure 11: Looking down into T3. Photograph shows the lack of footing to the wall.

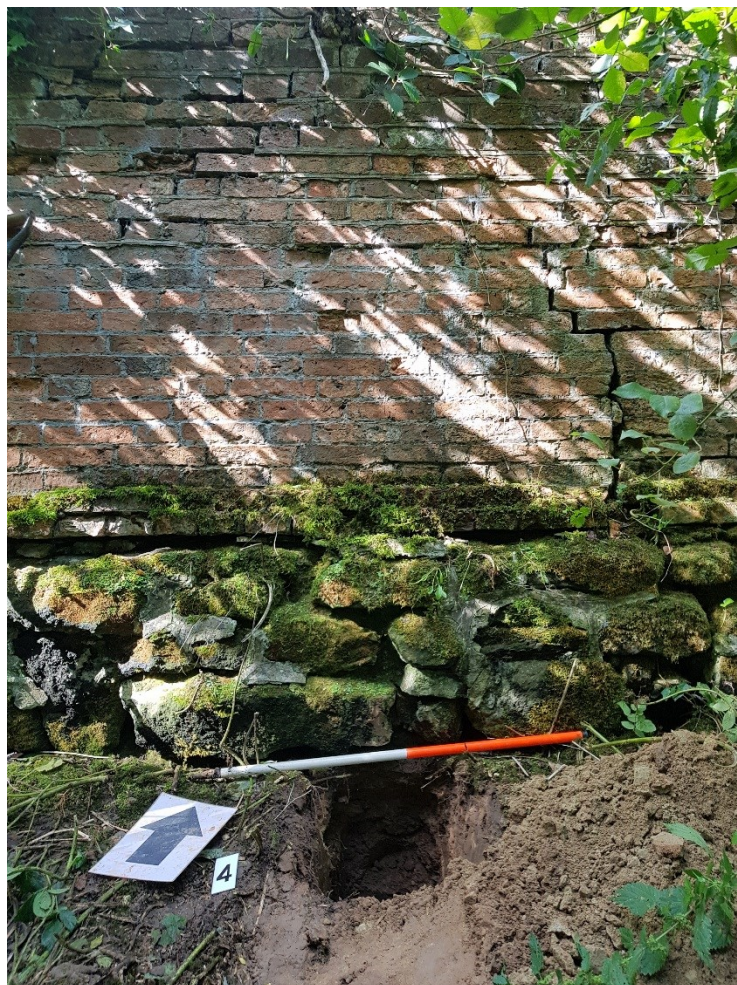
Figure 12: T4 surface of the investigative pit. Photograph showing lack of footing for the wall and also the poor state of the wall.

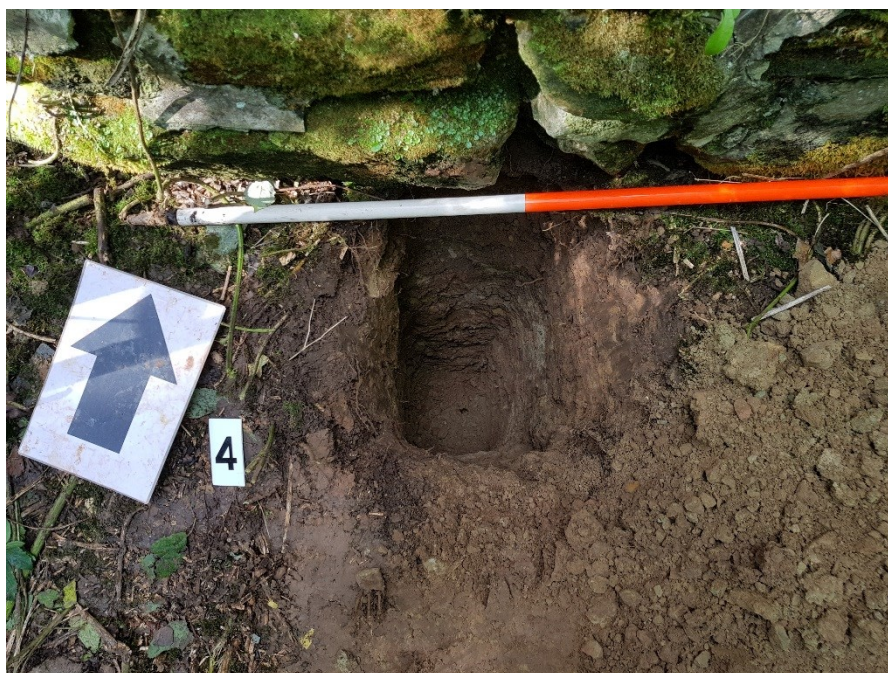
Figure 13: Looking down into T4 onto the natural sandstone of the embankment.
