**A Level 2 Historic Building Survey at
2 Kings Lane,
Barrowden,
Rutland.**

NGR: SK 94955 00091

ULAS Report No. 2017-143
©2017

For: Thomas Wilson Architects

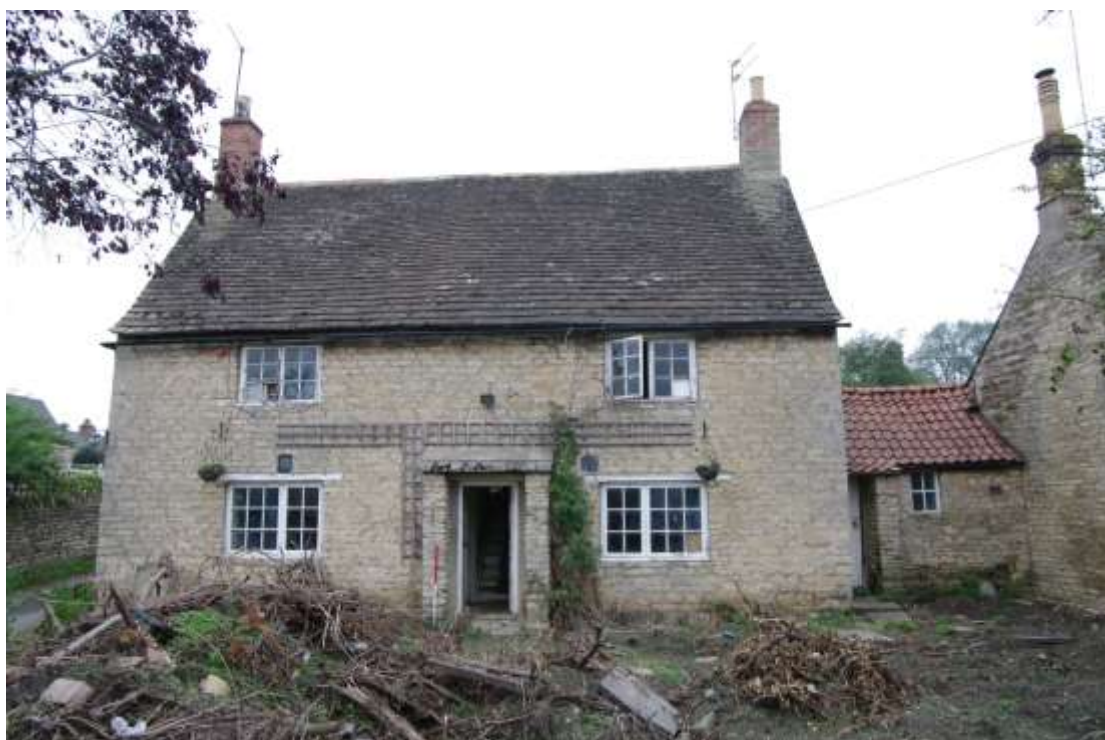
Figure 15 South-facing elevation
Looking north. 1m scale

The south-facing elevation is the principal elevation and houses the front door (Fig. 15). At ground-floor level two casement windows flank a central doorway. The windows are likely to be 20th century replacements but the timber lintels have stop chamfers which are probably original and which therefore indicate that the window openings have not altered in size (Fig. 16). Above the windows the ends of two substantial timber beams can be seen. The beams run from north to south across the width of the house. The wooden door is of 20th century date and has had a shallow stone-built porch and roof added to protect the doorway a little (Fig. 17). The walls of the porch are clearly later than the house as they butt against the house wall. The two first-floor casement windows are also later replacements and are the same size as the ground-floor windows (Fig. 18). These windows however do not have chamfers on their wooden lintels.

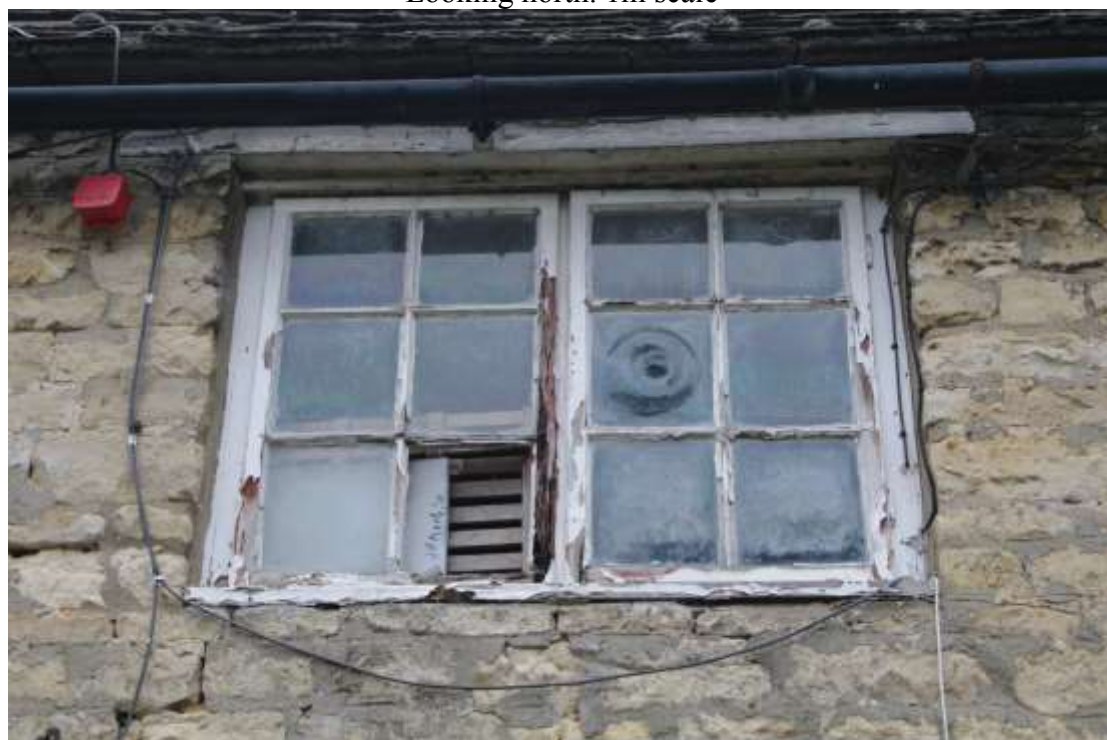
Figure 18 South-facing elevation, first-floor window detail
Looking north

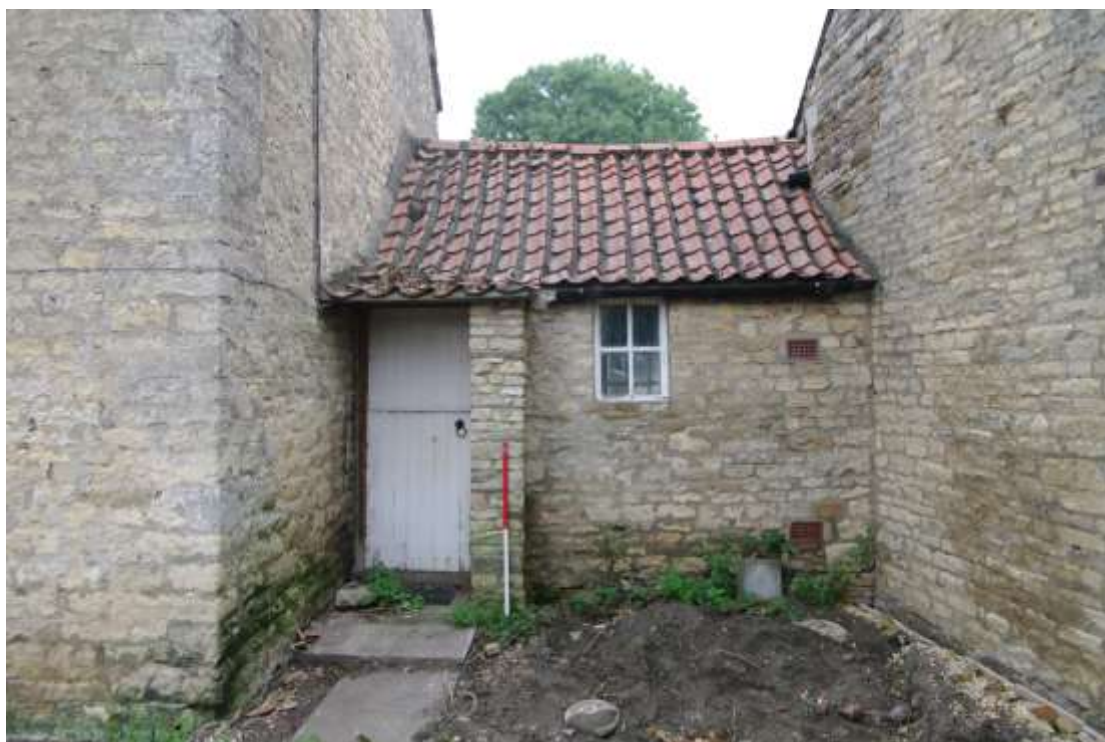
The single storey extension built against the eastern gable wall fills the gap between this house and the adjacent property. It is built with coursed stone rubble and has a pantile roof (Fig. 19). The extension butts against the house and also wraps around the adjacent property showing it to be later than both buildings. Despite being later in date it still appears to be present on the 1885 Ordnance Survey map. The doorway has a fairly crude shallow porch butted against the wall which may have been added at a similar time to the porch over the front door. The window on this elevation consists of a small fixed four-paned window.

Figure 19 South facing elevation. Single-storey extension on east of house
Looking north. 1m scale

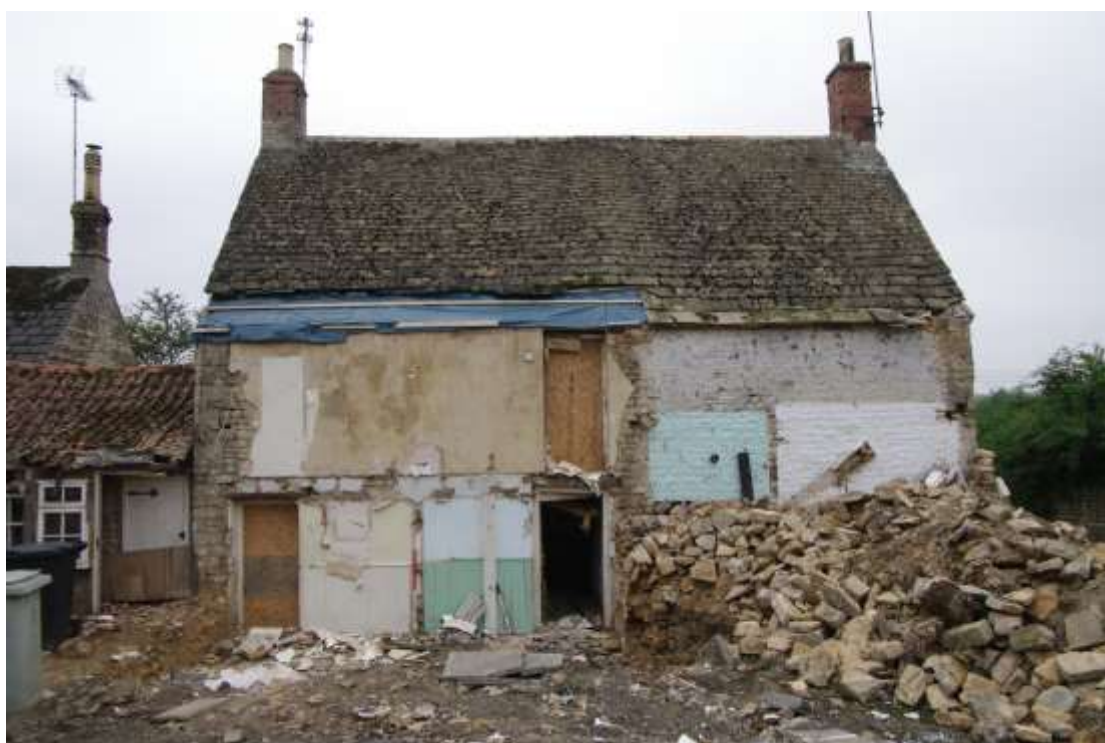
Figure 20 North-facing elevation
Looking south. 1m scale

The north facing elevation has been somewhat altered by the insertion and subsequent demolition of the lean-to extension (Fig. 20). The removal of the extension has left a scar on the lower edge of the roof where the lean-to roof was attached. A small terrace had been excavated by approximately 1m into the slope of the garden to accommodate the bathroom part of the extension. The outbuildings on the west side of the lean-to had their floor level at original ground level height (Fig. 21). The present state of the elevation shows that the lean-to was not keyed in to the house wall.

At ground-floor level are two single width doorways one of which leads into a space below the stairs in the central corridor. The other doorway, on the east side, leads into the corner of the eastern ground-floor room. At first-floor level is a single doorway which has been broken through the wall at the top of the stairs. This may have been a window or is a new opening inserted when the lean-to was built. There is no evidence of any other windows or openings on this elevation although at the time of the initial survey plaster still covered the eastern half of the first floor. Later internal stripping showed that there were never any windows on the north wall (see later in report).

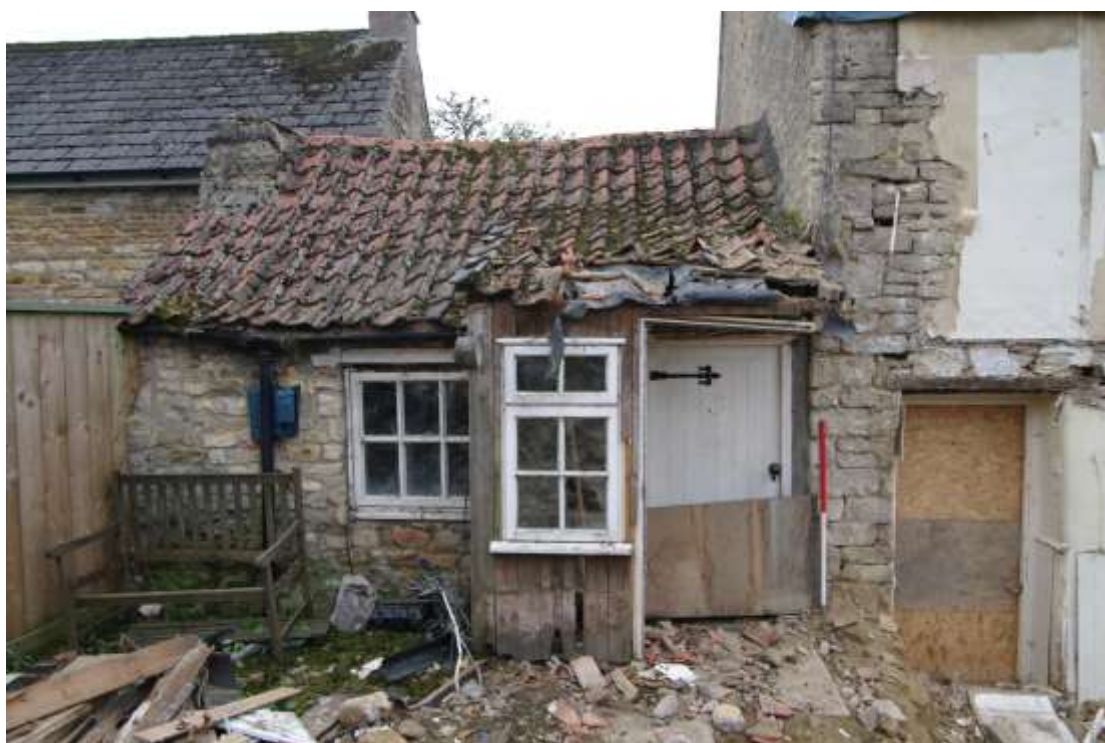
On the eastern side of the house is the single-storey extension (Fig. 22). A small wooden porch had been added to the extension but recent demolition work has partially removed this. The single doorway has a late 19th- or early 20th-century plank-built wooden door. The small wooden framed window is modern but has a chamfered timber lintel similar to those on the south facing elevation which suggests that it is likely to be relatively early.

Figure 22 North-facing elevation. Single-storey extension on east of house
Looking south. 1m scale

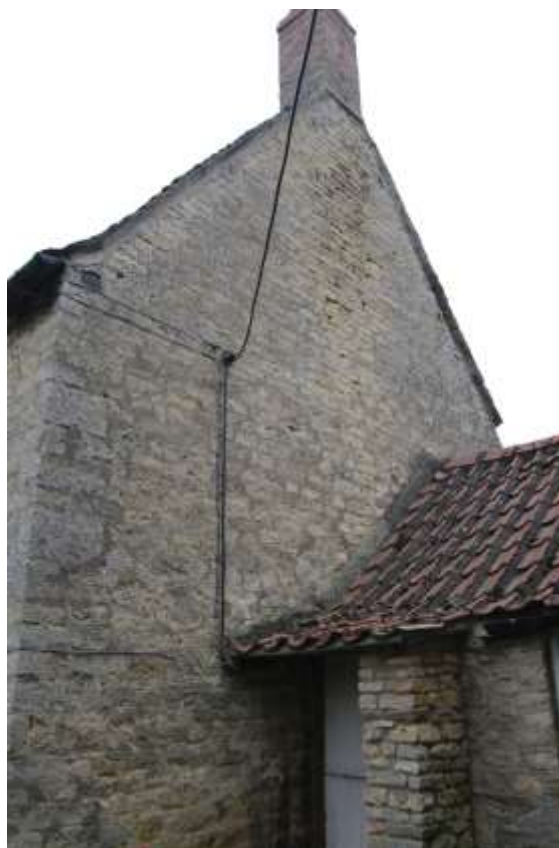
Figure 23 East-facing elevation
Looking north-west

Much of the east facing elevation is obscured by the single storey extension. However, most of the gable end can be seen from the south side of the building and inspection shows that there are no blocked (Fig. 23). As already noted, the single storey extension is butt jointed against the house wall.

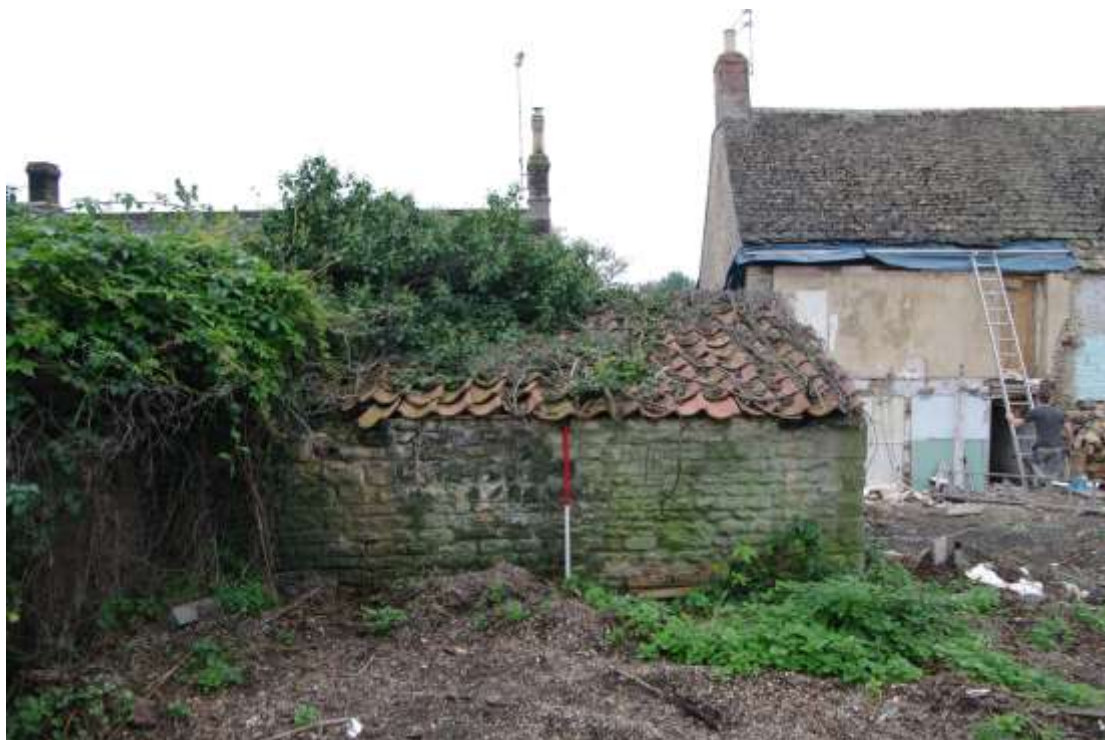
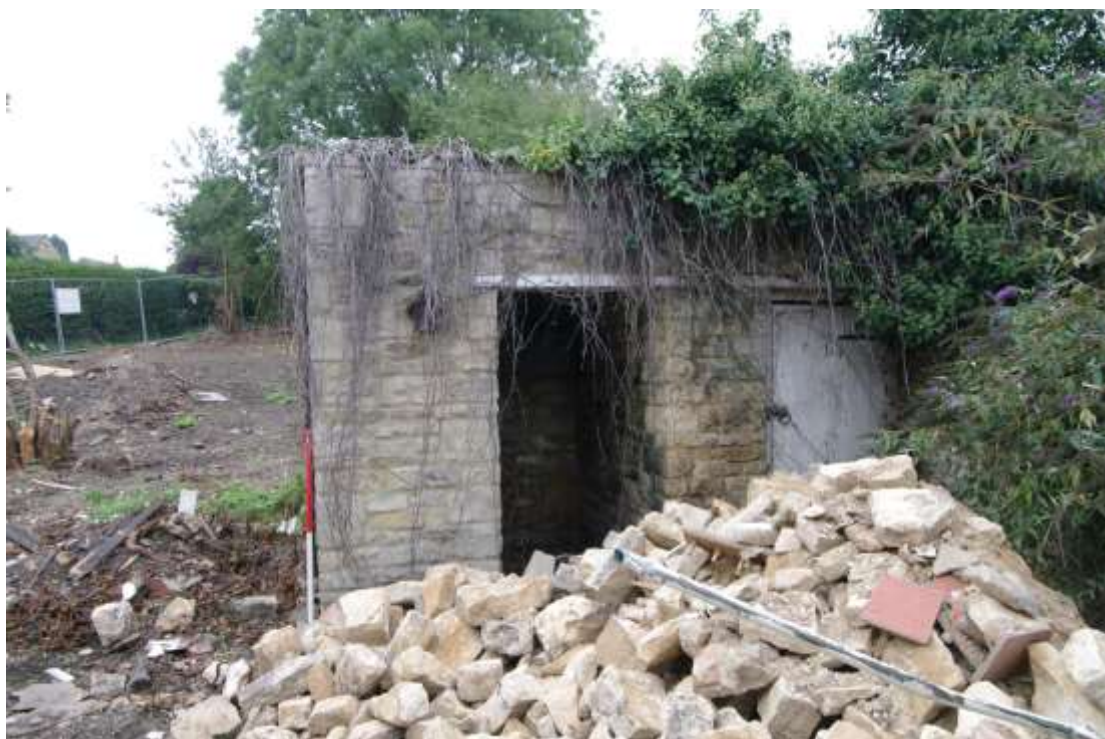
Although not part of the scheme the privy, located in the rear garden to the north-east of the house, is part of the property and was an important feature to household life. The structure is built using coursed limestone rubble and has a pantile roof (Figs 25 and 26). At the time of the survey the building contained two small rooms which had recently been used as outbuildings and stores. There was no evidence of the toilet seats or any other fittings.

Figure 25 Outdoor privy
Looking south. 1m scale

Figure 26 Outdoor privy
Looking north. 1m scale

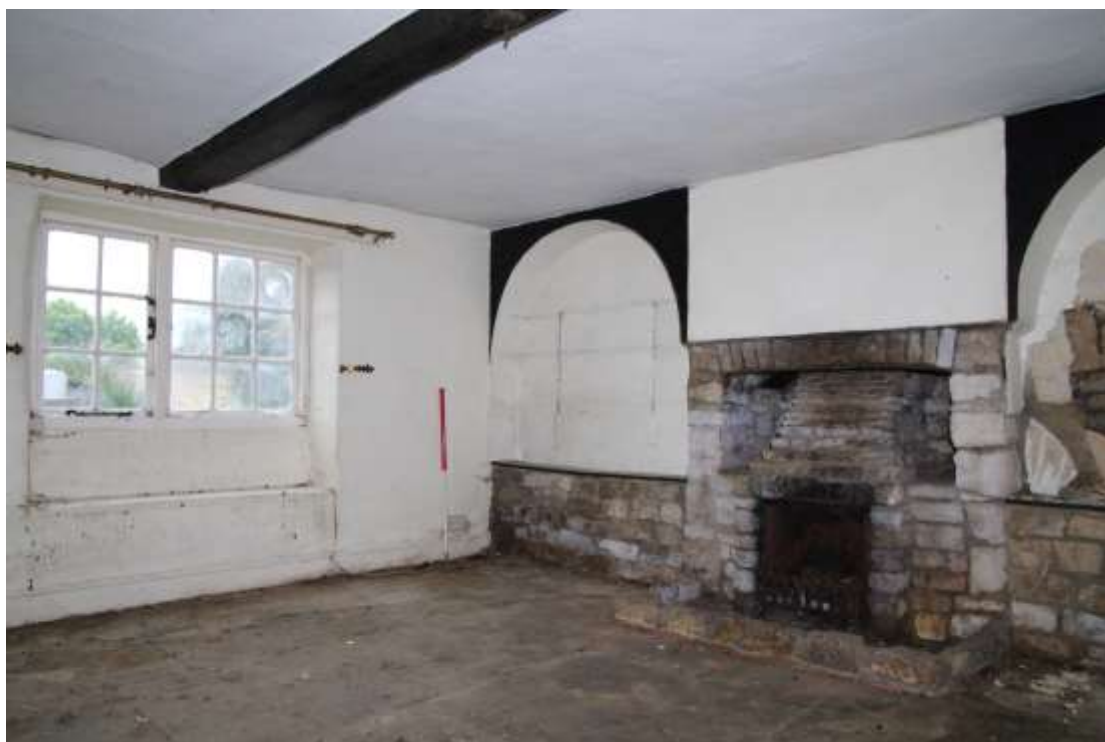
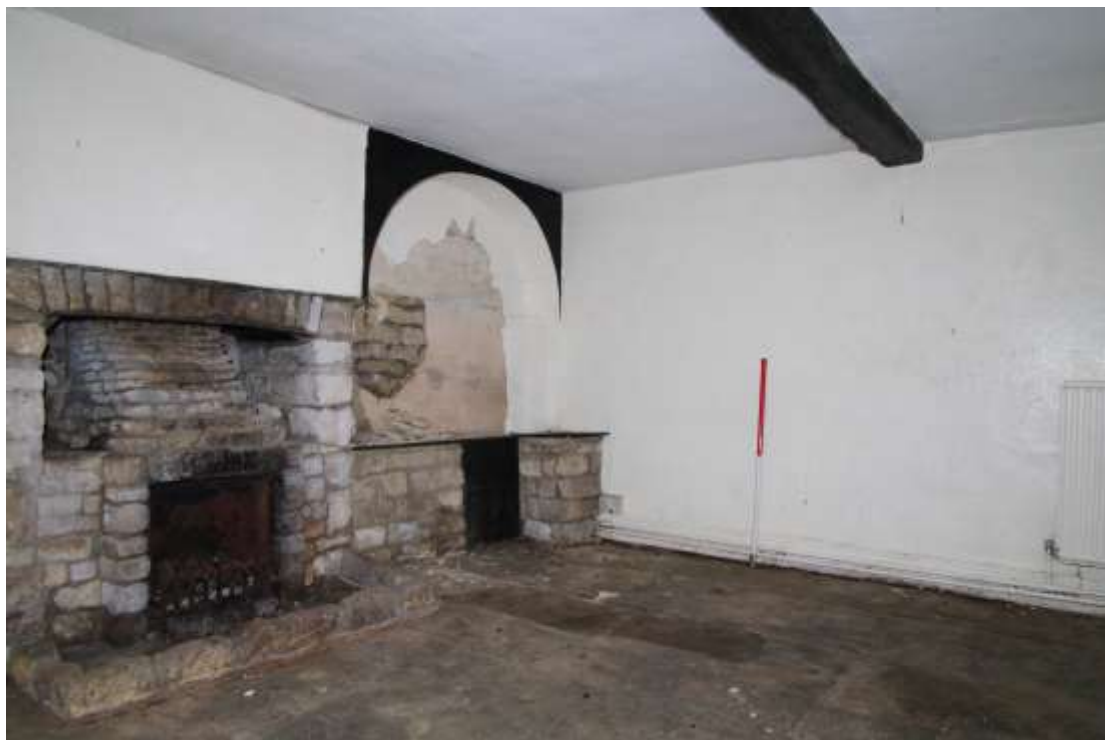
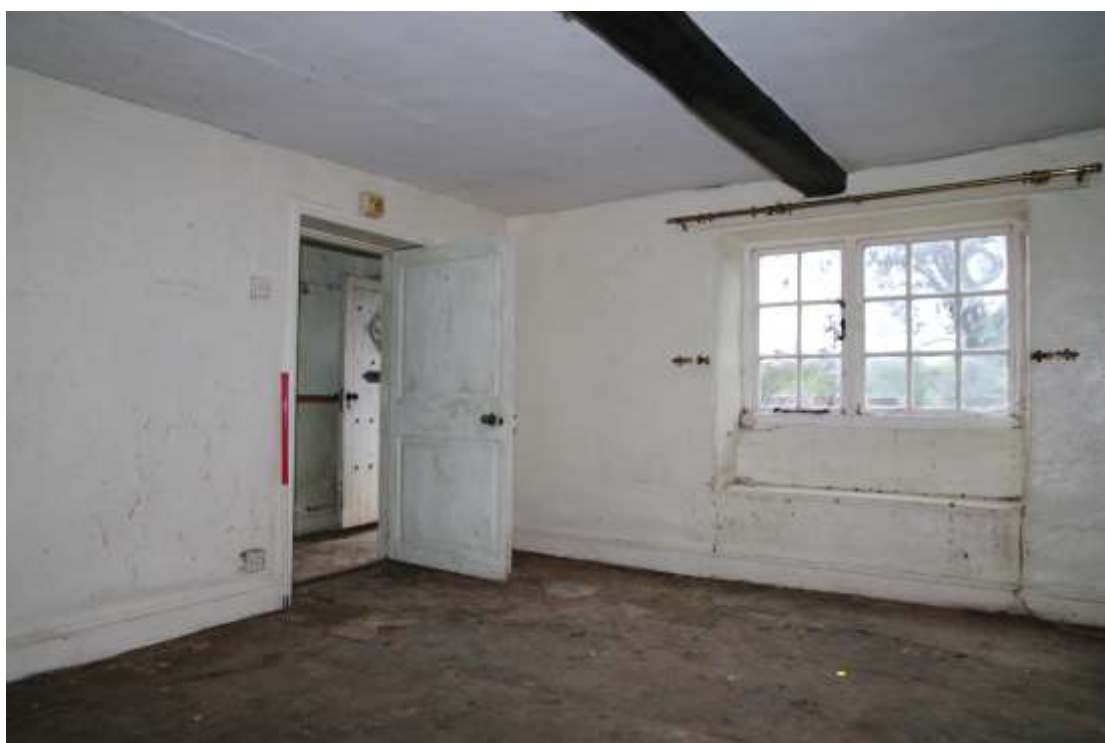
Room G1 is the westernmost room and is reached from a doorway in the central hallway (Figs 27 to 29). It has a solid floor laid with substantial stone flagstones which appear to be original. The fireplace and surround is built of stone but appears to have been remodelled probably in the latter half of the 20th century. Two arched recesses fill the gaps either side of the chimney breast. The room has a low skirting board with a basic moulding which may be original but seems more in keeping with a late 19th century design. The casement window as already noted is a modern replacement but fits into the original recessed opening in the south wall. There are no apparent window openings on any of the other walls. A substantial north to south timber beam supporting the first floor runs across the centre of the room. The beam has a crude chamfer on it which appears to be more functional than decorative. The ceiling is relatively low and there is no evidence of a picture rail on the plastered walls. The door out to the hall is a wide two-panelled door which were commonly used in better quality rural houses up to the middle of the 18th century (Fig. 30). The lock and door knobs may be later as there is evidence of modification in the woodwork. The doorway has a reeded moulding around it.

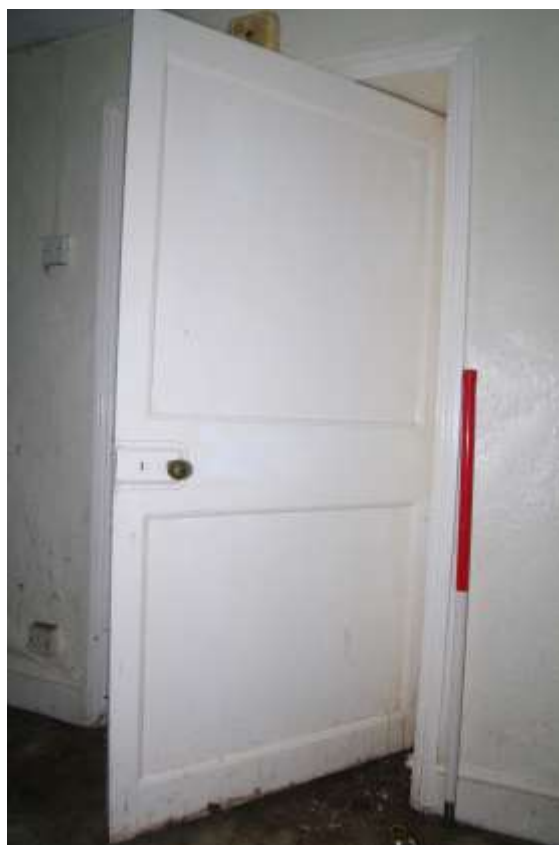
Figure 30 Room G1 door
Looking north-east. 1m scale. Note moulded door surround

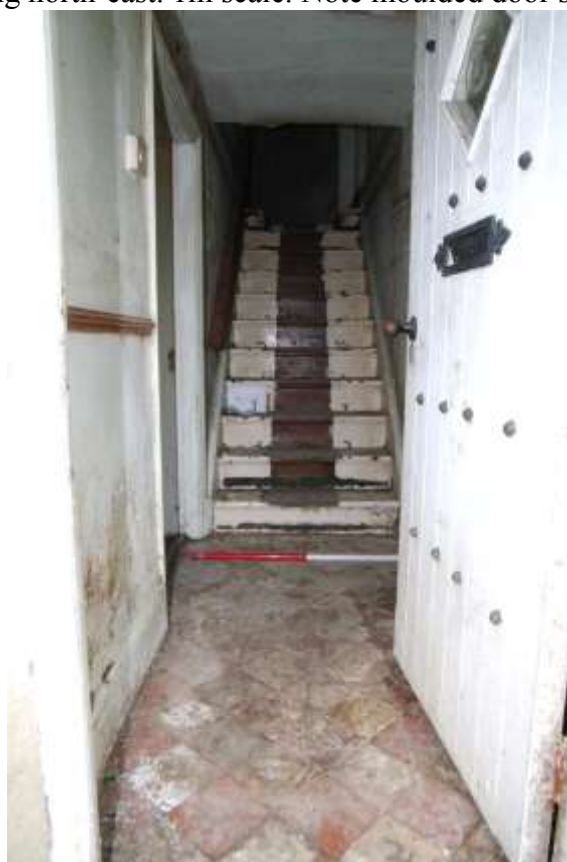
Room G2 is a narrow hallway leading from the front door to a wooden staircase leading up to the first floor (Fig. 31). The floor is laid with red and cream 6 inch square quarry tiles. Doors lead off to the west and east into Rooms G1 and G3. The doorways have moulded surrounds as seen in the side rooms. The moulded skirting boards may be late 19th century or later. Apart from a small window in the replacement front door there is no natural lighting in G2.

Figure 31 Room G2 hall and stairs
Looking north. 1m scale. Door to G1 on left at foot of stairs

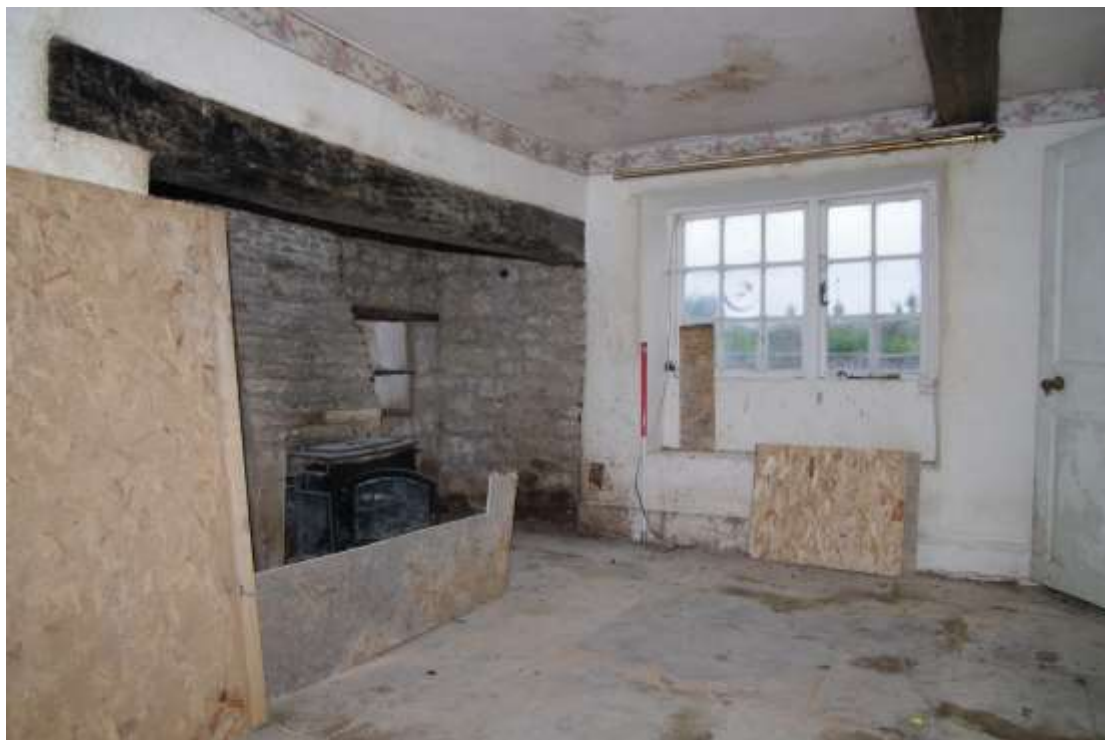
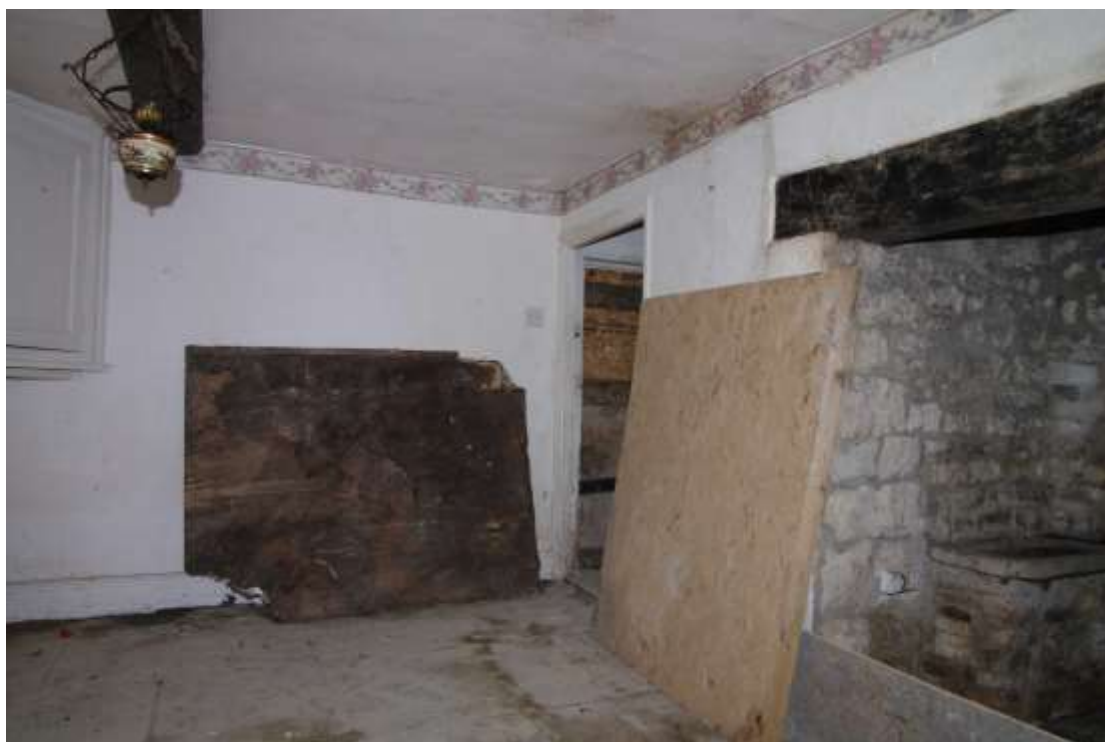
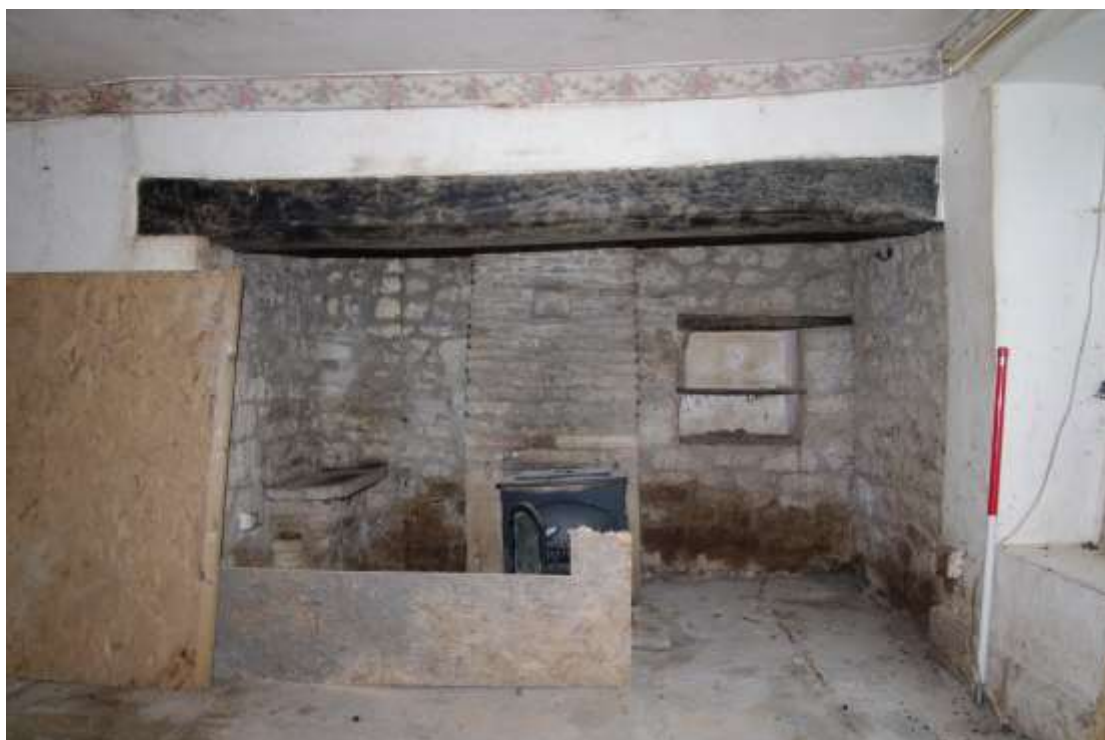
Room G3 is slightly smaller than G1 and has a large fireplace with a timber bressumer beam across it (Figs 32, 33 and 34). This room also has a stone flagged floor and a chamfered timber beam running from north to south across the room. The two panelled door to G2 matches the door in Room G1. The large fireplace has been modified to hold a small stove but was presumably built to house a large fire on which all cooking, and water heating would be carried out. There is no evidence of heat or burning on the flagstone within the fireplace suggesting that these at least must be later replacements. This room would therefore have been built as the kitchen making Room G1 the sitting room. The casement window on the south wall is the only window in the room although a door on the north wall in the north-eastern corner leads out to the rear garden. A small wall extends out from the side of the fireplace to create a small pantry and enclosed space so that the doorway did not lead straight into Room G3. Another doorway in this

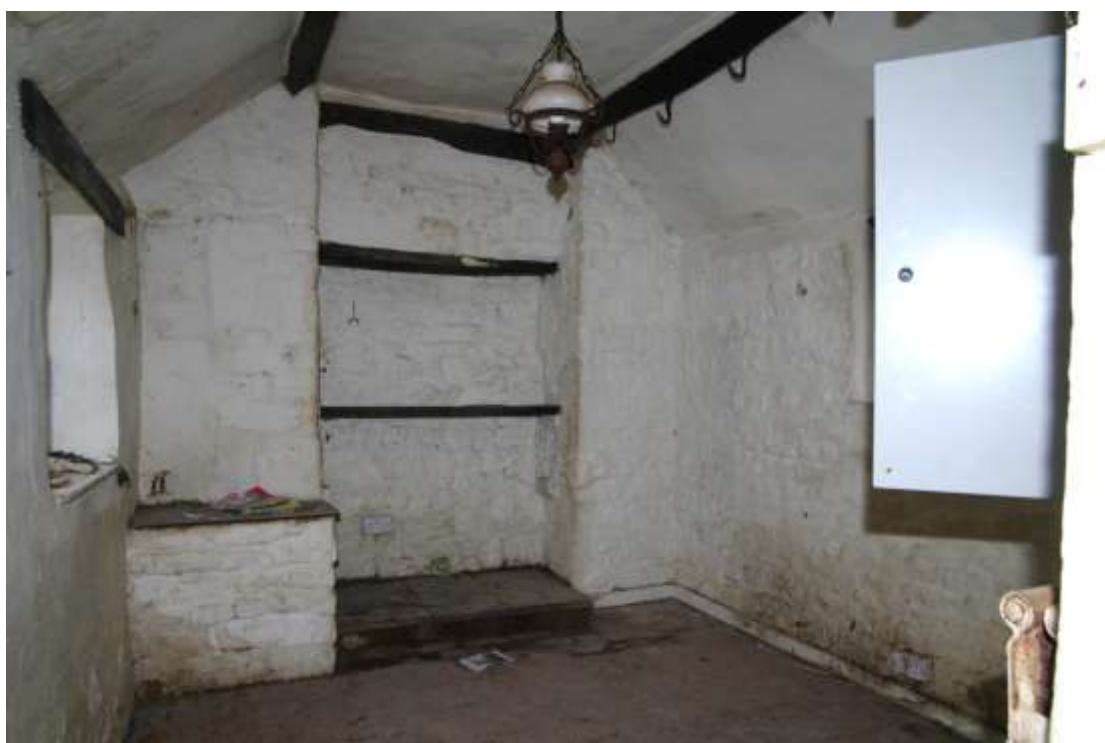
Figure 35 Ground floor Room G4
Looking south-east

Room G4 is the single room created by the single storey extension built between the eastern gable end of the house and the adjacent property (Fig. 35). This much more functional room has painted stone walls and 1930s style red quarry tiles. The room appears to have been used as a food storage room as there is a small stone thrall in the north-east corner and shelves set into a recess on the east wall. A row of meat hanging hooks are attached to the north purlin. The room has doors to the north and south leading out to each garden meaning that anything brought into or taken out of it need not be carried through the house.

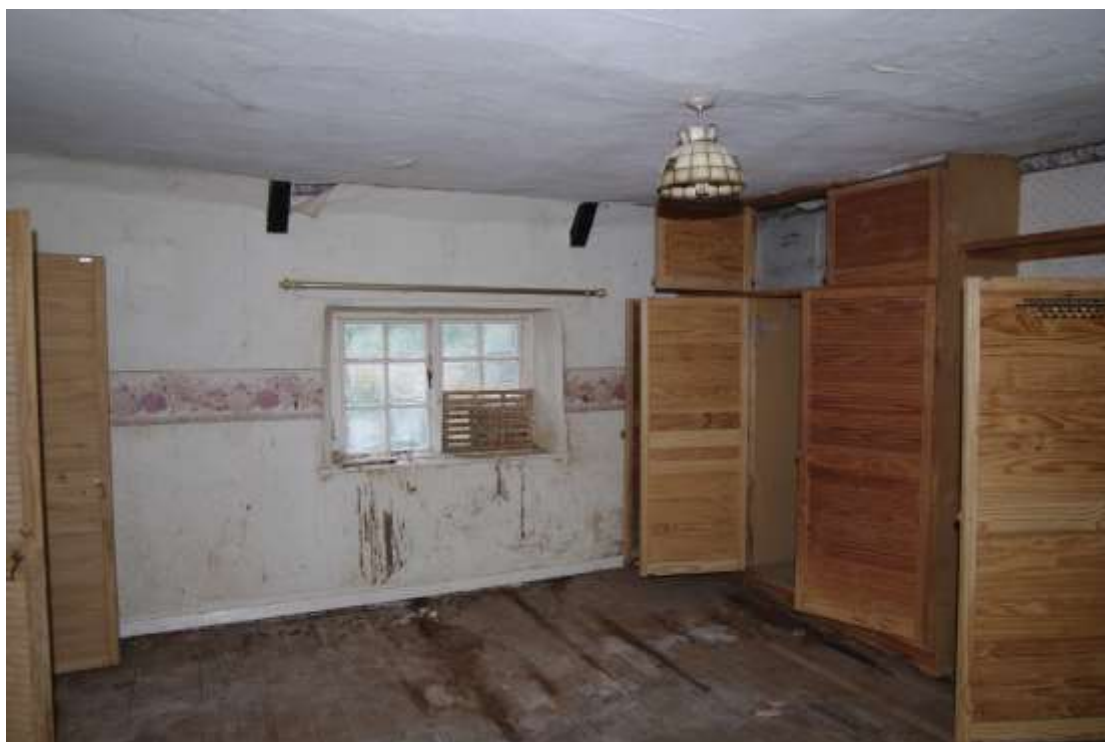
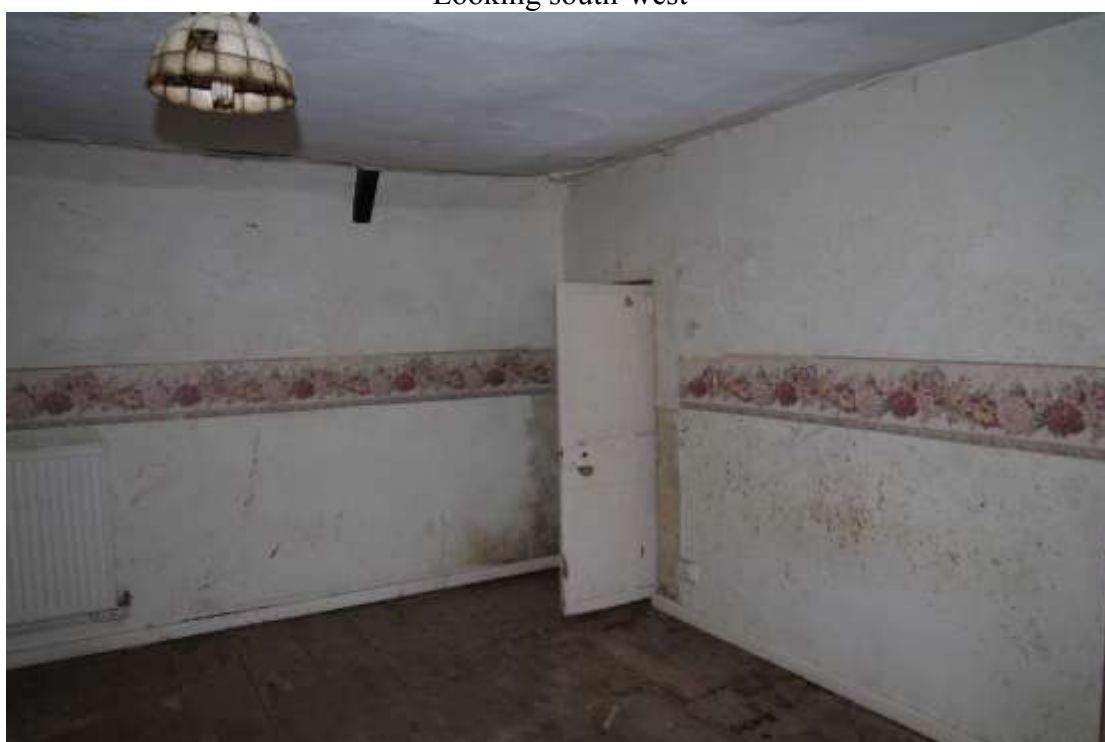
The western room is reached from the top of the stairs and appears to have served as the main bedroom. It has modern fitted wardrobes built against the plastered walls along the west wall (Figs 36 and 37). The casement window is a 20th century replacement of an earlier window. The room has a low plain skirting board which again is likely to be a modern replacement. The floorboards are of variable width up to 200mm and of different lengths which suggests that they were hand sawn from available timber rather than factory produced. A former cupboard or wardrobe built above the space over the stairs has been converted into a small toilet. The door to the stairs is a four-panelled door with beading around each panel. If not part of the original fittings this door is likely to be of early 19th century date.

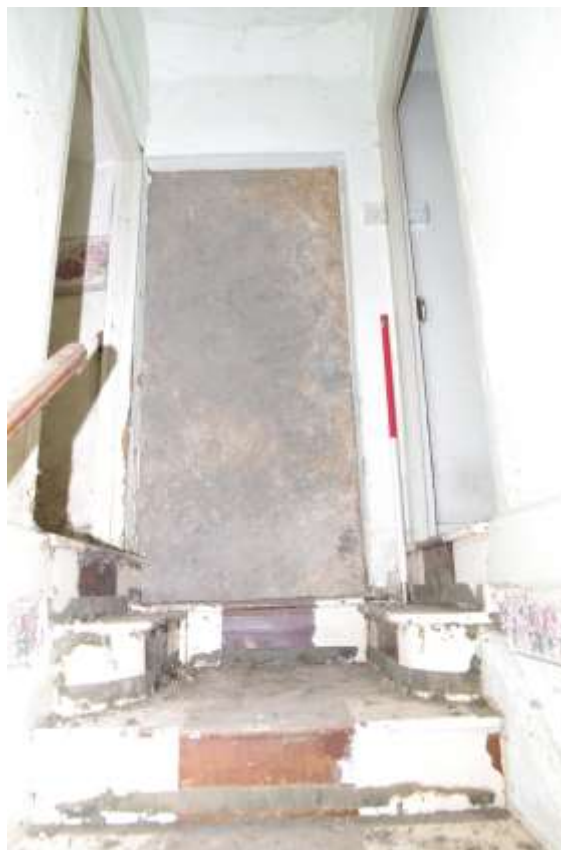
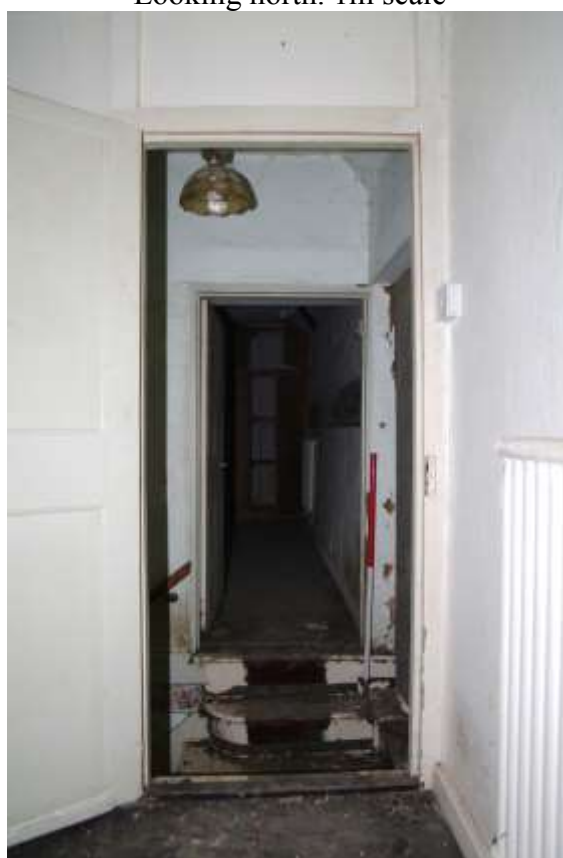
The wooden stairs rise from the ground-floor hallway to a small rectangular landing from which the east and west rooms are reached (Figs 38 and 39). A third doorway at the head of the stairs led northwards into the now demolished lean-to extension. At the time of the survey this had been boarded over. It is not clear if this was originally a window to light the otherwise unlit stairs, which seems likely. If this is the case then the window must have been enlarged to create the doorway.

Another question from the initial strip was whether the first-floor doorway at the top of the stairs had been modified from an earlier window. Whilst this seems highly likely, otherwise the stairs would have been very dark, no physical proof could be seen (Fig. 50). If the door did replace a window the door is much larger and wider so has removed any earlier traces.

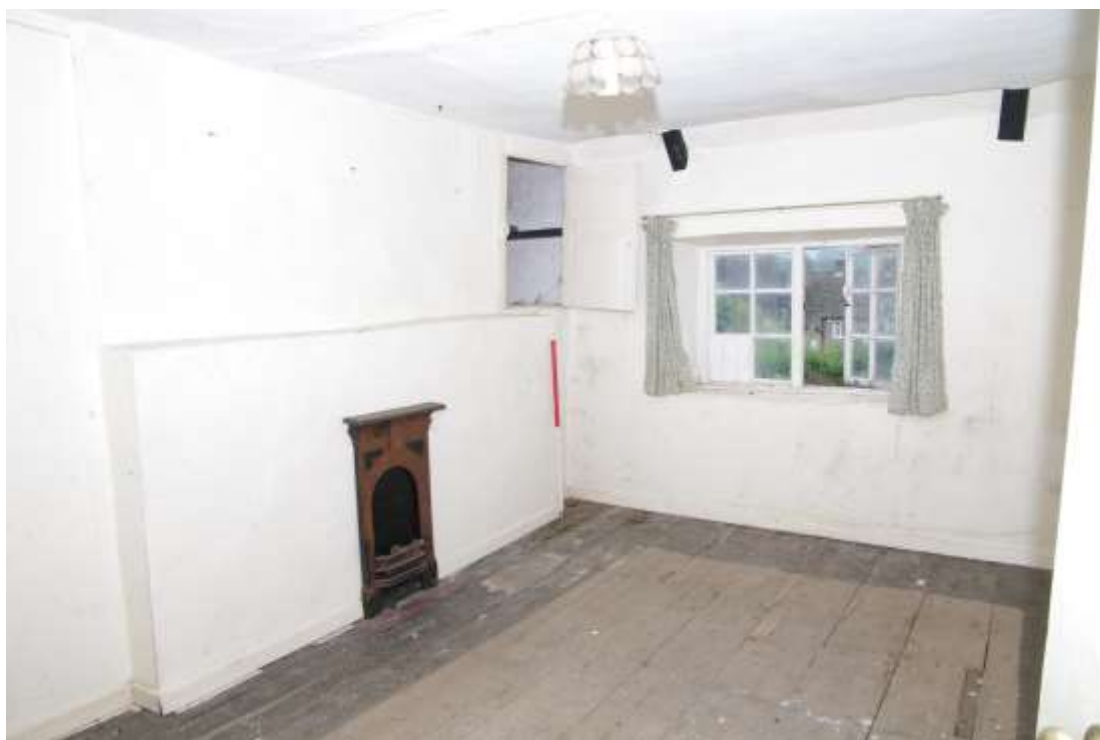
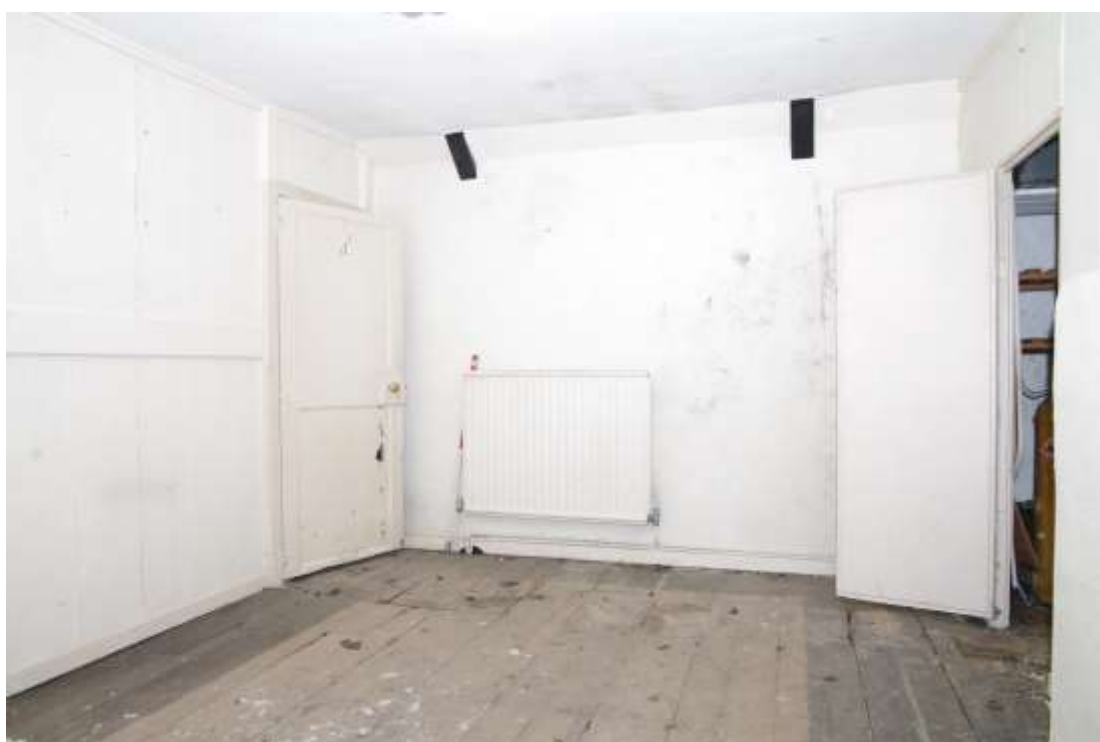
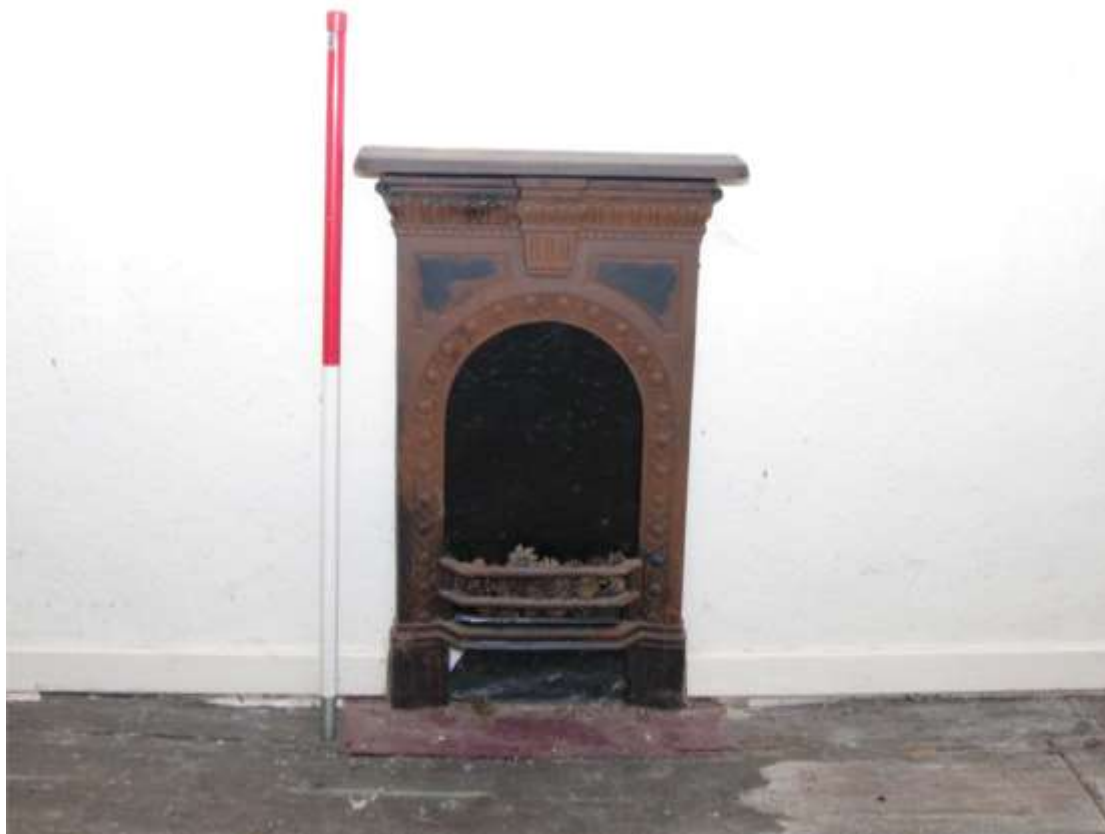
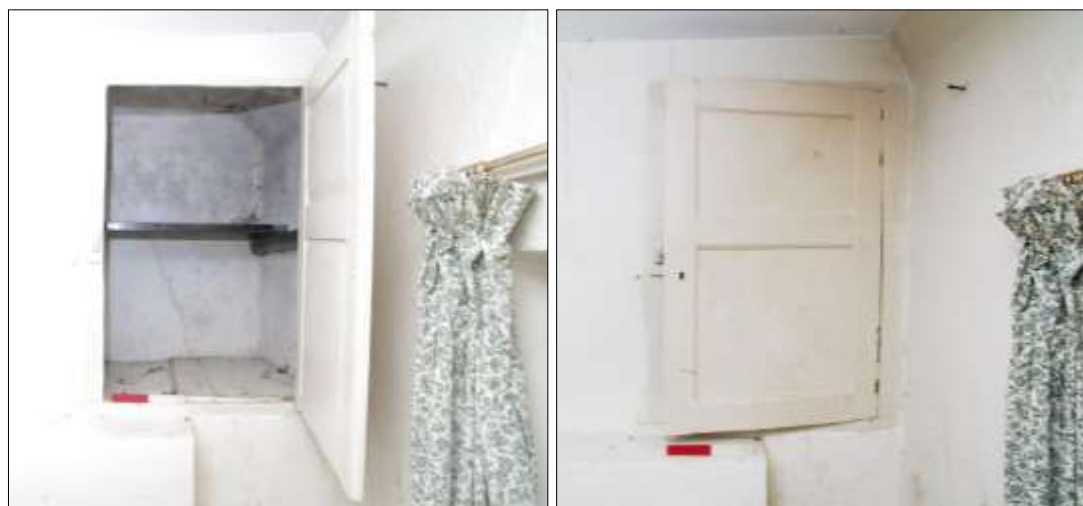
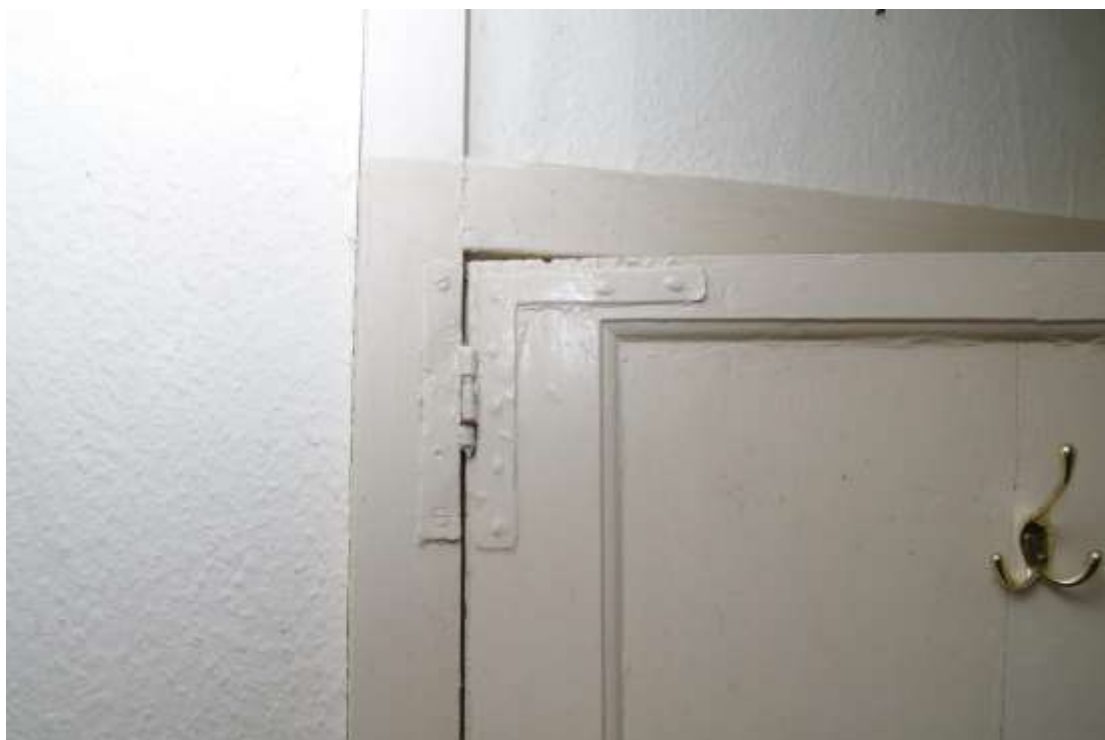
The east room, leading from the top of the stairs, is a relatively untouched room (Figs 40 and 41). It has a small cast iron fireplace on the east wall chimney breast which is probably of mid to late 19th century design (Fig. 42). At the side of the chimney breast is a small built-in cupboard with a two-panelled door and wooden catch (Fig. 43). The style of the door and the shelf supports suggest that this feature is probably mid to late 18th century and is therefore part of the original fittings. To the north of the chimney breast is another cupboard although this one is full height and has a full-sized door. The door has a modern hardboard sheeting hiding the panelling beneath. The cupboard has most recently been used to house the water immersion tank. The floorboards are of similar widths to those used in the western room and the skirting board is probably modern. The casement window is a modern replacement set into the original opening. The door to the stairs has two-panels and L-hinges and is likely to be original (Fig. 44).
