**A Level 2 Historic Building Survey at
2 Kings Lane,
Barrowden,
Rutland.**

NGR: SK 94955 00091

ULAS Report No. 2017-143
©2017

For: Thomas Wilson Architects

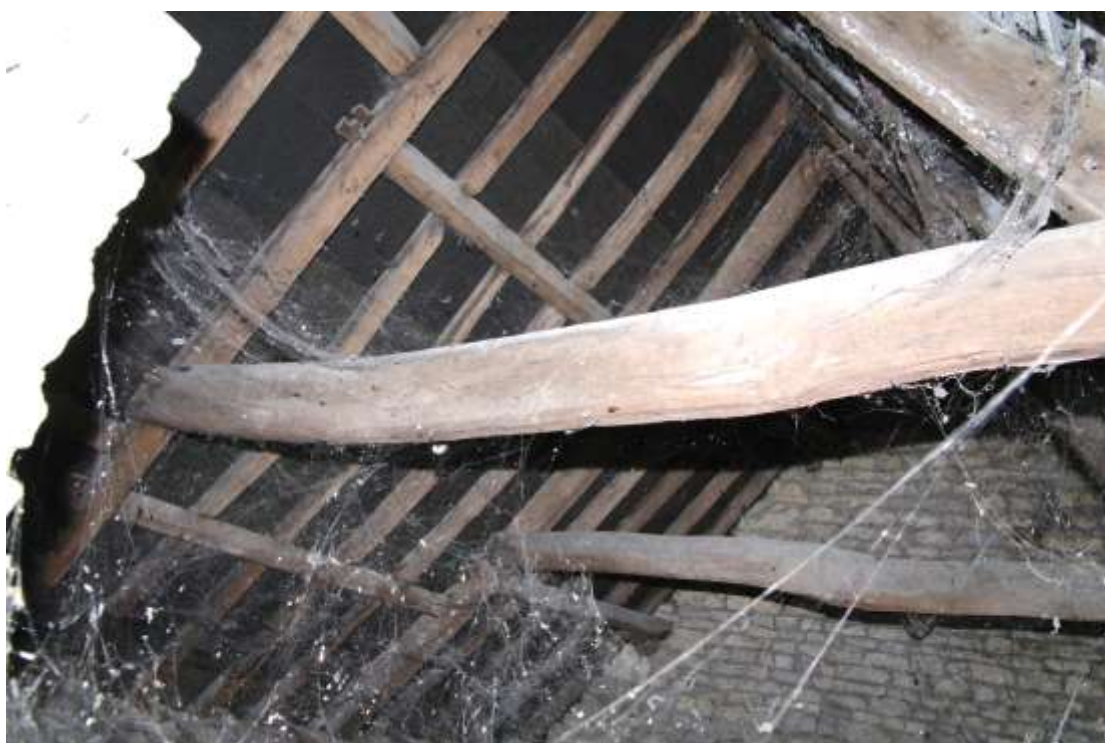
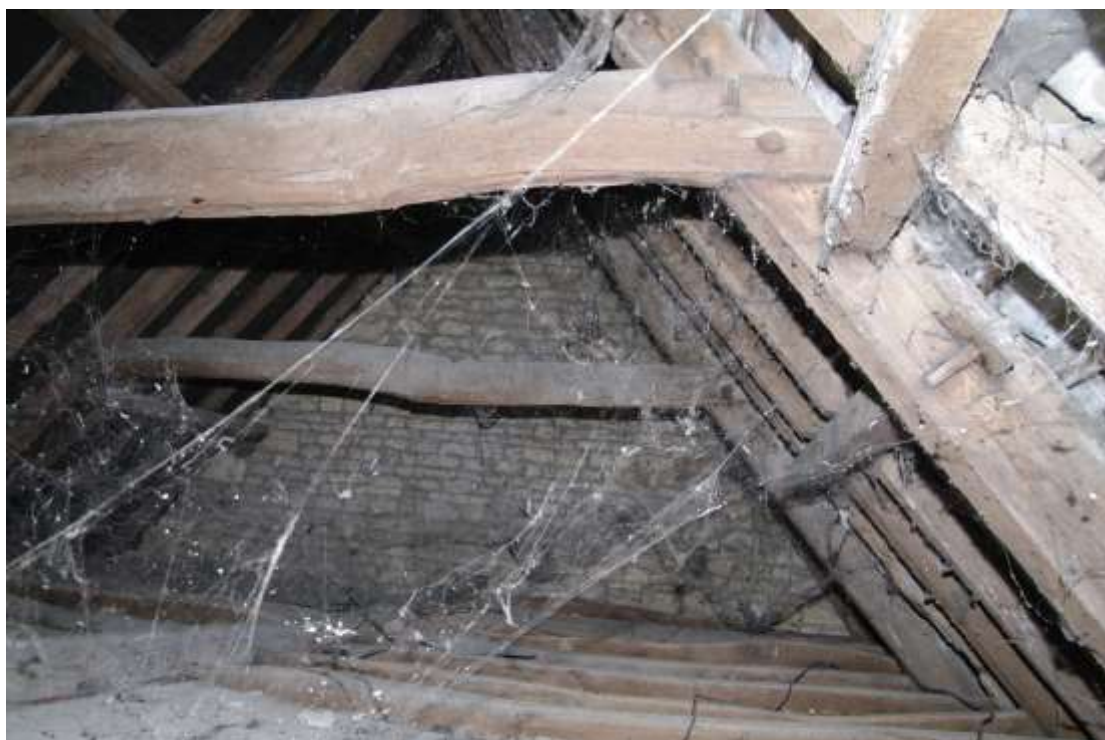
A small hatch in the ceiling of the cupboard in the east room leads into the roof space. Whilst it was not safe to enter this space a brief inspection could be made (Figs 45 and 46). Roofing felt under the stales indicates that the roof has been relaid relatively recently although the roof structure appears to have been untouched. The principal rafters are held by a collar which is lap jointed and pegged to them. The staggered purlins are tenoned into the principals with a wooden peg passing through the tenon which projects beyond the principal in a similar fashion to medieval carpentry tusk tenons. The common rafters are partially lapped around the back of the purlins. There

is no tie beam at eaves level which is slightly unusual. A substantial beam running from east to west at ground-floor ceiling height supports the ceiling joists. The beam and joists may have been reused from elsewhere as they seem to be too large for such a relatively small house.

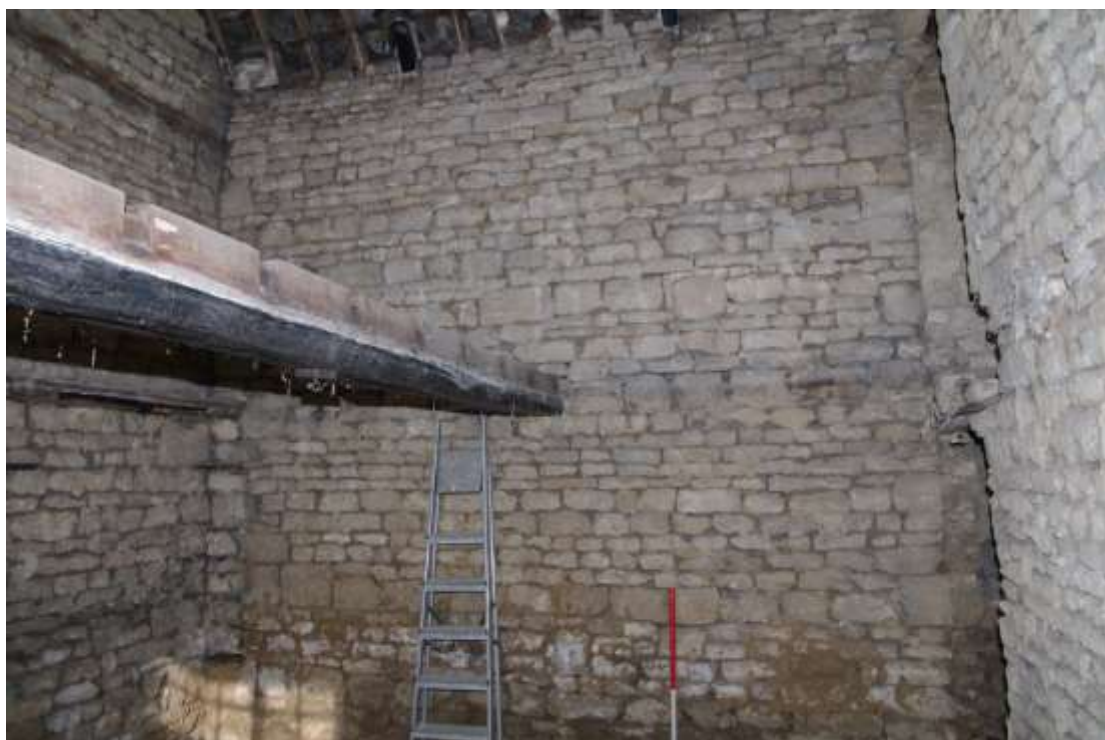
Figure 47 North wall of Ground-floor room G1 and first-floor west room
Looking north-west. 1m scale

The main question from the initial survey was whether or not there had ever been any windows on the north wall or if it had always been blank. Stripping away the internal plaster showed an unbroken wall with no evidence of any window openings facing north on either the ground or first floors (Fig. 47). However, interestingly the removal of the plaster revealed the presence of two hidden doorways leading from the north-east corner of G1 and the north-west corner of G3 to the space beneath the stairs and then out to the back garden (Fig. 48). These doors must have been quite awkward to use due to the small space below the stairs (see Fig. 21) (Fig. 49).

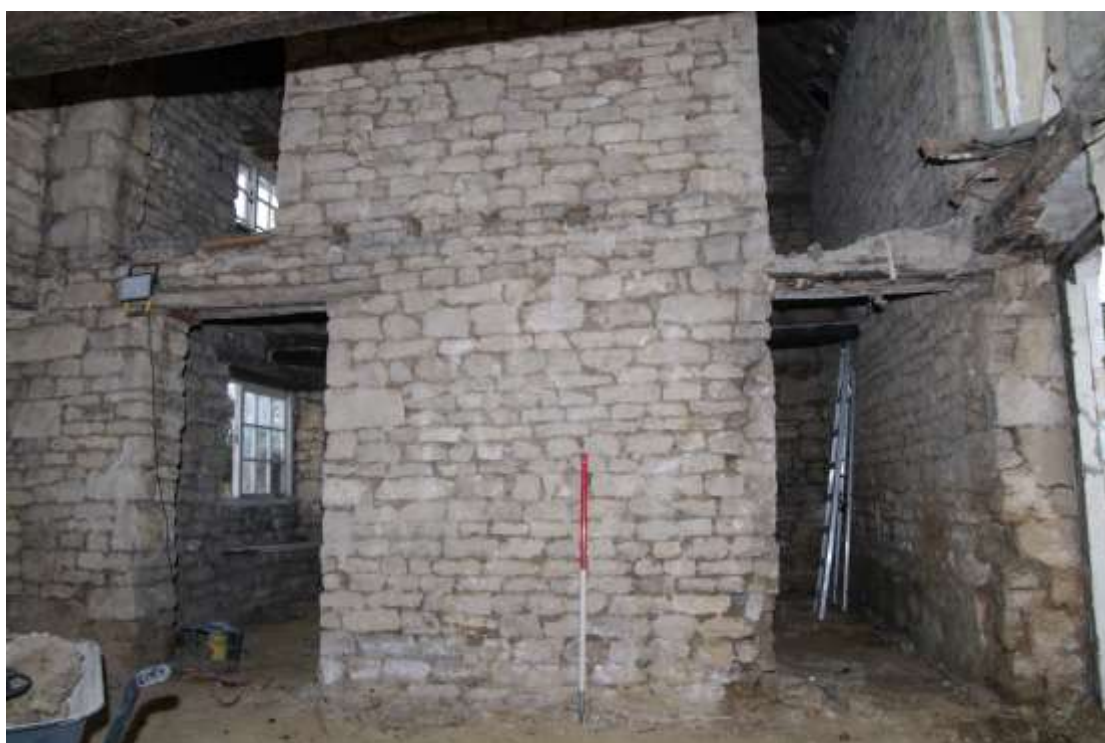
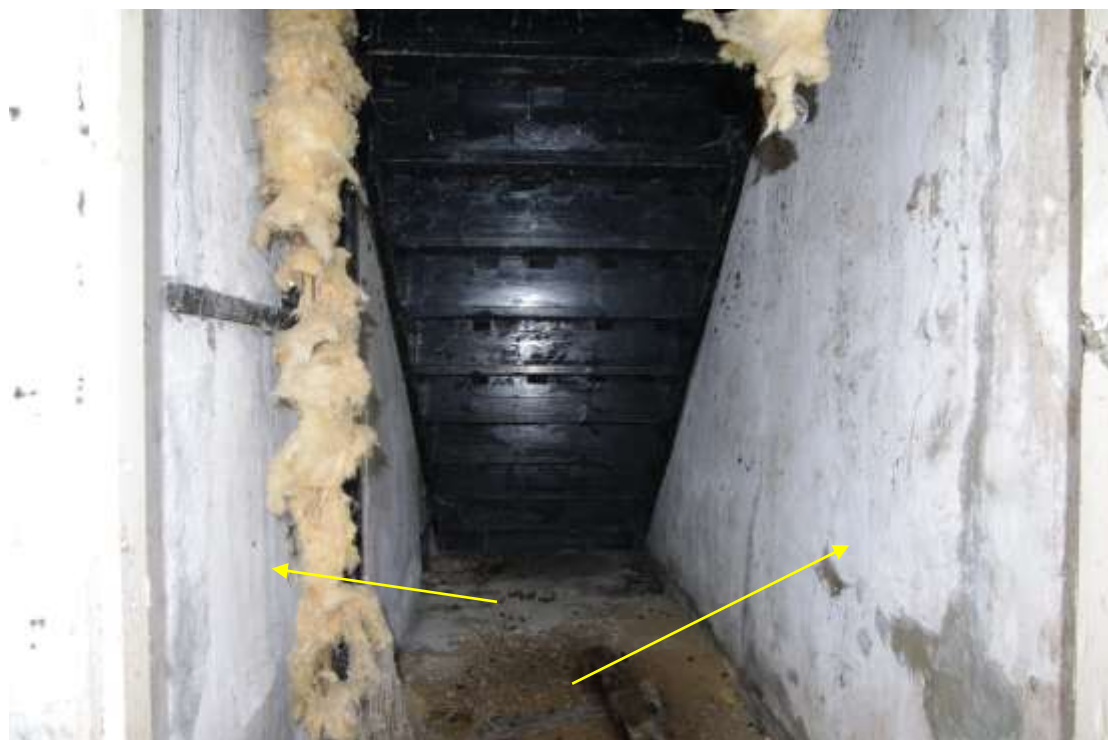
Figure 48 Doorways into western rooms
Looking west. 1m scale. Former blocked door from G1 beneath stairs is bottom right.
Door to outside is partially shown on right of picture

Figure 49 Space beneath stairs before stripping out of stairs and plaster
Looking south. Arrows point to blocked doorways revealed after strip

The two blocked doorways found during the strip show a re-ordering of the room layout and a change in the way the rooms may have been used. The blocking may have taken place when the extensions on the north side of the house were added which would have prevented direct access to the rear garden from the doorway below the stairs.

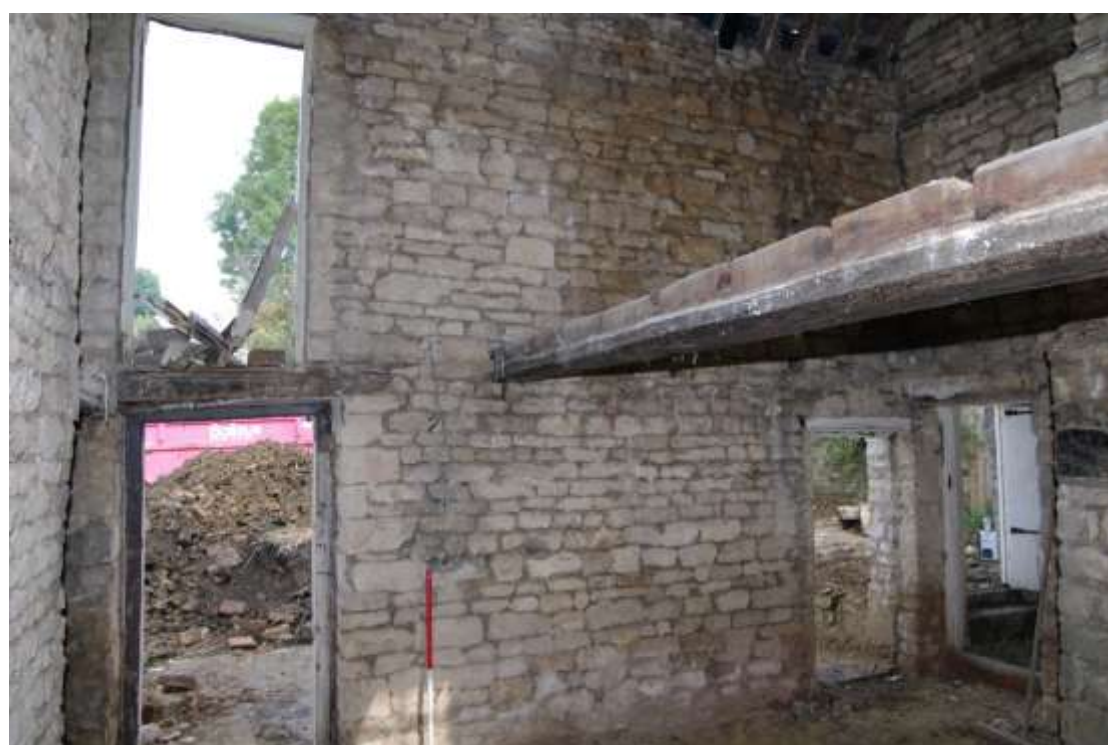
Figure 50 North wall after strip
Looking north-east. 1m scale. Photo taken from approximately the foot of the stairs

Another question from the initial strip was whether the first-floor doorway at the top of the stairs had been modified from an earlier window. Whilst this seems highly likely, otherwise the stairs would have been very dark, no physical proof could be seen (Fig. 50). If the door did replace a window the door is much larger and wider so has removed any earlier traces.

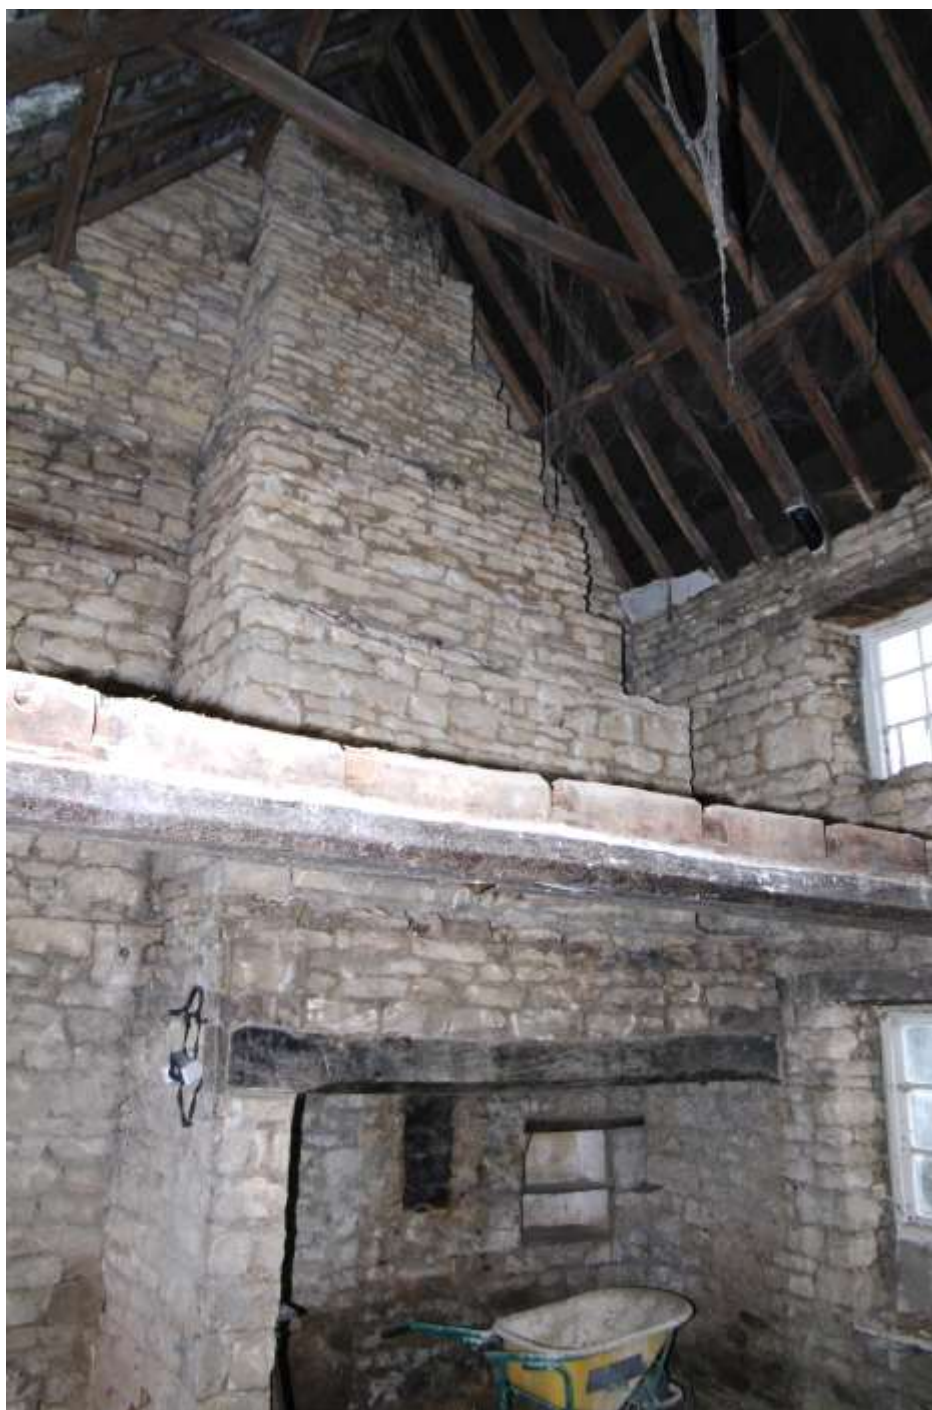
Figure 51 East wall fireplace and chimney stack
Looking south-east

The internal strip also revealed the high quality of the stonework and the skill of the builders. A good example of this is seen in the stepped chimney breast over the inglenook fireplace on the east wall (Fig. 51).
