**An Archaeological Observation,
Investigation and Recording of
Groundworks at Dairy Farm,
St. Andrew's Lane, Cranford
St. Andrew, Northamptonshire
NGR: SP 59628 86905**

ULAS Report No 2017-045
©2017

For: Mr Kersley Kershaw-Dalby

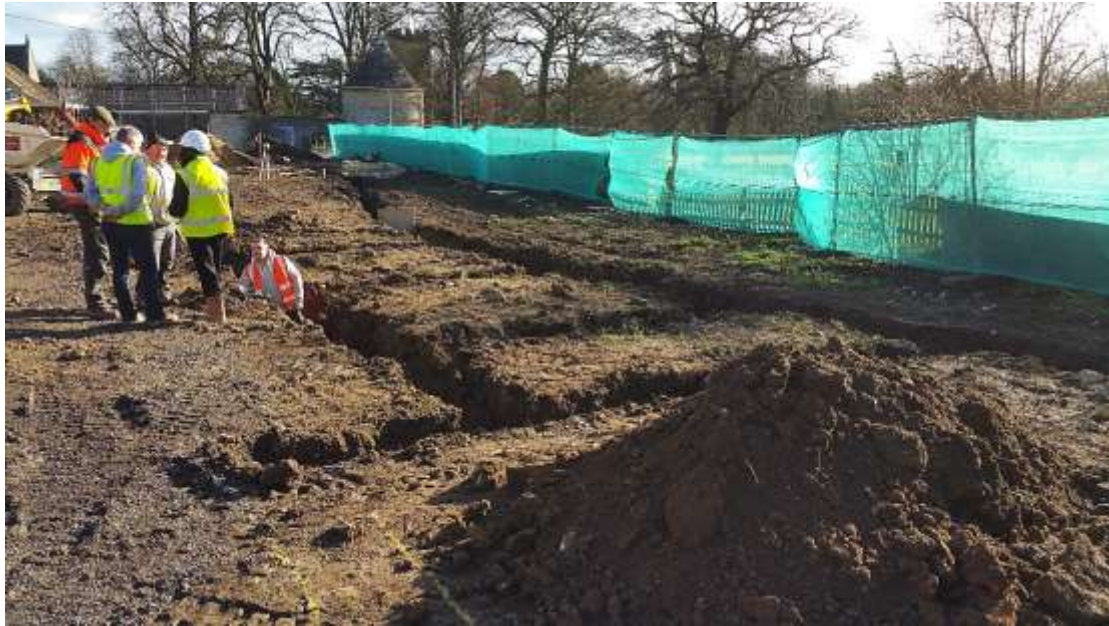
The programme of archaeological Observation, Investigation and Recording consisted of the observation of groundworks associated with construction of foundations for a single residential structure located in the former farmyard. A mechanical excavator equipped with a 0.6m wide toothed bucket excavated footings trenches to 1m depth (Figure 3).

Figure 3: General view southeast across development area

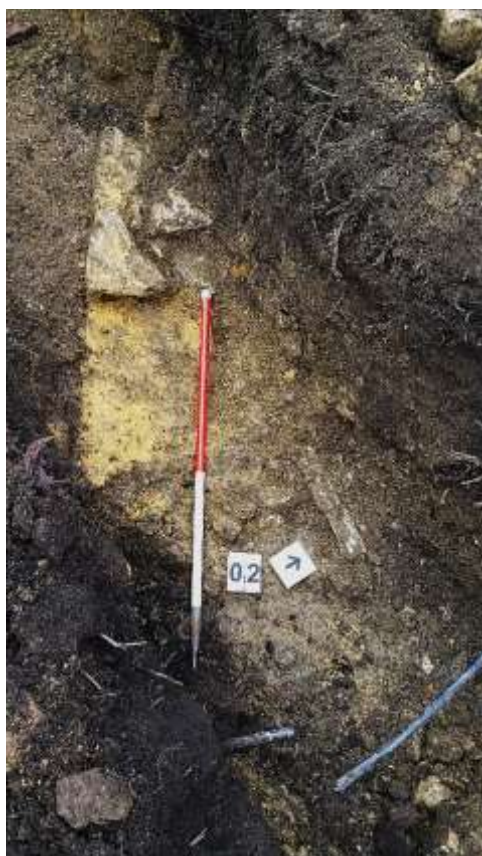
Traces of a possible undocumented building were located at the western end of the farmyard. The structure measured *c.*4m east-west and at least 7m north-south and was aligned broadly northwest – southeast. Four 0.4m wide walls, **(02)**, **(03)**, **(05)** **(06)**, with a uniform shaped, undressed coursed limestone block build with a pale yellow-brown sandy lime mortar bond were observed in groundworks trenches (Figure 5, Figure 56). **(06)** was completely truncated by the trench and comprised a 0.2m thick base of 10cm limestone lumps and CBM fragments in a tightly compact pale grey silt matrix, overlain by a 0.35m thick possible superstructure of two or three roughly coursed undressed limestone blocks set in a buff mortar matrix (Figure 7). Further modern brick rubble alongside the wall likely represented collapsed superstructure.

Figure 5: Wall (02): view northwest (1m scale)

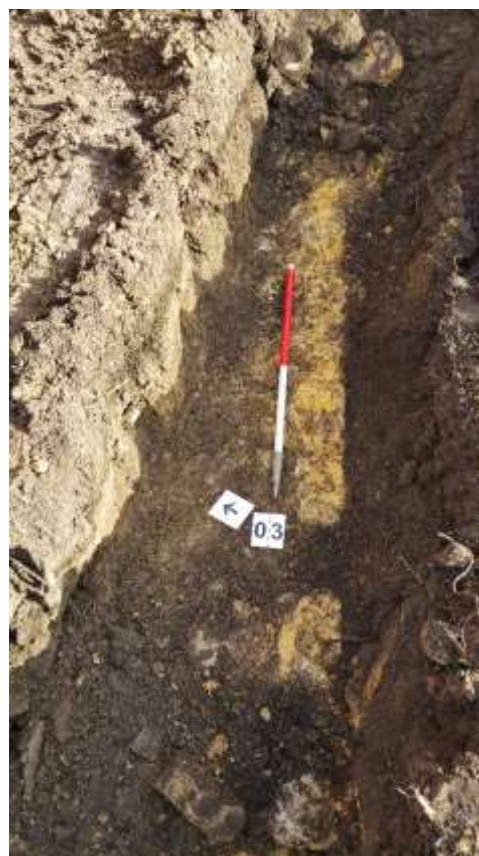
Figure 6: Wall (03): view northeast (1m scale)

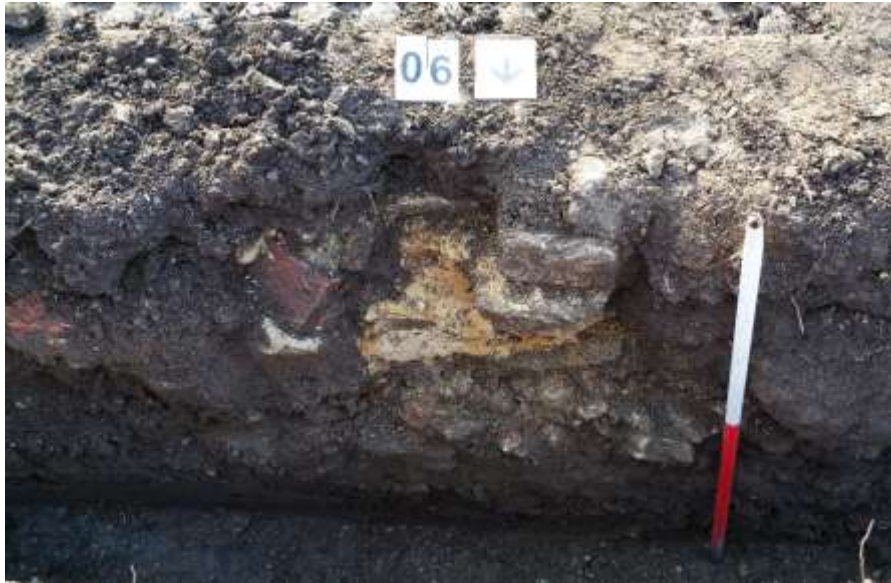
Figure 7: Wall (06): view south (1m scale)

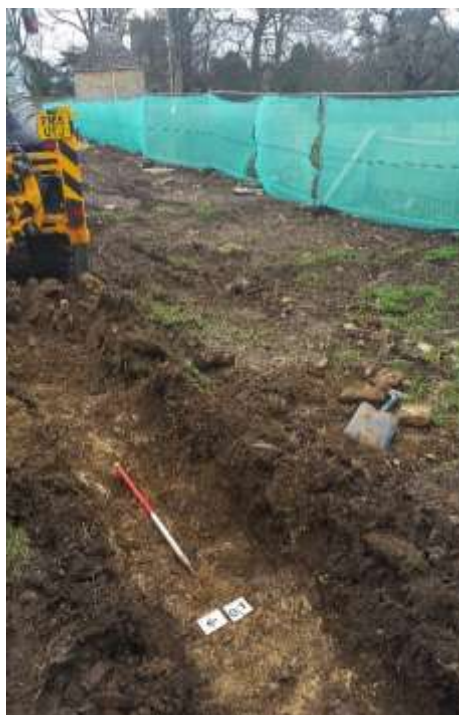
Traces of a possible second structure were revealed during groundworks directly east of the first. Fragmentary traces of a buff mortar wall base **(01)** were observed running east-west at the base of a footings trench *c.* 7m north of the farmyard wall (Figure 8). There were no indications of surviving masonry or CBM footings or superstructure. A fragmentary section of walling **(04)** with a curving outer face was encountered *c.* 7m to the north-east. Whilst not appearing to accord with the location of the building recorded on the 1900 OS map, its curvature may indicate that this formed part of a centrally placed well.

Figure 8: Wall (01): view southeast towards dovecote
