**A Level 2 Historic Building Survey at
Workspace 17,
Highfield Street,
Coalville,
Leicestershire.**

ULAS Report No. 2016-002
©2016

For: Leicestershire County Council

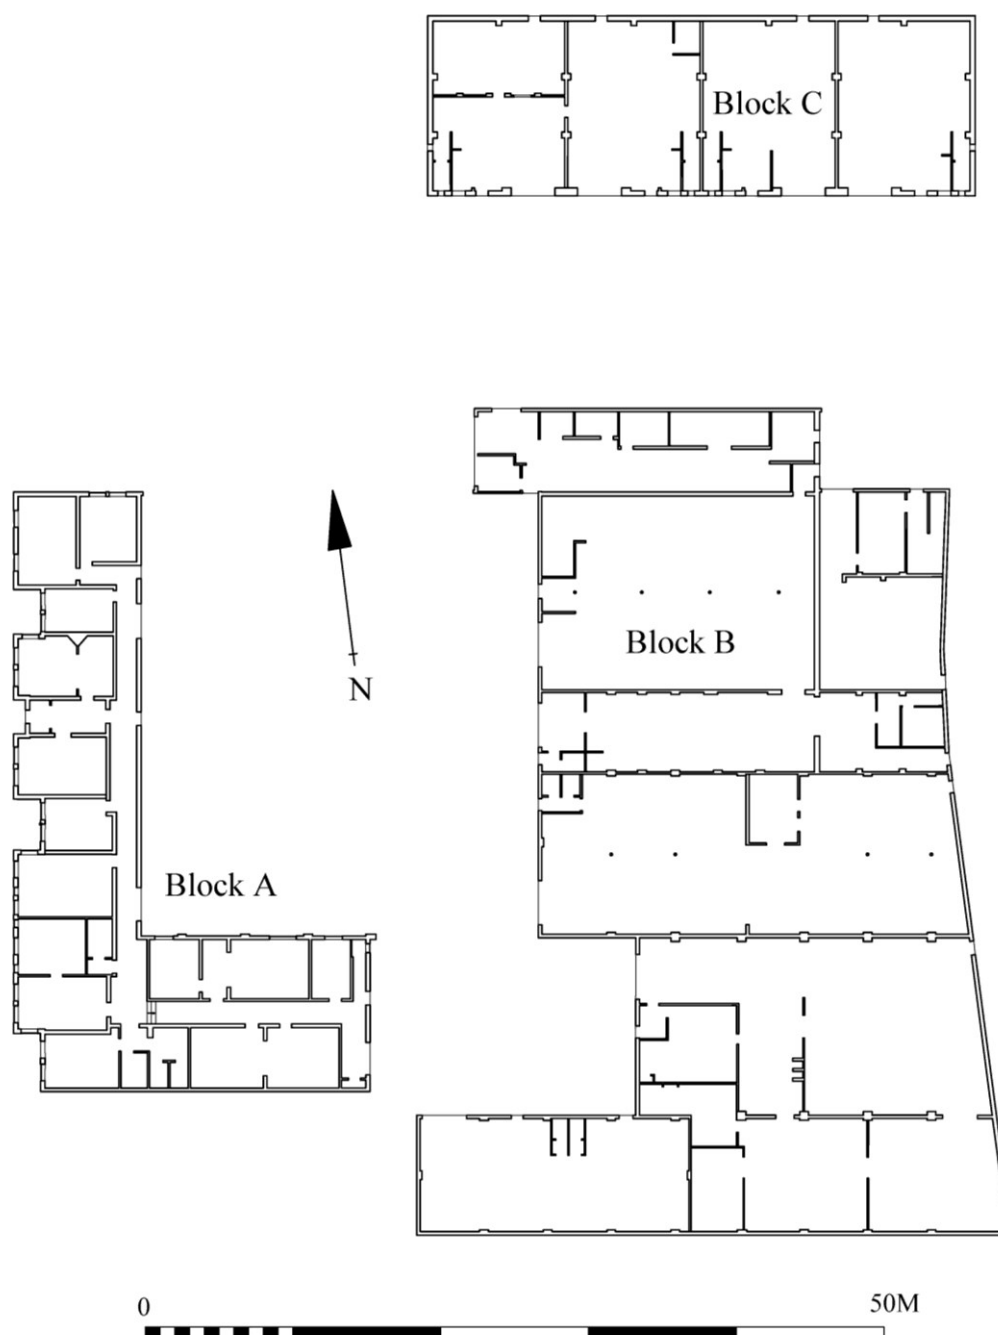
Figure 5 Plan of Workspace 17 buildings
Modified from Leicestershire County Council plans

The Workspace 17 site fills the combined area once covered by the former Clutson and Kemp buildings and the Roman Catholic chapel to the north. Nothing now remains of the chapel although a number of mature trees still survive. The present site consists of three blocks of buildings identified by the County Council as Blocks A, B and C (Figs. 2 and 5). Block A forms the roadside office block, Block B is made up of the group of former north-light factory buildings and Block C is a new warehouse building. All of the buildings have been subdivided to accommodate a number of small business units (Fig. 6).

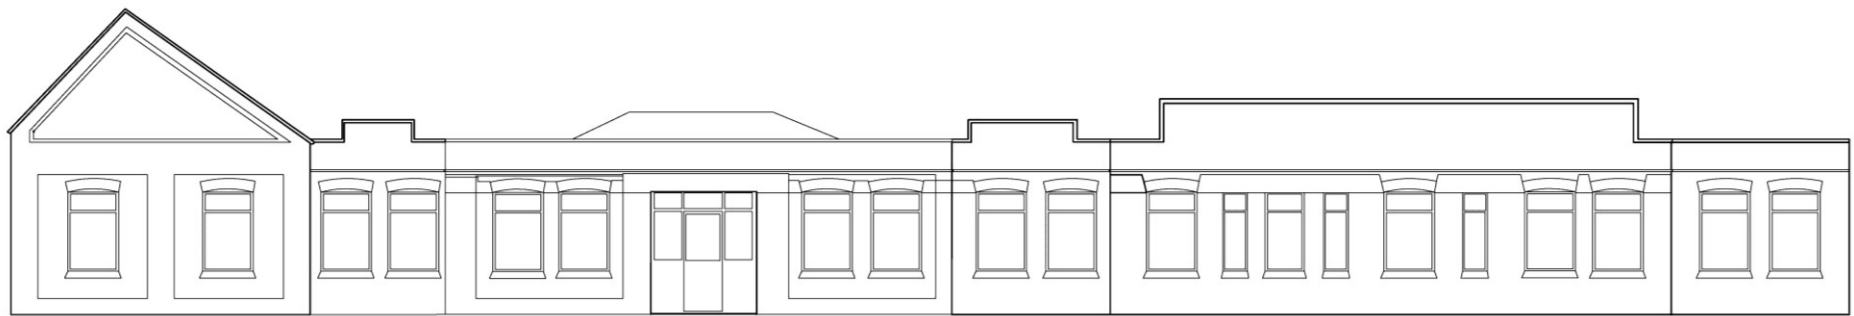
Figure 7 Block A, west facing elevation

The west facing elevation of the single storey Block A fronts onto Highfield Street and is the principal elevation of the complex (Figs. 7, 8 and 9). It is built in a rather utilitarian Art Deco style with flat parapets hiding the pitched roofs. The façade is broken into three segments separated by recessed segments. Red bricks are the main building material used with blue brick detailing and limestone blocks above the doors and windows. The courses generally use an alternating header and stretcher bond. All of the window fittings are modern replacements.

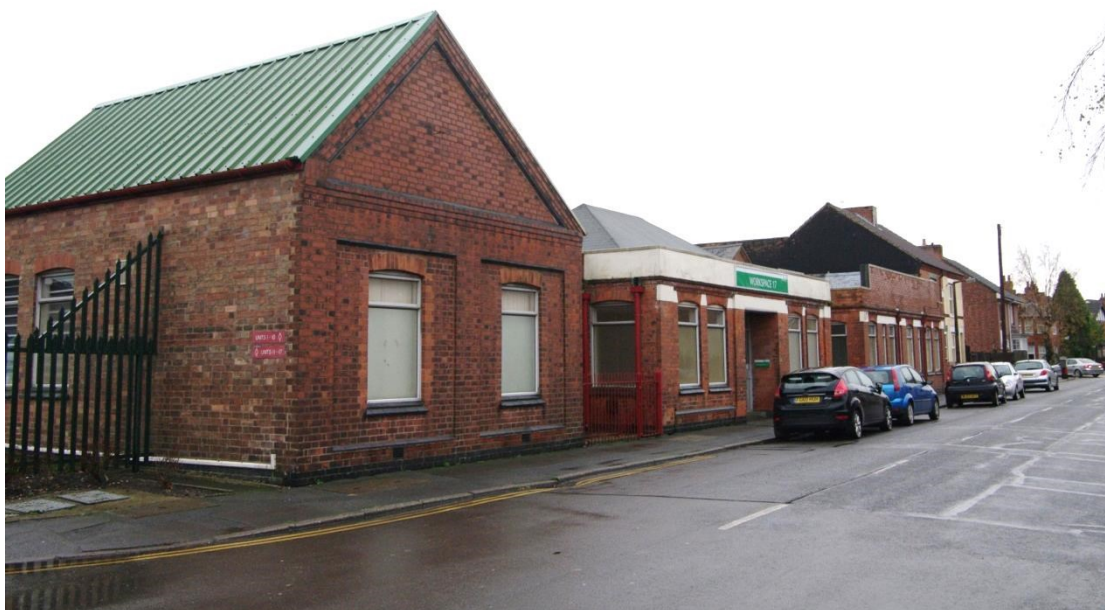
Figure 8 Block A, west facing elevation
Looking south-east

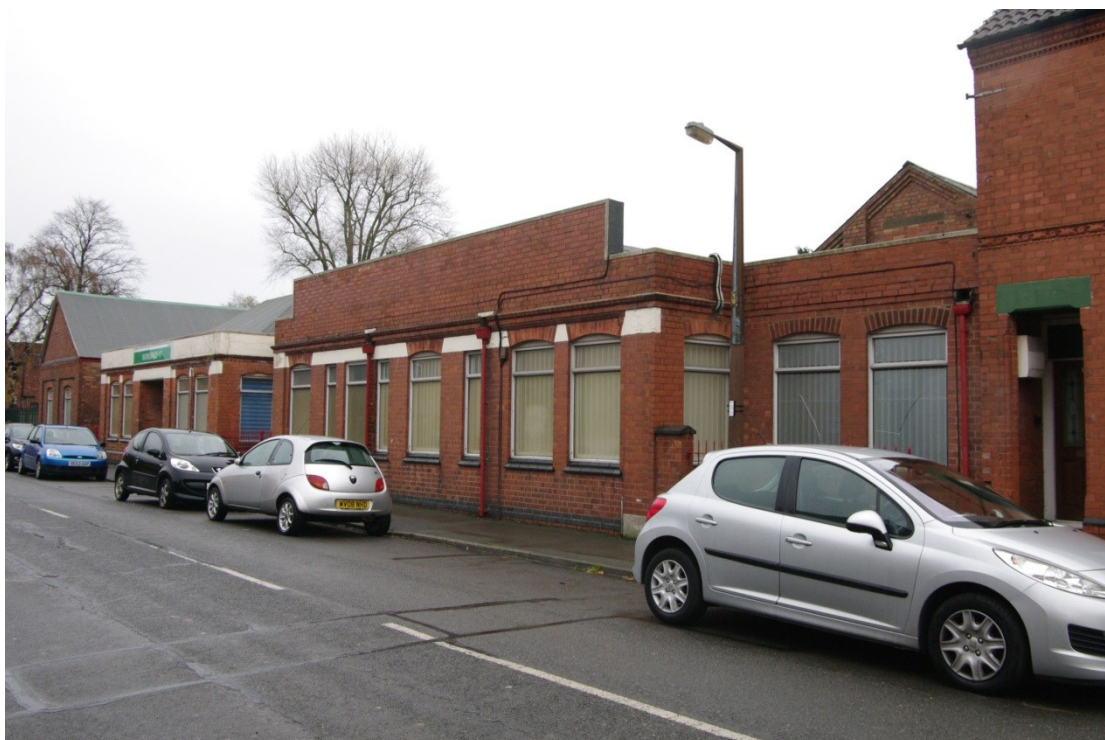
Figure 9 Block A, west facing
Looking north-east

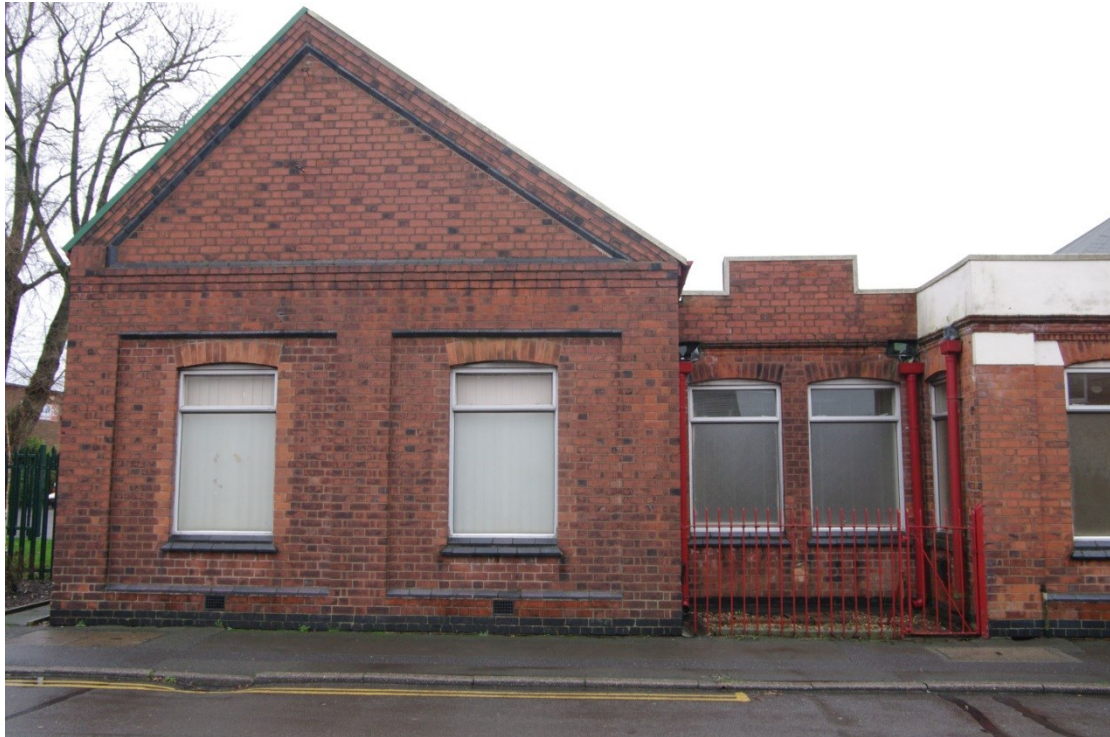
Figure 10 Block A, west facing elevation, north end
Looking east

building line steps back by around 2m to a 3m wide wall containing two office windows and a moulded brick string course above them (Fig. 10). At eaves height is a stepped parapet with rainwater hoppers at the roofline valleys. The parapet has a capping of what appears to be roofing felt. The recess is separated from the street by iron railings.

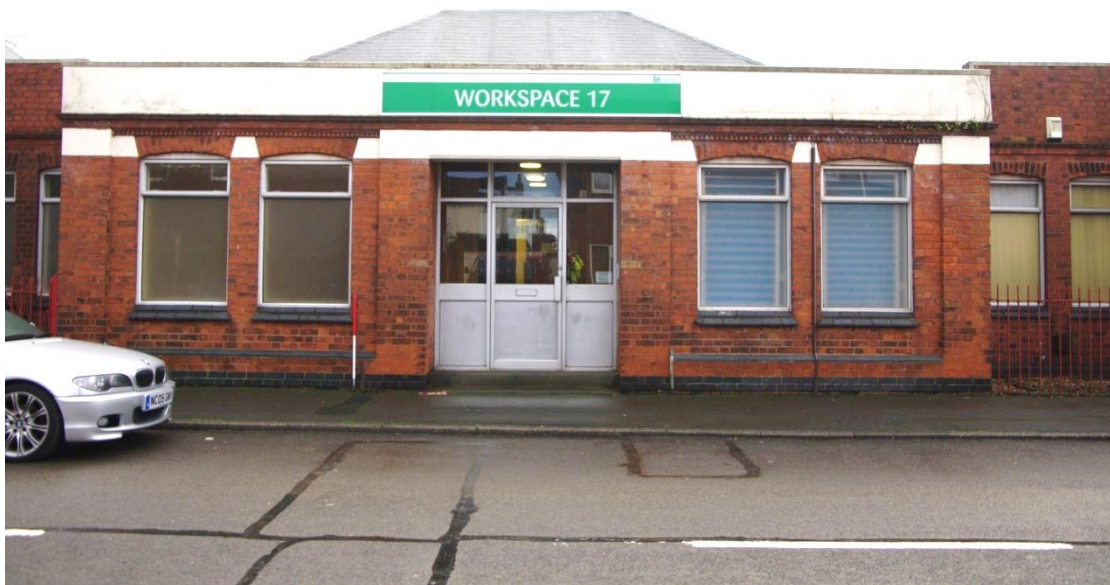
Figure 11 Block A, west facing elevation, entrance
Looking east. 1m scale

Beyond the recess, to the south, the building line steps forward again to become flush with the pavement (Fig. 11). This segment of the building contains the main entrance into the offices which is flanked on each side by two double windows. The entrance doors are modern metal replacements with no indication of what the original doors may have been like. At the top of the windows is a wide band of limestone which continues across the front of this segment and the large street-side segment to the south. Between the limestone band and the tops of the windows is a line of decorative dentil work made from red bricks. The parapet on this segment is flat and has been painted white. It is possible that this part of the parapet has been rebuilt as the current flat parapet fails to hide the roofline behind it. To the south of this segment the façade steps back to another pair of recessed windows behind a set of railings.

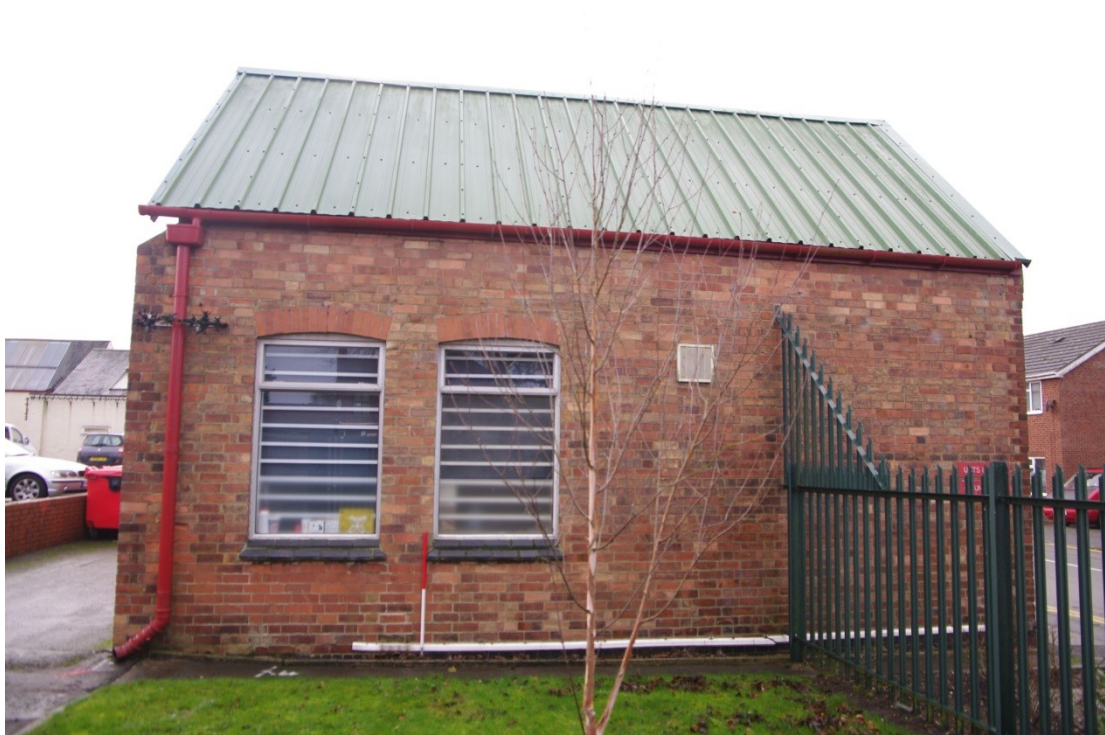
Figure 13 Block A, north facing elevation
Looking south. 1m scale

The north facing elevation of Block A has the same header/stretcher bond as seen on the street frontage and has the same sized arched windows although they are not set into recessed panels (Fig. 13). At the eastern end of the elevation the wall juts out to create a stub of wall which clearly shows where the building once extended further to the east as shown on the 1961 OS map (Fig. 14). The 1929 OS map shows a building on this spot which stopped short of the street frontage but there is no evidence of this in the brickwork which indicates that it was built after 1929.

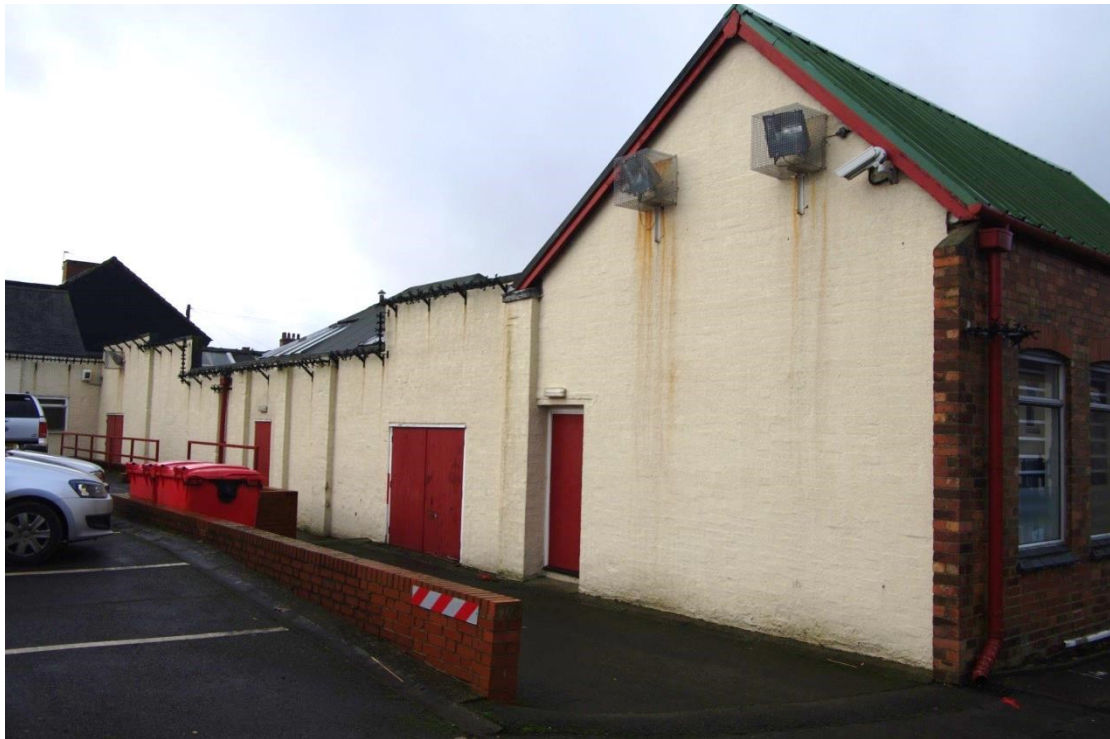
Figure 14 Block A, east facing elevation
Looking south-west. Note stub of what was a much longer wall on far right of picture
also the difference in heights of Block A ground floor and the car park

The east facing elevation faces into the car parking area which is approximately 0.7m higher than the ground floor of Block A (Fig. 14). The Ordnance Survey maps and the photographs on the Britain From Above website indicate that this elevation was once an internal wall backing onto the manufacturing area which consisted of a block of north-light buildings. The wall has been coated in render probably to mask scars and to provide some weather resistance to a wall that was never intended to be exposed to the elements. There are two sets of double doors, two single doorways but no windows on this elevation. The parapet wall at eaves height appears to have been reduced in height and modified from the original north-light building walls and is also capped with roofing felt to keep the top dry. There are a number of brick pilasters

which possibly supported the demolished roof structure but are now capped with lead sheeting.

It is not clear how the different ground levels would have worked when the whole area was covered in buildings but the present difference in heights of Block A and the car park suggests that the car park area has been heavily landscaped. When the now demolished buildings were present there must have been a number of steps within the buildings to accommodate the slope of the site.

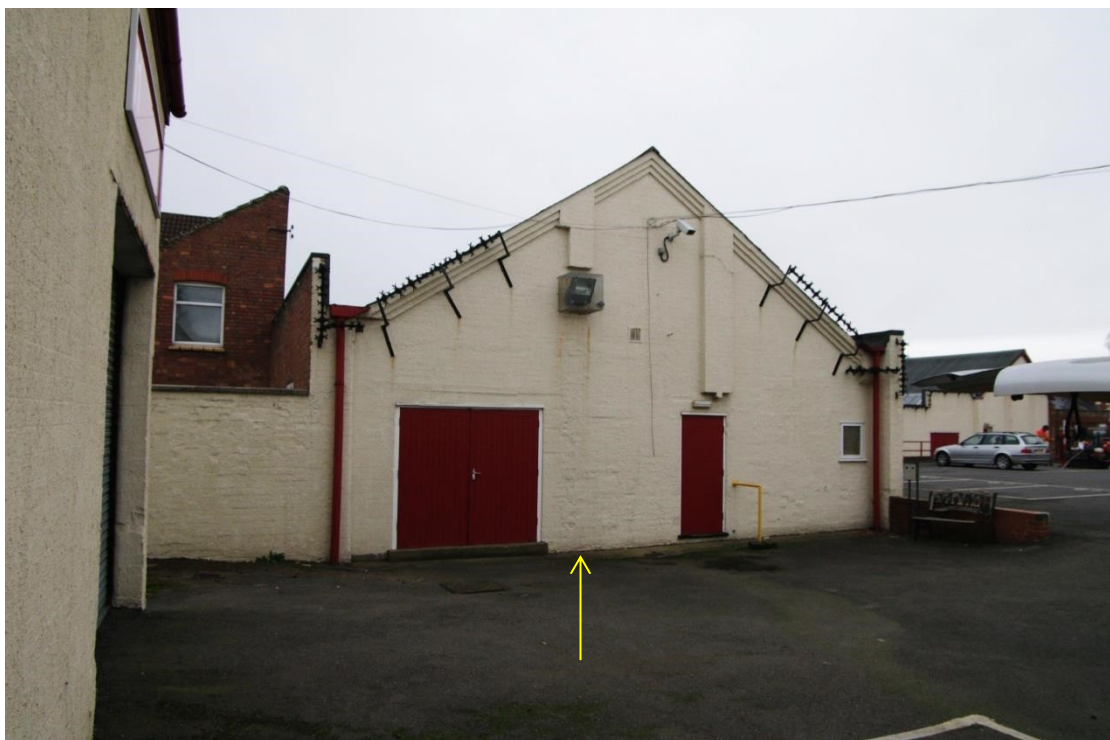
Figure 17 Block A, rear range, east facing elevation
Looking north-west. Note scarring on brickwork below truncated pilaster (arrowed)

The rear range of Block A runs eastwards from the south-eastern corner of the street frontage range. The building consists of a 15 metre long single storey structure with a pitched roof covered in slates (Figs. 15 and 16). Although all of the external walls have been painted white to match the render of the east facing elevation it can be seen that the range is built from red brick. A number of brick pilasters can be seen on the north facing wall which are likely to have supported the roof structure of the demolished buildings. The top of this wall is higher than the eaves suggesting that it actually belonged to another building. The east facing wall has three modern flat-headed windows which were probably inserted after the other buildings were demolished. The east facing gable end has a double doorway which appears to be original (Fig. 17). Two brick pilasters supporting the demolished building have been partially removed leaving a scar on the brickwork (Fig. 17). At each side of the elevation the side walls are much thicker than would be needed for a single storey building. They also extend above the eaves level which suggests that they were part of the demolished building complex.

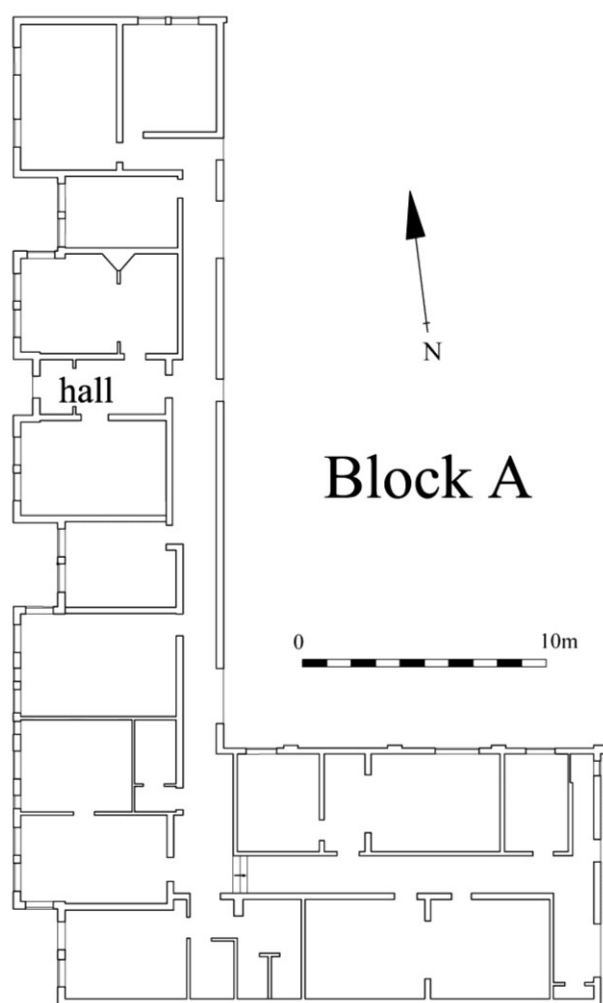
Figure 18 Block A floorplan
Modified from Leicestershire County Council plans

Block A consists of a number of small offices which have been divided into a number of individual small business units (Fig. 18). The offices are linked by a corridor which runs along the eastern side of the street side range before turning east through the middle of the rear range. Access is via a small entrance hall from Highfield Street or through the back door into the car park.

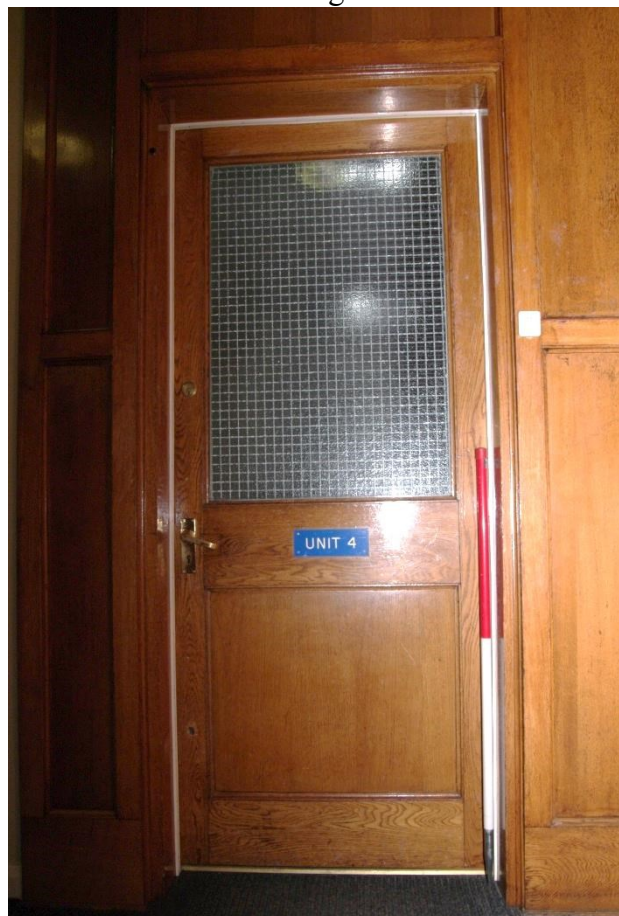
Figure 21 Block A, entrance hall office door
Looking south. 1m scale

The entrance hallway is the only part of Block A which has not been stripped and modernised. The modern metal doors from Highfield Street lead into a small porch area with 1950s or 60s linoleum tiles and full-height glass internal doors which lead into the main hallway. The hall is panelled in heavily varnished oak even on the ceiling (Figs. 19 and 20). The south wall is partially covered in plasterboard which may hide an opening for earlier reception desk hatch. Single doors on the north and south walls lead into offices (Fig. 21). An open doorway at the east end of the hall

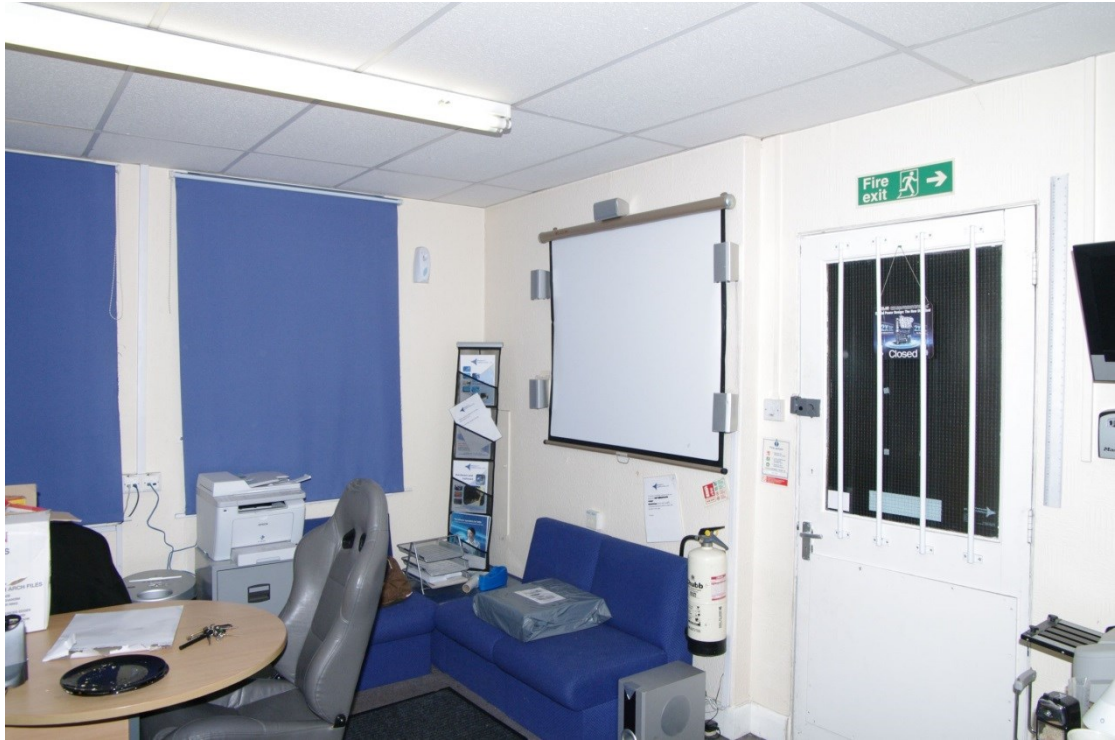
Figure 22 Block A, typical office interior
Looking north-west in room on south side of entrance hall

leads into the back corridor and the other offices. Both side offices have been completely modernised with no trace of any pre-1980s fittings (Fig. 22). The office to the south of the hall may have been the director's offices as it appears to have been two offices with corner fireplaces. The fireplaces have been blocked and plastered over to remove any trace of them. The two former offices have been knocked through to create a single larger office now identified as Unit 4.

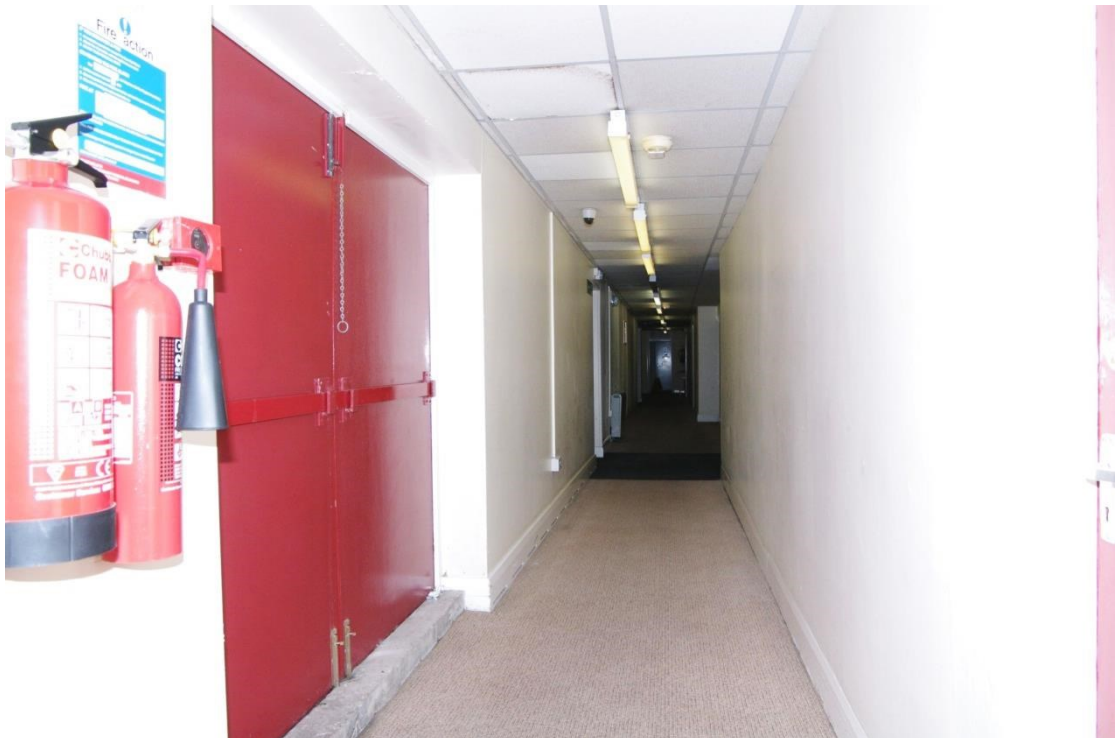
Figure 23 Block A, rear corridor
Looking south

The back corridor runs from north to south giving access to the other offices in this block (Fig. 23). At least part of the office-side (west) corridor wall is modern plasterboard giving the impression that walls have been moved. Most offices are now empty but none retain any original features or any indications regarding their former use. Doors on the eastern wall lead out to the car park. The offices towards the south end of the Highfield Street frontage may have been rearranged as the oddly shaped windows seen from the outside now light single large offices (Fig. 24). The corridor turns eastwards at its southern end where it meets the rear range. Most of the office walls along this part of the block appear to be modern plasterboard which again indicates a significant rebuilding to accommodate the offices.

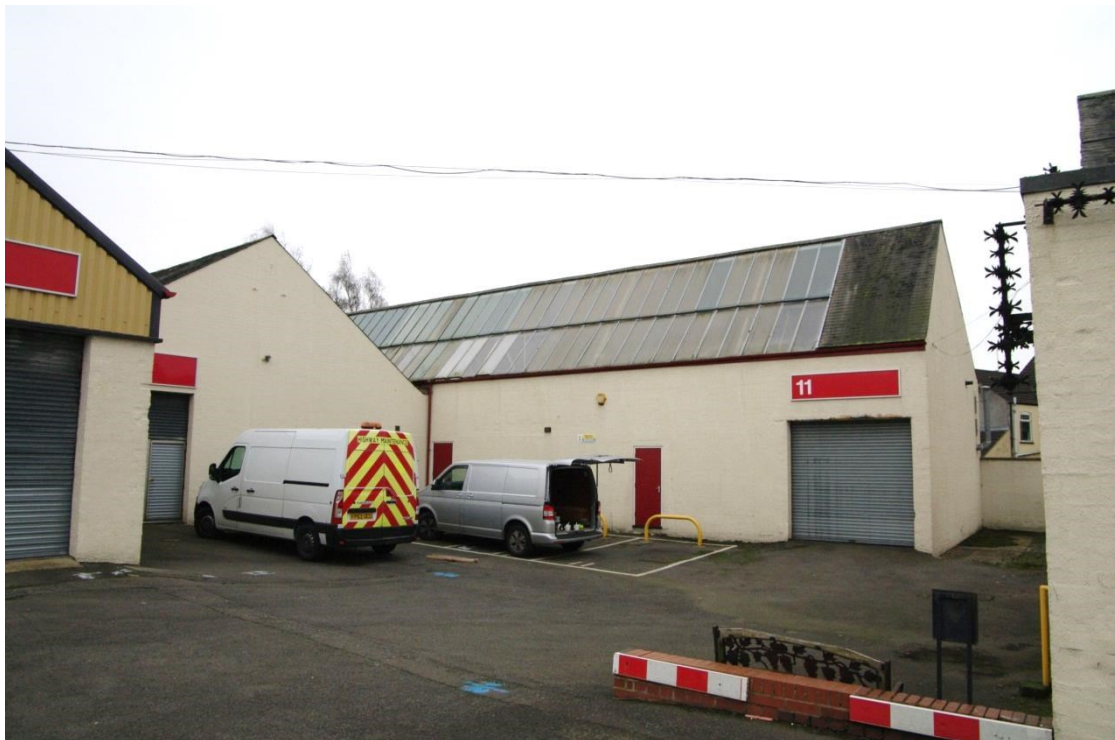
Figure 28 Block B, Unit 11 north and west facing elevations
Looking south-east. Unit 12 is in front of the vans

Unit 11, located along the southern boundary of the site, consists of a single north-light unit with a glazed and slated roof (Fig. 28). Unit 12 wraps around, and obscures, part of its north facing elevation and the entire east facing gable end. The west facing gable end is painted red brick with no openings or blocked openings. On the north facing elevation there are two single doorways and what appears to be a modern inserted opening with a roller shutter.

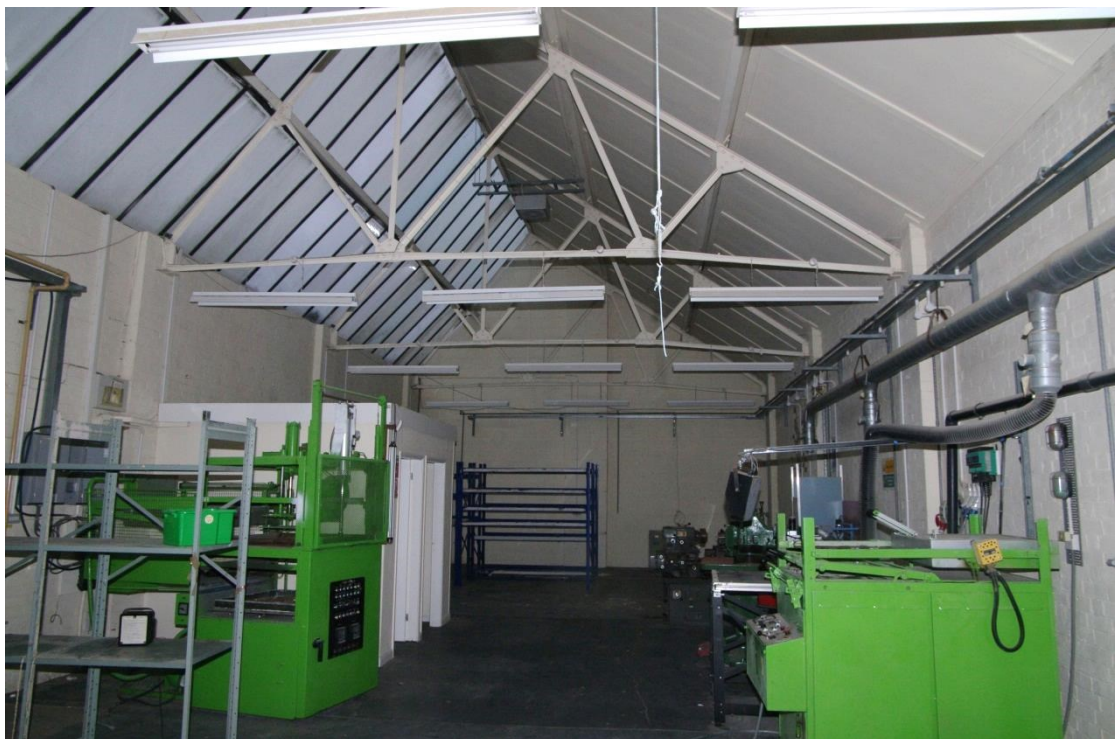
Figure 29 Block B, Unit 11 internal details
Looking east

Inside, Unit 11 has a lightweight angle steel roof structure commonly seen in factory roofs built during the post First World War period (Fig. 29). There are a number of modern pieces of processing equipment but nothing relating to the former uses of the building. Brick pilasters support the roof trusses which are a similar size to the truncated ones seen on the rear of Block A. A small modern toilet block has been added to the north side of the room.

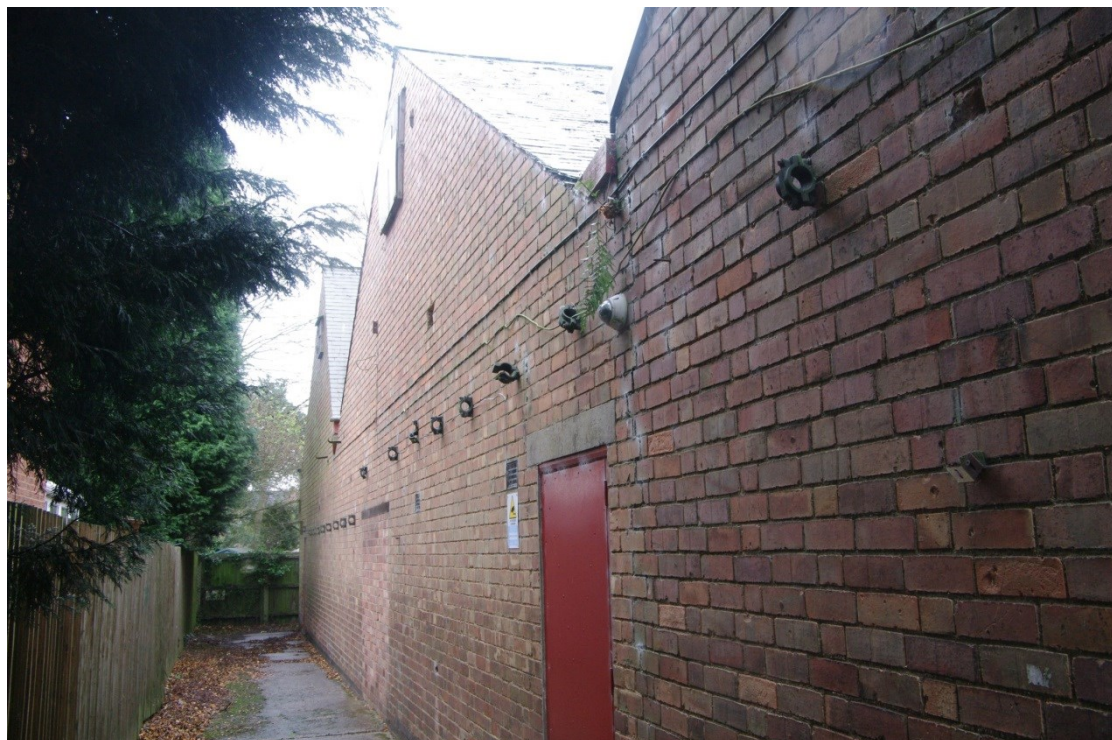
Figure 31 Block B, Unit 12 east facing elevation
Looking south. Unit 12 consists of two gable ends on this elevation

The east facing elevation of Unit 12 incorporates the north-light end of Unit 11 and the roof of Unit 12 seen to the west (Fig. 31). There is a joint in the brickwork between the gables of Units 11 and 12 showing a difference in construction dates. A blocked doorway may have led into the factory to the east of the site which is now occupied by houses.

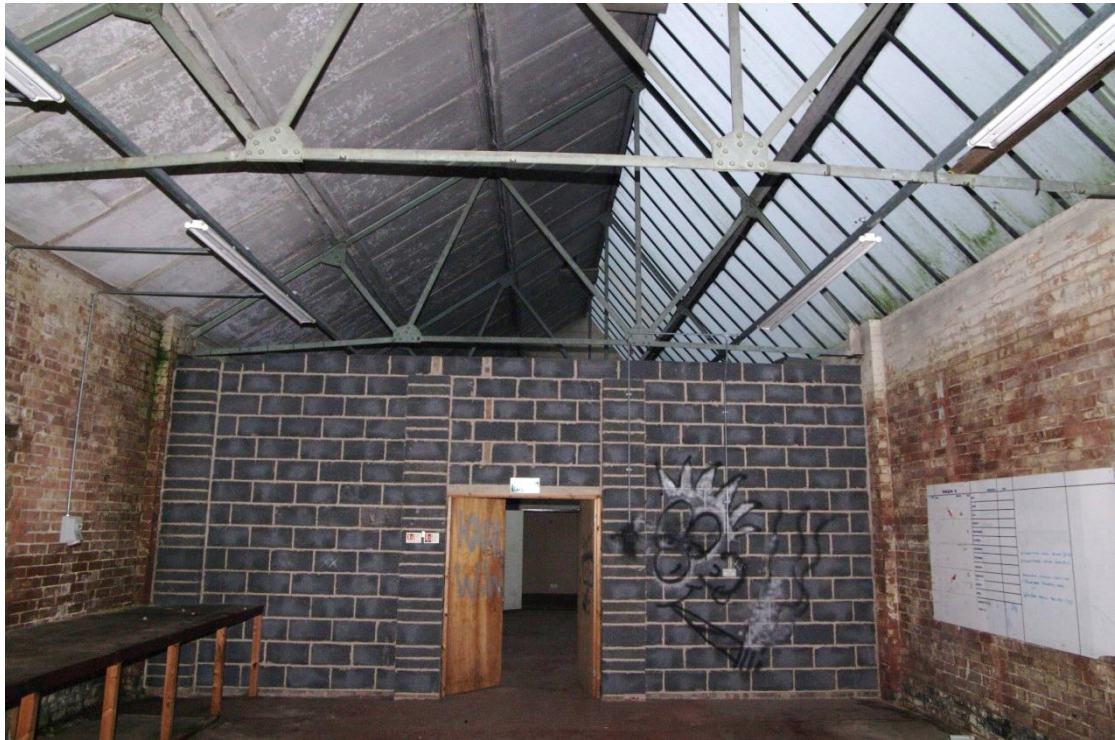
Figure 32 Block B, Unit 12 south building
Looking west

Inside Unit 12 the southern building, behind Unit 11, is a continuation of the Unit 11 building and shares the same walls and roof structure (Fig. 32). It has been subdivided by a centrally located modern cross-wall. Access between the north and south Unit 12 buildings is via three doorways which have been knocked through the party wall. The roof of the northern building uses the same system of angle steel as the southern building suggesting that, although this building is earlier, the construction dates are not too far apart (Fig. 33). A single width doorway to the north of the roller shutter door has been bricked in (Fig. 34). Modern subdivisions built from breeze blocks divide this building but no original fixtures or fittings survive in this unit.

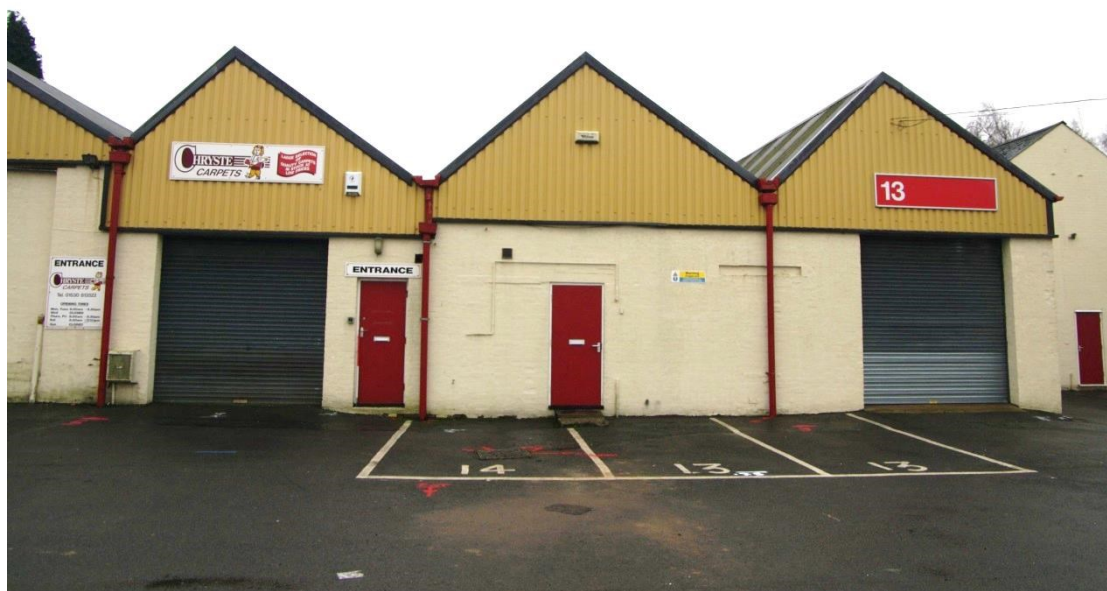
Figure 35 Block B, west facing elevation of Units 13 and 14
Looking east. Unit 13 on right, Unit 14 on left

Unit 13 consists of a double bay unit with a pair of north-light roofs (Fig. 35). The pitch of the north-lights is not very pronounced when compared to the adjacent Units 14 and 15. The gable end apexes of the west facing elevation have been clad in a modern corrugated sheeting material which hides any earlier detail. The west facing elevation has a modern roller shutter door and a single doorway. A possible lintel to the north of the single door suggests another blocked doorway. The east facing elevation is plain brick with a single fire door (Fig. 36). The brick bond between Units 13 and 14 has been keyed in but there is the trace of a joint. The angle of the eastern wall changes at this point to follow the angle of the site boundary.

At the time of the survey Units 14 and 15 were occupied by a carpet retail unit and warehouse. The frontage of Unit 14 matches that of the adjoining units either side (Fig. 35). This unit is relatively narrow and is only one bay wide, the roof of which is the same height as Unit 13. The west facing frontage has a modern roller shutter door and a single doorway. To the rear the east facing elevation is plain brick (Fig. 36).

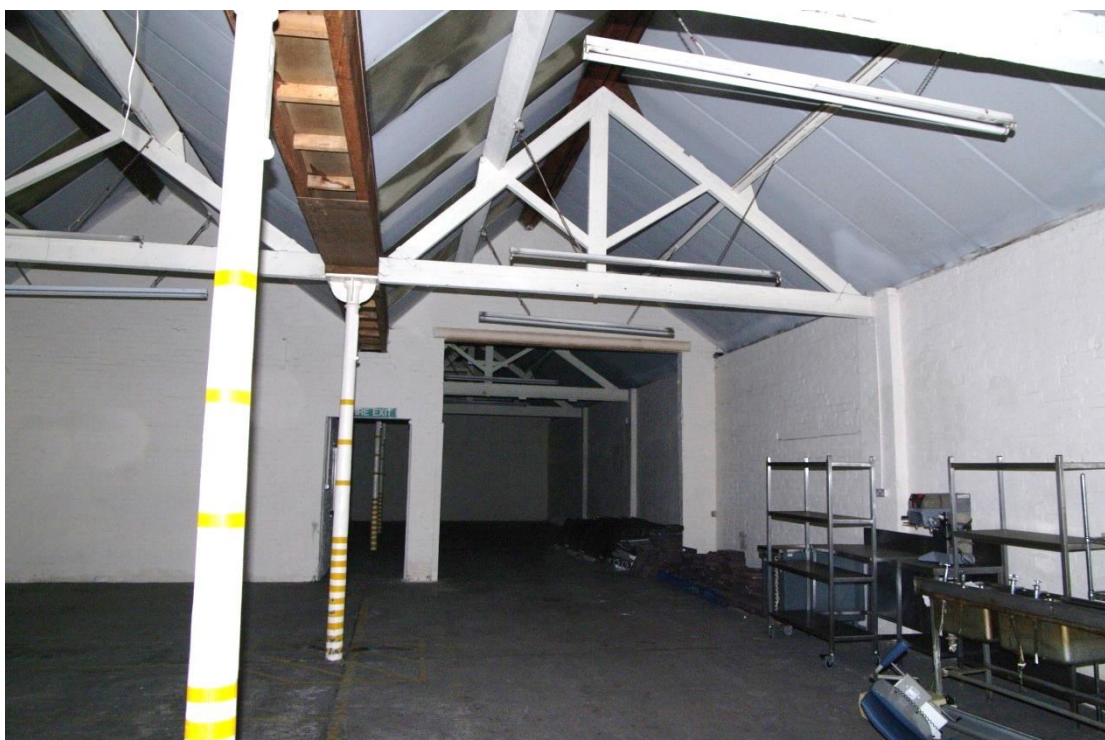
Figure 37 Block B, inside Unit 13
Looking east

Inside the unoccupied unit the double width space has a row of cast iron columns supporting the timber roof structure (Fig. 37). The structure consists of a king post with raking struts supporting the principals which are attached with iron stirrups. The purlins sit on the backs of the principals and are supported by cleats. The columns have flat caps which support the trusses and the rainwater valleys (Fig. 38). Cast into the upper parts of each column is a flat section with two keyhole slots to hold machinery or drive systems. There are two blocked doors on the north wall which once led into the Unit 14 building.

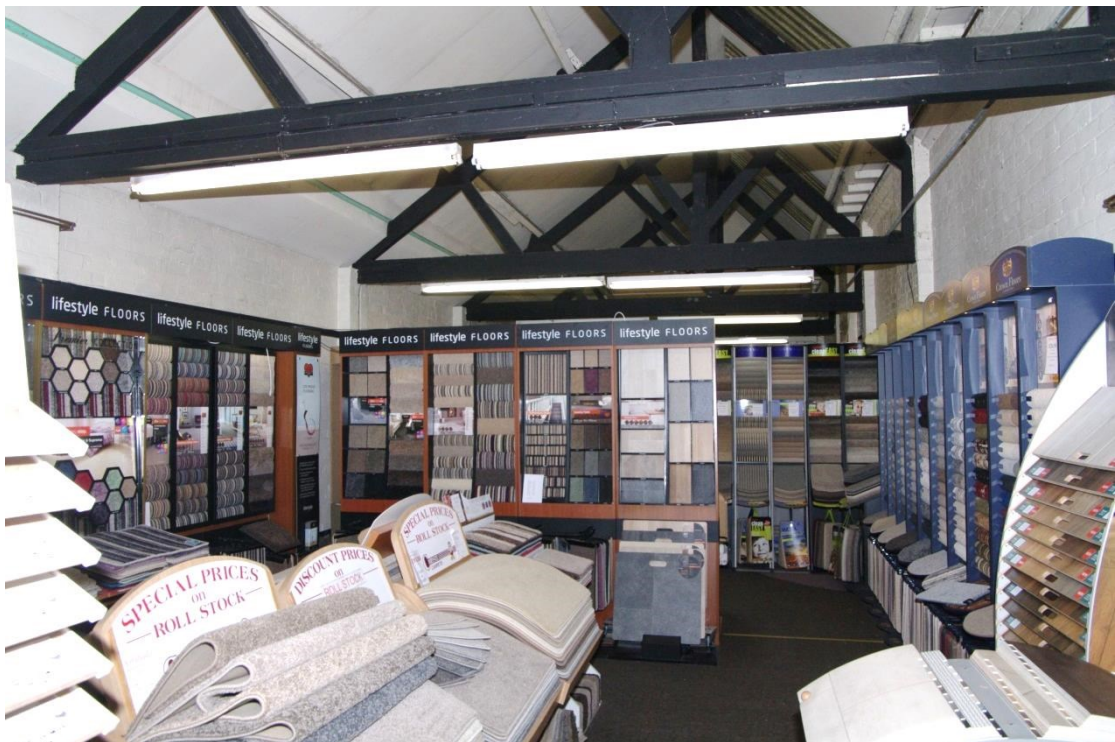
Figure 39 Block B, Unit 14 inside
Looking west

Inside Unit 14 is full of carpets and display units but it clearly has the same wooden roof structure as seen in Unit 13 (Fig. 39). A modern office has been built into the north-east corner of the room. There are no visible fixtures and fittings which survive from the Clutson and Kemp era.

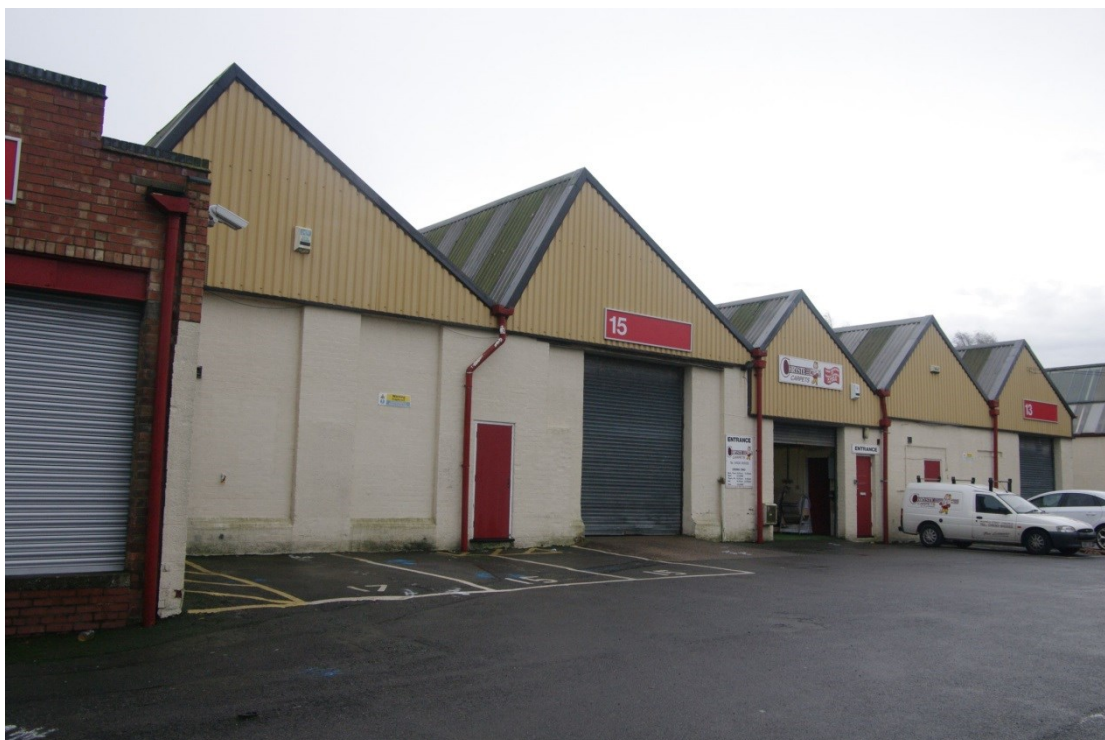
Figure 40 Block B, Unit 15 west facing elevation
Looking south-east

Unit 15 forms a two bay building with a north-light roof (Fig. 40). The west facing elevation with corrugated sheeting matches Units 13 and 14 but the roofline is higher on this unit. The unit has modern roller shutter door and a single door as well. Much of the northern bay west facing elevation is covered by two recessed panels with chamfered bricks at their base which suggests that this elevation was once an outside wall. The East facing elevation is obscured by Unit 16.

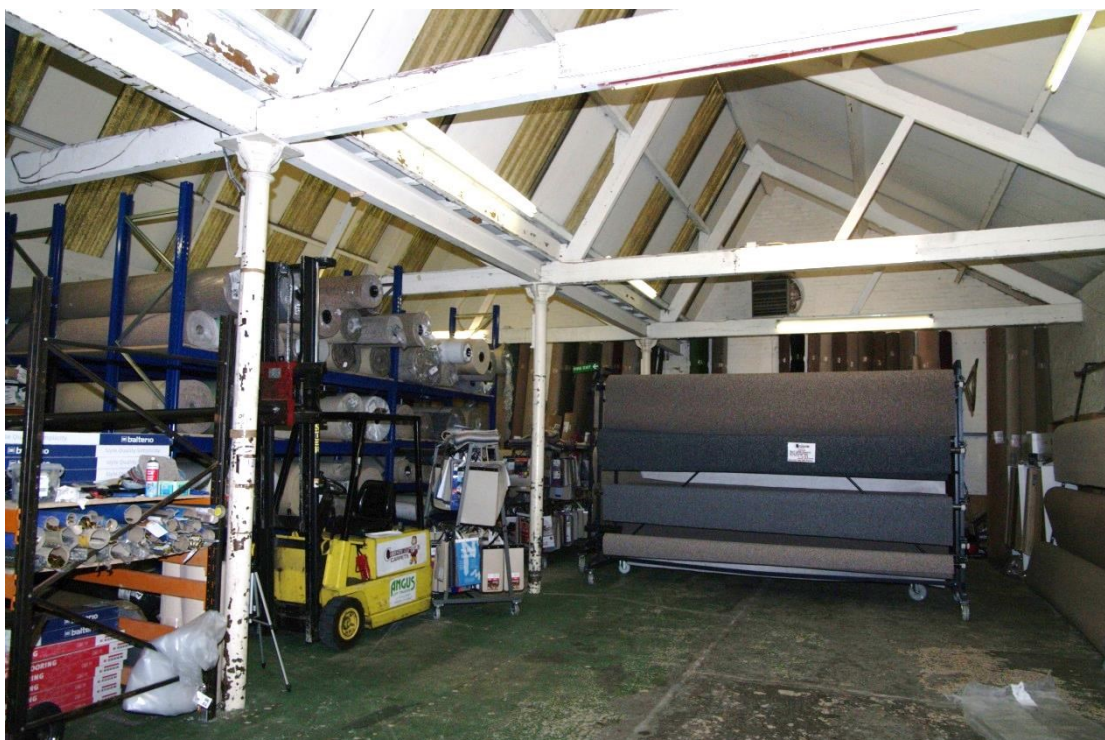
Figure 41 Block B, Unit 15 inside
Looking east

The unit is presently used as a carpet warehouse but most of the walls and the roof structure are visible (Fig. 41). The wooden roof structure and cast iron columns match those in Unit 12 suggesting a similar, if not identical, date of construction (Fig. 42).

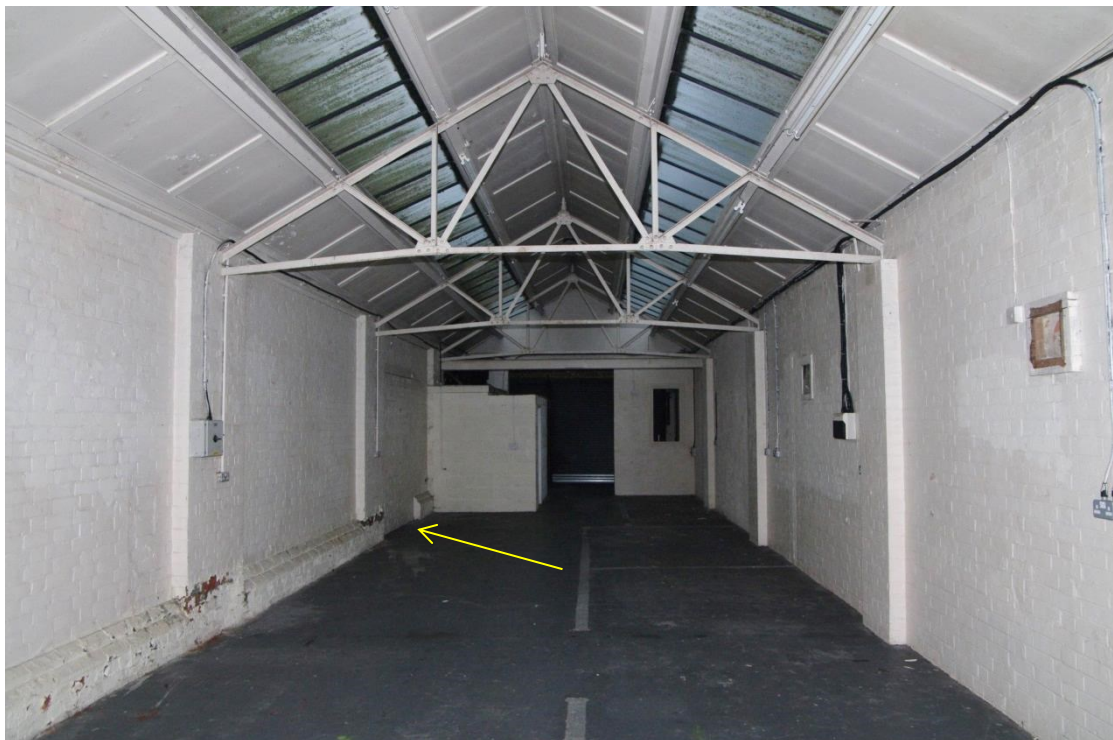
Figure 45 Block B, Unit 17 inside
Looking west. Note blocked doorway into Unit 15 shown by arrow

Inside, the building consists of a long narrow open shed although marks on the floor show where a row of temporary partitions were located (Fig. 45). The floor is level with the outside of the loading bay which means it must be higher than the adjacent unit. A wide blocked doorway on the south wall once led into Unit 15. The roof structure is made from the lightweight steel seen in Units 11 and 12.
