**A Level 2 Historic Building Survey at
Workspace 17,
Highfield Street,
Coalville,
Leicestershire.**

ULAS Report No. 2016-002
©2016

For: Leicestershire County Council

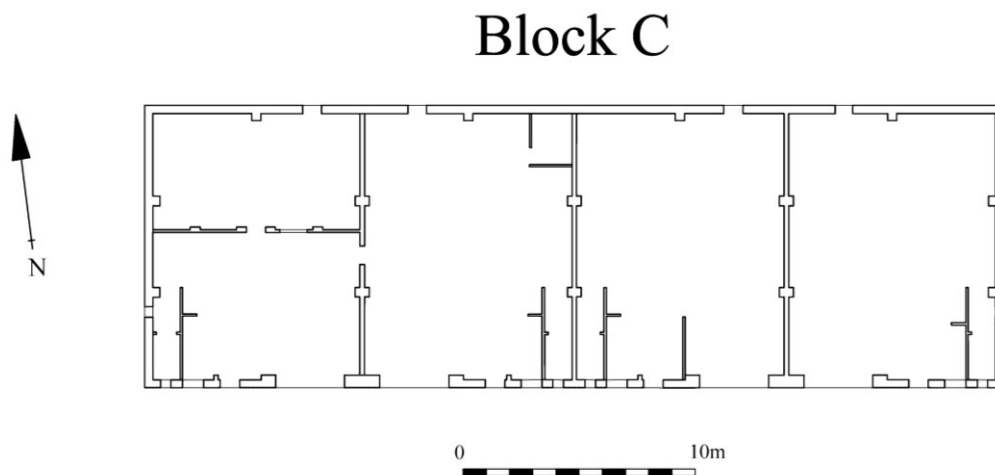
Figure 46 Block C floorplan
Modified from Leicestershire County Council plans

Block C is a modern brick-built structure standing on the site formerly occupied by the Roman Catholic chapel to the north of Block B. It is not shown on the 1973 Ordnance Survey map so must date from after this time. Because of its modern date no elevation drawings were produced for this survey and only the plan supplied by Leicestershire County Council was modified to suit the purposes of this report and shown here (Fig. 46).
