**An Archaeological
Evaluation at
Jewry Wall Museum,
Welles Street, Leicester
NGR: SK 58191 04509**

ULAS Report No 2017-064
©2017

**For:
Leicester City Council**

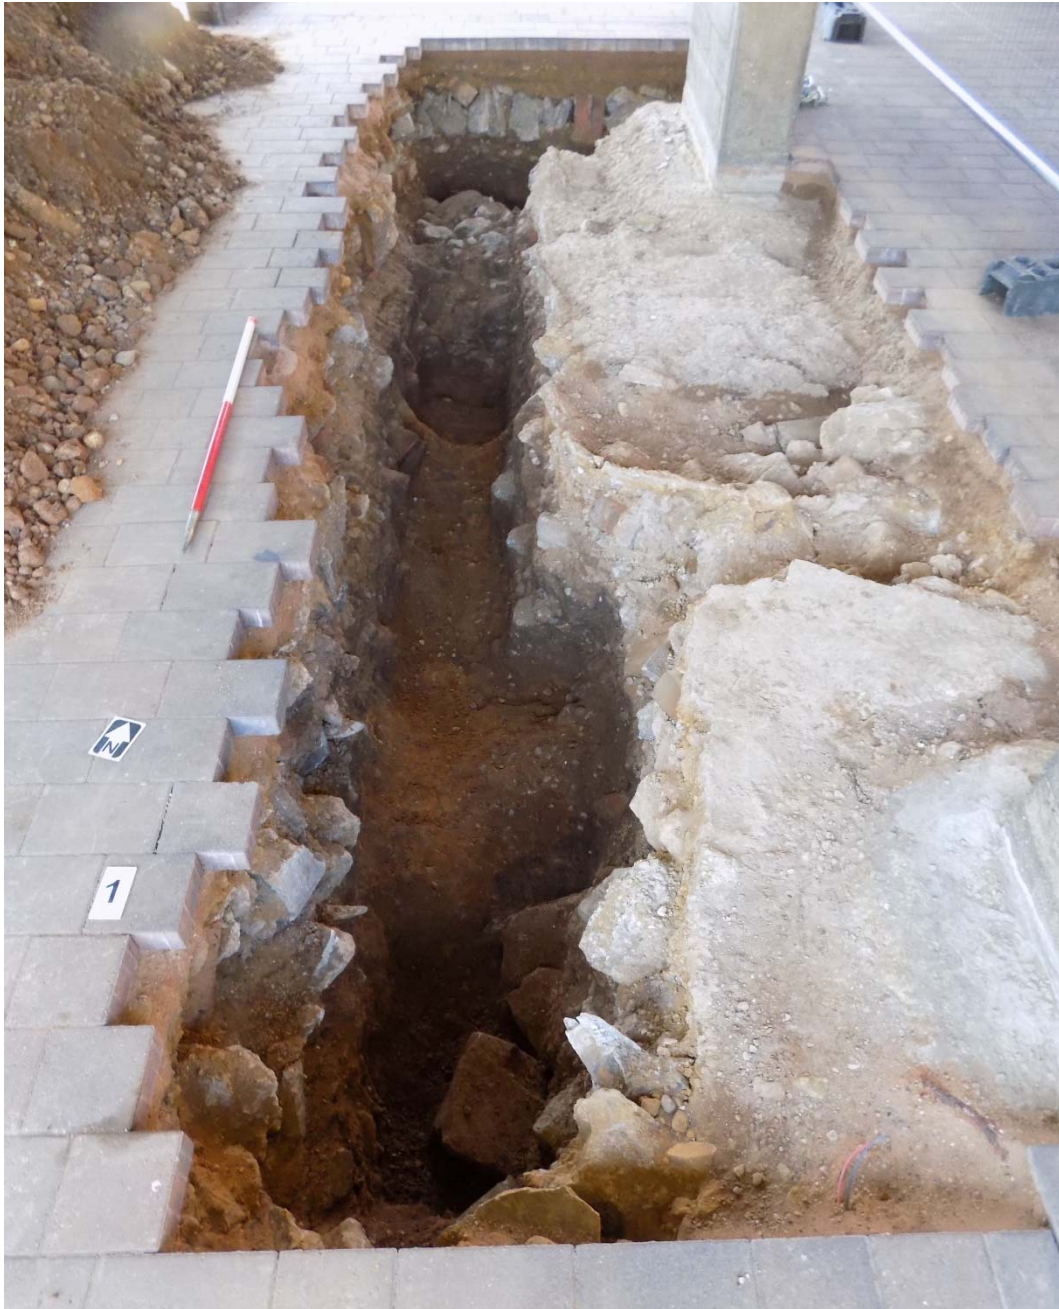
Trench 1 was the largest trial hole measuring 6m by 2m and was excavated to a minimum depth of 0.2m and a maximum of 1.1m. It was located directly to the southeast of two stanchions and included their foundations. As a result the north-western extent of the trench was limited by the level of the concrete foundations. The trench was excavated through a number of modern layers, comprising levelling and consolidation below the current building and car park. These consisted of modern paving blocks, layers of sands and gravel, hardcore and rubble. Archaeological deposits were encountered below these levels and included pits, layers, and the remains of mortared foundations.

Figure 6: View of excavated Trench 1

Despite the disturbance caused by the later building, the evaluation did locate surviving, although heavily truncated, archaeology. Trench 1 revealed the location of the two parallel walls excavated by Kenyon, represented by part of the foundation (2) and a robber trench (10), [11]. A series of pits were also identified. The upper ones were filled

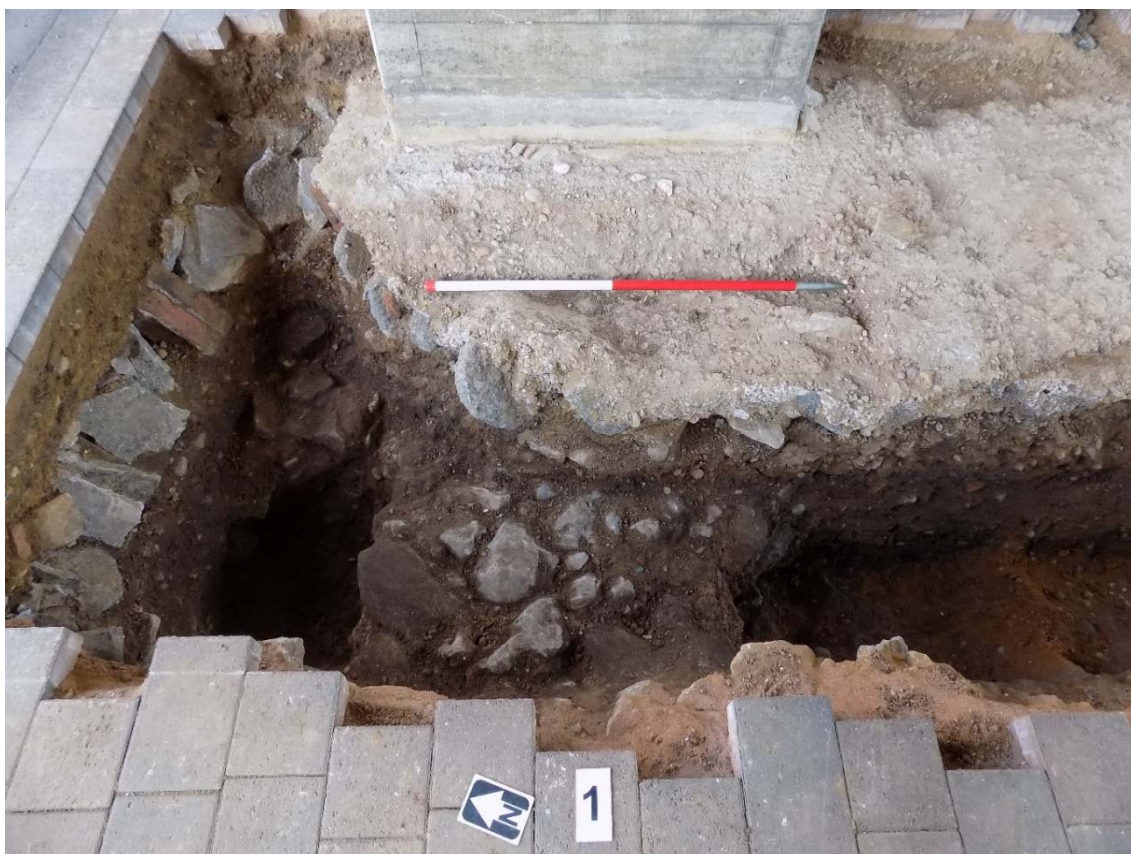
The wall foundations (2) were 0.5m high and measured 1.04m wide. They consisted of roughly finished granite blocks, measuring up to 0.3m long and 0.25m wide, bonded with a yellowish-brown sandy mortar, with white flecks. A pit was noted on either side of the wall suggesting that it may be partially disturbed. Pit [3] (4) appeared to have been dug up against the wall foundations on the north side. The fill was a greenish-brown silty sand, with charcoal flecks and finds including mid-late 1st-century pottery, animal bones and *opus signinum*. It truncated an earlier pit [20] with three silty sand fills; (17), (18) and (19) with late 1st-early 2nd century greyware. Pit [3] also cut a possible surface (5), which was made from granite fragments within a red clay matrix. On the south side of the wall foundation a further pit [6] contained a very similar fill to (1), which contained *tegula*. An adjacent feature, pit [8] also contained a similar fill and these features may represent pits that were excavated in the 1930s and later backfilled with a mixed deposit.

Figure 7: North end of Trench 1 showing in situ Roman masonry (1m scale)

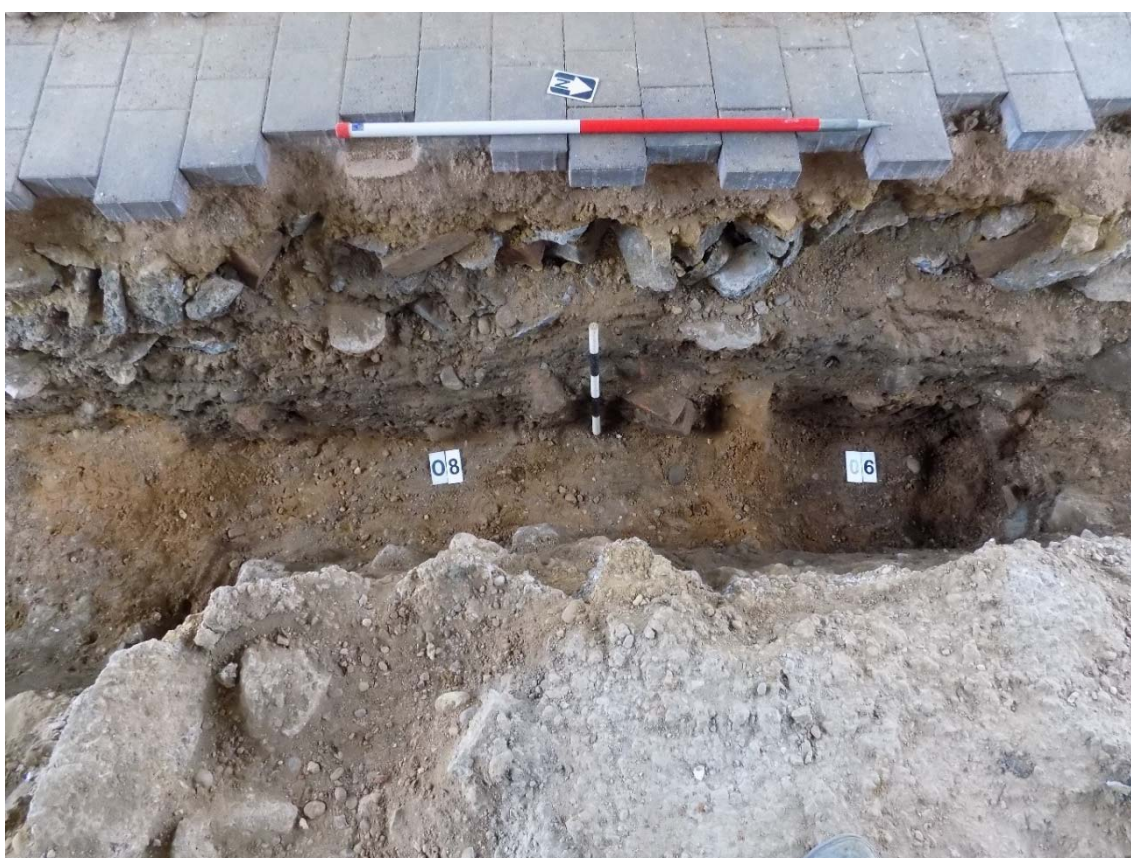
Figure 8: View of central part of Trench 1, showing pits [6] and [8] (1m and 0.5m scales)

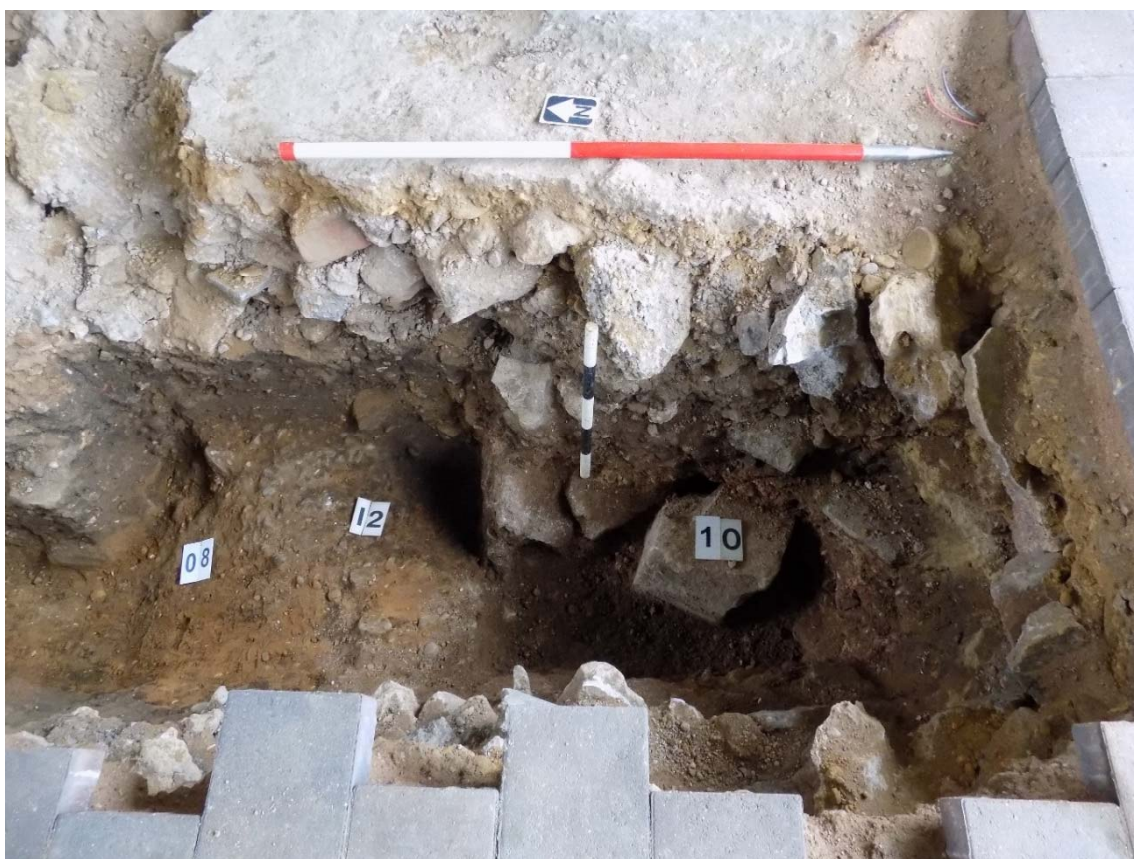
At the other end of the trench, a robber trench [10] was identified below the second concrete stanchion. It was backfilled with yellow-brown silty sand (11) containing frequent Roman building debris, including granite blocks, plaster, mortar, *opus signinum* and box flue tile. This cut through, and was therefore later than, layer (16), a mortar-rich deposit, which overlies a

greenish-brown silty clay, possibly representing a trample layer (14), which contained late 1st to mid-2nd century sandy wares. An earlier pit, [12], was identified beneath this layer, backfilled with greenish brown sandy silt containing frequent charcoal flecks and early Roman pottery. A second possible trample layer (15) appeared to have been cut by the pit [12]. This may represent a buried topsoil, as it sat directly above the natural sand and gravel subsoil, which was encountered at a depth of 58.14m OD in this location, although cut by archaeological deposits in other parts of the trench.

Figure 9: South end of Trench 1, showing robber trench [10], pit [12] and pit [8]

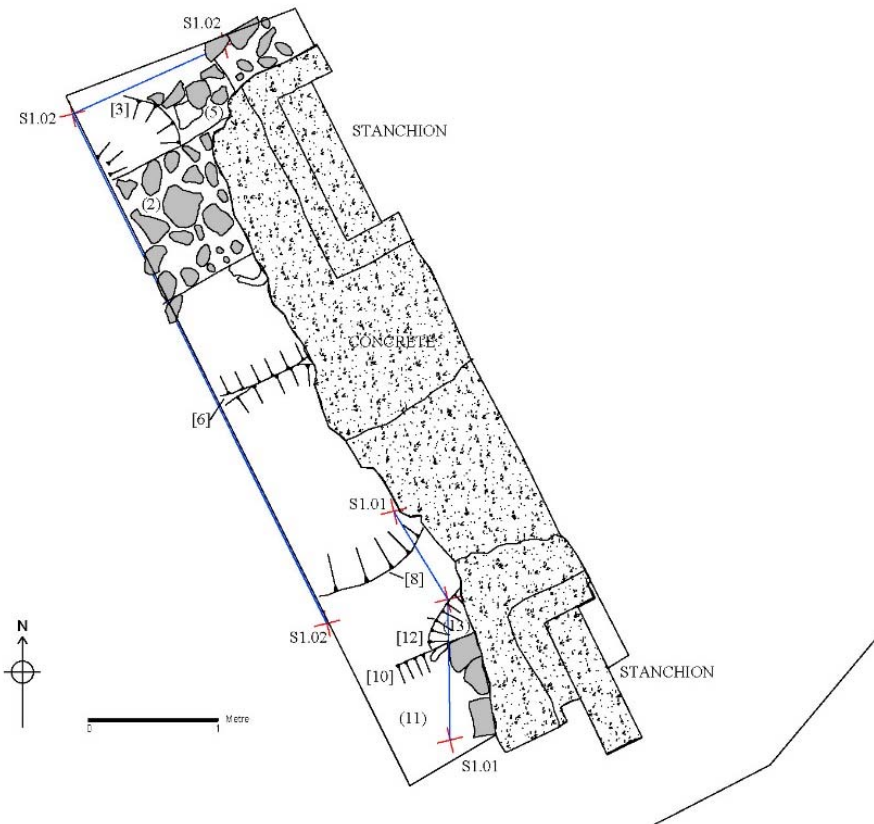
Figure 10: Plan of Trench 1, showing extent of concrete and archaeological features

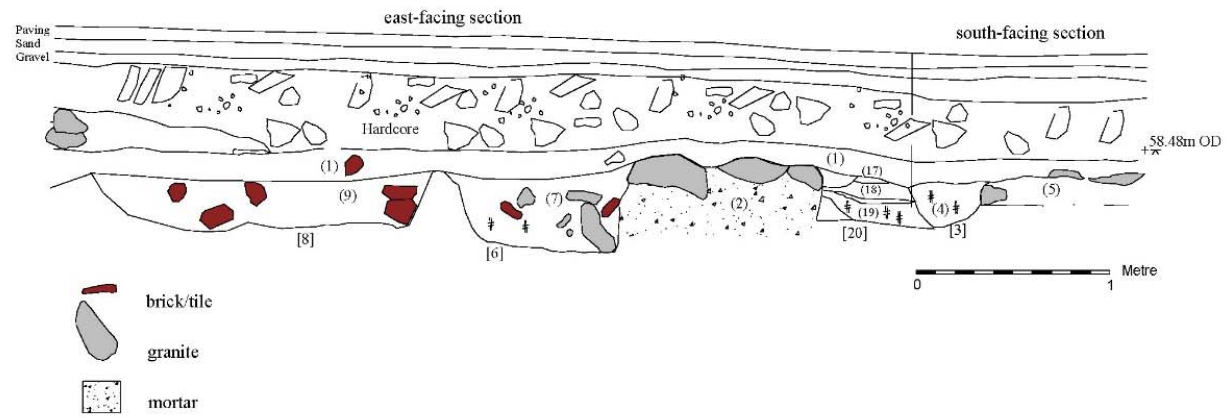
Figure 12: East and south facing sections at the north end of Trench 1

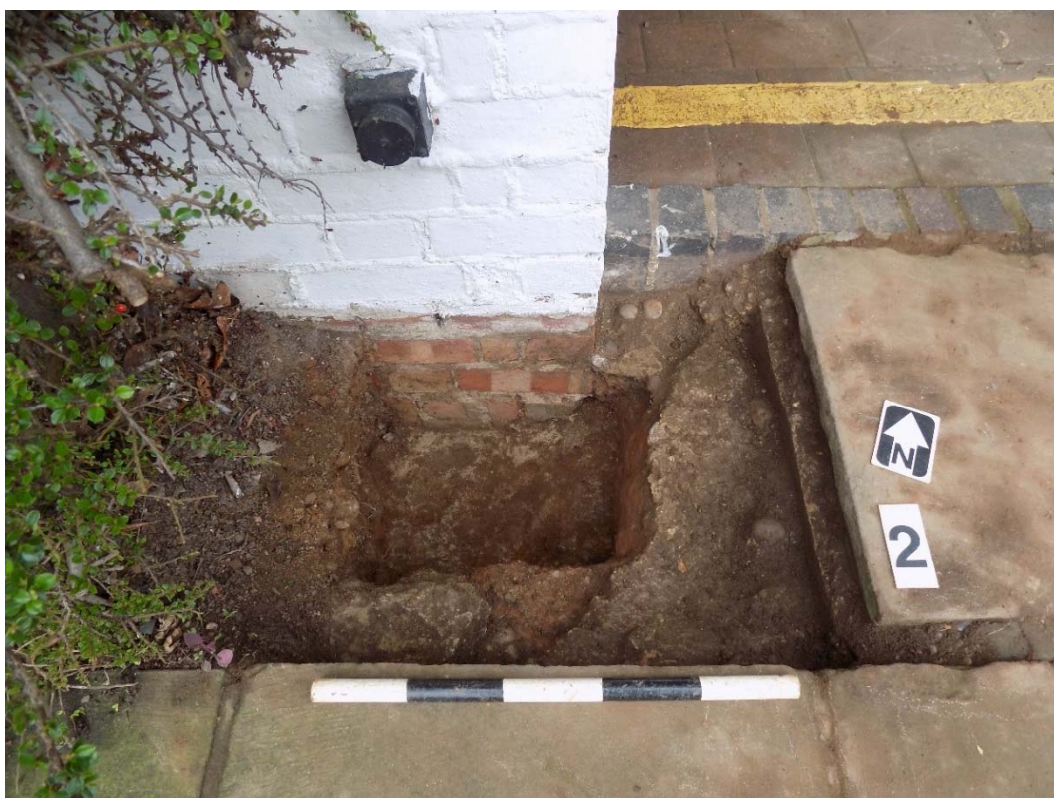
Trench 2 was a small trench excavated around the end of a northeast-southwest aligned modern brick wall. The trench was hand-excavated in the flower border between the paved path and the wall. Below the paving slab (0.07m thick) was a layer of concrete (0.07m thick), which overlay a thicker layer of red clay (23), possibly representing make-up. A single sherd of early Roman pottery was recovered from this layer. It lay above a bedding layer of sandy silt with frequent stones (24). The archaeological significance of this layer is unclear in such a small trench. Both the clay and the sand were cut by the construction trench for the brick wall.

Figure 13: Trench 2 following excavation (0.5m scale)

Trench 2 was a very small investigation hole, under a metre square, around the base of a modern brick wall. This encountered a clay deposit (23) and bedding layer of sand (24). It was unclear if these represented archaeological deposits associated with the bathhouse or levelling following the excavation of the site in the 1930s. The abortive Trench 5 was excavated very close to a previous archaeological intervention (Gnanaratnam 1999), which produced evidence for the northern wall of the baths, robbed out in the medieval period. The robber trench was itself cut by later pits. Roman activity included pits of 1st and 2nd century date, the earliest phase of road north of the baths and signs of industrial activity. Therefore, although it was not possible to excavate Trench 5 to the desired depth, it is entirely possible that pockets of archaeology survive in this area.

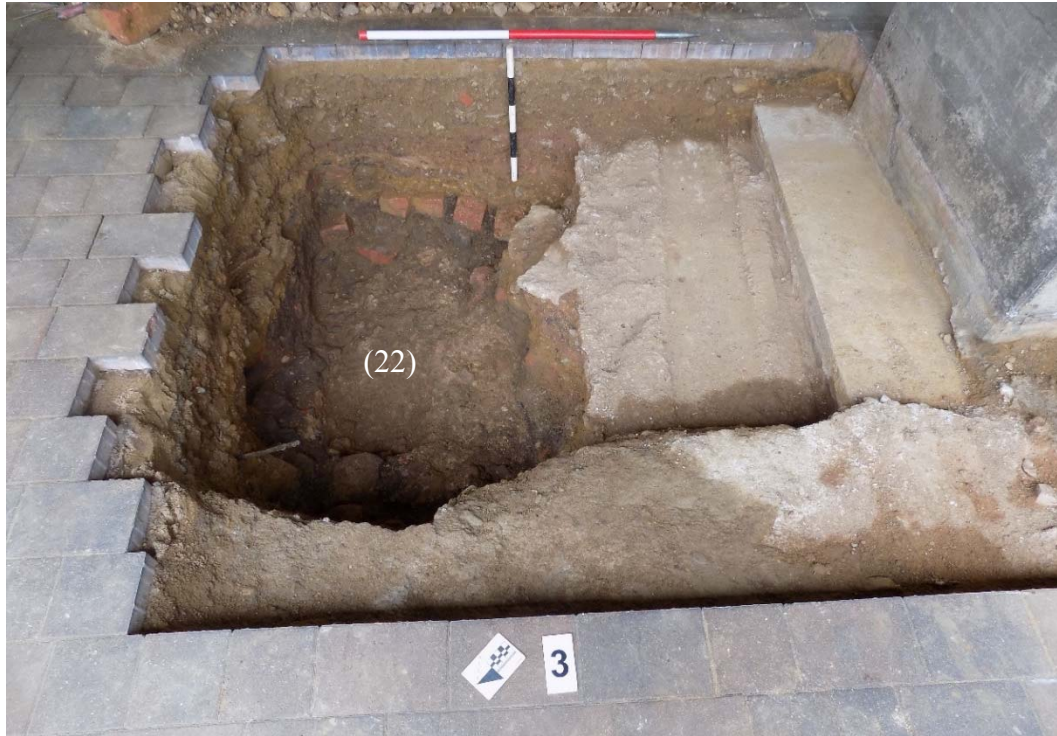
Trench 3 was located adjacent to a concrete stanchion close to the entrance to Vaughan College. The west and south-western parts of the trench were occupied by the modern concrete slab and foundation for the stanchion. It was possible to excavate deeper in the north-eastern part of the trench. The top layers, to a depth of 0.36m below the surface, consisted of modern paving blocks bedded in sand, overlying a thick layer of gravel and hardcore within a soil matrix. Below lay a layer of red clay containing rubble and gravel (0.10m thick), above compact yellow-brown sands and gravels. The lowest modern layer consisted of grey-brown sandy clay containing brick and concrete rubble (21), which may be associated with the demolition of the Victorian buildings, prior to the clearance of the site in the 1930s. The deposit also contained late 1st- to 2nd-century

pottery as well as a fragment of medieval Potters Marston. At the base of the trench, the top of a highly compact whitish-brown mortar deposit (22) was encountered at approximately 0.76m below ground level. It contained frequent pebbles and fragments of Roman box flue tile. Unfortunately, it was not possible to explore the nature or function of this deposit, too little was visible, within this small trench.

Figure 14: Trench 3 following excavation, showing compact mortar layer at the base of the trench

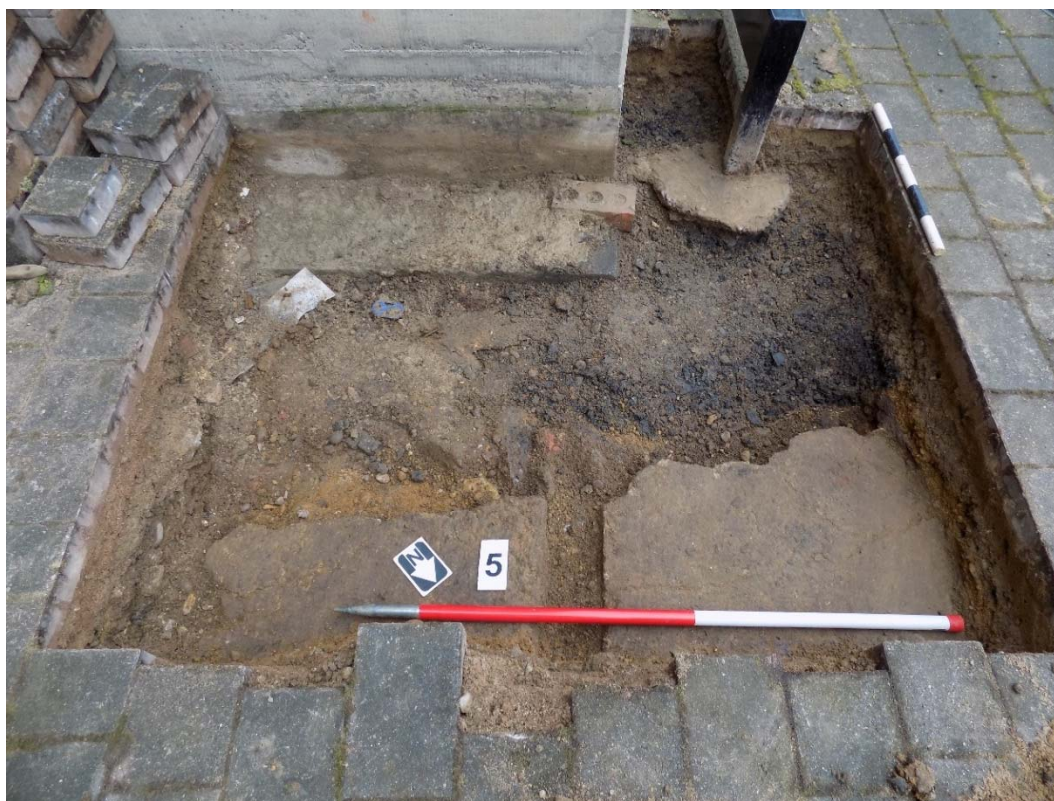
Trench 5 was positioned on the corner of Vaughan College. A series of make-up layers for the modern car park lay directly below the paved surface. The concrete foundation for Vaughan College extended 0.30m out from the building. A further raft of concrete was present at the northeast end of the trench. Between the two concrete areas was a gap filled with dark grey brown clayey sand with stone and brick rubble, with a cut visible in the section of the trench. A CAT scan over the area detected signals indicating a live cable. The trench was therefore not excavated further.

Figure 15: View of Trench 5 (1m scale)

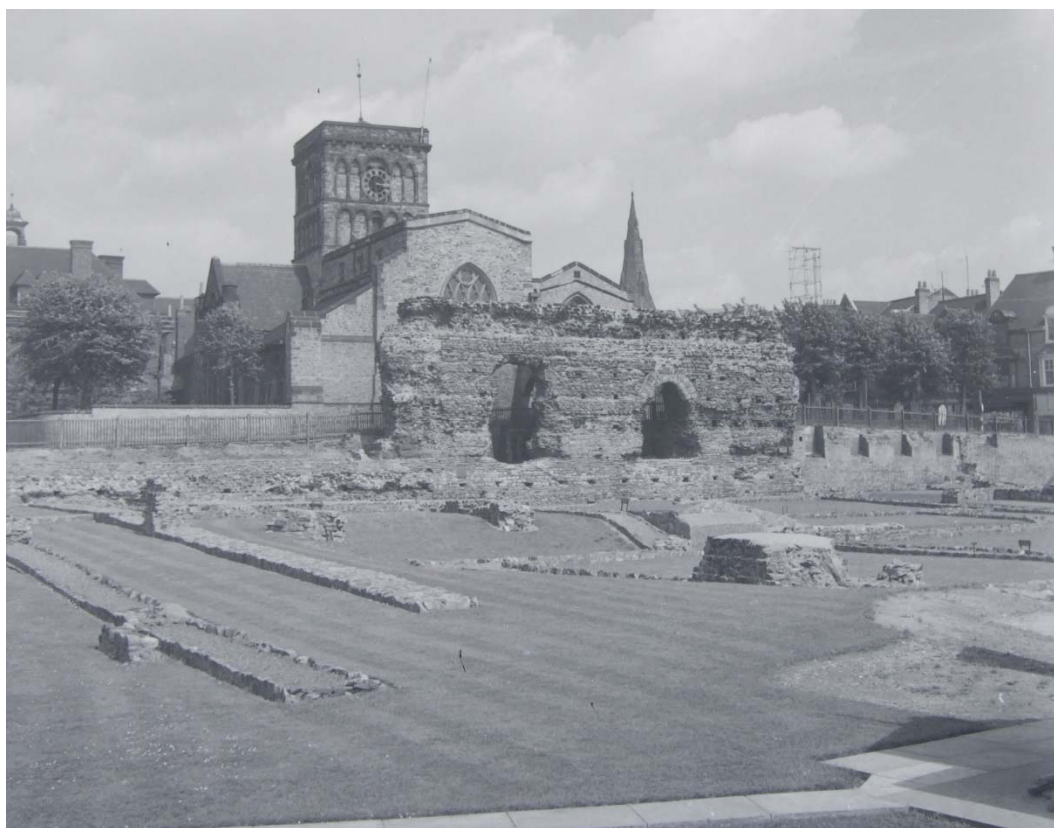
Figure 16: Archive photos of the Jewry Wall site, following consolidation and reconstruction. The portico walls beneath the current classroom can be seen on the left of the photograph

Photographs taken prior to the building of Vaughan College show the site with reconstructed wall lines and remaining superstructure. The remains of the two walls targeted by the investigation, with their fragments of upstanding foundations (Figure 16-Figure 18) are also visible. While several of the photographs suggest the area was relatively flat, they do however, show that the surviving masonry of the walls is at a higher level than the foundations of the adjacent semi-circular extension, which still exists, strongly suggesting that the area was levelled for the construction of the classroom and car park.
