**A Heritage Assessment of  
The Settling Rooms, Springfield Street,  
Market Harborough, Leicestershire**

**NGR: SP 73708 87075**

ULAS Report No. 2016-131  
©2016

**For: Market Harborough District Council**

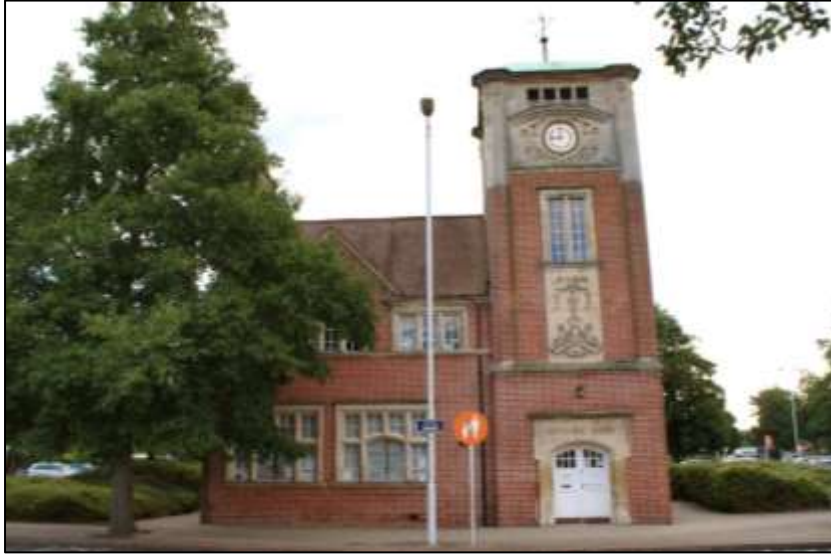
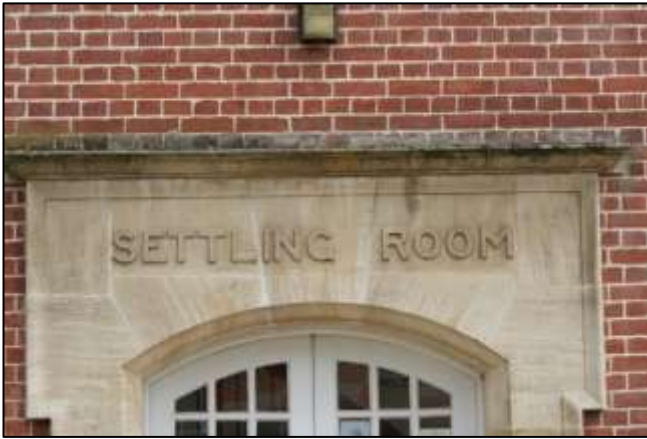
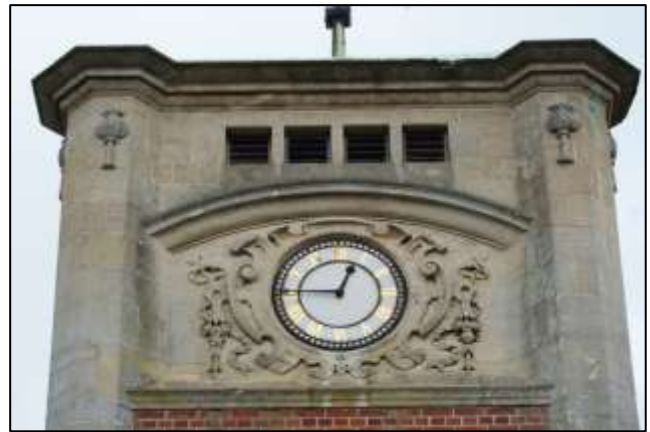
The principal elevation is the west facing elevation, with the clock tower to the south. The ground floor has an arched doorway with SETTLING ROOM in relief above. There is a stone string course between ground and second storey with waterleaf decoration. The 2<sup>nd</sup> stage of the tower has a large stone carving of the arms of the Earls of Harborough. The 3<sup>rd</sup> stage has a two light mullioned window and the 4<sup>th</sup> stage displays the clock, alike and visible on all four sides in ashlar with stone pineapples decorating the corners of the tower. The ogee copper roof carries a wind vane with spiked ball finial (Fig. 16).

Figure 16: Photograph showing the west facing elevation, looking east, and details of the clock tower.

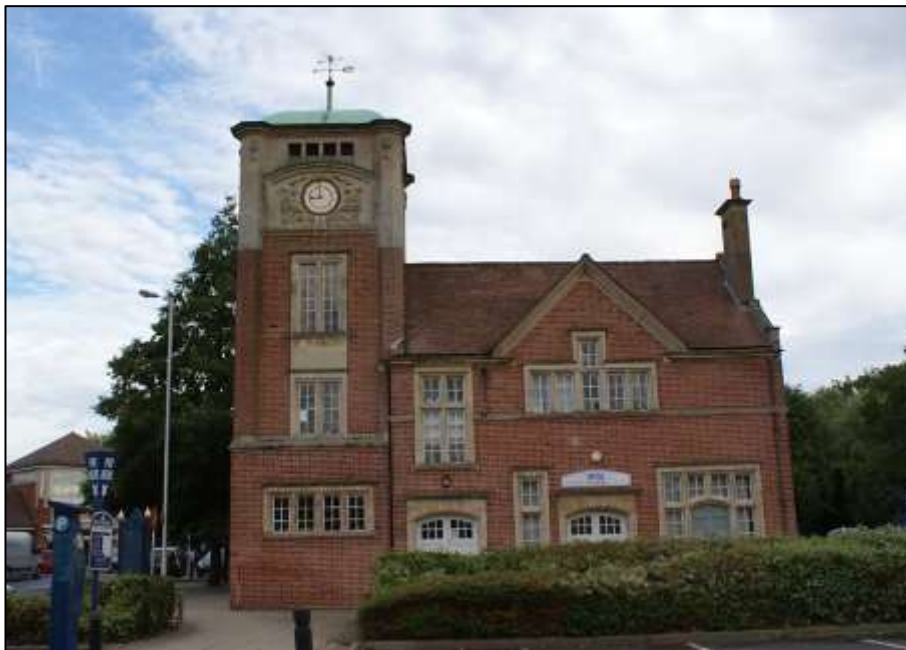
The south facing elevation has two arched doorways to the ground floor and three stone mullioned windows, one with arched transom. The first floor has moulded string course at cill level and three further windows, the one to the east extending into the gable pediment (Fig. 17).

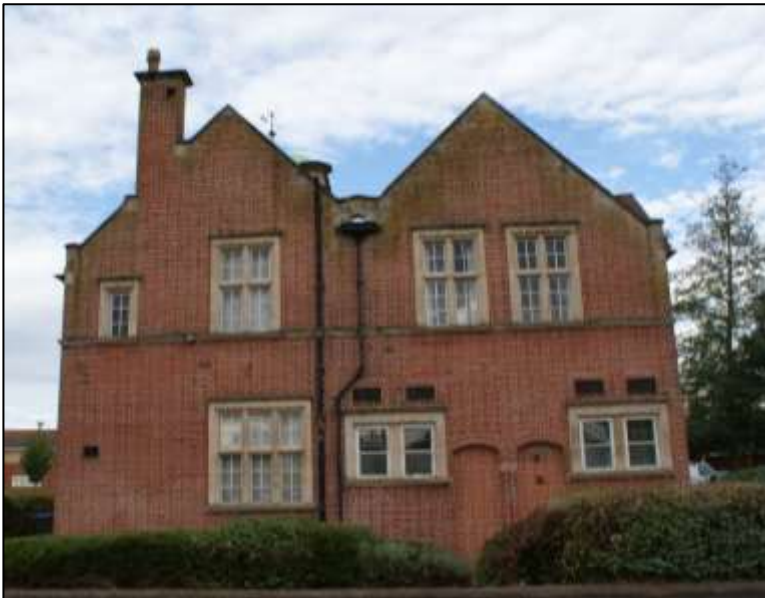
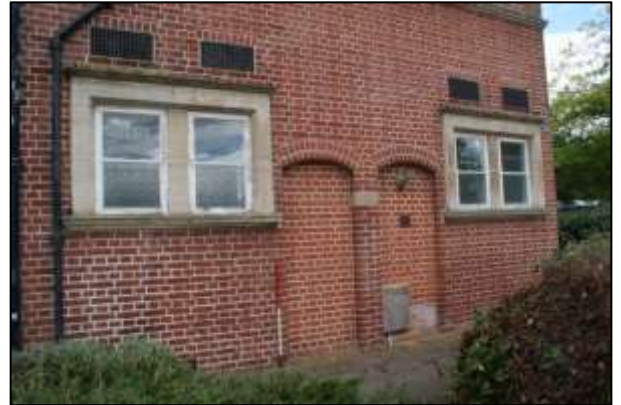
The east facing elevation shows stone mullioned windows to both floors and a gable end stack to the southern pile. Noticeable are the blocked doorways on the ground floor to the north and the newly decorated glass to the ground floor toilet windows (Fig. 18).

Figure 18: Photographs of the east facing elevation looking west with detail of the blocked doorways to the north

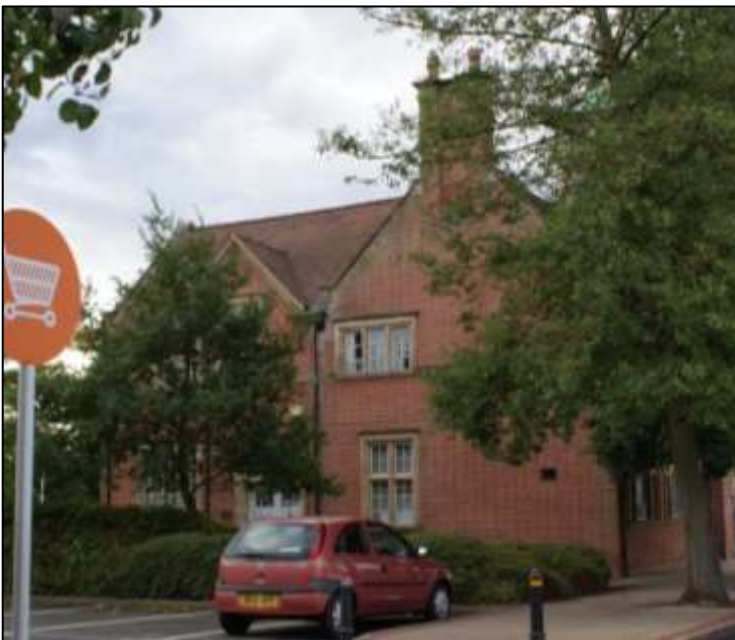
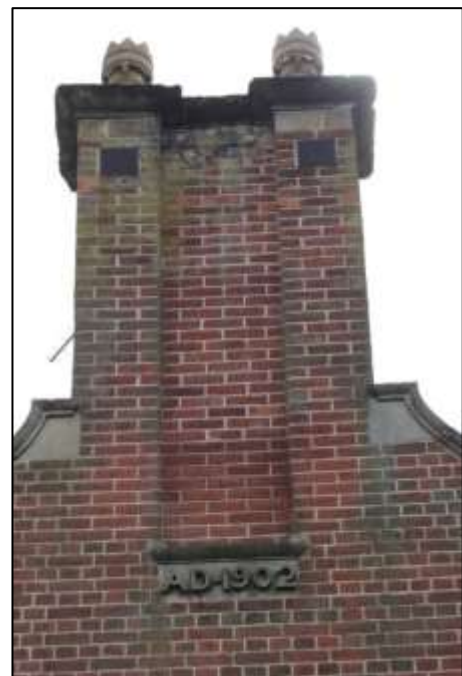
The north facing elevation has similar stone mullioned windows, an arched doorway and window extending into a gable pediment. The western range has a gable end stack with stone dated AD.1902 at the base of the stack (Fig. 19).

Figure 19: Photographs of the north facing elevation and datestone.

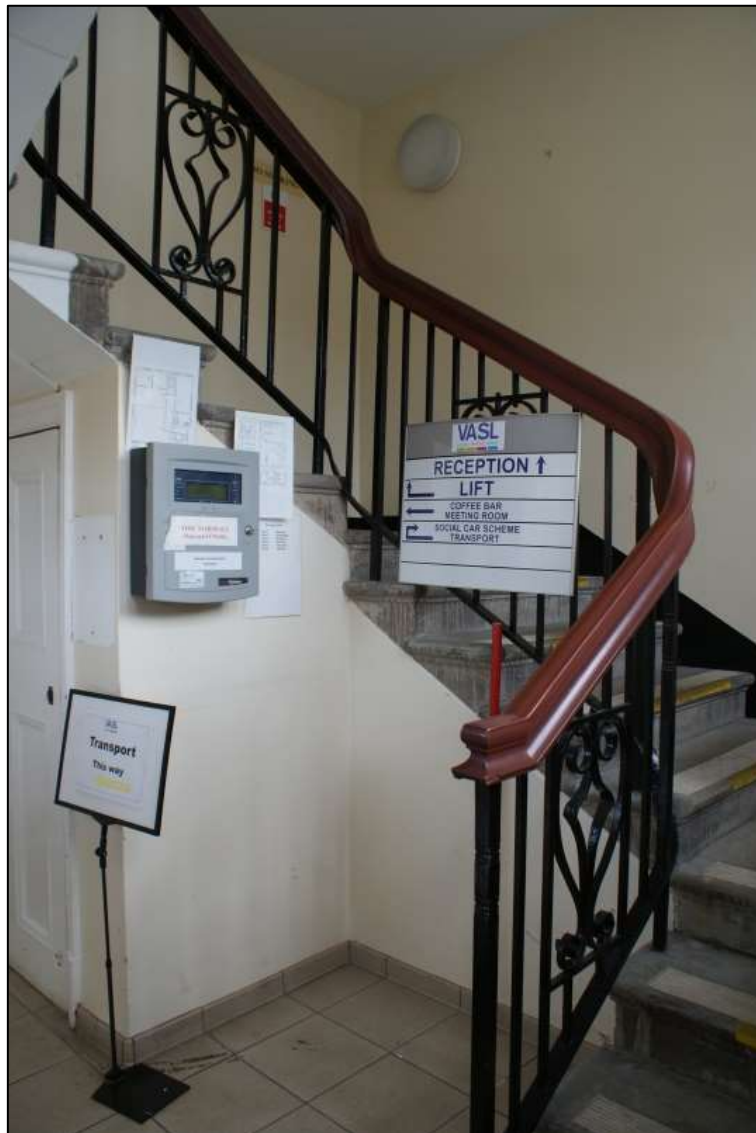
Recent plans, provided by the current tenants, show the current layout of the building and date to the last refurbishment in 2007 and these are shown in Fig. 21. The main entrance is through a double door at the base of the tower on west side into a hall and stairwell. This space is dominated by a staircase of five flights with wrought iron balusters, integral motifs and a wooden rail (Fig. 20).

Figure 20: The entrance and stairwell with wrought iron balusters.

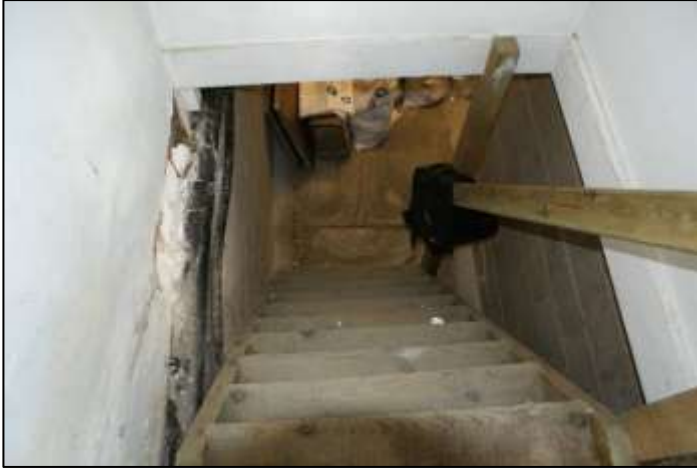
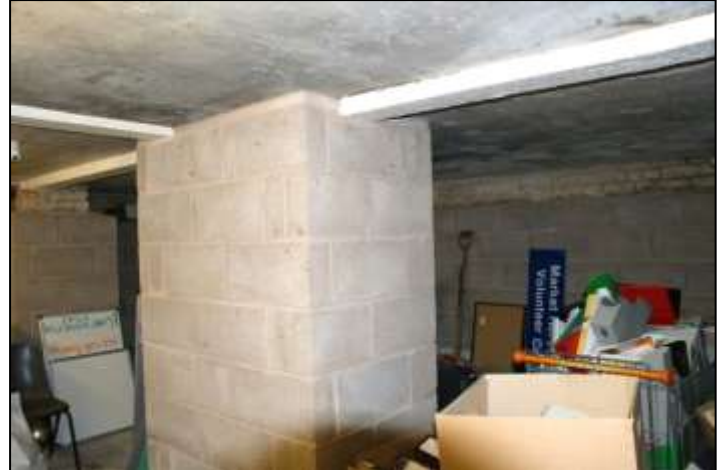
There is an entrance door to the cellar beneath the stairs, although this no longer provides access having been blocked at some point. The cellar is now accessed through what was the bell tower stairwell. The cellar is not large for a building of this size bearing in mind the past need for the storage of coal and beer. The cellar has recently been lined with breeze block and it is possible that there may be internal walls reducing the visible size (Fig. 22).

Figure 22: The bell tower entrance to the cellar and cellar detail

The interior has seen more alteration with changes of use over time. The points of access to the cellar and the bell tower have altered and the accessible cellar space may have been altered. The access and configuration of the toilets has changed. Wall partitions have been added and removed on both floors to allow for a change of function and a lift has been inserted for access purposes and modern kitchen facilities added.

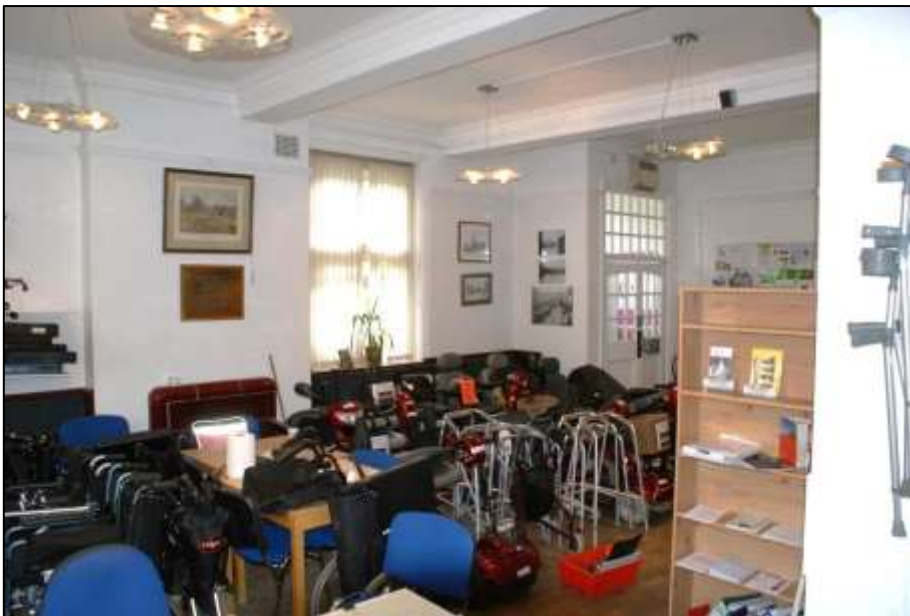
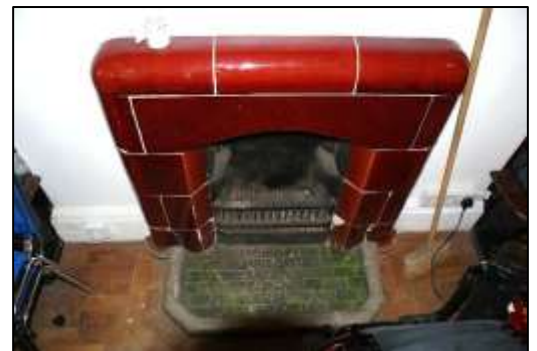
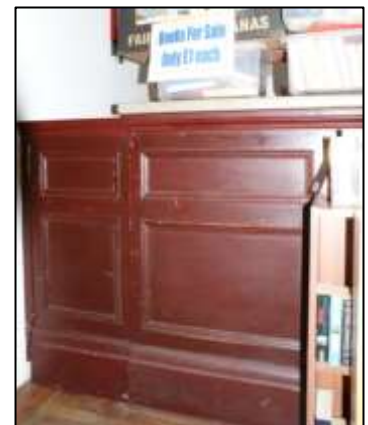
On the ground floor, the original ‘first class’ bar remains an open area of similar dimensions, but is now used for the storage of mobility scooters and other shopmobility aids, which masks many of the features. Visible, however, are the original fireplace, the mahogany bar and the peripheral seating (Fig 23).

Figure 23: The layout of the coffee bar looking north east, with details of fixtures and fittings.

Original features where they survive should be incorporated into the new proposal. Particularly worthy of retention are the fireplaces, the mahogany bar, the wood block flooring and the window fittings. Access to the clock tower should be maintained as regular adjustment of the clock is required. The clock tower is a recognized landmark and the clock relied upon by the inhabitants of the town.

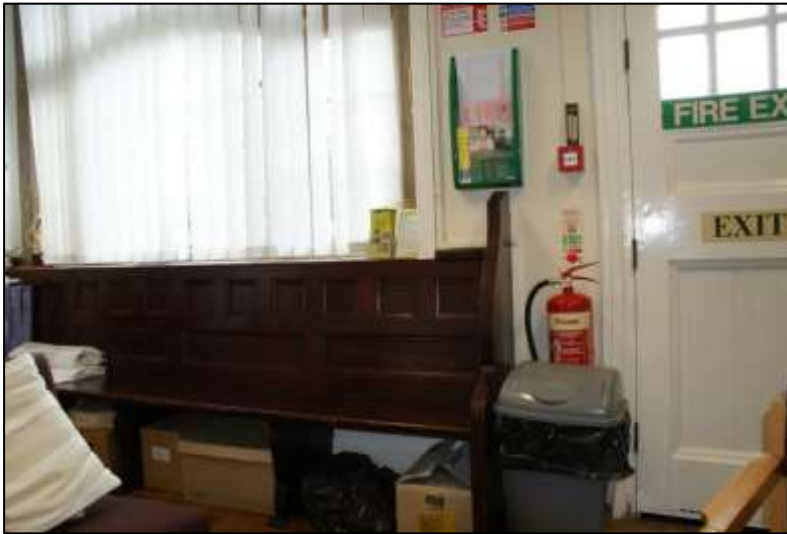
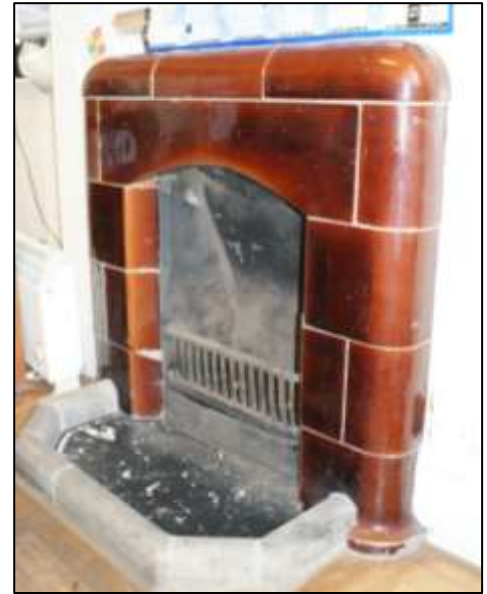
The 'second class' bar area is now an office space, slightly open plan with original fireplace and peripheral seating (Fig. 24). The lift occupies a portion of this open space.

Figure 24: Features of the second class bar area

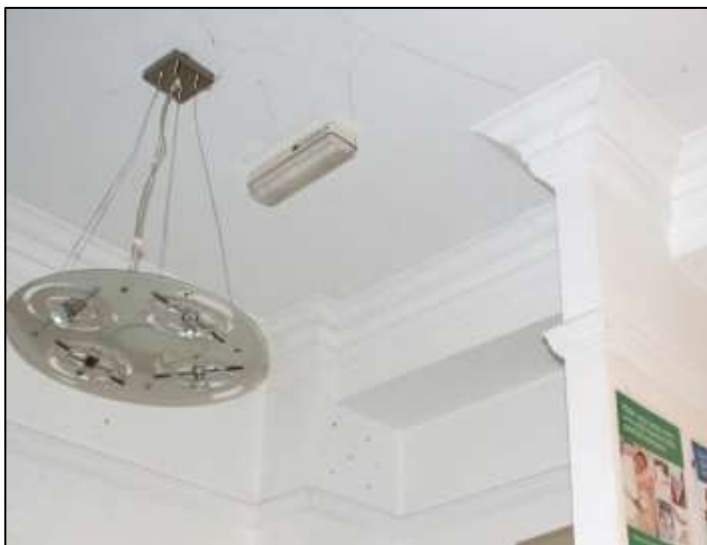
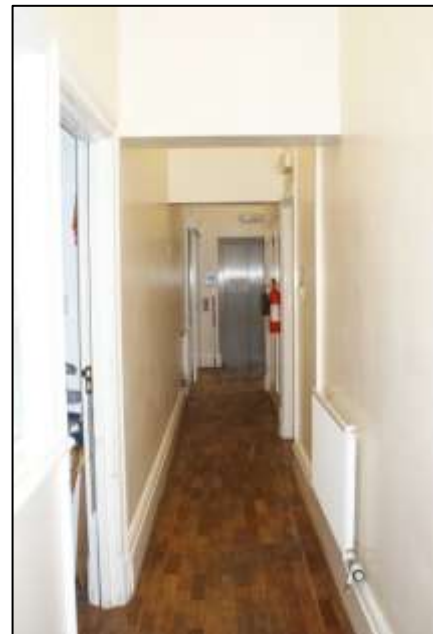
There are now three toilets with tiled floors, the layout as per the recent plan. This area has possibly been refurbished several times. The bars and corridors have wooden block floors which may be the original blocks mentioned in the contract. There are high skirting boards throughout and the bar areas have picture rails and moulded cornices. (Fig. 25)

Figure 25: Detail from the bar area ceiling and the wood block corridor with lift, looking east.

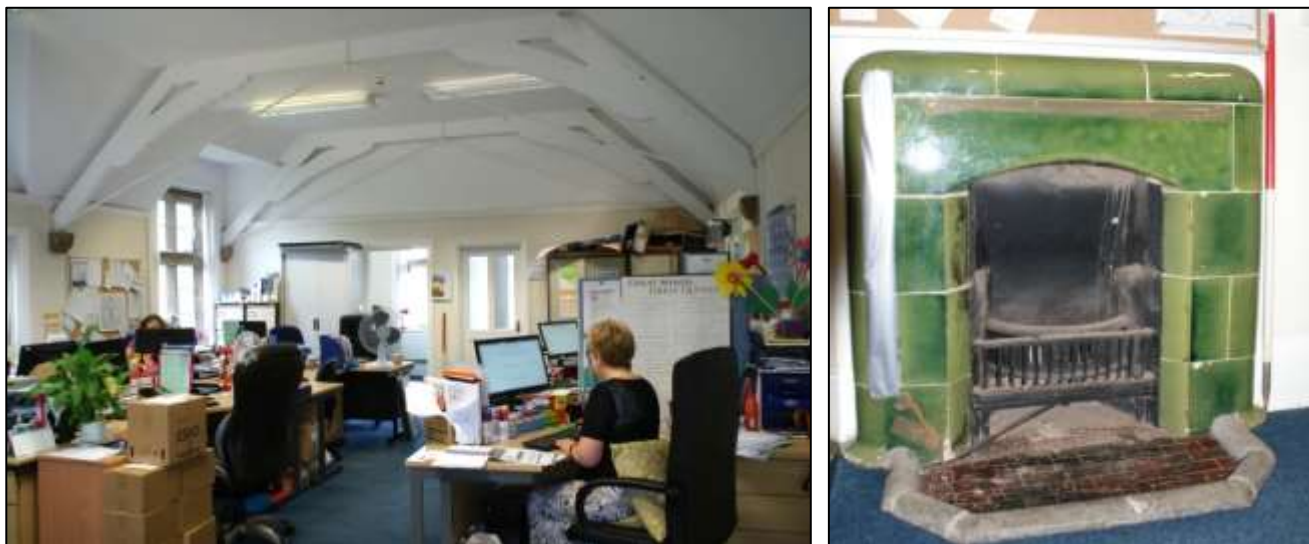
The wrought iron tower staircase is the only access route to the first floor and leads to a carpeted corridor which mirrors that of the ground floor. The room over the first class bar or what was the original settling and dining room is now an open plan office space. There are two further offices at the east end of the room. Features of the room include braced roof beams resting on stone corbels and supported by metal ties. These beams are illustrated in Herbert Coales original drawings in Appendix B. Also an original fireplace can be found on the north wall (Fig. 26).

Figure 26: The Settling Room as office space with beams to the east end and original fireplace.

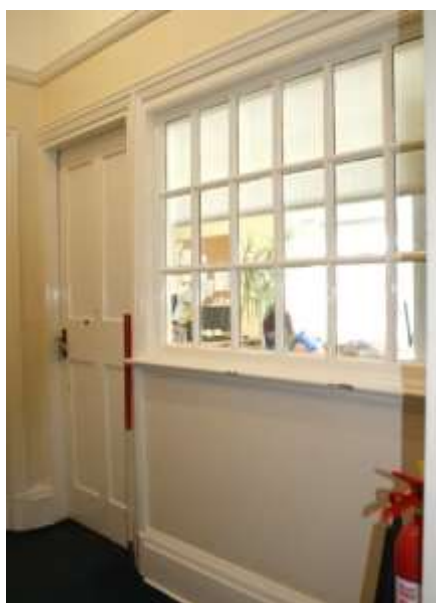
The area that was originally a kitchen, larder and scullery is now an office space. This is now enclosed by a glass partition similar to one on the ground floor between the corridor and the coffee bar. It is likely that these relate to the refurbishment of 1983 (Fig. 27), although possibly re-using original doors. There are no indications of a fireplace, if this existed, as was suggested on the earlier plans. Interestingly there is also no evidence of a corresponding chimney stack.

Figure 27: Partition to the office space that once housed the kitchen

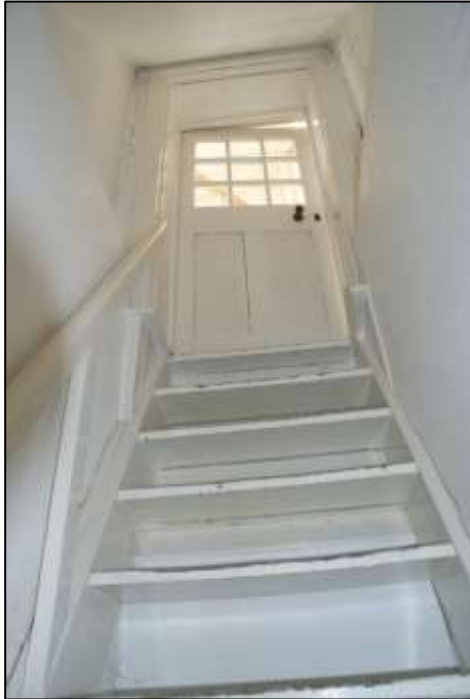
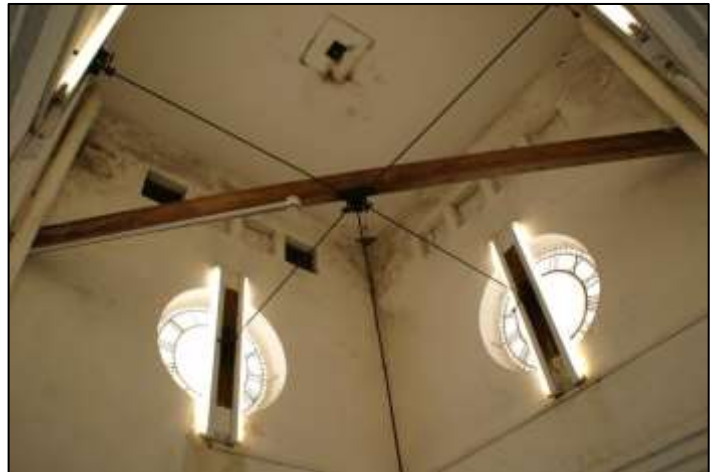
The modern kitchen occupies the space that once housed the stairs to the bell tower and if the plans of 1953 are accepted, also a bathroom. It appears that the request to replace the upper bell tower stairs with an iron ladder was not carried out as steps still rise from the modern kitchen. The original four faced electric clock manufactured by Gillett and Johnson still functions and is checked and adjusted regularly (Fig. 28).

Figure 28: The bell tower steps and clock faces

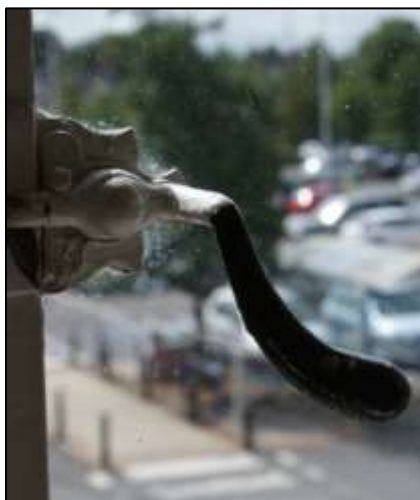
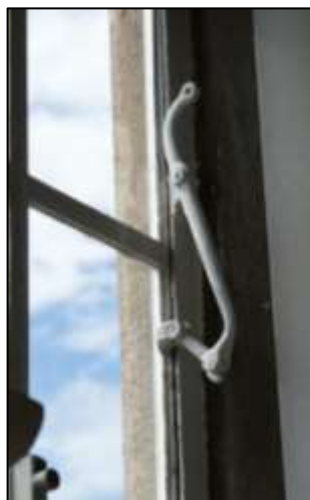
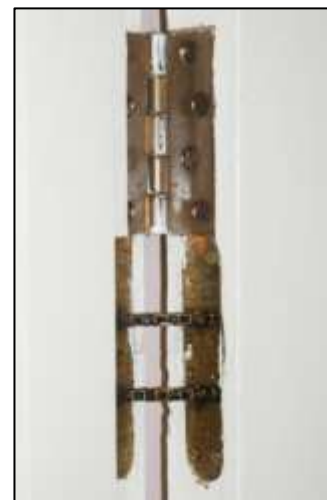
There are some final observations concerning fixtures and fittings. The stone mullioned windows, with iron frames, still possess the original catches and the description of door panelling by Coales matches some of the existing doors. Whilst some may have been copied, others retain original fittings such as the Perkomatic door closer to the kitchen door (Fig. 29).

Figure 29: Window fittings to the stone mullioned windows and an example of door furniture.
