**Archaeological Investigations
during Restoration Work at
Oakham Castle,
Oakham,
Rutland
(SK 86101 08904)**

ULAS Report No 2016-105
©2017

for
**Rutland County Council
Planning application Ref: 2014/0395/LBA**

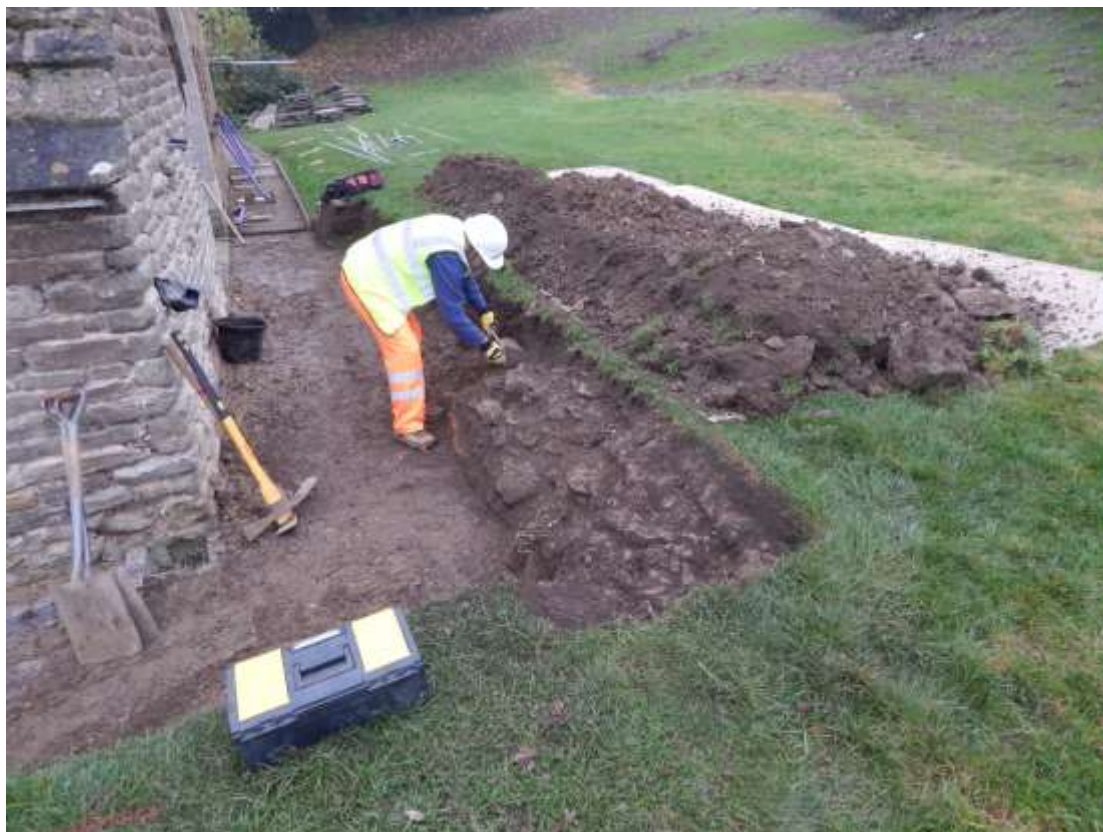
Plate 1: Work in progress on Test Pit 4, where path turns to the east, looking south-west

A total of 10 test slots of varying sizes were archaeologically excavated around and through the edges and bank around the path (Plate 1). Some were excavated to the full 1.8m mark width of the path (Test Pits 1,2,4,5 & 6) and others were excavated to the 1.2m mark (Test Pits 7-9). Test Pits 3 and 10 were excavated across the base of the path itself.

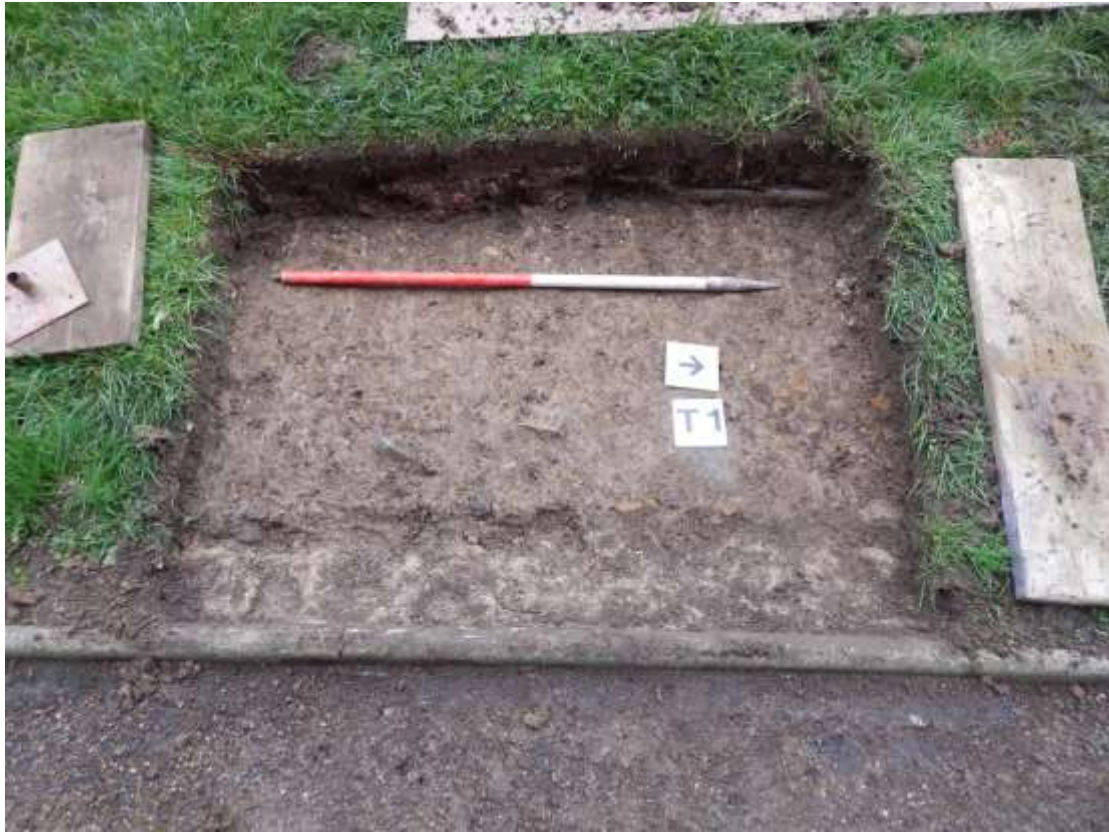
Plate 2: Test Pit 1, post excavation, looking west

This was excavated on the western side of the hall into the shallow bank here where the bank next to the path was low and had no revetment. It measured 1.2m by 0.9m by 0.20m, although it was later deepened along the northern edge to provide a section across to the path (Plate 2). The section revealed 0.10m of turfed topsoil over 0.10m of yellowish-grey subsoil, with inclusions of ceramic building material (CBM), mortar and small stones throughout. At the east edge of the test pit was around 0.16m of concrete and a narrow concrete edging strip (Figure 5).

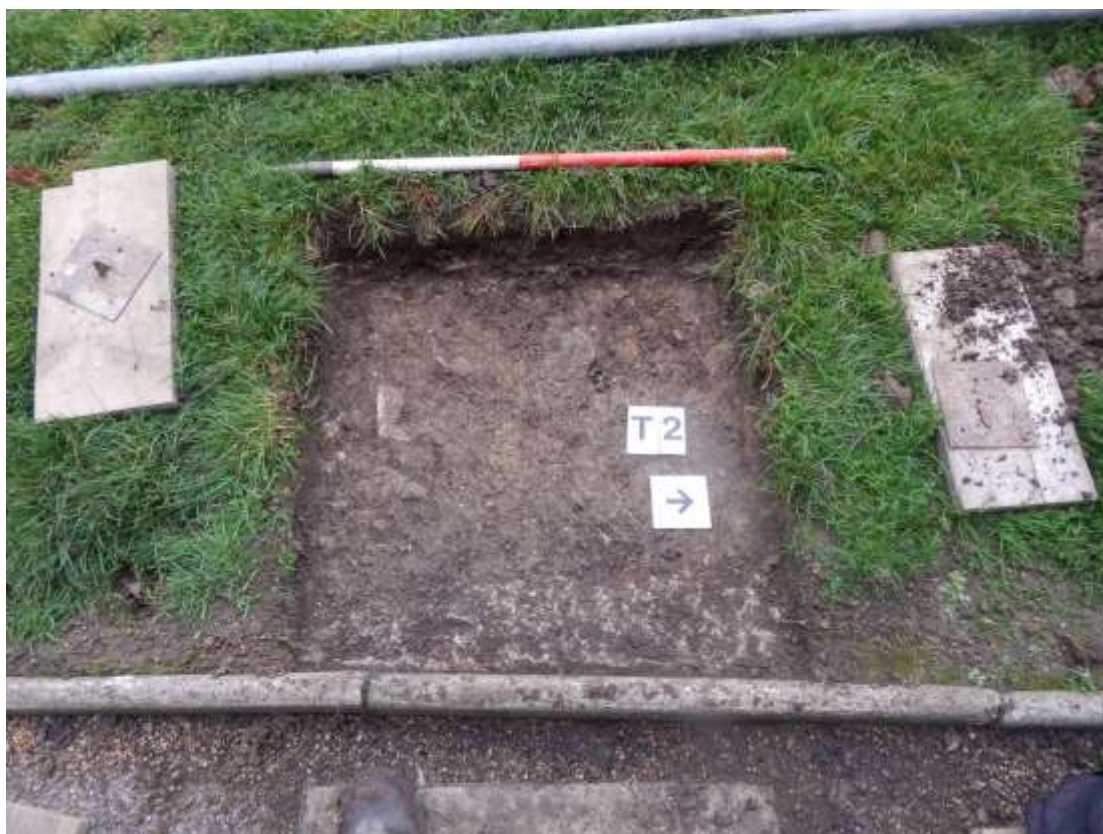
Plate 3: Test Pit 2, post excavation, looking west

This was also excavated on the western side of the hall into the shallow bank, to the south of Test Pit 1 and the sequence was very similar (Plate 3). The pit measured 0.8m by 0.83m and was 0.30m deep. The section revealed 0.17m of dark-brown topsoil over 0.13m of yellow-brown silty clay subsoil. The concrete and path edging seen in Test Pit 1 was also present here. Both soil deposits contained ironstone fragments and CBM.

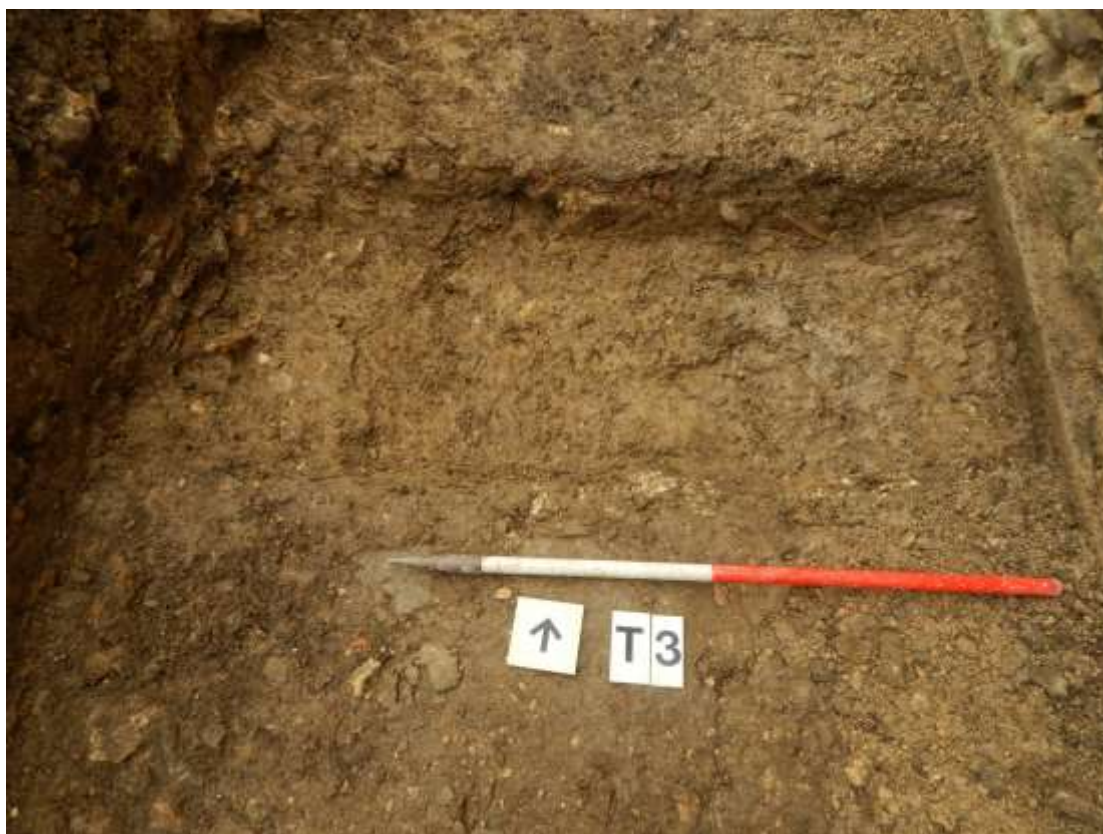
Plate 4: Test Pit 3, post excavation, looking north

This was a narrow section placed across the path itself from Test Pit 4 (see below) to the hall outbuildings' west wall. It measured 1.60m by 0.70m and was 0.17m deep, oriented east to west. The section revealed 0.10m of mortar, hardcore and CBM over 0.07m of yellowish-brown clay and limestone, with mortar and limestone flecks. The section against the west wall of the outbuilding revealed that the building here sat on a slab with no foundations (Plate 4). The test pit quickly filled with water due to a leaking pipe and was abandoned.

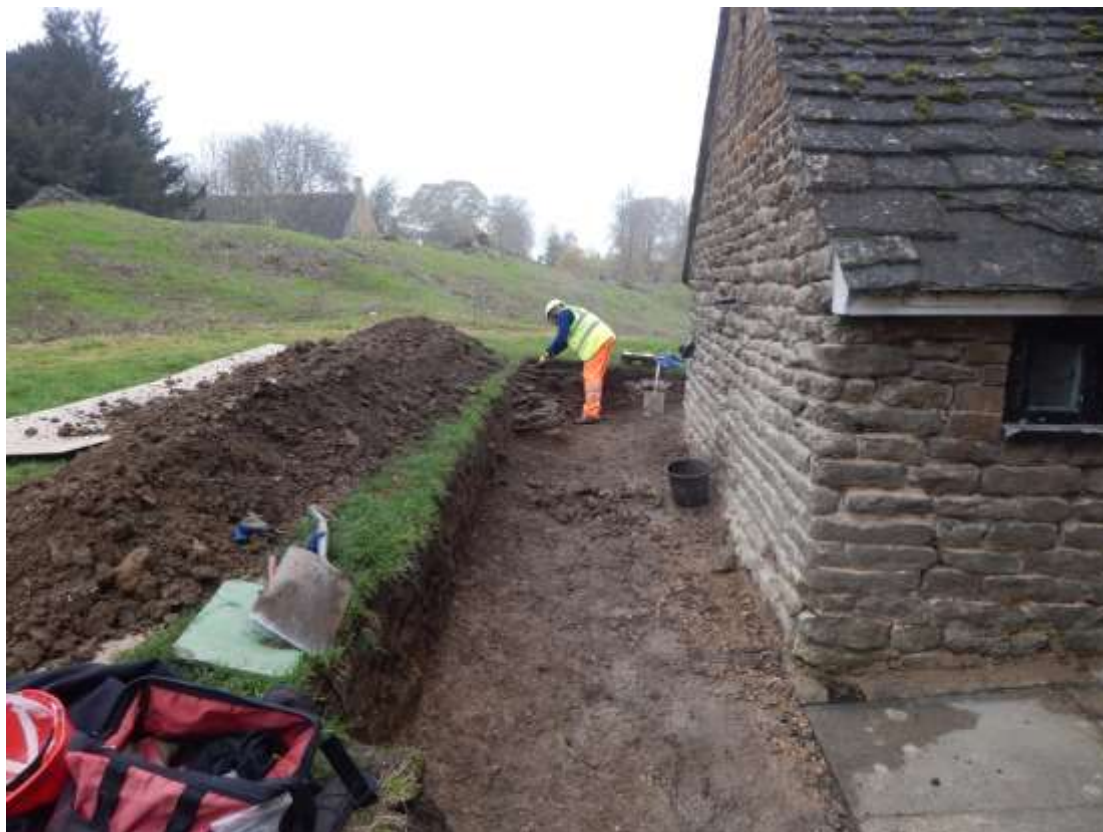
Plate 5: Work in progress on Test Pit 4- long section, looking north

Although numbered as a test pit, this was a long section of the bank, which was dug back to the full 1.8m extent of the proposed path close to the Time Team Trench 3 to see if the archaeology continued across the path from Trench 3 to the hall (Plate 5). This was 7.30m long, 0.45m wide (1.37m at north end) and between 0.55m and 0.70m wide.

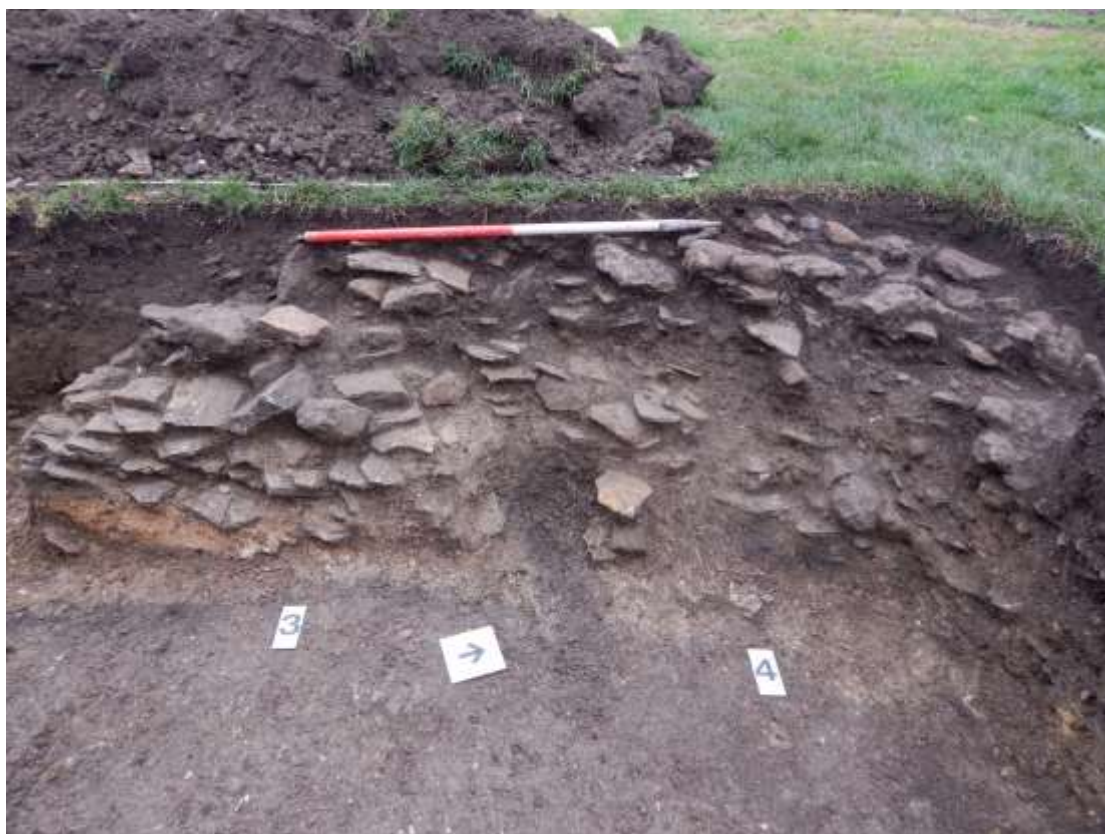
Plate 6: Masonry of (03) and (04) exposed in Test Pit 4, looking west.
Post-hole/ slot [09] in centre of picture

There was a clay matrix between the masonry of (03) and (04). This was a mid yellowish-brown clay (05), with flecks of mortar, and sherds of 15th-17th century pottery. Under the masonry/ collapse (04) was a layer of mid greyish-brown silty clay (06), which a variety of medieval pottery, including several sherds of 15th-17th century pottery, plus modern earthenware (Figure 6: Plate 6).

Cut into the masonry of (03) and (04) was a possible post-hole or beam slot that had been truncated along the eastern edge by the path [09]. The feature was 0.30m in diameter and 0.35m wide, with a fill (10) of mid greyish-brown clayey silt.

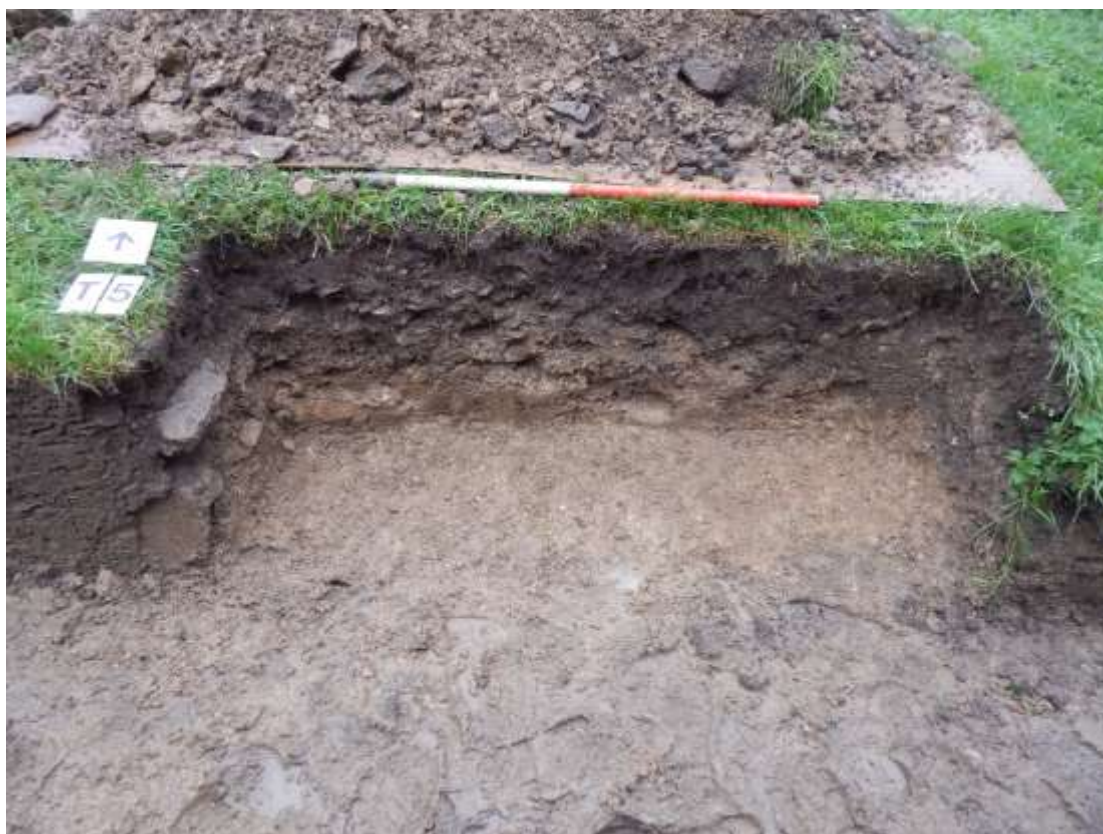
Plate 7: Test Pit 5, post excavation, looking north

This pit section was excavated into the bank around the access path at one of its wider points as it turns to the east. It was 1.60m long and only 0.44m wide as the path is quite wide here. Behind the removed slabs there were several chunks of concrete that were removed to expose 0.20m of topsoil (01) over 0.26m-0.30m of subsoil, containing a large amount of crushed limestone, particularly in the north-east corner of the section (Plate 7).

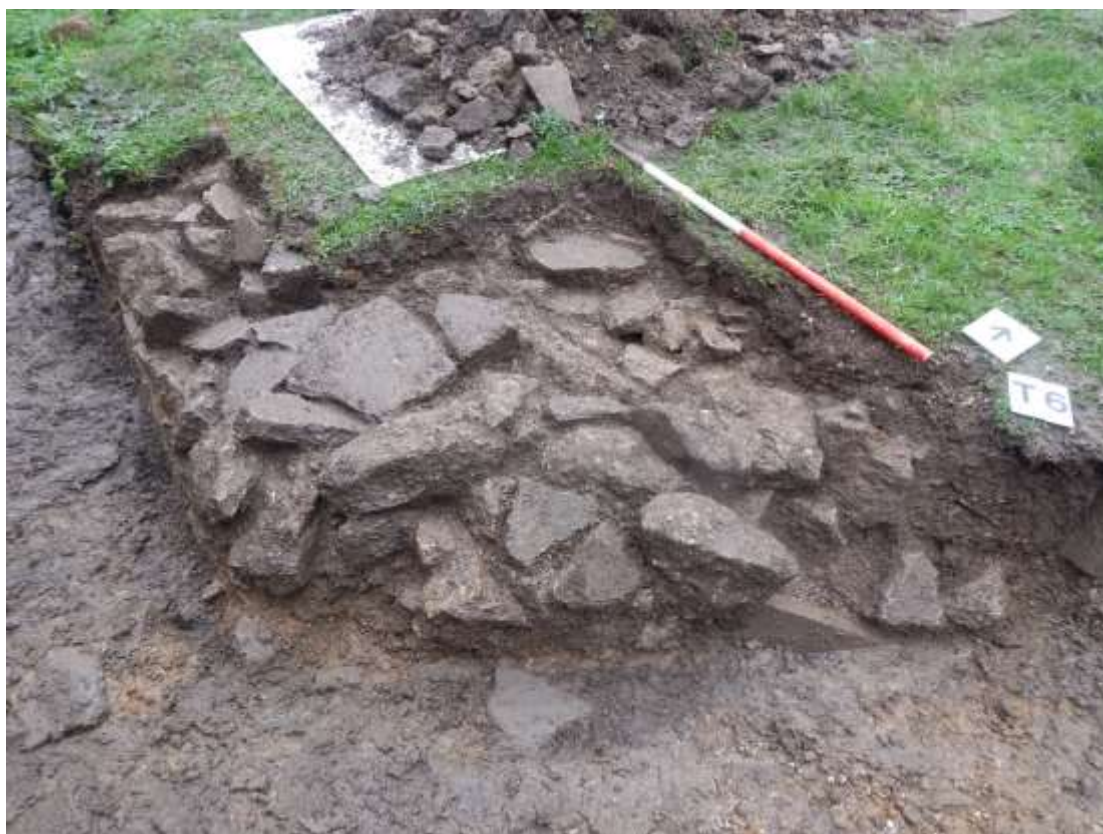
Plate 8: Test Pit 6, post excavation, looking north-west

This was excavated to the full 1.8m extent of the proposed path and therefore was 1.15m wide across the northern edge and 0.4m wide across the western edge. The full length was around 1.85m and the test pit was between 0.45m and 0.55m deep. The topsoil was very shallow under the turf. Under the thin topsoil were a series of stepped concrete pieces of average size 0.25m by 0.15m by 0.06m, and there was a lot of modern material between the pieces, such as plastic and sweet wrappers etc. The concrete pieces were sat on a silty clay subsoil with limestone and ironstone fragments, plus crushed limestone (Plate 8).

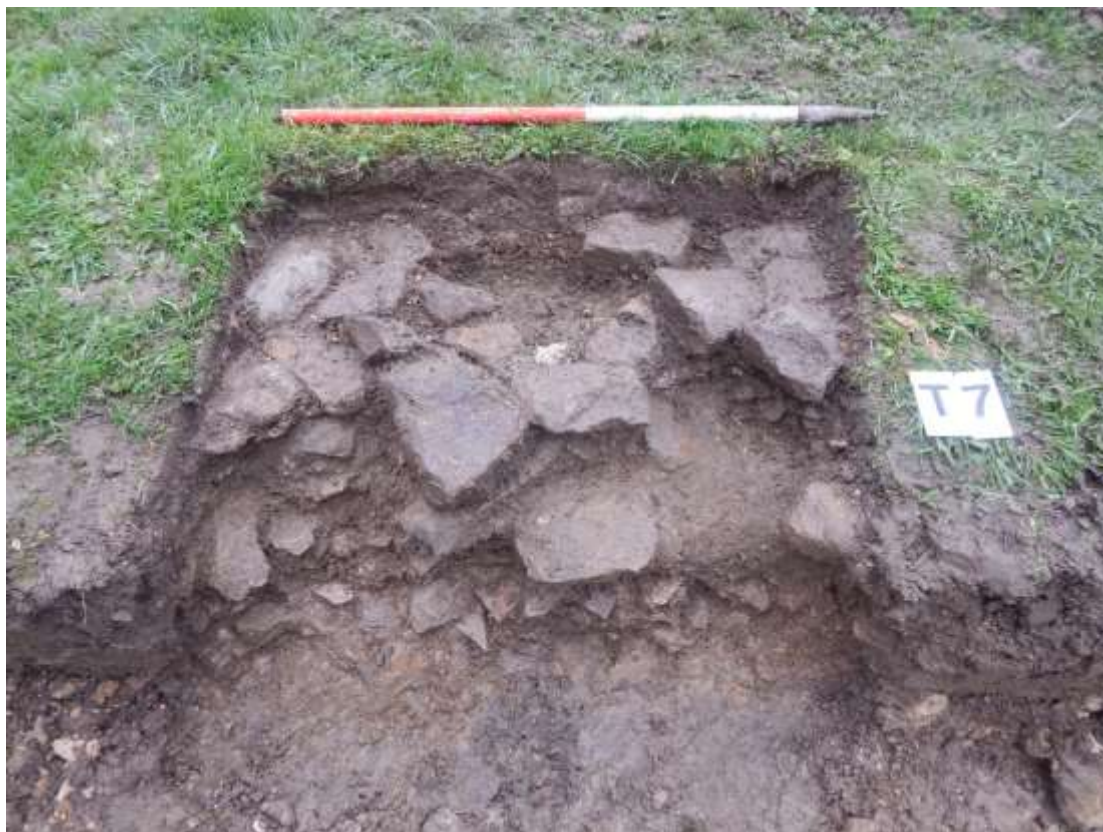
Plate 9: Test Pit 7, post excavation, looking west

Test Pit 7 was excavated into the bank, opposite the remains of the old boiler room, where the new toilet block was to be constructed. The pit was excavated 0.69m into the bank and it was 0.90m long and 0.48m deep. The pit was only excavated to the 1.2m mark for the proposed building. Under a thin turf and topsoil layer there was a similar tumble of material, but this was mainly ironstone and limestone and some pieces of plaster, with silty clay and crushed limestone as a matrix between the stone (Plate 9).

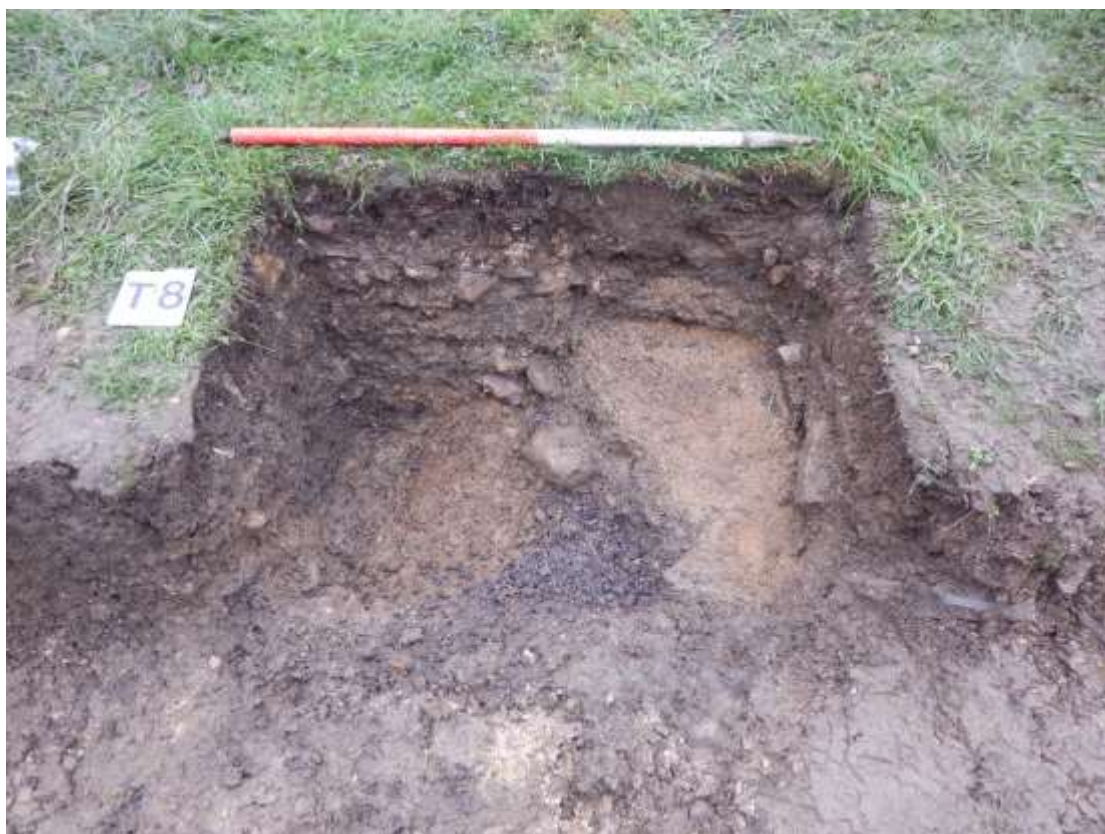
Plate 10: Test Pit 8, post excavation, looking west

This test pit was placed just north of Test Pit 7; into the bank opposite the old boiler house. It was 1m long, 0.60m wide and between 0.38m and 0.60m deep. Much of the area was disturbed ground and the pit contained the cuts for two modern services. The thin topsoil was very mixed loamy soil, with CBM and charcoal/ cinders, possibly the remains of fuel from the nearby boiler house. There was some subsoil at the base of the pit, which was similar to (02), with a lot of ironstone fragments. The rest of the pit showed modern backfill (Plate 10).

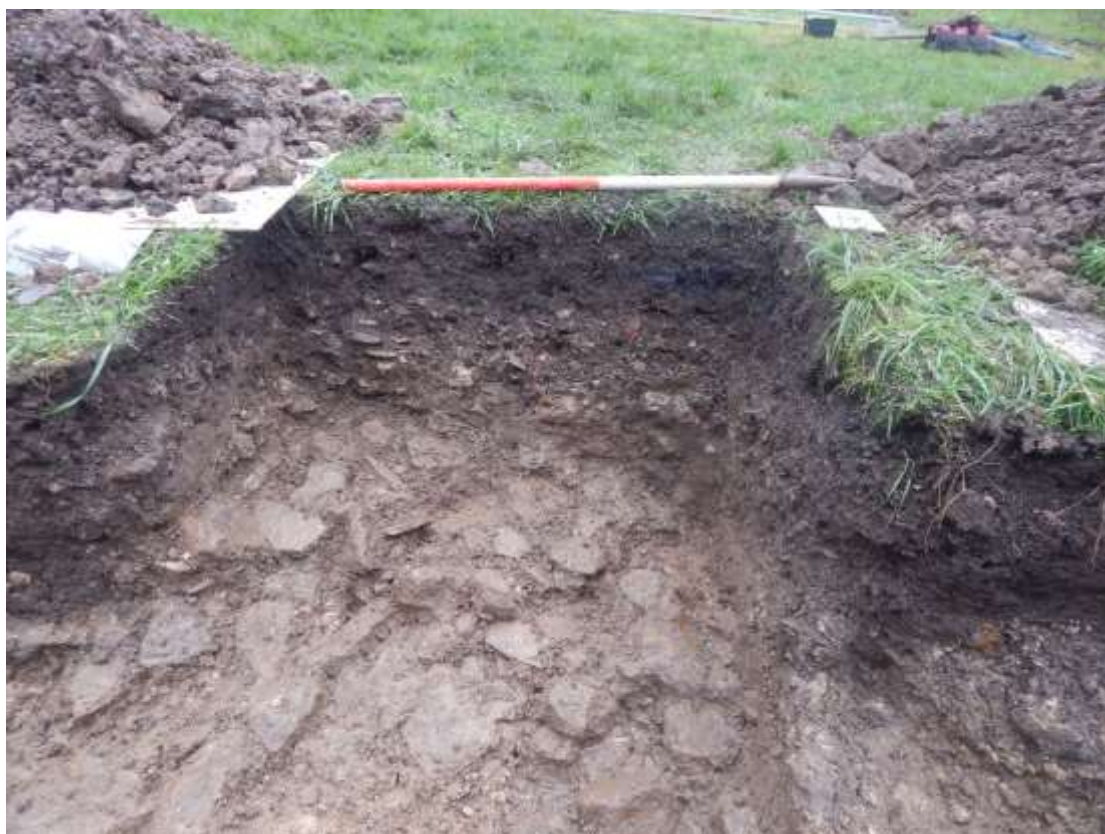
Plate 11: Test Pit 9, post excavation, looking west

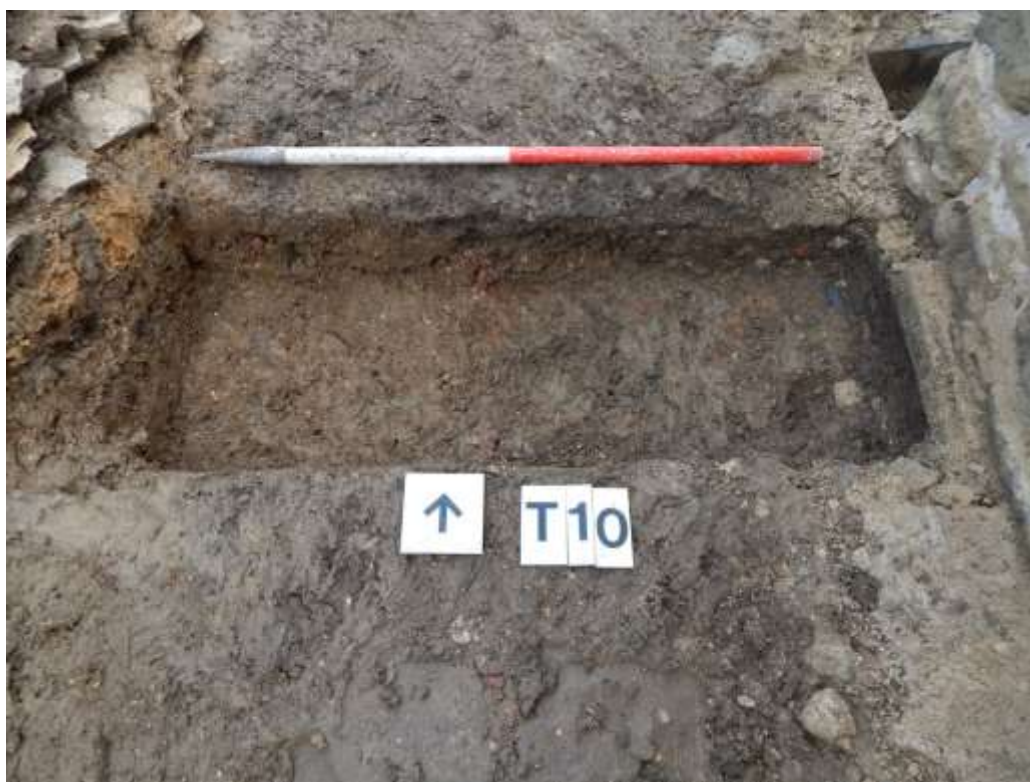
Plate 12: Test Pit 10, post excavation, looking north

This pit was placed across the path itself, close to where Test Pit 3 was excavated, in order to provide a complete section across from Test Pit 4 section to the wall of the out building of the Great Hall. It was 1m wide (most of the width of the current path), 0.40m long and 0.18m deep.

The sequence shown consisted of a mid orange brown clay and crushed limestone 0(8) with ironstone pieces, measuring 0.59m in length by a maximum depth visible of 0.08m. This overlay a dark yellowish-grey silty clay (14), with CBM, mortar and small stones.

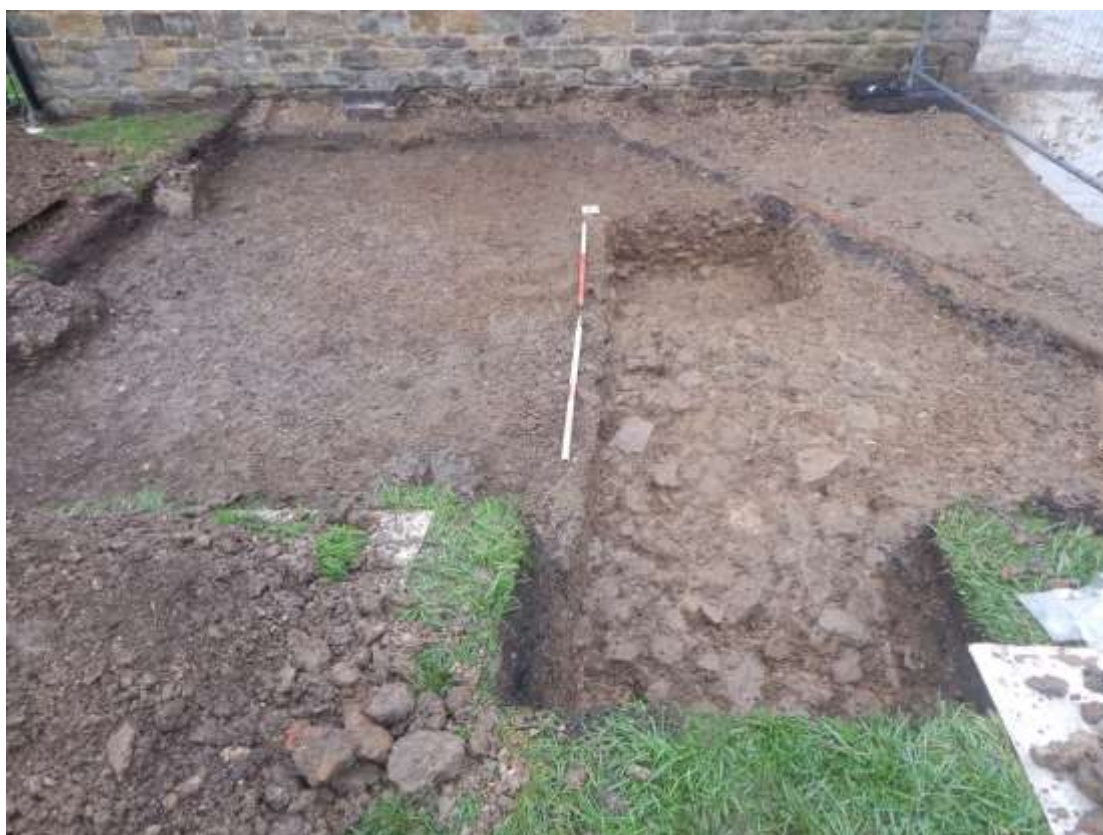
Plate 13: Footprint of new build, partially stripped, with part of made-up ground (11) removed and Test Pit 9a excavated

The made-up ground or levelling layer (11) overlay much of the exposed area. This overlay a similar layer (12) of mid yellowish-brown silty clay, which was slightly cleaner material than (11), with few inclusions apart from gravel and charcoal flecks. Under (12) was a layer of demolition debris, largely consisting of limestone and ironstone rubble and silty clay (13) (Plate 13).

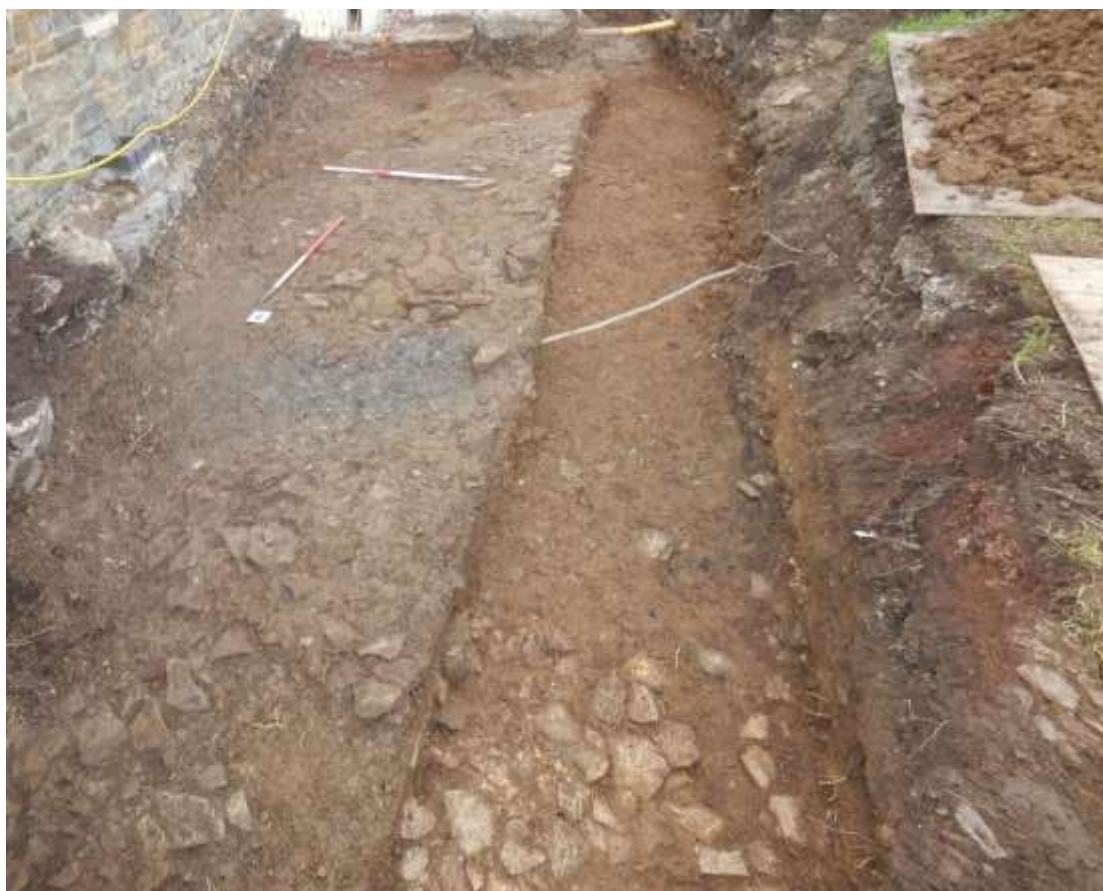
Plate 14: The evaluation trench, from the north, looking south

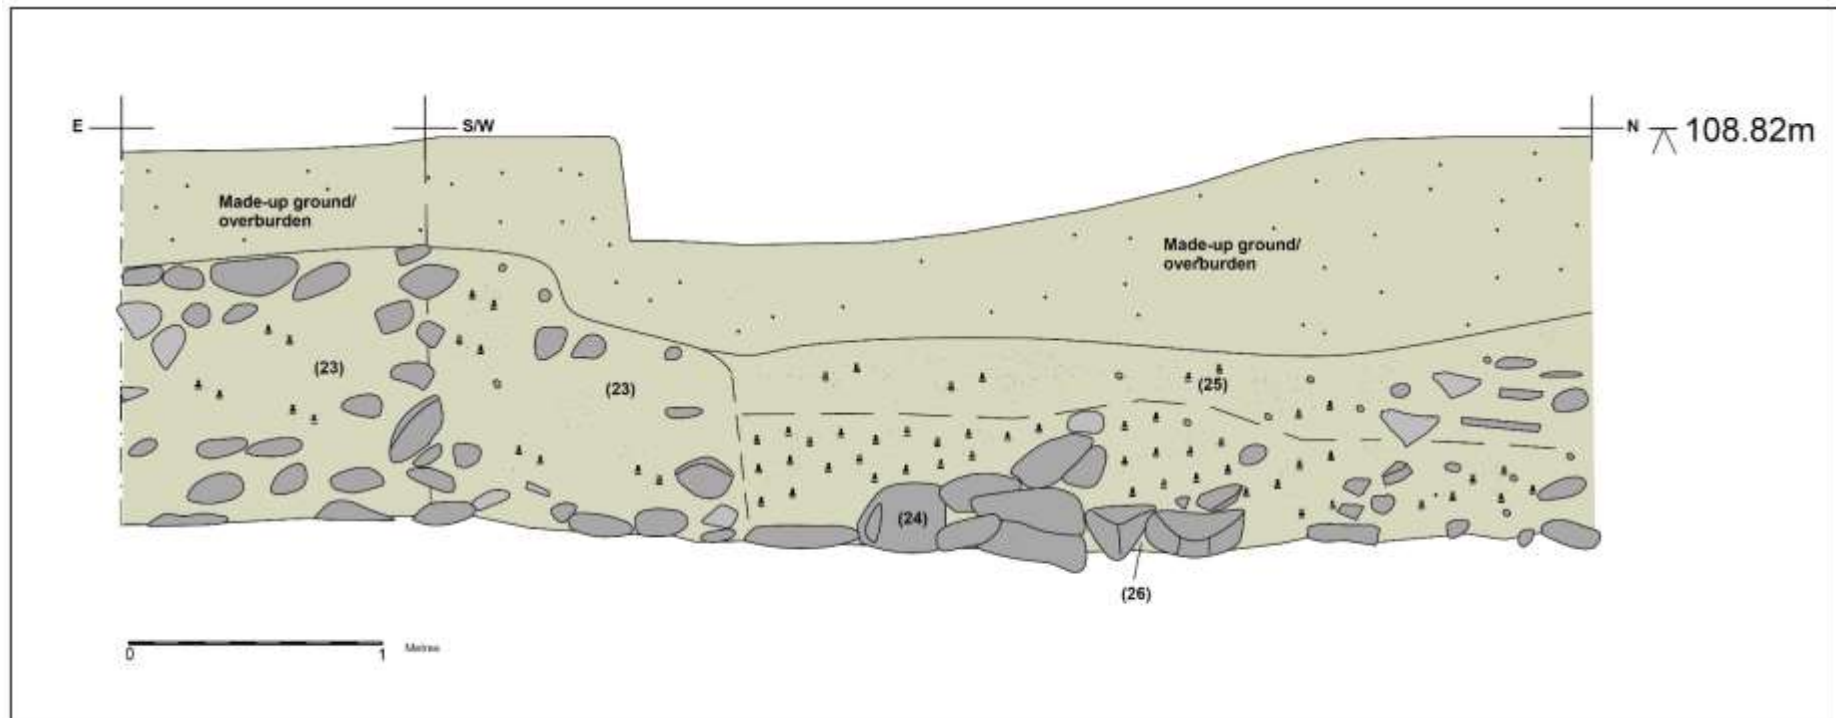
Figure 11: North and east facing section of southern end of trench

(27), but an earlier surface (Figure 11). This appeared to lay over (26) at this point, and therefore, in this area at least the reddish-brown silty clay of (26) was the lowest layer in the sequence, with pottery of an 11th- to 12th-century date.

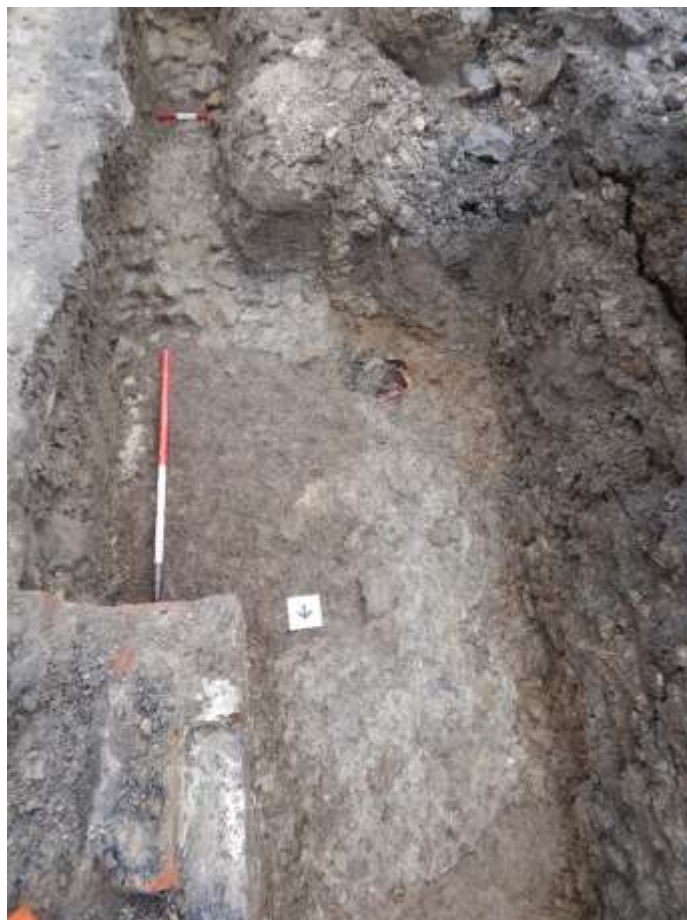
Plate 15: The southern end of the footprint trench, looking south, showing surface and clay layers

Along the southern part of the new building footprint, the trench was excavated to a depth of around 0.8m (to accommodate the toe of the new foundation slab) and was very narrow, around 0.45m, due to the extant cellar remains here. A modern yellow plastic gas main ran across the area from west to east and the brick pillar of the boiler house extended into the trench making excavation somewhat awkward (Figure 10: Plate 15).

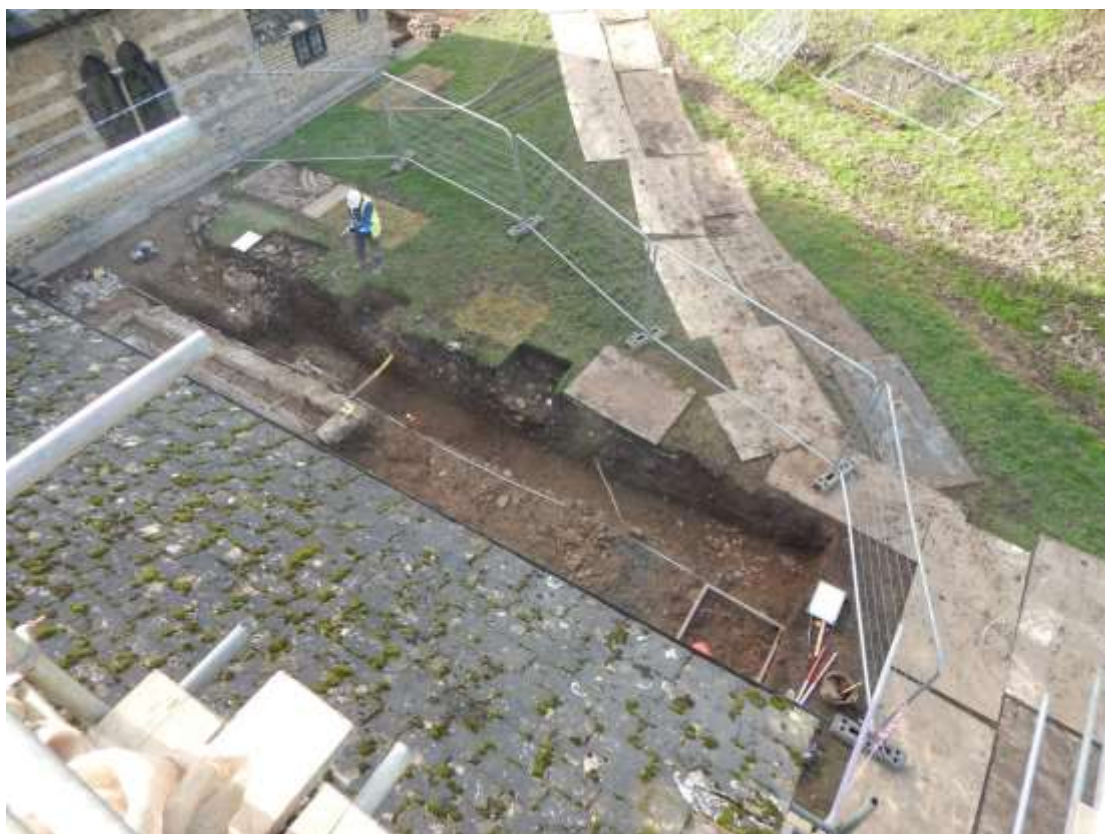
Plate 16: Recording the evaluation trench on the footprint of the proposed toilet block, looking south-west from roof

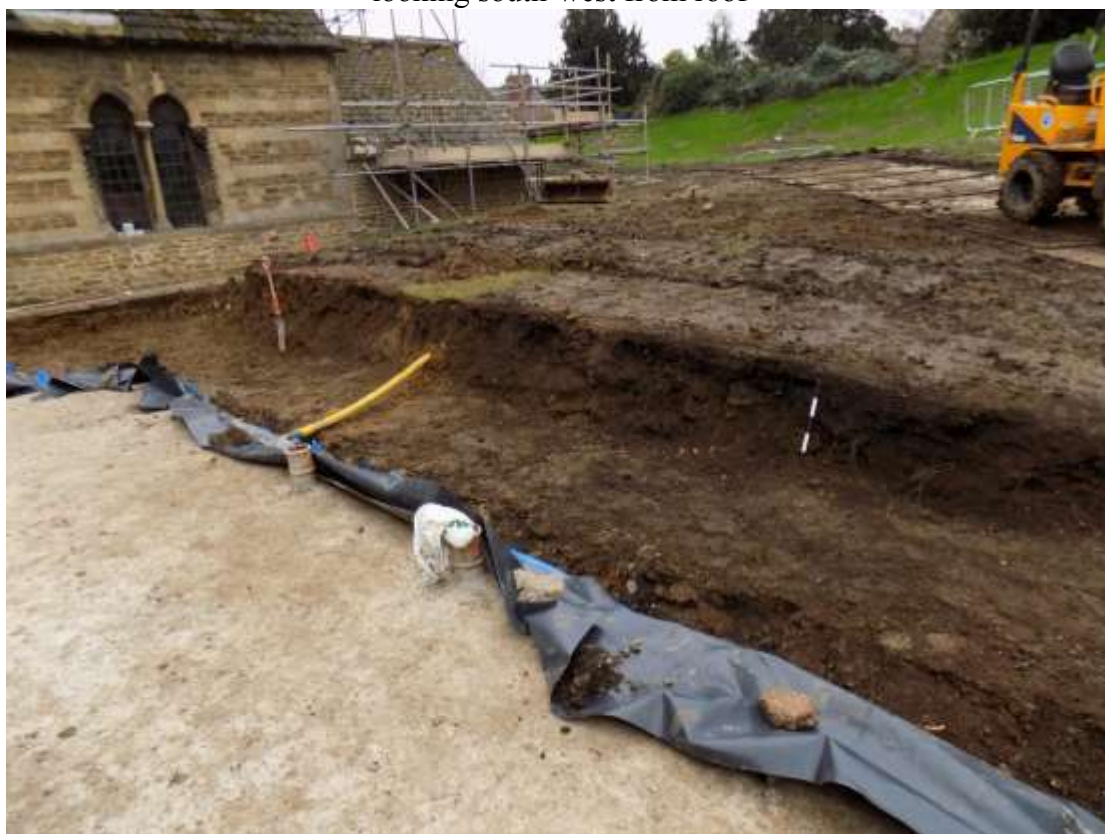
Plate 17: Stripping for pathway, after concrete had been laid, looking south-west

Subsequently, the cellar of the former boiler house was filled by the contractors and the concrete slab for the new toilet block was laid. The ground around the slab was reduced for the new pathway by between 0.3m and 0.70m. This was monitored by an archaeologist on Friday 17th and Friday 18th of December 2015. Only made-up ground similar to that seen at the southern end of the trench was observed and the works did not penetrate deep enough to uncover any further archaeological features (Plate 17).

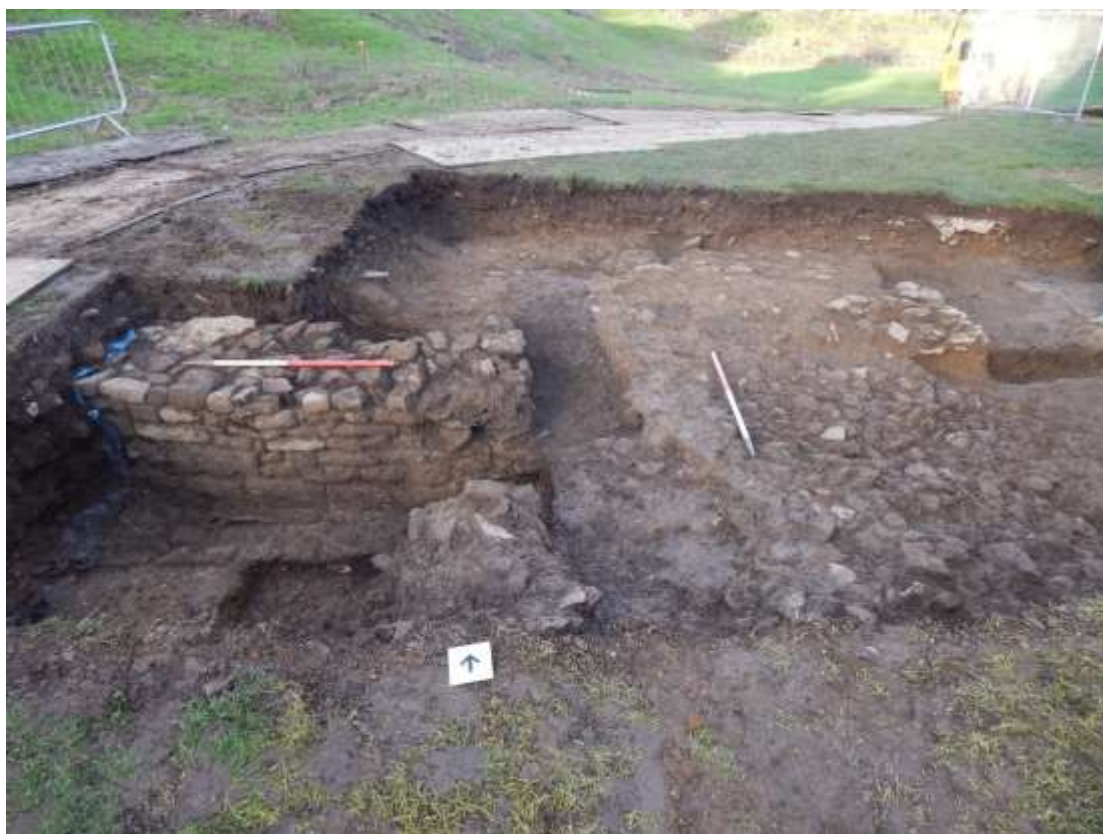
Plate 18: The extension to the Wessex Trench, partially excavated, looking north

The eastern ends of the walls revealed within the previous Wessex Trench 3 were soon identified. A further 0.8m of the upper wall (304) was identified (now wall (38)), along with 0.3m of the lower wall (309) (now wall (52)). As in the case of (304) the new section of wall (38) ran approximately east to west with a slight kink to the north-east. It was roughly coursed and roughly earth bonded and was constructed of ironstone (with one or two pieces of limestone) roughly finished blocks of differing sizes, from a few around 0.10m across to many around 0.40m across. The core was of ironstone rubble. It was truncated at the eastern end by what at first appeared to be a robber trench [37]/(36), but after investigation proved to be the cut for a modern gas pipe. The fill of the gas pipe (36) contained a large amount of pottery and ridge tile including 15th- to 16th-century wares, and some earlier 13th- to 14th-century material. This was between 0.26m and 0.48m wide and ran broadly from south to north before turning to the north-east, clearly on the same alignment as the gas pipe identified in the footprint evaluation trench (see above).

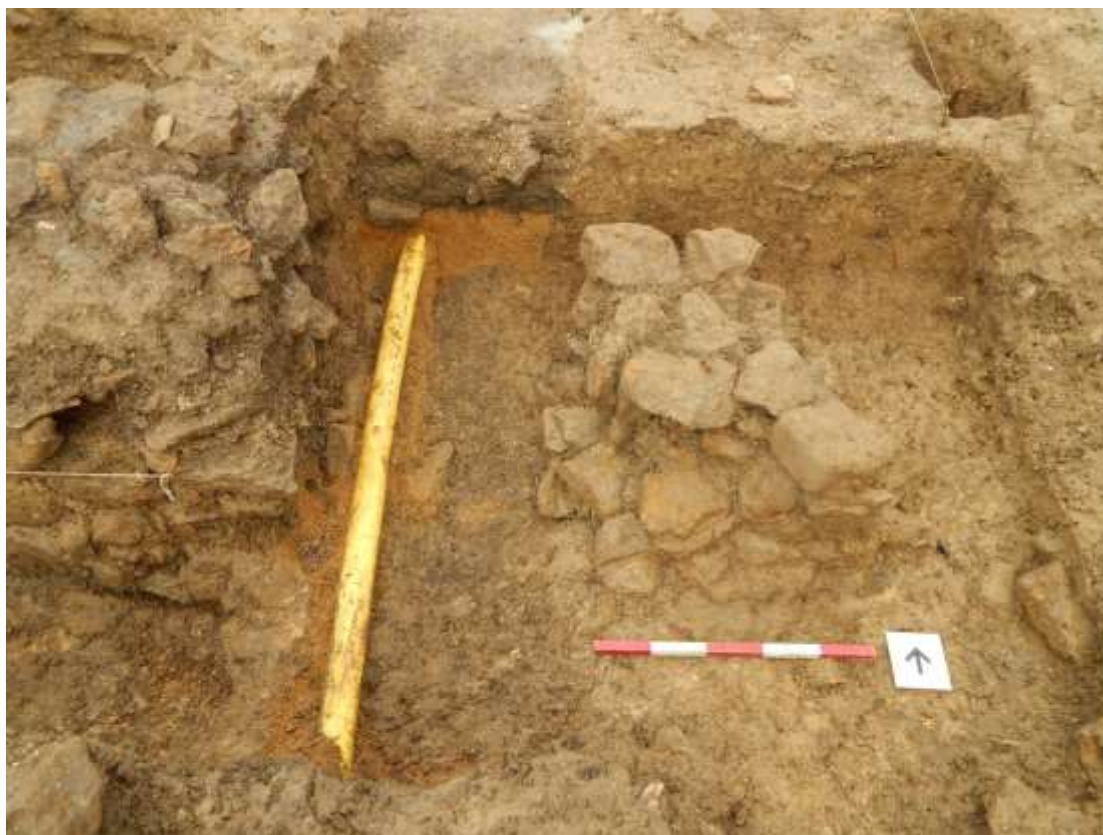
Plate 19: Wall remnants (38) and (44) truncated by gas pipe, looking north

with (38)), approximately the width of the wall itself and cut into a mid reddish-brown slightly silty clay layer (54) with charcoal flecking and small angular stones. Given that the wall cut appeared to truncate this layer, it seems to be the oldest deposit in this trench.

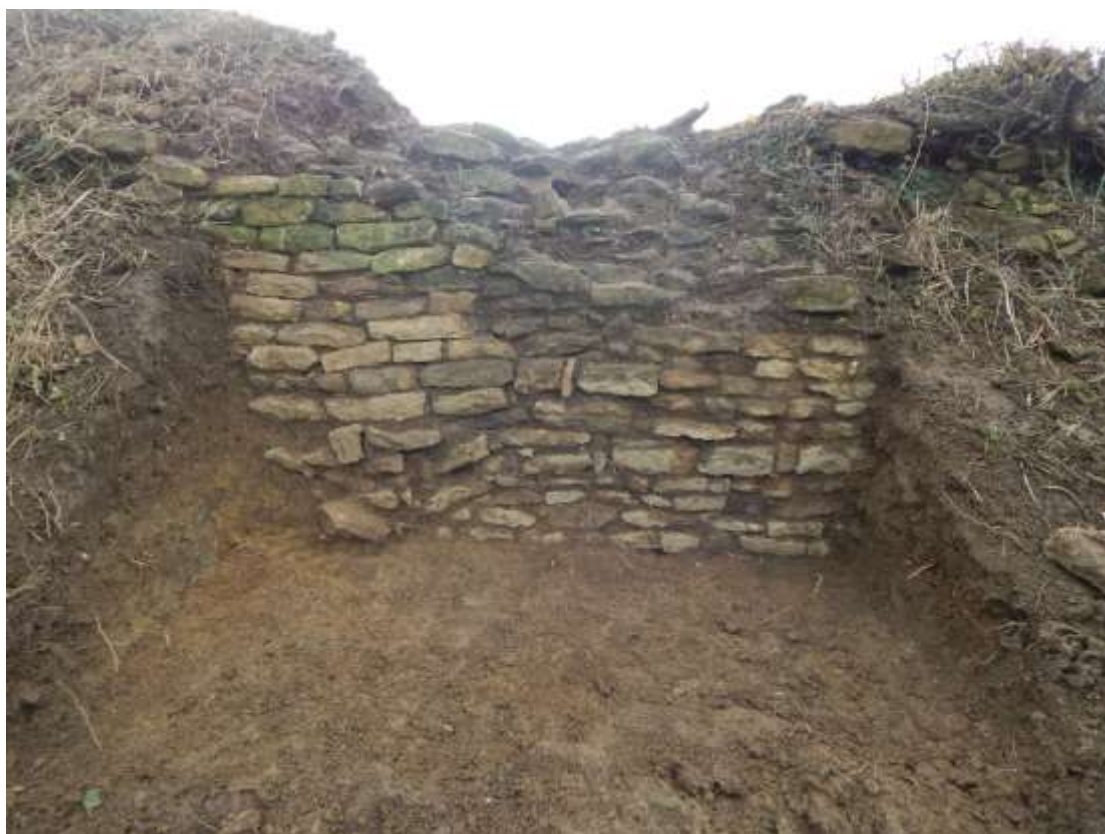
Plate 20: View of external face of rampart wall, looking south-west

The core material and top three courses of the wall on the exterior face were already exposed due to erosion and root damage. The section of wall uncovered (31) was approximately 1.80m wide, but it was unknown whether this is the original width due to the internal face (32) being re-faced with probably displaced stone and concrete, possibly as a blocking measure to prevent the core material from collapsing. Such collapse and erosion was evident across the ramparts.
