**Archaeological Investigations
during Restoration Work at
Oakham Castle,
Oakham,
Rutland
(SK 86101 08904)**

ULAS Report No 2016-105
©2017

for
**Rutland County Council
Planning application Ref: 2014/0395/LBA**

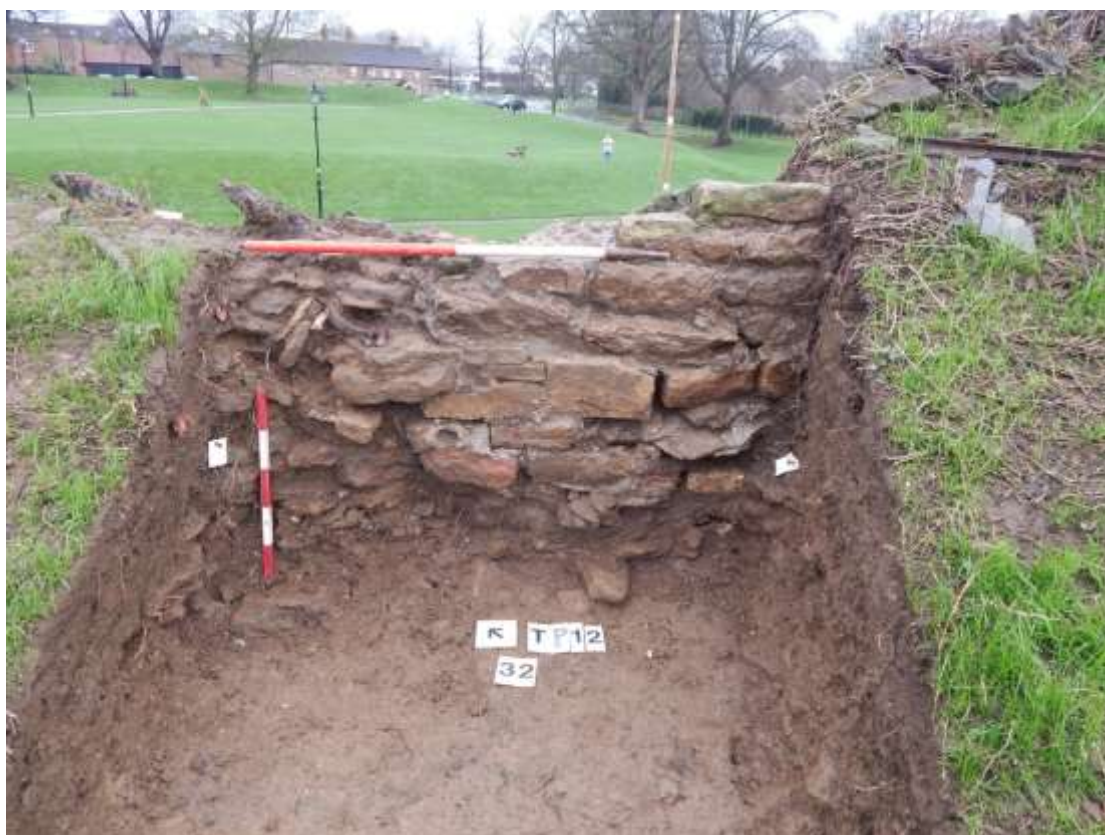
Plate 21: View of internal face of rampart wall, looking north-east

The evaluation through the northern curtain wall and rampart showed that the wall had been cut into the rampart material and the outer face showed seventeen courses of stone, with fewer on the inner face, which had been repaired with modern brick and concrete at some time in the past.

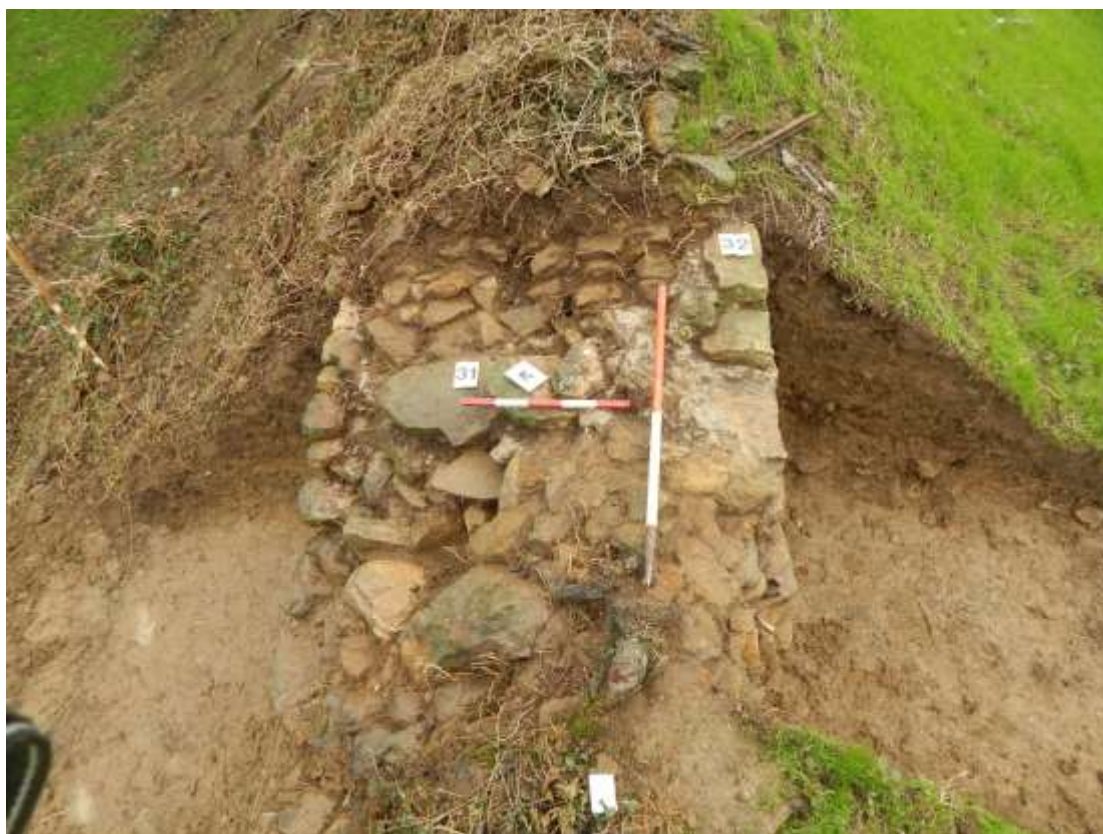
Plate 22: View of rampart wall from above, looking east

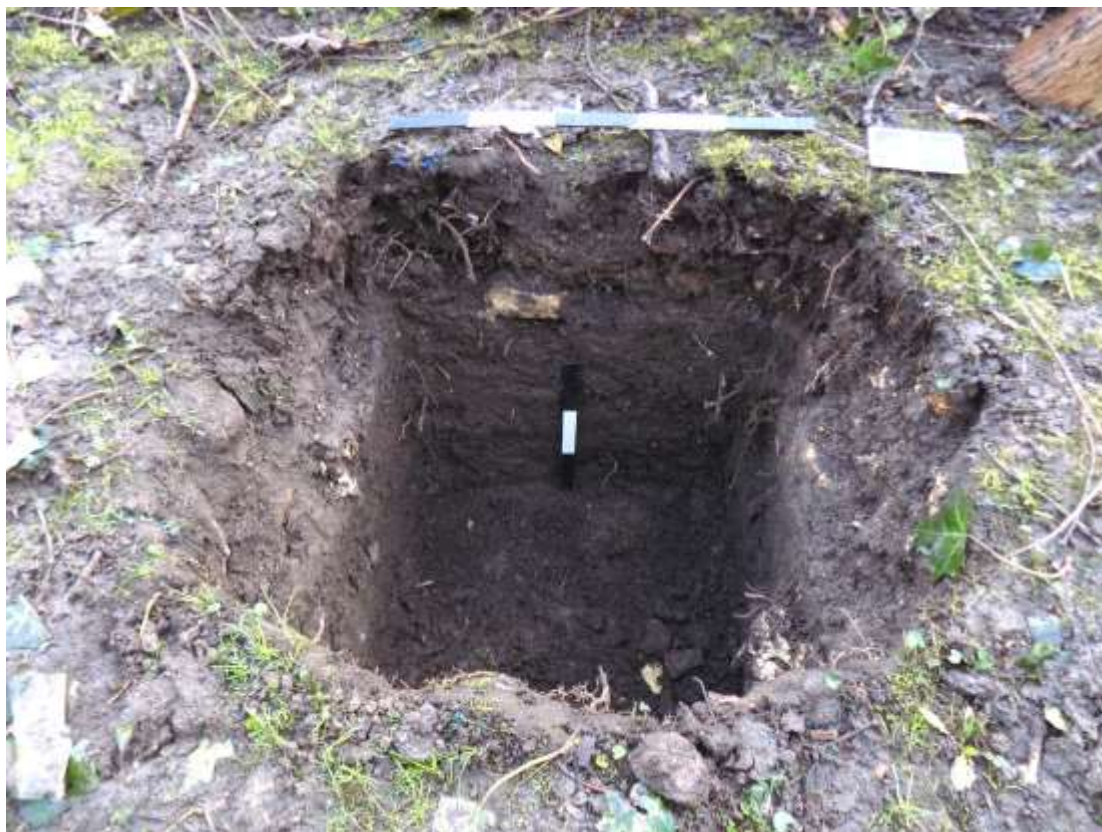
Plate 23: West facing section of Test Pit A at perimeter fence, looking east

A metal perimeter fence was installed around the western and northern sides of the rampart walls, between the ramparts and Cutts Close. It was decided that every tenth post hole would have a 0.50m by 0.50m test pit excavated to record any potential archaeological deposits present. Test Pits A and B were excavated along the Western side of the castle ramparts, Test Pit A revealed approximately 0.20m of topsoil (1) overlaying a layer of mixed dark brownish-grey silty clay (66), most likely eroded rampart material (Plate 23). Before Test Pit B could be excavated, concrete slabs which were part of a short path had to be removed which were sitting on top of the probable eroded rampart material (66). Test Pits C, D, E, F and G were excavated along the North side of the castle ramparts. Test Pits C and D revealed topsoil overlaying a layer of mixed light brownish-grey silty clay (67) which was the backfill surrounding a modern storm drain. Test Pits E and F revealed topsoil overlaying a layer of mixed light greyish-brown silty clay (68), most likely eroded rampart material. Test Pit G was unable to be fully excavated due to compacted, modern made ground beneath the topsoil.

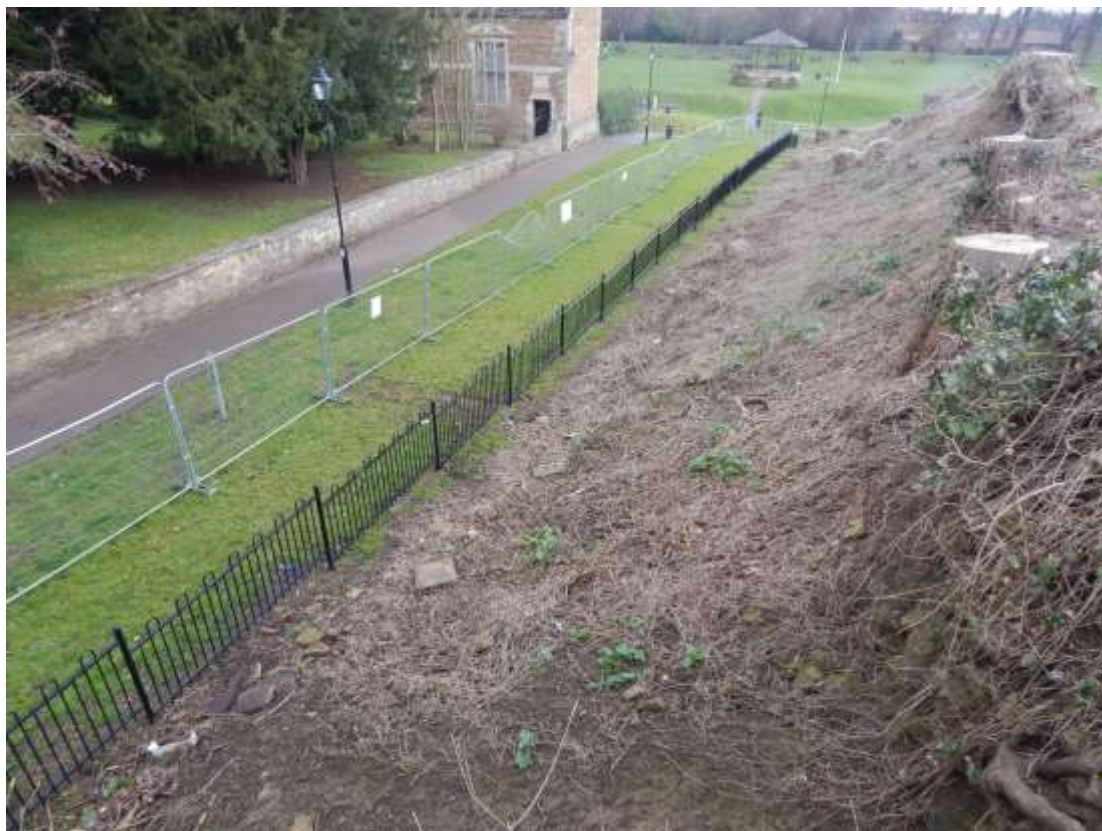
Plate 24: View of the completed perimeter fence, looking north from western rampart

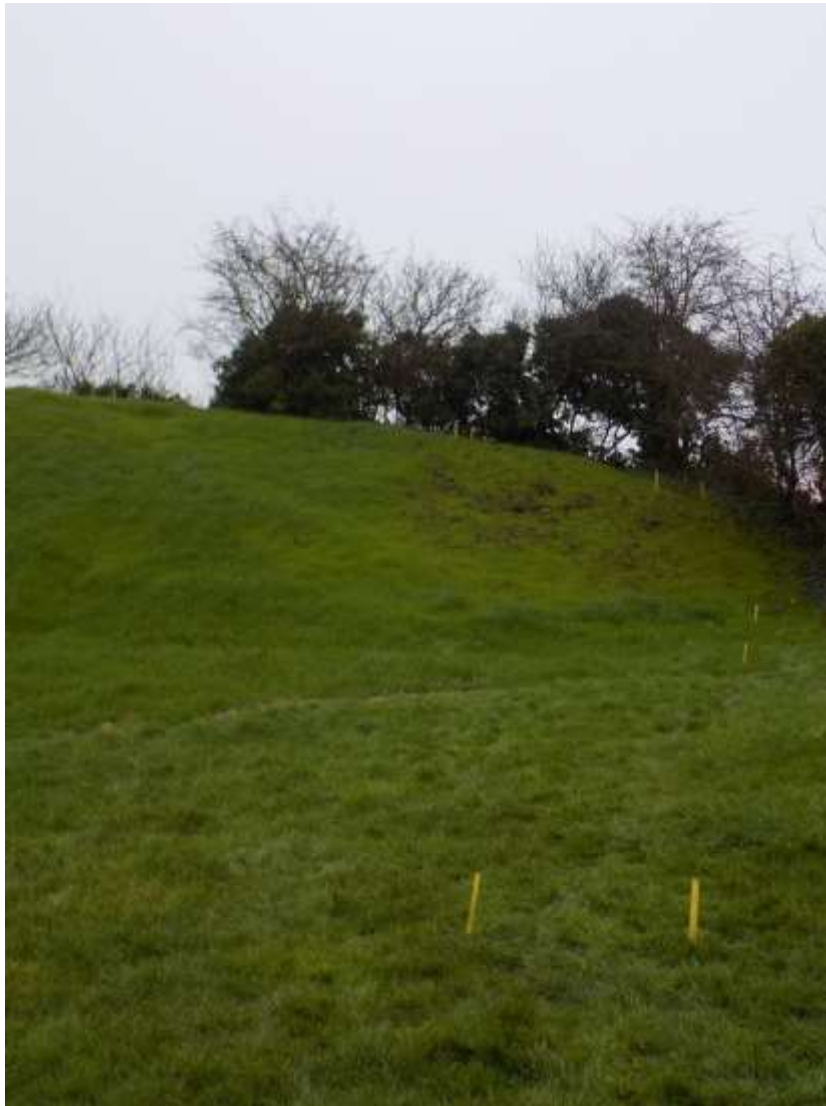
Plate 25: Line of new access steps to Motte marked out, looking east

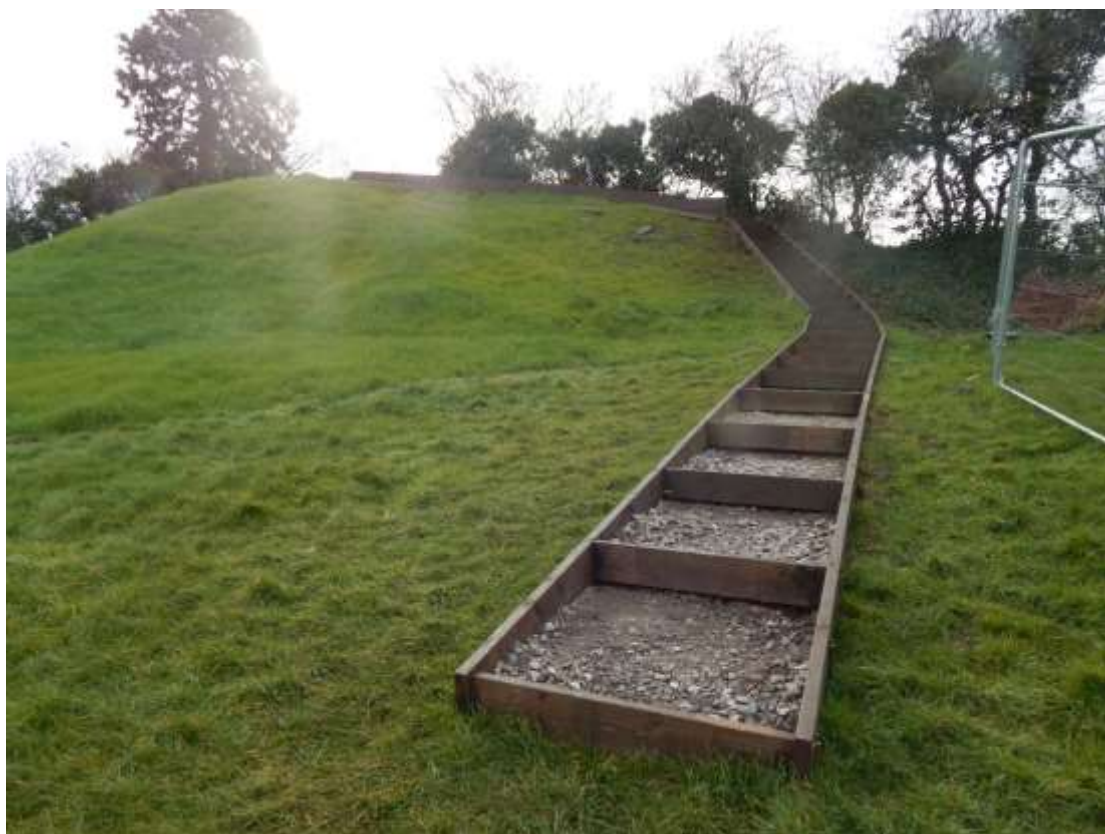
Plate 26: Steps to Motte partially constructed, looking east

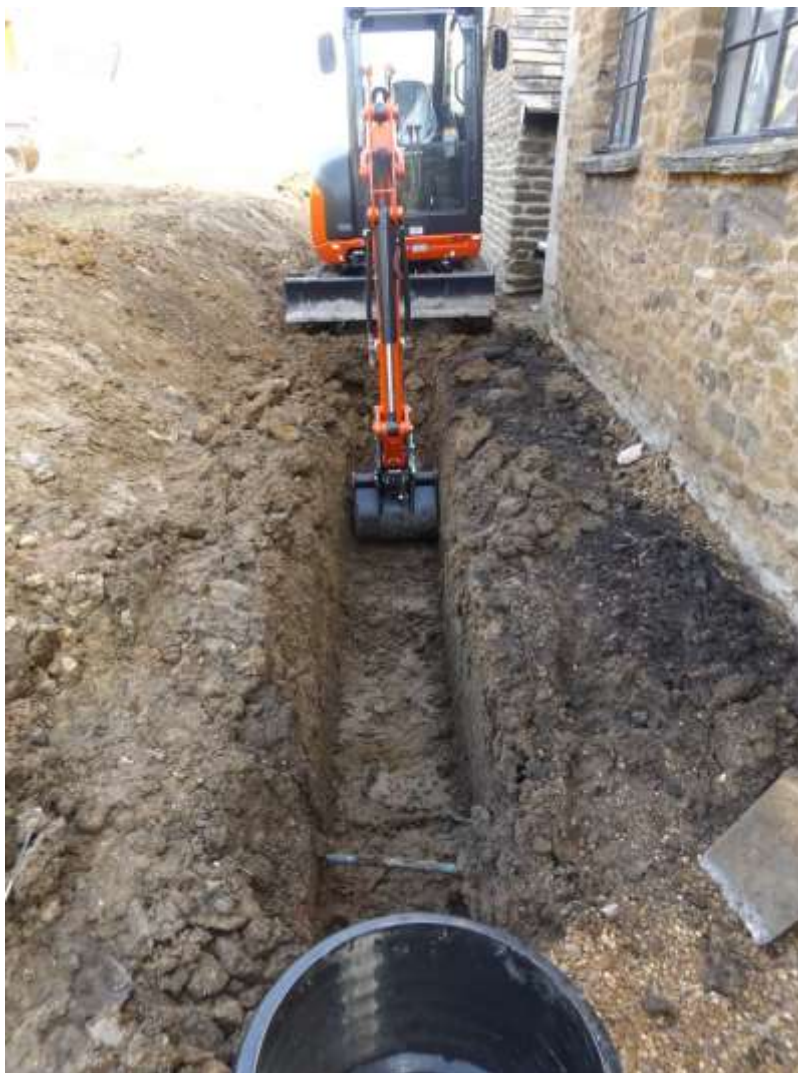
Plate 27: Work in progress on water pipe trench, west side of building, looking north

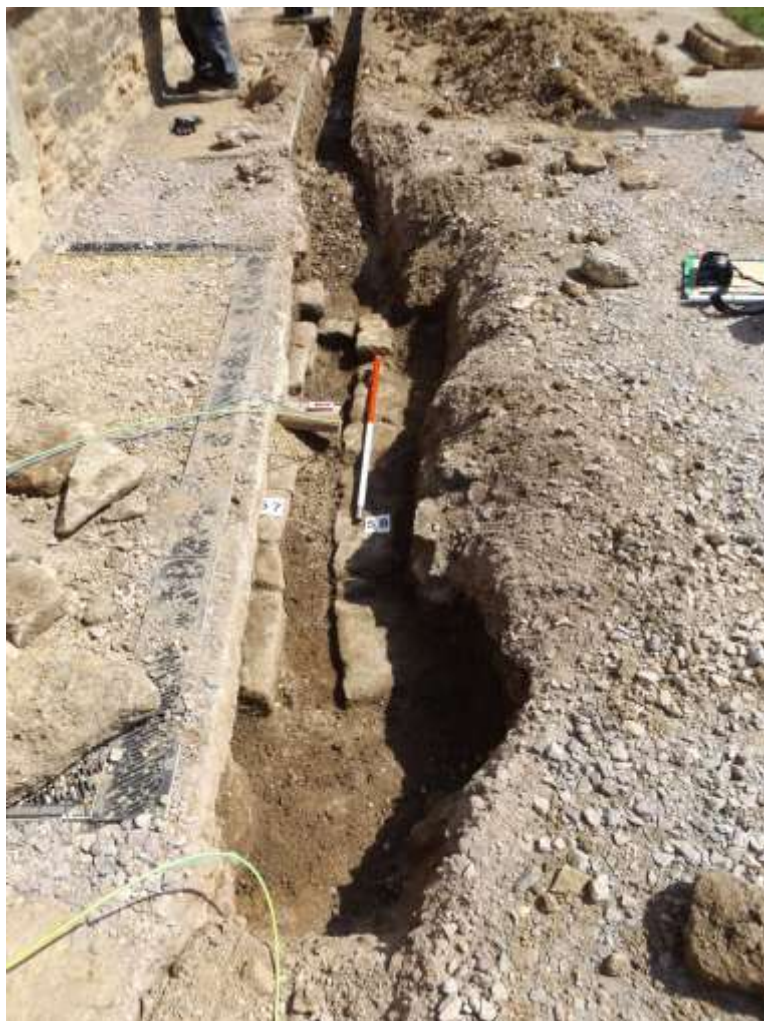
Plate 28: Stone drain in electrical trench, looking east

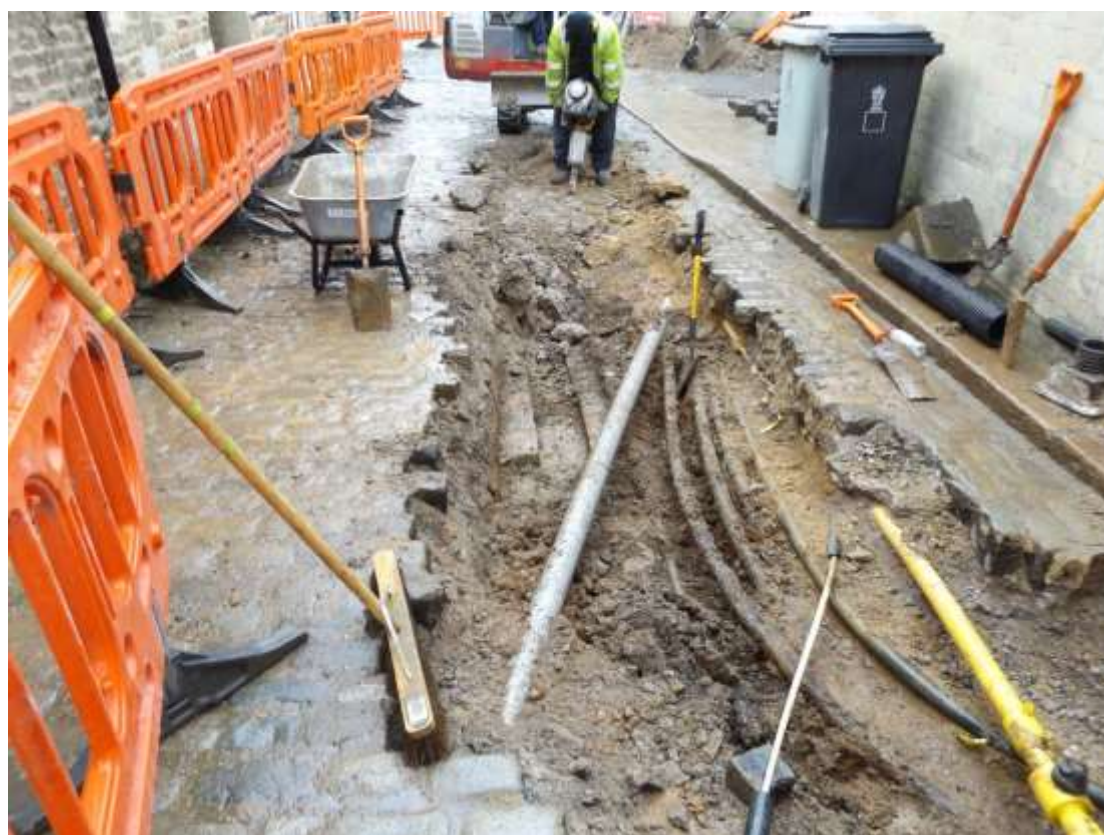
Plate 29: Work in progress Castle Lane, looking south

An area was excavated in Castle Lane to replace faulty high voltage cables (Plate 29). After the contractors had removed the cobbles, concrete and made ground (62), a brick-built post-medieval drain (59) was revealed running the length of the street (Figures 23 & 24). The drain was approximately 0.50m wide but the full length is unknown due to

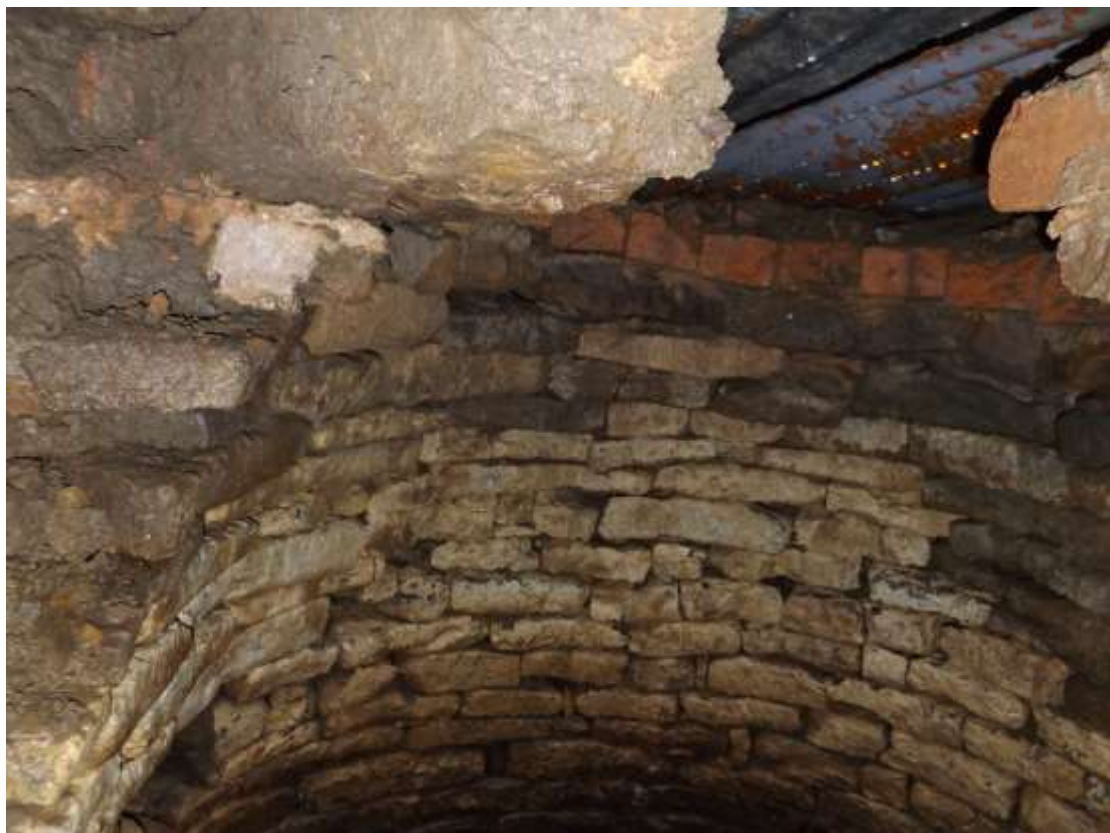
Plate 30: Internal shot of well, cap in place

Due to the unstable ground surrounding the well and the risk of the well collapsing, a strategy involving lowering a digital camera on a camera pole through a hole in the concrete cap was proposed and undertaken. The photographs showed that the well was constructed of roughly shaped iron stone blocks with no obvious bonding material. Due to limited access it was not possible to determine the full depth (Plates 30 & 31).

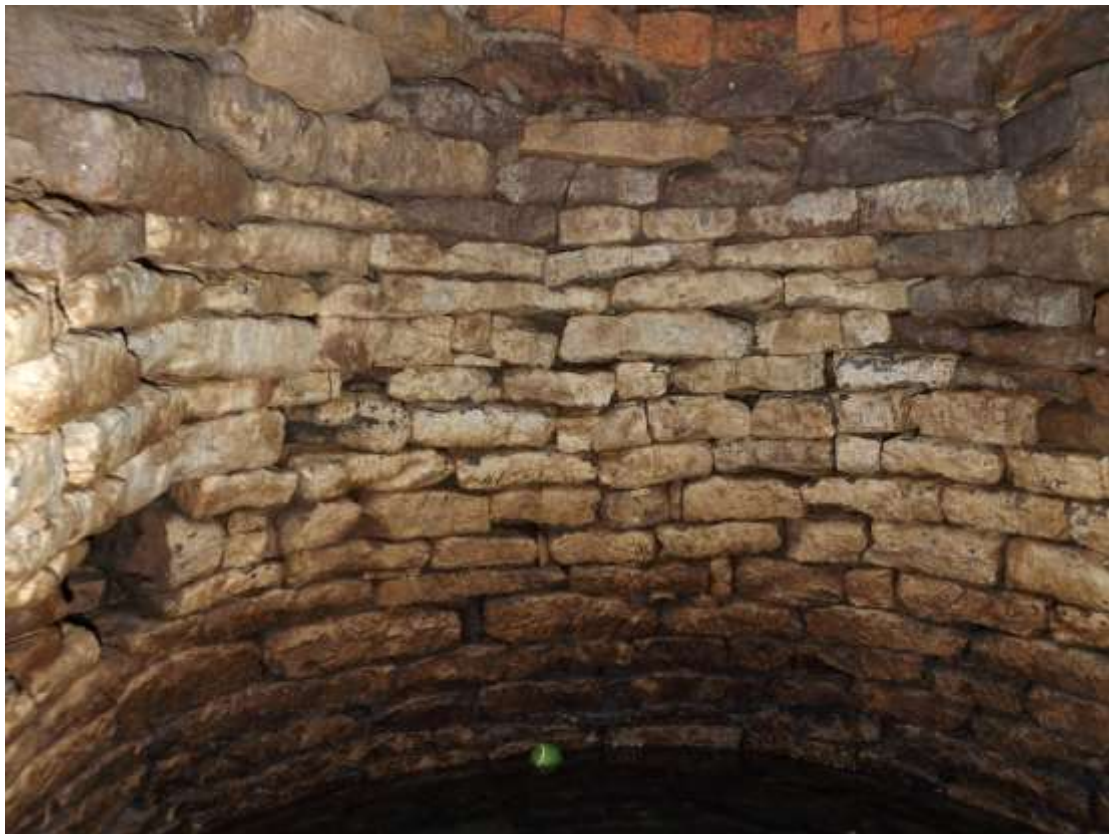
Plate 31: Internal Shot of well. It was not possible to include a scale, but the tennis ball measures 6.86 cm in diameter

After the concrete cap had been removed it became clear that the walls of the well were very unstable and the western side had already started to collapse inwards (Plate 32). The well was backfilled with mixed rubble and hardcore, then covered with topsoil and grass seed.

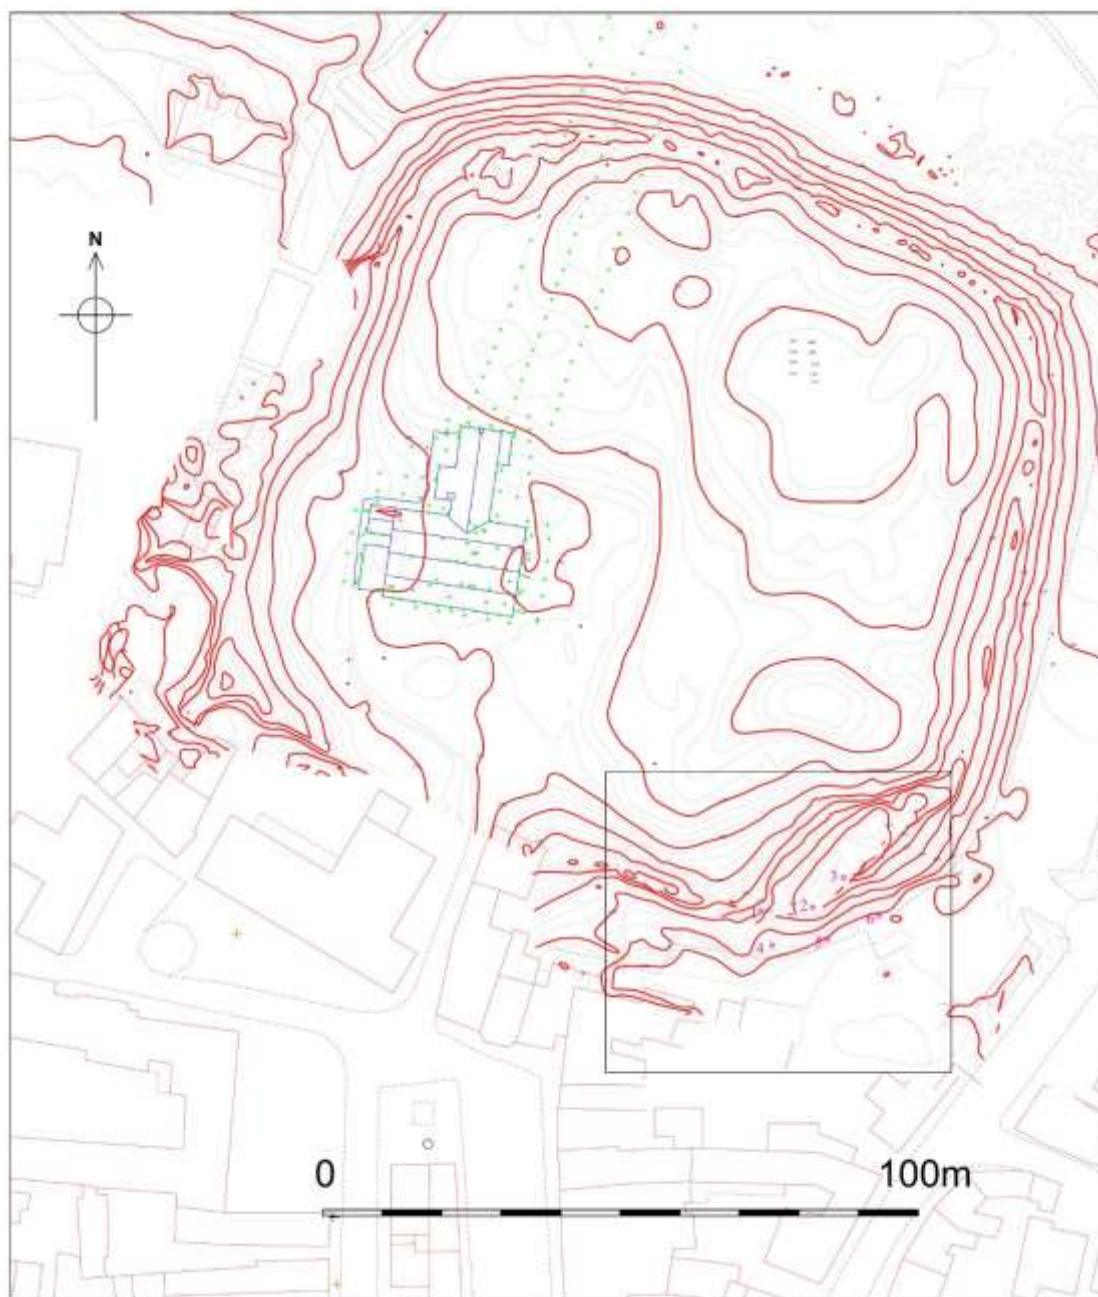
Figure 25: Location of motte and borehole survey

Six borehole cores were extracted from the Oakham Castle motte by Intec Consulting at locations decided by them (Figures 25 & 26). It was felt that their study had the potential to help understand the construction methods, materials used and dating evidence for this feature.

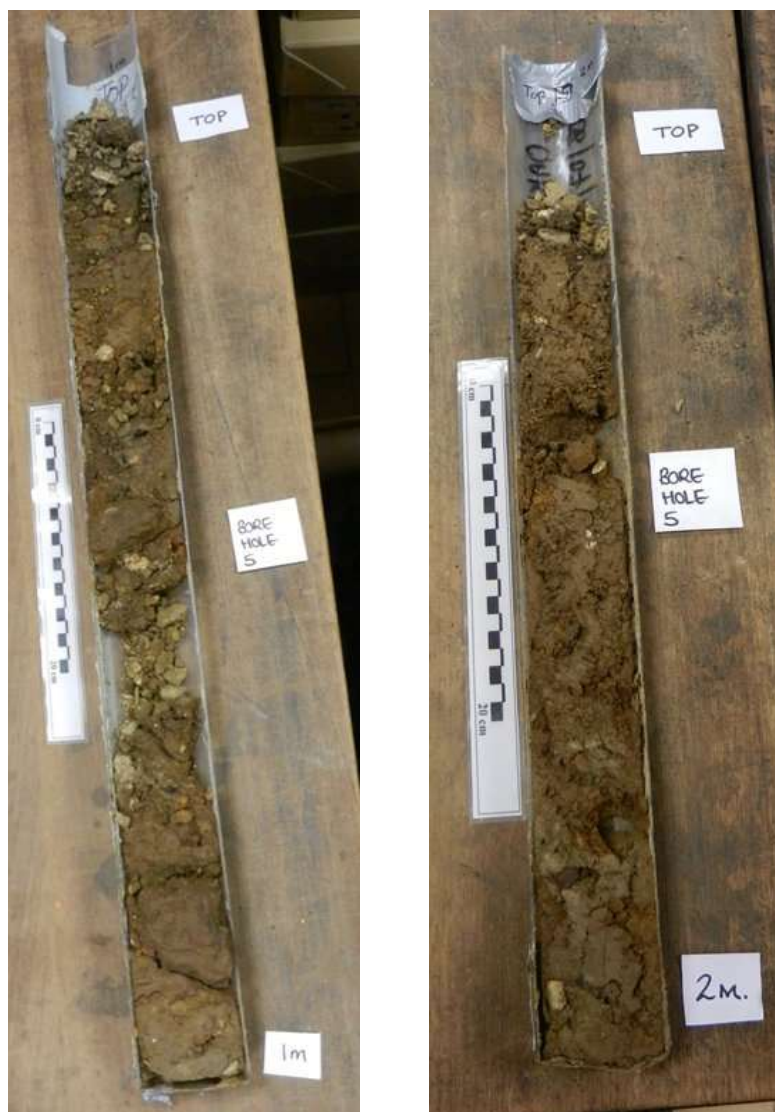
Plate 34: Borehole core 5

Like borehole 4, the horizons in borehole 5 were distinct. Mid brown sub soil (A) (10cm) was present. Below this was a mid-orange brown silty clay layer (B) (10cm). This was followed by mid-brown silty clay (C) (17.5 cm), which contained charcoal flecks and rare poorly sorted iron stone inclusions. Fragments of post-medieval glass were obtained from the residue of this deposit. A small void circa 10cm was present where a large stone had been removed. A deposit (D) (25cm) similar to the previous and likely associated then followed. A large void (75cm) was below this representing material lost during the extraction process. The final deposit (H) was very large (50cm) and homogenous, it was light orange-brown silty clay. Like borehole 4, it highly possible that the base of the motte or ditch was not reached (Figure 27).

Cores 4 and 5 were spilt longitudinally using a saw. The two halves studied were photographed and drawings completed to illustrate stratigraphy (Figure 27: Plate 33 & 34). Associated soil descriptions were made following ULAS (2015) recording guidelines. Sub samples were taken, approximately 250ml from each deposit. The exception was deposit H, from which three sub samples were taken - top, middle and bottom - as the deposit was thick. Modern top soils and sub soils were not sub sampled.

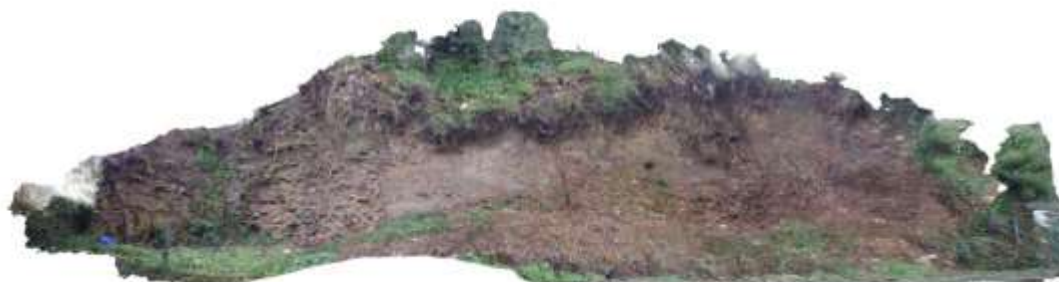
Plate 35: 3D Model of Motte south-eastern elevation, looking north-west

Despite this the survey was reasonably successful (Plates 35 & 36).

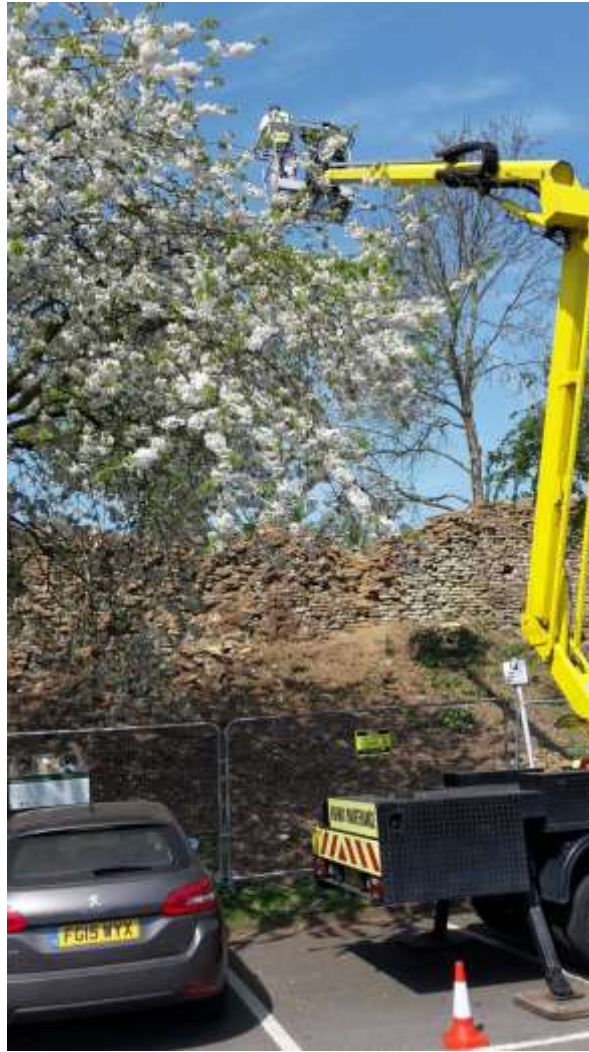
Plate 37: Photogrammetry survey in progress

The photogrammetry survey was undertaken on 9th and 11th May 2016. The weather conditions were bright and sunny, with some shade on parts of the walls. The wall was obscured by contractor’s scaffolding in the north-east corner of the wall. Photos were taken in this area, but the 3D modelling was not possible due to the scaffolding. Trees were present along the length of the east wall, many were in spring blossom (Plate 37)

Photographs were taken using a Nikon Coolpix L310. Photos were taken with good focus of the entire subject area. This increased the amount of points that can be detected, and therefore increasing the quality of the model. Lighting was not an issue as weather conditions were bright, a flash was not used. There was an overlap of at least 60% between the photos, this is the most important rule of photogrammetric recording (the higher the percentage of matched area, the more points the software can match, creating a higher quality model). Due to the size of the curtain wall, a cherry picker was used to get high and overhead photographs, remaining perpendicular to the surface. Over 250 photos were taken of the east side, over 100 photos were taken of the west side. The photogrammetry survey was georeferenced by photographing survey points (5m intervals), that were subsequently surveyed in using Topcon dGPS Hyper V, with a <1cm accuracy, tied into Ordnance Survey data.

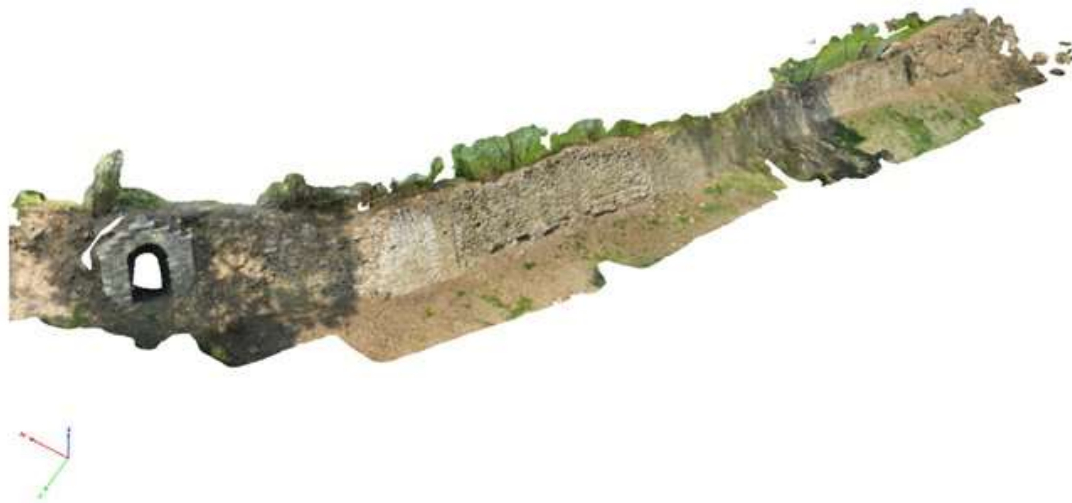
Plate 38: 3D model view of east side, looking north-west

The photogrammetry survey was successful on both the east and west walls, though on the east wall part was not possible as it was obscured by scaffolding (Plates 38-41). The survey data (photos, Photoscan files, and GPS survey) will be deposited in the site archive as digital data.

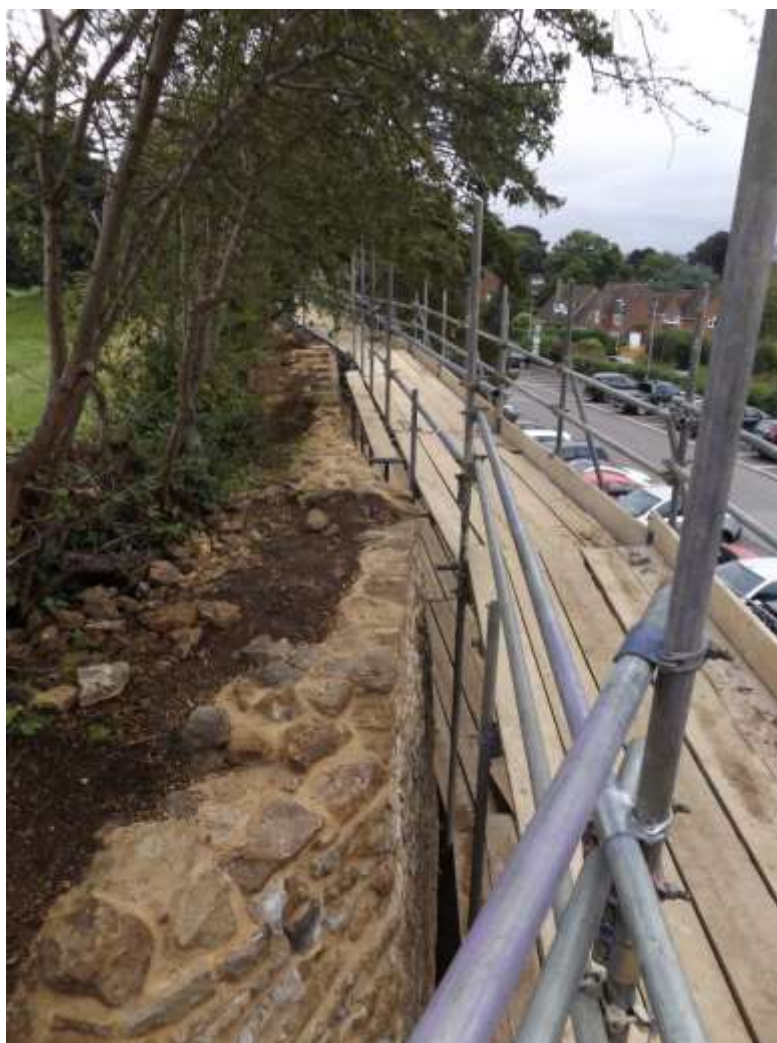
Plate 43: General shot of east side of walls, showing scaffolding, looking north

A series of visits between the 28th June and 2nd September 2016 took place to monitor the restoration works on the curtain wall in the Burley Road car park and the postern gate area. Scaffolding was erected in both areas to gain access to the higher sections of the wall and was constructed in a way that did not impact on the archaeology or damage any part of the walls (Plate 43).

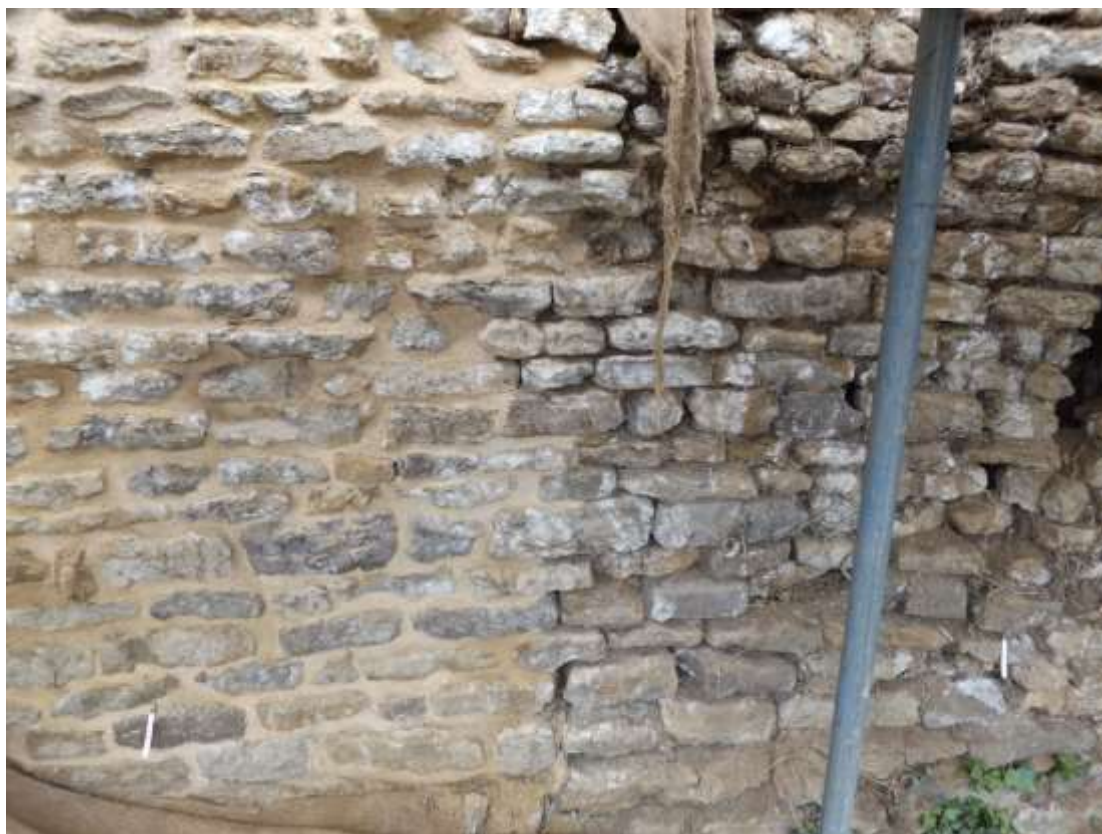
Plate 44: Section of wall showing before and after restoration

The works in the Burley Road car park mainly consisted of re-pointing the exposed stonework to the external face of the walls and making the collapsed areas safe (Plate 44). The most invasive work the masons undertook was to remove a part of the outer face of the northern section of the wall which had been badly damaged by tree root and animal disturbance and had started to collapse and had large voids appearing behind the face.

The work involved the removal of plant growth on the masonry without causing the structure to be undermined or collapse, followed by the repointing of the stone-work and the replacement of loose or missing masonry with suitable stone (Plate 42). Replacement materials were to be of an appropriate stone type and the mortar was to be of a 1: 2.5 lime/aggregate mix with sand from a previously agreed source. The walls were to be topped with soft turf capping.

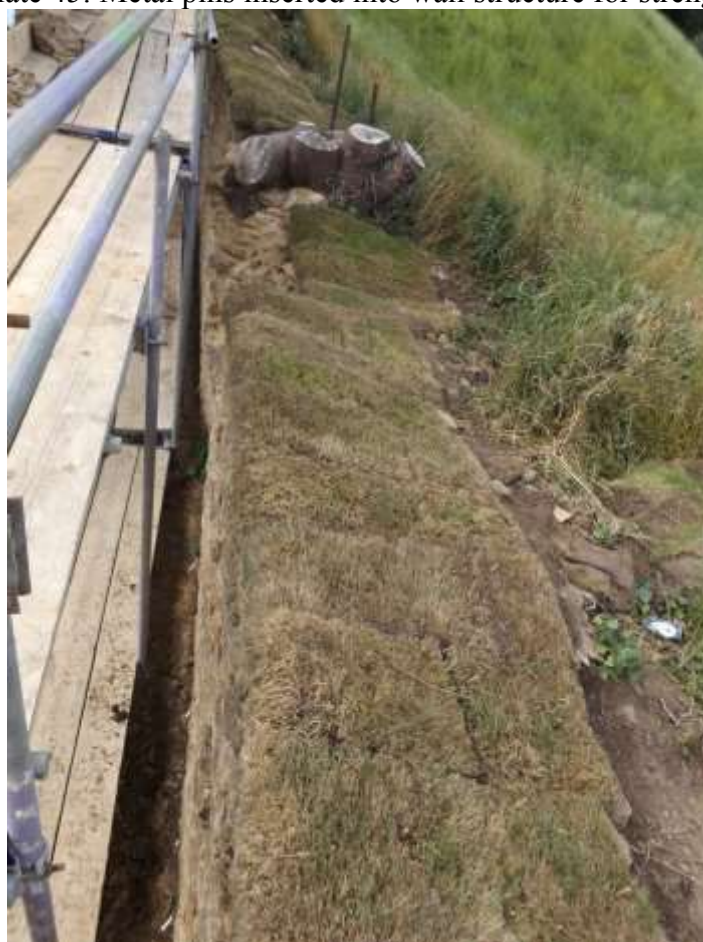
Plate 46: Soft turf capping upon restored walls

Once this was completed the masons made the core material of this section structurally safe by replacing the stonework and inserting metal rods to strengthen the wall, they were then able to re-lay the external face which needed moving back by approximately 0.20m to ensure it lined up correctly with the rest of the wall once again (Plate 45). The masons decided to leave the collapsed sections as they were but laid mortar around the exposed core material to make it safe and prevent further collapse. Once the re-pointing of the external face had been completed rolls of turf (soft capping) were laid over the top of the walls to cover the exposed stonework and to make it more in keeping with the Castle ramparts (Plate 46).

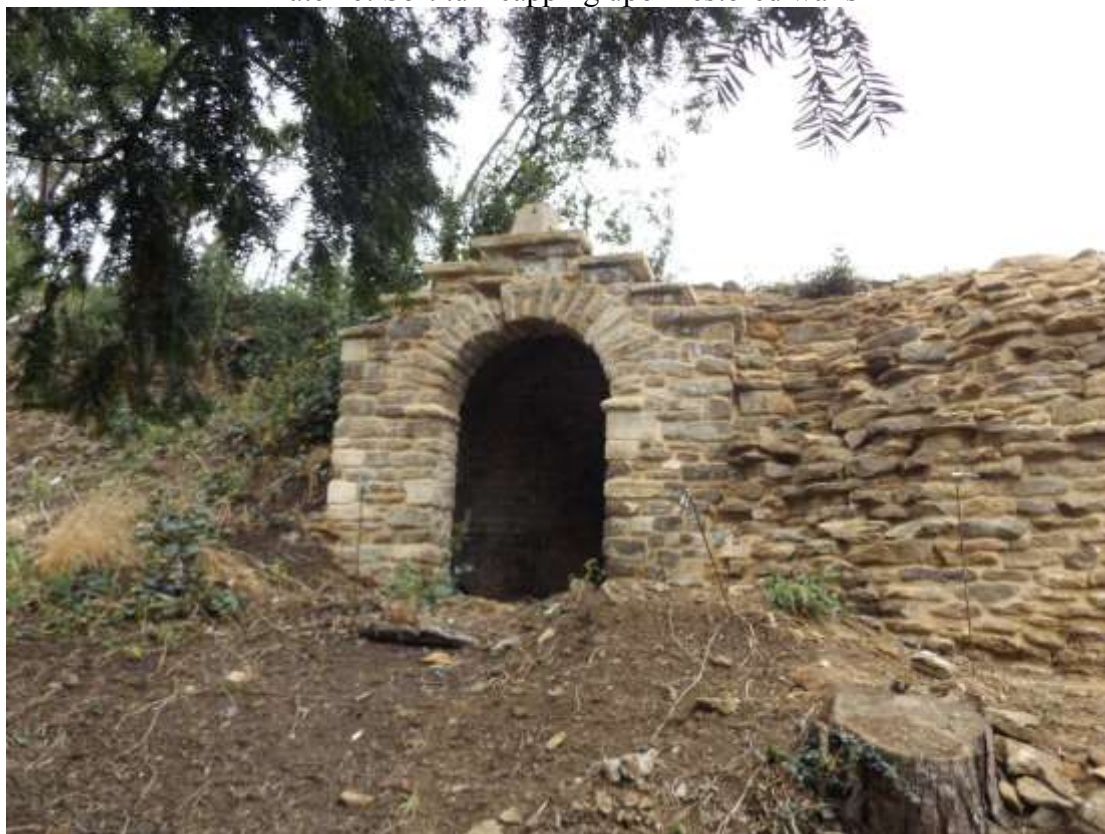
Plate 47: The restored grotto feature, looking west

There is a small grotto or shelter which was built into the south-east walling at some point in the 19th century. This was constructed of stone on the outside with brick walling and an arched roof within. Its interior is 2.15m x 1.28m in size. There is no evidence for former seating within it. The wall restoration was very effective on this feature (Plate 47).

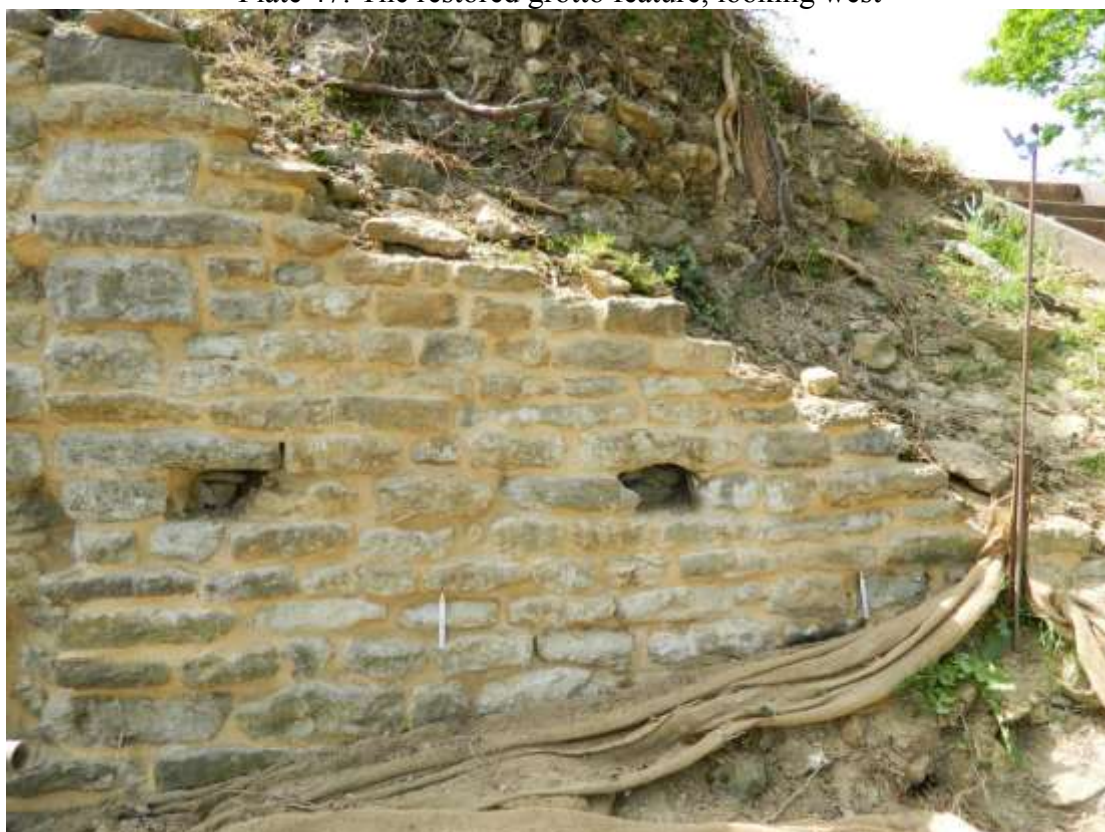
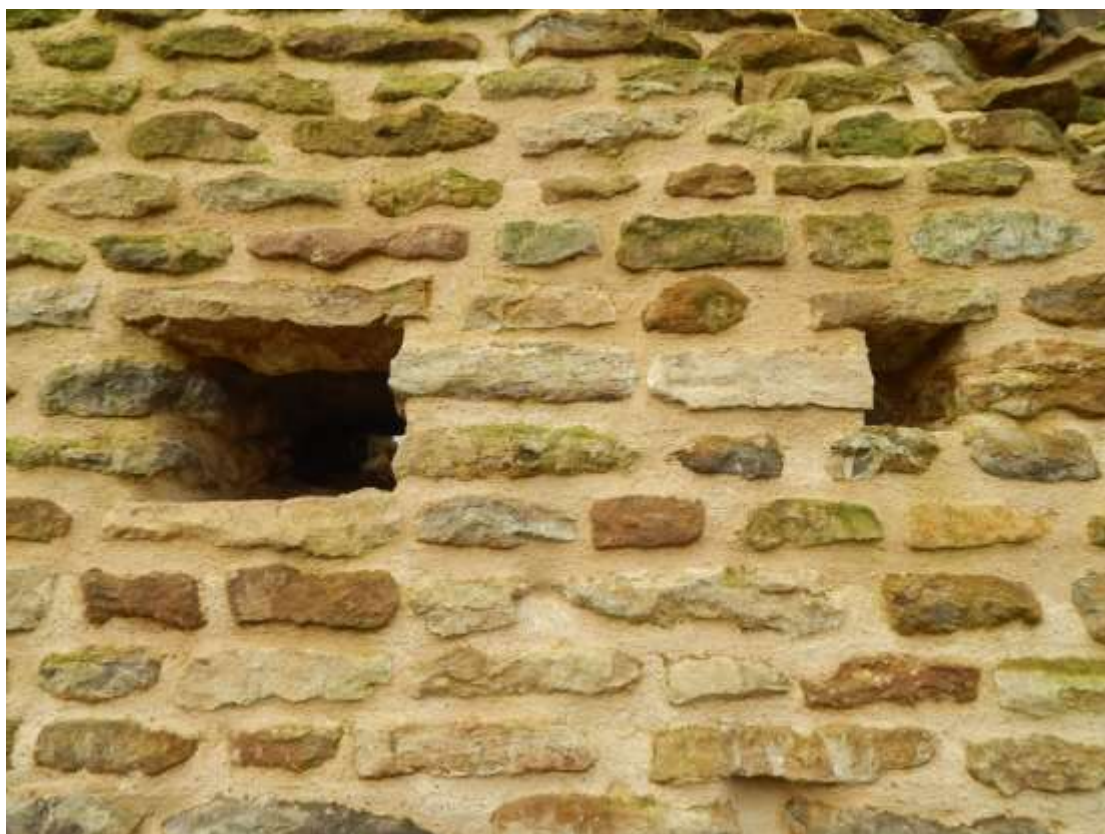
Plate 48: Restored putlog holes in castle walling

The rampart walls have been successfully restored and pointed to preserve them. They have been rebuilt in the areas where collapse was imminent and strengthened in some places using metal pins. The putlog holes and other features have been preserved and the vegetation growth removed and restricted from causing more damage (Plates 61 & 62).

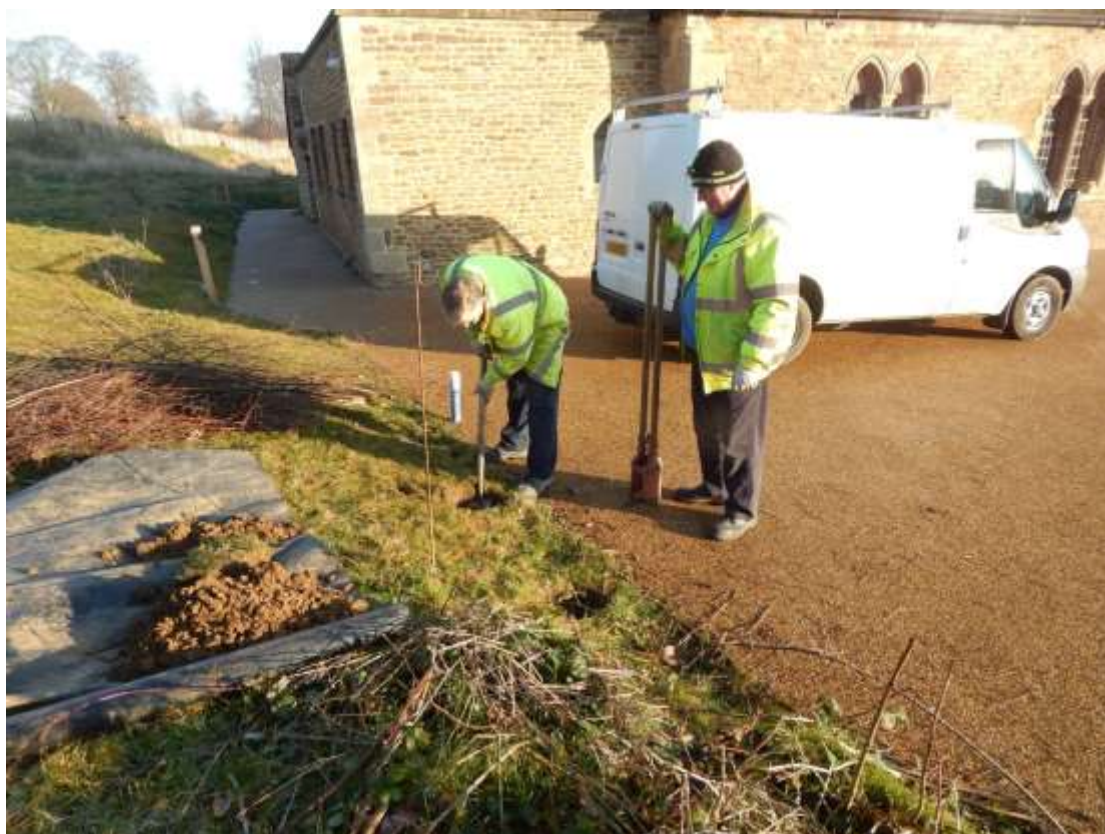
Plate 50: Work in progress on interpretation board holes

All holes were excavated by hand; de-turfed with a spade and then excavated with a post-hole digger (Plate 50). All were excavated to around 600mm, with the exception of the rear feet holes of Boards 1 and 3, which were excavated to 700mm due to the change of incline being situated slightly into a bank. The holes of Board 5 were only 500mm as the ground level here was 100mm below the last step of the Birley Road access, where the viewer would stand.
