**Archaeological Investigations
during Restoration Work at
Oakham Castle,
Oakham,
Rutland
(SK 86101 08904)**

ULAS Report No 2016-105
©2017

for
**Rutland County Council
Planning application Ref: 2014/0395/LBA**

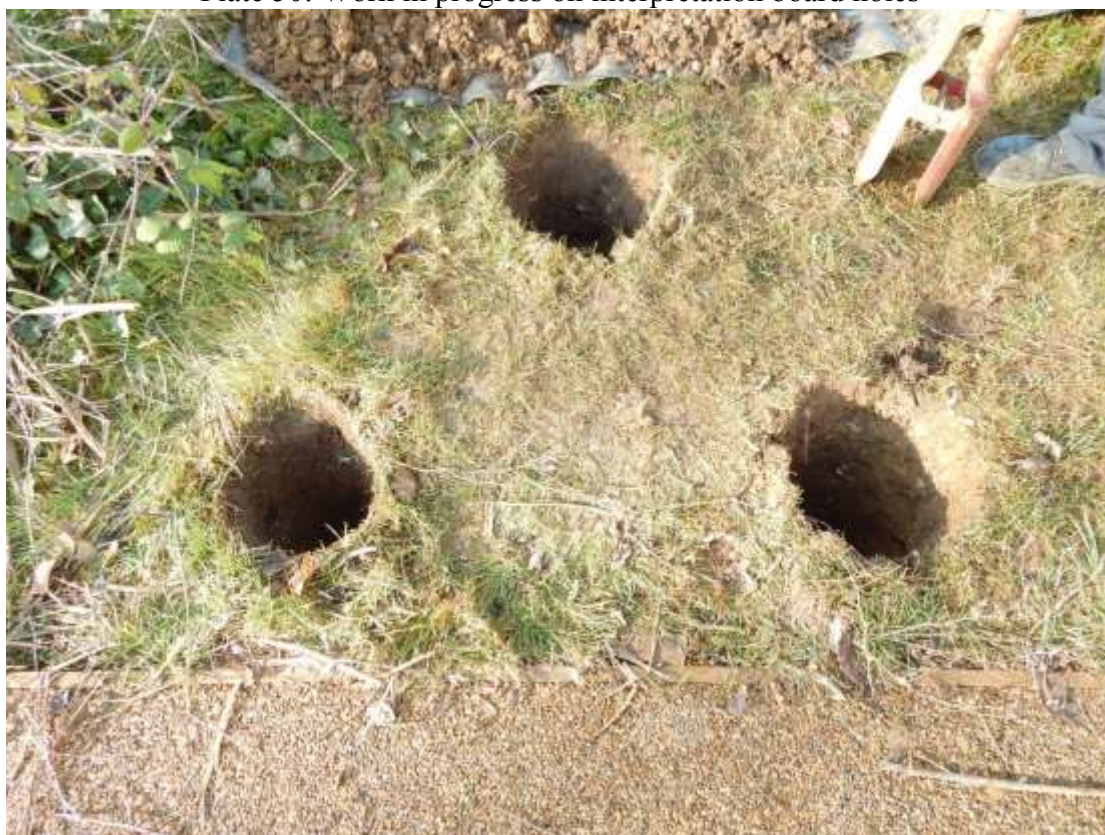
Plate 51: Finished holes of Board 1, looking west

All the boards consisted of a metal frame in the shape of a stylised horseshoe, with three feet (two front and one rear) to be concreted into the ground at a depth of around

The sequence identified within each hole was largely 0.15m-0.25m of topsoil over disturbed yellowish brown subsoil with small to medium pieces of ironstone. Modern pot, a piece of animal bone, a section of clay pipe and a section of slate were recovered from the holes of Board 2 and were not retained. The holes of Board 3 contained a larger amount of limestone and ironstone chunks and were therefore more difficult to excavate. A modern brick was found at the edge of one hole of Board 5 and was possibly in situ.

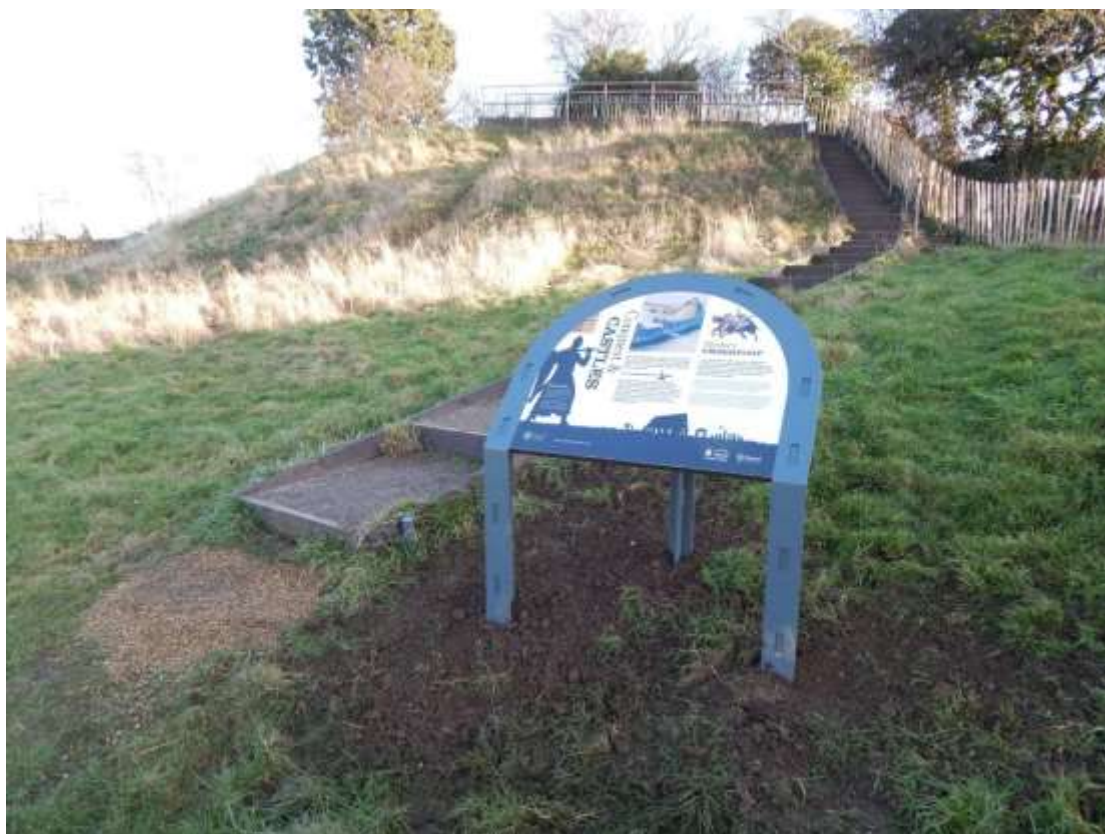
Plate 53: Finished interpretation Board 3 at base of Motte steps, looking east

Five were to be situated within the castle grounds (Figure 29). Board 1 was positioned to the east of the castle within the car park. Board 2 was to the west in a spot previously occupied by an older interpretation board. Board 3 lay at the foot of the new steps to the Motte and Board 4 was at the base of the steps of the new steps to the Birley Road car park. At the base of these steps within the car park lay Board 5.

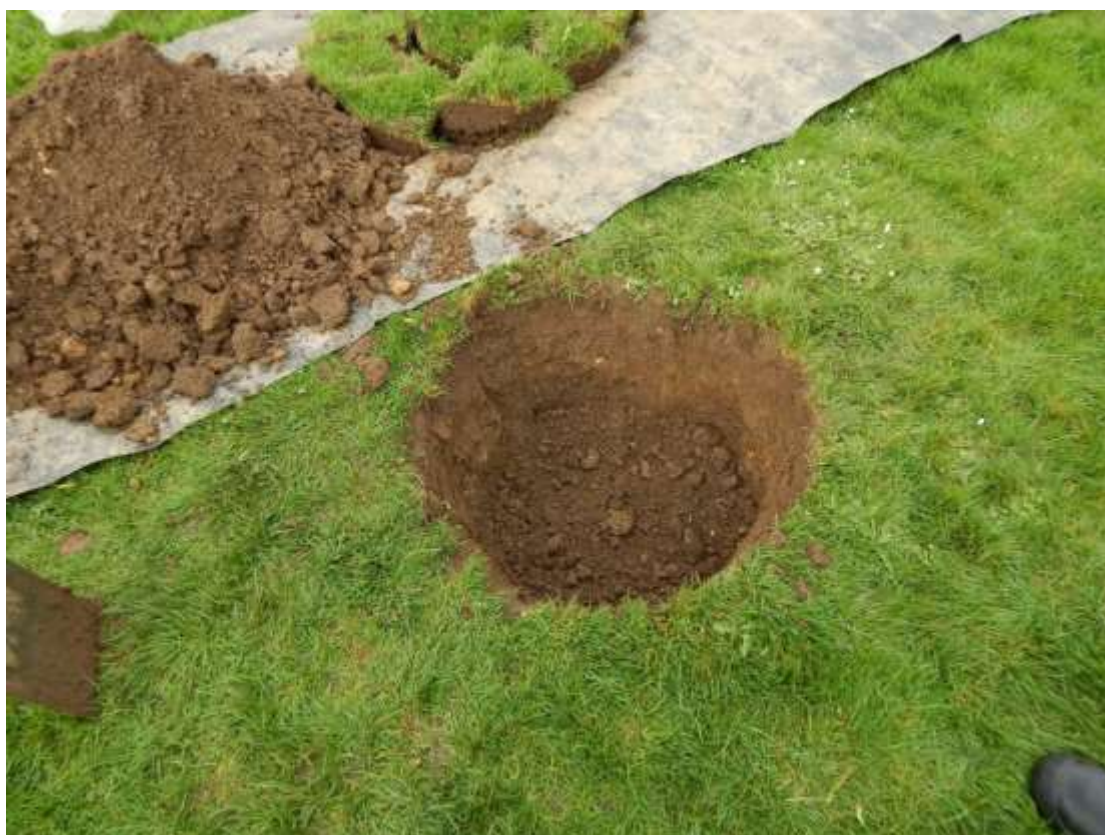
Plate 54: Excavated hole for commemorative tree, Cutts Close

A circular hole measuring approximately 0.5 in diameter and around 0.30m deep was excavated by hand, with the turf removed first (Plate 54). The sequence revealed was very similar to that seen during the excavation of the holes for the notice boards consisting of 0.15m of topsoil over disturbed yellowish brown subsoil with small to medium pieces of ironstone. A small piece of chicken bone and a sherd of modern white pottery was retrieved from the subsoil.

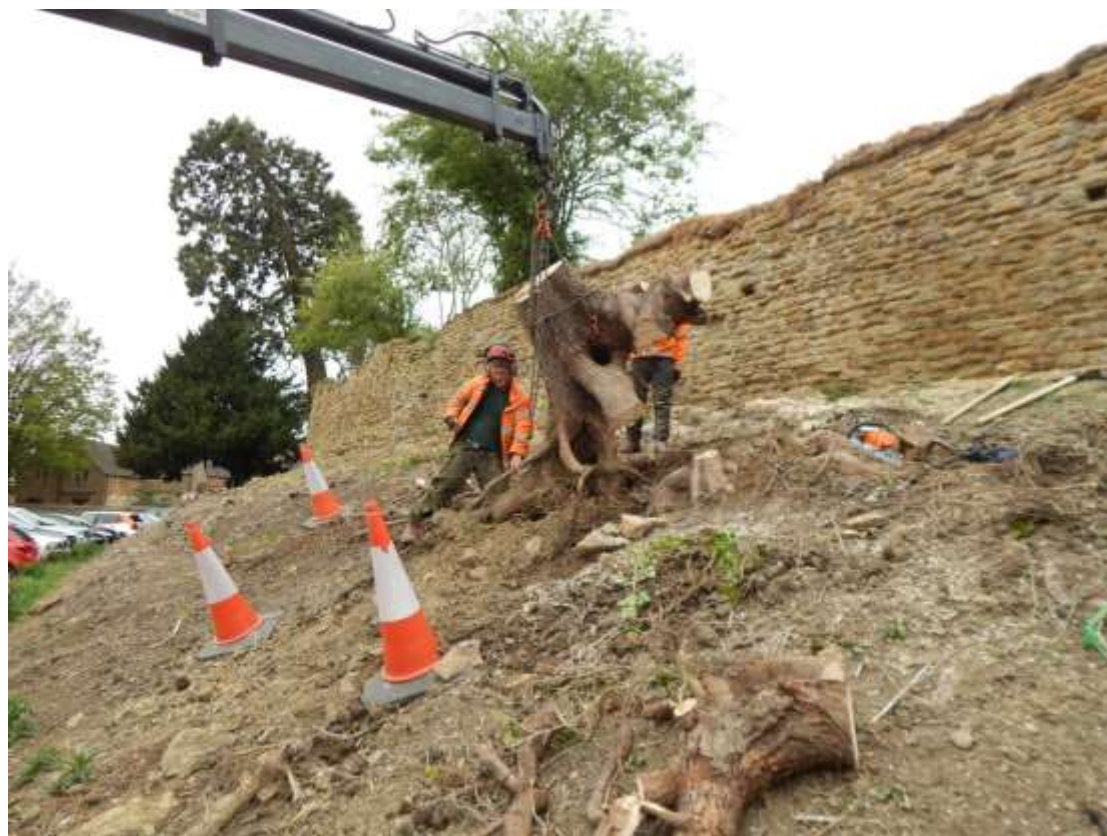
Plate 55: The large conifer root bole being removed, looking south

During February 2017 Storm Doris brought 94 mph winds and rain to the UK, causing destruction throughout the Midlands, and this included Oakham. Parts of a large oak were damaged in Cutts Close and a large conifer fell in the Birley Road Car Park, damaging a number of cars. The main part of the trunk and branches were removed soon afterwards leaving a large stump and roots.

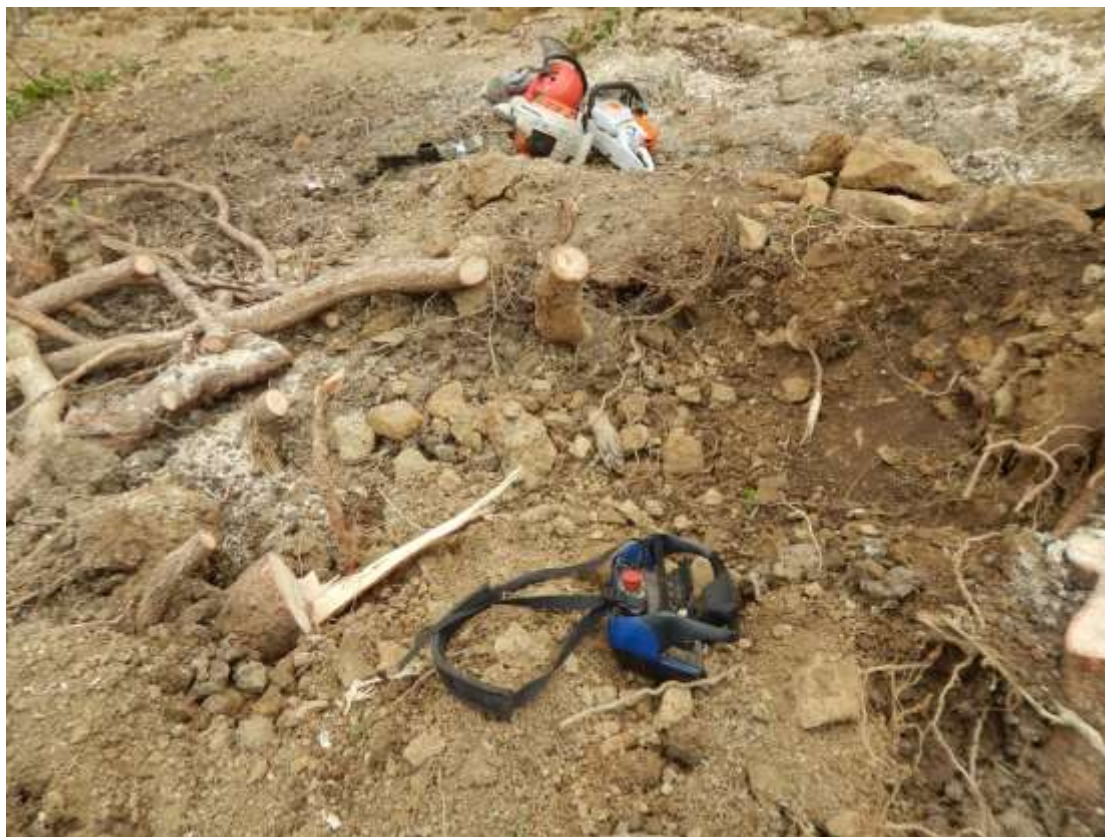
Plate 56: The hollow left by the removal of the root bole

After the root bole was removed the remaining root system was cleared leaving a shallow hollow around 0.10m deep (Plate 56). No archaeological features were observed and only a pair of modern beer bottles were retrieved from the upper soils.

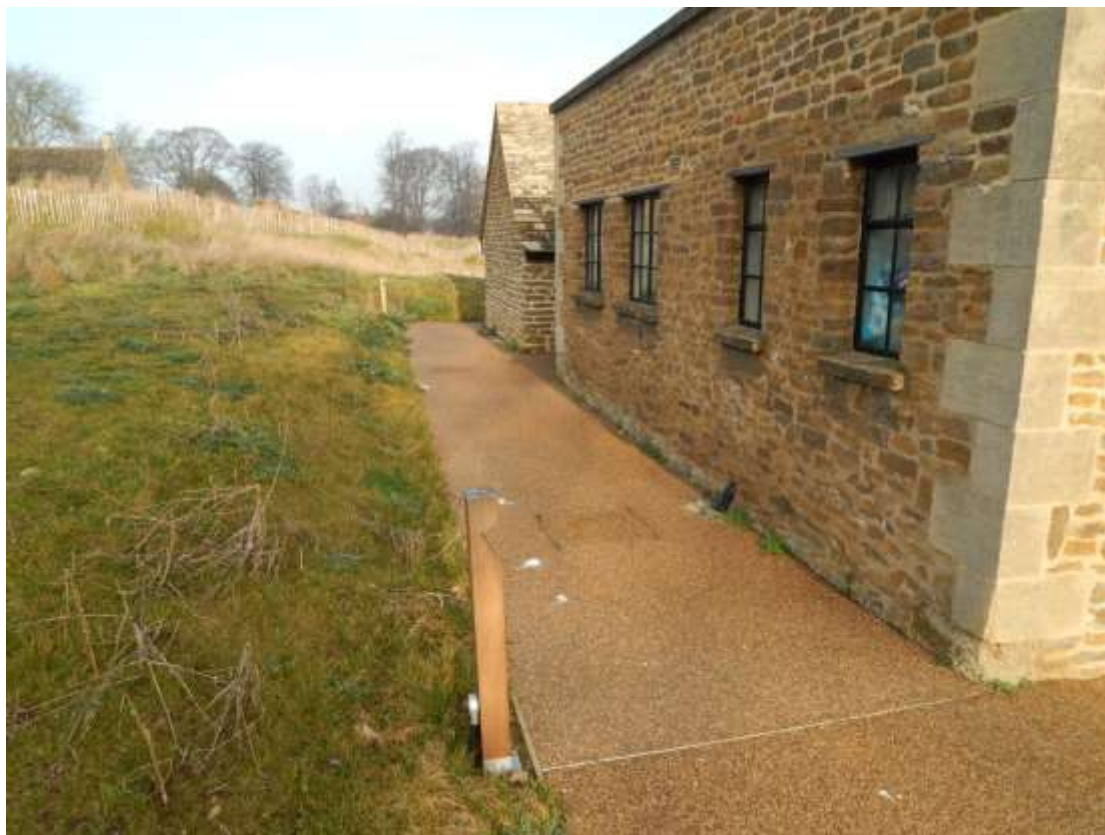
Plate 57: The new access path around the western side of the Great Hall, looking north

After the work here the pathway here was widened and a new surface laid to provide access to the western side of the hall (Plate 57).

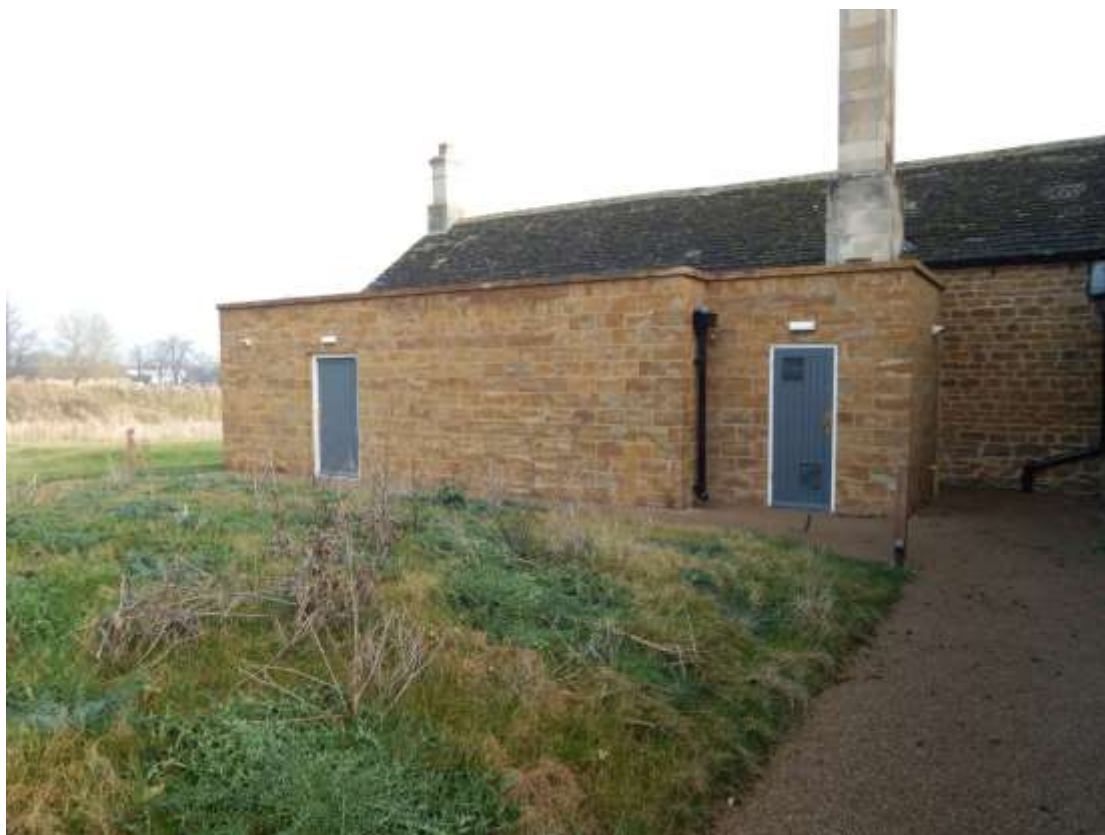
Plate 58: Completed new toilet block, looking east

Following the archaeological work here; work started on the new toilet block and facilities (Plate 58).

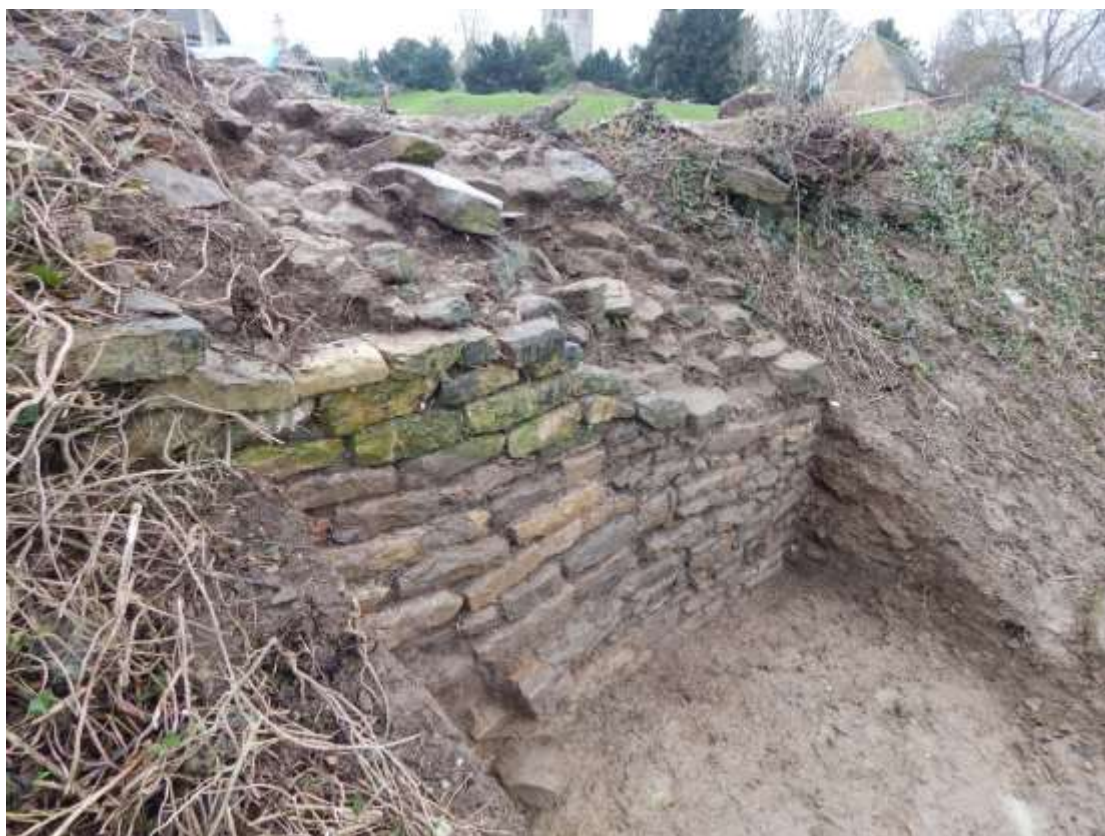
Plate 59: The curtain wall in the evaluation trench, looking south-west

The evaluation through part of the northern defences revealed a section of the wall and rampart of around 1.8m wide, but it was unknown whether this is the original width due to the internal face being re-faced with probably displaced stone and concrete, perhaps as a blocking measure to prevent the core material from collapsing. Sections of wall had collapsed and eroded across the ramparts.

The external face of the curtain wall had survived fairly well with up to at least seventeen courses exposed during the evaluation (Plate 59). It was constructed of roughly hewn ironstone blocks of differing sizes and shapes, and was roughly coursed and earth bonded. The depth and extent of the wall is unknown, but appears to have been cut into the rampart material.

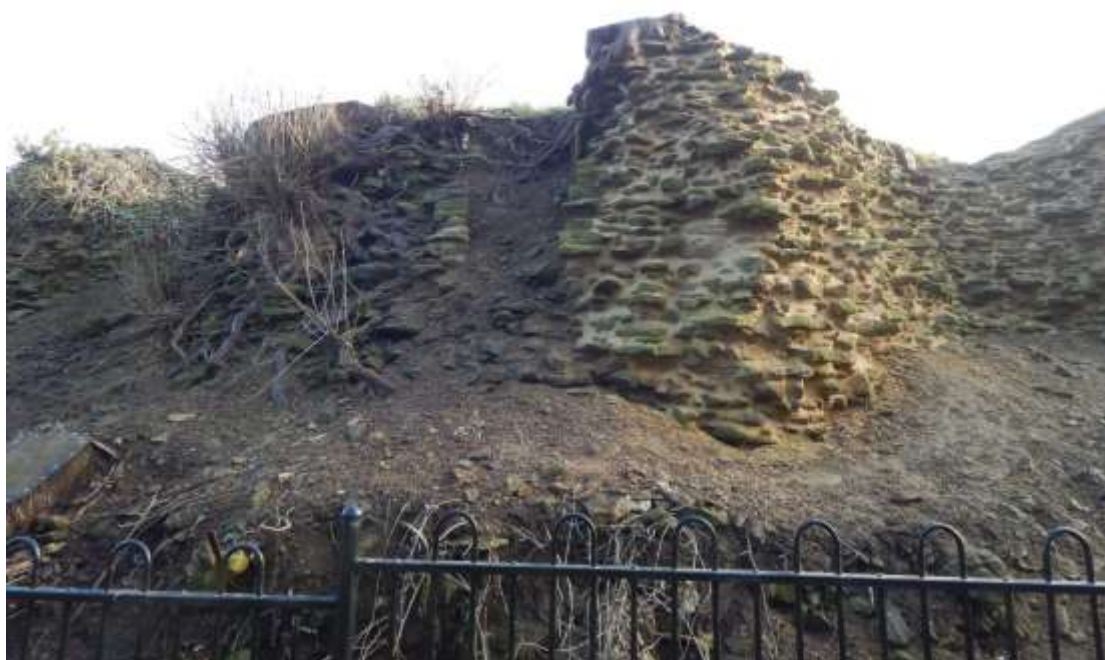
Plate 62: The restored postern gate in 2017, looking east

The modern grotto and the postern gate area have been preserved, although the restoration of the postern gate has not revealed any more information about the feature, mainly as it has been so heavily disturbed by large tree growth and erosion.
