**A Level 2 Historic Building Report  
for outbuildings at  
The White House,  
Main Street,  
Ullesthorpe,  
Leicestershire**

ULAS Report No. 2017-164v2  
©2017

**For: Mr and Mrs Brown**

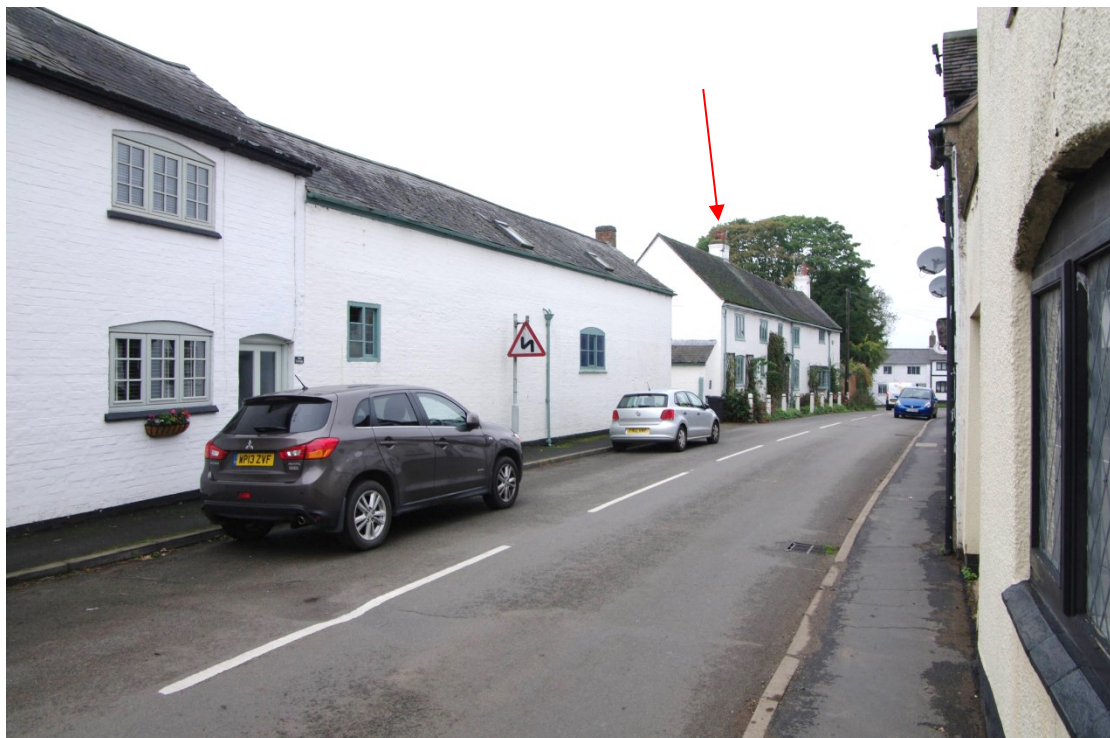
Figure 3 Site from Main Street  
Looking west. White House shown with red arrow, north range outbuilding in the foreground

Main Street (Figs 3 and 4). The outbuildings and former stables form a small, partially enclosed, courtyard on the eastern side of the house and driveway.

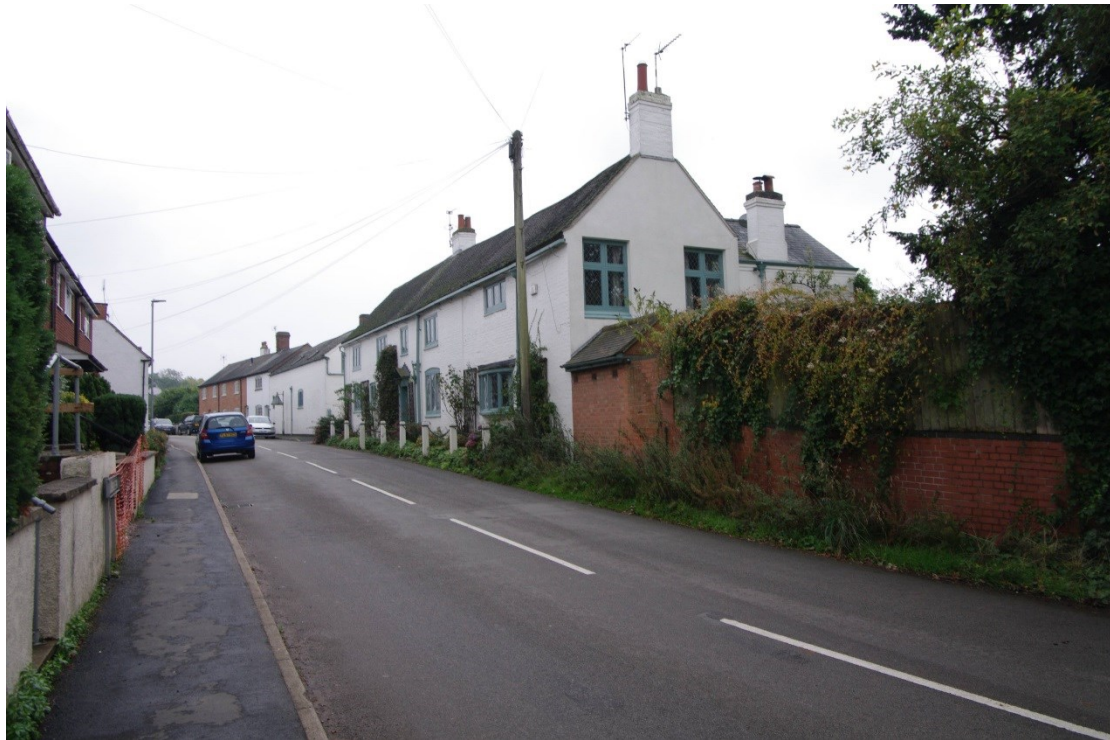
Figure 4 Site from Main Street  
Looking south-east

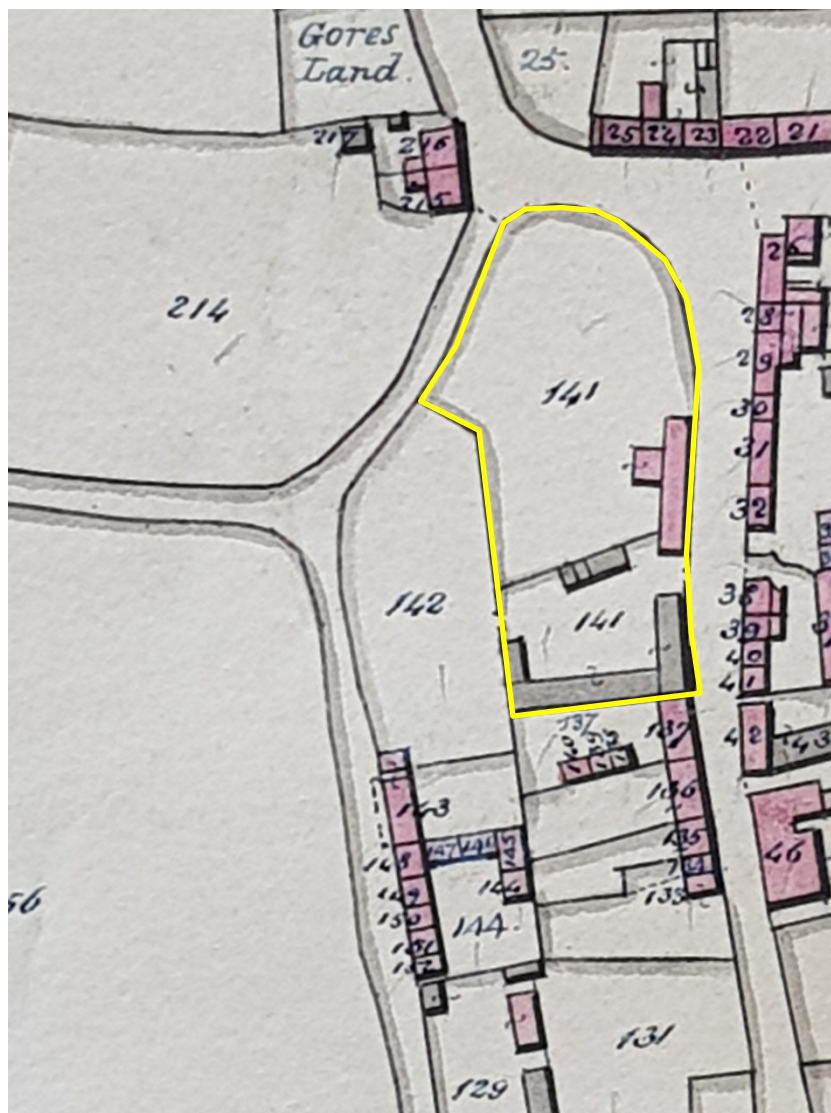
Figure 6 Detail from the 1839 Tithe map  
Site highlighted. North to right of plan. Outbuildings shown in grey, house in pink

The first available map showing any useful details of the site is the 1839 Tithe map which shows the White House apparently as a single dwelling with the small detached outbuilding block to the south-east (Fig. 6). The stables appear to be much larger than they are at present and have a range running along the eastern boundary of the site which then turns along the southern boundary. A plan produced in 1840 for Robert Goodacre which depicts all of his holdings within Ullesthorpe and shows the same site layout of The White House and outbuildings. The inventory attached to the 1840 plan states that the White House site consists of the house, buildings, garden and a fold and that it was rented to a Mr Charles Watson.

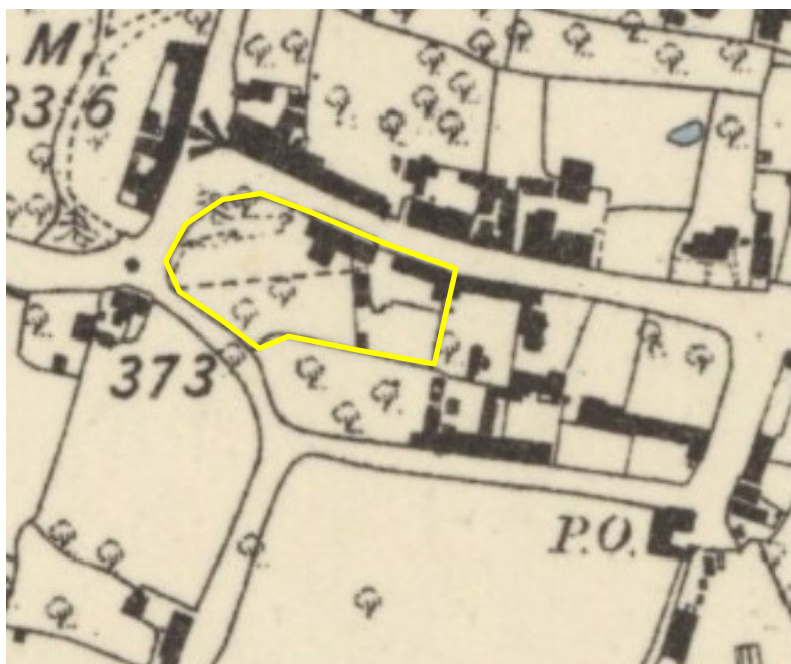
Figure 7 1886 First Edition Ordnance Survey map Sheet XLVIII.NE. Original scale 6 inch to 1 mile

The next available map is the First Edition Ordnance Survey map published in 1886 shows the house in a similar state but the southern end of the easternmost **outbuilding range has been shortened** in length and the east-west small outbuilding which joined the bottom of this range has also been removed (Fig. 7). The yard also appears to have been subdivided from east to west, possibly as a continuation from Robert Goodacre's fold. The Second edition published in 1904 shows no change to the layout or size of the buildings. The 1951 edition shows the same details but by the time of the 1963 edition the eastern range has been extended to its present length.

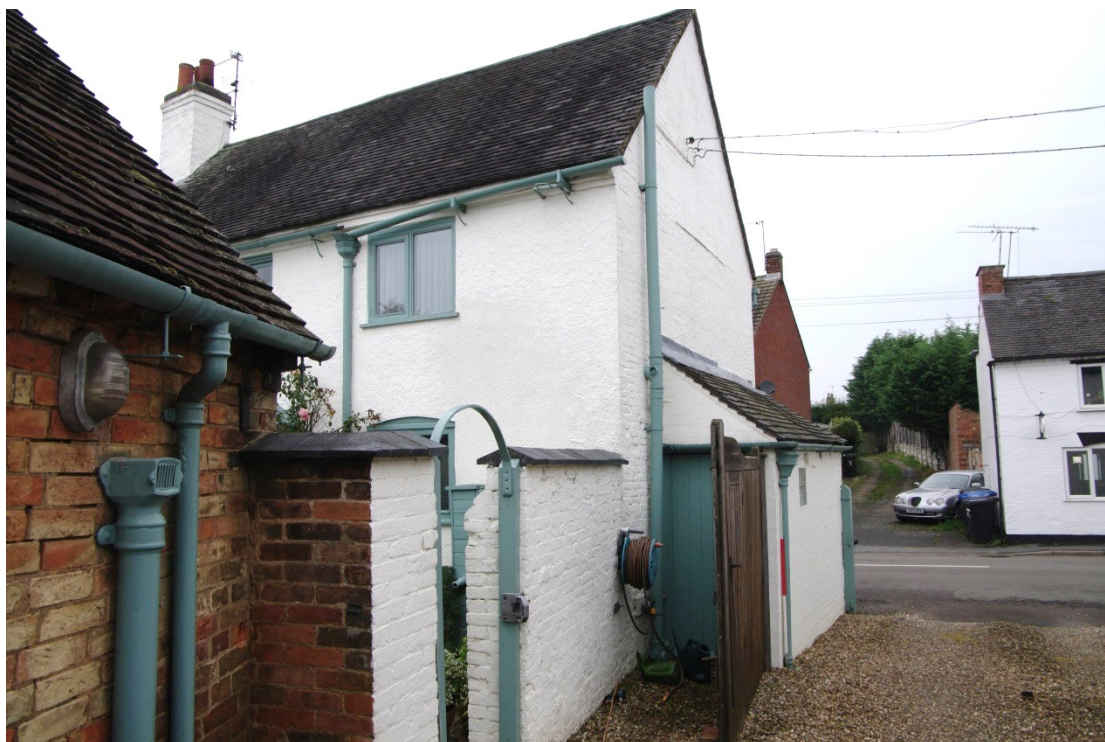
Figure 8 Lean-to which is to be demolished  
Looking north. 1m scale.

The proposal to remove the small lean-to attached to the eastern end of the White House should have no significant effect upon the historic fabric of the house provided it is carried out carefully. The brickwork of the lean-to appears to be butted against the house wall and is clearly of a much later date than the house.

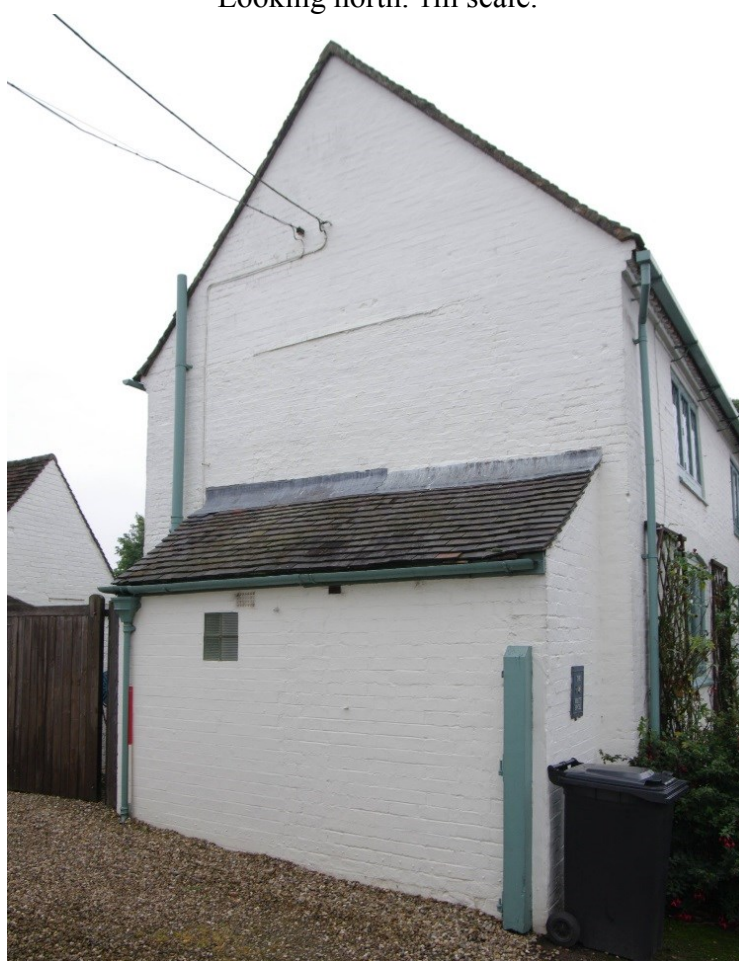
Figure 9 Lean-to on main house  
Looking south-west from road. 1m scale

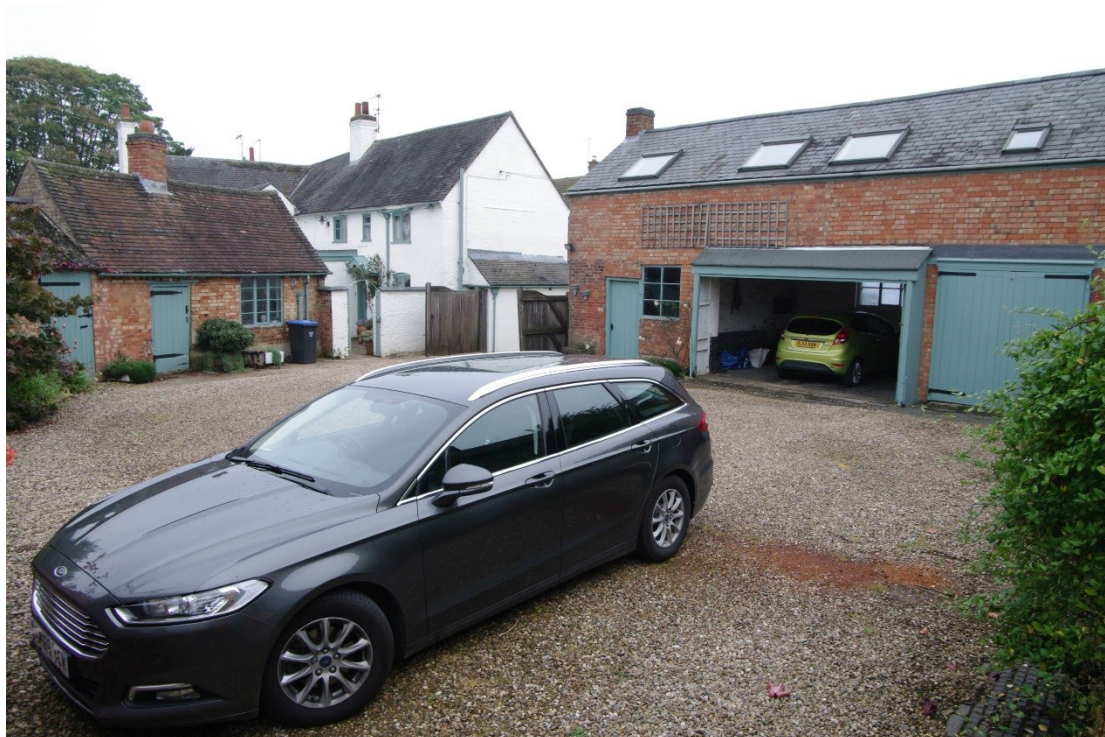
Figure 10 General view across courtyard  
Looking north-west

The outbuildings, which will be converted into domestic dwellings, consist of two small single storey outbuildings joined together at their gable ends on the western side of the courtyard and an L-shaped range of former stable buildings on the north and eastern side of the yard (Figs 10 and 11).

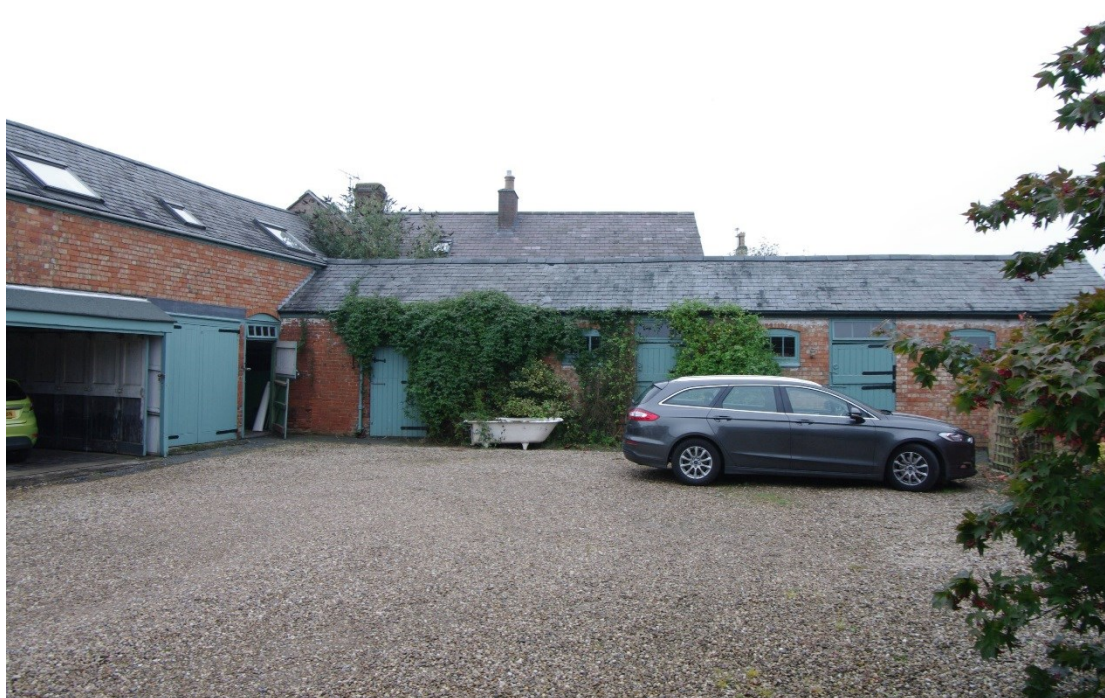
Figure 11 General view across courtyard  
Looking east

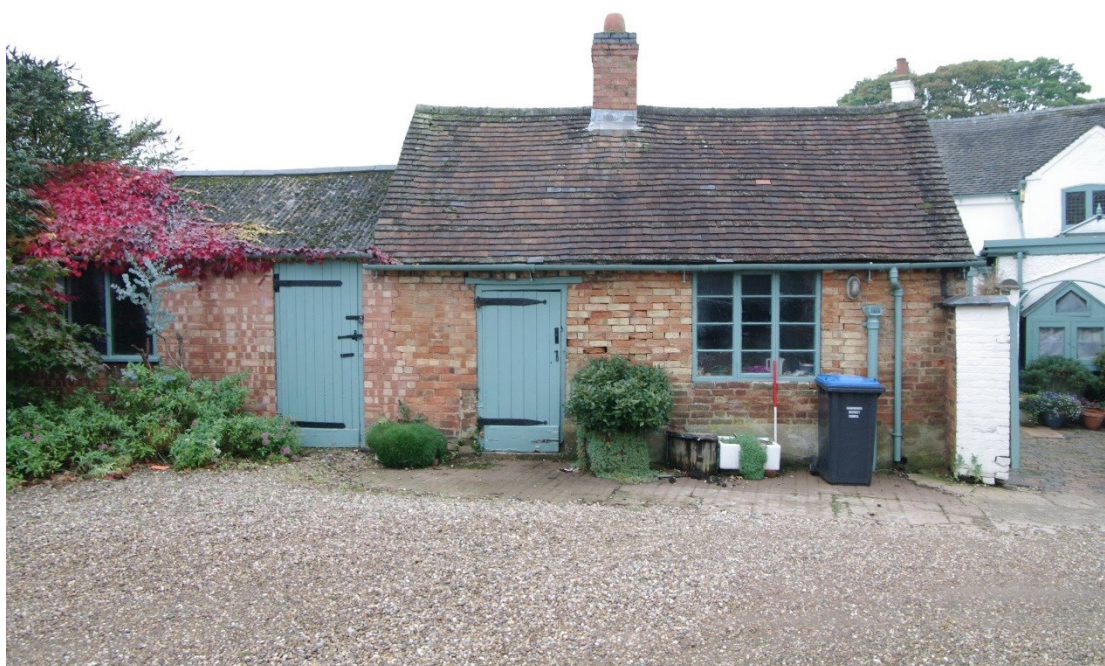
The freestanding outbuildings on the western side of the courtyard consist of two single storey brick-built structures joined at their gable ends and facing eastwards into the courtyard (Fig. 12). The northernmost of the two buildings has a steeply pitched tiled roof, whilst the southern building is lower and has a modern corrugated sheet roof (Figs 13 to 15). The 1839 tithe map indicates that the northern building, consisting of two rooms, was present at that time but that only a small, single roomed structure was attached to its south end. The east facing elevation suggests that the southern building is relatively new as the brickwork appears to date from the middle of the 20th century and uses hard-fired mass produced bricks. It is clearly newer than the northern building which uses softer-fired yellow and cream coloured bricks which are showing signs of frost damage and weathering. The northern building has a plank door with handmade strap hinges and evidence of a wooden lock case which has now been removed. The door to the southern building is modern.

Figure 13 Outbuildings, east facing elevation  
Looking west. 1m scale

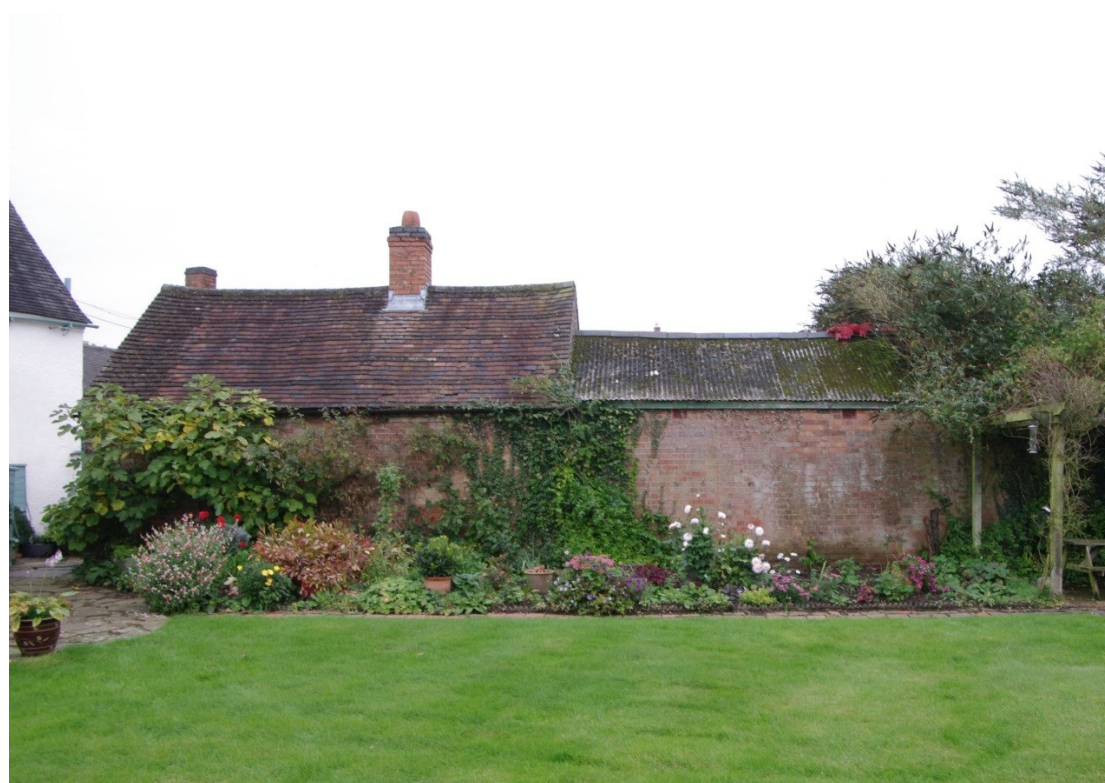
The west facing elevation of both buildings, facing into the garden, is partially obscured with vegetation and ivy making detailed observation difficult (Fig. 14). However, both elements appear to be solid brick walls with no evidence of blocked windows or doors. The brickwork of the southern building is possibly late 19th century suggesting that it began life as a garden wall which was then adapted to become a roofed building.

Figure 14 Outbuildings, west facing elevation  
Looking east

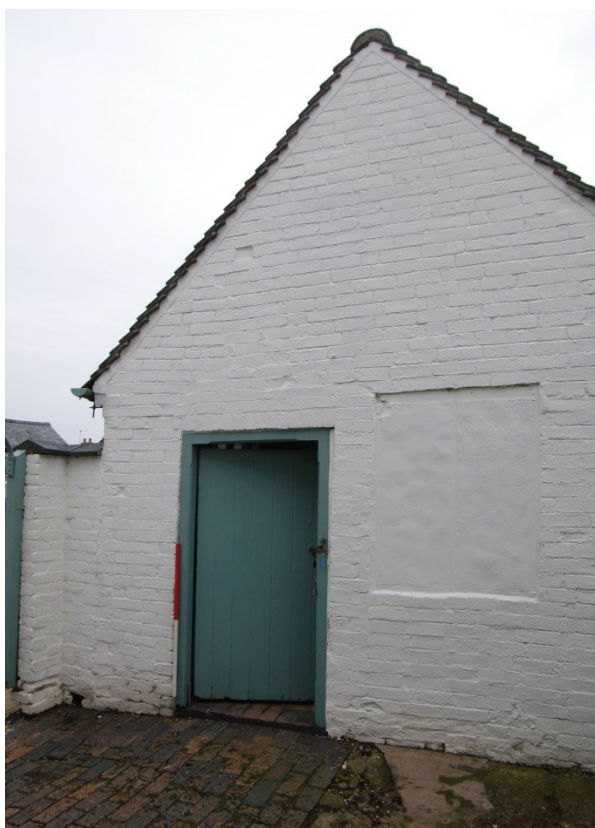
The north facing gable end elevation of the northern building faces towards the back door of the house (Fig. 15). It has a blocked window to the west of the plank door.

Figure 15 Outbuildings, north facing elevation  
Looking south. 1m scale

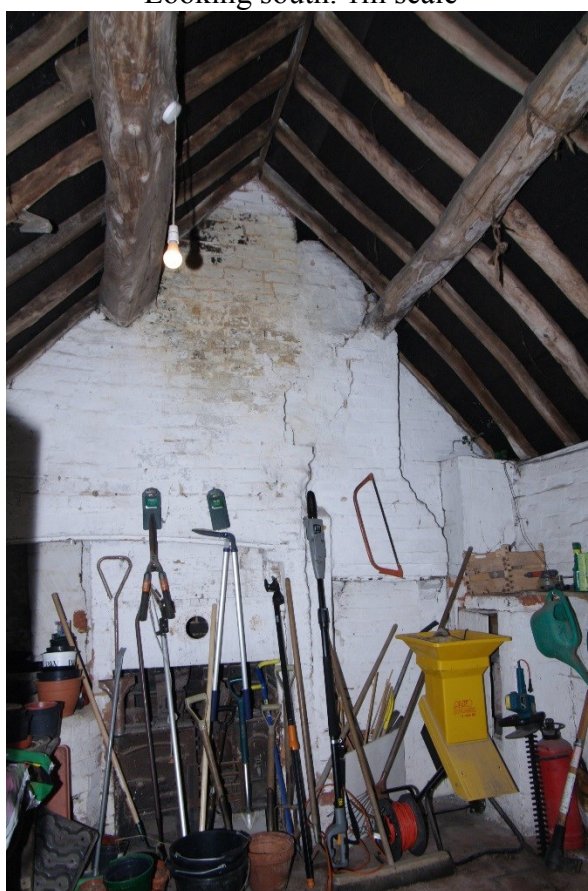
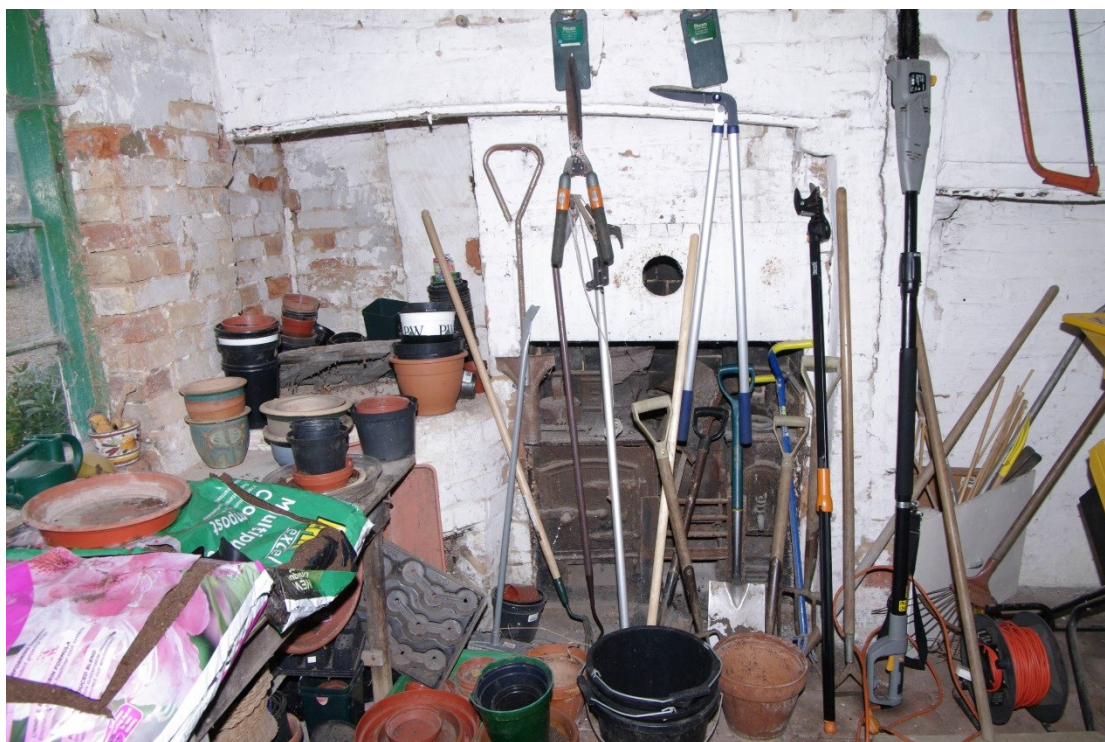
Inside the northern building is the former washhouse which still retains its copper and a small cast iron range built against the south wall (Figs 16 and 17). The floor is paved with square quarry tiles. The door is plank-built and has a wooden lock case, probably of late 18th or early 19th century date (Fig. 18). The roof is supported by two very substantial purlins which have been roughly shaped but are still relatively unworked. Their size within such a small building suggests that they may have been recovered

Figure 16 Inside northern end of northern outbuilding  
Looking south

Figure 17 Copper and range in northern end room  
Looking south

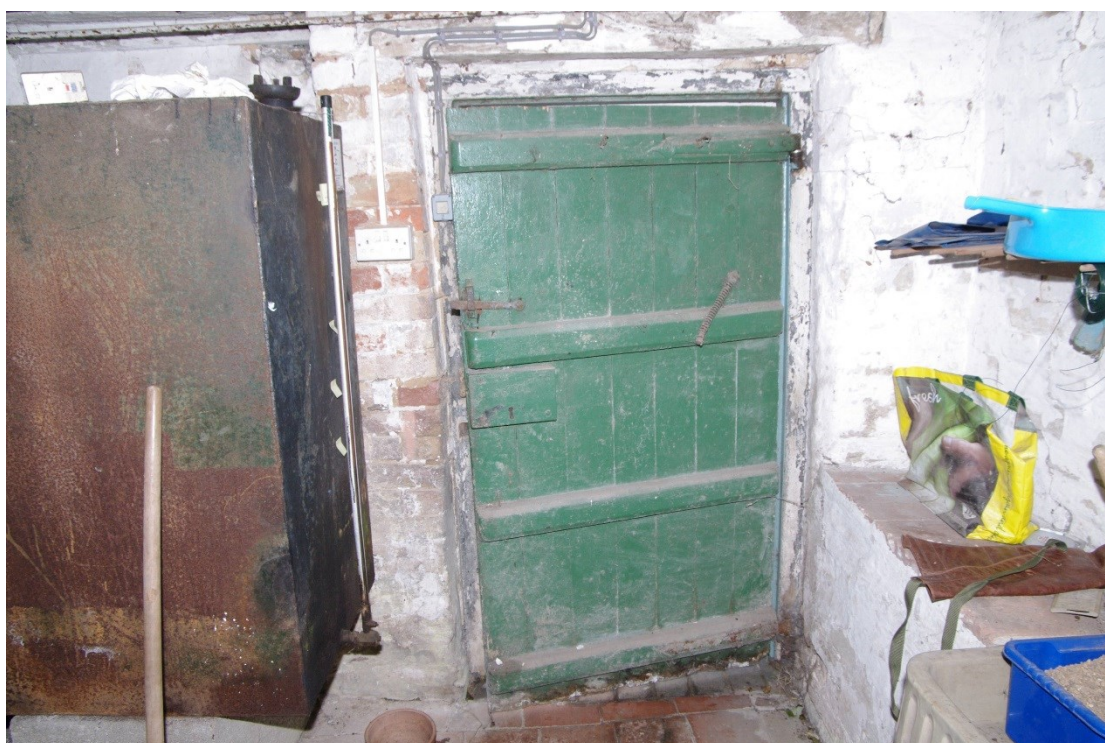
Figure 18 Outbuildings northern room, door detail  
Looking north

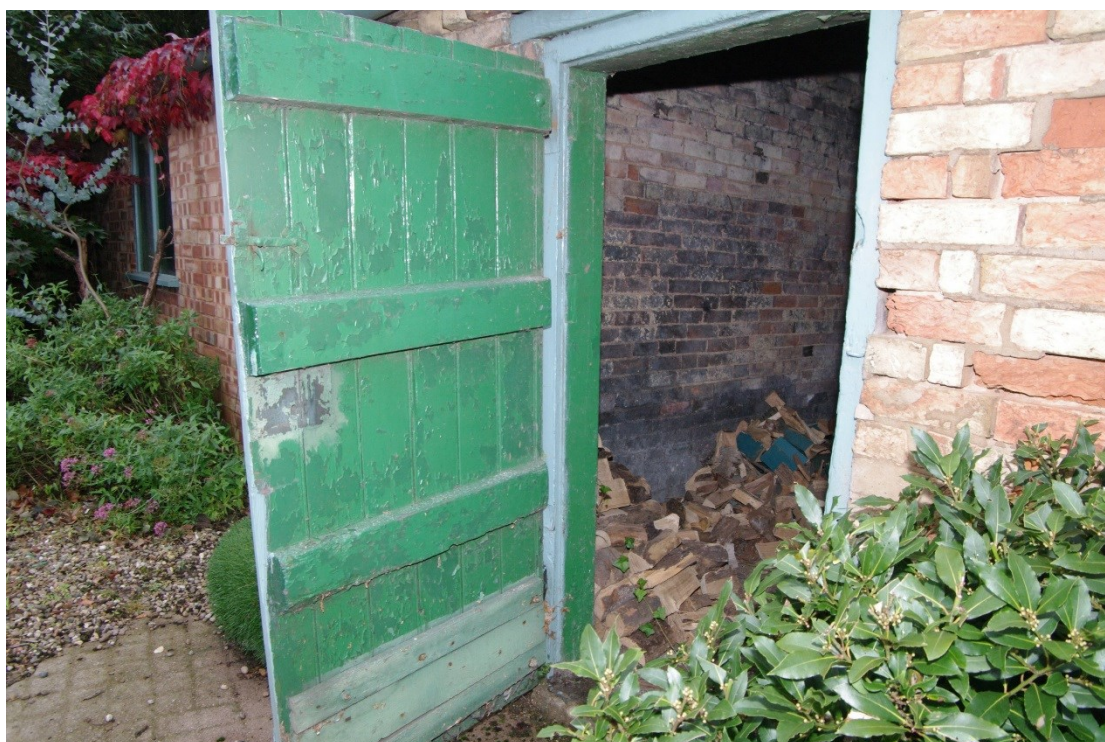
The southern room of the northern outbuilding is reached via a door on the east facing elevation (Fig. 19). This is an empty room and presently used as a wood store. The roof structure is the same as in the northern room and the floor is laid with stone cobbles. The south wall has bricks matching the rest of the northern building indicating that the northern outbuilding were built in a single episode.

Figure 19 Doorway into south room of northern outbuilding  
Looking south-west

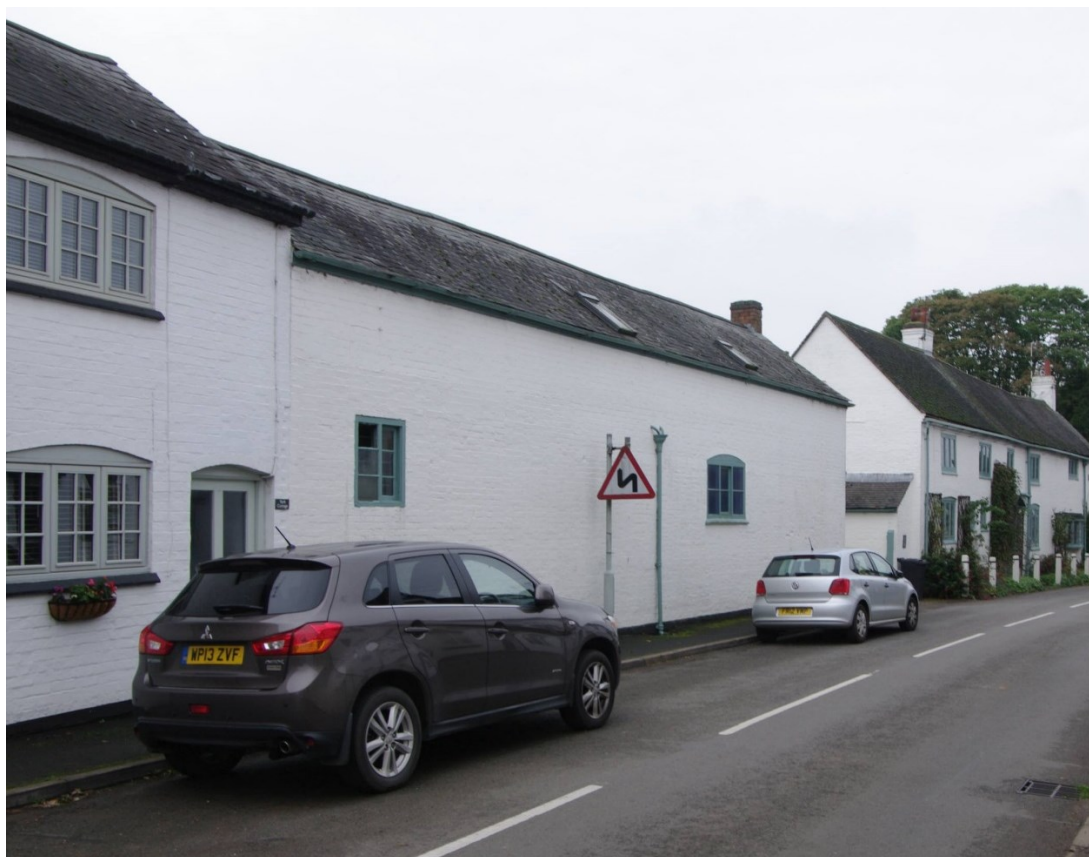
The north facing elevation of this range faces out onto Main Street and forms a white painted brick façade broken only by two casement windows (Fig. 22). The windows appear to be of a different date to each other as the western one has a low arched lintel whereas the eastern is flat. At lintel height there is a trace of a change in brickwork where the wall appears to have been raised. This was confirmed by the owner who said that within living memory the building had been raised from a fairly low thatched building to its present form.

Figure 22 North range stables on Main Street  
Looking south-west

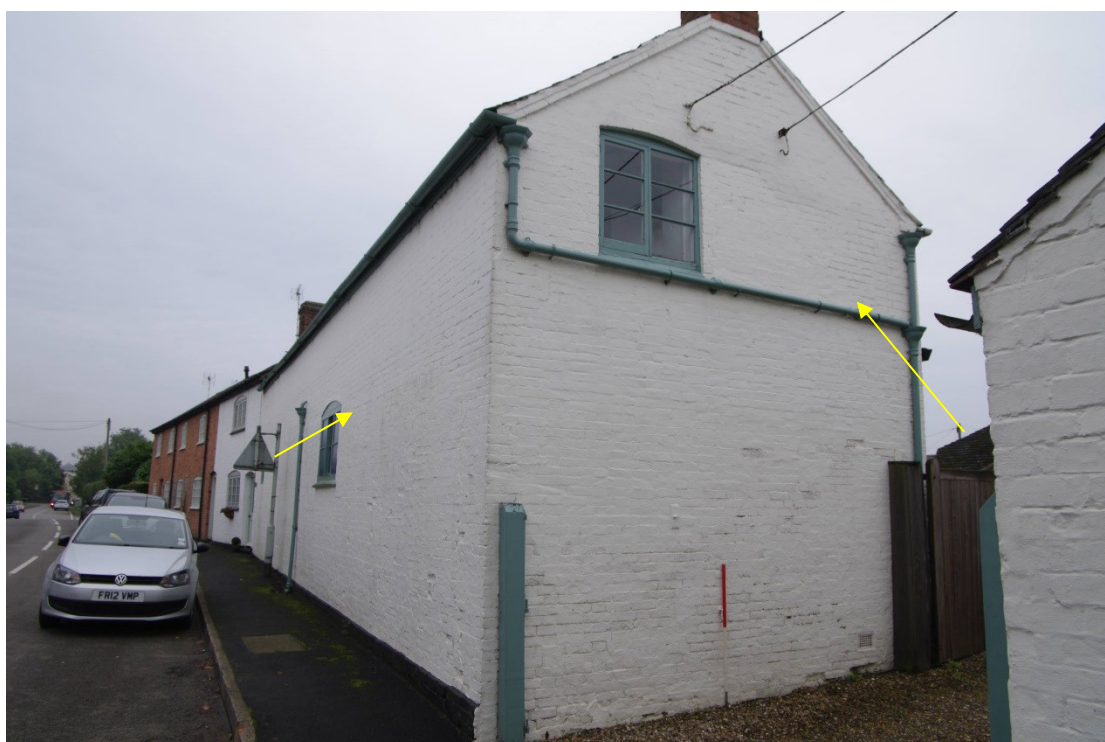
The west facing gable end also shows evidence of being raised in height (Fig. 23). A clear line in the brickwork can be seen which matches the change in brickwork seen on the north facing elevation. Such a modification would most likely require a change in the pitch of the roof from thatch to slate and would result in the brickwork changes seen here. The first floor window cuts across this joint so is likely to date from, or after, this change.

Figure 23 North range stables, west facing elevation  
Looking south-east. 1m scale. Arrows point to original wall and gable height

The roof of the north range was raised in the 20th century and may coincide with the alterations of the shutter doors added to create a garage. The present eastern range is a relatively late addition but is sat upon the footprint of an earlier range of buildings which had been demolished prior to 1886. It is possible that the present eastern range was built at the same time, or close to the time, when the north range was modified.

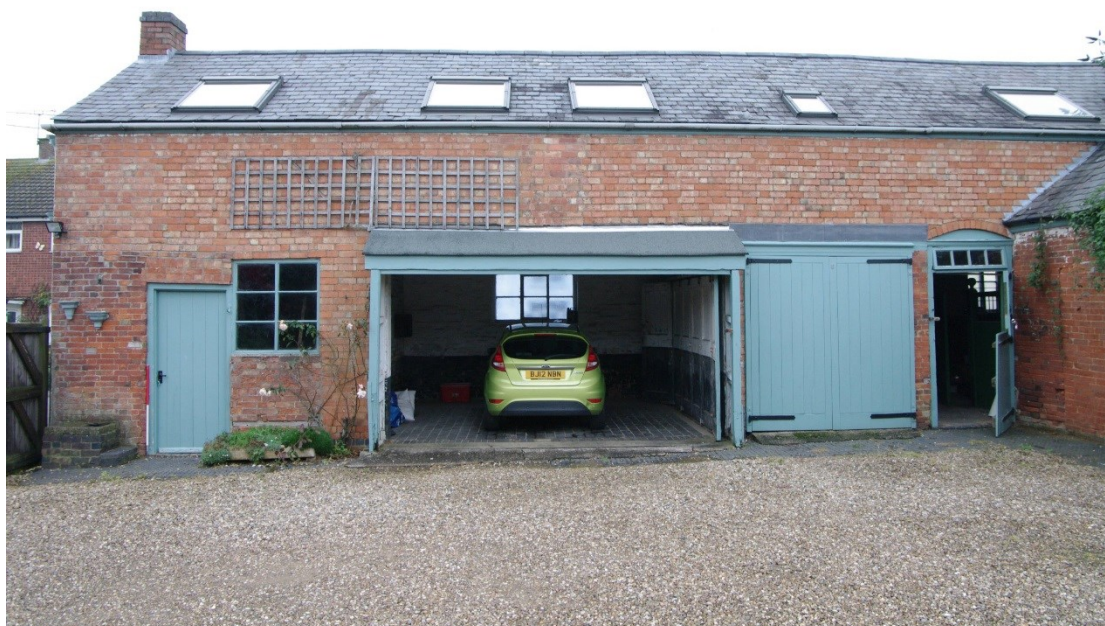
The south facing elevation looks into the courtyard (Fig. 24). Because this elevation has unpainted brickwork the change in bricks where the roof was altered can be seen more easily. Because the eaves are so low the first floor rooms are lit by modern Velux style roof lights rather than windows in the walls. At the western end of the elevation the brickwork shows evidence of a number of modifications, patches and repairs suggesting that the façade of the building has undergone a number of changes during its lifetime. A small doorway with a fixed-paned window set very close to it is located within the modified brickwork at this end. The main doorway into the range has a sliding garage door which probably dates to just before or just after the Second World War. This is likely to have been modified from a carriage shed to a garage for the newly introduced car which was becoming more widespread around this time. A pair of

Figure 24 North range, south facing elevation  
Looking north. 1m scale

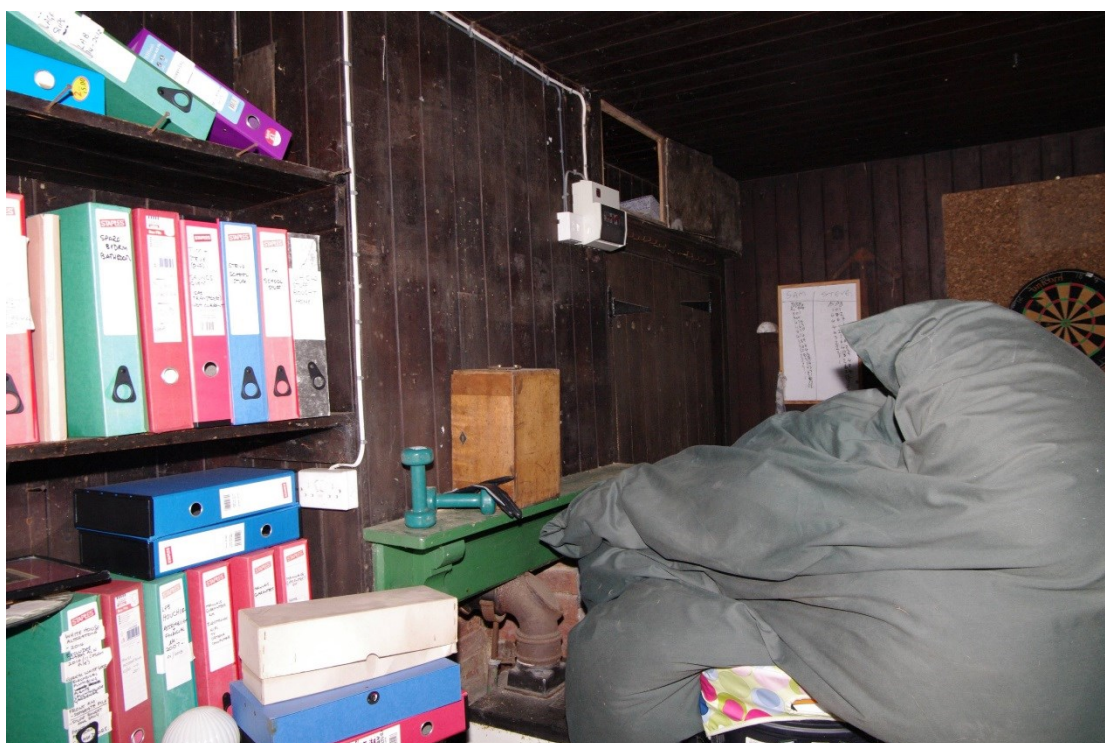
Figure 25 North range ground floor, west end room  
Looking north-west from doorway

The westernmost ground floor room is accessed via the single doorway close to the western corner. At the time of the survey the room was in use for storage making close inspection quite difficult. It is clad with dark matchboard and has a small fireplace with a wooden mantelpiece on the west wall (Fig. 25). The fireplace has been removed leaving the mantelpiece which appears to be of late 19th century date. A set of steep steps is located in the south-east corner and goes up to the first floor (Fig. 26).

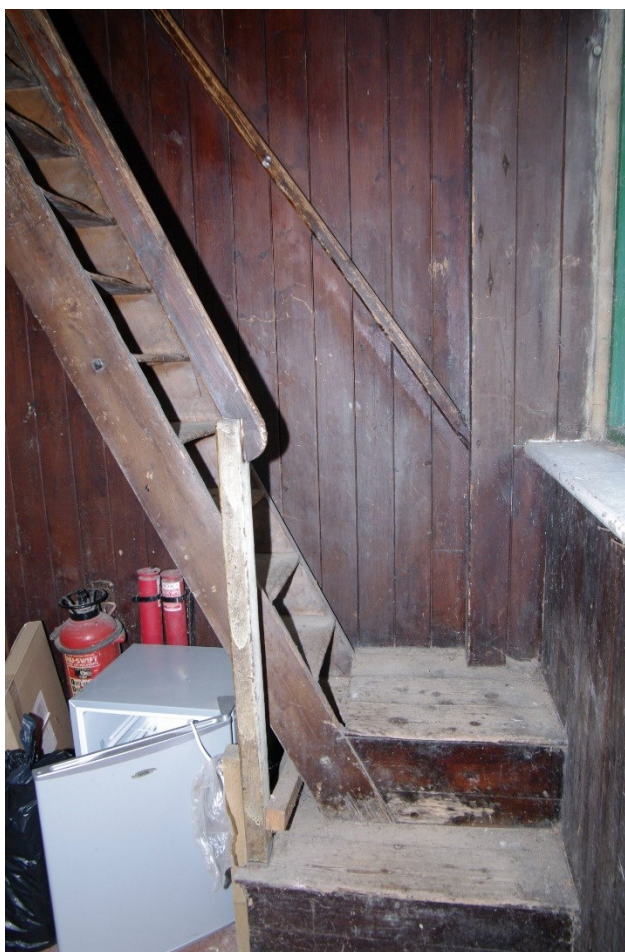
Figure 26 North range ground floor, west end room stairs  
Looking east

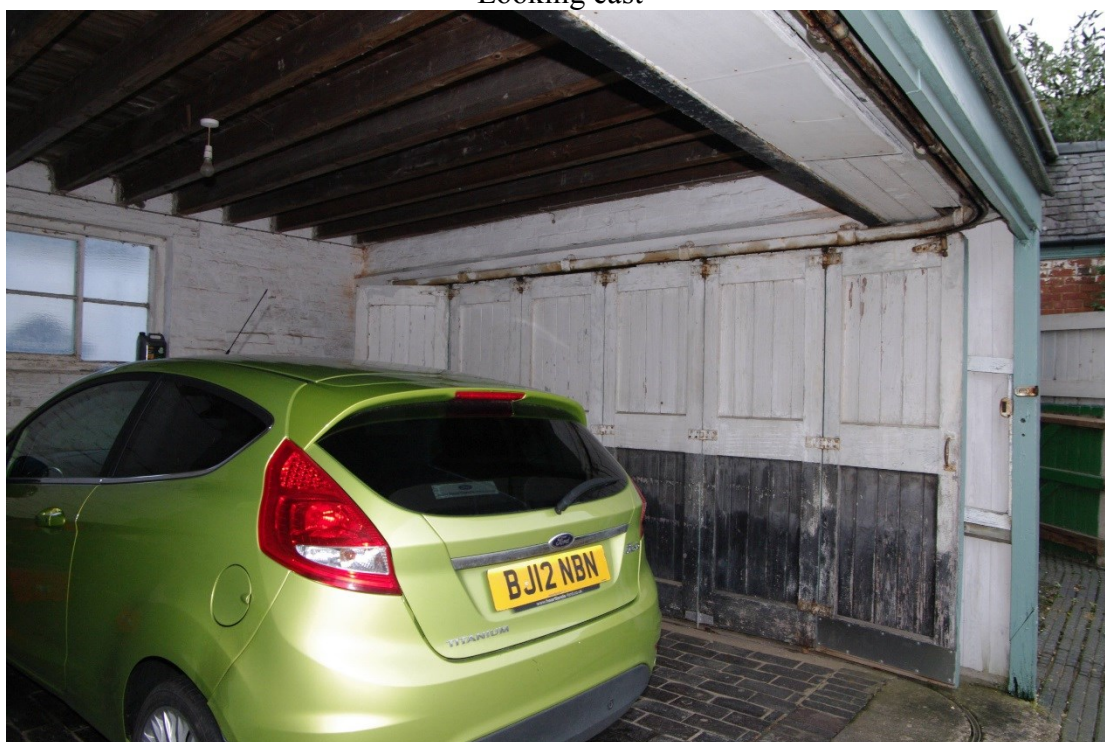
The next room to the east has been modified, as discussed earlier, by the addition of the sliding garage door (Fig. 27). It has a blue brick floor which appears to be relatively modern. The walls are brick painted with a black dado and white upper. No fixtures or fittings remain from the possible former carriage shed. Between the garage and the easternmost room is a narrow room which was not accessible at the time of the survey.

Figure 27 North range ground floor, garage  
Looking north-east

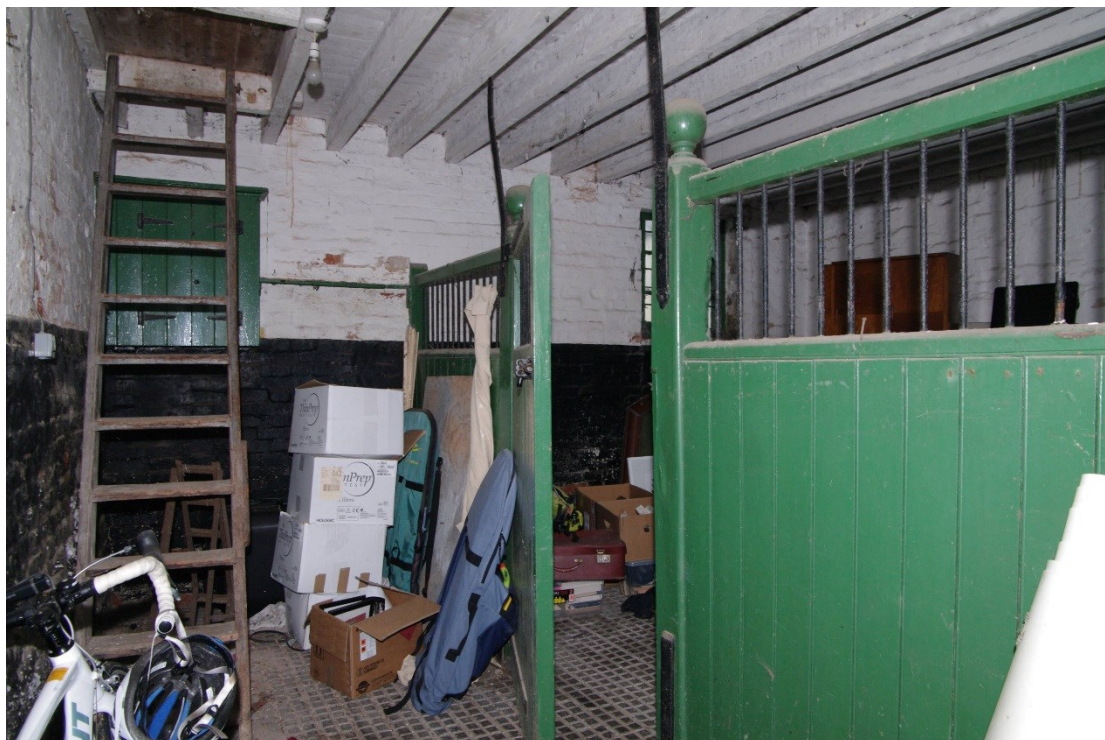
The easternmost room retains its large loosebox which fills most of the room (Fig. 28). The owner indicated that this may have been used for the stallion which kept him away from the other horses. The floor is laid with blue stable paviments. A set of narrow ladder-type stairs lead up to a hatch in the first floor.

Figure 28 North range ground floor, east end room  
Looking north-east

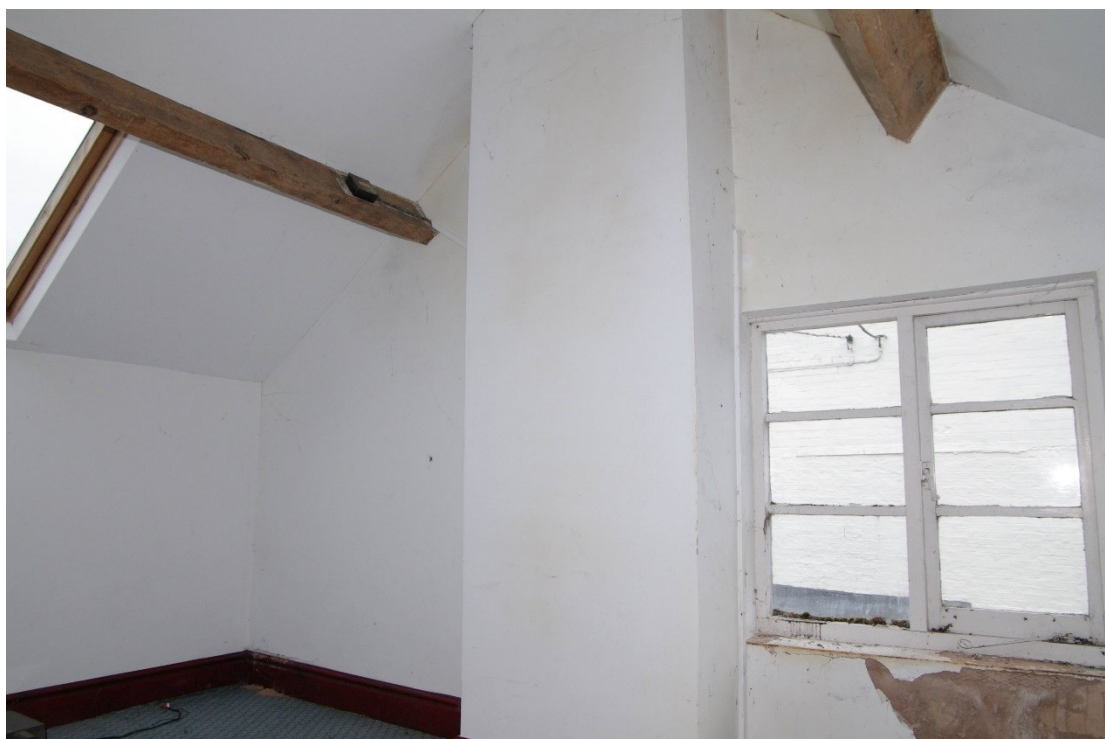
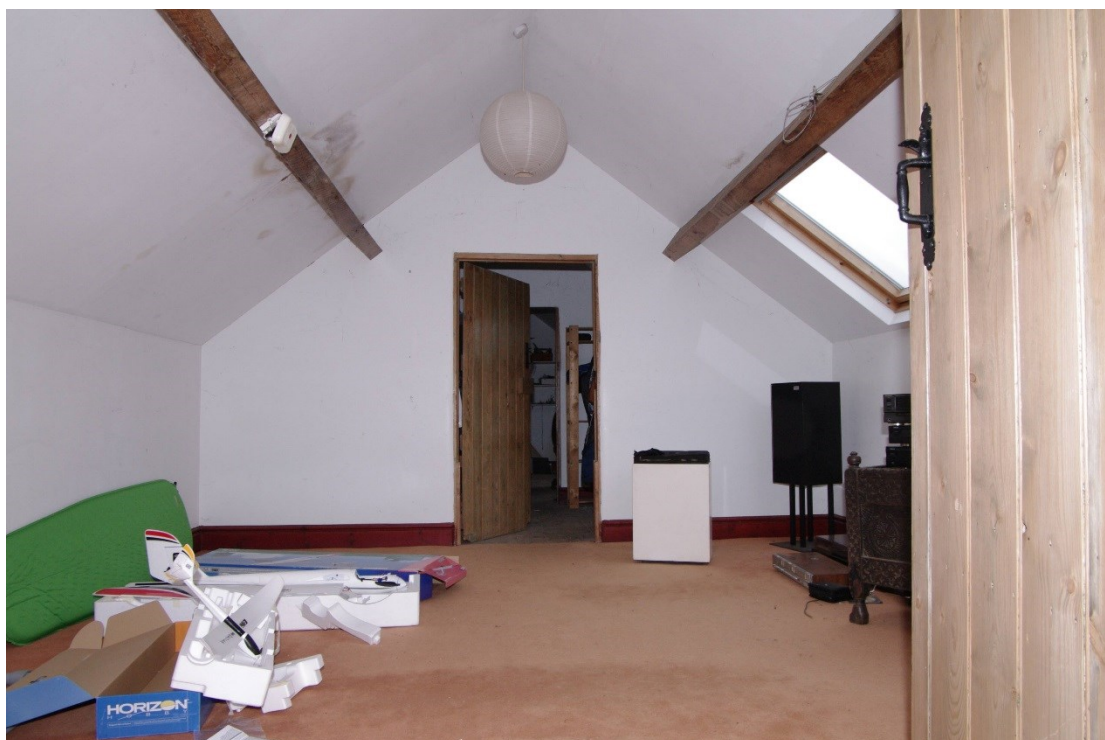
The first floor of the north range consists of a long space subdivided into four unequally sized rooms connected by centrally located doors (Figs 29 and 30). The roof is supported by a pair of sawn purlins running the length of the roof. The rooms are quite plain and have been covered with modern plasterboard. Plank-built doors separate each room. One door has a mid to late 19th century lock attached whilst another door has a wooden lock case. There are no other fixtures or fittings relating to any former uses of the buildings.

Figure 29 North range building, first floor, west room  
Looking south-west

Figure 30 North range building, first floor  
Looking east

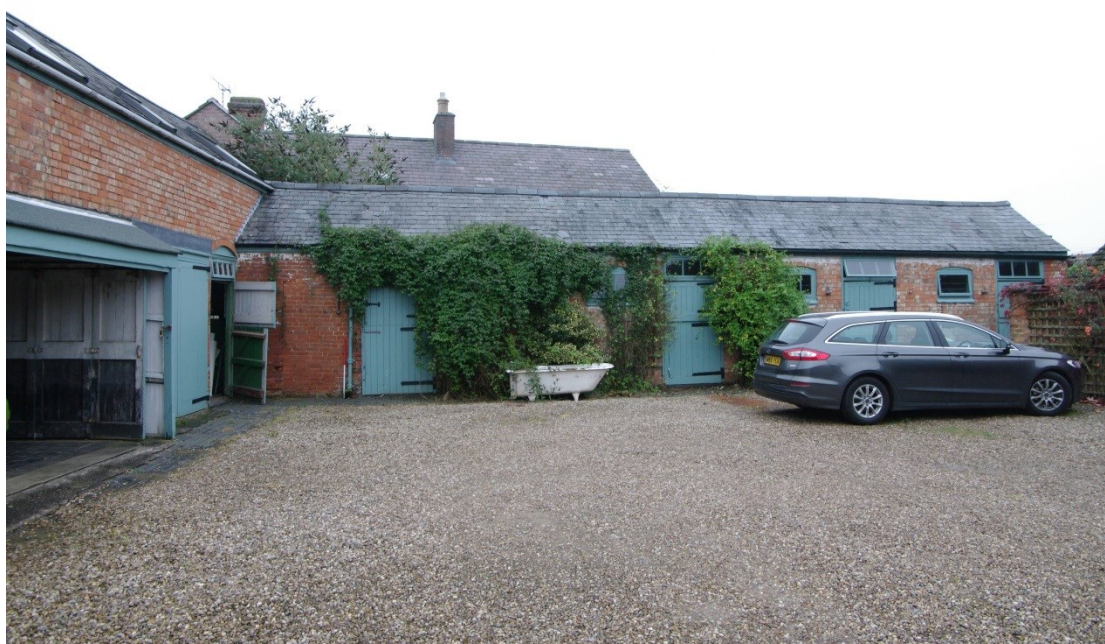
The west facing elevation is the only elevation with any openings and has clearly been built as a stable (Fig. 31). There is a joint close to the north end of the elevation which seems likely to correspond to the shortened stub of building shown in the 1886 Ordnance Survey map. The remaining brickwork appears to be of mid-20th century date, possibly coinciding with the modified garage on the north range. The stable doors have door lights above them and are of similar design (Fig. 32). The south facing gable end is plain brick with no evidence of any former openings (Fig. 33).

Figure 31 East range, west facing elevation  
Looking east. Brick joint to left of 1m scale

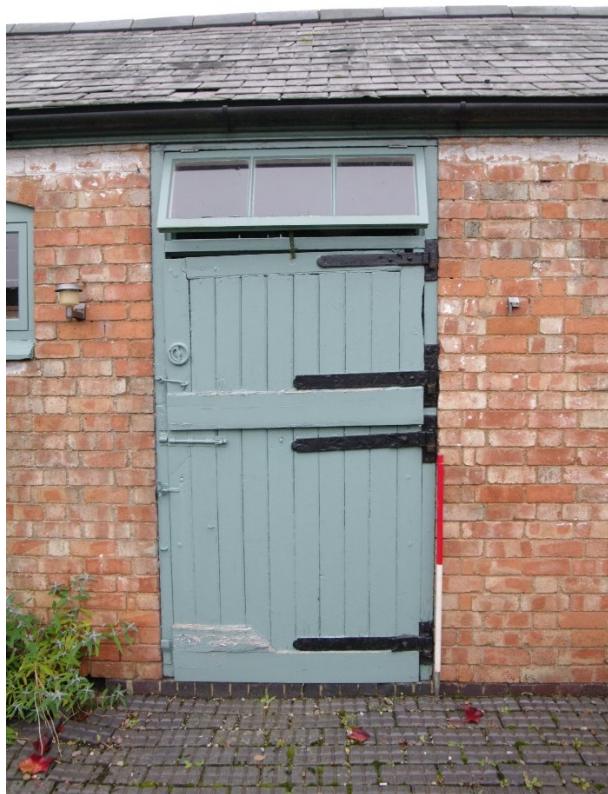
Figure 32 East range, west facing elevation door detail  
Looking east. 1m scale
