**A Level 2 Historic Building Report  
for outbuildings at  
The White House,  
Main Street,  
Ullesthorpe,  
Leicestershire**

ULAS Report No. 2017-164v2  
©2017

**For: Mr and Mrs Brown**

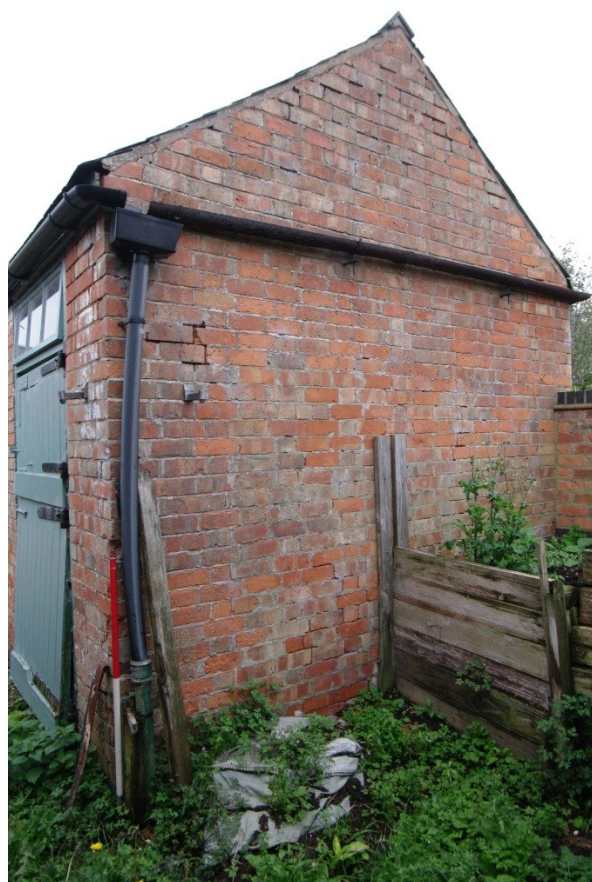
Figure 33 East range, south facing gable end  
Looking north-east. 1m scale

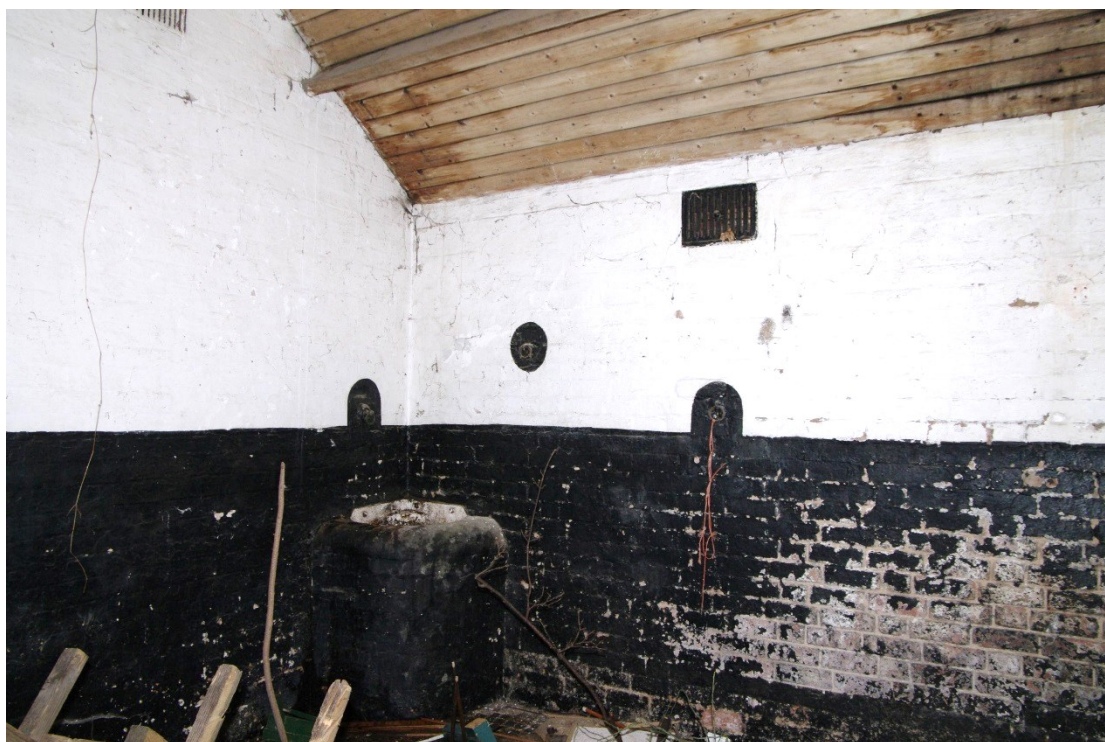
Inside, the east range consists of four rooms with the northernmost room being the largest of the four. The painted walls are brick with a number of iron ring attachments for holding tack and fodder bags etc (Fig. 34). The roof is supported by a pair of longitudinal purlins with close fitting boards covering the common rafters. A semi-

Figure 34 East range, internal detail  
Looking north-east

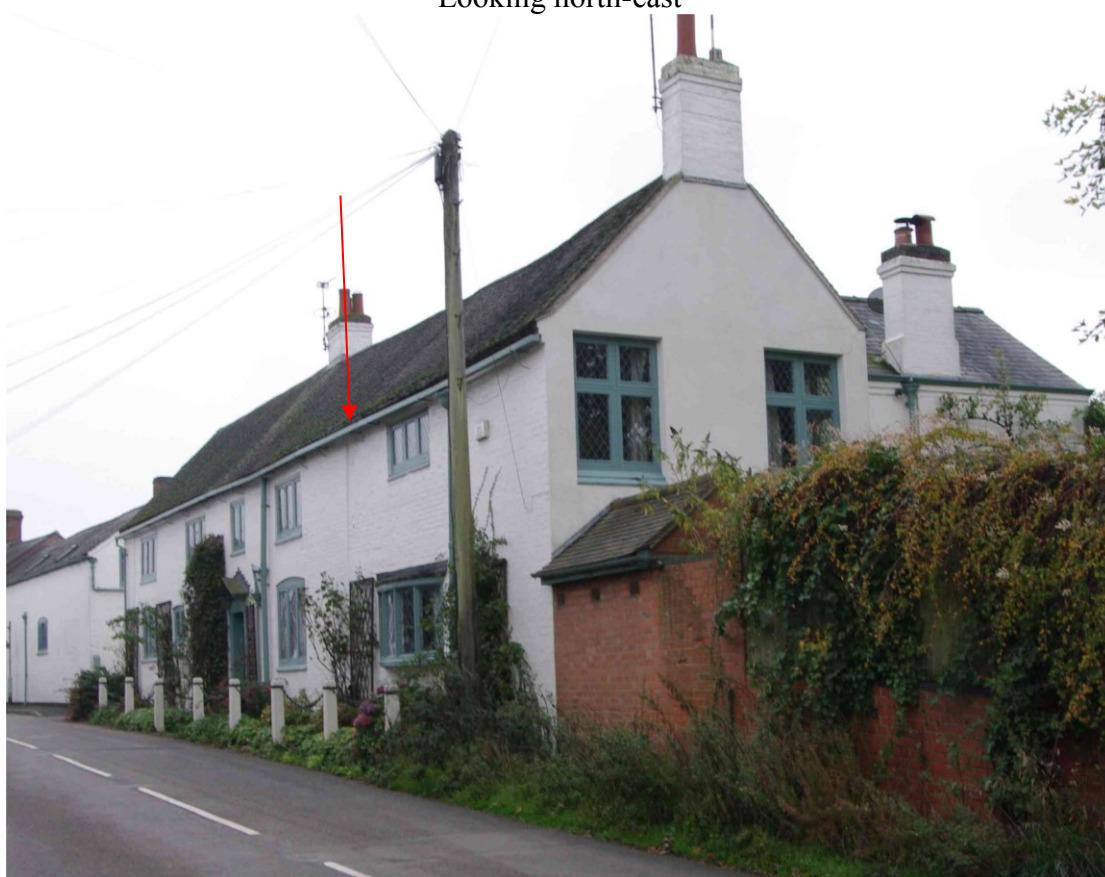
Figure 35 North facing elevation of The White House (western end)  
Looking south-east. Arrow marks joint in brickwork

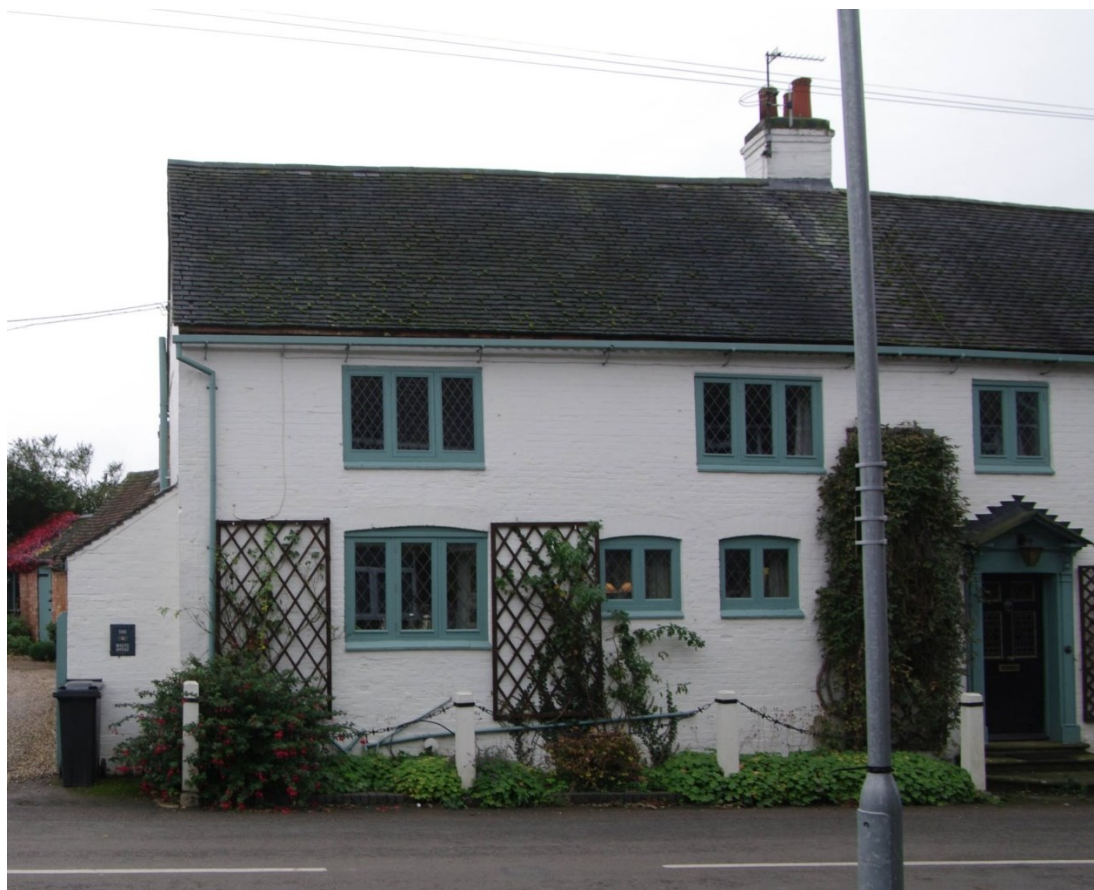
Figure 36 Eastern end of The White House north facing elevation  
Looking south

As noted above, although not physically affected by the proposed works, with the exception of the lean-to which will be removed, the setting of the White House may be affected by the new dwellings. The main body of the White House fronting onto Main Street seems likely to have been built as three separate dwellings although there is no available map evidence to support this. A joint in the brickwork towards the western end of the range indicates that the west end was either added to the existing two dwellings or that they were added to the existing western building. Internal inspection may help to determine the phasing of these buildings (Fig. 35). There is no apparent joint in the brickwork of the two potential dwellings towards the eastern end of the frontage but much of this is hidden by vegetation (Fig. 36). If there is no joint then it is likely that the two were built in a single episode. There are no joints in the roofline.

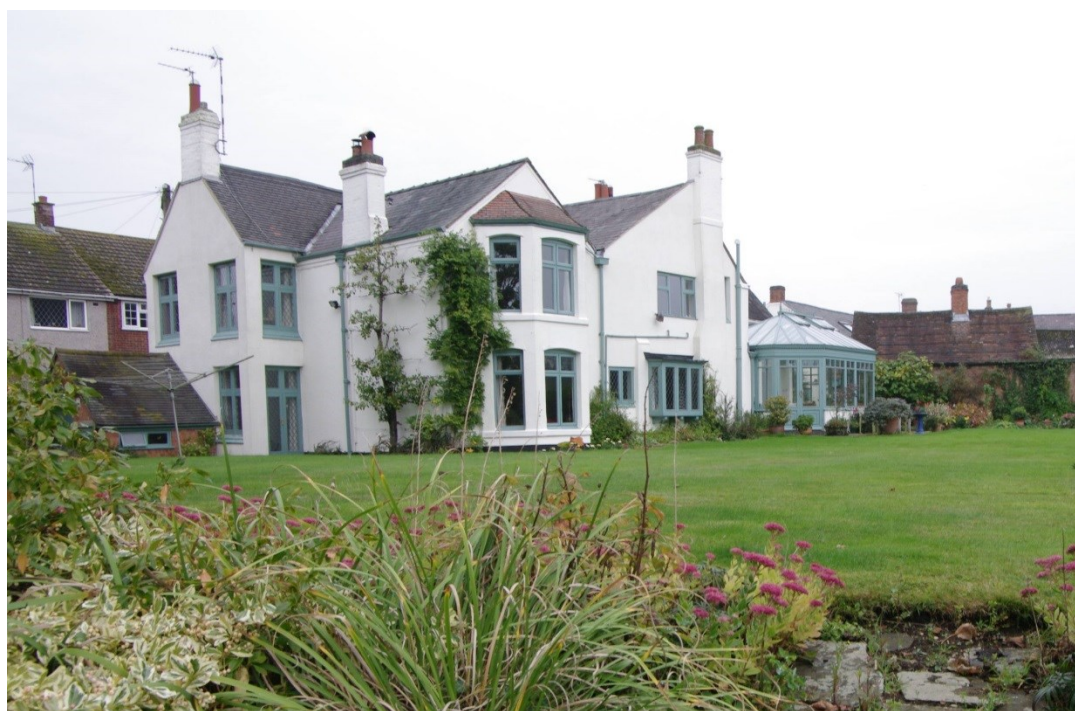
Figure 37 The White House, south facing elevation  
Looking north-east

The back of the White House (the south side) faces onto the garden where the proposed new dwellings will be constructed. Two large two-storey north to south ranges extend out from the main house (Figs 37 and 38). The western north to south range is shown on the 1839 tithe map. The eastern range, built against the western range is not shown on the 1903 OS map but is present on the next available map published in 1963 which gives it a relatively late construction date. A modern (late 20th century) conservatory covers the remainder of the south facing elevation of the house.

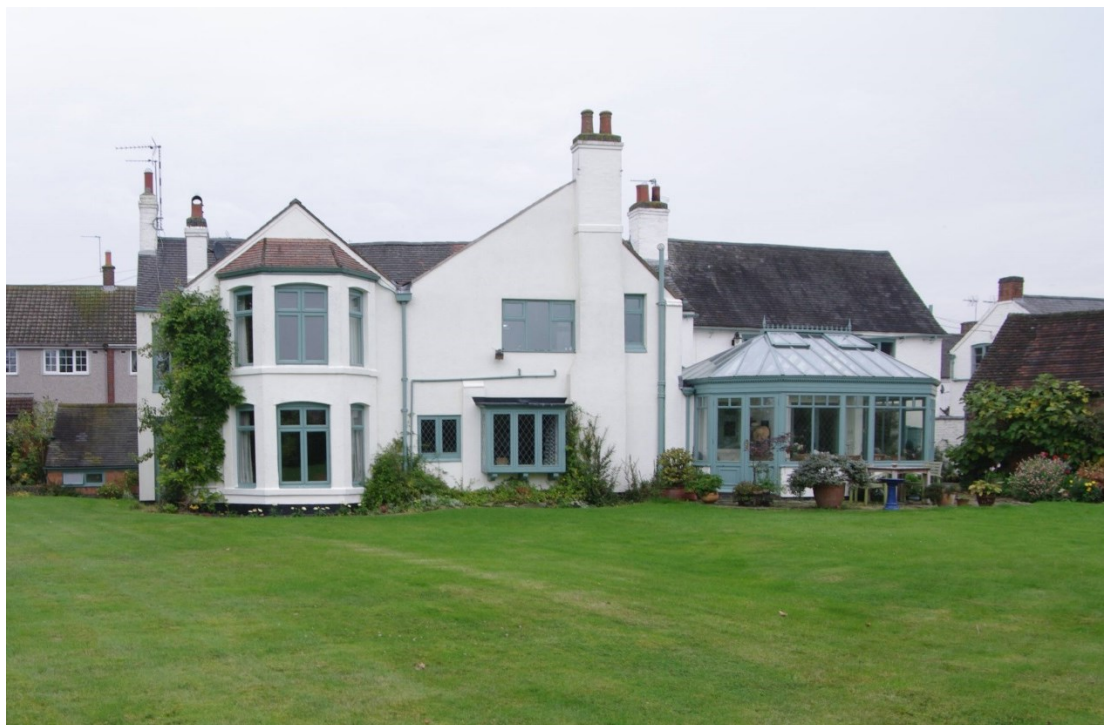
Figure 38 The White House, south facing elevation  
Looking north

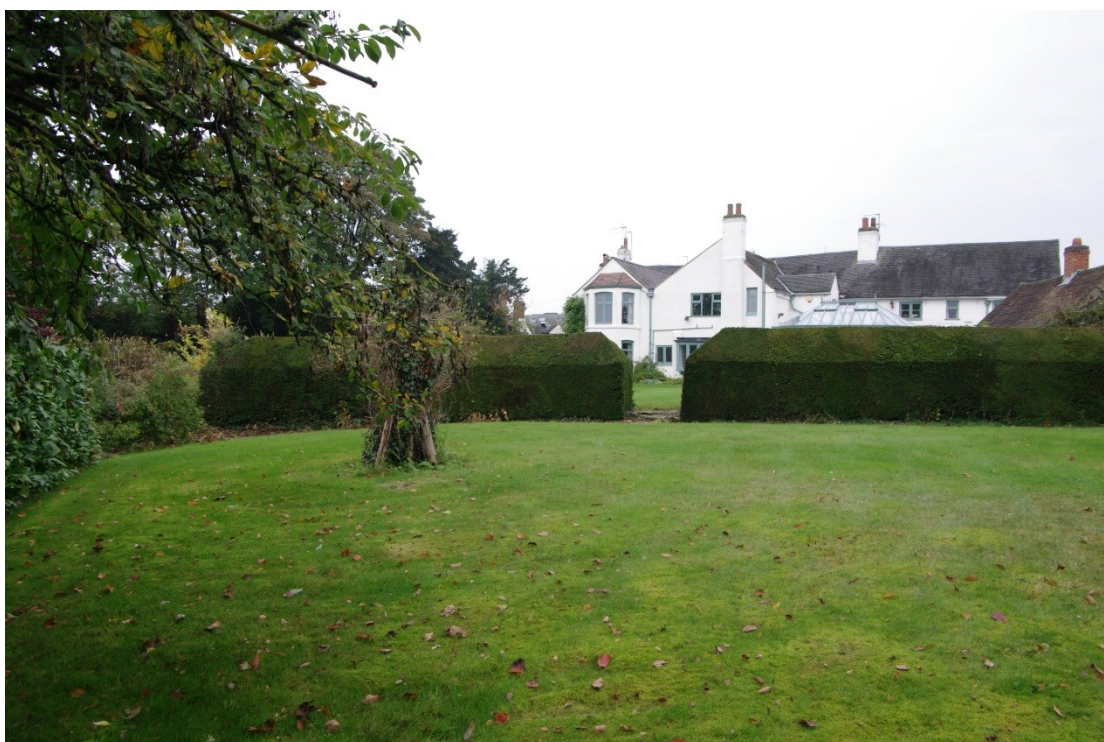
Figure 39 The White House viewed from approximate location of new houses  
Looking north-west

Two new dwellings are proposed to be built towards the south-east corner of the garden (Fig. 39 also see Figure 5). The ground at this point drops away from the house which may help reduce the visual impact of the new houses. Because the land drops away to the south and west they may not be particularly visible from outside the site. The exception being a mid-20th century house located on a higher piece of ground on the southern side of Station Street.
