**An Archaeological Watching Brief
At Butt Close, Riverside Road, Sysonby,
Melton Mowbray, Leicestershire**

NGR: SK 7397 1907

ULAS Report No. 2017-180
©2018

For: Edren Homes Ltd

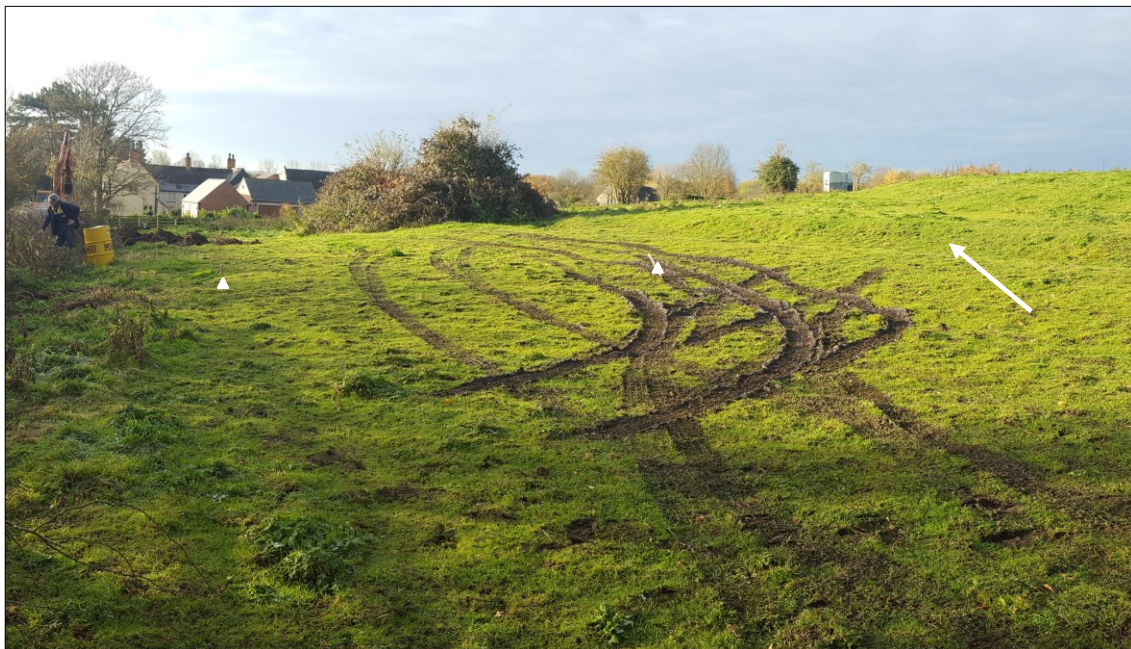
Figure 3: The site area prior to groundworks, looking south towards Riverside Farm. The front (north) edge of the site is staked out, marked with triangles. The north-east to south-west earthwork is visible just beyond the plot, to the west (arrowed).

was excavated. The Butts survive as visible earthworks to the west of the proposed site. Additionally, a potentially related north-east to south-west earthwork crosses just west of the site (Figure 3 and Figure 4 **Error! Reference source not found. Error! Reference source not found.**). The 1884 map shows this earthwork and also a trackway running parallel to it. The track ran north-east from the church of St. Mary (see below) across Butt Close field and through the proposed site to meet Riverside Road. The remains of this trackway were identified during the watching brief (Figure 6-Figure 9). To the south-west of the site area is a large rectangular cutting into the hillside, which also shows on the 1884 Ordnance Survey map (Figure 5). These earthworks have not been subjected to detailed survey.

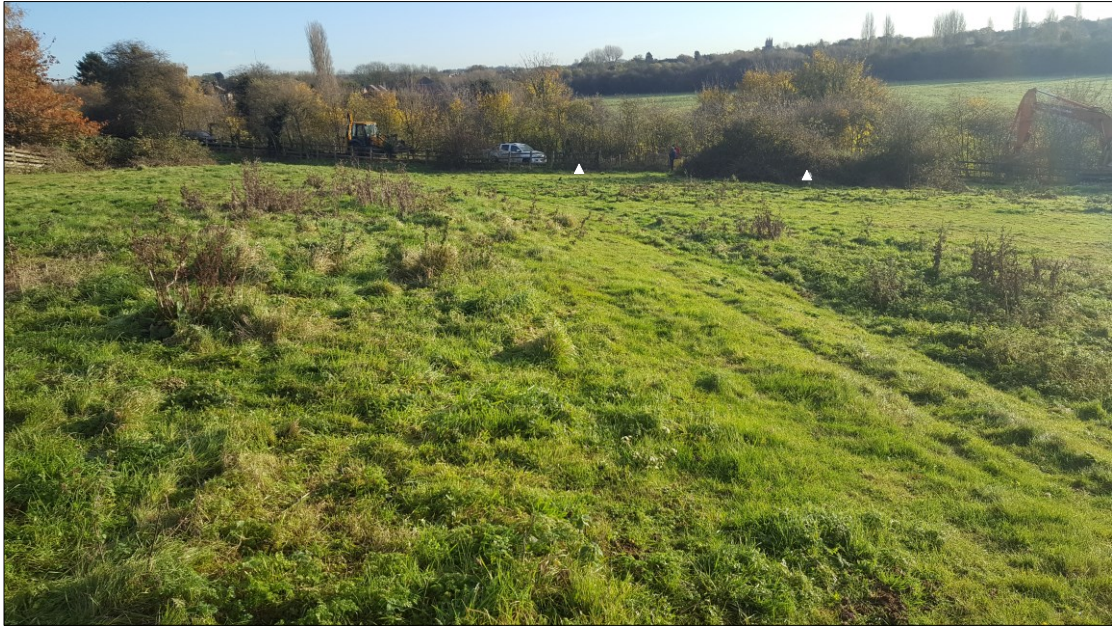
Figure 4: The site area prior to groundworks, looking east towards Melton Mowbray. Earthworks are visible beyond in the foreground. The plot (staked out, triangle markers) is in front of the contractors.

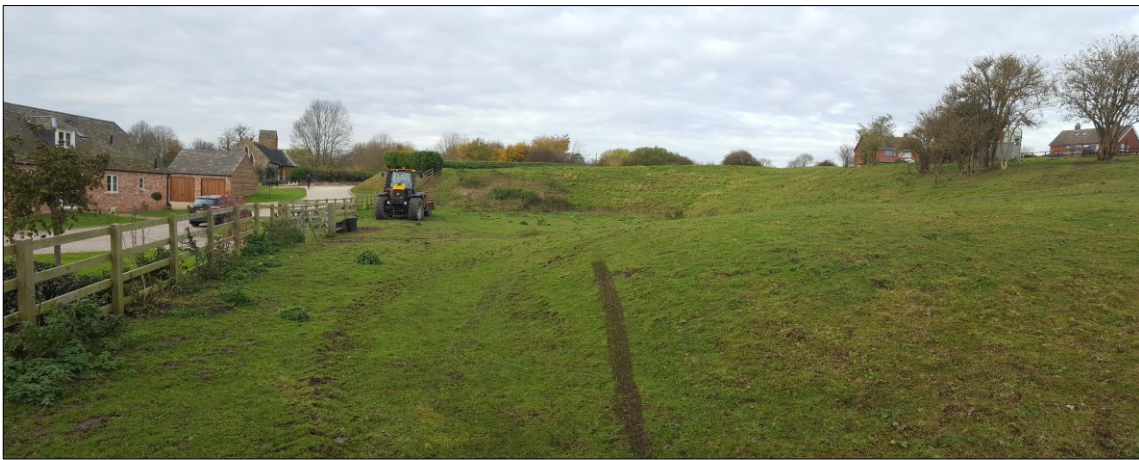
Figure 5: The area just to the south within Butt Close, looking west. The church of St. Mary is in the background. Adjacent to the tractor the large rectangular cutting into the hillside is clear, and was shown on the 1884 Ordnance Survey map.

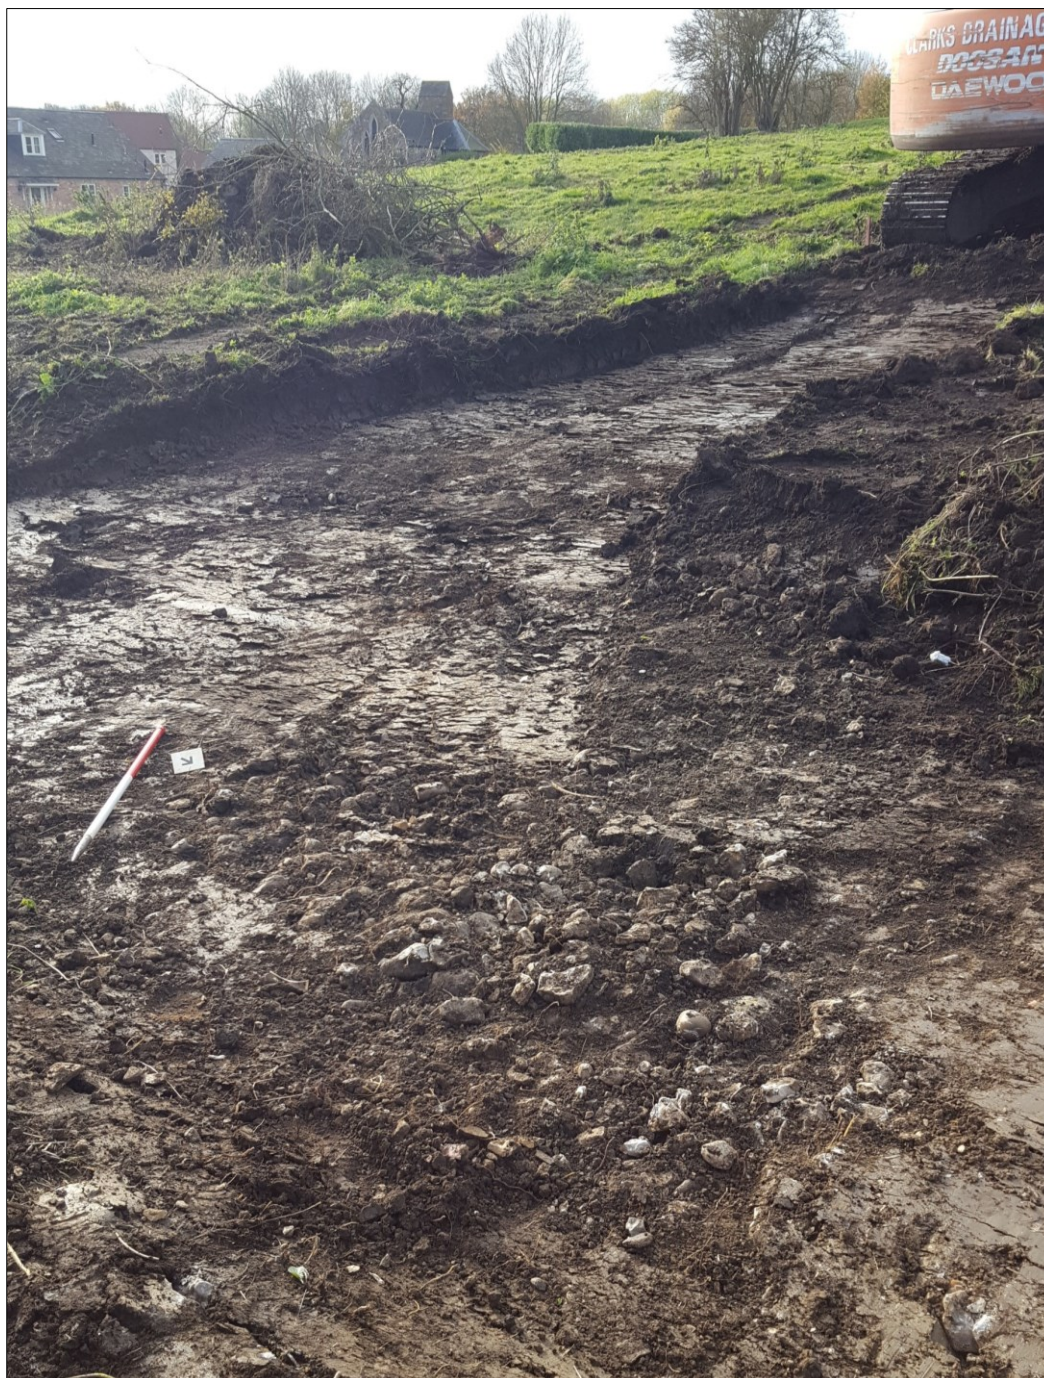
Figure 7: Metalling observed in the south-east of the plot. The ranging rod (1m) indicates the direction of the track, and the church of St. Mary is in the background...

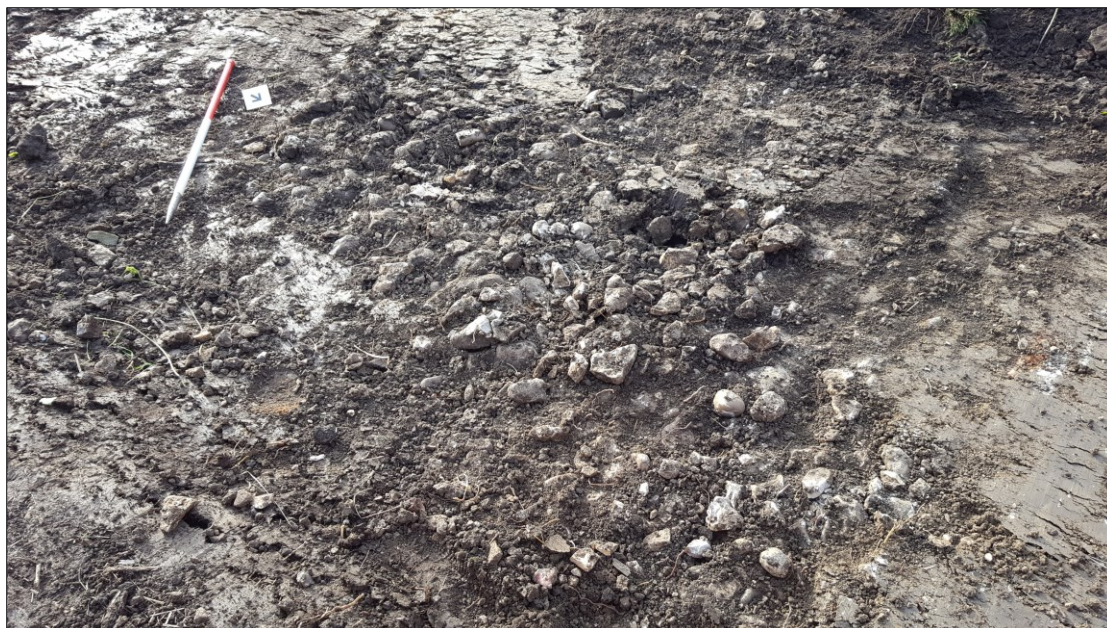
Figure 8: ...Metalling observed (detail).

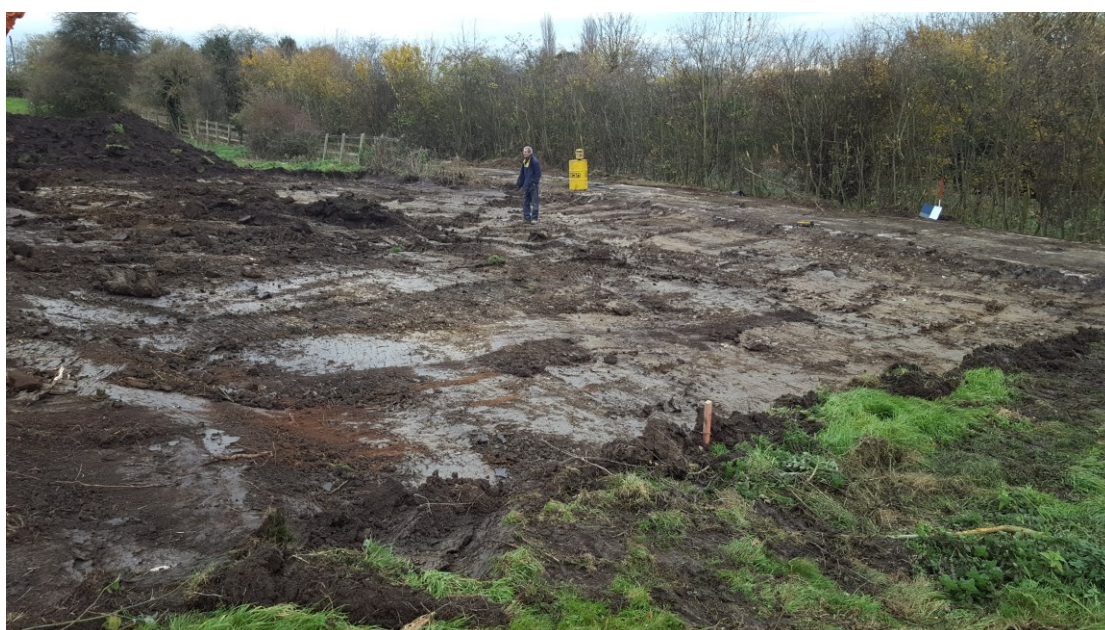
Figure 9: Site strip, looking north-east. The metalling can be seen (right) and in the foreground one of the tree root holes (brown earth).

Several tree root holes were observed, rotted out relatively recently (Figure 9), these probably being part of the landscaping that is known to have been carried out in the mid-nineteenth century (Richards 2008, p.6-7). No archaeological features were observed cutting natural, and no other features or deposits were present within the area of the development area. Once natural was observed across the site area, the 'cut and fill' was not observed; this was due to involve the removal from the north-west half of the stripped
