**An Archaeological Watching Brief at  
Jewry Wall Museum, St Nicholas Circle,  
LE1 4LB, Leicester**

**NGR: SK 58198 04506**

ULAS Report No 2017-102  
©2017

*for*  
Leicester City Council

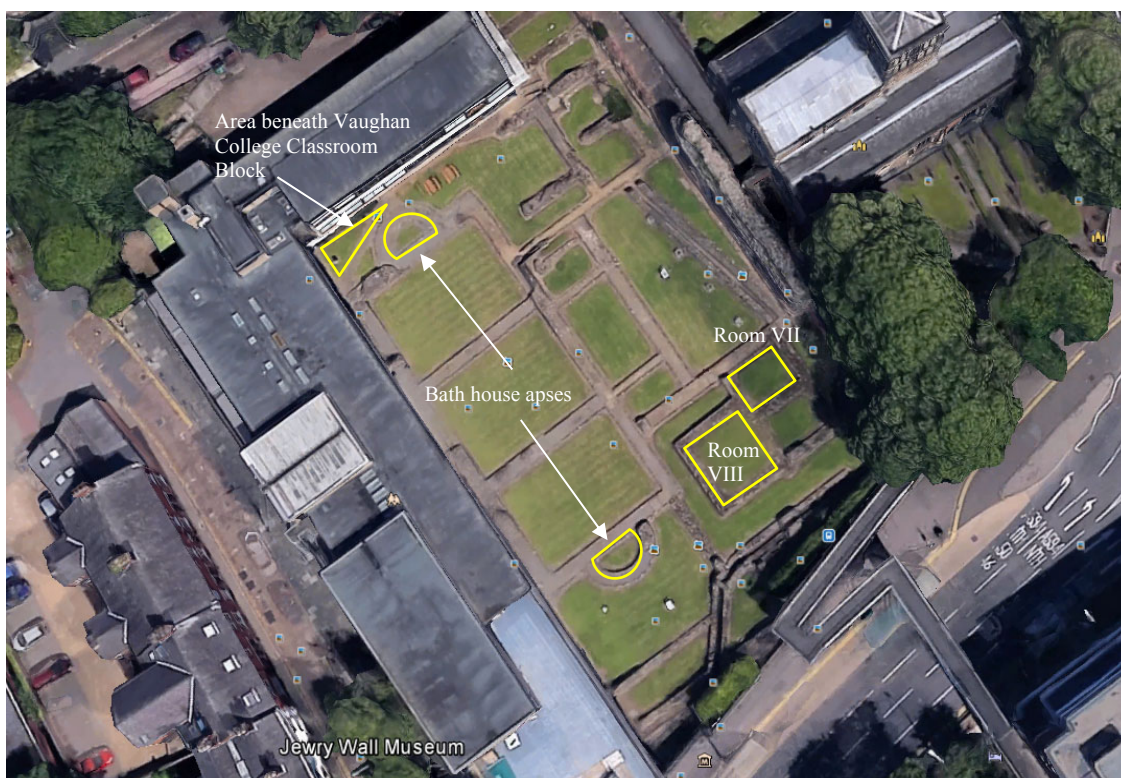
Figure 2. Location of landscaping works (yellow) within scheduled monument.

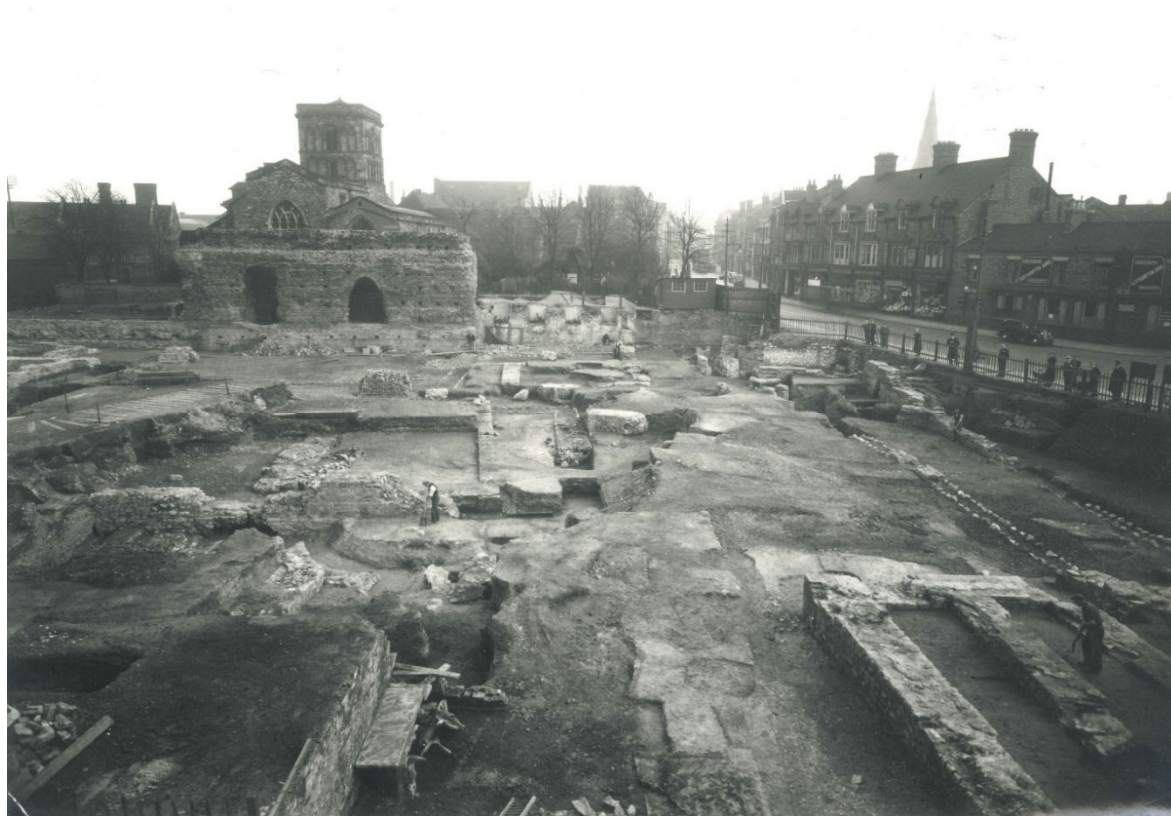
Figure 3. Archive photograph of Kenyon's excavations at Jewry Wall

The remains of the bath house were excavated in the 1930s (Figure 3) and are thus quite well understood, revealing several unparalleled details on an unusual plan. [...] As a result of their presentation for public display, the bath house remains also serve as an important educational and recreational resource. The area of the *palaestra* and overlying Anglo-Saxon church is largely unexcavated and will thus preserve architectural, artefactual and ecofactual remains of a period of over a thousand years. The superimposition of the Anglo-Saxon church on the Roman building will provide a valuable insight into the manner in which civil authority was transferred to the church between the late Roman period and the Anglo-Saxon era.

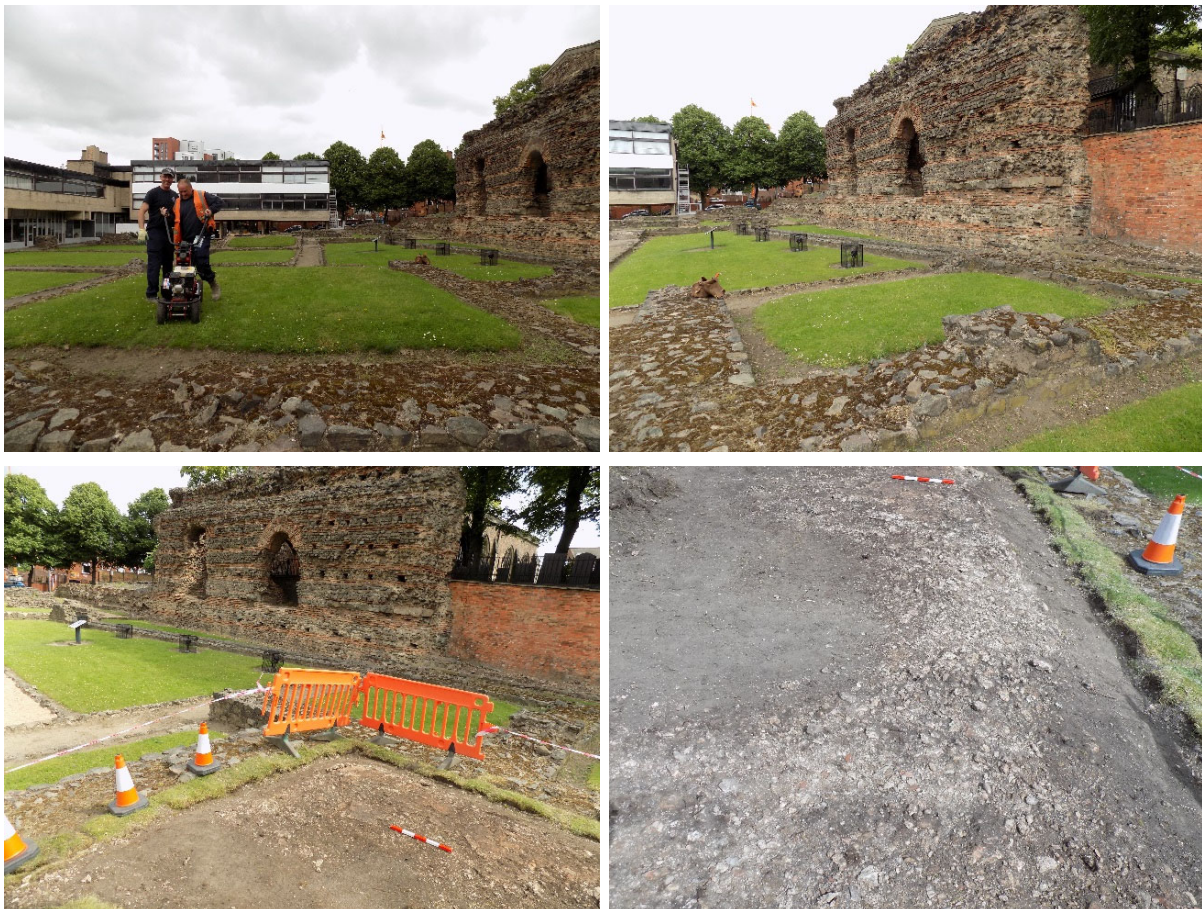
An *opus signinum* floor (8) was found in Kenyon's Room VIII directly below the turves and topsoil (1) from which two sherds of Samian ware were recovered. Only the eastern side of Room VIII was exposed where the floor measured 5.70m x 2.10m and consisted of a whitish mortar with fragments of orangey tile and it is at a height of 60.40m aOD. The floor was in a poor state of preservation due to bioturbation and root damage. Although described as a 'floor', levels suggest that the *opus signinum* is actually the base upon which hypocaust pilae stood.

Figure 8. Pre-landscaping works in Kenyon's Rooms VIII and VII (top left and top right) and *opus signinum* floor in Room VIII (0.5m scale) (below).

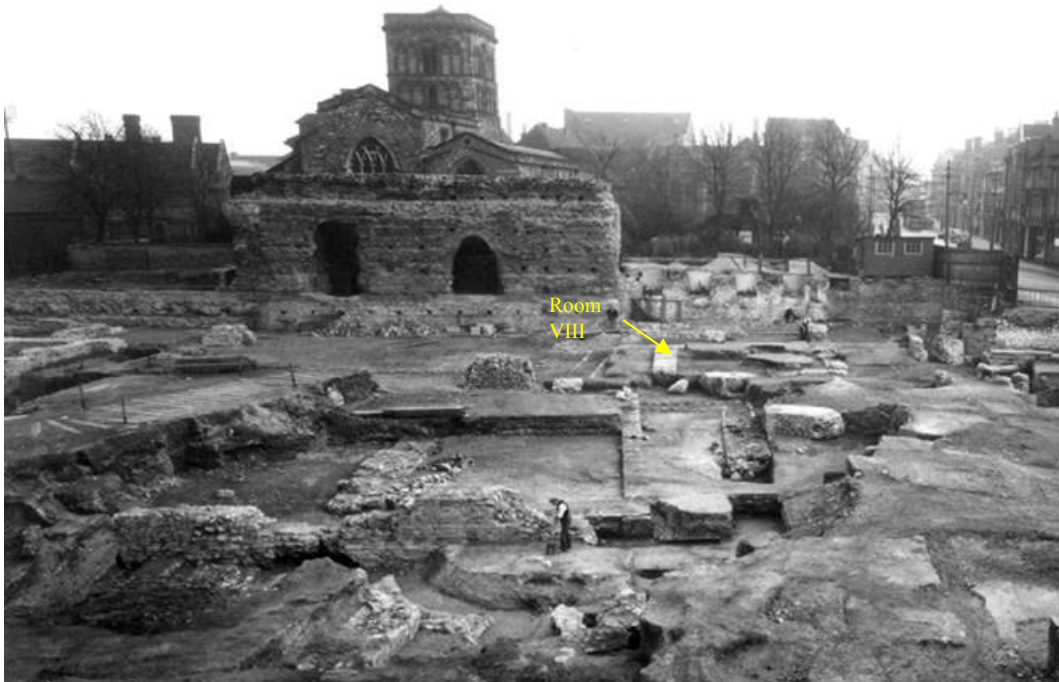
Kenyon's plan of the baths record the presence of a concrete floor on the eastern area of Room VIII with no suggestion for it to extend towards the west. A photograph from the 1930s excavations (Figure 9) shows the work in progress in the southern area of the site and the floor exposed, slightly raised, showing the stratigraphy below the concrete floor.

Figure 9. View of Kenyon's excavation showing location of floor in Room VIII

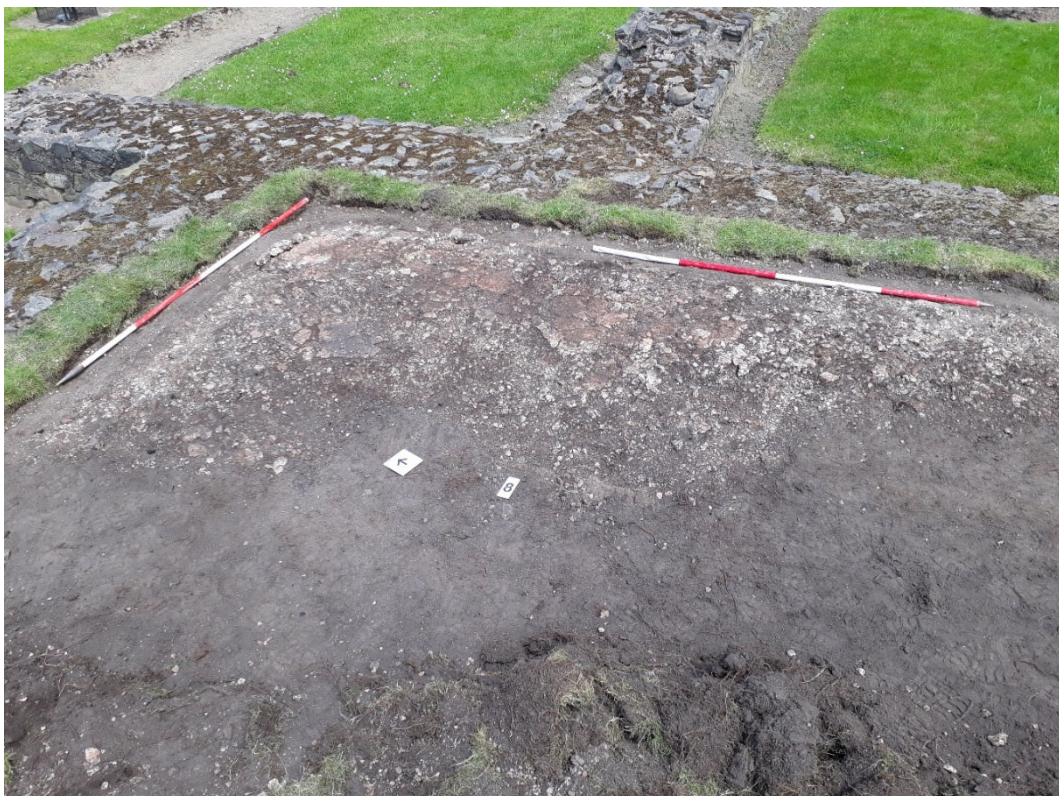
Figure 10. East side of Room VIII with surviving floor (2.00m scale)

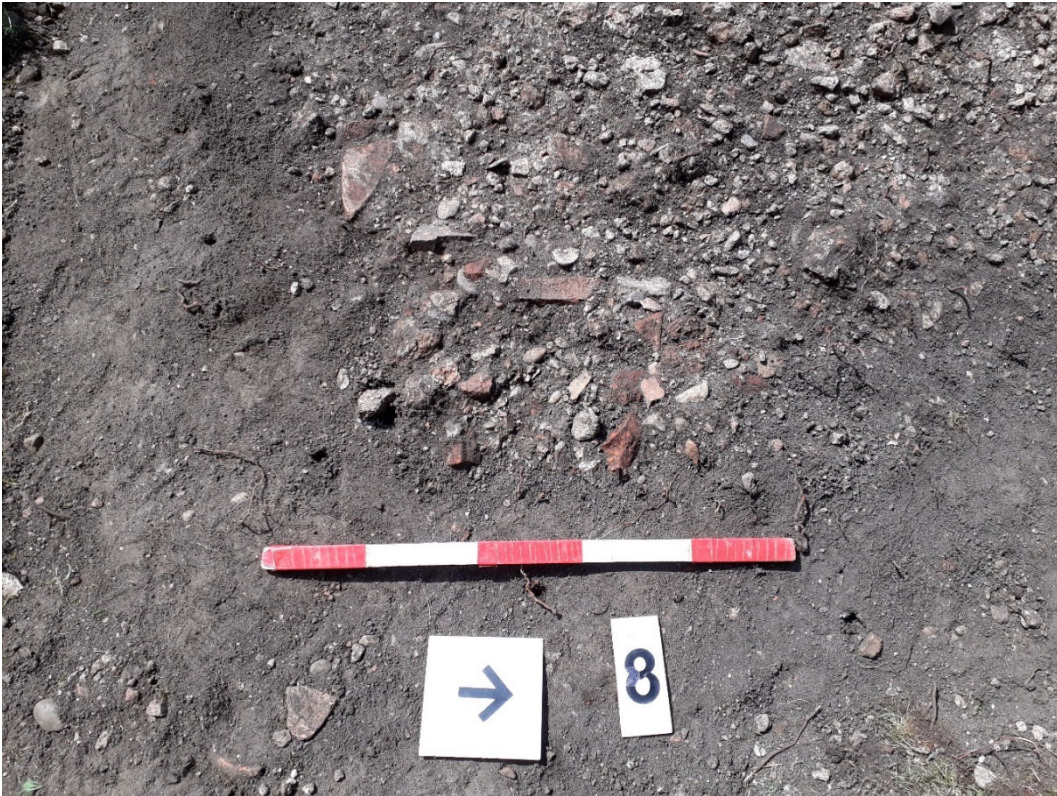
Figure 11. Detail of core below floor (8) in southeast corner of Room VIII (0.5m scale)

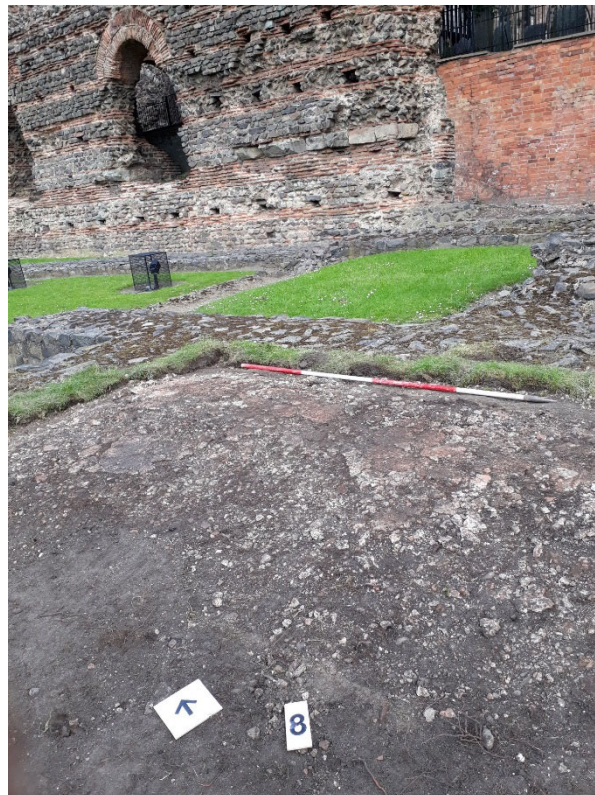
Figure 12. General view of floor (8) in northeast corner of Room VIII (2.00m scale)

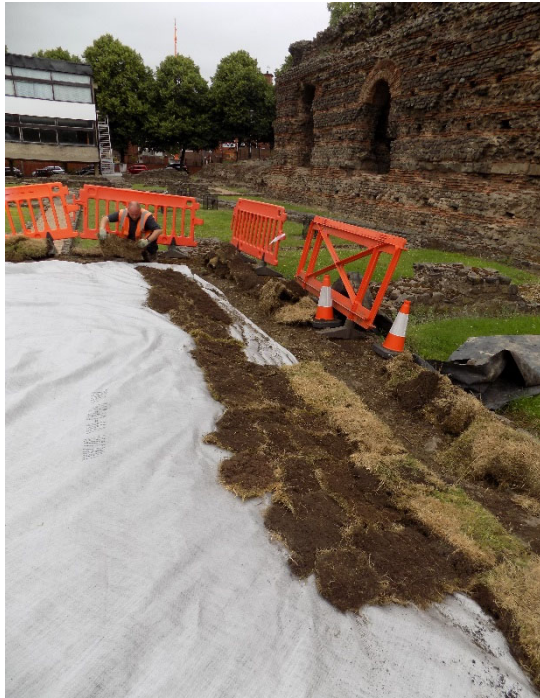
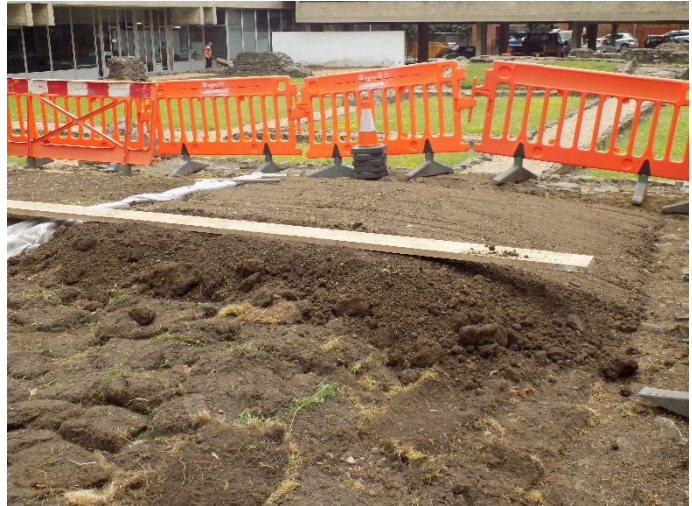
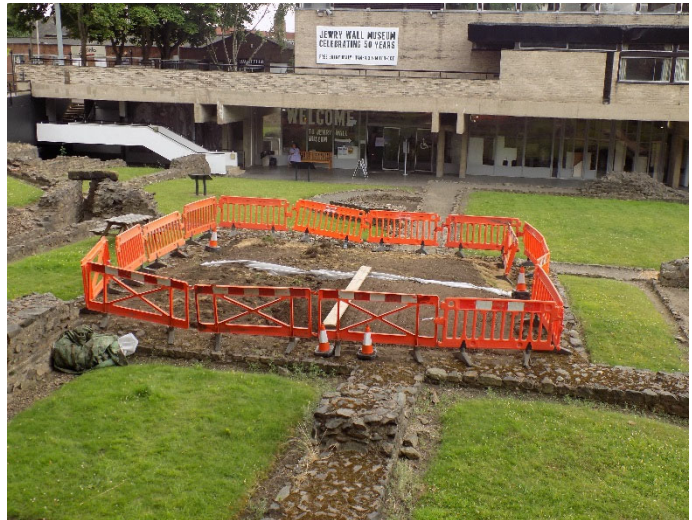
Figure 14. Preservation of *opus signinum* floor (8) *in situ*

a. Preservation in situ of floor: covering with terram for protection

b. Building up the gradient of the slope and soil levels to a minimum of 150mm above the floor

c. Preservation works in progress

The preservation *in situ* of the Roman floor followed Historic England 2016 guidelines *Preserving Archaeological Remains*. A Terram non-woven geotextile membrane was used to separate and protect the surviving floor from the topsoils with the aim to provide a permanent barrier that will cause no mechanical change to the stratigraphy nor releases any constituent part of itself into the stratigraphy, and will be visible to future archaeologists.

In order to further protect the floor, the gradient of the slope was moved towards the wall to create a further 150mm separation between the edge of the floor, which has deteriorated due to landscaping, and the wall. In addition to this, the ground level has been raised >150mm across Room VIII to create further protection.
