**An Archaeological Evaluation  
On Land at Starmore Farm,  
Swinford  
Leicestershire  
NGR: SP 56970 79250**

ULAS Report No 2018-018

*University of Leicester Archaeological Services (ULAS) carried out an archaeological evaluation on land to the rear of Starmore Farm from the 8th to 10th January 2018 on behalf of Starmore Farm. Five trenches, totalling 160m<sup>2</sup>, a 4.1% sample of the site, were excavated to evaluate a field next to Starmore Farm, where it is proposed to construct two new dwellings (Planning Ref: 16/01804/FUL).*

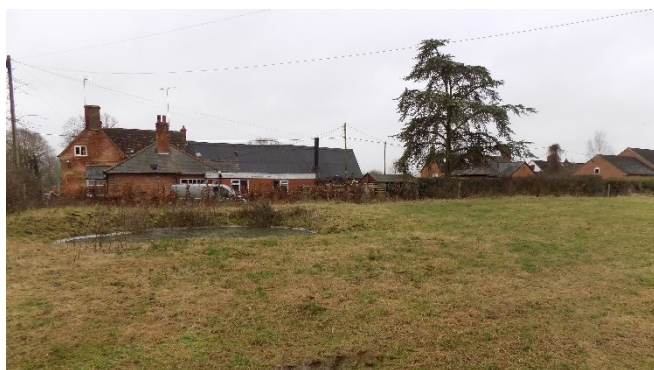
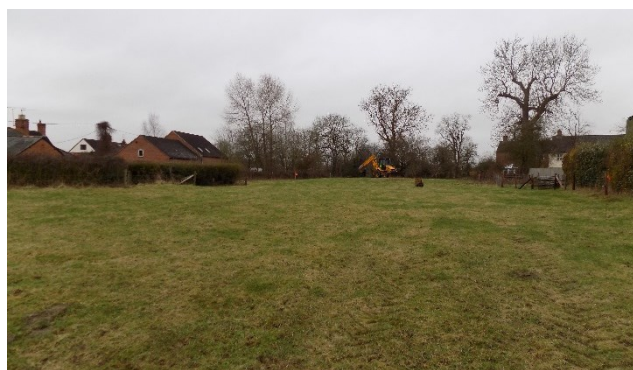
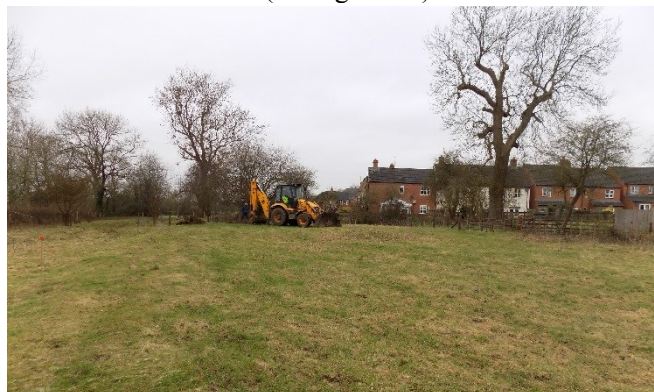
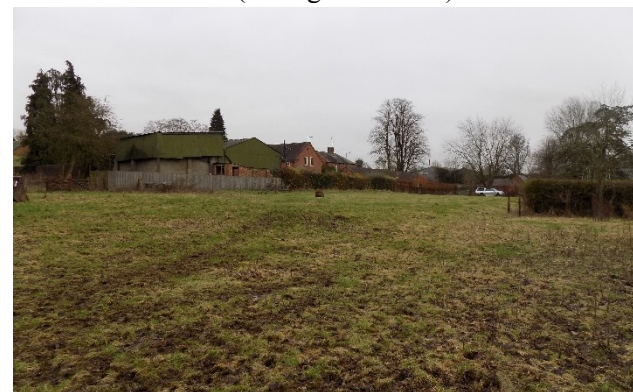
Figure 3: Pre Excavation Shots

a. South side of site (Facing South)

b. West side of site (Facing Southwest)

c. North West side of site (Facing North West)

d. North East side of site (Facing Southwest)

The land is currently a grassed field between farm buildings and is currently vacant with ponds and overgrown areas (Fig. 3). To the north of the site is the barns and houses of Starmore Farm and to the east is one of the main roads, Stanford Road, leading out of the village. The Ordnance Survey Geological Survey of Great Britain, indicates that the underlying geology of the site is Charmouth mudstone formation, overlain with Diamicton till deposits and the land lies at approximately 115m aOD.

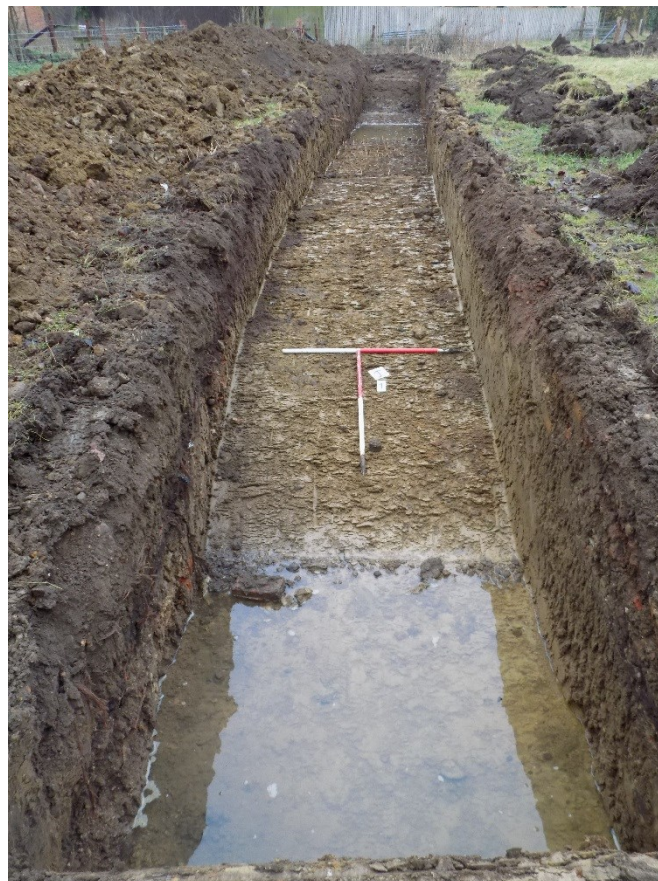
Trench 1 was located on the western edge of the assessment area. The trench was truncated by two large pits filled with modern rubble from the farm cutting through the topsoil and the mid-light brownish yellow clay subsoil with occasional gravel (Fig.).

Figure 6: North-east facing view of Trench 1 (Scale 1.00m) Modern pit is visible in the foreground.

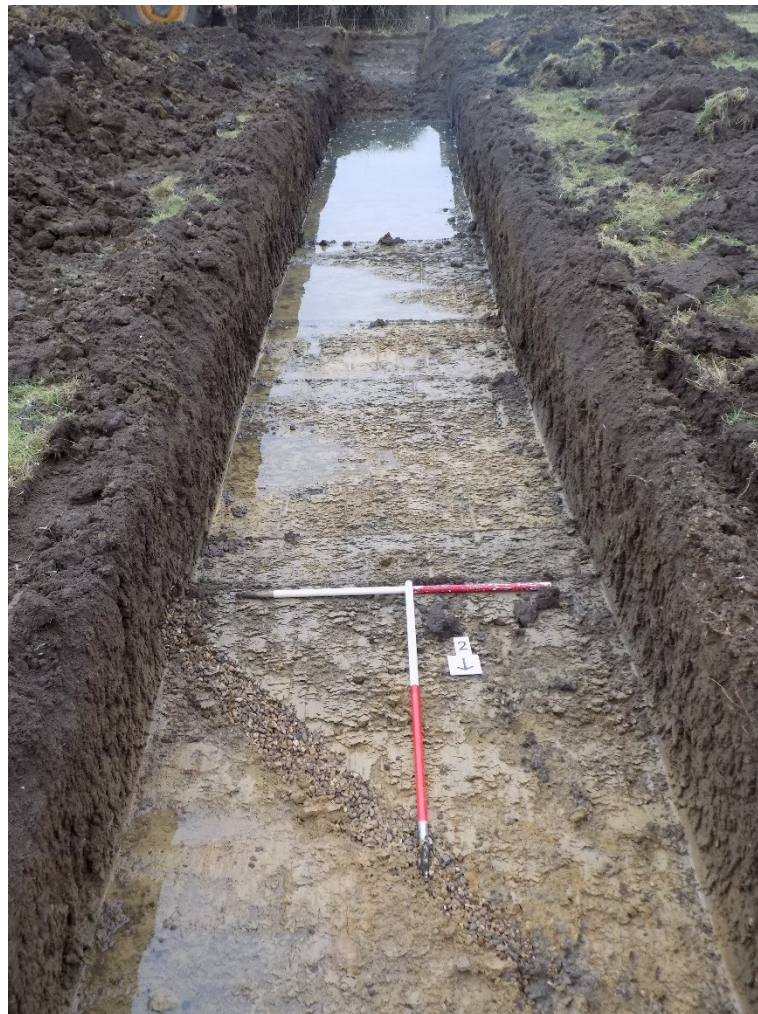
Trench 2 was positioned across the assessment area at a right angle to the field boundaries, running north to south with a slight slope towards the south. No archaeology was identified although a number of land drains were seen running across the trench (Fig. 7).

Figure 7: South facing view of Trench 2 with drain in foreground (Scale 1.00m)

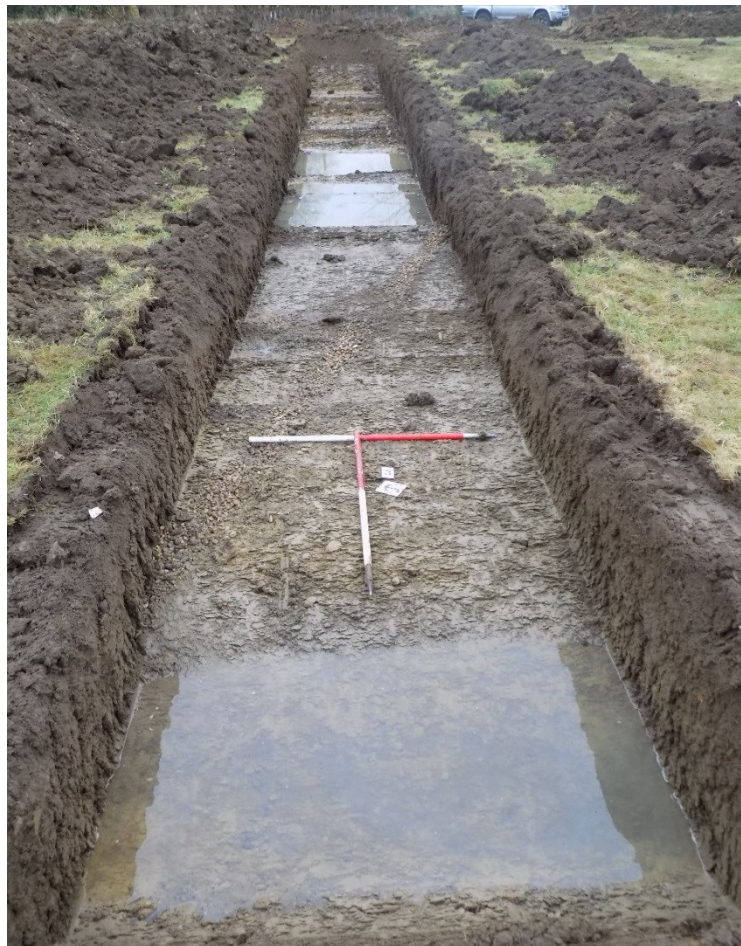
Trench 3 was located to the east of Trench 2 and oriented north-east to south-west. No archaeology was identified although again evidence for several land drains was identified (Fig. 9).

Figure 8: North-east facing view of Trench 3 (Scale 1.00m)

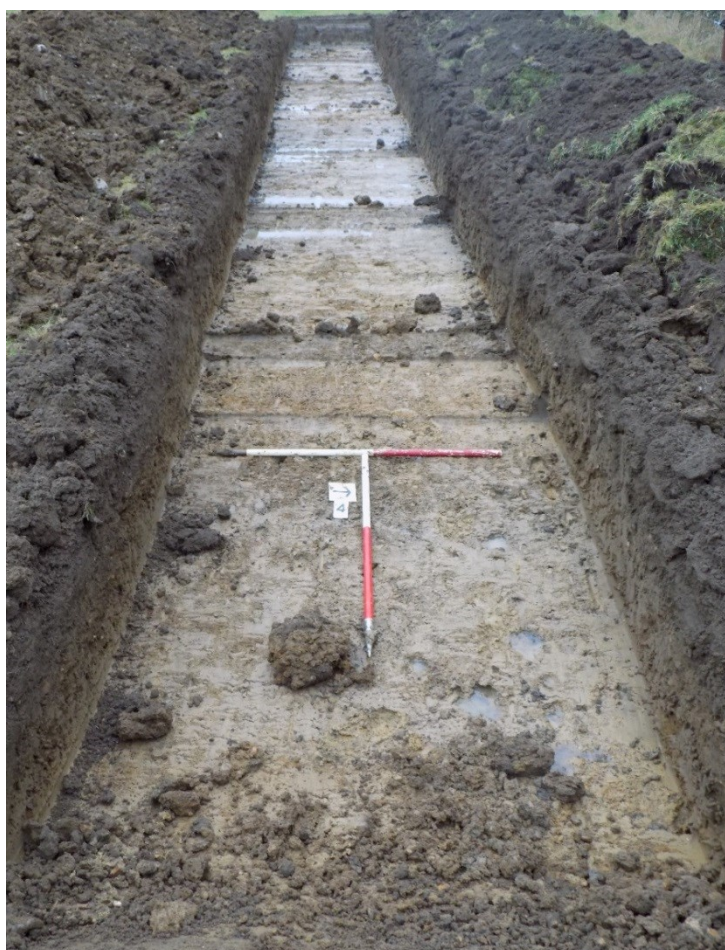
Trench 4 was positioned parallel to the north edge of the assessment area running from east to west. Potential evidence for ploughing was seen in the form of widely spaced furrows approximately 6-7m apart. Modern drains were also visible (Fig. 9).

Figure 9: West facing view of Trench 4 (Scales 1.00m)

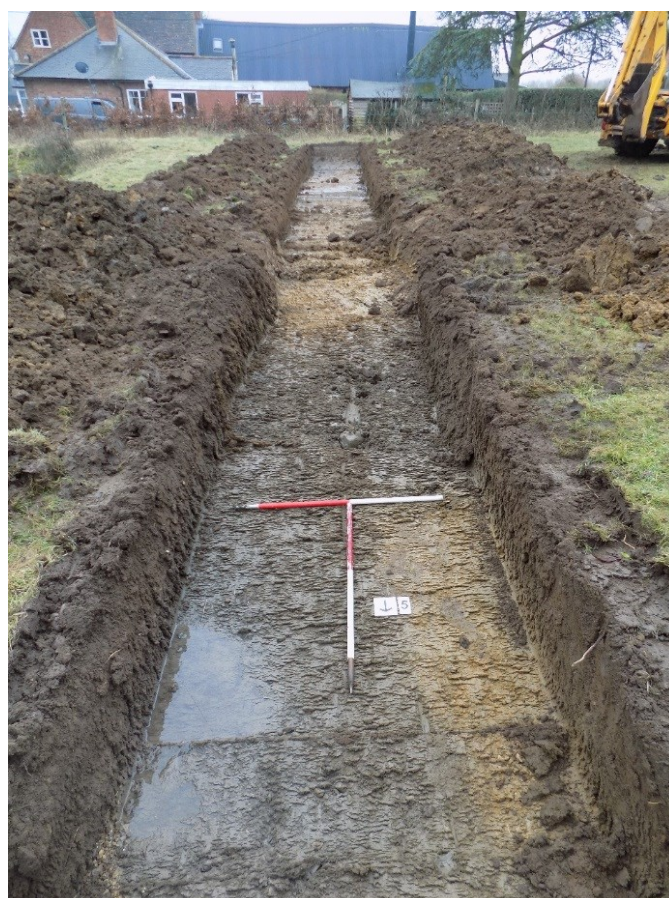
Trench 5 lay at the east end of the site closest to the road. Within the trench two possible ditches were seen cutting into the mid-light brownish-yellow natural clay.

One lay at the northern end of the trench with another possible ditch was visible at the southern end running roughly east to west. Due to high water levels and flooding in the trenches, the southern end of the trench could not be investigated further and was backfilled. Two pieces of brick were found on the surface of the southern ditch and it seems likely that this is a post-medieval boundary ditch.

Figure 10: South facing view of trench 5 (Scale 1.00m)

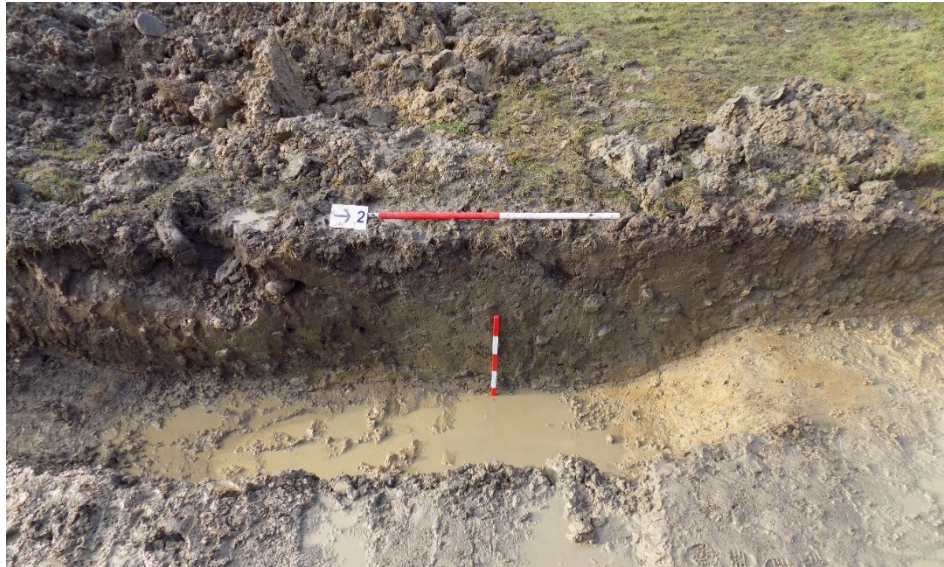
A slot was excavated in the northern ditch although this also flooded and only the upper levels were able to be excavated (Figs 10-12). The ditch was orientated approximately east to west with a second ditch running northwards from it. The excavated section was about 3m wide, and the fill was a dark brown silty clay. Within the excavated section two fragments of bone from a large mammal and a single sherd of post medieval pottery were recovered.

Figure 11: East facing section of ditch [2], partially excavated.
