**An Archaeological Excavation  
at Jewry Wall Museum,  
St Nicholas Circle,  
Leicester.**

**ULAS Report No 2018-023**

**For: Leicester City Council**

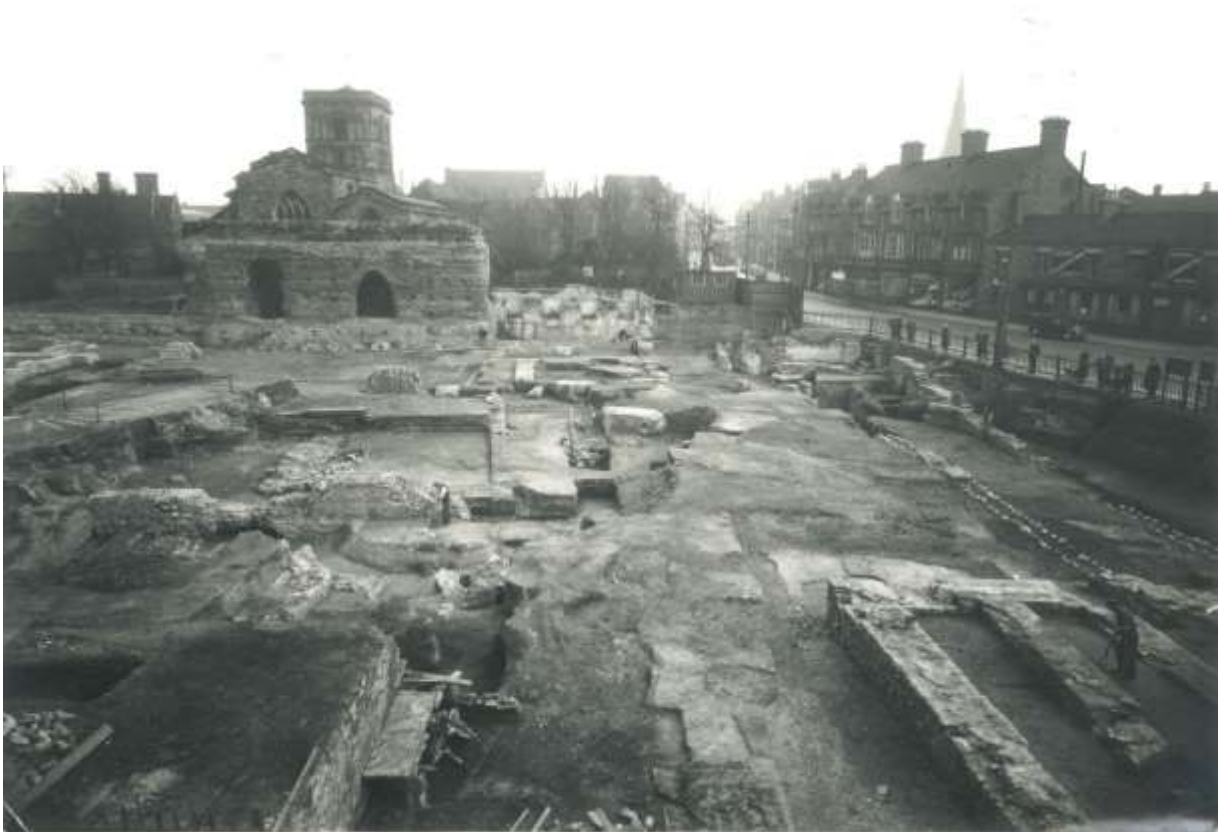
Figure 3: Archive photo from 1930s excavation, the 2018 excavation lay close to the edge of the excavation on the right. Image credit: Leicester Arts and Museums Service.

The area of the excavation lay on the south-east side of the bath complex, just within the area of the 1930s excavation (see archive photos, Section 3). This is an area just to the south of a row of porticos enclosing the bath complex (Kenyon 1948, 30; see also Wacher 1974, 356 fig.80 and **Error! Reference source not found.** below). The Kenyon report describes a portico as ending against a channel (drain?). After this the south-east area was on a high level (Kenyon 1948, 30). After the channel 'An additional wall was built in this south-east angle, probably cutting off the area to the east...' (Kenyon 1948, 30). A wall projected to the south of this and ran beyond the edge of the excavation, under the street. This is the wall (4) rediscovered during these new investigations. On the west side of this was a brick tessellated floor (Kenyon 1948, 30). The red tile tessellated floor (3) re-discovered in this excavation is the same as found by Kenyon. We can now know that it was a plainly decorated red tile floor, constructed with very large tesserae, and well-worn. The small fragment of *opus signinum* floor found in Trench 3 in the 2016 evaluation (Speed 2016, 47) lay on the east side of wall (4), most likely in a different room. An earlier mosaic floor was likely removed prior to the construction of red tile floor (3), as evidenced in the smaller grey and white tesserae recovered in a make-up layer below the tile floor (2).

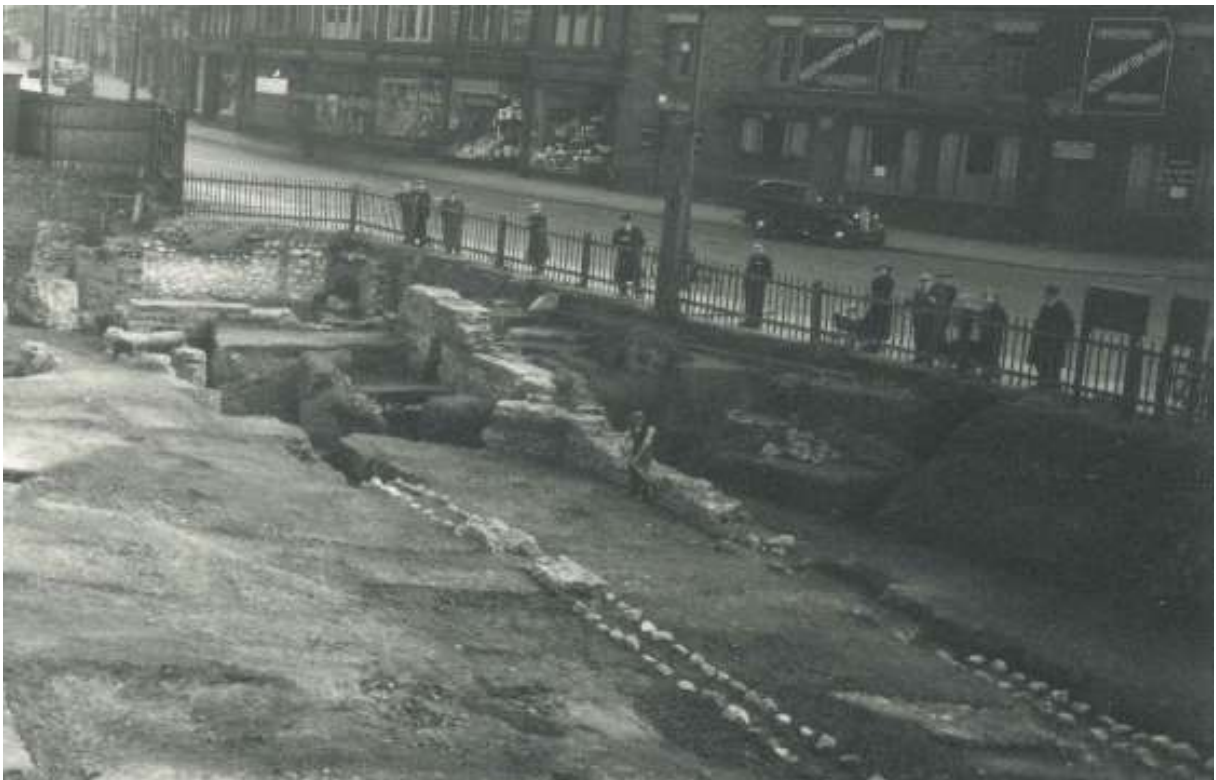
Figure 4: Close up of the edge of the excavation during the 1930s excavations (Kenyon 1948)

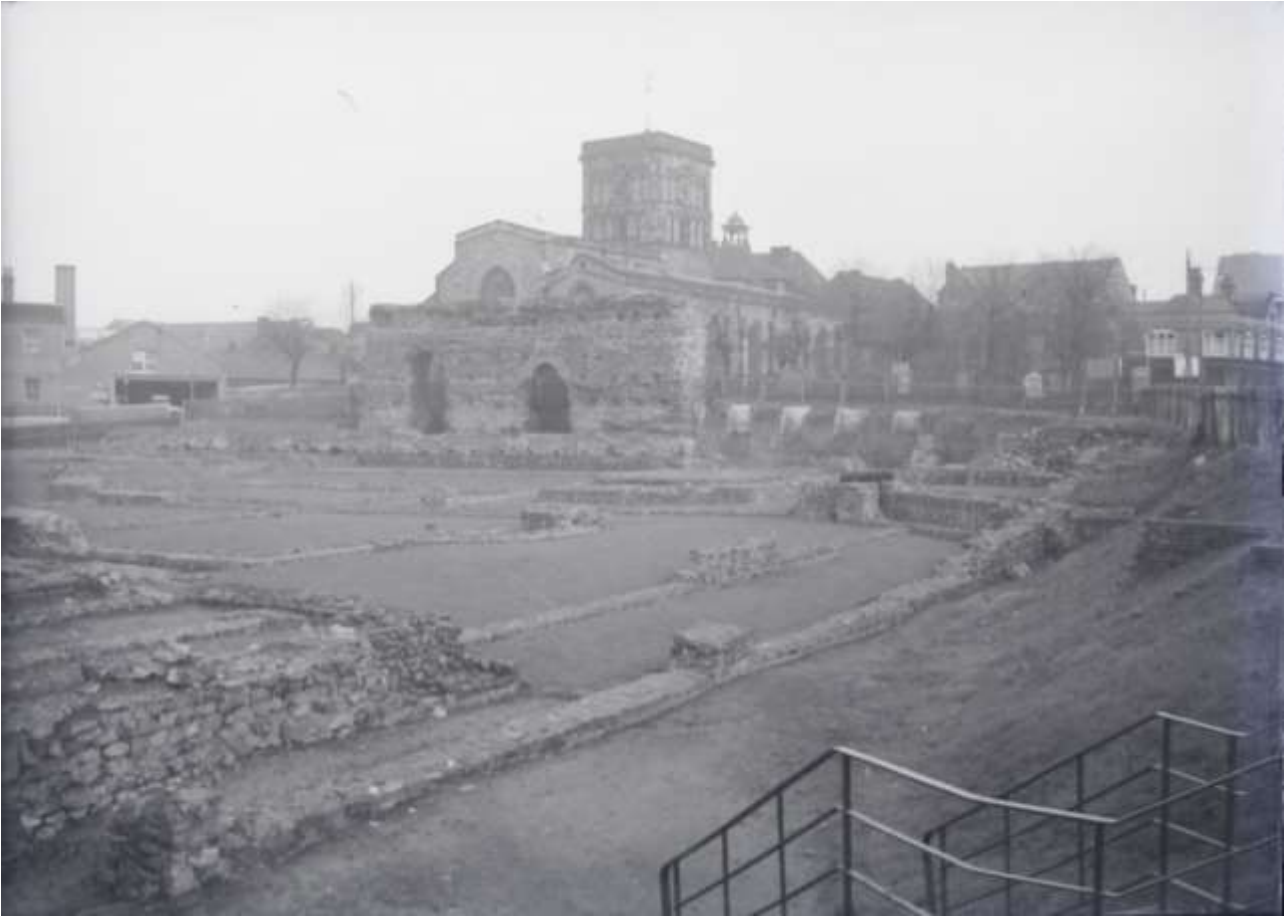
Figure 5: Glass plate negative from 1962. Showing landscaped bank on right, prior to construction of museum (Image credit: Leicester Arts and Museums Service, LCC ID NO. GP4242).

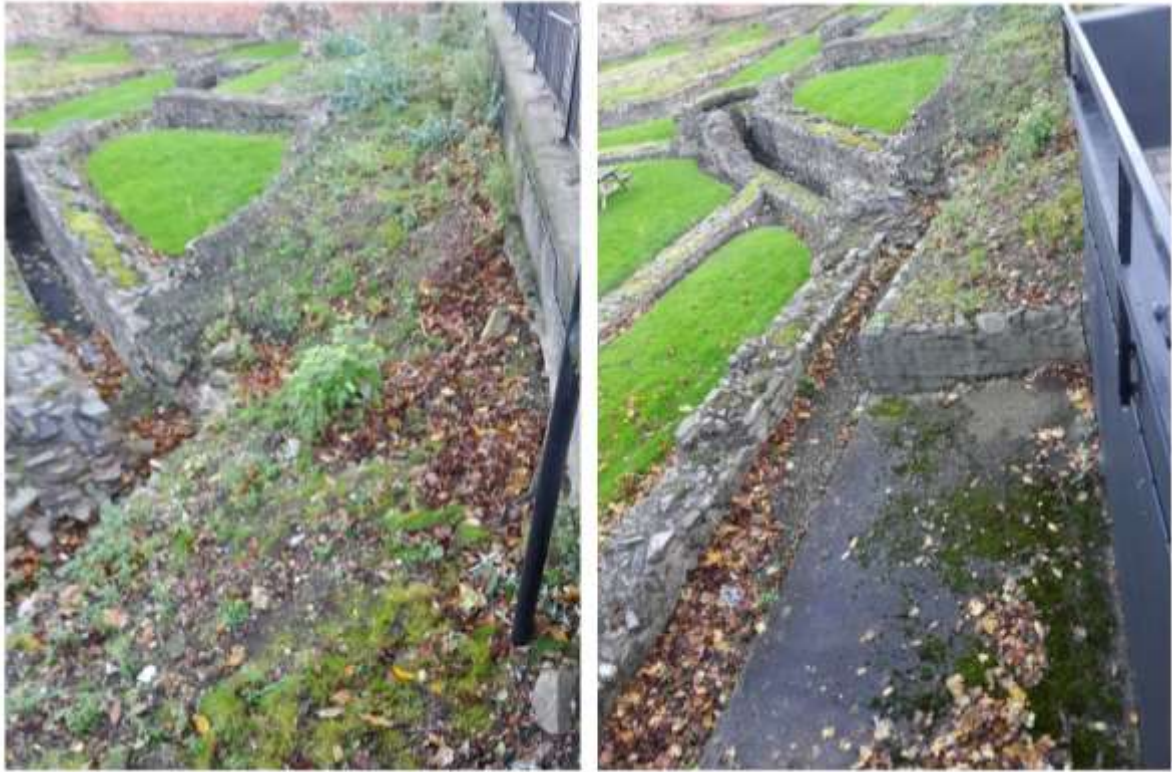
Figure 6: Views of the investigation area (looking east), prior to start

though the concrete pile bases remain in situ, just over a 1 metre away from the 2016 evaluation trenches 2, 4, and 5 (visible in Figure 6).

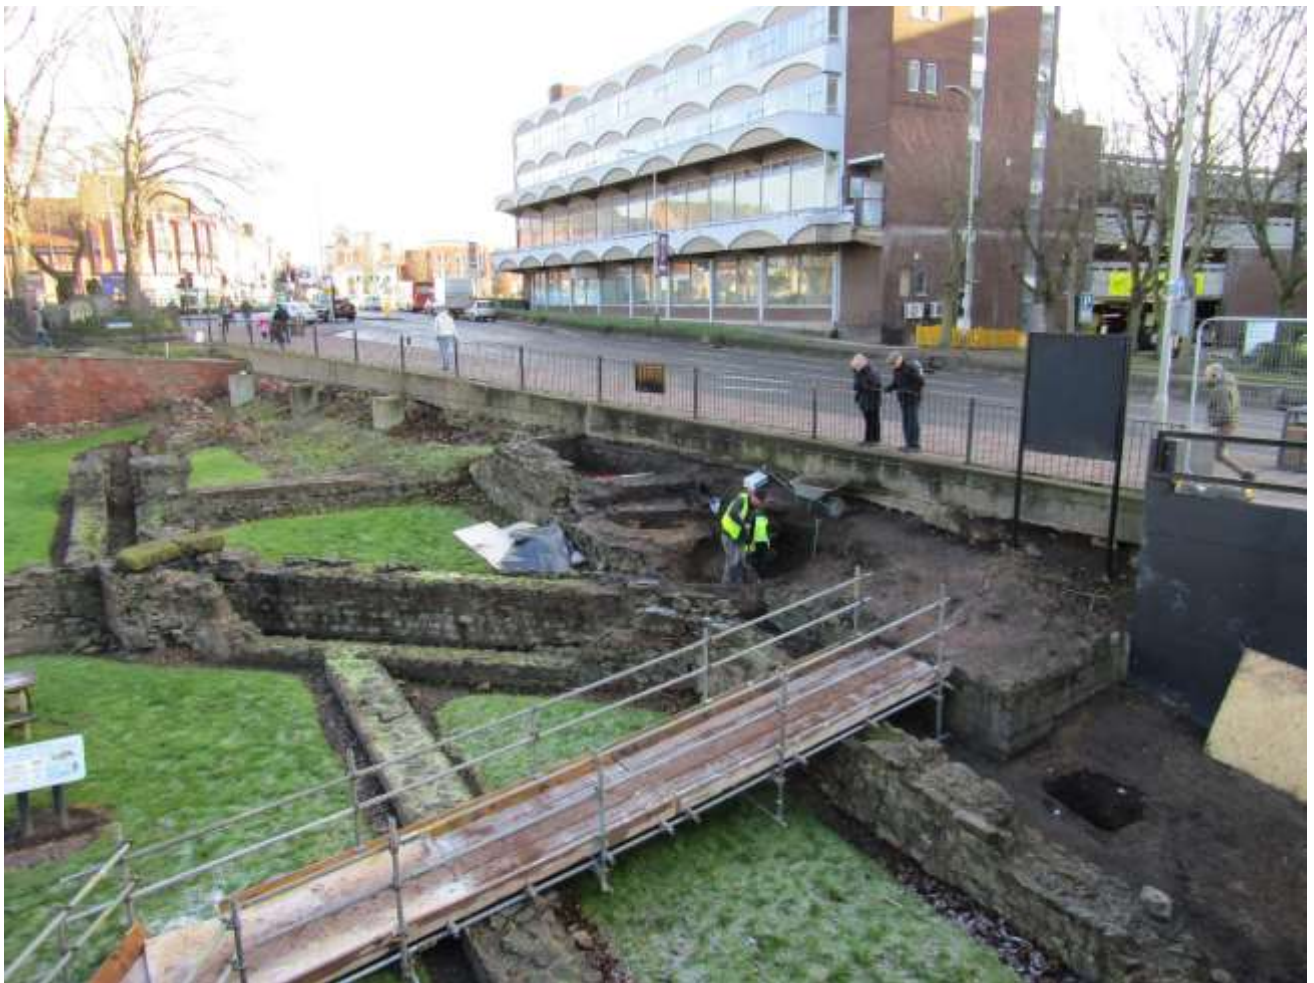
Figure 7: View of the investigation area (looking east), during removal of the top soils.

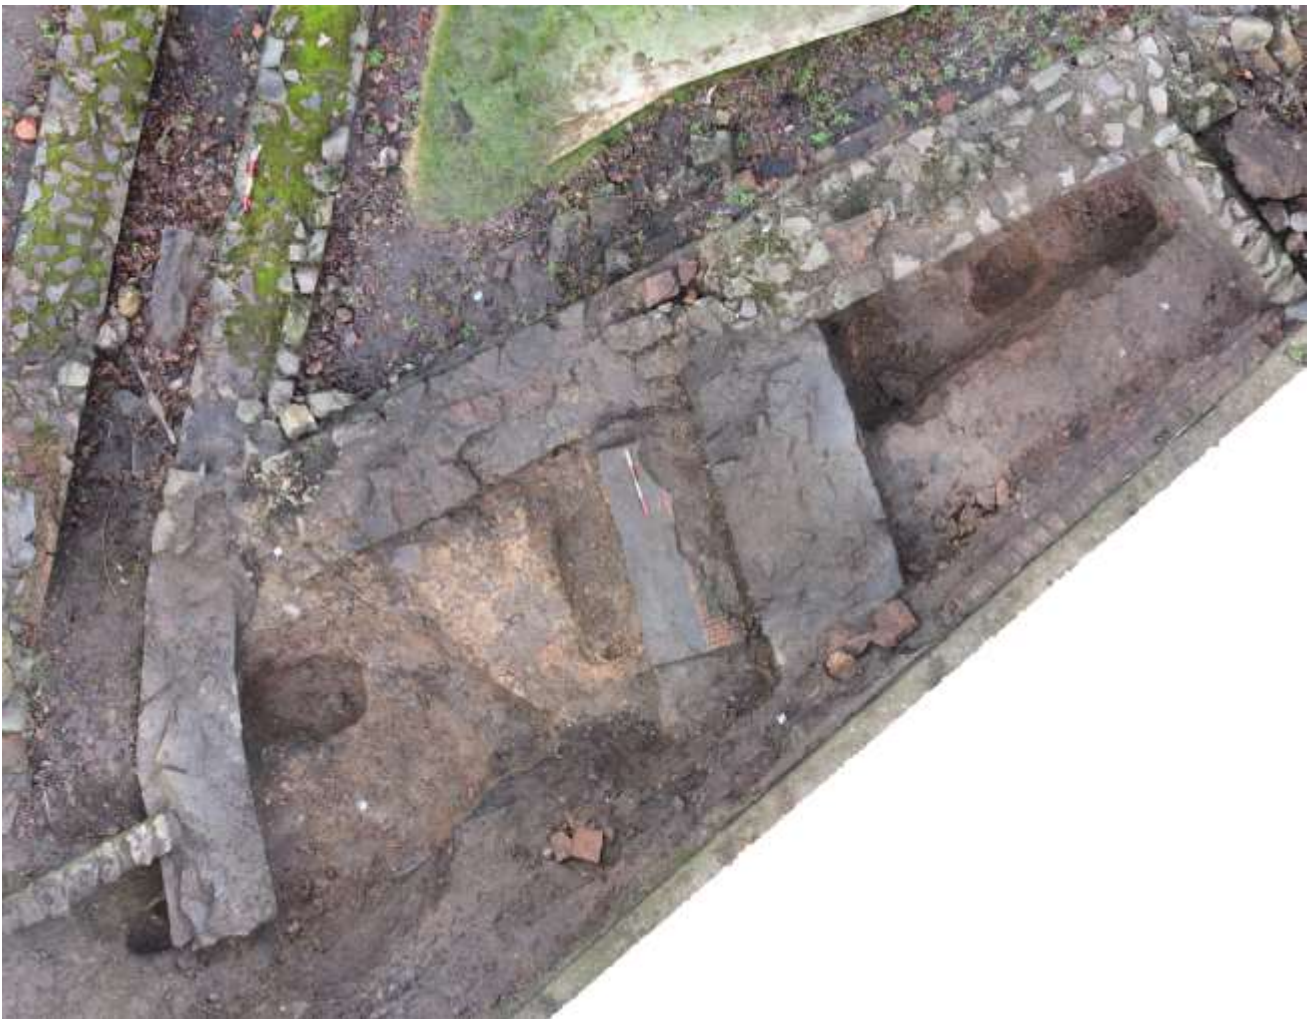
Figure 10: Aerial view of central area, created using photogrammetry (0.4m scale)

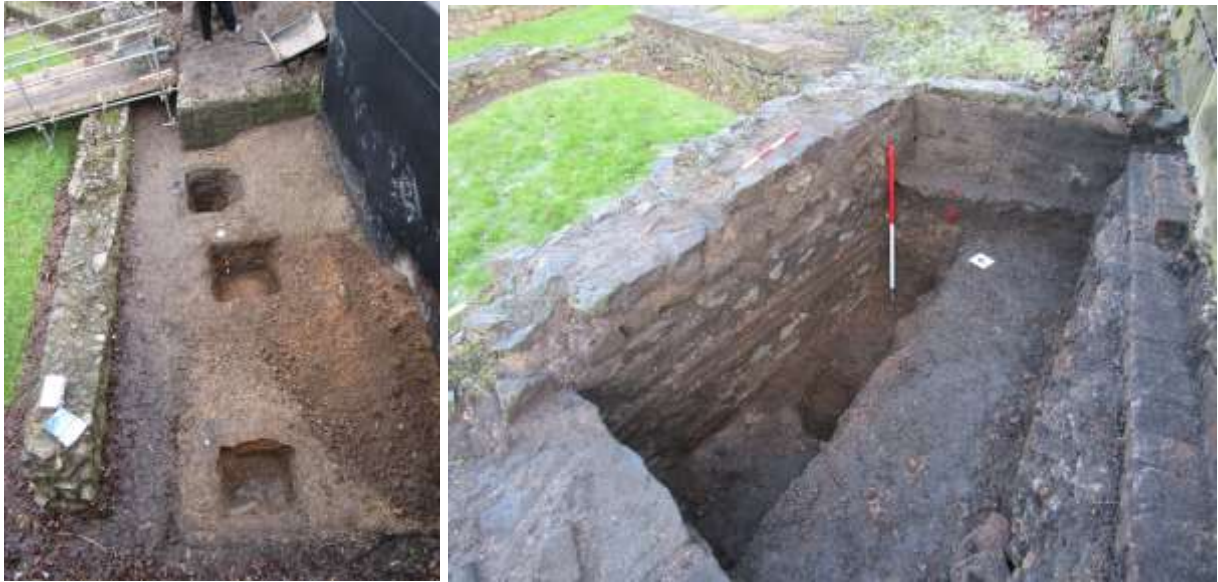
Figure 12: East (left) and west (right) ends of investigation area showing mixed soils and natural substratum

At the west-end of the investigation area was a 15cm thick concrete base. This was removed with a concrete breaker. Below was a mixed soil (1), this contained metal and modern brick debris and a mixed of finds (1st or 2nd century Roman pottery sherd, a 15th to mid-16th century Late medieval pottery sherd, and a fragment of post-medieval or modern clay pipe stem). Three test pits were excavated through (1) to check for potential underlying archaeological deposits. Natural substratum was quickly reached at 58.95 – 58.47m OD (sloping downwards to the west).

To the east of Roman wall (4) were further mixed soils (7). As with the soils in the western-end, the soil appears to be landscaped soils, perhaps put in place in the early 1960s. Within this was Roman pottery, one fragment of painted wall plaster, and a sherd of a post-medieval jar. These were excavated down to 60.28m OD. A concrete breeze block wall was located to the west. To the east of this a trial trench excavated in 2016 showed similar mixed soils, along with a displaced fragment of Roman wall (Speed 2016, 60-61).

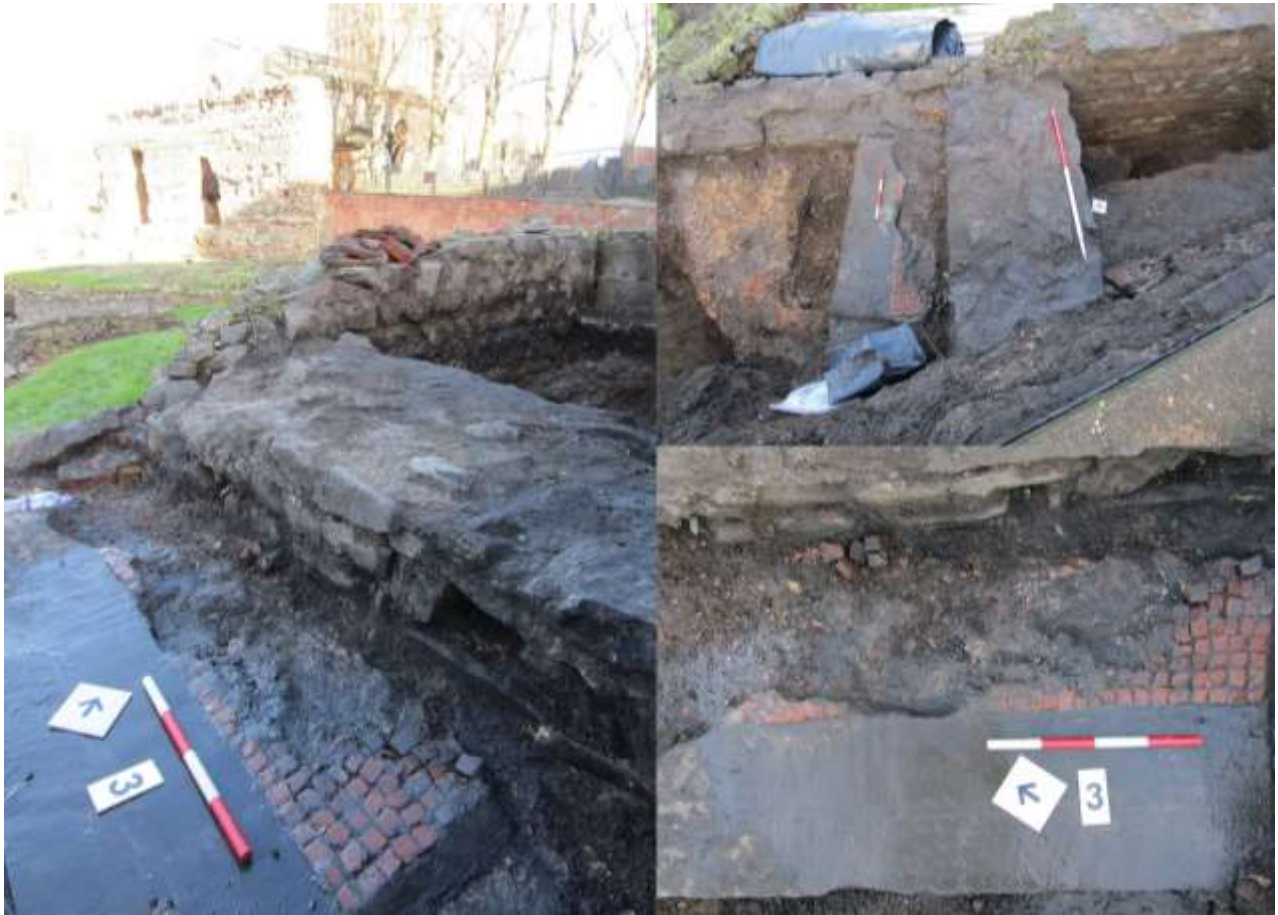
Figure 13: Views of tessellated floor (3) and wall (4)

Between walls (4) and (9), and under the mixed soils (8) was a good sequence and survival of Roman stratigraphy. The uppermost survival was part of a tessellated pavement (61.15m OD). This was composed of red tile tesserae (3). These were *c.*33mm, though roughly cut. This had been consolidated in the past with a concrete block on its west-side. These were set in a mortar layer (5). Below this (61.01m OD) was a mixed 'demolition' levelling layer, consisting of crushed Roman brick / tile and mortar (6). This layer had been truncated on its SE side, and the underlying layer (2) was seen at a much lower level (60.28m OD). This was a clean Roman sand layer, perhaps for consolidation / makeup. Within this, Roman pottery dates to the mid 2<sup>nd</sup> century AD. Also within this layer were grey and white tesserae (notably smaller than the red tile floor (3), indicating an earlier tessellated floor had been disturbed during construction of the red tile pavement (3).

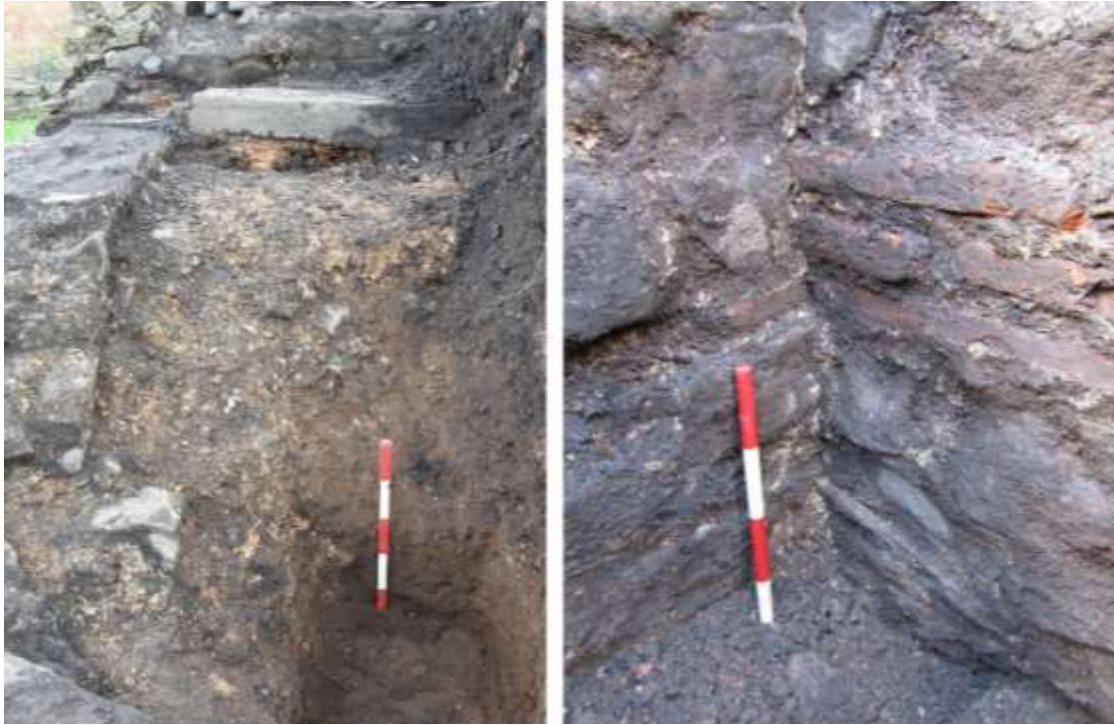
Figure 14: View of Roman layers under tessellated pavement (left), relationship between walls (4) and (10) (right)

After removal of the mixed soils (8) a further part of Roman wall (9) was revealed (60.45m OD). This wall was *c.*0.6m wide, it had a single course of granite blocks, under this were three courses of tiles. It formed part of the consolidated wall remains of the drain. A further 3.2m east a further Roman wall was uncovered under more mixed soils (7), at 61.51m OD. This wall (4) was 0.95m wide over 0.95m deep, and 1.8m long. It abutted wall (10), and was made purely of granite stone, unlike wall (10) which had tile coursing and was thinner.
